# **Overview of the Geologic Effects of the November 14, 2016, $M_w$ 7.8 Kaikoura, New Zealand, Earthquake**

By Randall W. Jibson, Kate E. Allstadt, Francis K. Rengers, and Jonathan W. Godt

Scientific Investigations Report 2017–5146

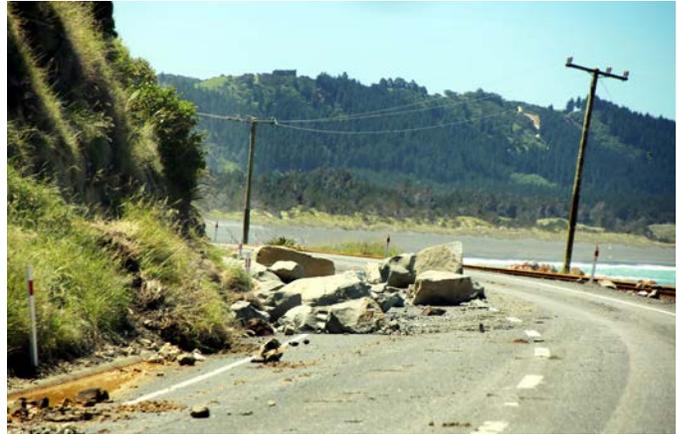
**Figure 4.** Photograph showing debris from a road cut that was shaken during the  $M_w$  5.5 aftershock of December 4, 2016, following the 2016 Kaikoura, New Zealand, earthquake. (See fig. 1B.)

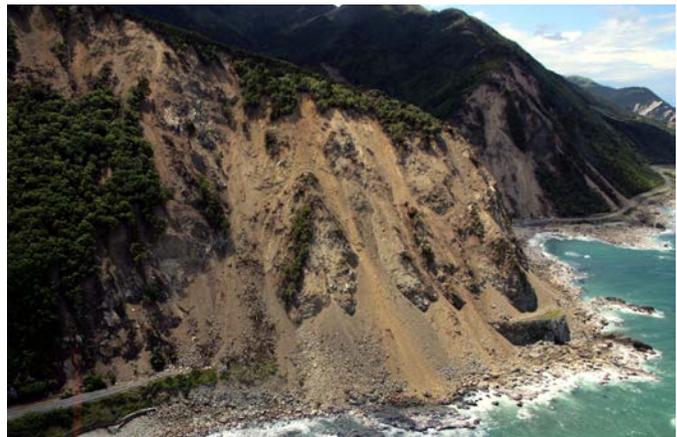
**Figure 5.** Photograph showing a small rock fall along State Highway 1 near Waipapa Bay. (See fig. 1F.)

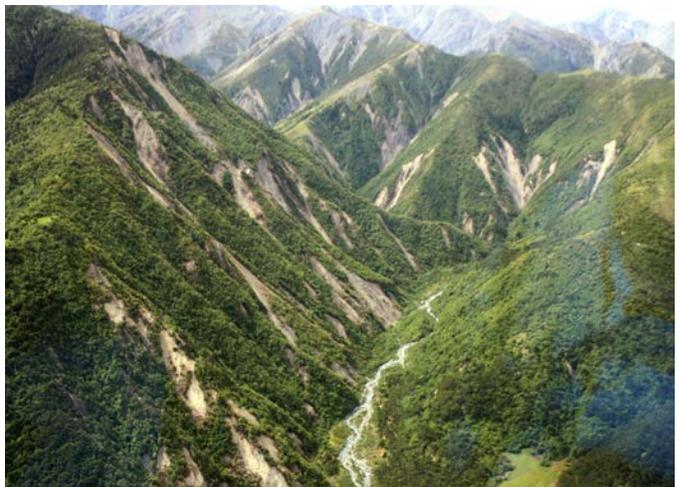
**Figure 6.** Photograph showing a debris slide along State Highway 1 about 14 kilometers southwest of Waipapa Bay. (See fig. 1B.)

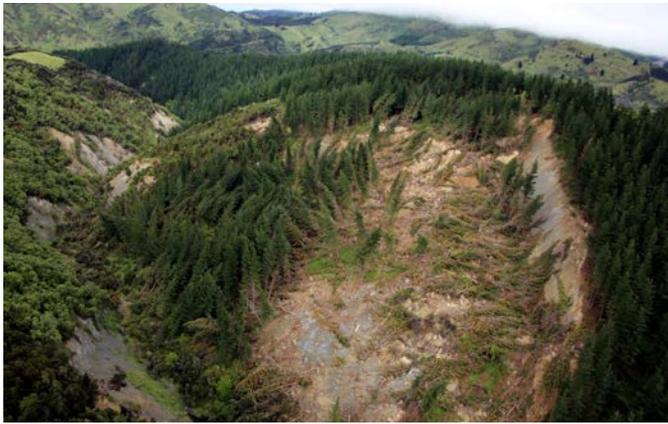
**Figure 8.** Photograph showing the Stanton Left Tributary 220 landslide. (See fig. 1H.)

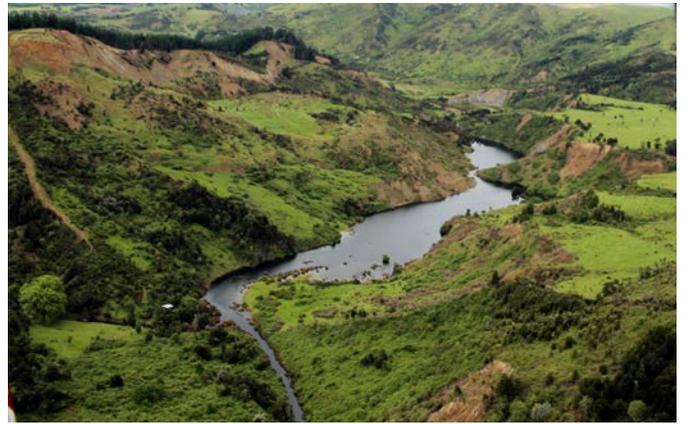
**Figure 10.** Photograph showing the Leader 220 landslide dam. (See fig. 1H.)

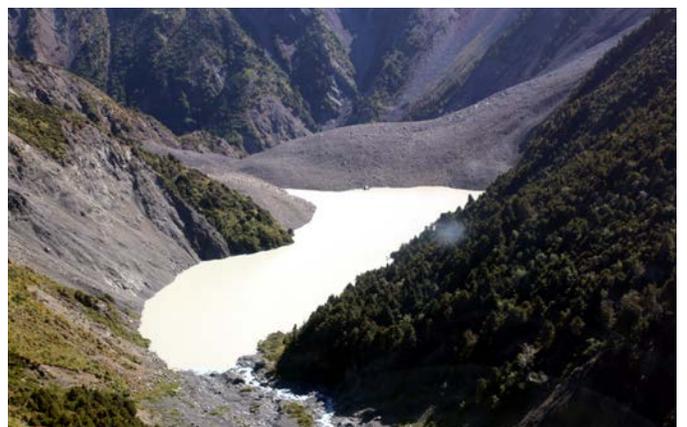
**Figure 11.** Photograph showing the Hapuku 740 landslide dam. (See fig. 1B.)

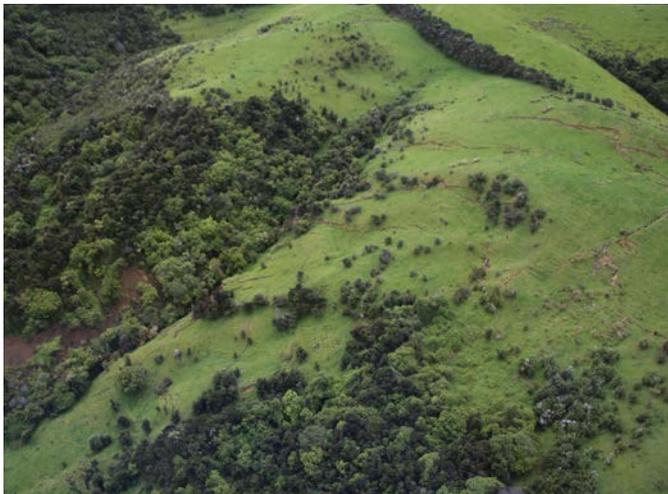
Ground cracking was widespread following the earthquake. Cracks on steep slopes appear to be gravitationally influenced and to relate to incipient landsliding (fig. 12). Likewise, cracks along the outboard edges of roads excavated into steep slopes (fig. 13) are common and probably relate to incipient sliding or slumping in fill material along the edge of the road as well as possible amplification of ground shaking at steep breaks in slope (Ashford and others, 1997). Other cracks appear unrelated to topography and probably resulted from strong ground shaking (fig. 14). Topographic noses (spur ends) at the ends of ridges experienced extensive cracking, probably related to topographic amplification of ground shaking; such concentration of cracking on the ends of ridges has been observed in previous earthquakes (Keefer and Manson, 1998; Collins and Jibson, 2015).

**Figure 12.** Photograph showing ground cracking on a hillside near Conway River. (See fig. 1H.)

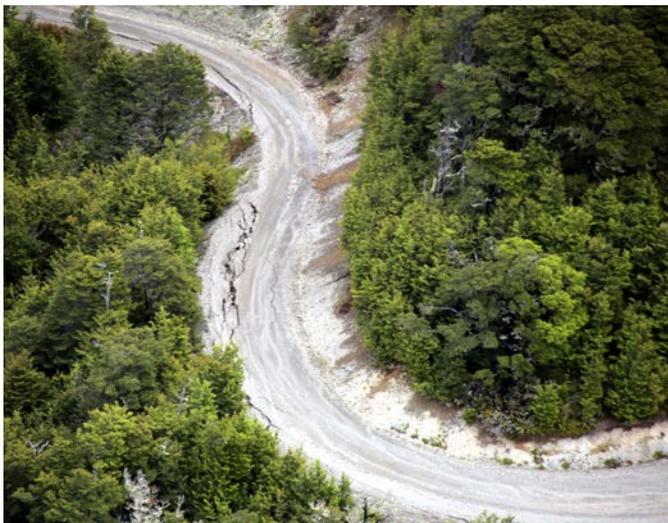
**Figure 13.** Photograph showing cracks along the outboard edge of a mountain road above Mount Lyford. (See fig. 1G.)

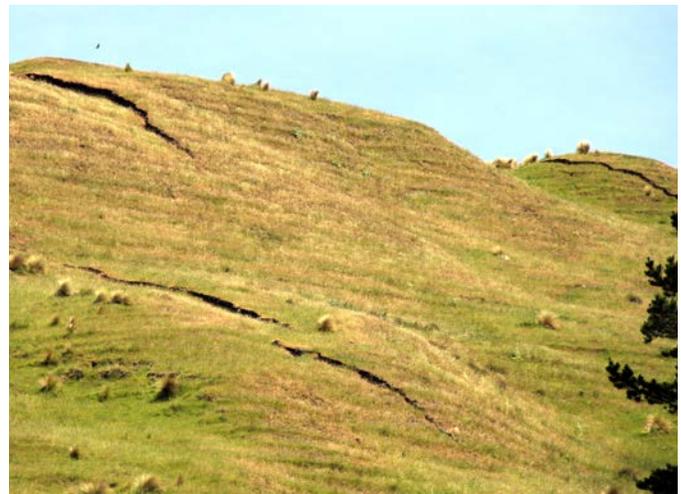
**Figure 14.** Photograph showing ground cracks unrelated to slope failure. (See fig. 1E.)

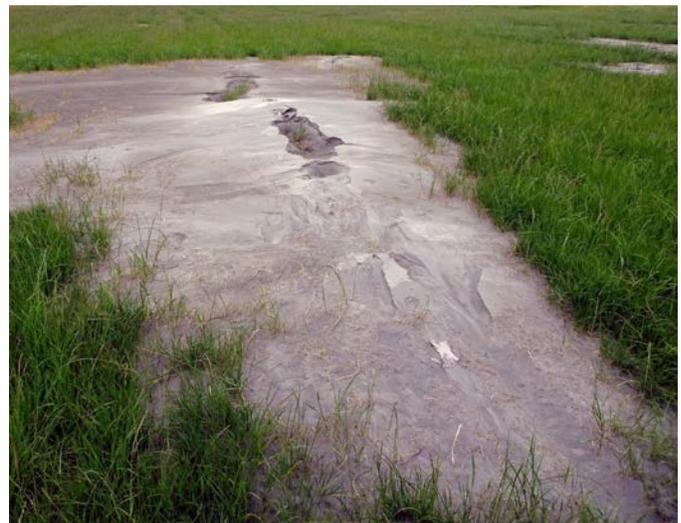
**Figure 15.** Photograph showing ejected sand near the Wairau River northeast of Blenheim. (See fig. 1B.)

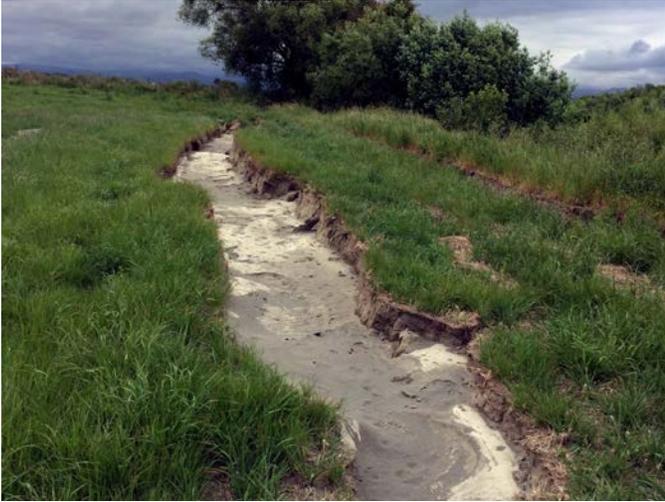
**Figure 16.** Photograph showing lateral spread along the Wairau River northeast of Blenheim. (See fig. 1B.)

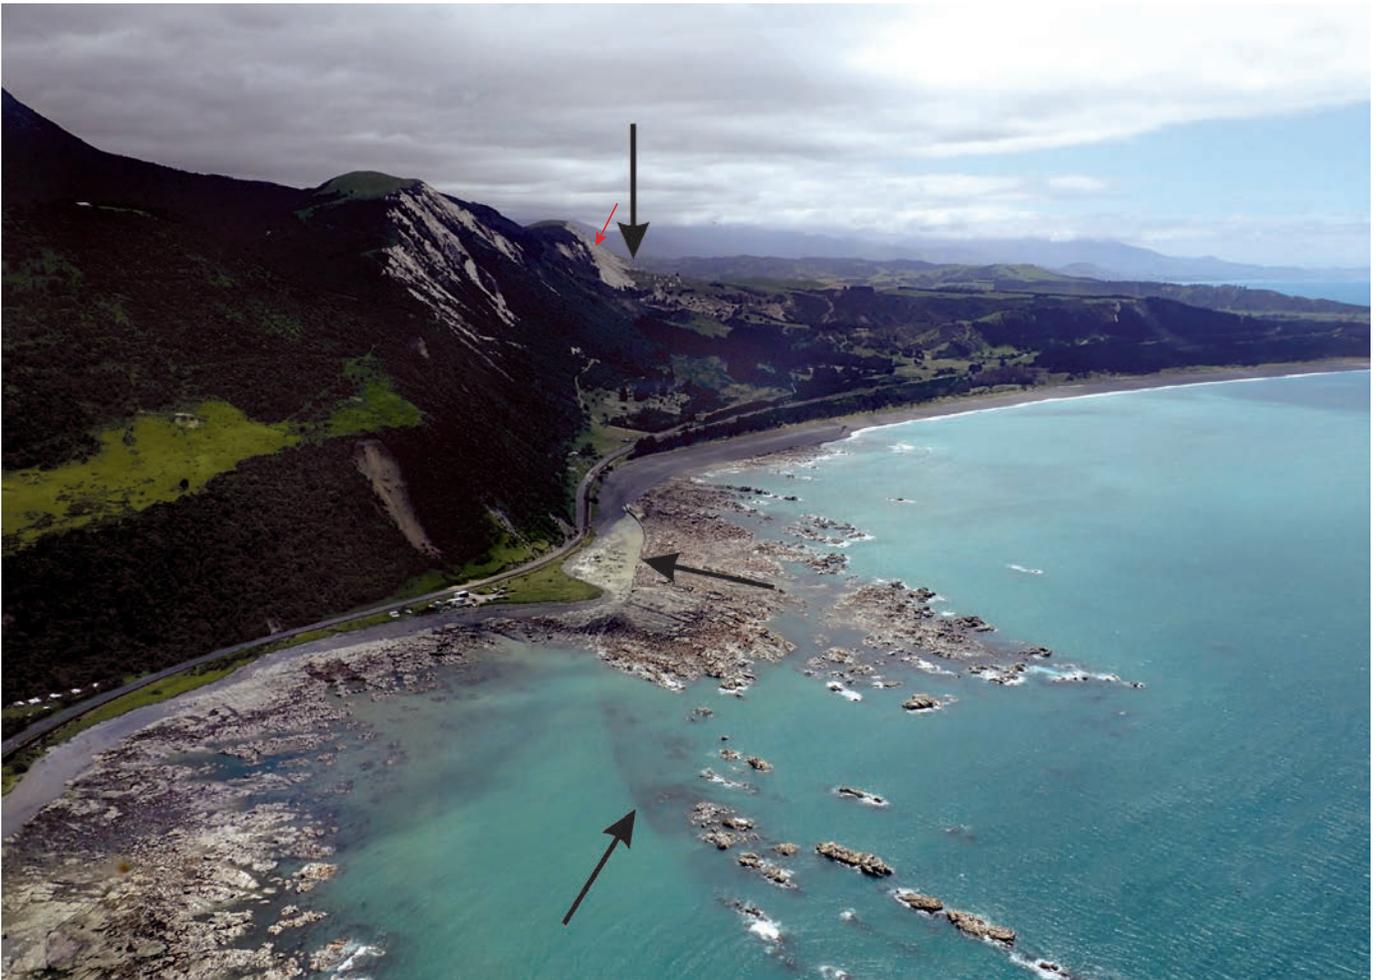
**Figure 17.** Photograph showing surface fault rupture along the Papatea fault (indicated by black arrows) extending through the source area of the Sea Front landslide (indicated by red arrow). (See fig. 1F.)

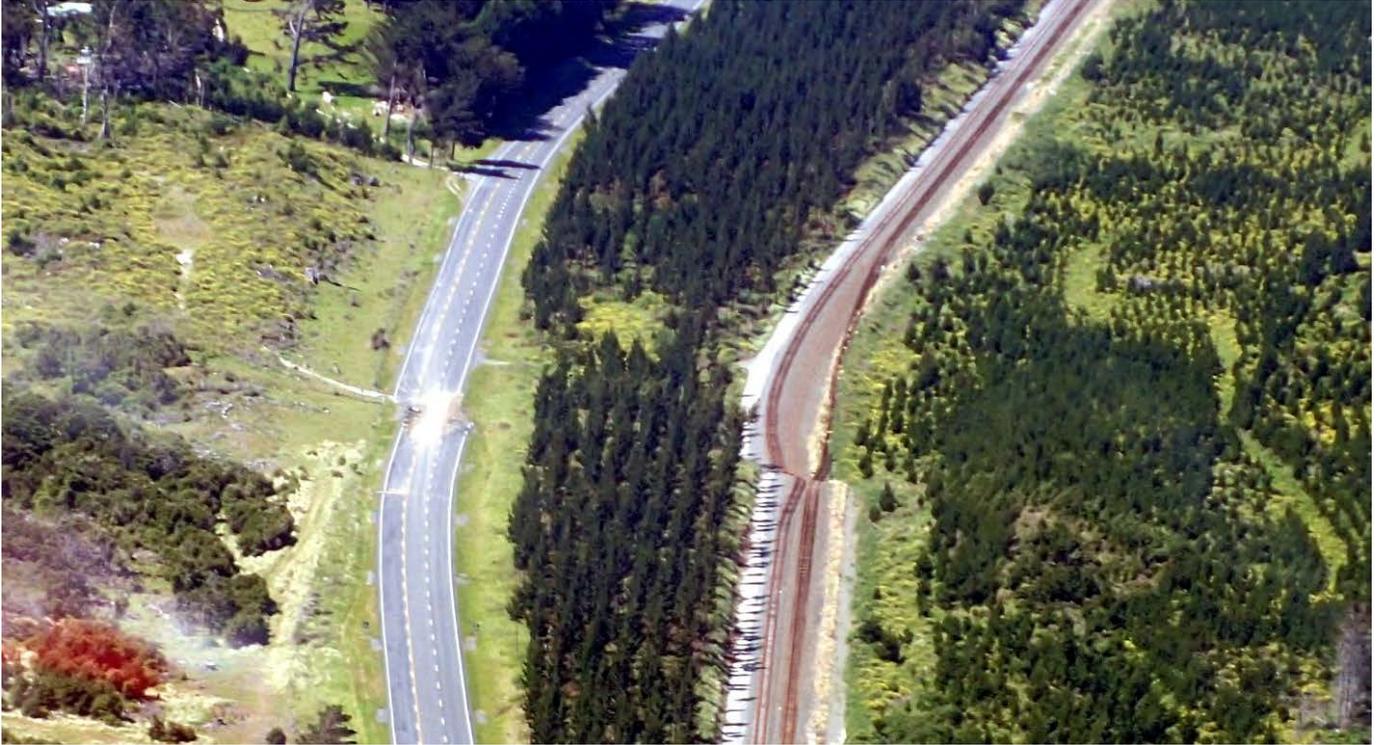
**Figure 18.** Photograph showing the Papatea fault offsetting State Highway 1 and South Island Main Trunk rail line near Waipapa Bay, aerial view. (See fig. 1F.)

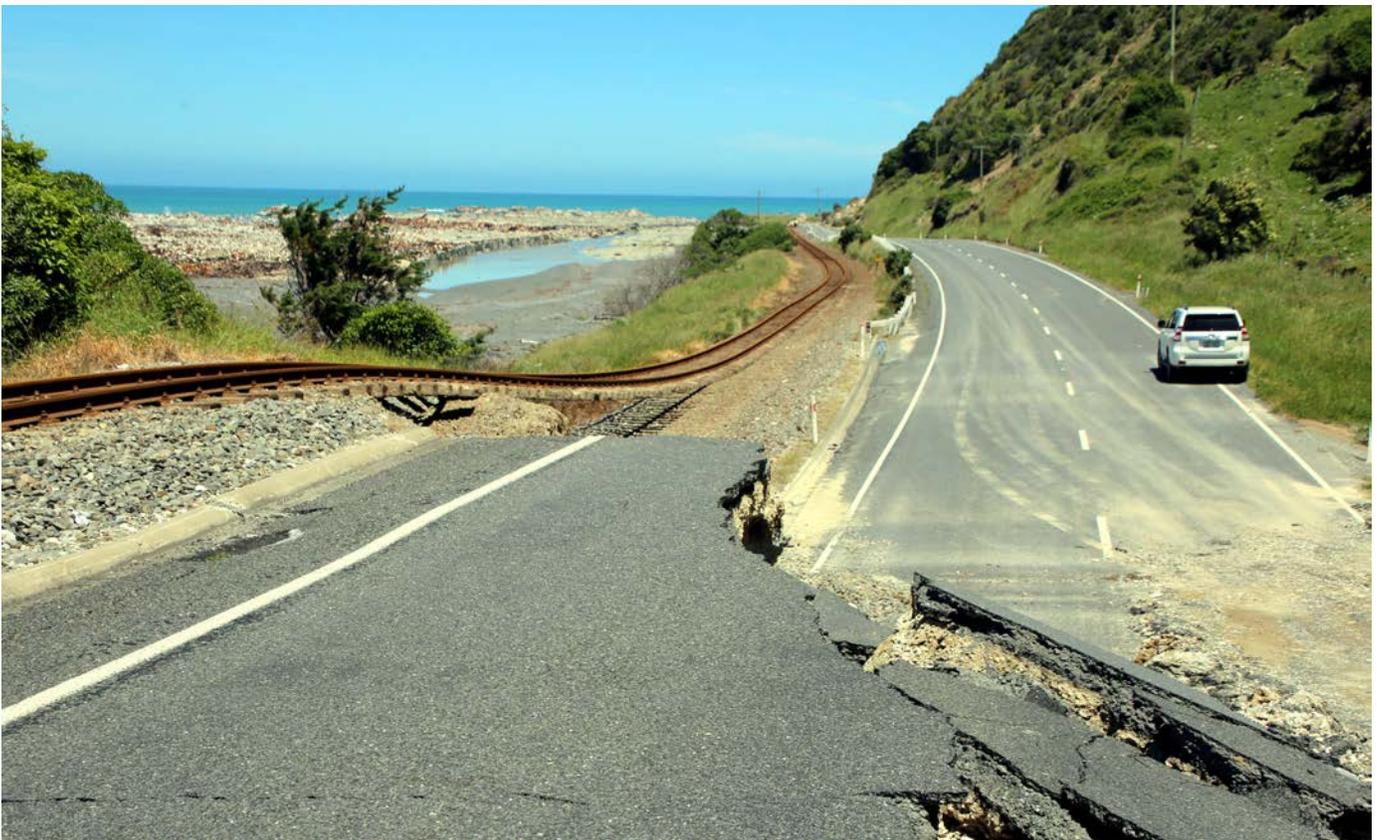
**Figure 19.** Photograph showing the Papatea fault offsetting State Highway 1 and South Island Main Trunk rail line near Waipapa Bay, ground view. (See fig. 1F.)

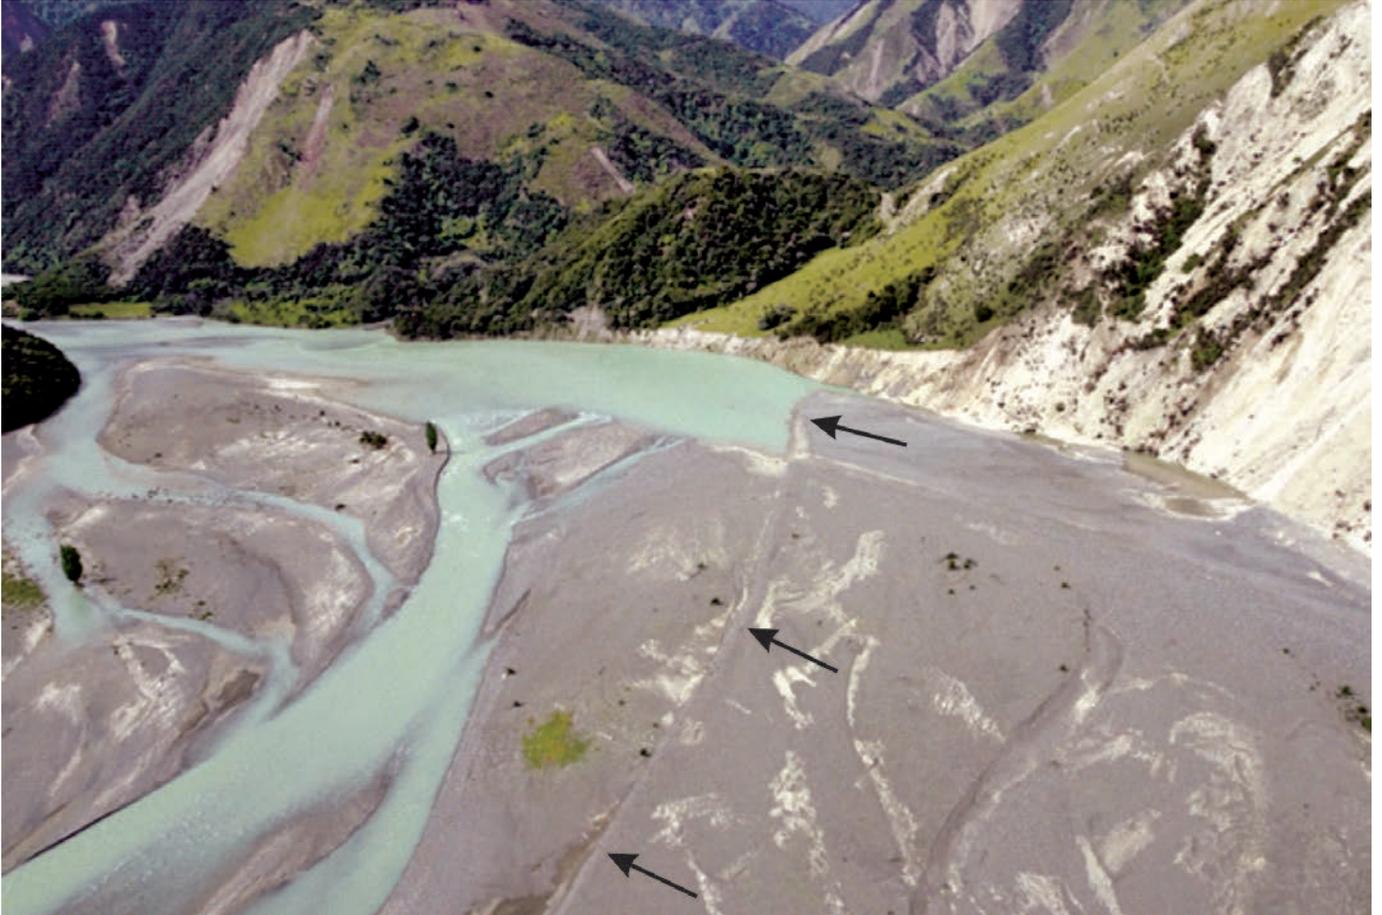
**Figure 20.** Photograph showing the Kekerengu fault extending through alluvium in the Clarence River channel. (See fig. 1E.)

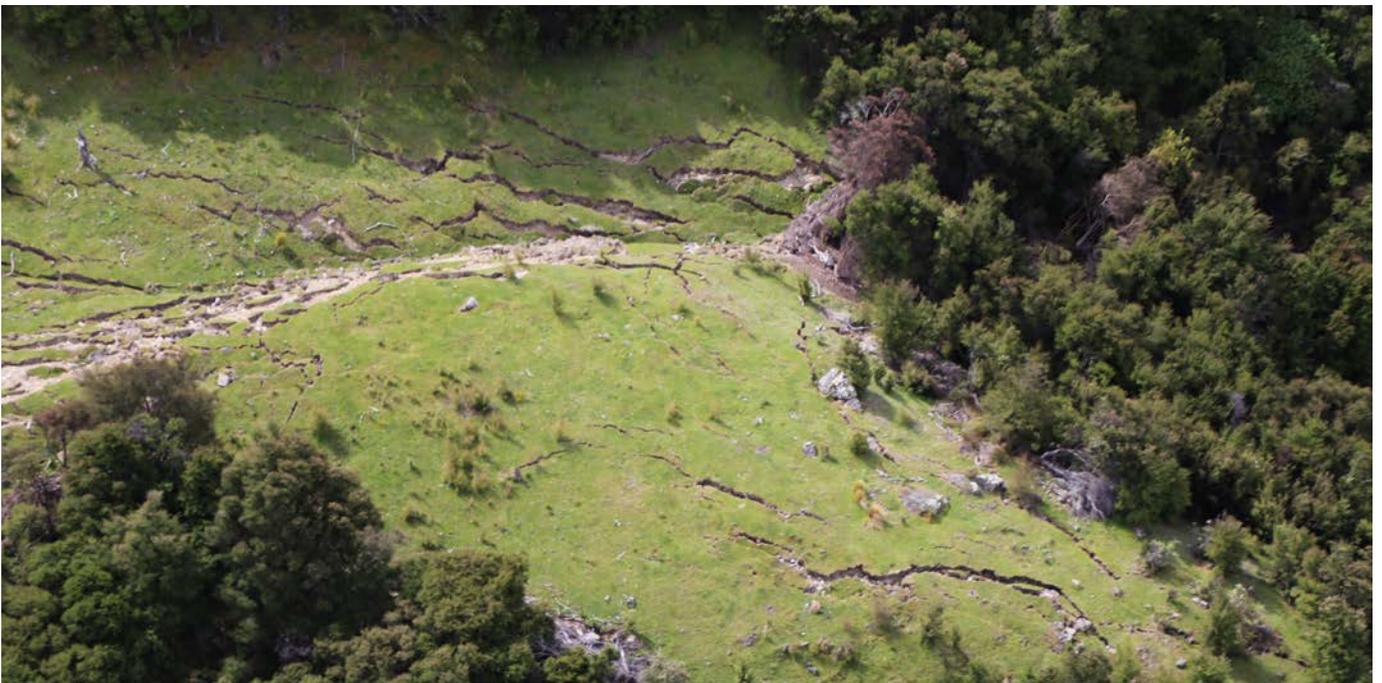
**Figure 21.** Photograph showing ground cracks along the trace of the Kekerengu fault about 10 kilometers northwest of Waipapa Bay. (See fig. 1D.)

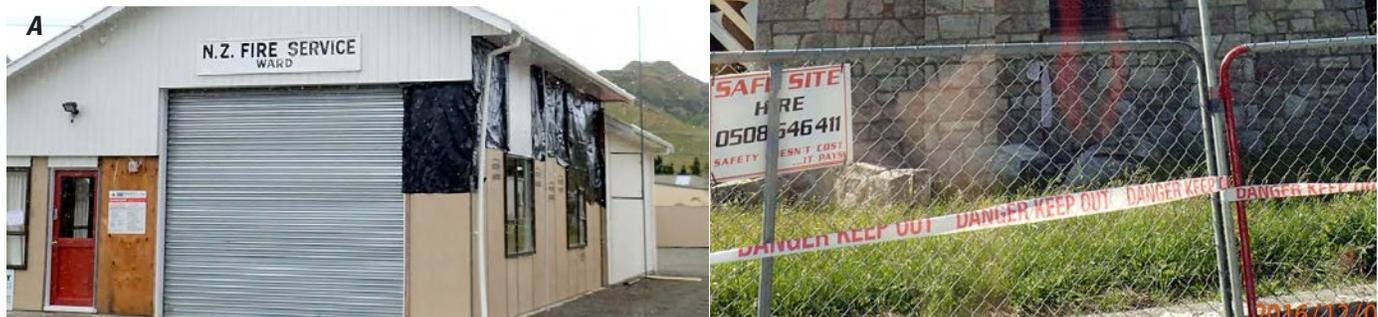
**Figure 22.** Photographs of ground-shaking damage to structures. *A*, Damaged exterior walls at Ward Fire Station. (See fig. 1E.) *B*, Stone tower toppled from Saint Oswald's Church about 13 kilometers south of Ward along State Highway 1. (See fig. 1E.)

About 13 km south of Ward along State Highway 1, we saw structural damage to St. Oswald’s Church (see fig. 22B).

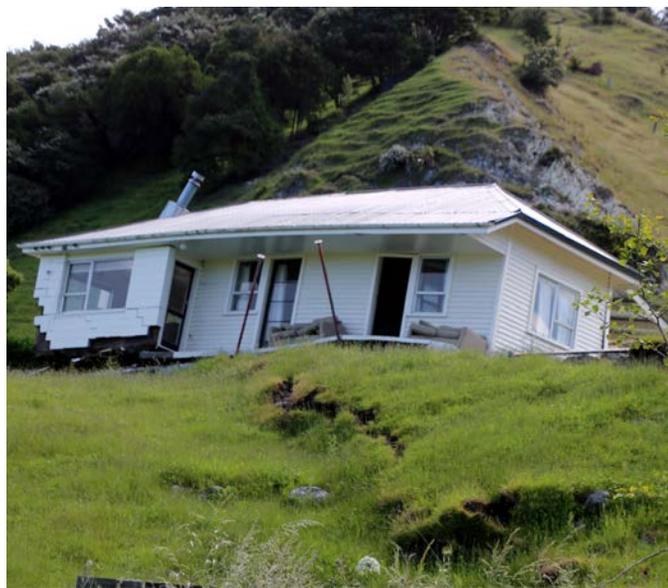
**Figure 23.** Photograph showing a house damaged by displacement on the Kekerengu fault about 20 kilometers north-northeast of Waipapa Bay. (See fig. 1E.)

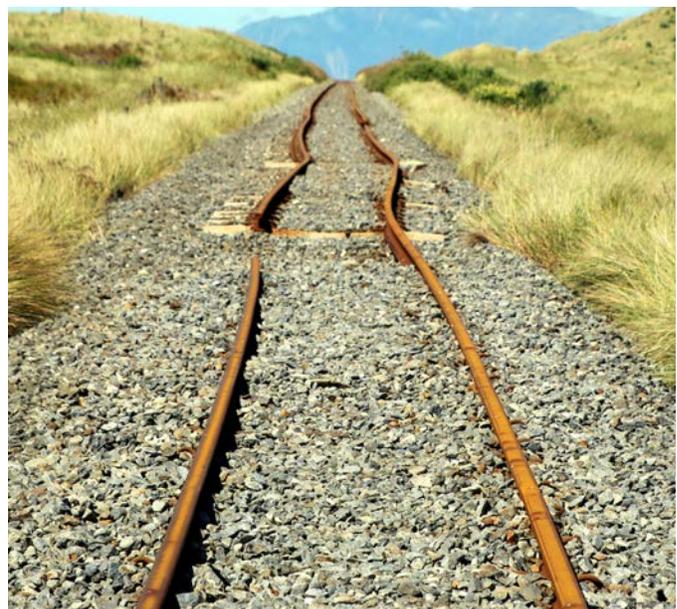
**Figure 24.** Photograph showing railroad tracks disrupted by ground deformation 16 kilometers southwest of Ward. (See fig. 1E.)

Even in areas not directly affected by surface fault offset, rail lines were displaced and rendered unusable by the effects of strong ground shaking, fill settlement, and crustal deformation (folding and subsidence) (fig. 24). Several river bridges were damaged or destroyed by strong ground shaking and fault offset (fig. 25).

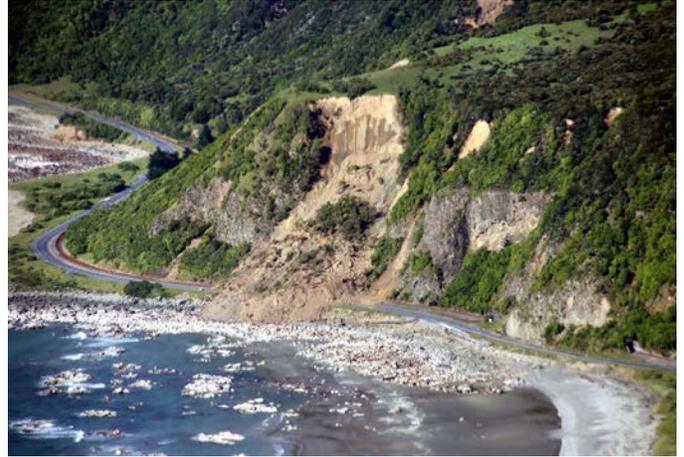
**Figure 27.** Photograph showing State Highway 1 and the South Island Main Trunk rail line blocked by landslides about 7 kilometers southwest of Waipapa Bay. (See fig. 1F.)

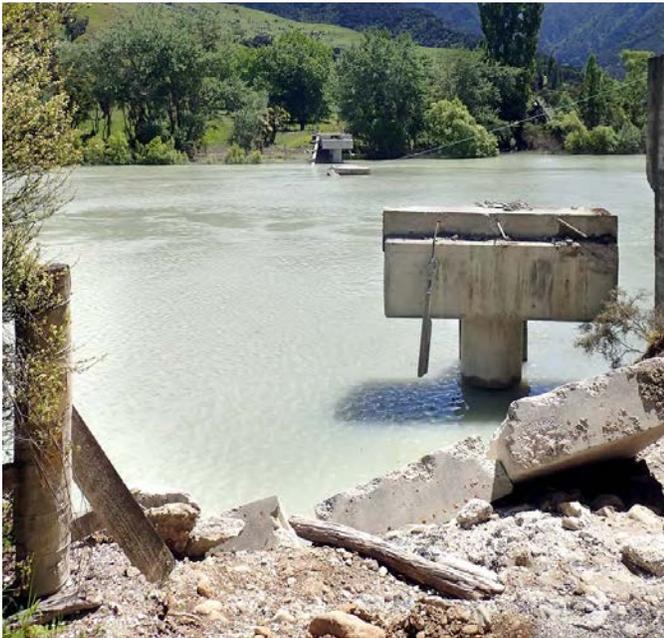
**Figure 25.** Photograph showing a destroyed bridge over the Clarence River. (See fig. 1D.)

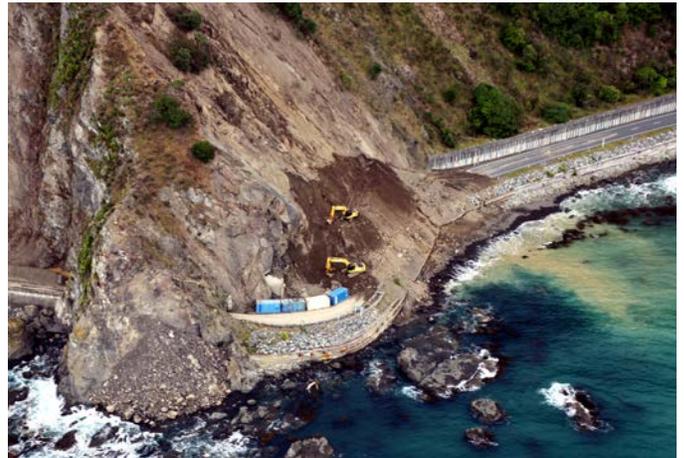
**Figure 28.** Photograph showing a landslide blocking State Highway 1 and a tunnel portal west of Kaikoura. (See fig. 1B.)

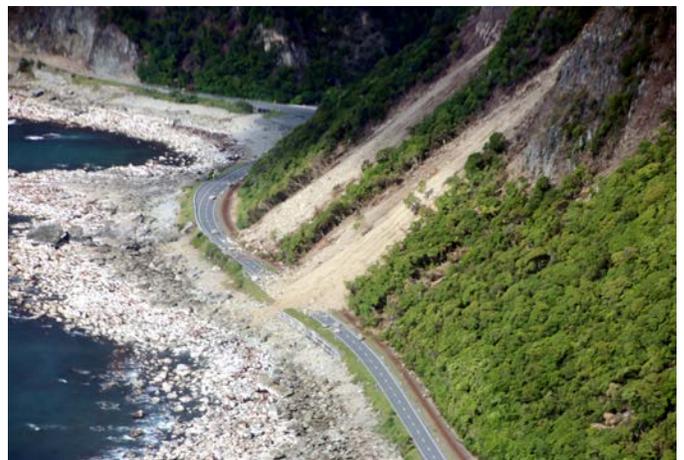
**Figure 29.** Photograph showing the South Island Main Trunk rail line along State Highway 1 blocked by landslides about 7 kilometers southwest of Waipapa Bay. (See fig. 1F.)

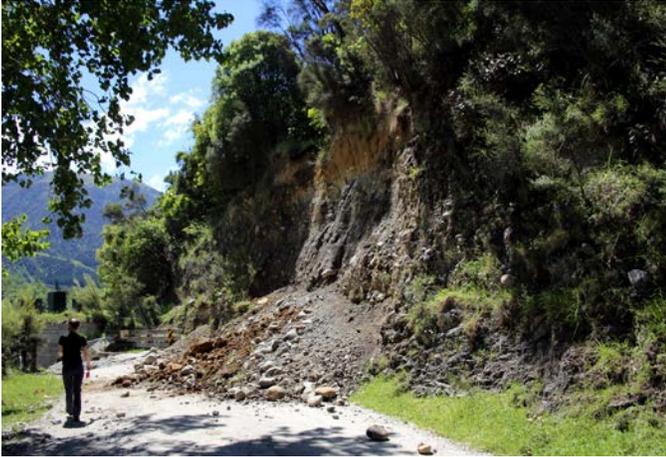
**Figure 30.** Photograph showing a landslide blocking a minor road along the Clarence River. (See fig. 1D.)

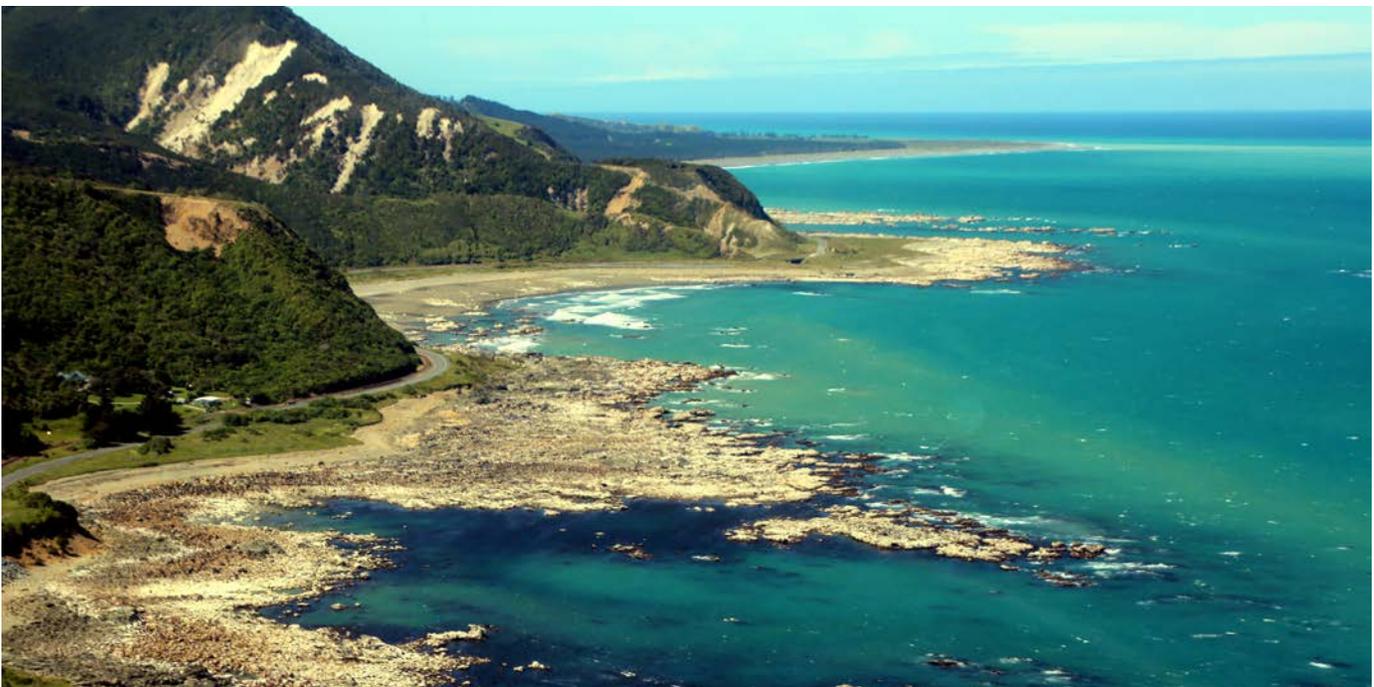
**Figure 31.** Photograph showing uplifted marine platforms about 10 kilometers southwest of Waipapa Bay. (See fig. 1B.)

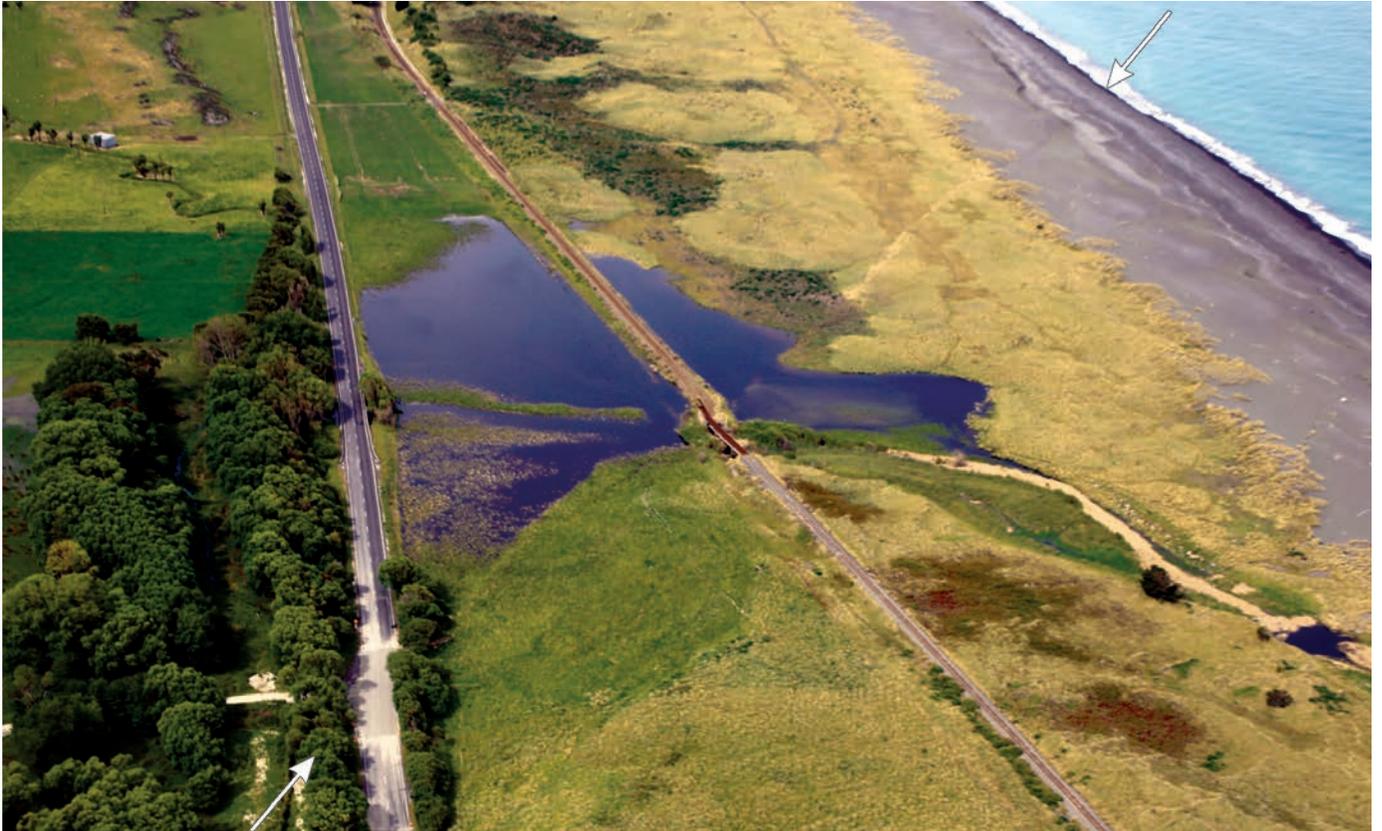
**Figure 32.** Photograph showing ponding in a subsided area astride the Kekerengu fault (indicated by white arrows) 15 kilometers southwest of Ward. (See fig. 1E.)

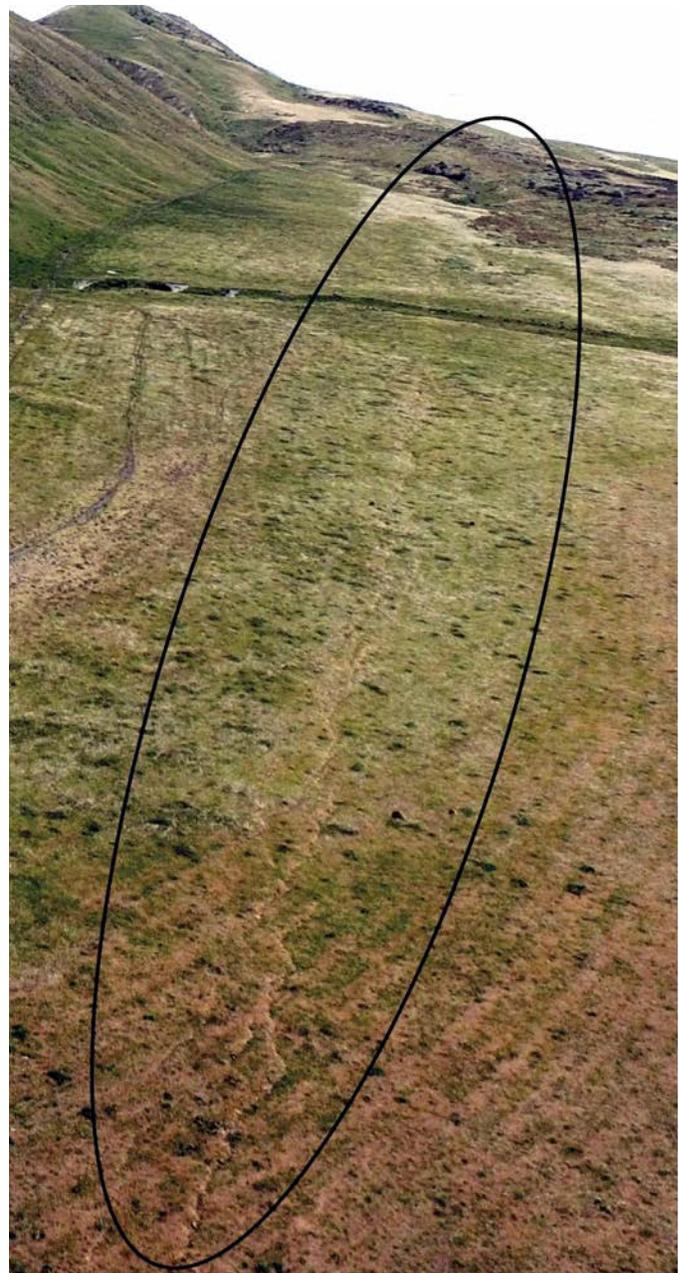
**Figure 36.** Photograph showing surface fault rupture on Cape Campbell. (See fig. 1C.)

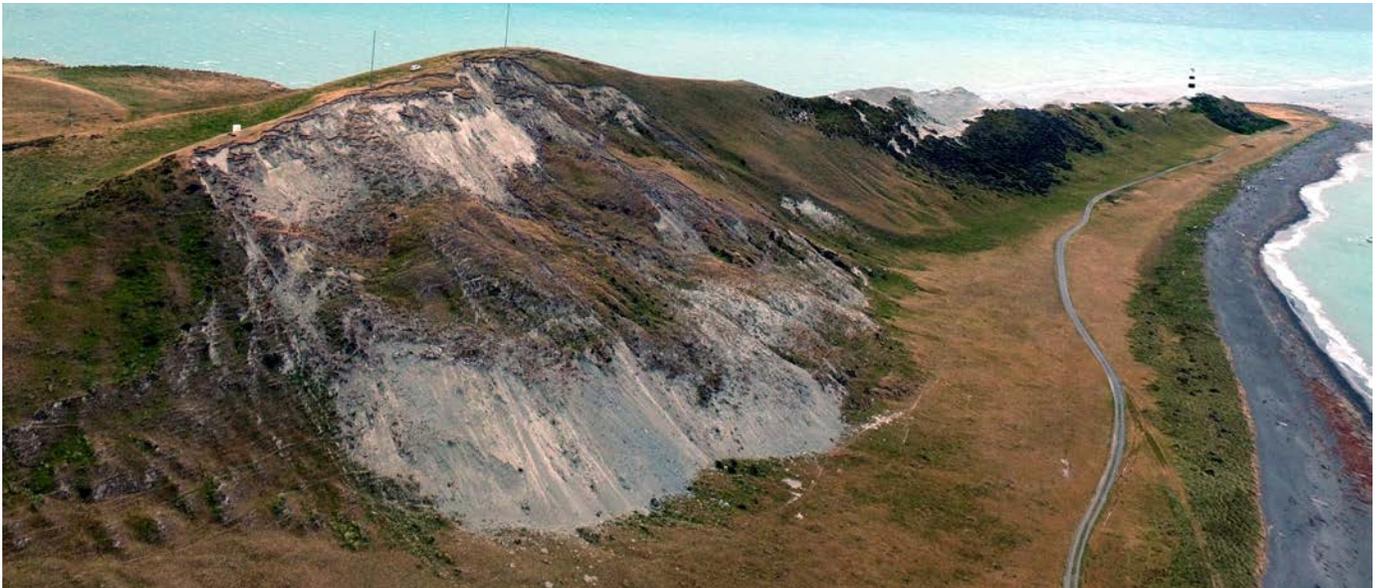
**Figure 37.** Photograph showing a preexisting landslide on Cape Campbell that was reactivated and significantly enlarged during the earthquake. (See fig. 1C.)

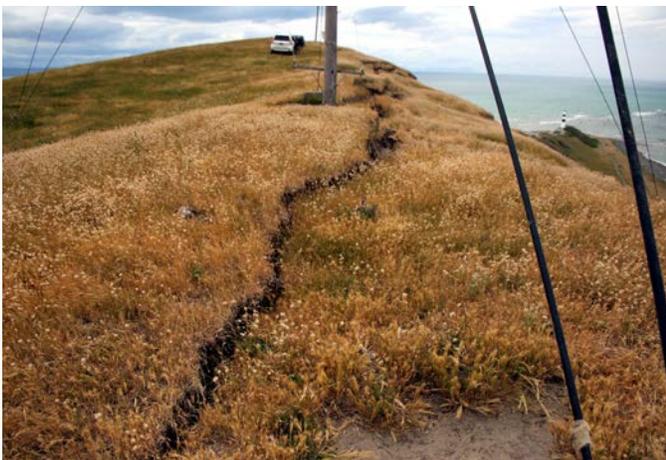
**Figure 38.** Photograph showing a fresh crack on crest of hillside above Cape Campbell landslide. (See figs. 1C and 37.)

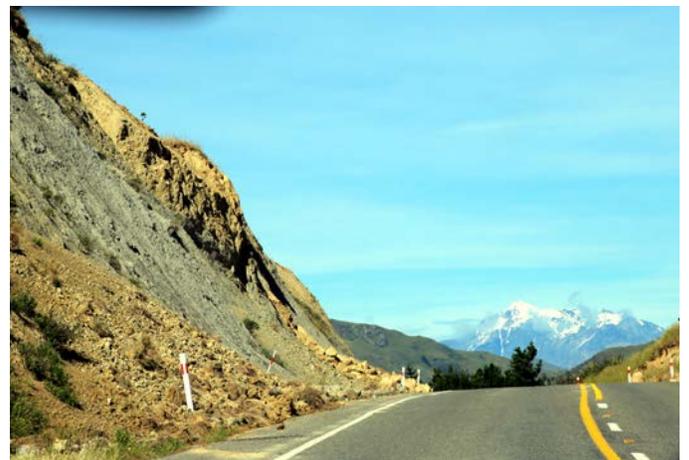
**Figure 40.** Photograph showing landslides from roadcuts between Blenheim and Ward. (See fig. 1E.)

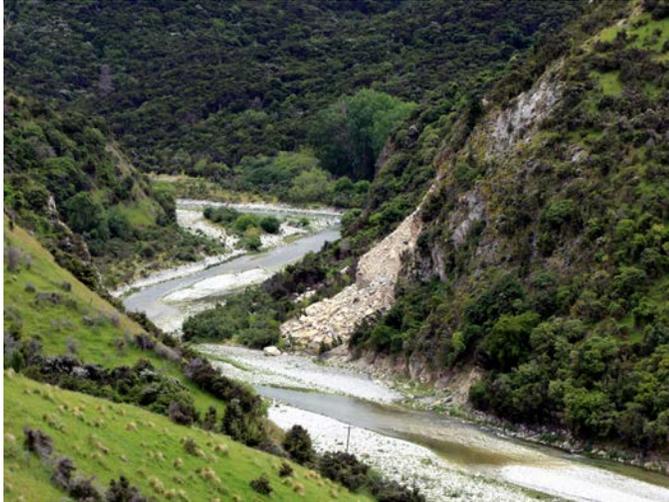
**Figure 42.** Photograph showing fresh landslide on the end of a ridge directly entering the Ure River near Sawcut Gorge. (See fig. 1E.)

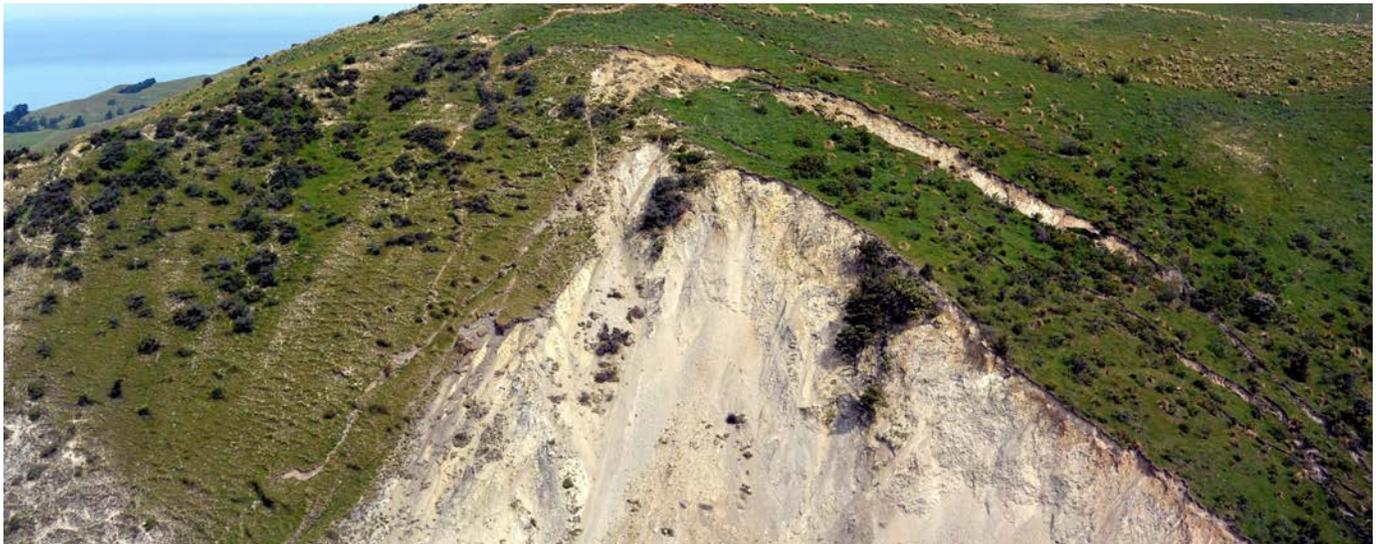
**Figure 43.** Photograph showing hillside cracks that indicate incipient landslide movement above the shallow failure triggered by the earthquake in the Seaward Kaikoura Range. (See fig. 1E.)

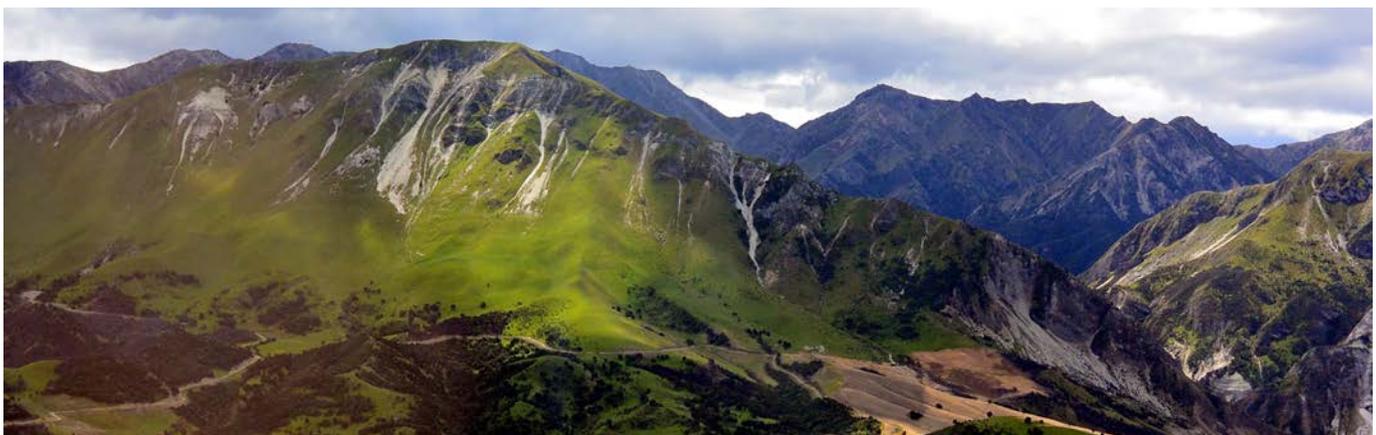
**Figure 44.** Photograph showing debris slides triggered by the earthquake in the Seaward Kaikoura Range. (See fig. 1E.)

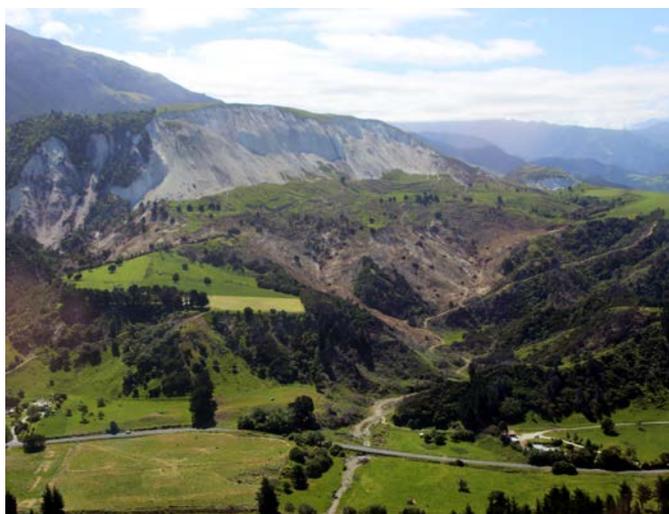
**Figure 45.** Photograph showing the Sea Front landslide near Waipapa Bay. (See fig. 1D.)

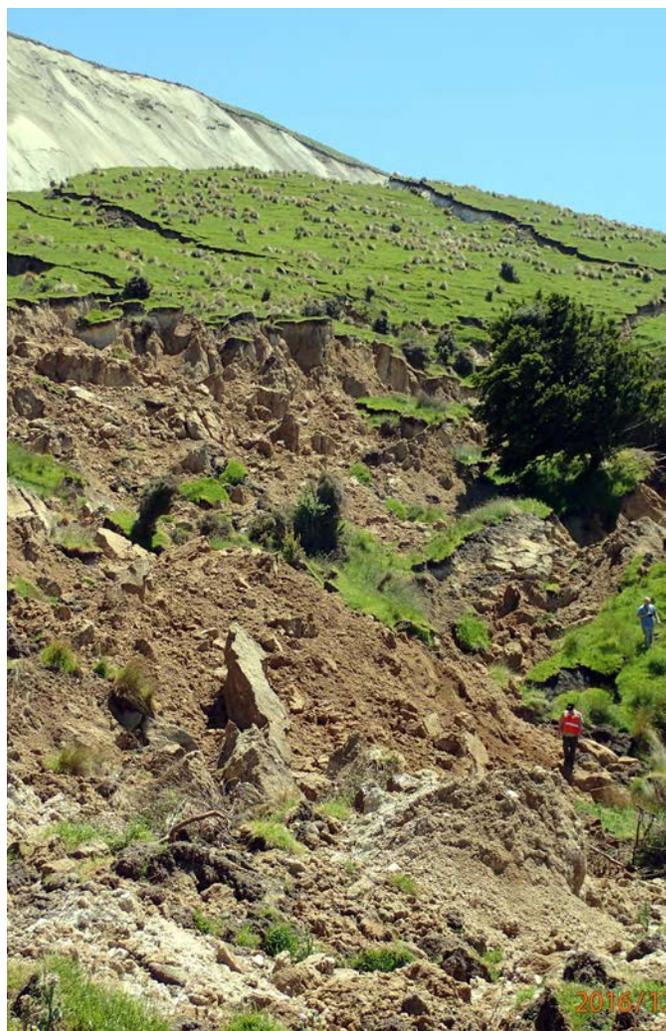
**Figure 47.** Photograph showing the central part of the Sea Front landslide. (See fig. 1D.)

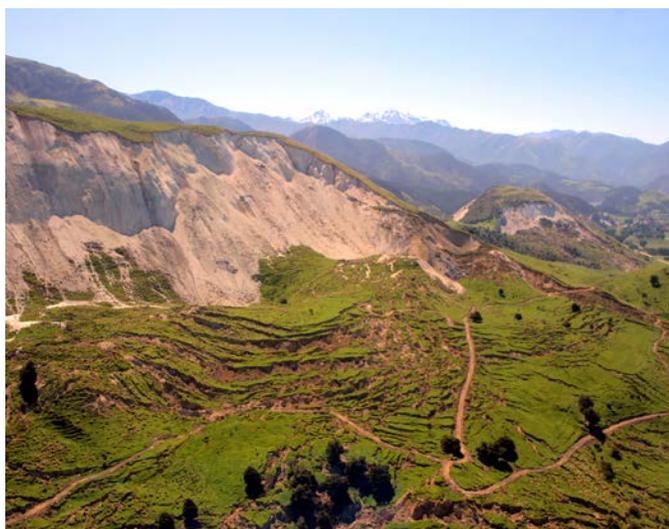
**Figure 46.** Photograph showing the main scarp and upper part of the Sea Front landslide. (See fig. 1D.)

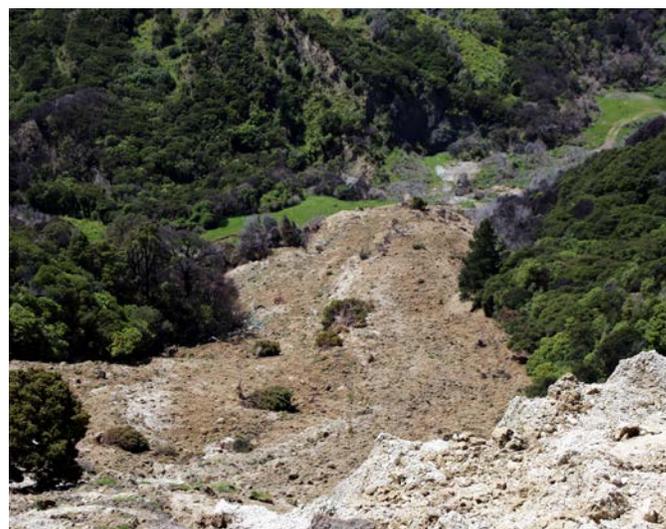
**Figure 48.** Photograph showing the toe of the Sea Front landslide that transformed into an earth flow. (See fig. 1D.)

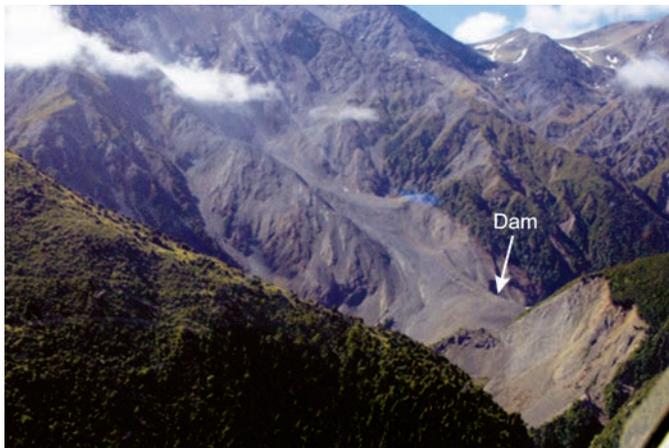
**Figure 49.** Photograph showing the Hapuku 740 rock avalanche and dam. (See fig. 1B.)

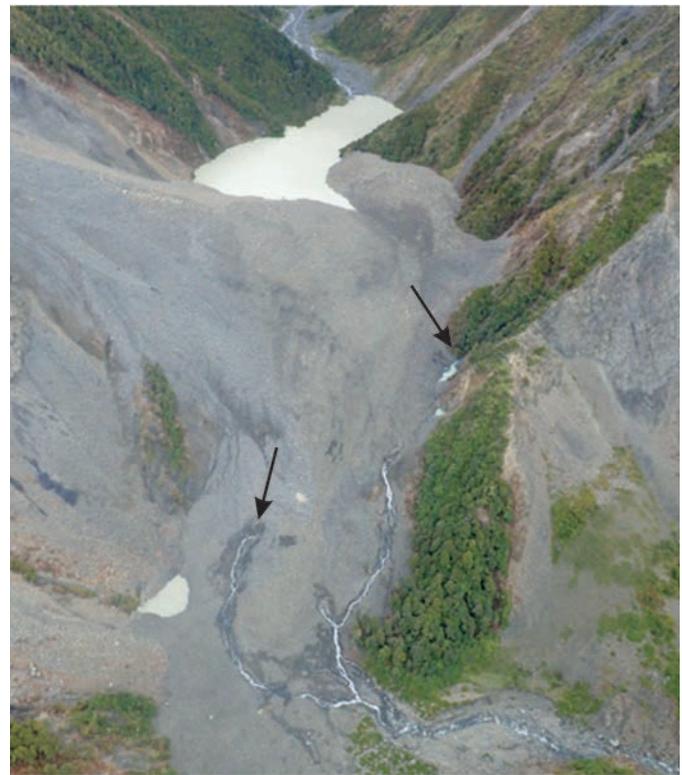
**Figure 50.** Photograph showing the downstream face of the Hapuku 740 landslide dam. Arrows indicate locations of seeps. (See fig. 1B.)

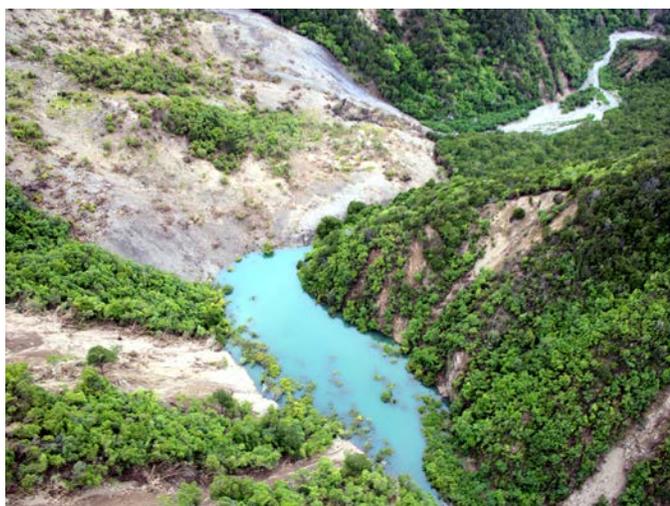
**Figure 51.** Photograph showing the Linton 340 landslide dam. (See fig. 1B.)
