# **Overview of the Geologic Effects of the November 14, 2016, $M_w$ 7.8 Kaikoura, New Zealand, Earthquake**

By Randall W. Jibson, Kate E. Allstadt, Francis K. Rengers, and Jonathan W. Godt

Scientific Investigations Report 2017–5146

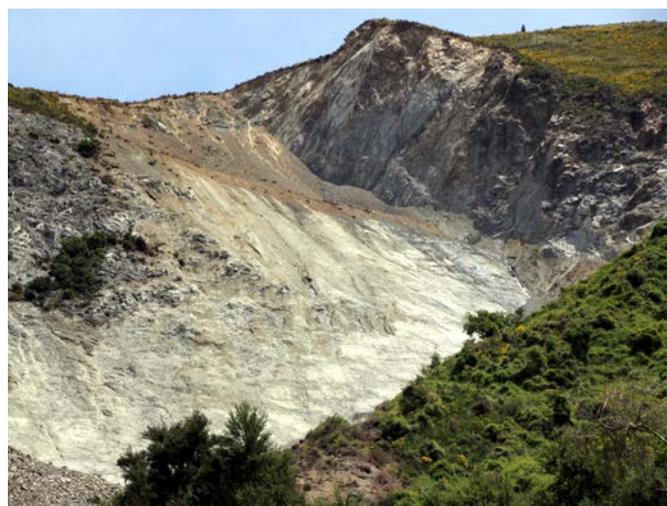
**Figure 53.** Photograph showing the planar failure surface of the Conway 420 landslide. (See fig. 1G.)

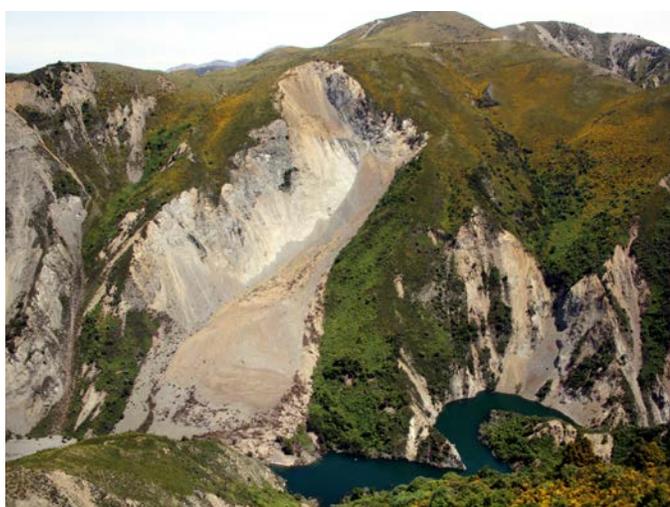
**Figure 52.** Photograph showing the Conway 420 landslide dam. (See fig. 1G.)

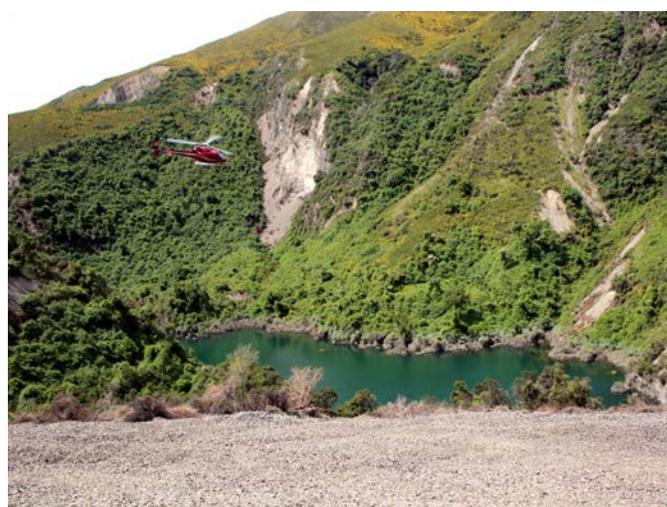
**Figure 54.** Photograph showing the lake impounded by the Conway 420 landslide dam. (See fig. 1G.)

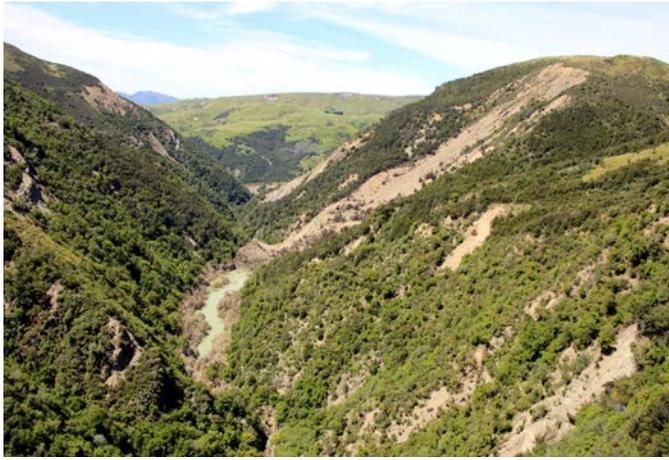
**Figure 55.** Photograph showing the Towy 500 landslide dam and the remaining impounded lake. (See fig. 1G.)

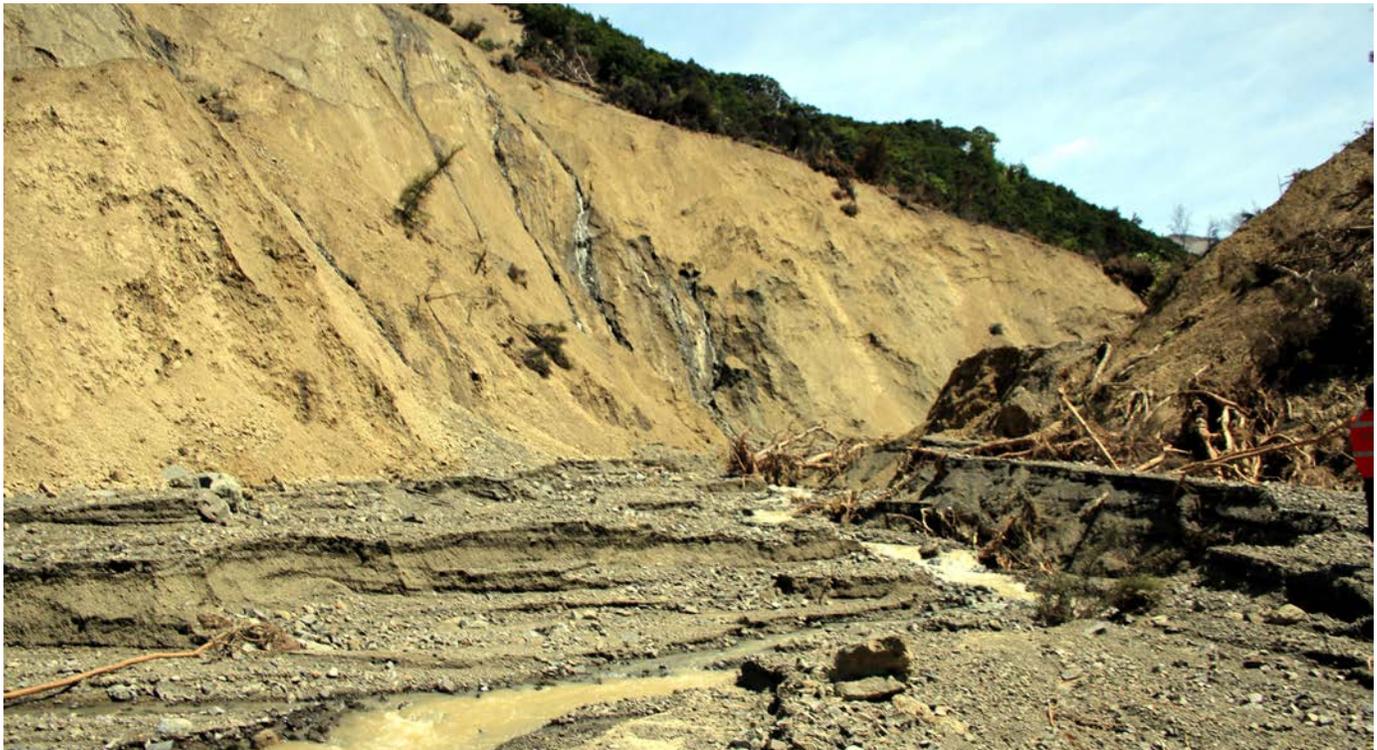
**Figure 56.** Photograph showing the area where the Towy 500 landslide dam breached. (See fig. 1G.)

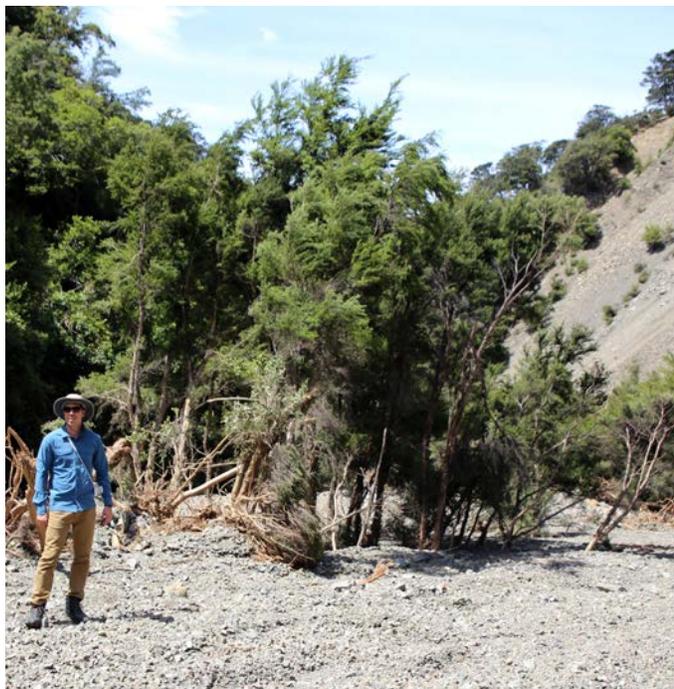
**Figure 57.** Photograph showing deposits of the eroded Towy 500 landslide dam burying trees near original river channel. (See fig. 1G.)

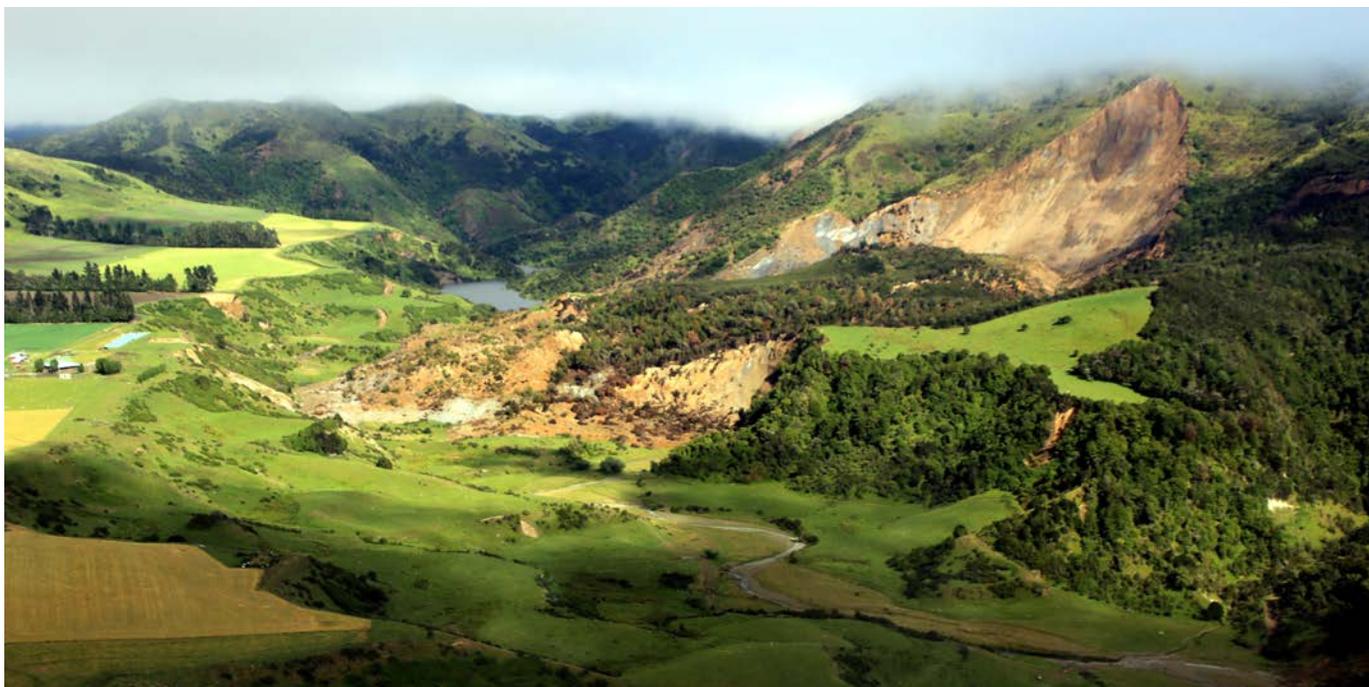
**Figure 58.** Photograph showing the Leader 220 landslide dam. (See fig. 1H.)

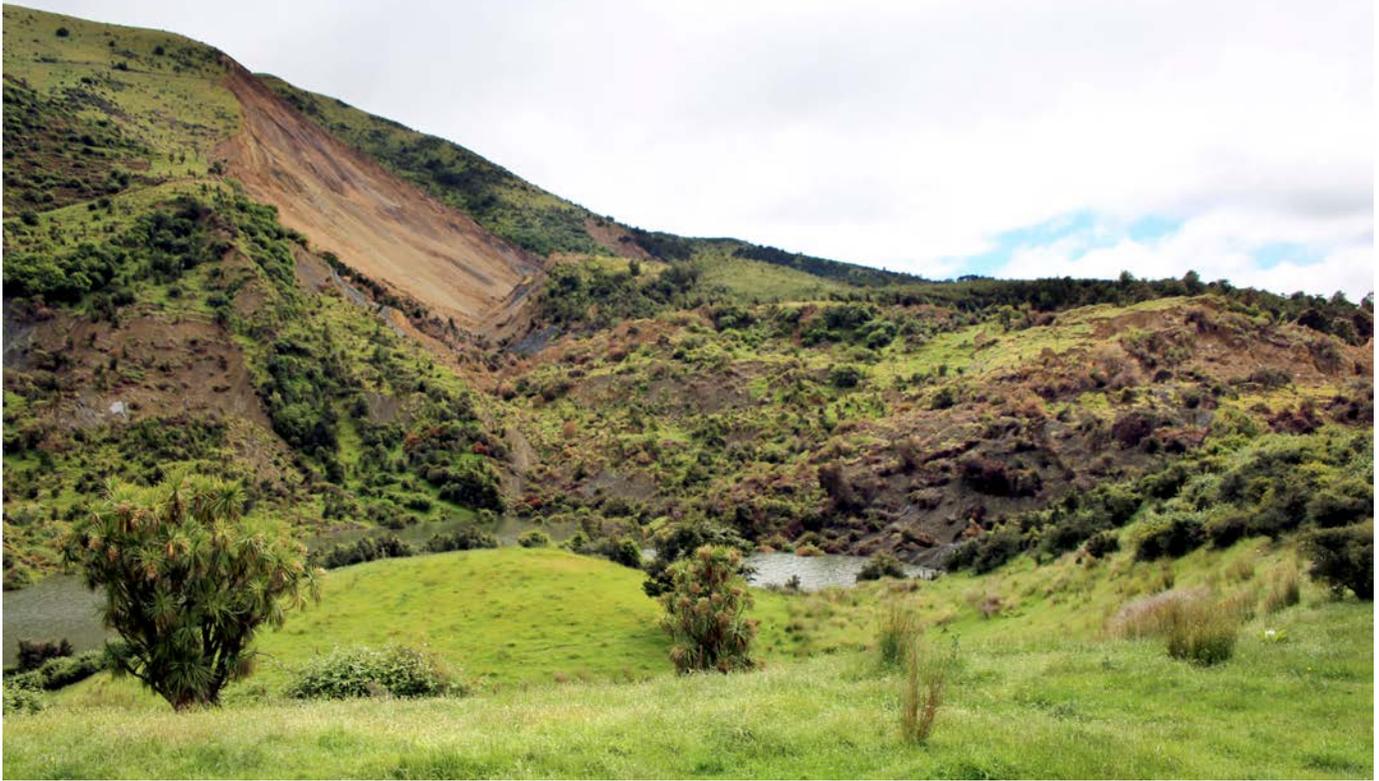
**Figure 59.** Photograph showing the main scarp and head of the Leader 220 landslide. (See fig. 1H.)

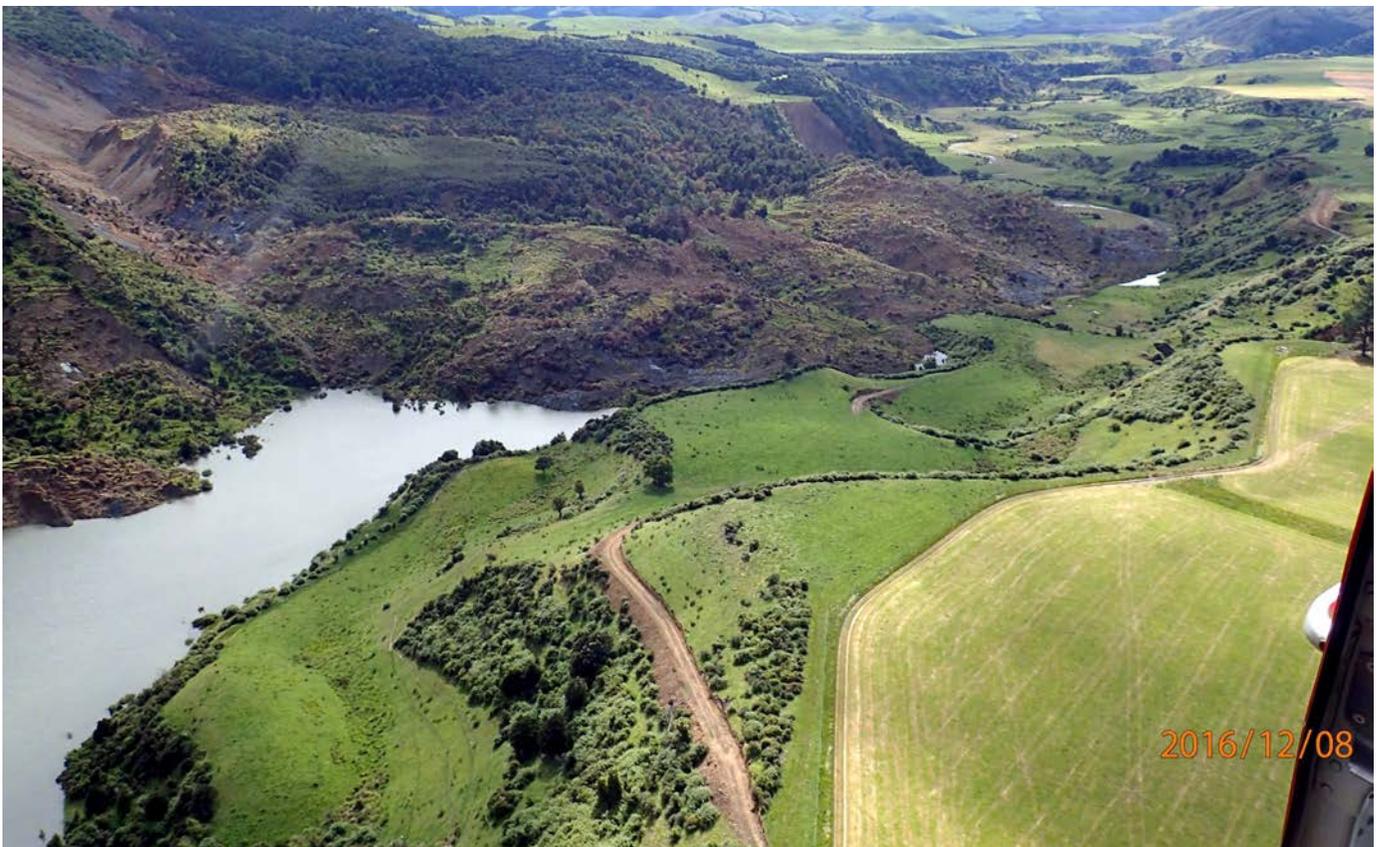
**Figure 60.** Photograph showing the lake impounded by the Leader 220 landslide dam. (See fig. 1H.)

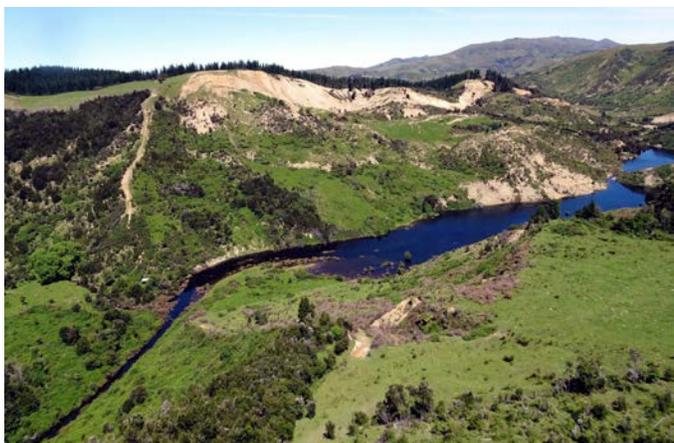
**Figure 61.** Photograph showing the Stanton 200 landslide dam and impounded lake. (See fig. 1H.)

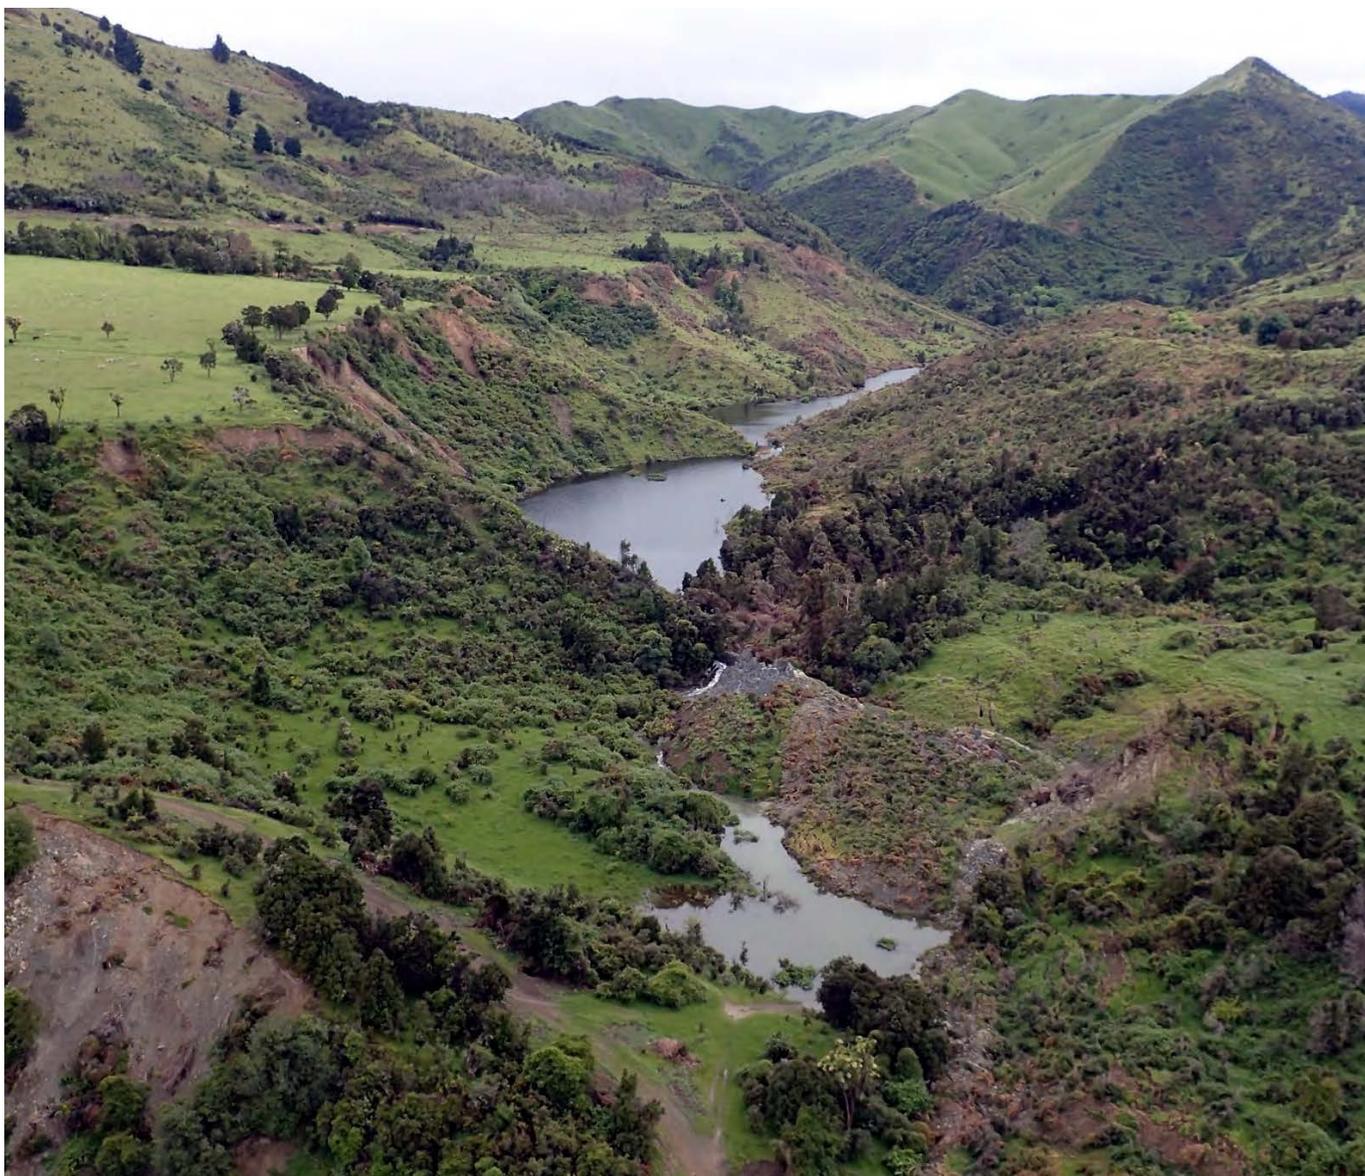
**Figure 62.** Photograph showing water flow over the Stanton 200 landslide dam and ponding below the dam. (See fig. 1H.)

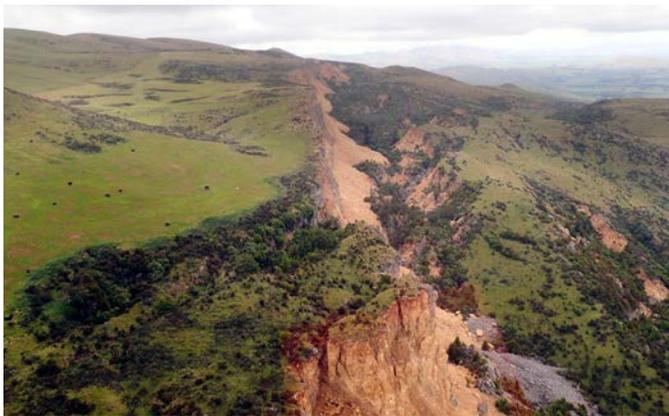
**Figure 63.** Photograph showing the main scarp of the Mason 360 (Battery) landslide. (See fig. 1H.)

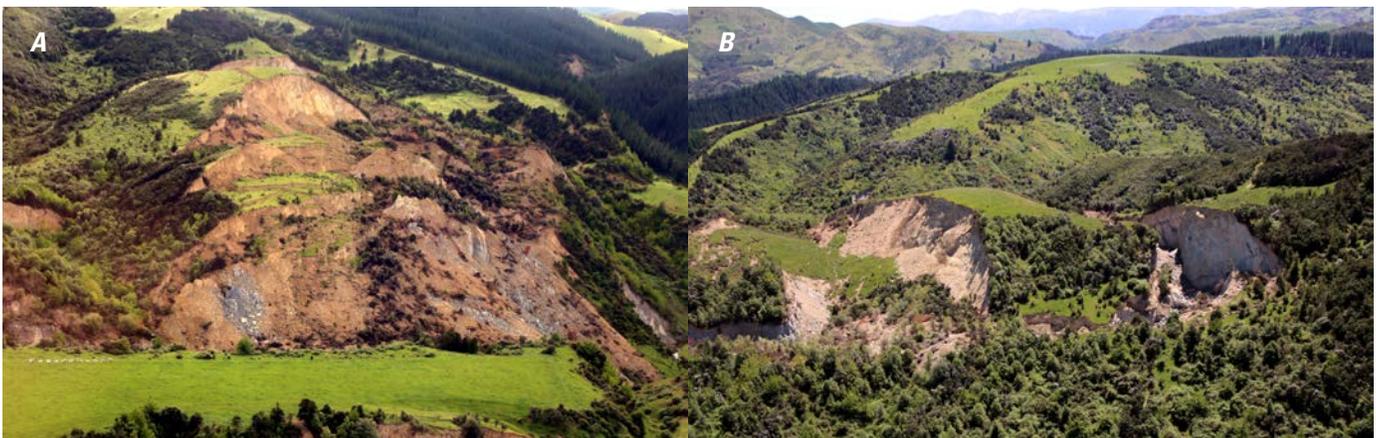
**Figure 64.** Photographs showing the Stanton East Tributary 170 landslide. *A*, Main body of the landslide consisting of several large, fairly coherent blocks. *B*, Nearly vertical main scarp and upper landslide blocks; landslide moved from right to left in photograph. (See fig. 1H.)

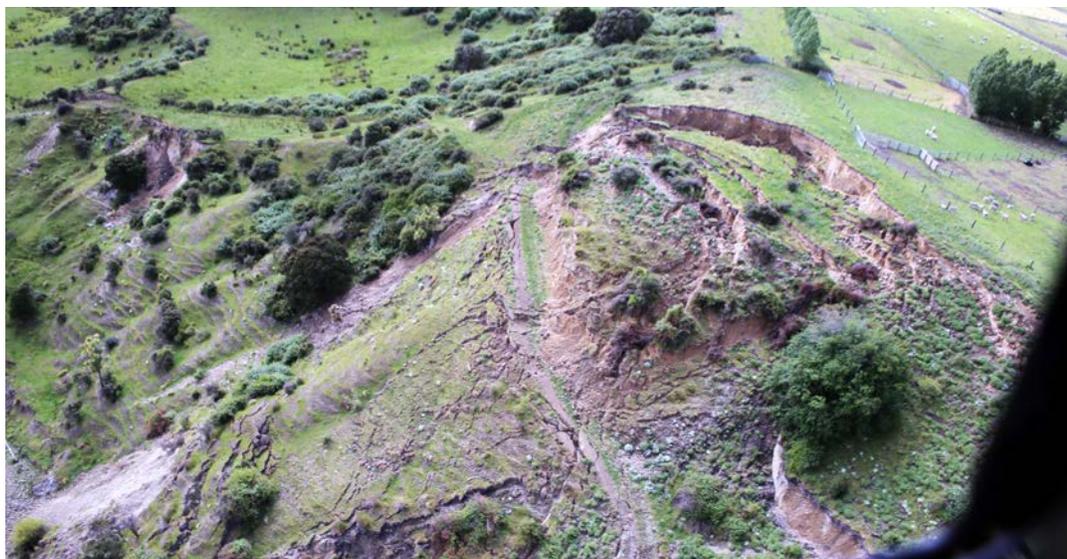
**Figure 65.** Photograph showing a landslide from the edge of the terrace directly across the valley from the Leader 220 landslide. (See fig. 1H.)

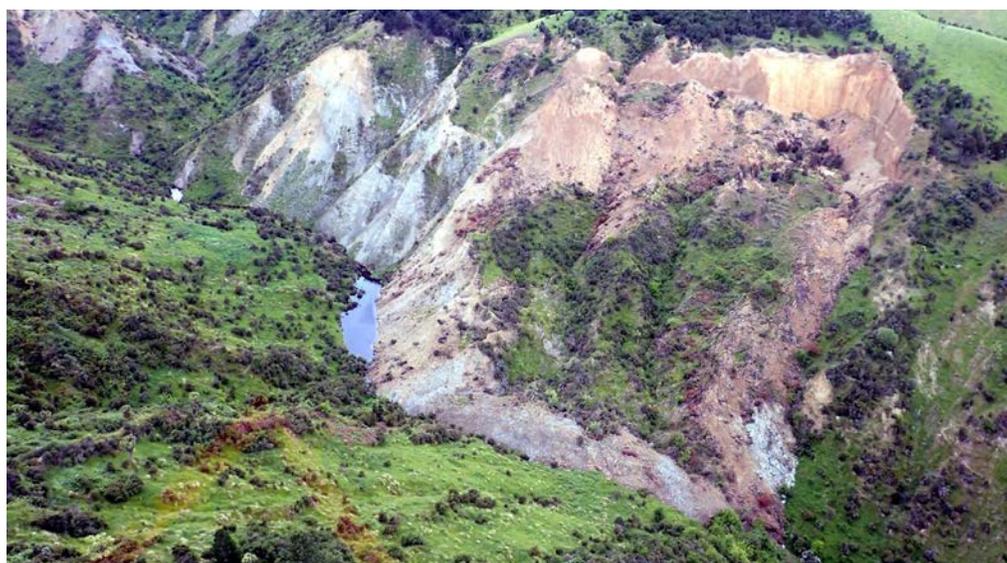
**Figure 67.** Photograph showing the Bourne 270 landslide with a near-vertical headscarp. (See fig. 1H.)

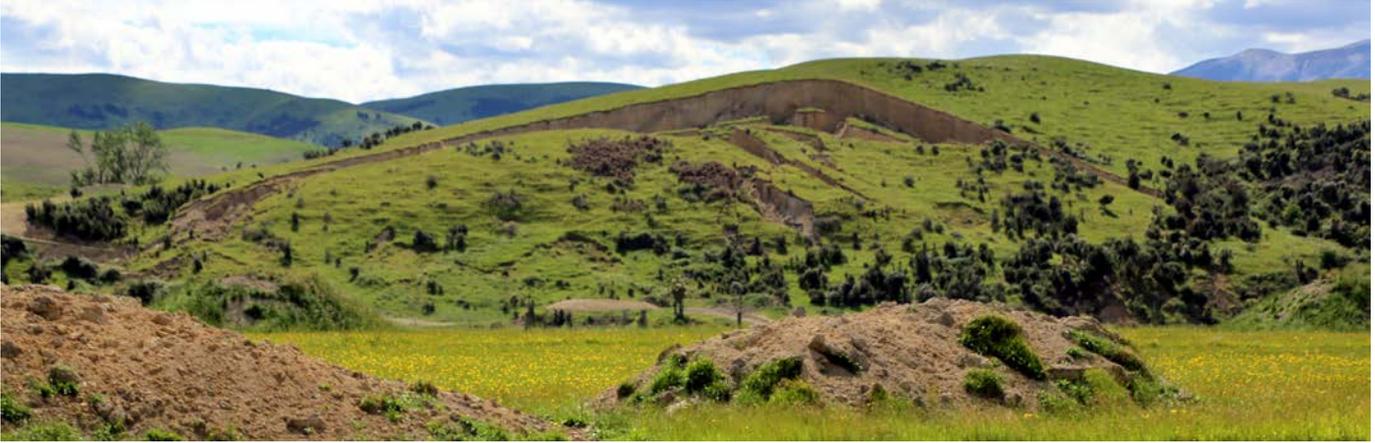
**Figure 68.** Photograph showing a landslide between Waiau and Mount Lyford with a near-vertical headscarp. (See fig. 1H.)

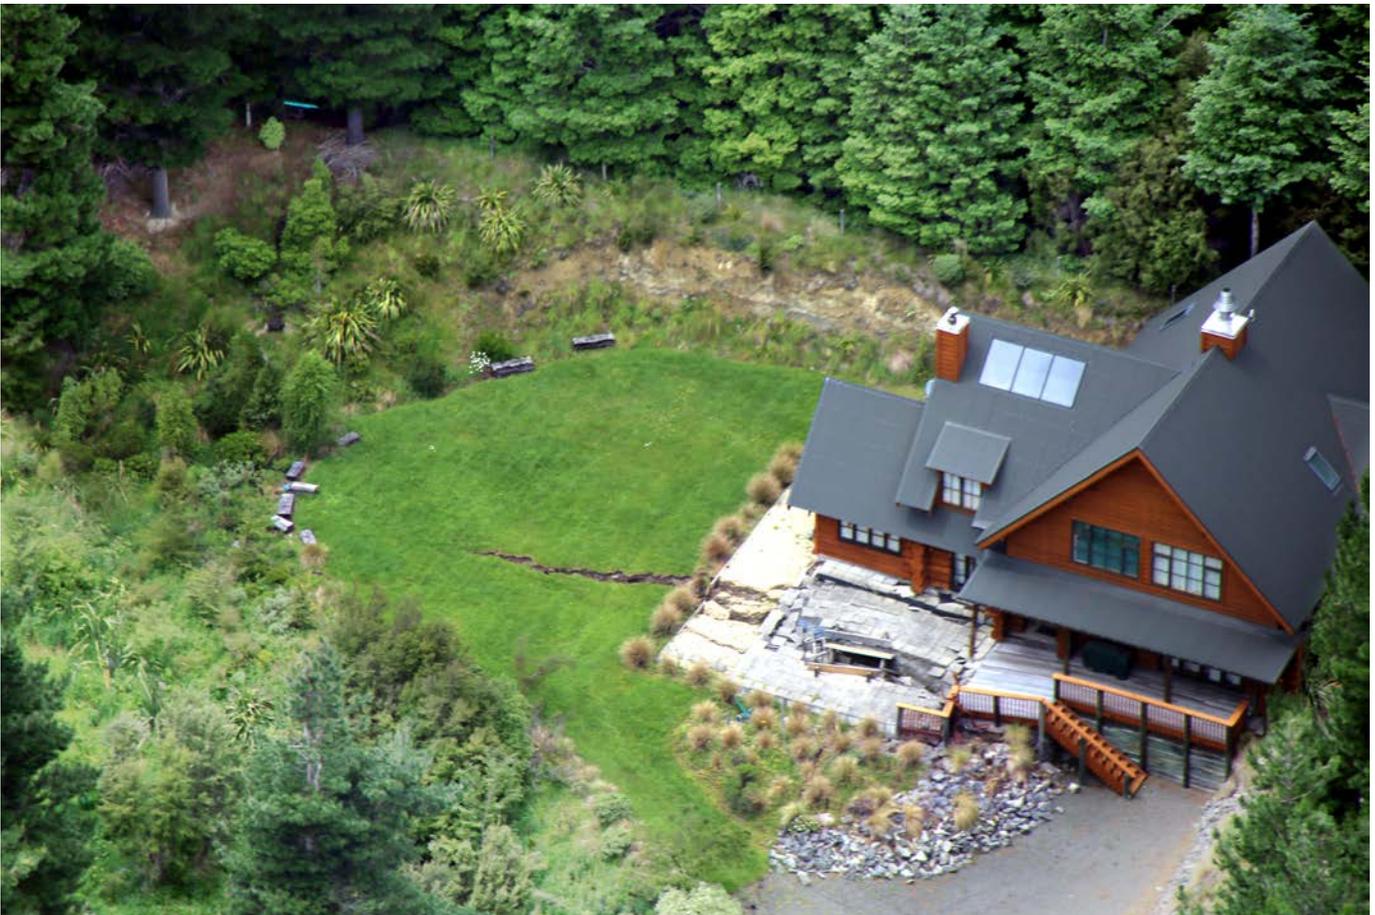
**Figure 69.** Photograph showing a ridgetop crack extending through a house in Mount Lyford. (See fig. 1G.)

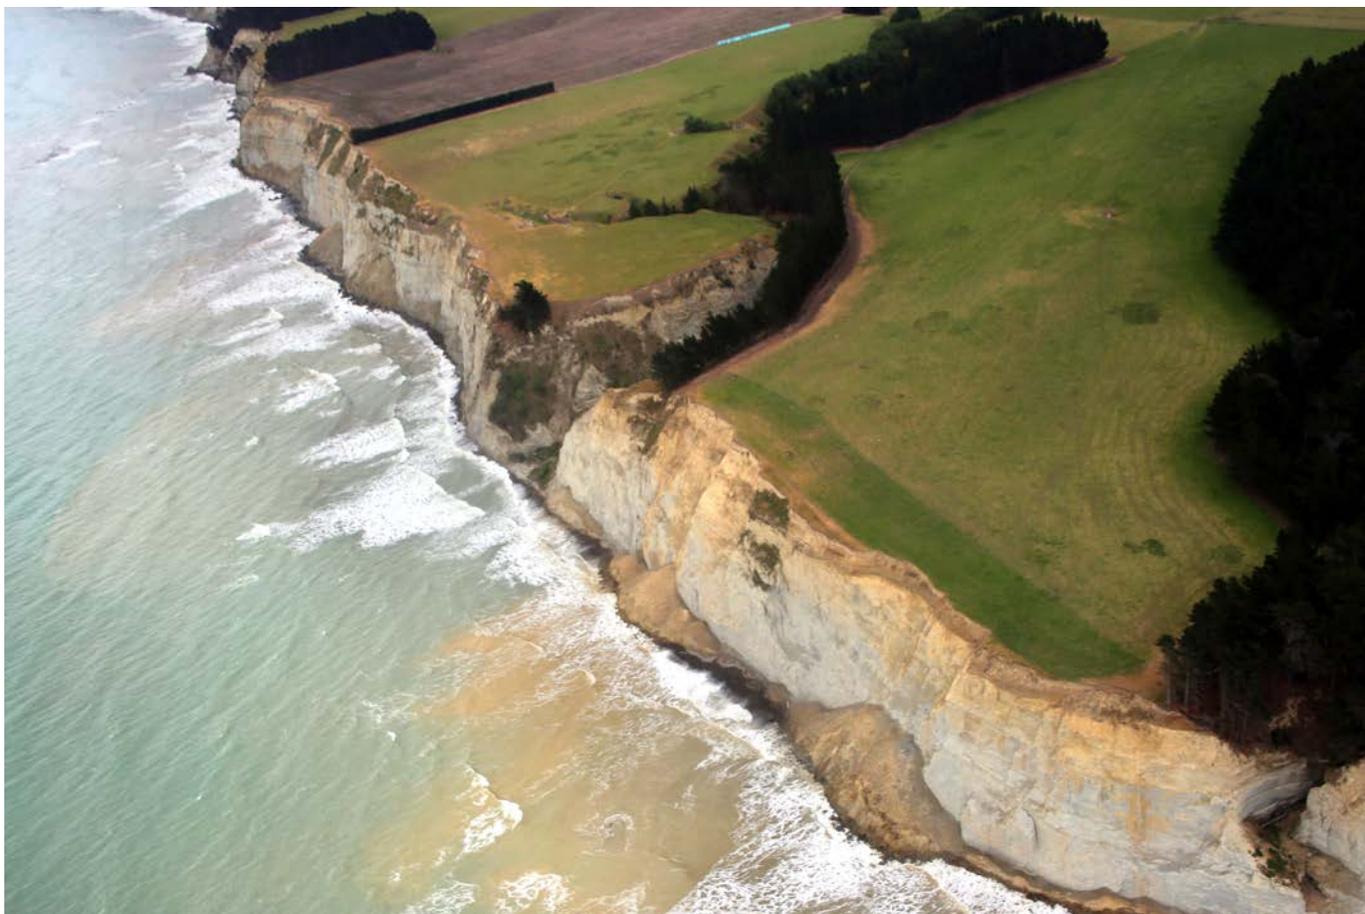
**Figure 70.** Photograph showing debris falls along coastal cliffs south of Kaikoura. (See fig. 1B.)

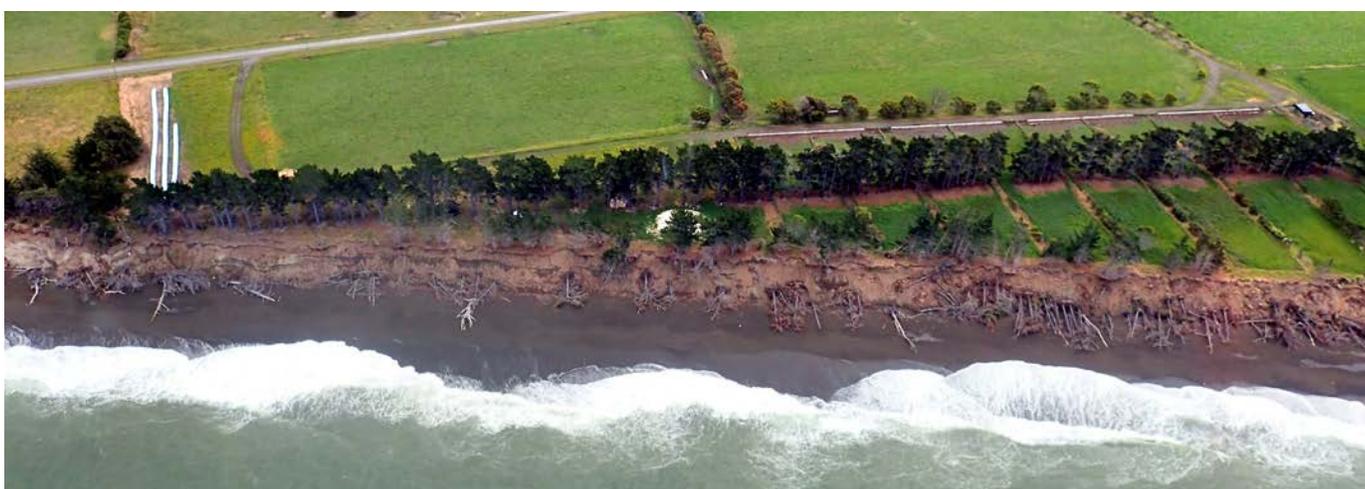
**Figure 71.** Photograph showing toppled trees along a section of sea cliff that failed south of Kaikoura. (See fig. 1B.)
