Bathymetric and Velocimetric Surveys at Highway Bridges Crossing the Missouri and Mississippi Rivers on the Periphery of Missouri, July–August 2018

Scientific Investigations Report 2020–5088

By Richard J. Huizinga

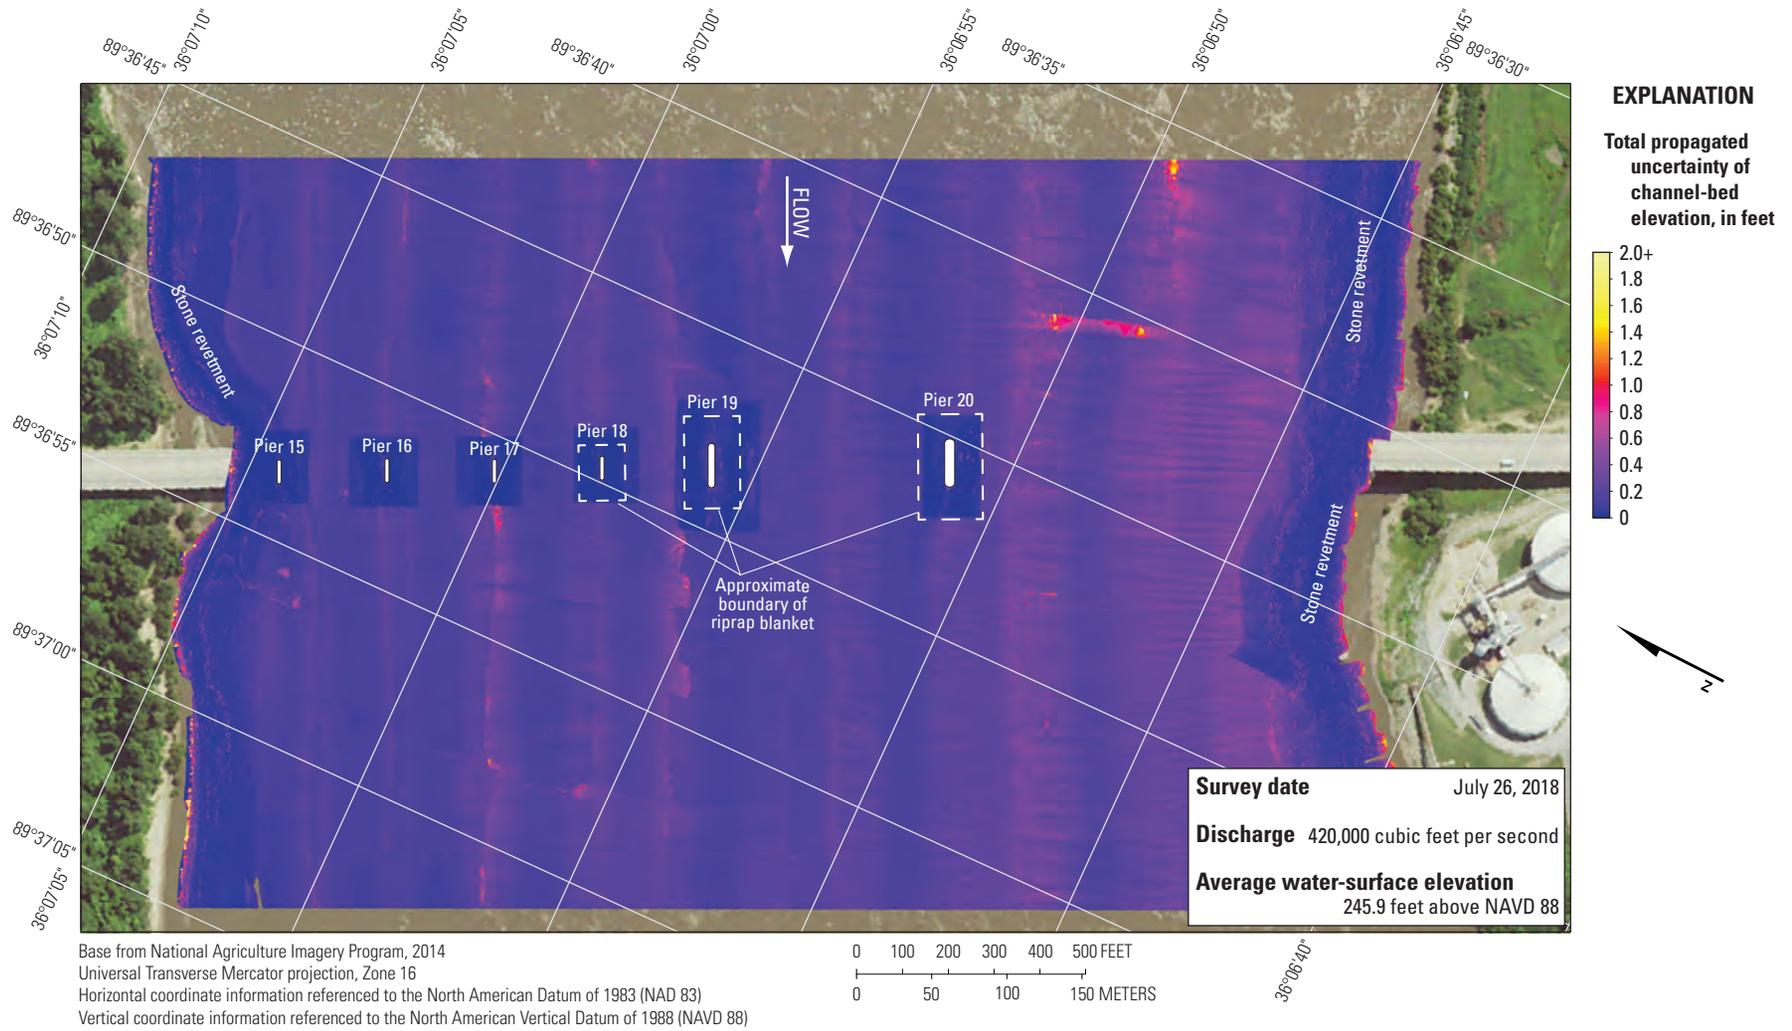
The largest TPU in this group of surveys was about 3.74 ft (table 6); however, as noted in previous studies, TPU values of this magnitude typically happened near high-relief features, such as the front or side of a pier footing (fig. 5). More than 98 percent of the TPU values were less than 0.50 ft (table 6), which is within the specifications for a “Special Order” survey, the most-stringent survey standard of the International Hydrographic Organization (IHO; International Hydrographic Organization, 2008). As has been noted in previous surveys with this equipment, the TPU values were larger near moderate-relief features (banks, spur dikes, rock riprap and outcrops, and scour holes near piers). Occasionally, the TPU values also were larger (1.00 ft or greater) in the outermost beam extents of the multibeam swath in the overlap with an adjacent swath, particularly when the MBES head was electronically tilted for the survey lines along the banks or near the piers. Overlapping adjacent swaths in the channel thalweg (the line of maximum depth in the channel) also can display larger TPU values because substantial bed movement can happen between survey passes. More than 77 percent of the TPU values were less than 0.25 ft (table 6). The tops of bridge substructural elements (pier footings and seal courses) typically had TPU values of less than 0.25 ft.

Figure 5. Total propagated uncertainty of bathymetric data from the Mississippi River channel near structure A1700 on Interstate 155 near Caruthersville, Missouri.

longitudinal swathes (fig. 5), which was the case at nearly all the sites surveyed in this study. The primary anomaly at this site was in the upstream mid-channel area where abrupt course changes or insufficient overlap of the swath outer beams resulted in higher TPU values. Secondary anomalies were observed along the banks, where the sonar was used in an electronically tilted configuration to extend the potential coverage in these areas, resulting in higher TPU values. Generally, the magnitude and distribution of TPU values observed at this site are representative of those observed at all the other surveyed sites.

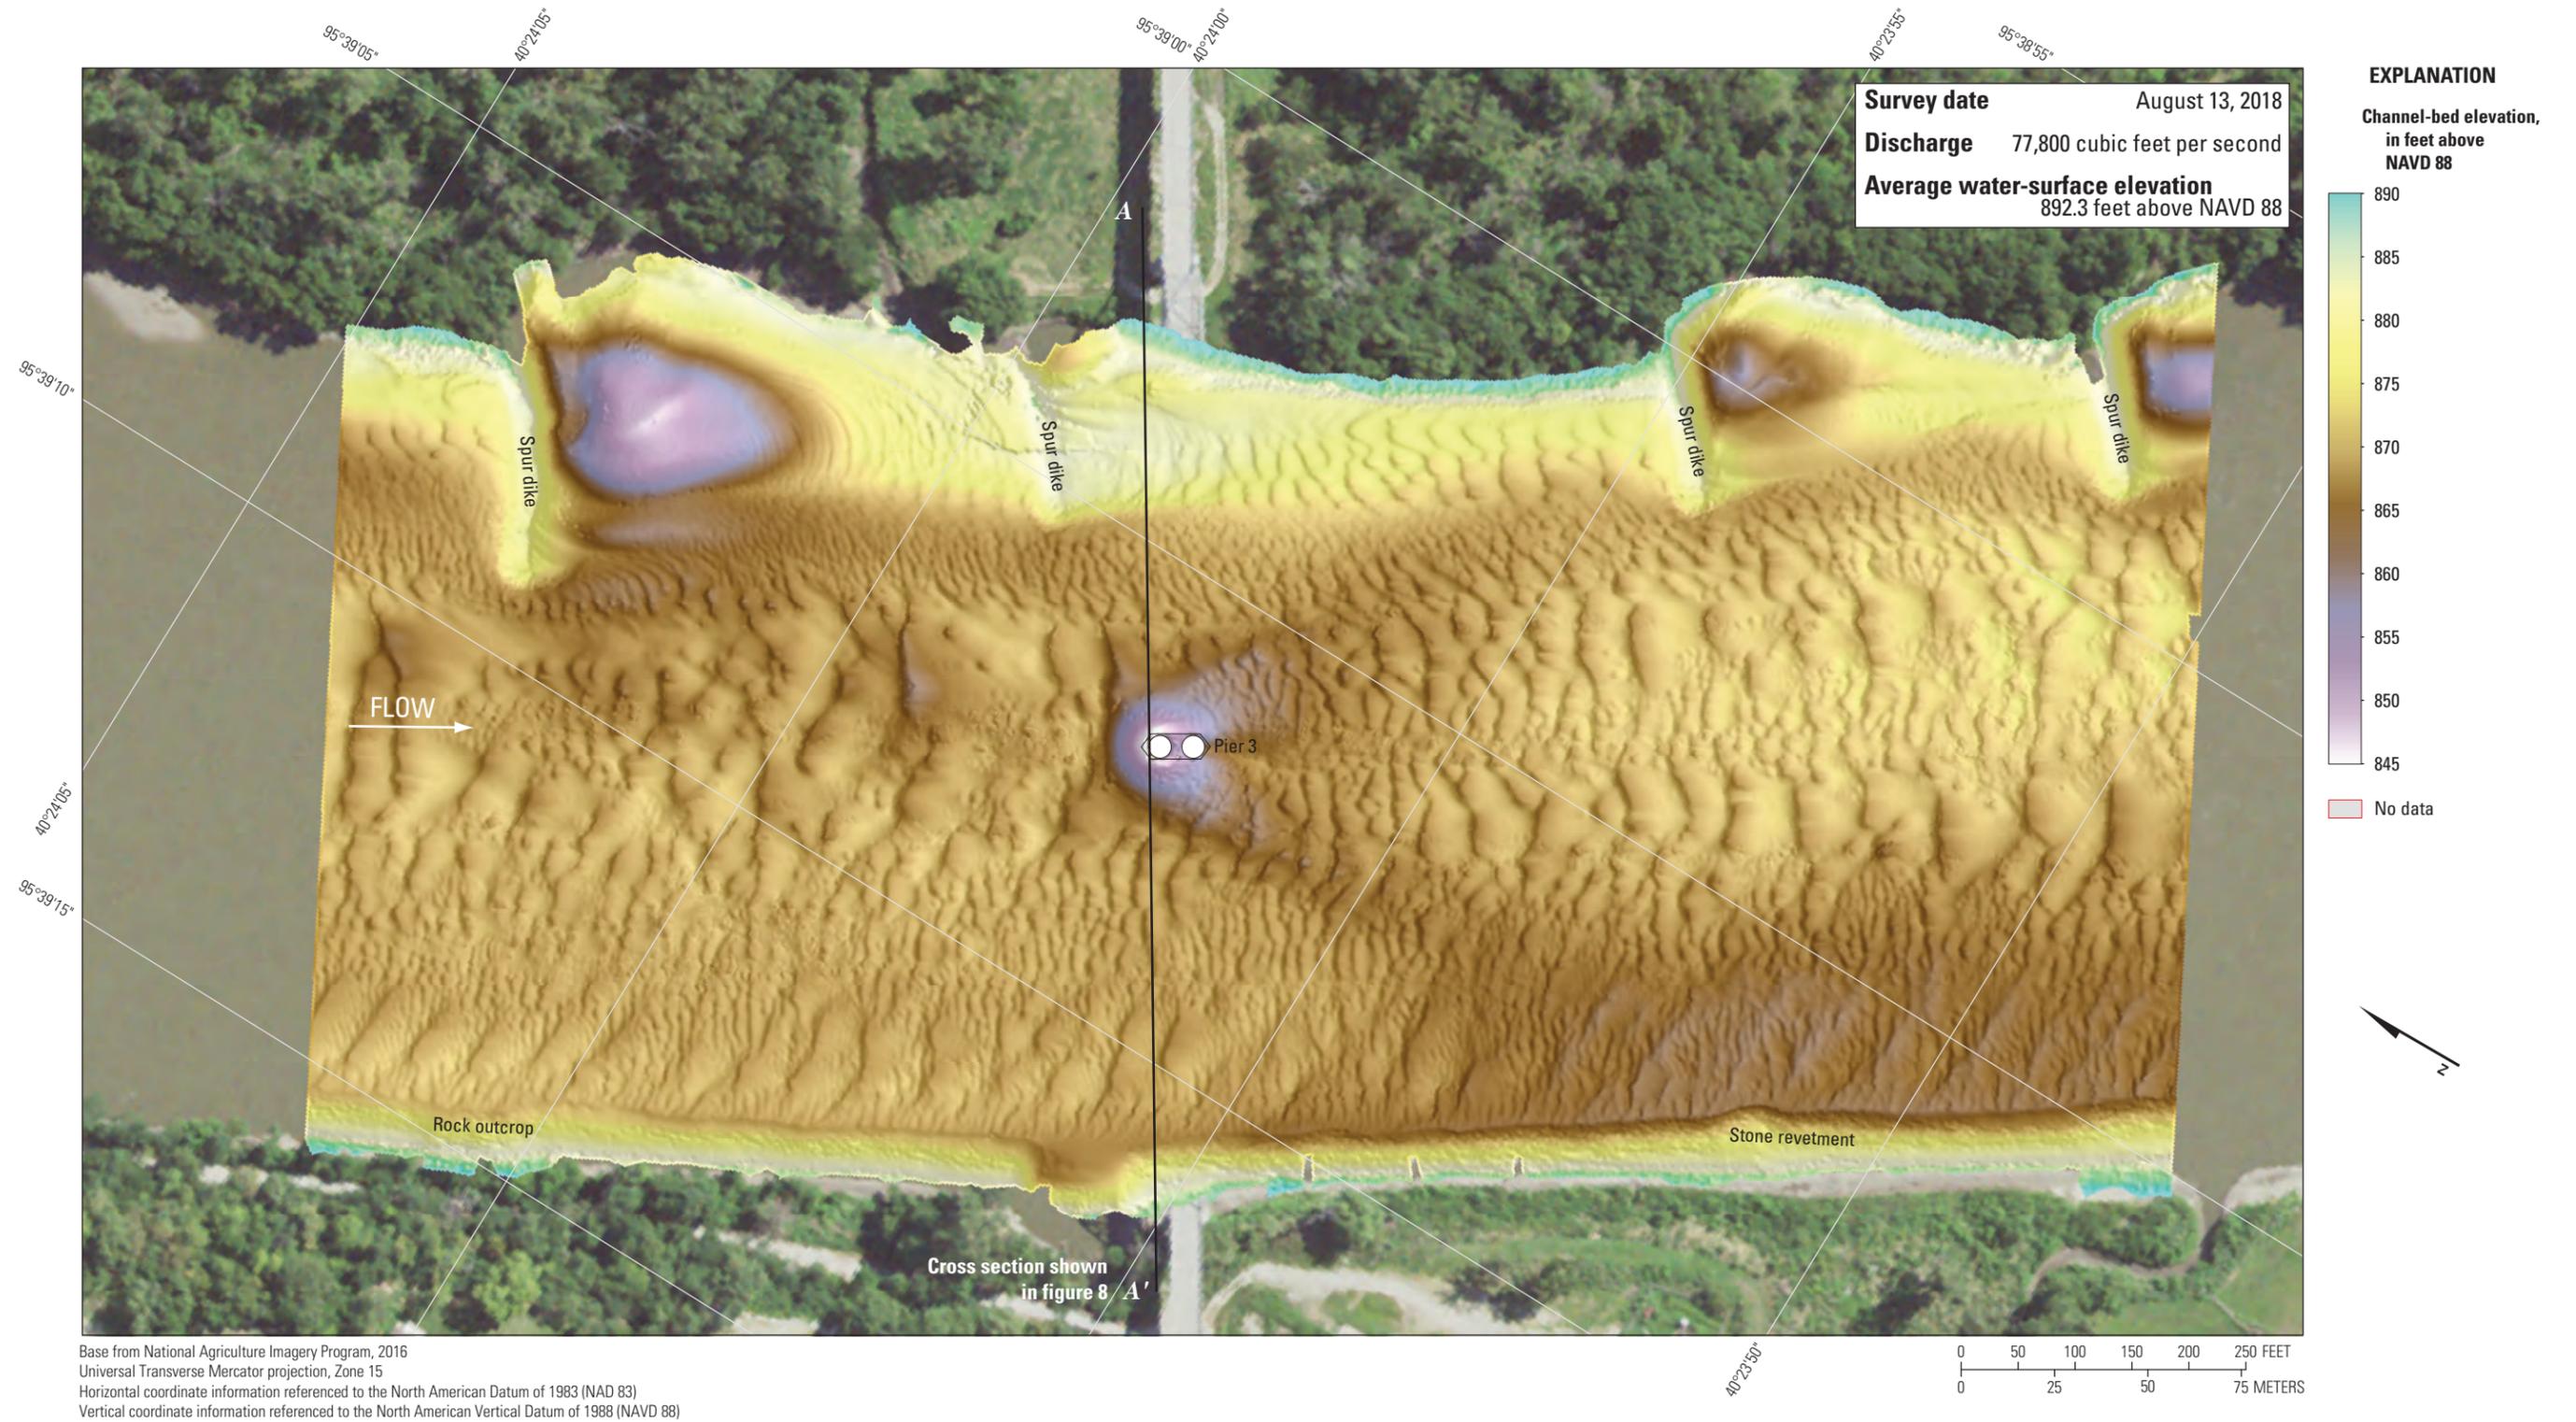
(Missouri Department of Transportation, written commun., 2002) indicates that pier 3 is founded on sheet piling caissons on bedrock, with about 30 ft of bed material between the bottom of the scour hole and bedrock at the upstream face of the pier (fig. 8; table 7). The unique configuration of the sheet pile caissons and ice breaker of the pier are clearly seen in the shaded TIN images for main channel pier 3 (fig. 1.1). The surveyed bed along the cross section generally was between the two previous multibeam surveys in 2011 and 2014, except in an area of deposition near the left bank (fig. 8).

Figure 6. Bathymetric survey of the Missouri River channel near structure L0098 on U.S. Highway 136 at Brownville, Nebraska.

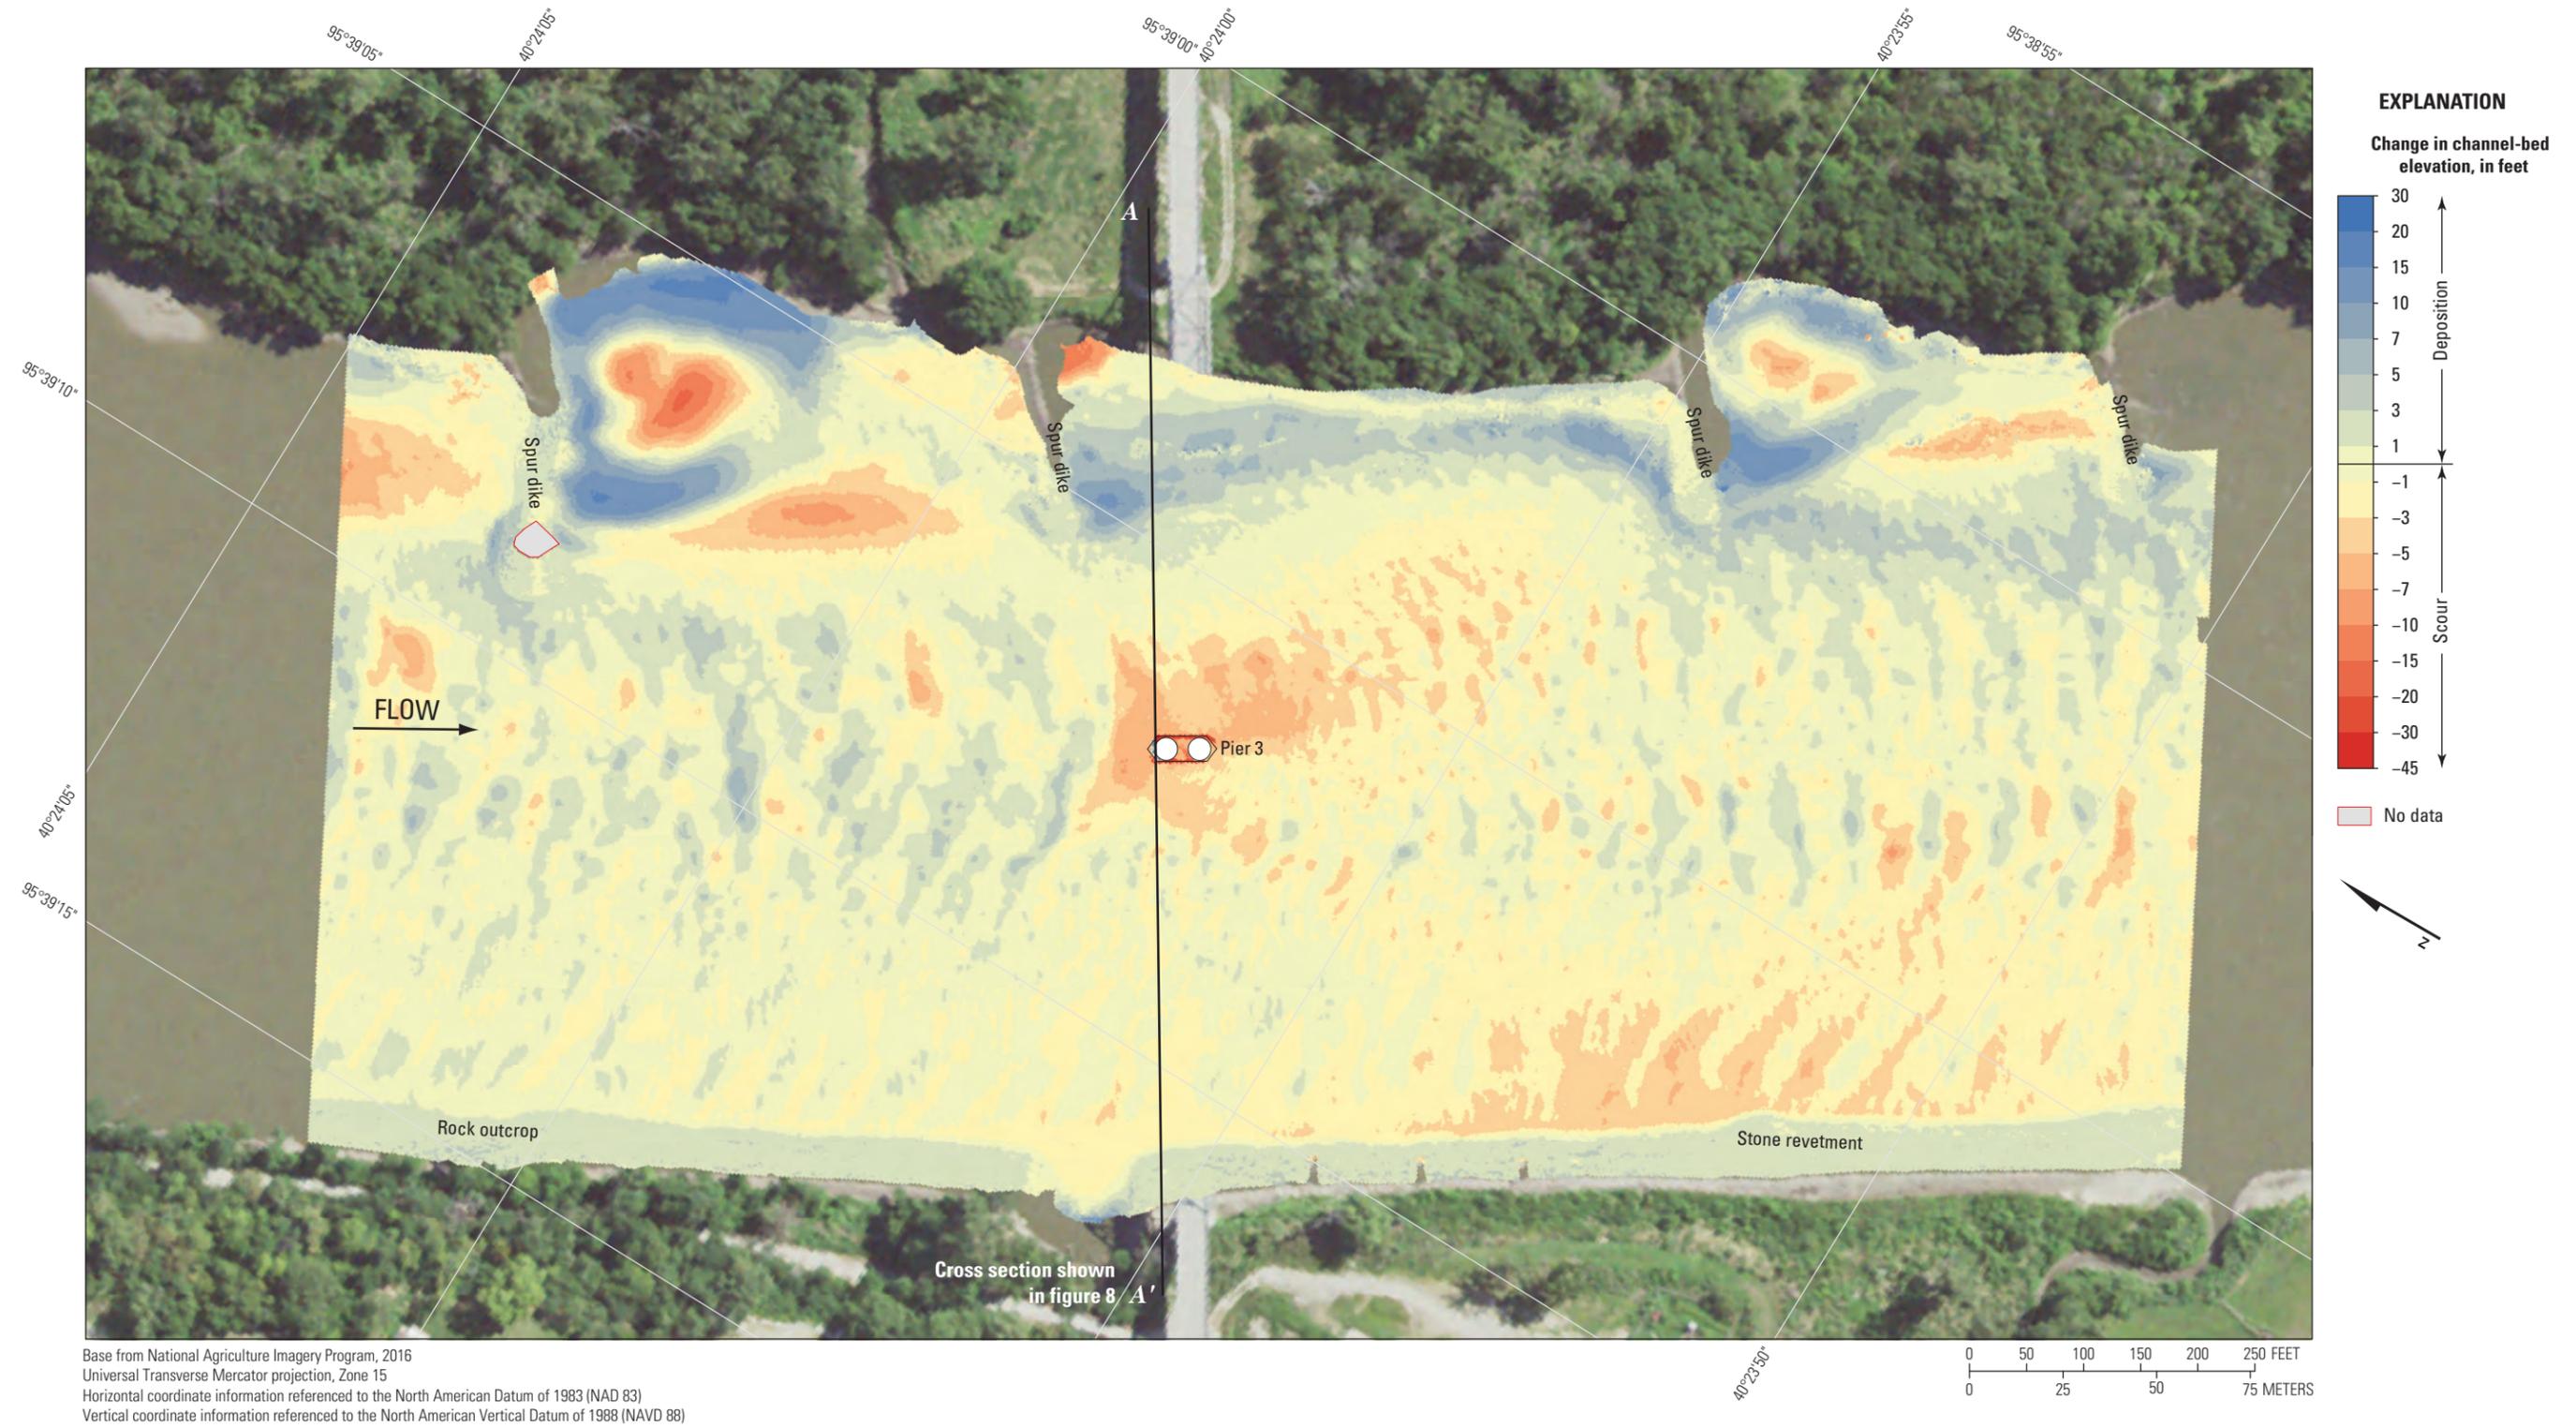
and degradation between the 2014 and 2018 surveys for the area common to both surveys. The net volume of cut in the reach from 2014 to 2018 was about 43,200 cubic yards (yd³), and the net volume of fill was about 43,500 yd³, resulting in a net gain of about 300 yd³ of sediment. This similarity between 2014 and 2018 is further substantiated by the frequency distribution of bed elevations (fig. 7), which clearly shows the 2018 distribution as being similar in shape to 2014, with nearly equal values at the 50 percent point of the cumulative percentage curves.

Figure 9. Difference between surfaces created from bathymetric surveys of the Missouri River channel near structure L0098 on U.S. Highway 136 at Brownville, Nebraska, on August 13, 2018, and June 3, 2014.

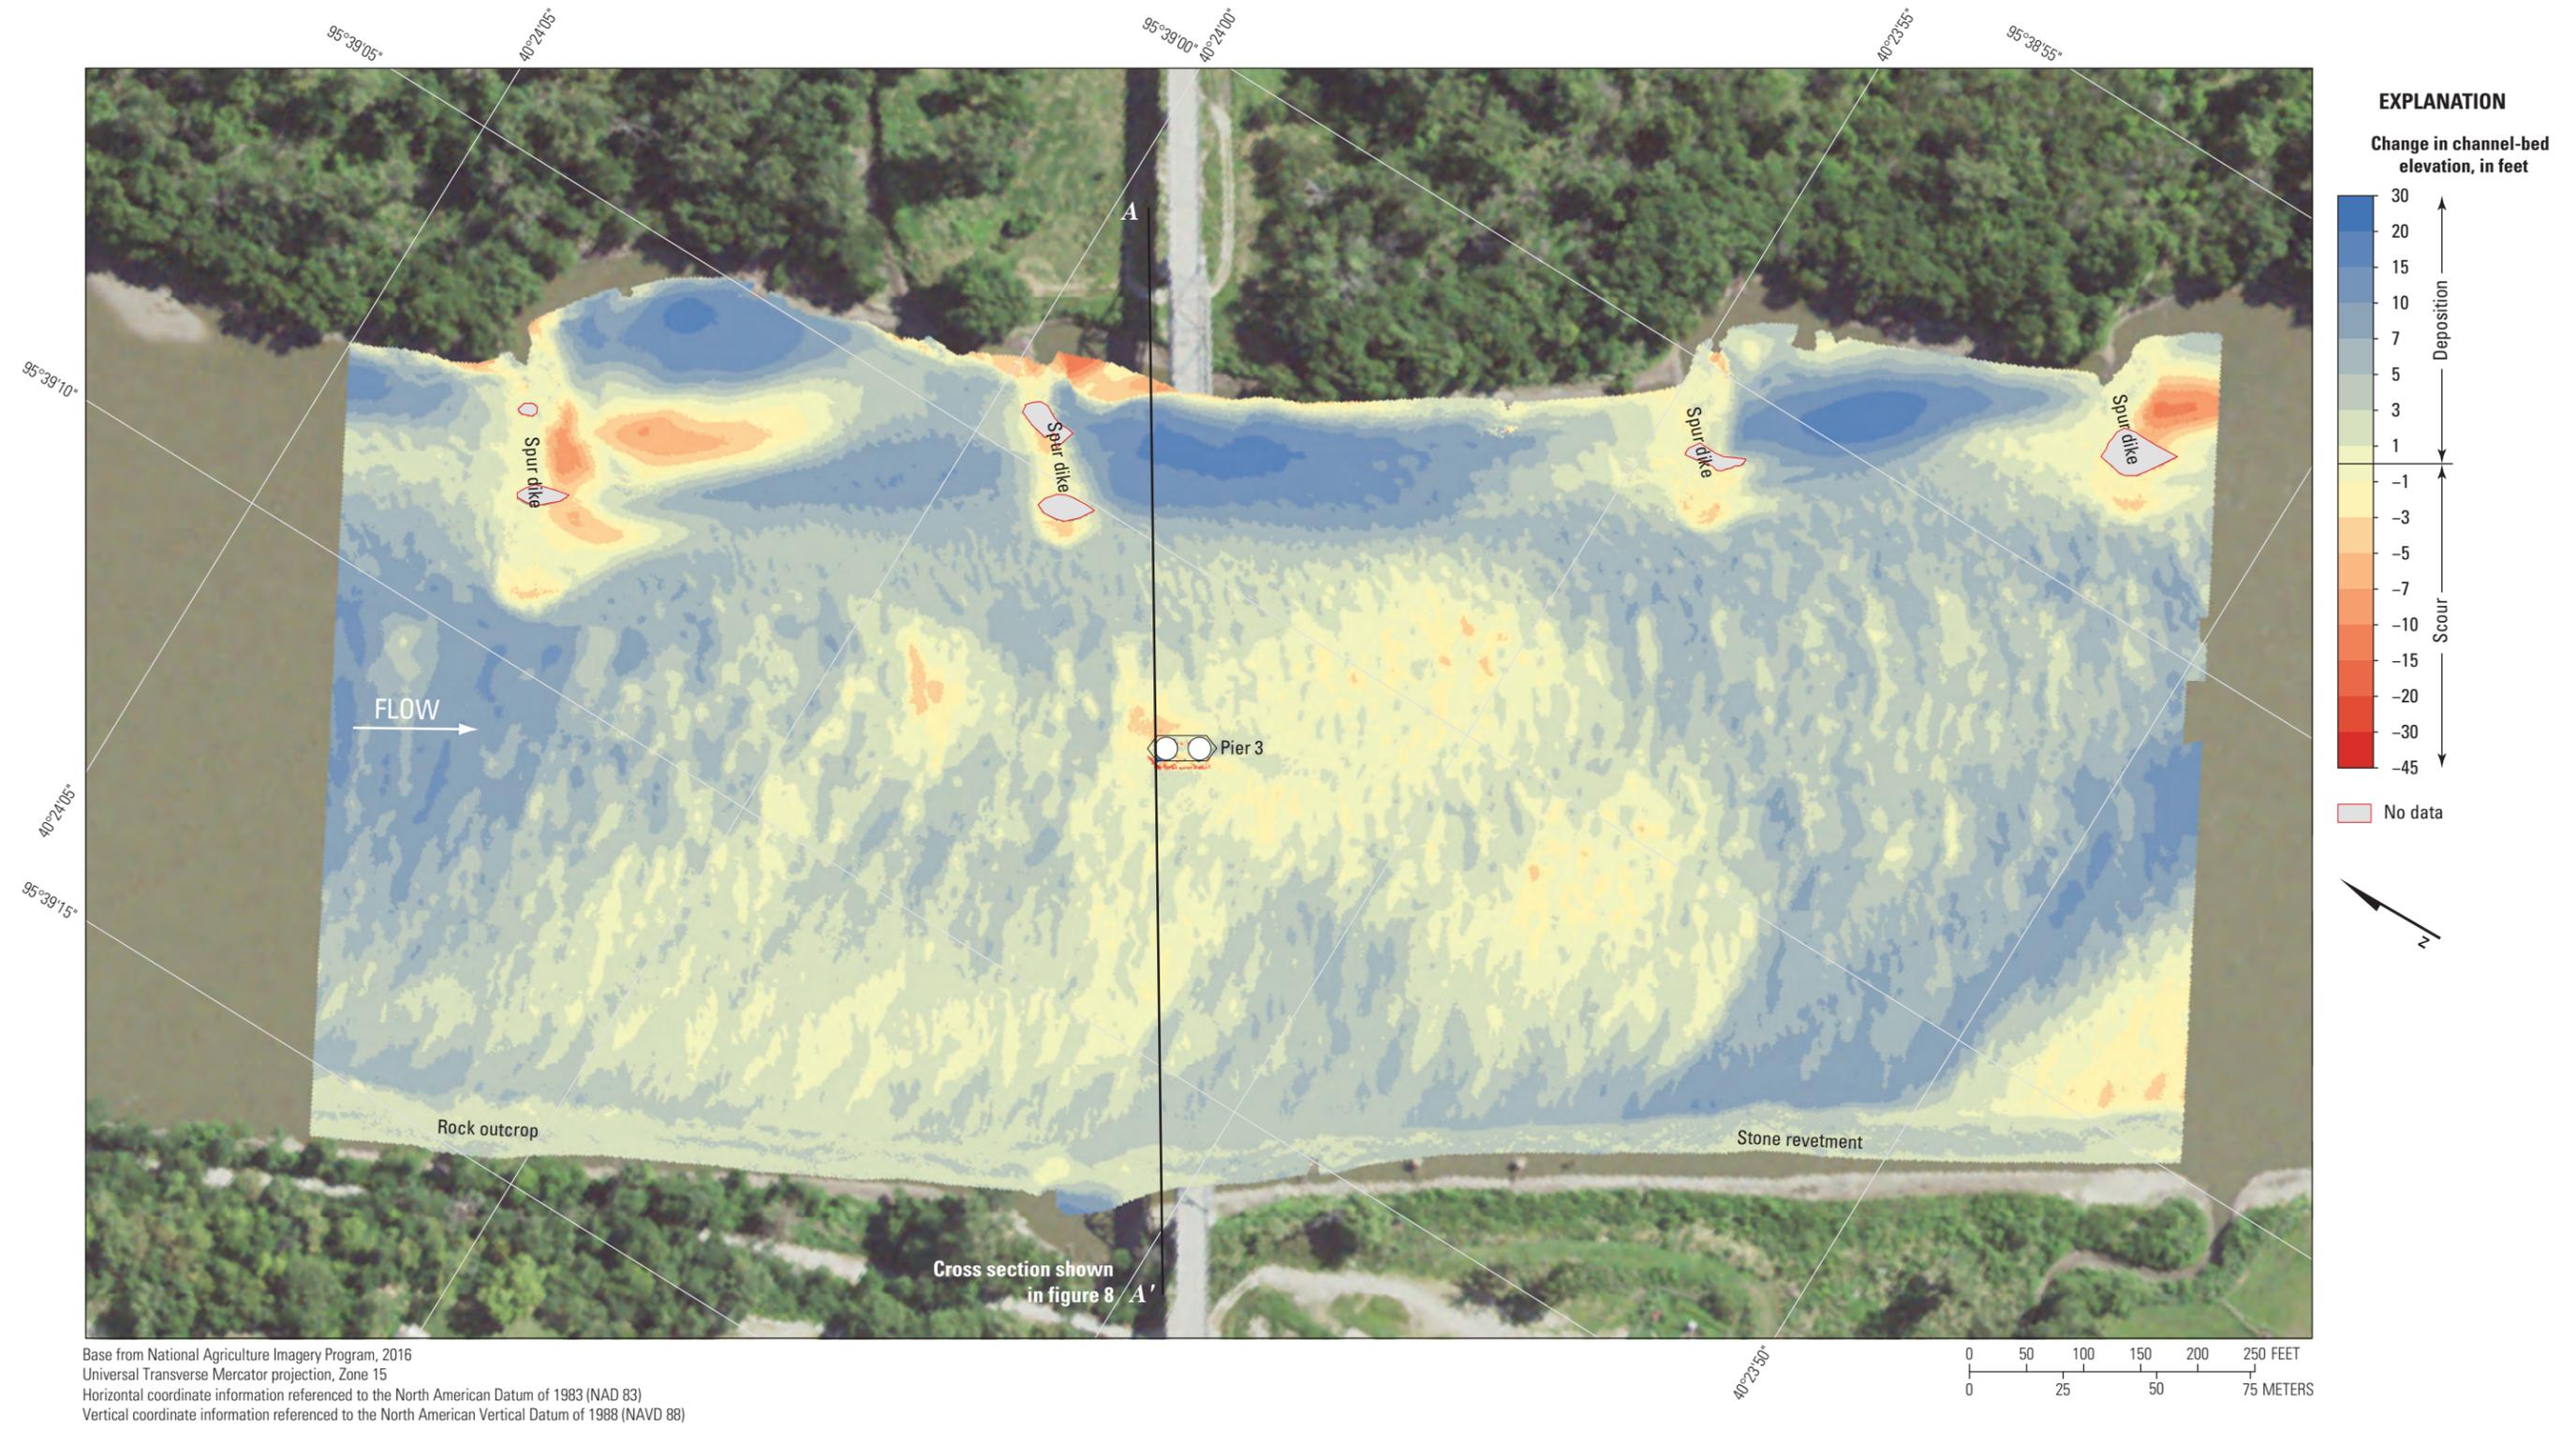
The difference between the survey on August 13, 2018, and the previous flood survey on July 13, 2011, indicates substantial deposition has occurred throughout the channel reach from 2011 to 2018 (fig. 10). Widespread moderate deposition of as much as 15 ft was observed upstream and downstream from the bridge, and more than 20 ft of deposition was observed downstream from the spur dikes on the left (east) bank (fig. 10). Small, localized areas of minor scour were observed immediately downstream from the spur dikes, near pier 3, and at the base of the right (west) bank at the extreme downstream end of the reach (fig. 10). Minor deposition of 3 ft or less indicated along the rock outcrop and stone revetment on the right (west) bank substantiates the probability of minor

Figure 10. Difference between surfaces created from bathymetric surveys of the Missouri River channel near structure L0098 on U.S. Highway 136 at Brownville, Nebraska, on August 13, 2018, and July 13, 2011.

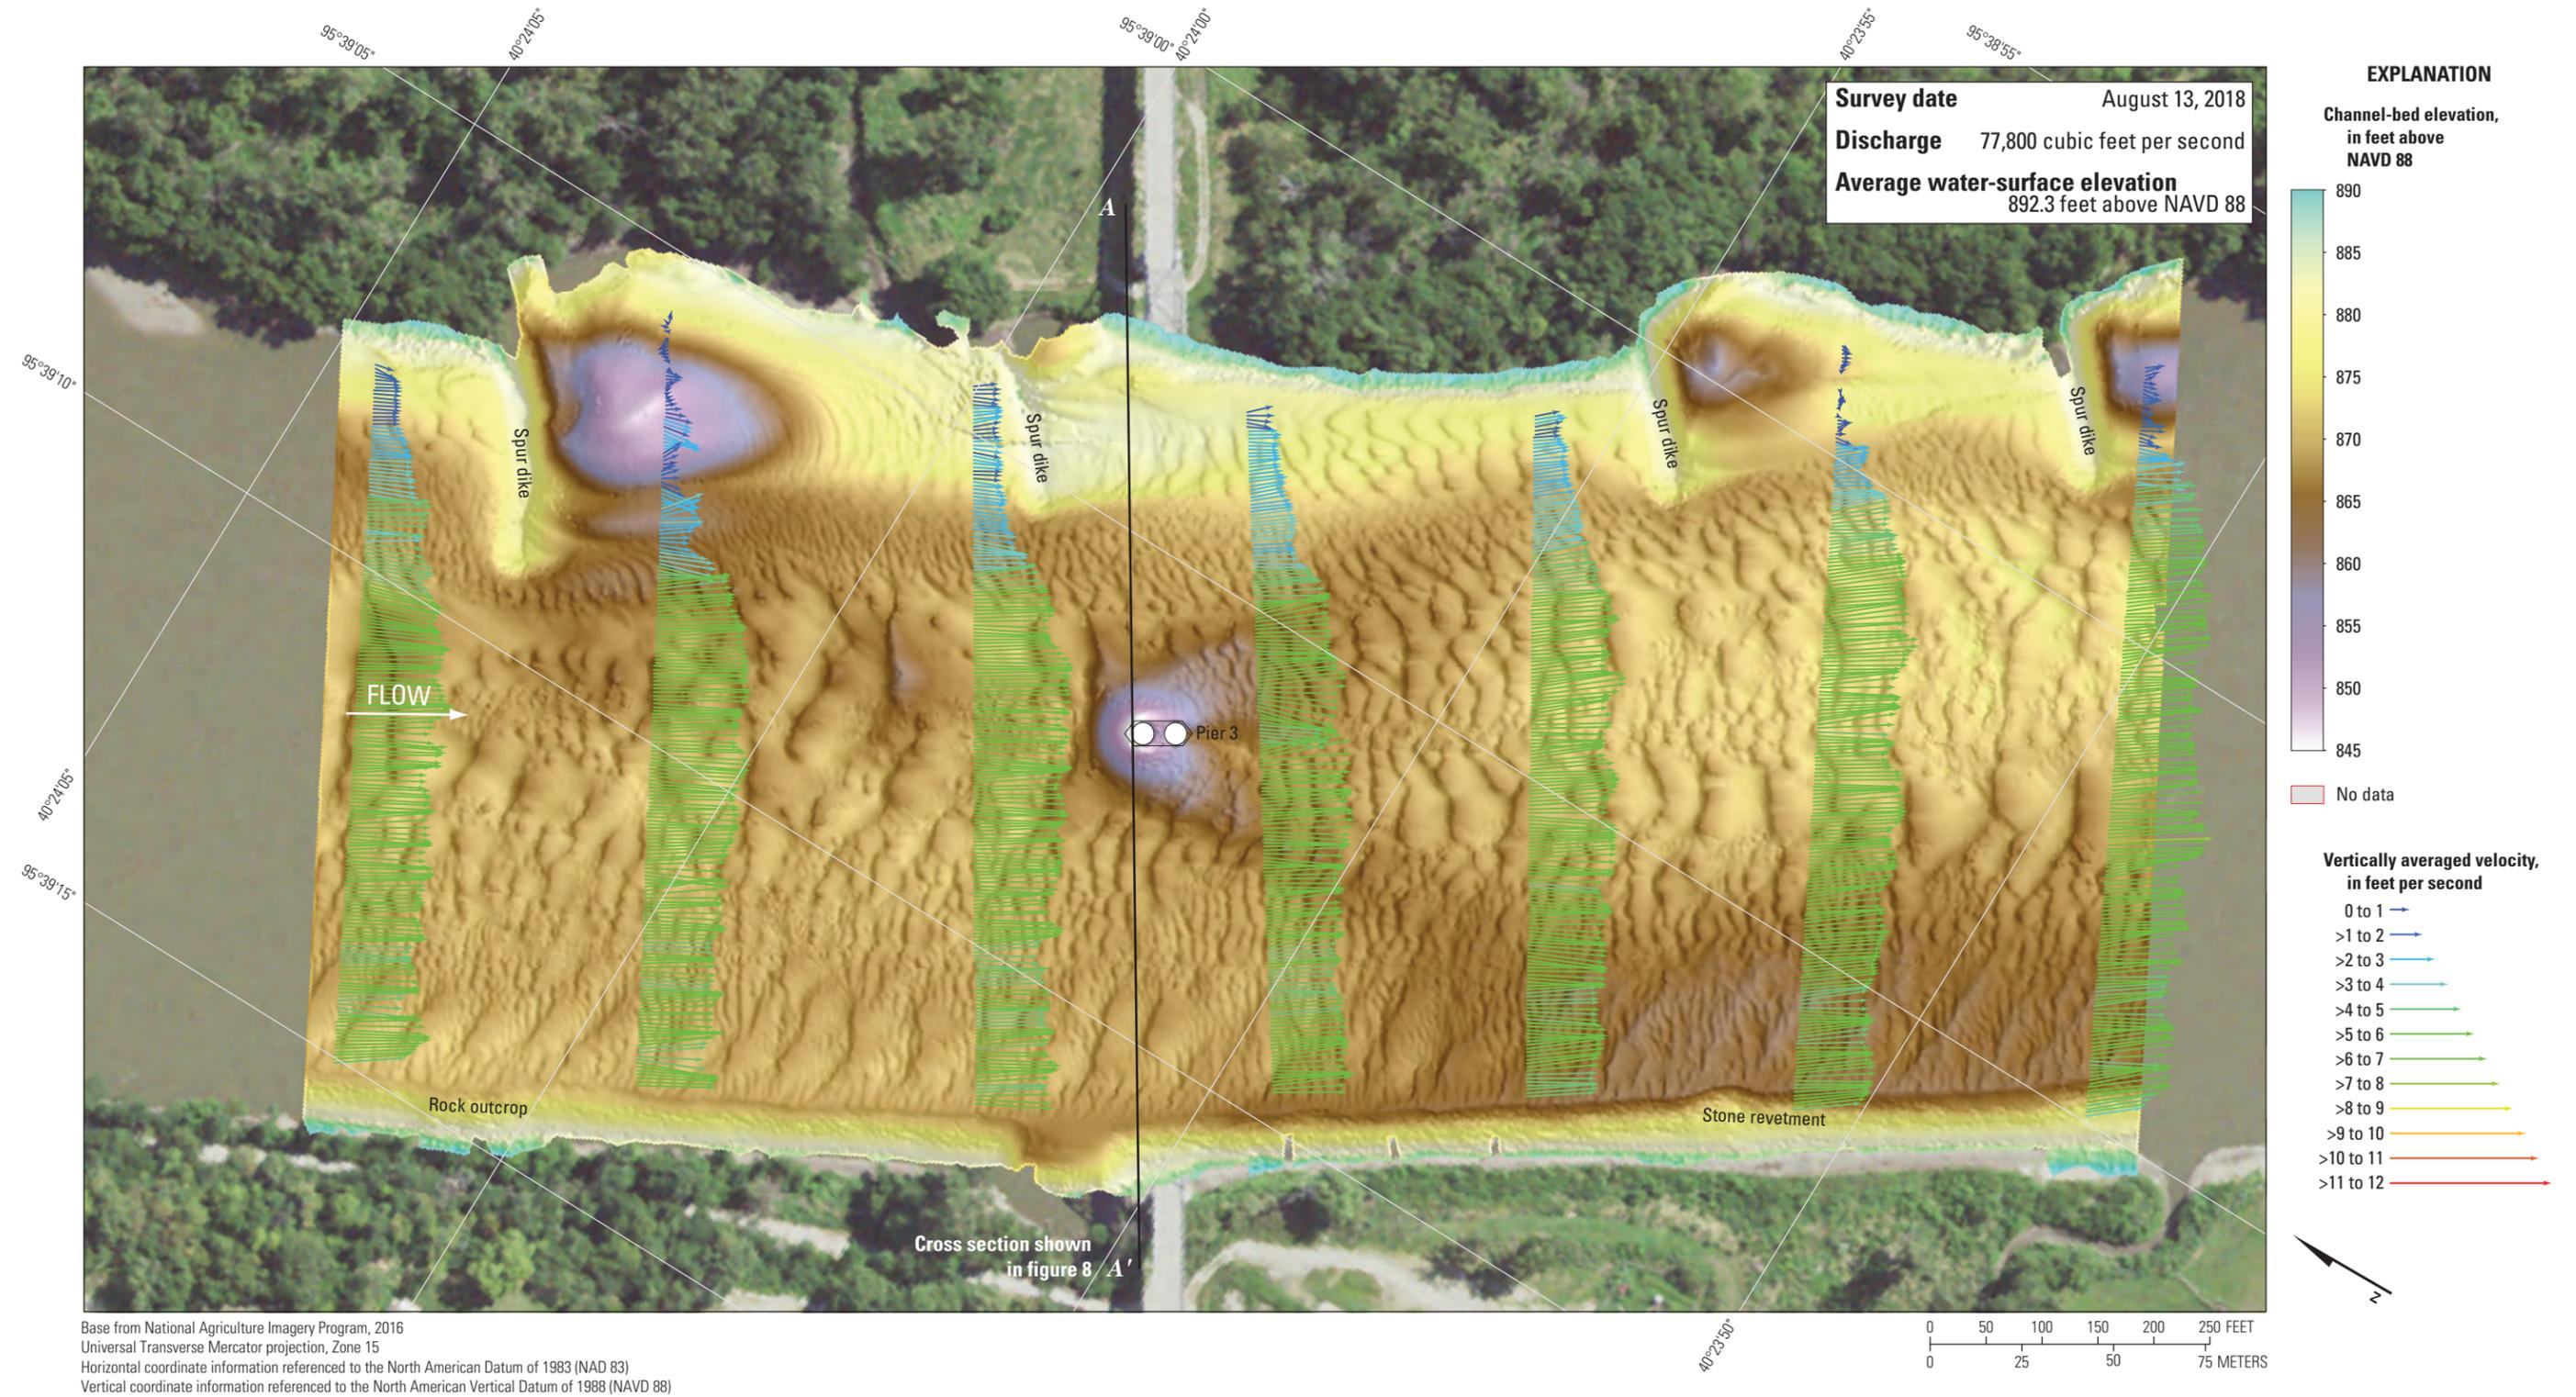
The vertically averaged velocity vectors indicate mostly uniform flow throughout the reach (fig. 11). A maximum velocity of about 8 feet per second (ft/s) was present in the upstream middle of the channel and a minimum of 1 ft/s with flow reversal was present downstream from the various spur dikes in the reach (fig. 11). The wake vortices downstream from pier 3 were not pronounced, and seemed to be no greater than the general non-uniformity of flow observed in the channel (fig. 11). Minor turbulence was present in all the sections (fig. 11).

Figure 11. Bathymetry and vertically averaged velocities of the Missouri River channel near structure L0098 on U.S. Highway 136 at Brownville, Nebraska.

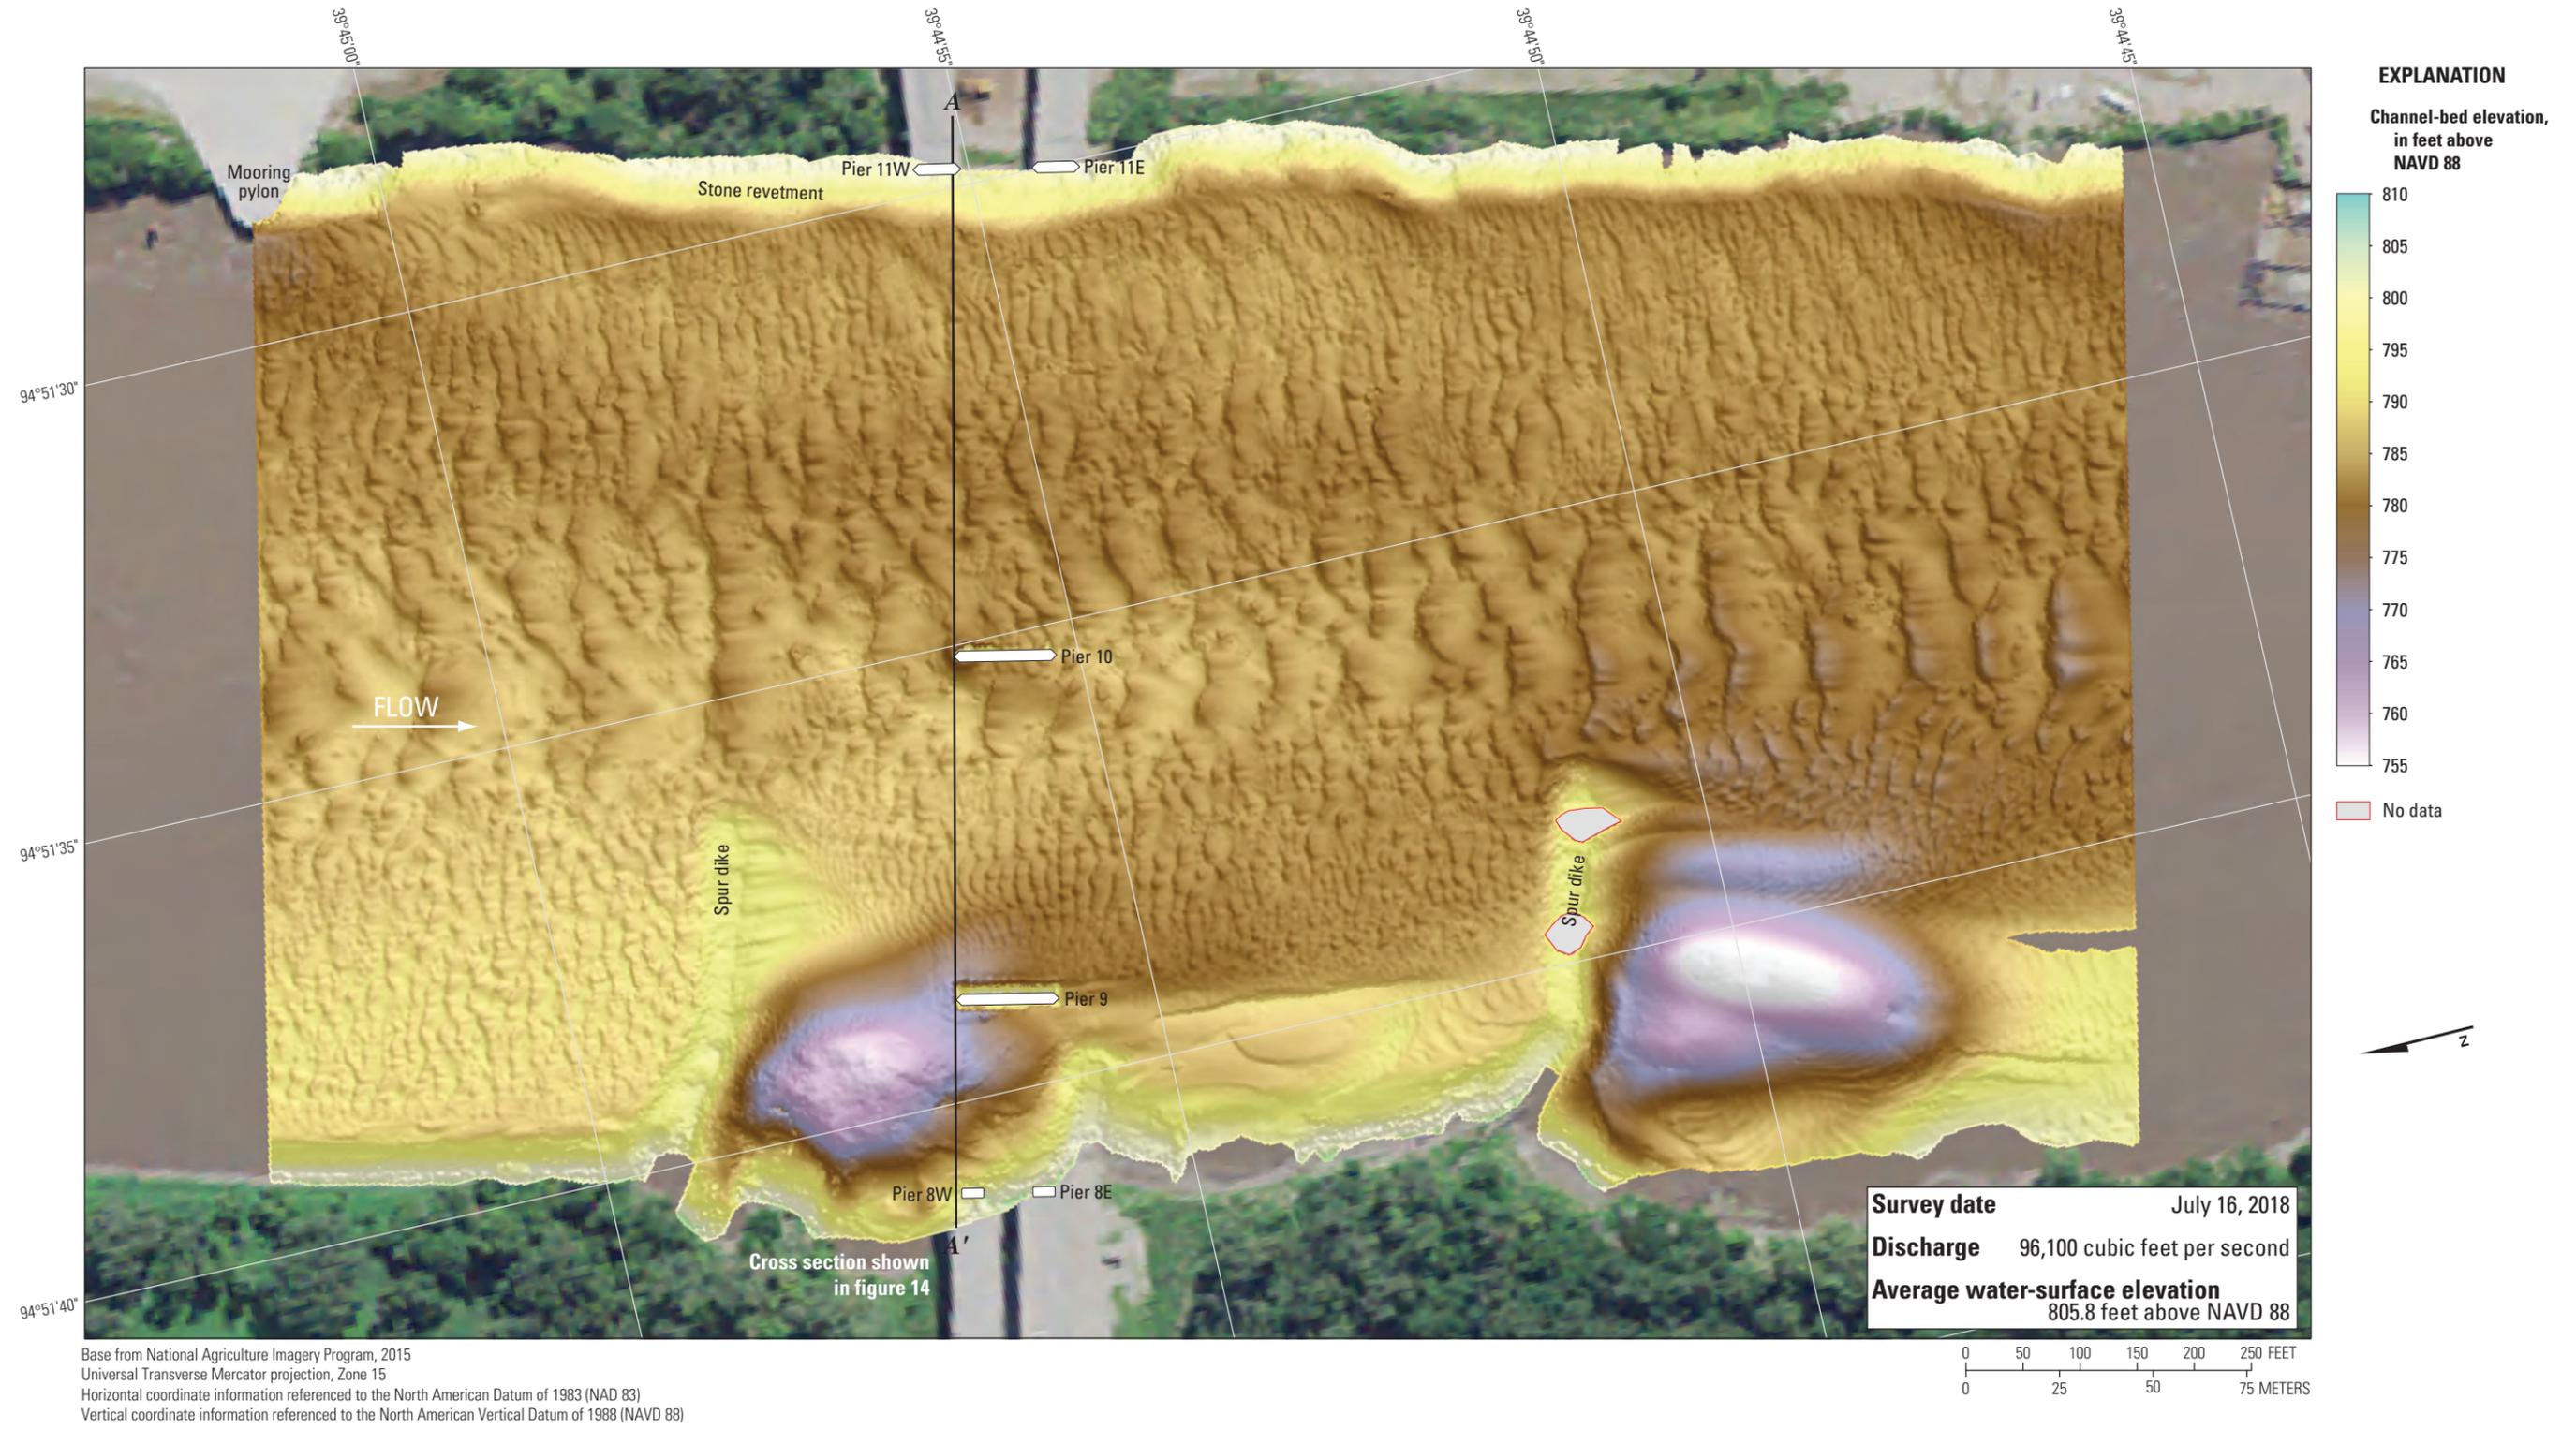
The minor scour hole near pier 10 was difficult to discern from nearby dunes and ripples (figs. 12, 1.2A, 1.2B), but had a minimum channel-bed elevation of about 777 ft (table 7). The top of the footing of pier 9 was evident on the upstream and left (east) sides, primarily because of the scour hole from the upstream spur dike (figs. 12, 1.2C, 1.2D). Information from bridge plans indicates that piers 9 and 10 are founded on shafts drilled into bedrock, with about 24 ft of bed material between the bottom of the scour hole and bedrock at the upstream face of pier 9 (table 7). The surveyed bed was generally similar to the multibeam survey on July 14, 2011, except on the left side of pier 10 (fig. 14).

Figure 12. Bathymetric survey of the Missouri River channel near dual bridge structure A3664 on U.S. Highway 36 at St. Joseph, Missouri.
