Bathymetric and Velocimetric Surveys at Highway Bridges Crossing the Missouri and Mississippi Rivers on the Periphery of Missouri, July–August 2018

Scientific Investigations Report 2020–5088

By Richard J. Huizinga

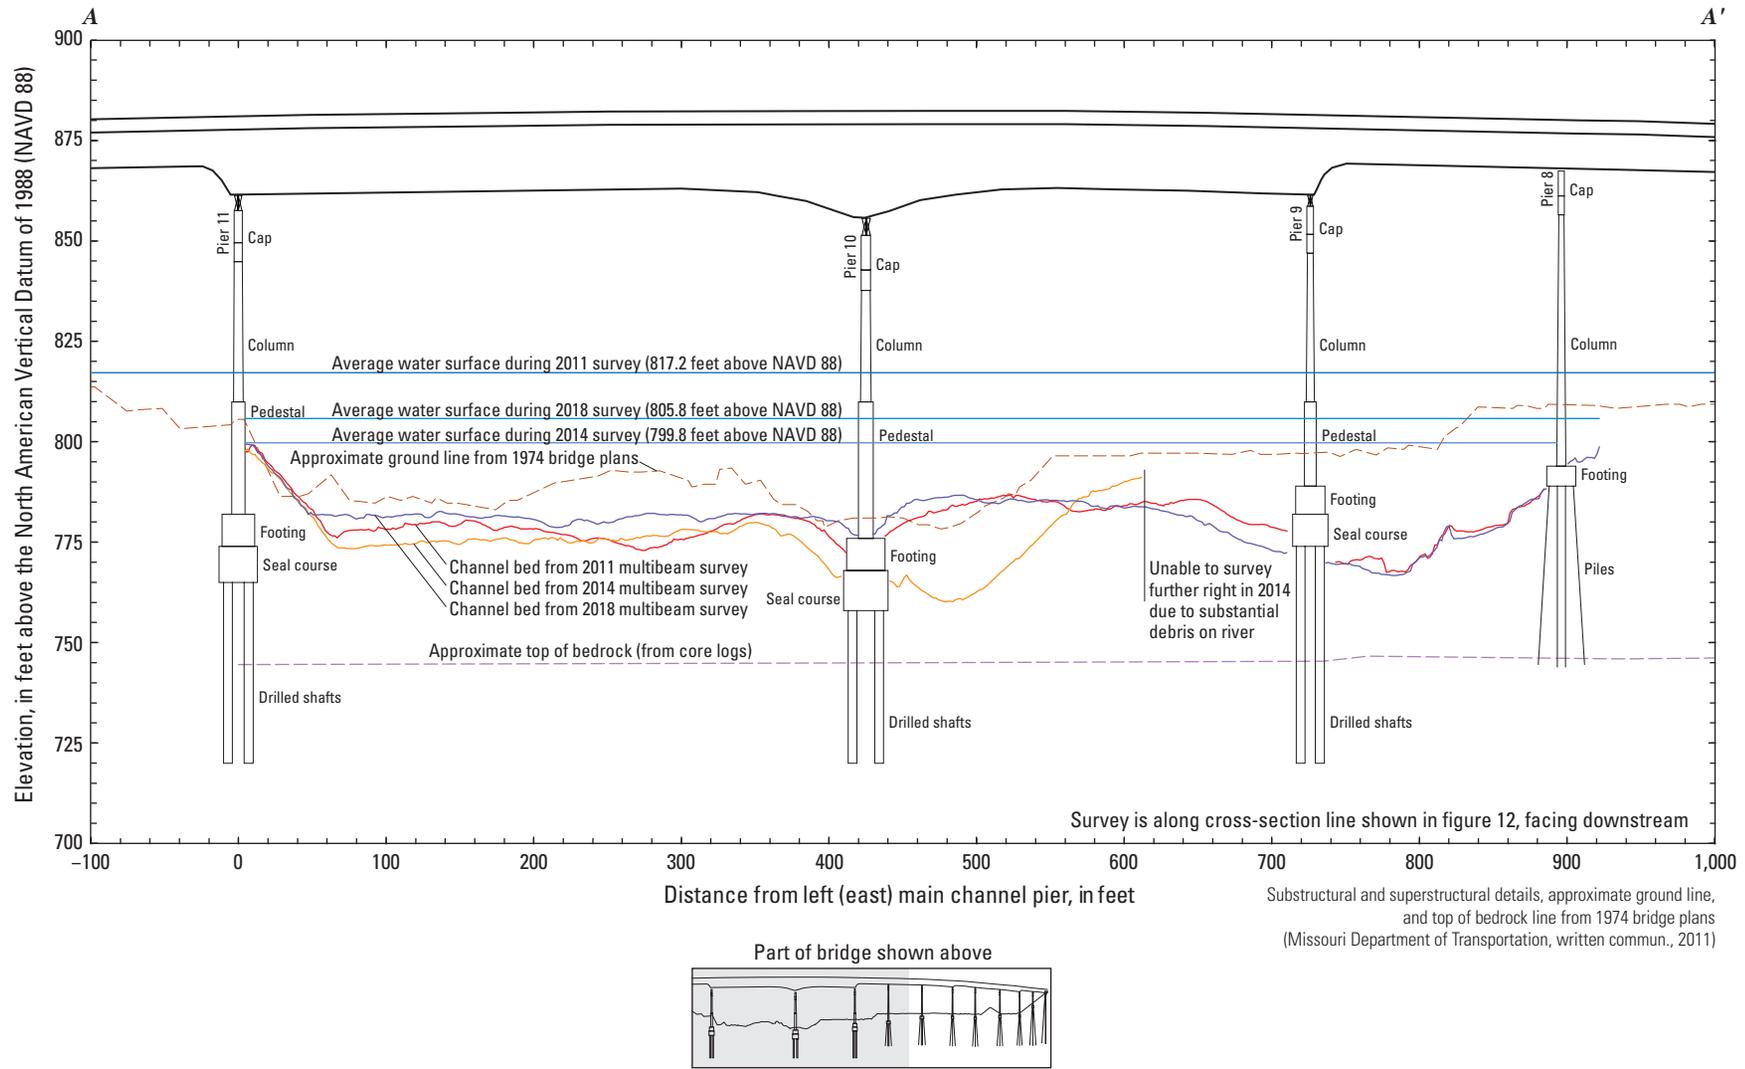
Figure 14. Key features, substructural and superstructural details, and surveyed channel bed of dual bridge structure A3664 on U.S. Highway 36 crossing the Missouri River at St. Joseph, Missouri.

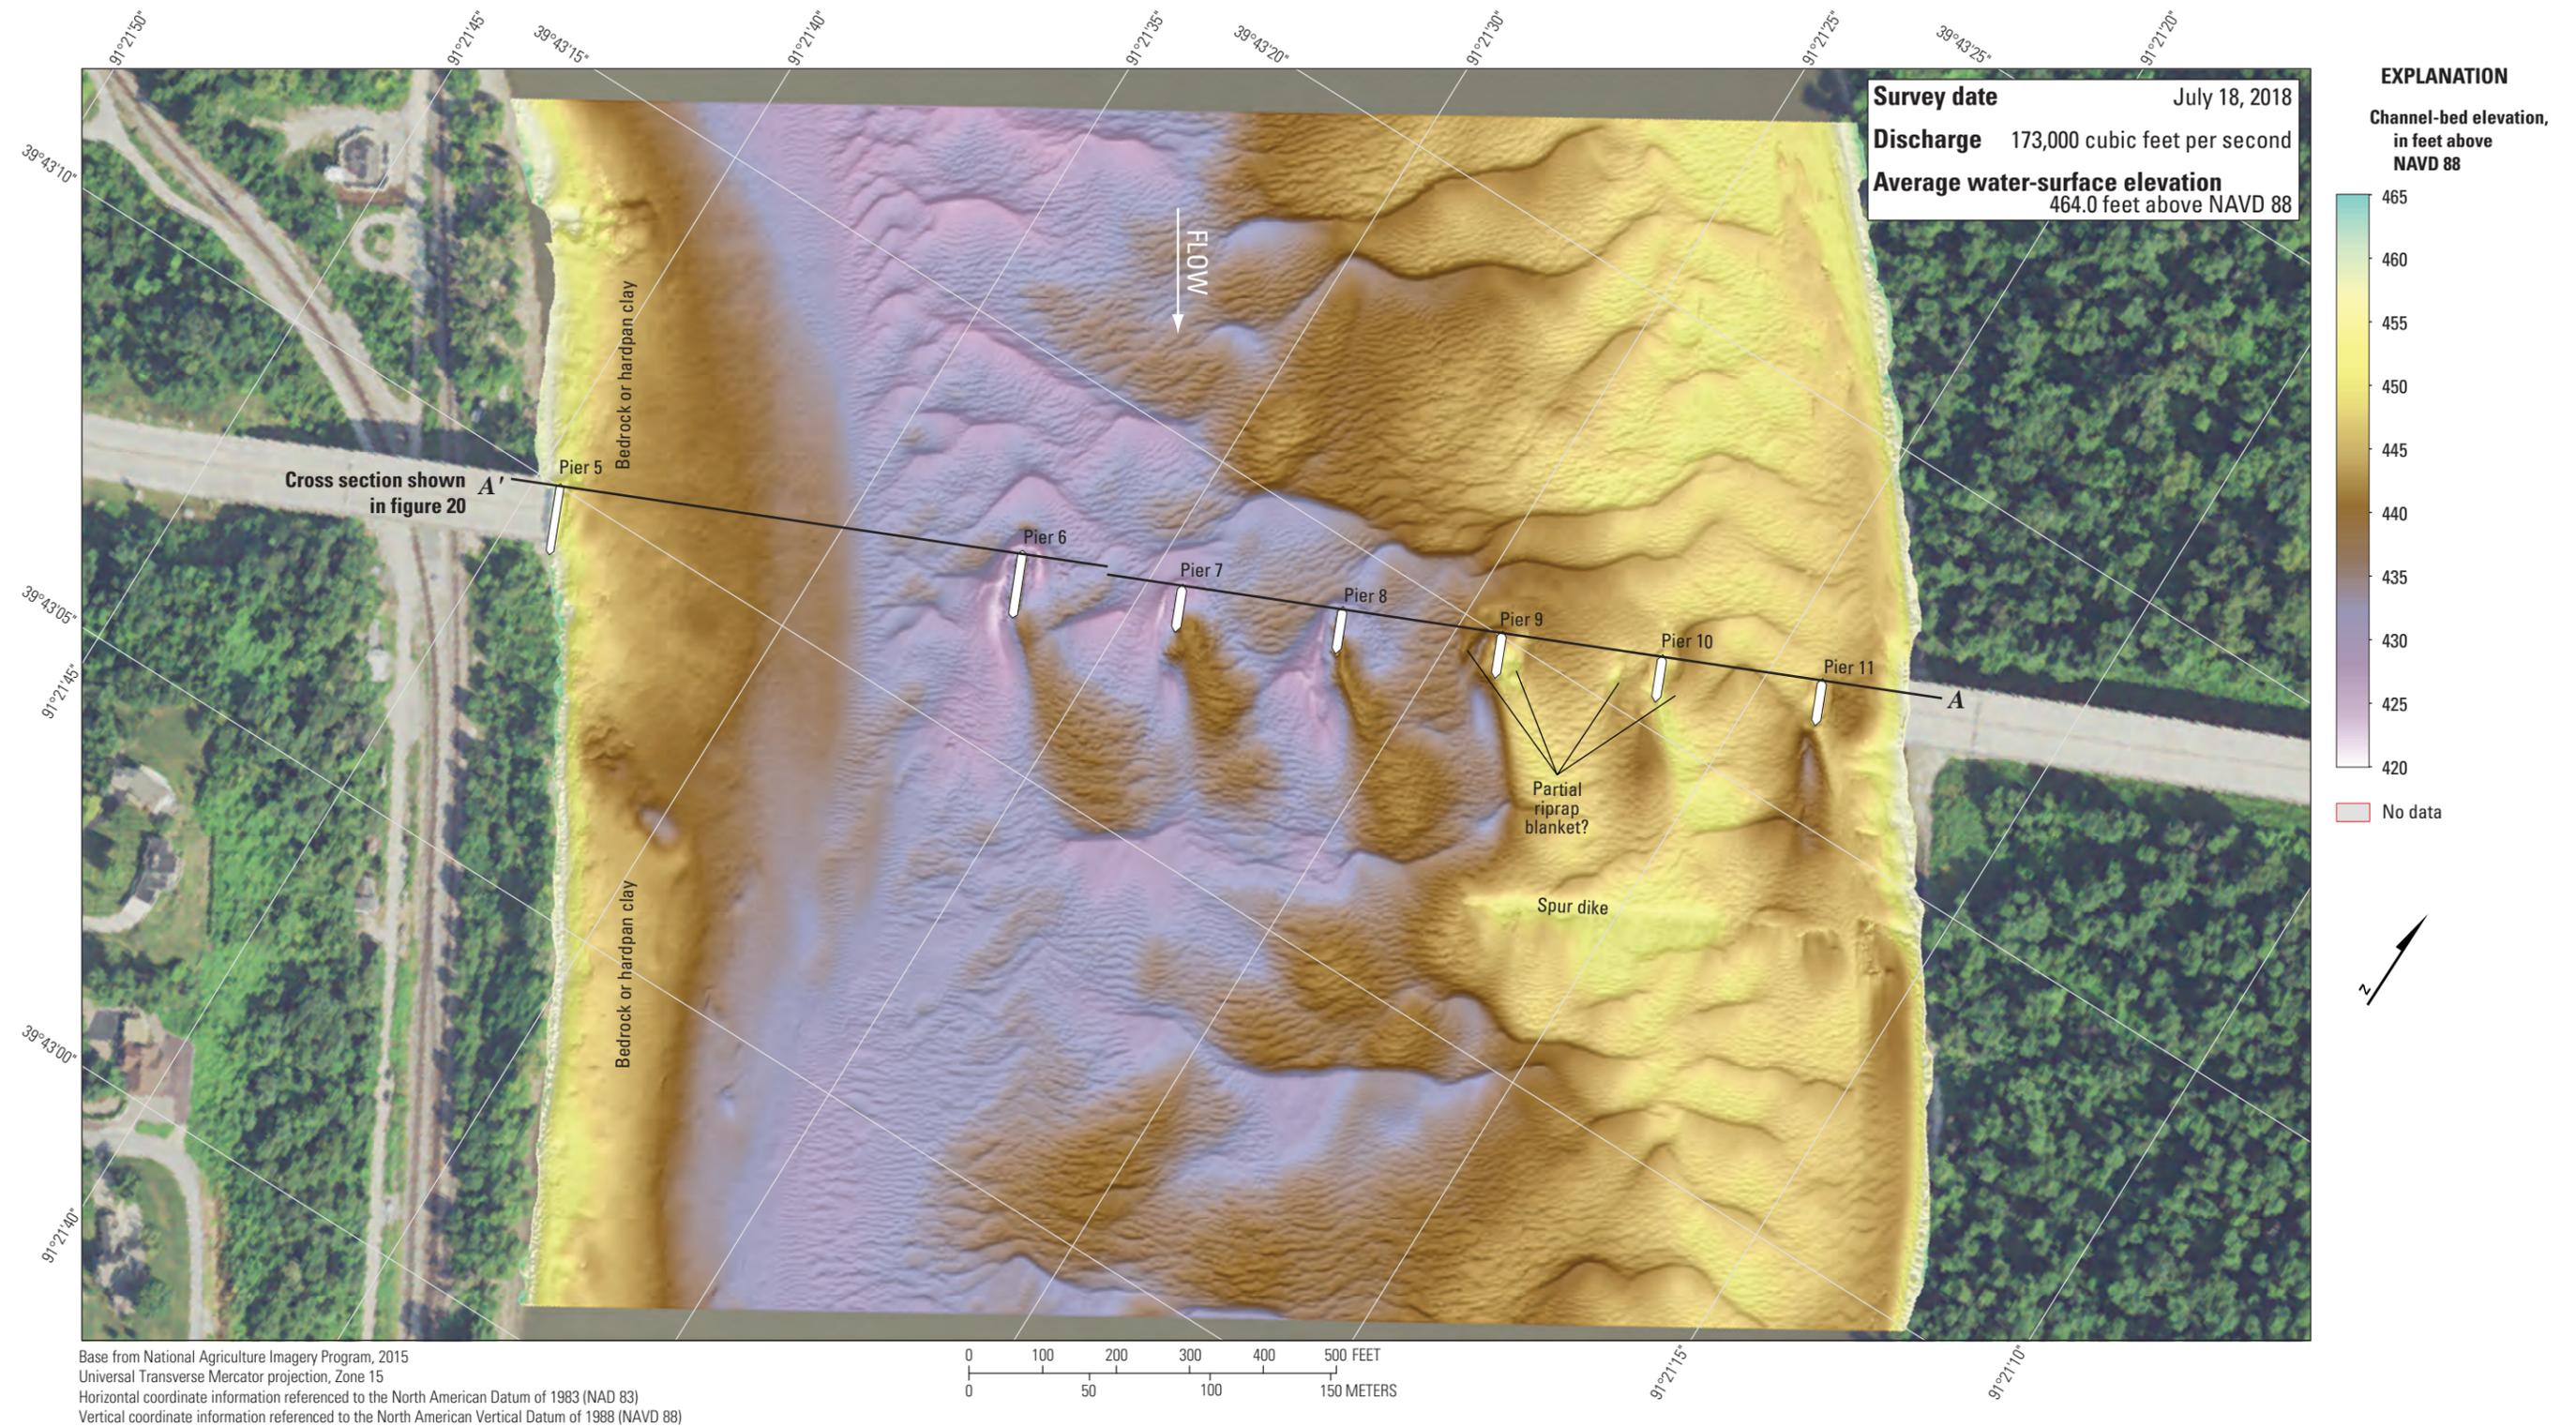
Figure 18. Bathymetric survey of the Mississippi River channel near structure A5054 on Interstate 72 at Hannibal, Missouri.

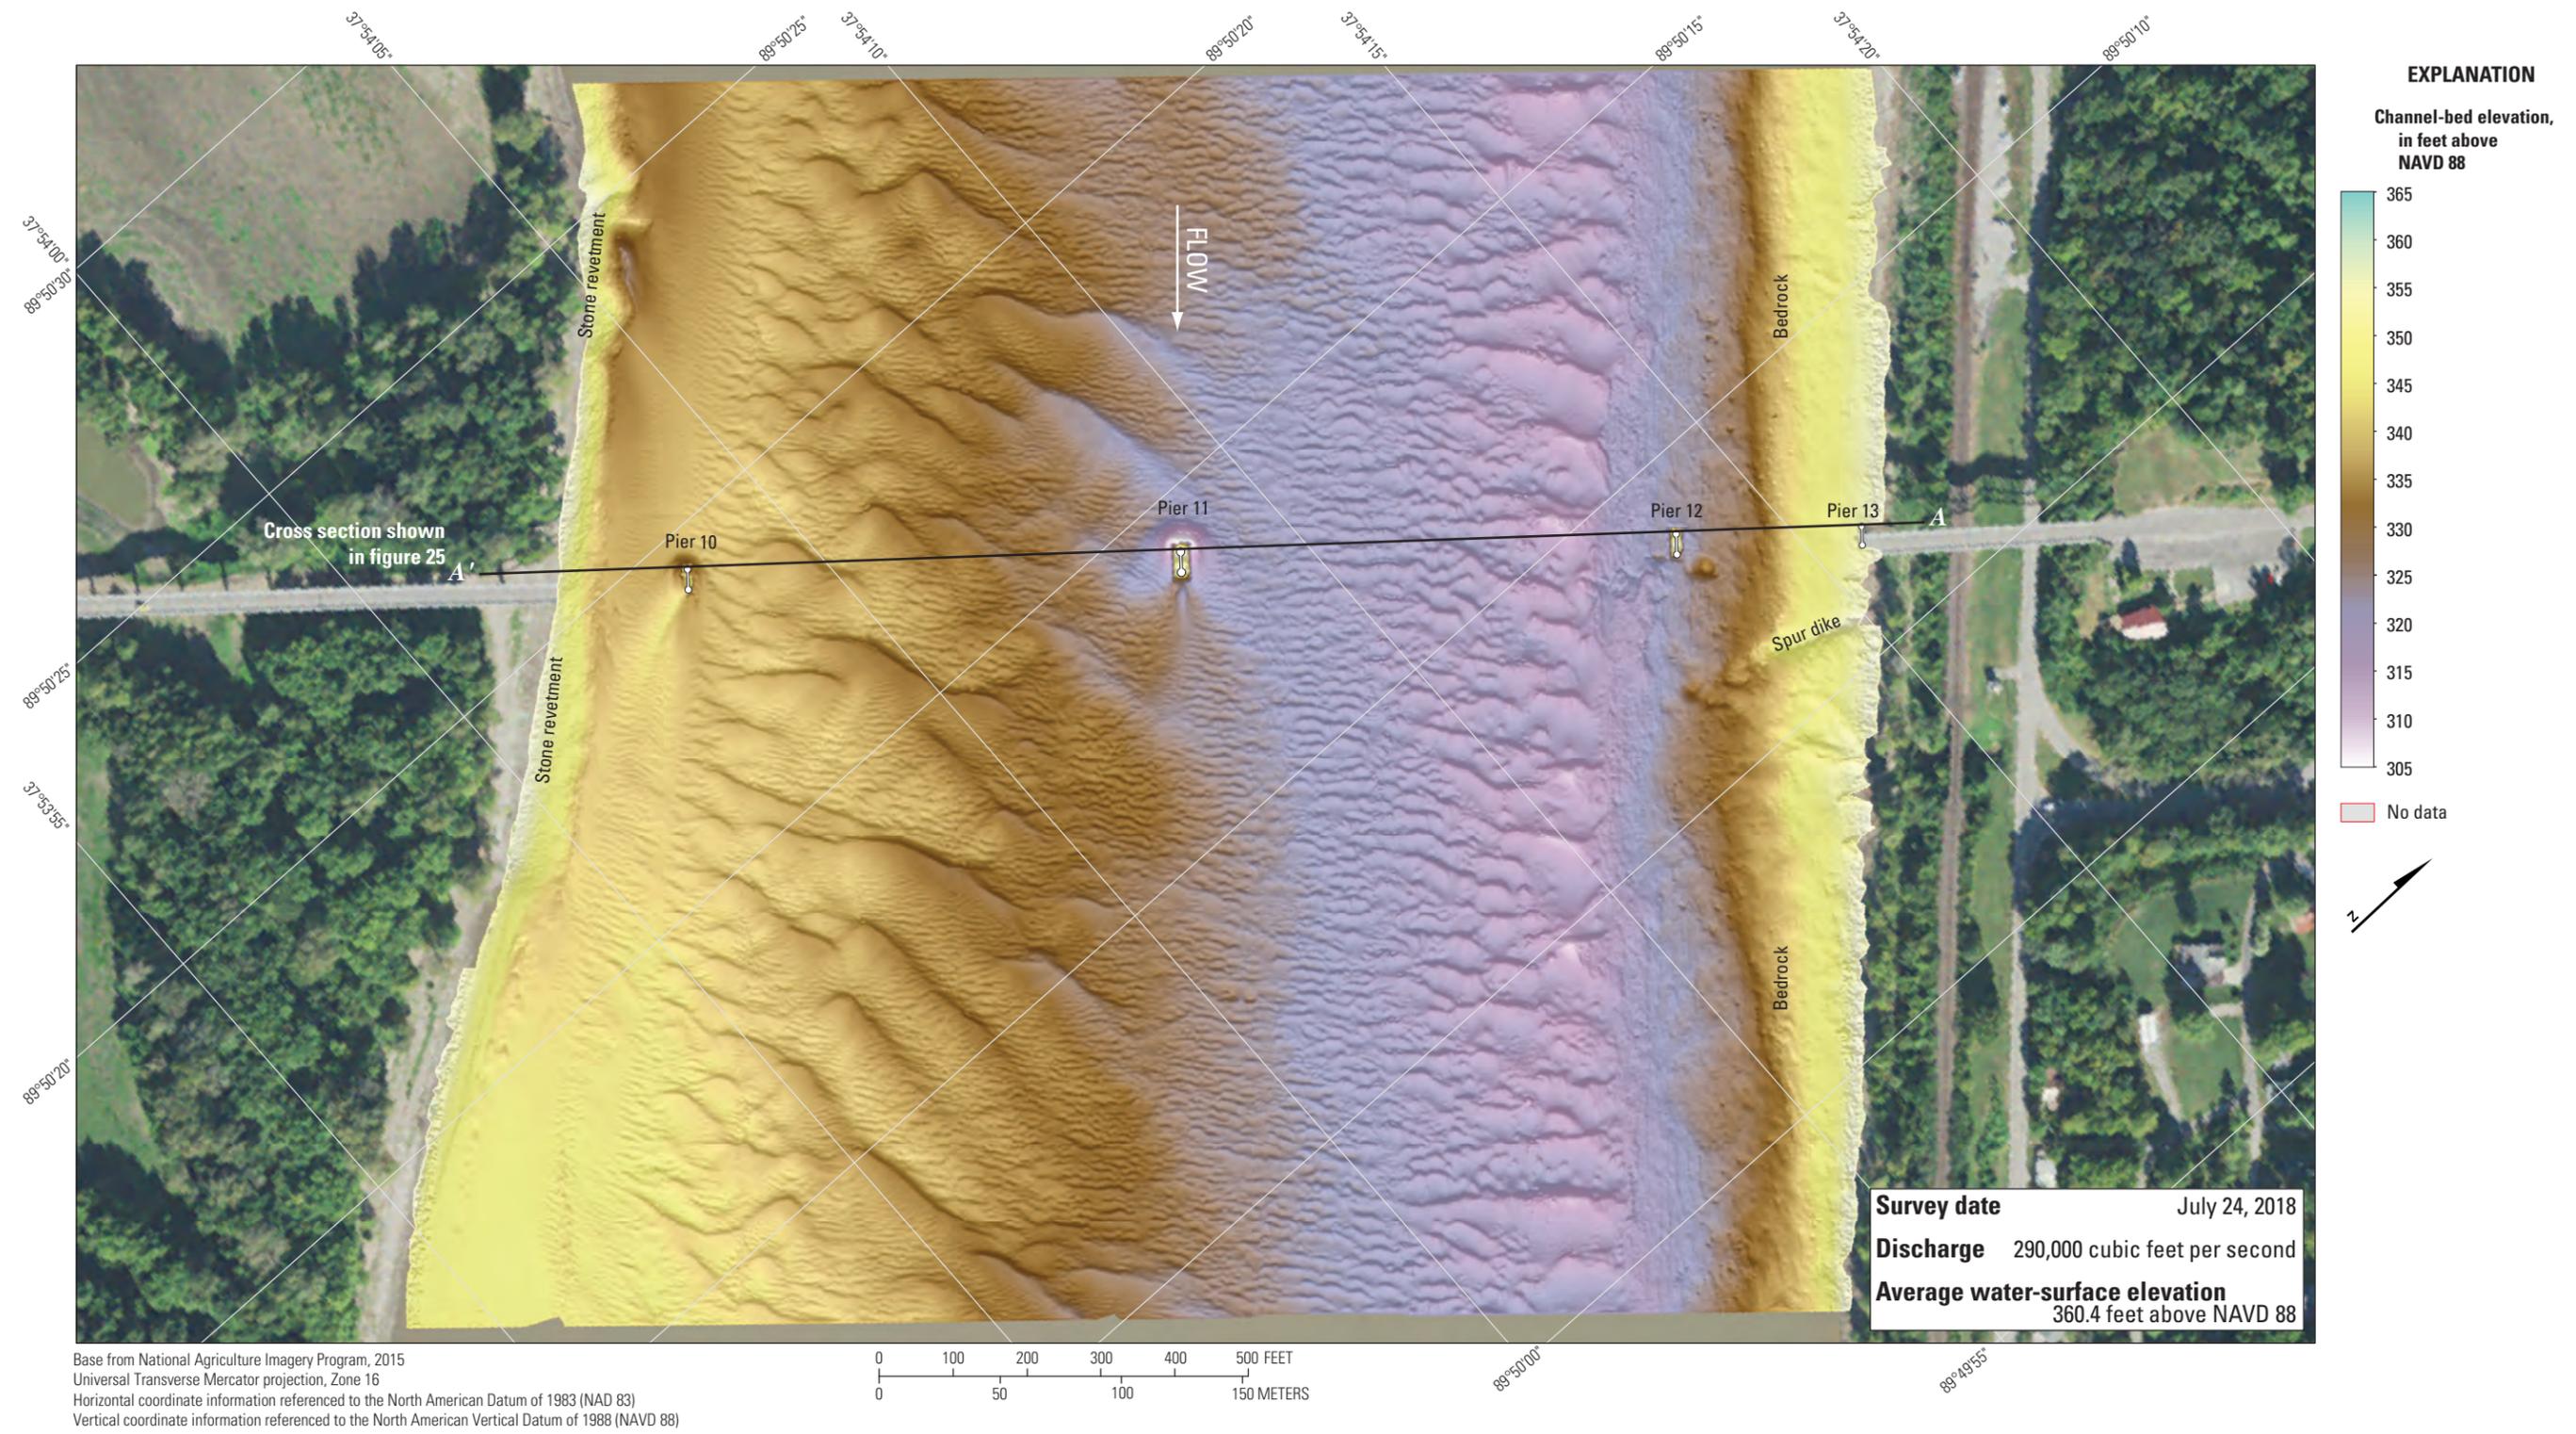
observation, even when designed to be exposed. The surveyed bed generally was lower than the original ground line from 1940 bridge plans (Missouri Department of Transportation, written commun., 2000) between piers 9 and 10 and between piers 11 and 13, and higher than the original ground line between piers 10 and 11 (fig. 25). The surveyed bed was approximately the same as the bed from the Level 2 scour survey in 2000 (Huizinga and Rydlund, 2004), except on the left bank (fig. 25); however, the ground line from the Level 2 bridge scour assessment was along the downstream side of the bridge and may have incorporated part of the downstream spur dike (fig. 23).

Figure 23. Bathymetric survey of the Mississippi River channel near structure L0135 on State Highway 51 at Chester, Illinois.

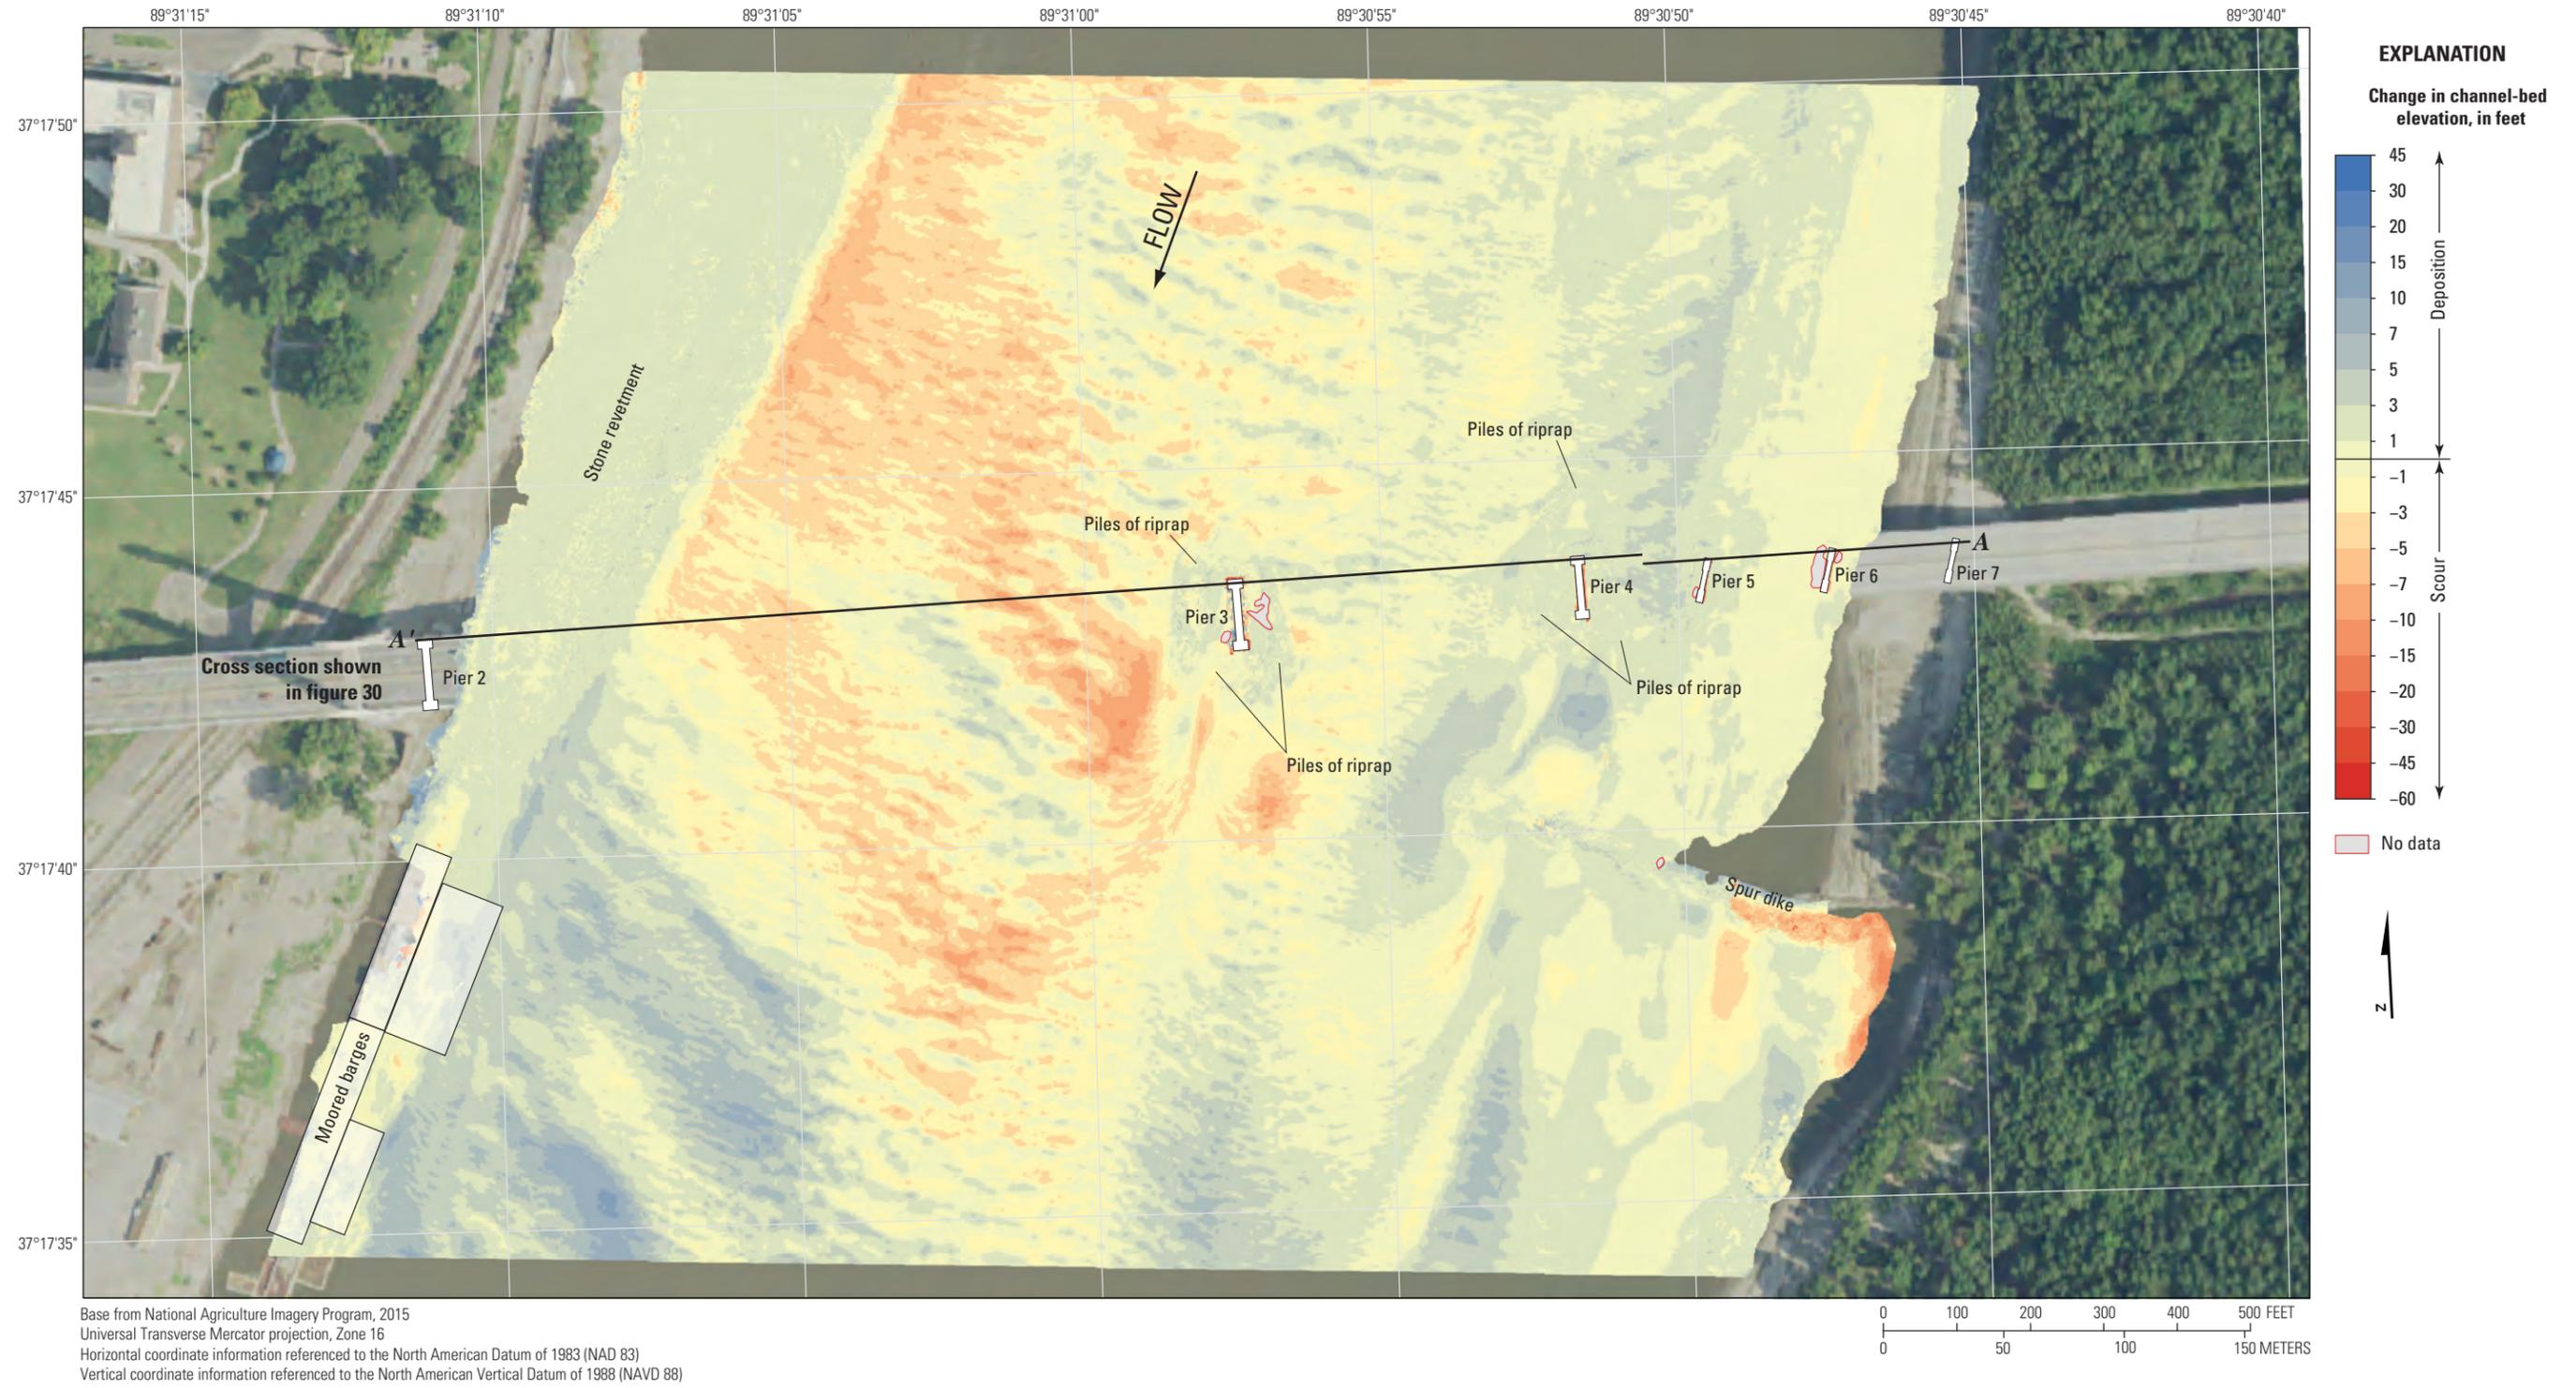
The difference between the survey on July 25, 2018, and the previous survey on June 10, 2014 (fig. 31), indicates a general balance between scour and deposition (an average difference of +0.21 ft between the bathymetric surfaces) throughout the reach from 2014 to 2018 (table 8). The net volume of cut in the reach from 2014 to 2018 was about 108,300 yd³, and the net volume of fill was about 132,400 yd³, resulting in a net gain of about 24,100 yd³ of sediment. Scour was observed in the upstream right and downstream middle of the channel, and downstream from the spur dike on the downstream left bank (fig. 31). Minor deposition was observed on the stone revetment on the upstream right side of the channel, and moderate deposition of as much as 7 ft was observed along the toe of the right bank downstream, as well as along the left side of the

Figure 31. Difference between surfaces created from bathymetric surveys of the Mississippi River channel near structure A5076 on State Highway 34 at Cape Girardeau, Missouri, on July 25, 2018, and June 10, 2014.

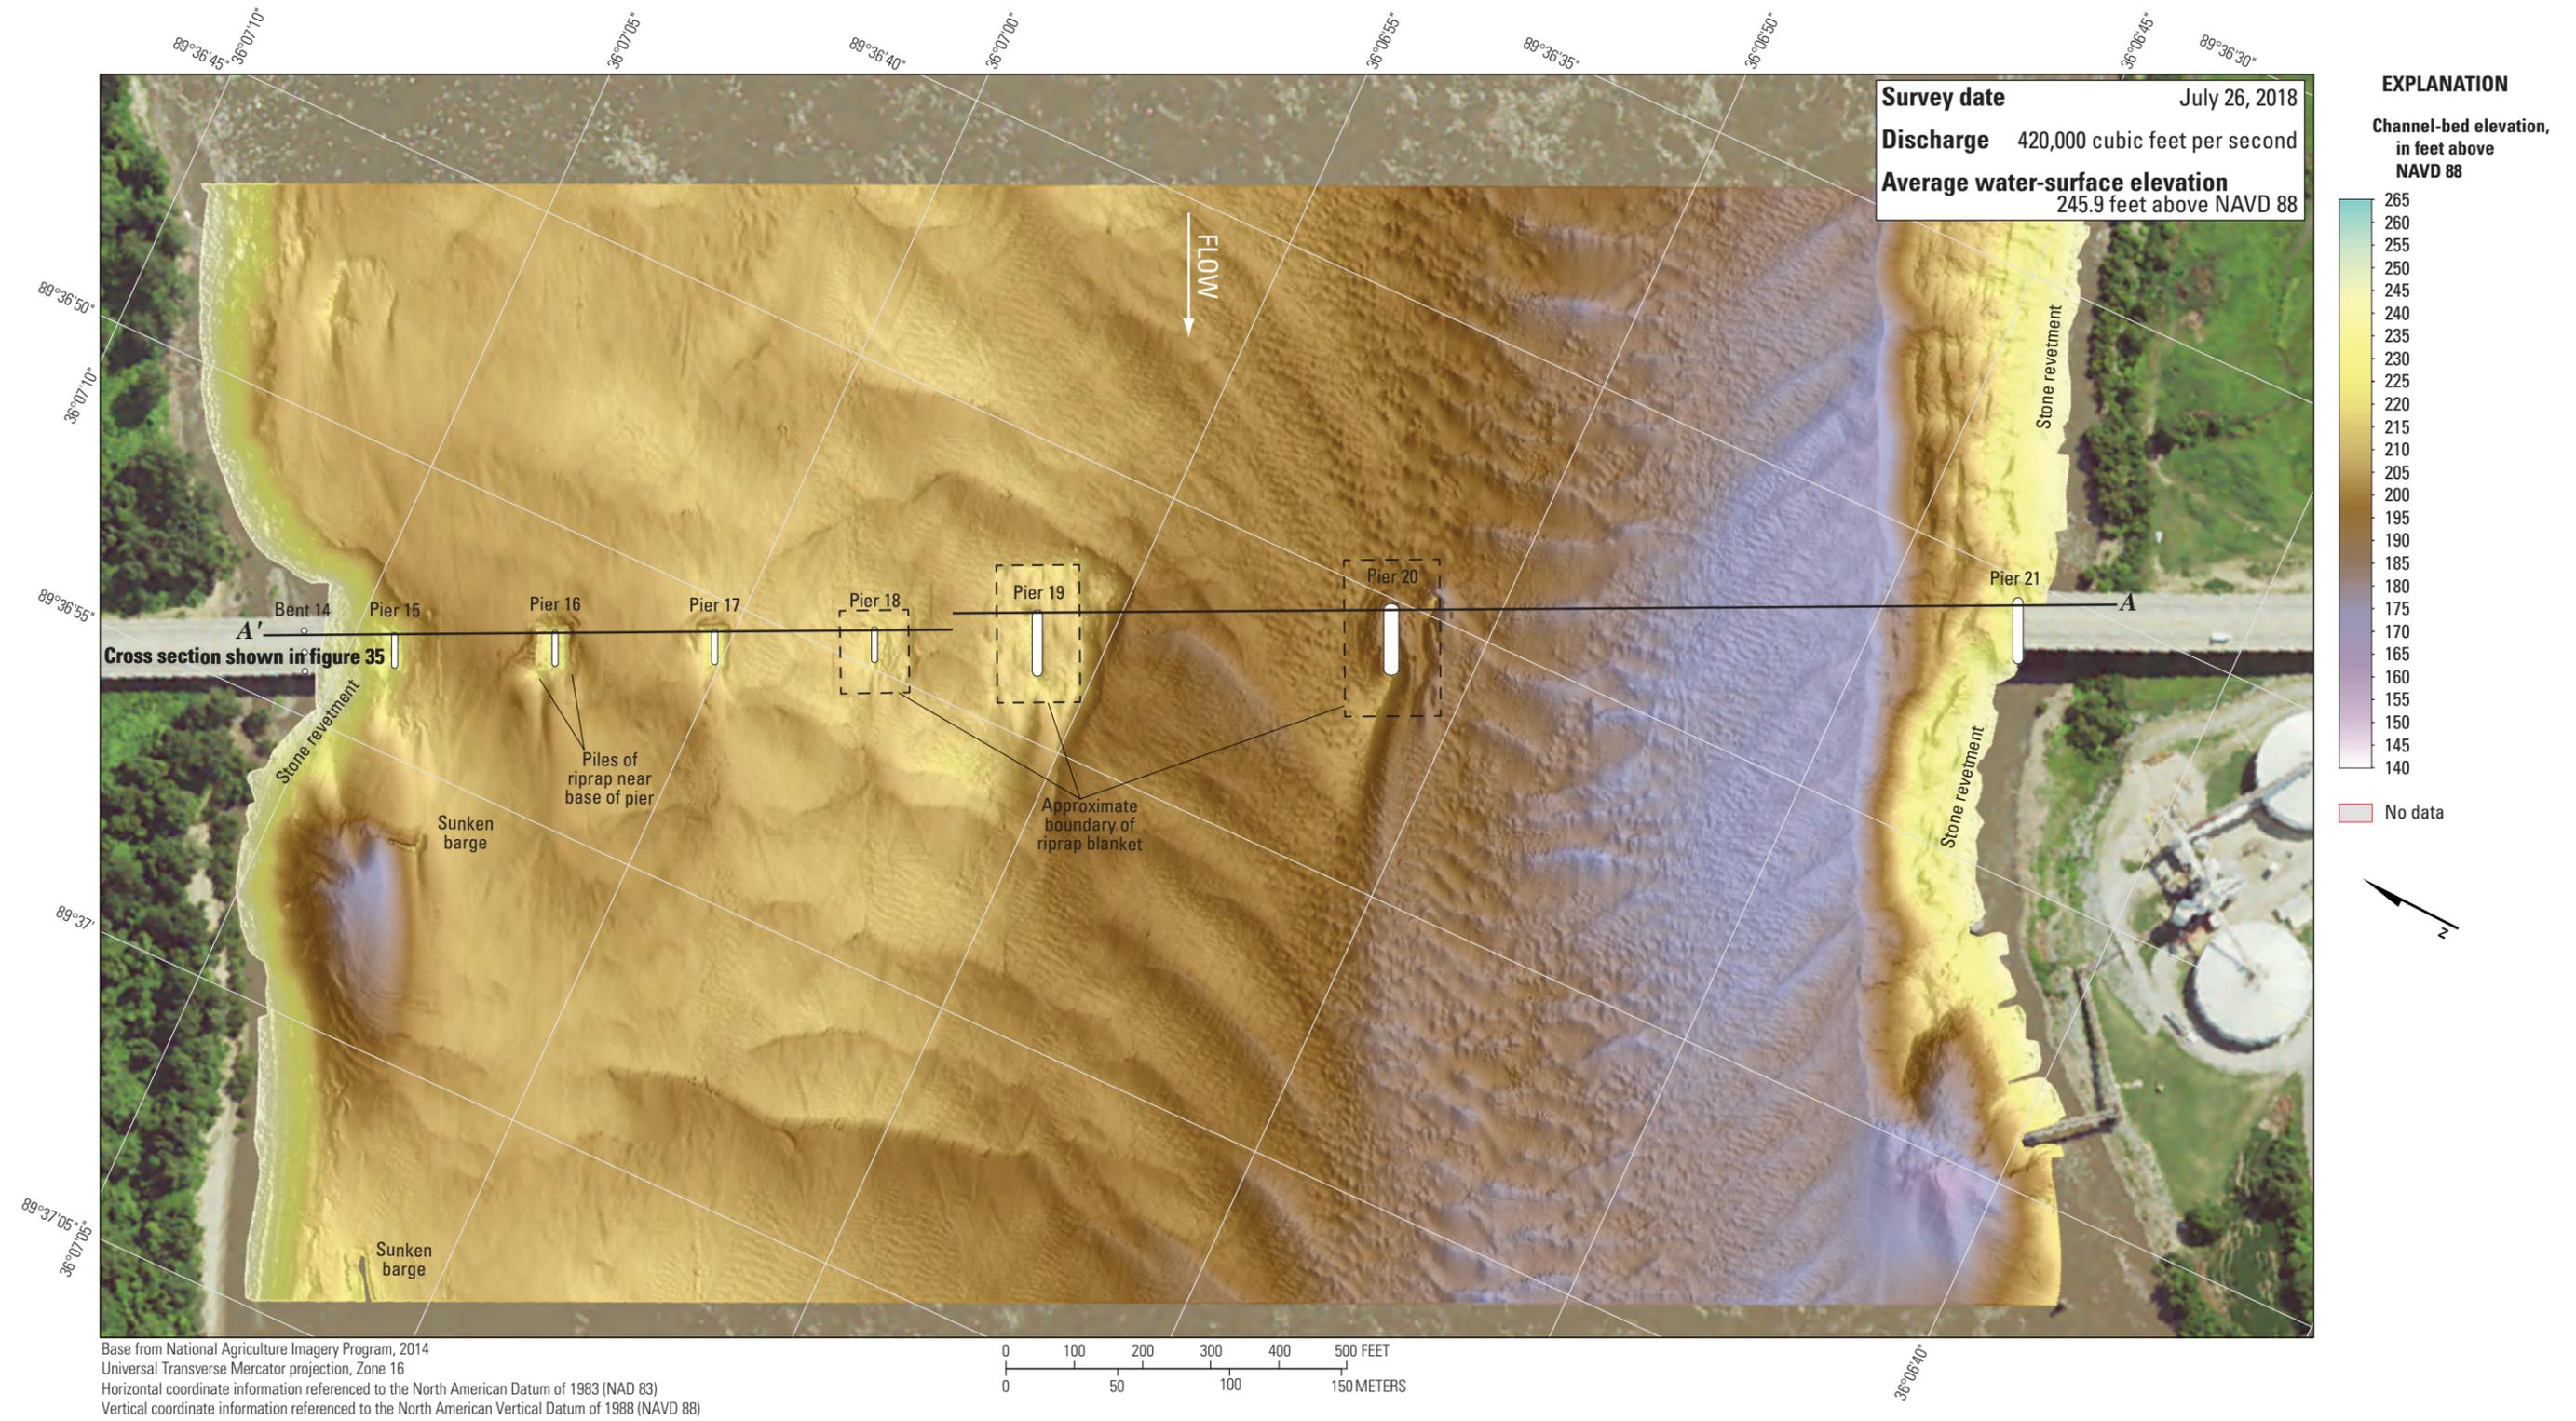
into flow. The cross section along the upstream bridge face (fig. 35) shows a localized high bed elevation near the left edge of the riprap blanket at pier 20 that coincides with the observed object. Pier 15 is embedded in the stone revetment along the right bank (figs. 33, 35, 1.8E, 1.8F), and pier 16 seems to be surrounded by several almost random piles of riprap, which may help mitigate scour (figs. 33, 35, 1.8C, 1.8D).

Figure 33. Bathymetric survey of the Mississippi River channel near structure A1700 on Interstate 155 near Caruthersville, Missouri.
