Bathymetric and Velocimetric Surveys at Highway Bridges Crossing the Missouri River near Kansas City, Missouri, August 2019, August 2020, and October 2020

Scientific Investigations Report 2021–5098

By Richard J. Huizinga

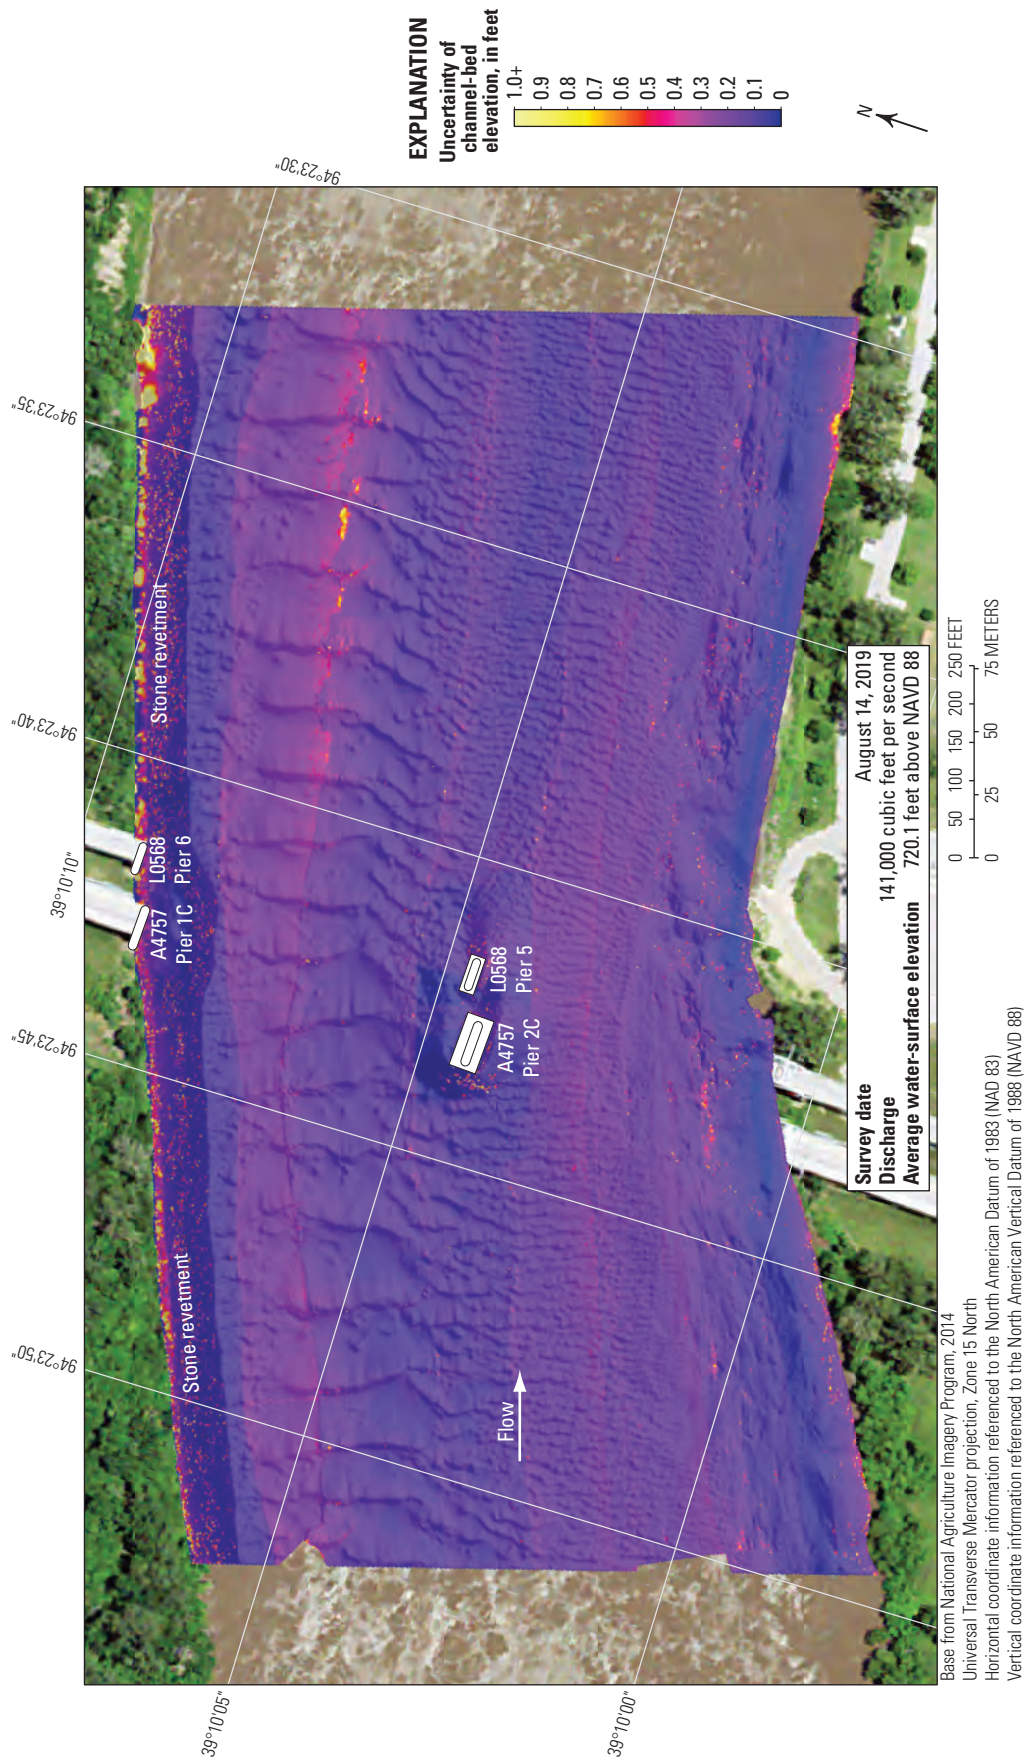
The survey at structures A4757 and L0568 on State Highway 291 had the third-highest maximum value of uncertainty, as well as the lowest percentage of bathymetry points with an uncertainty of less than the various thresholds ([table 4](#)). The survey was obtained with relatively smooth longitudinal swaths ([fig. 5](#)), which was the case at nearly all the sites surveyed in this study. The primary anomalies at this site were observed along the banks, where the sonar was used in an electronically tilted configuration to extend the potential coverage in these areas, resulting in high uncertainty values. Secondary anomalies at this site were in the downstream mid-channel area where thalweg migration and insufficient overlap of the swath outer beams resulted in high uncertainty values. Generally, the magnitude and distribution of uncertainty observed at this site are representative of those observed at all the other surveyed sites.

Figure 5. Uncertainty of gridded bathymetric data from the Missouri River channel near structures A4757 and L0568 on State Highway 291 near Kansas City, Missouri.

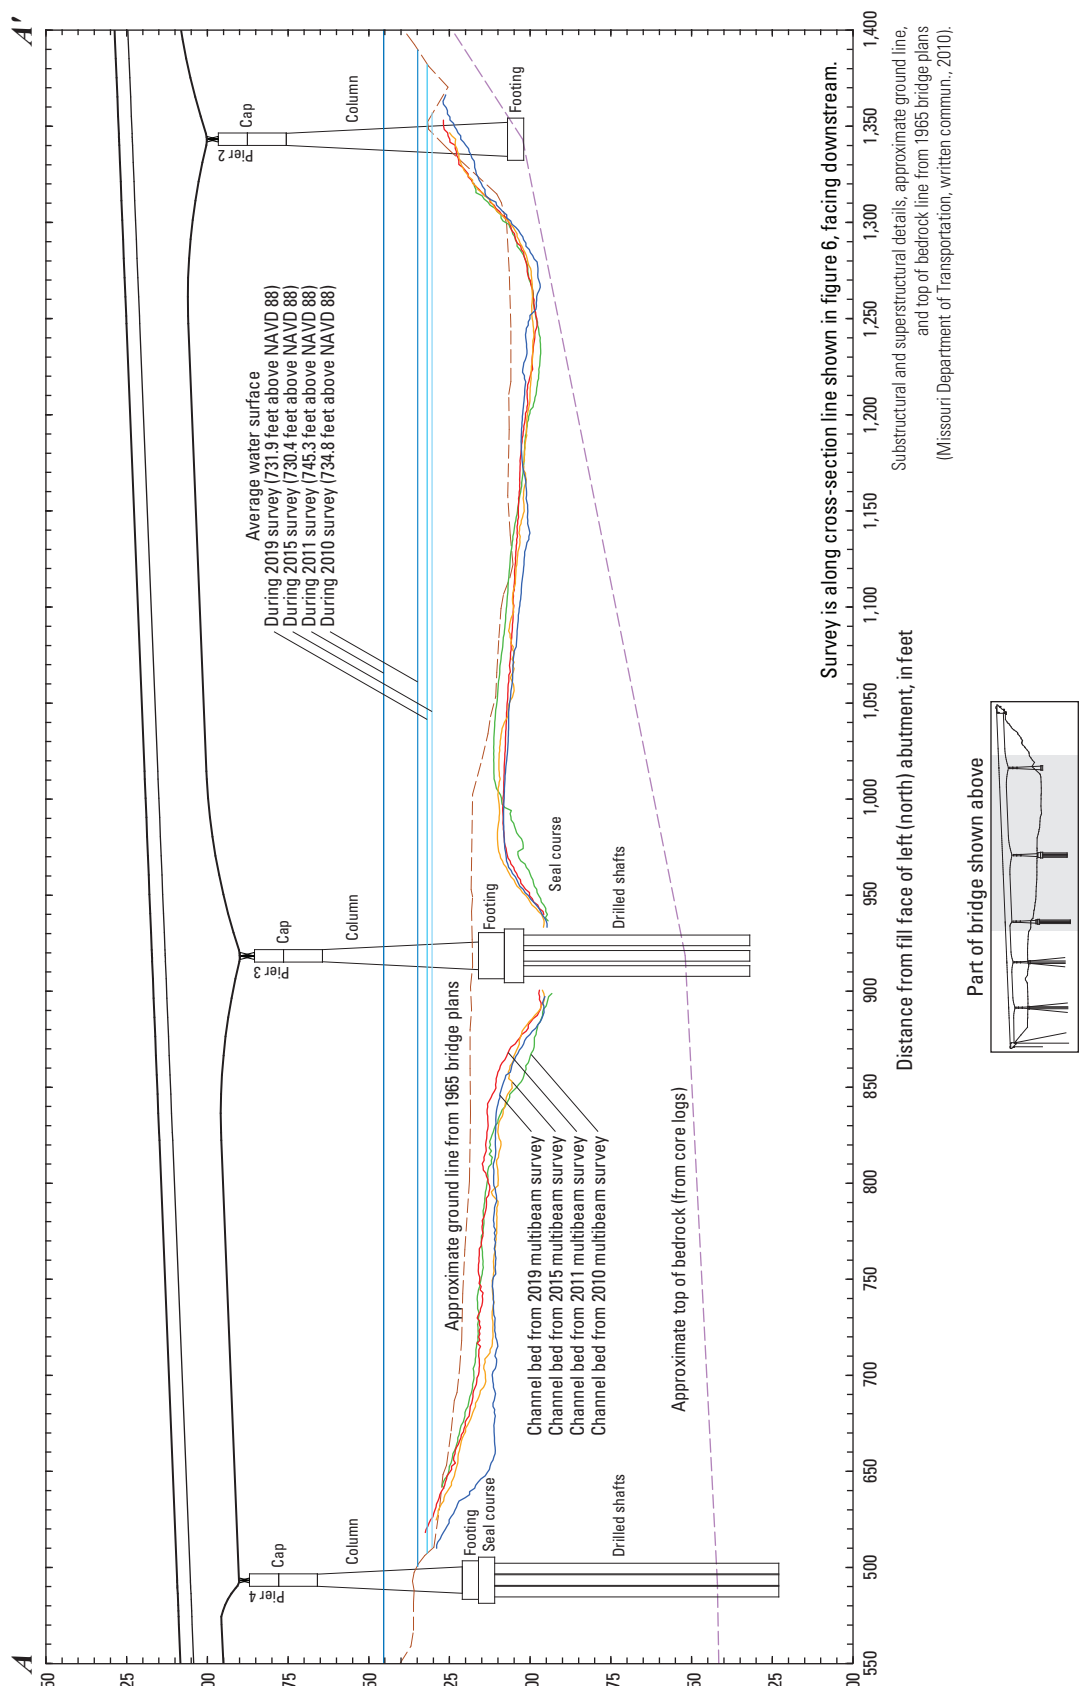
The scour hole near main channel pier 3 had a minimum channel-bed elevation of about 692 ft ([table 6](#)), about 18 ft below the average channel bed immediately upstream from the pier (the value of the “depth of scour hole from upstream channel bed” in [table 6](#); [fig. 6](#)), and about 10 ft below the elevation of the bottom of the pier seal course of 702.28 ft ([fig. 8](#); [table 6](#)). Information from bridge plans indicates that pier 3 is founded on shafts drilled 20 ft into bedrock, and about 40 ft of bed material are between the bottom of the scour hole and bedrock at the upstream face of pier 3 ([fig. 8](#); [table 6](#)).

Figure 8. Key features, substructural and superstructural details, and surveyed channel bed of structure A1800 on Interstate 635 crossing the Missouri River in Kansas City, Missouri.

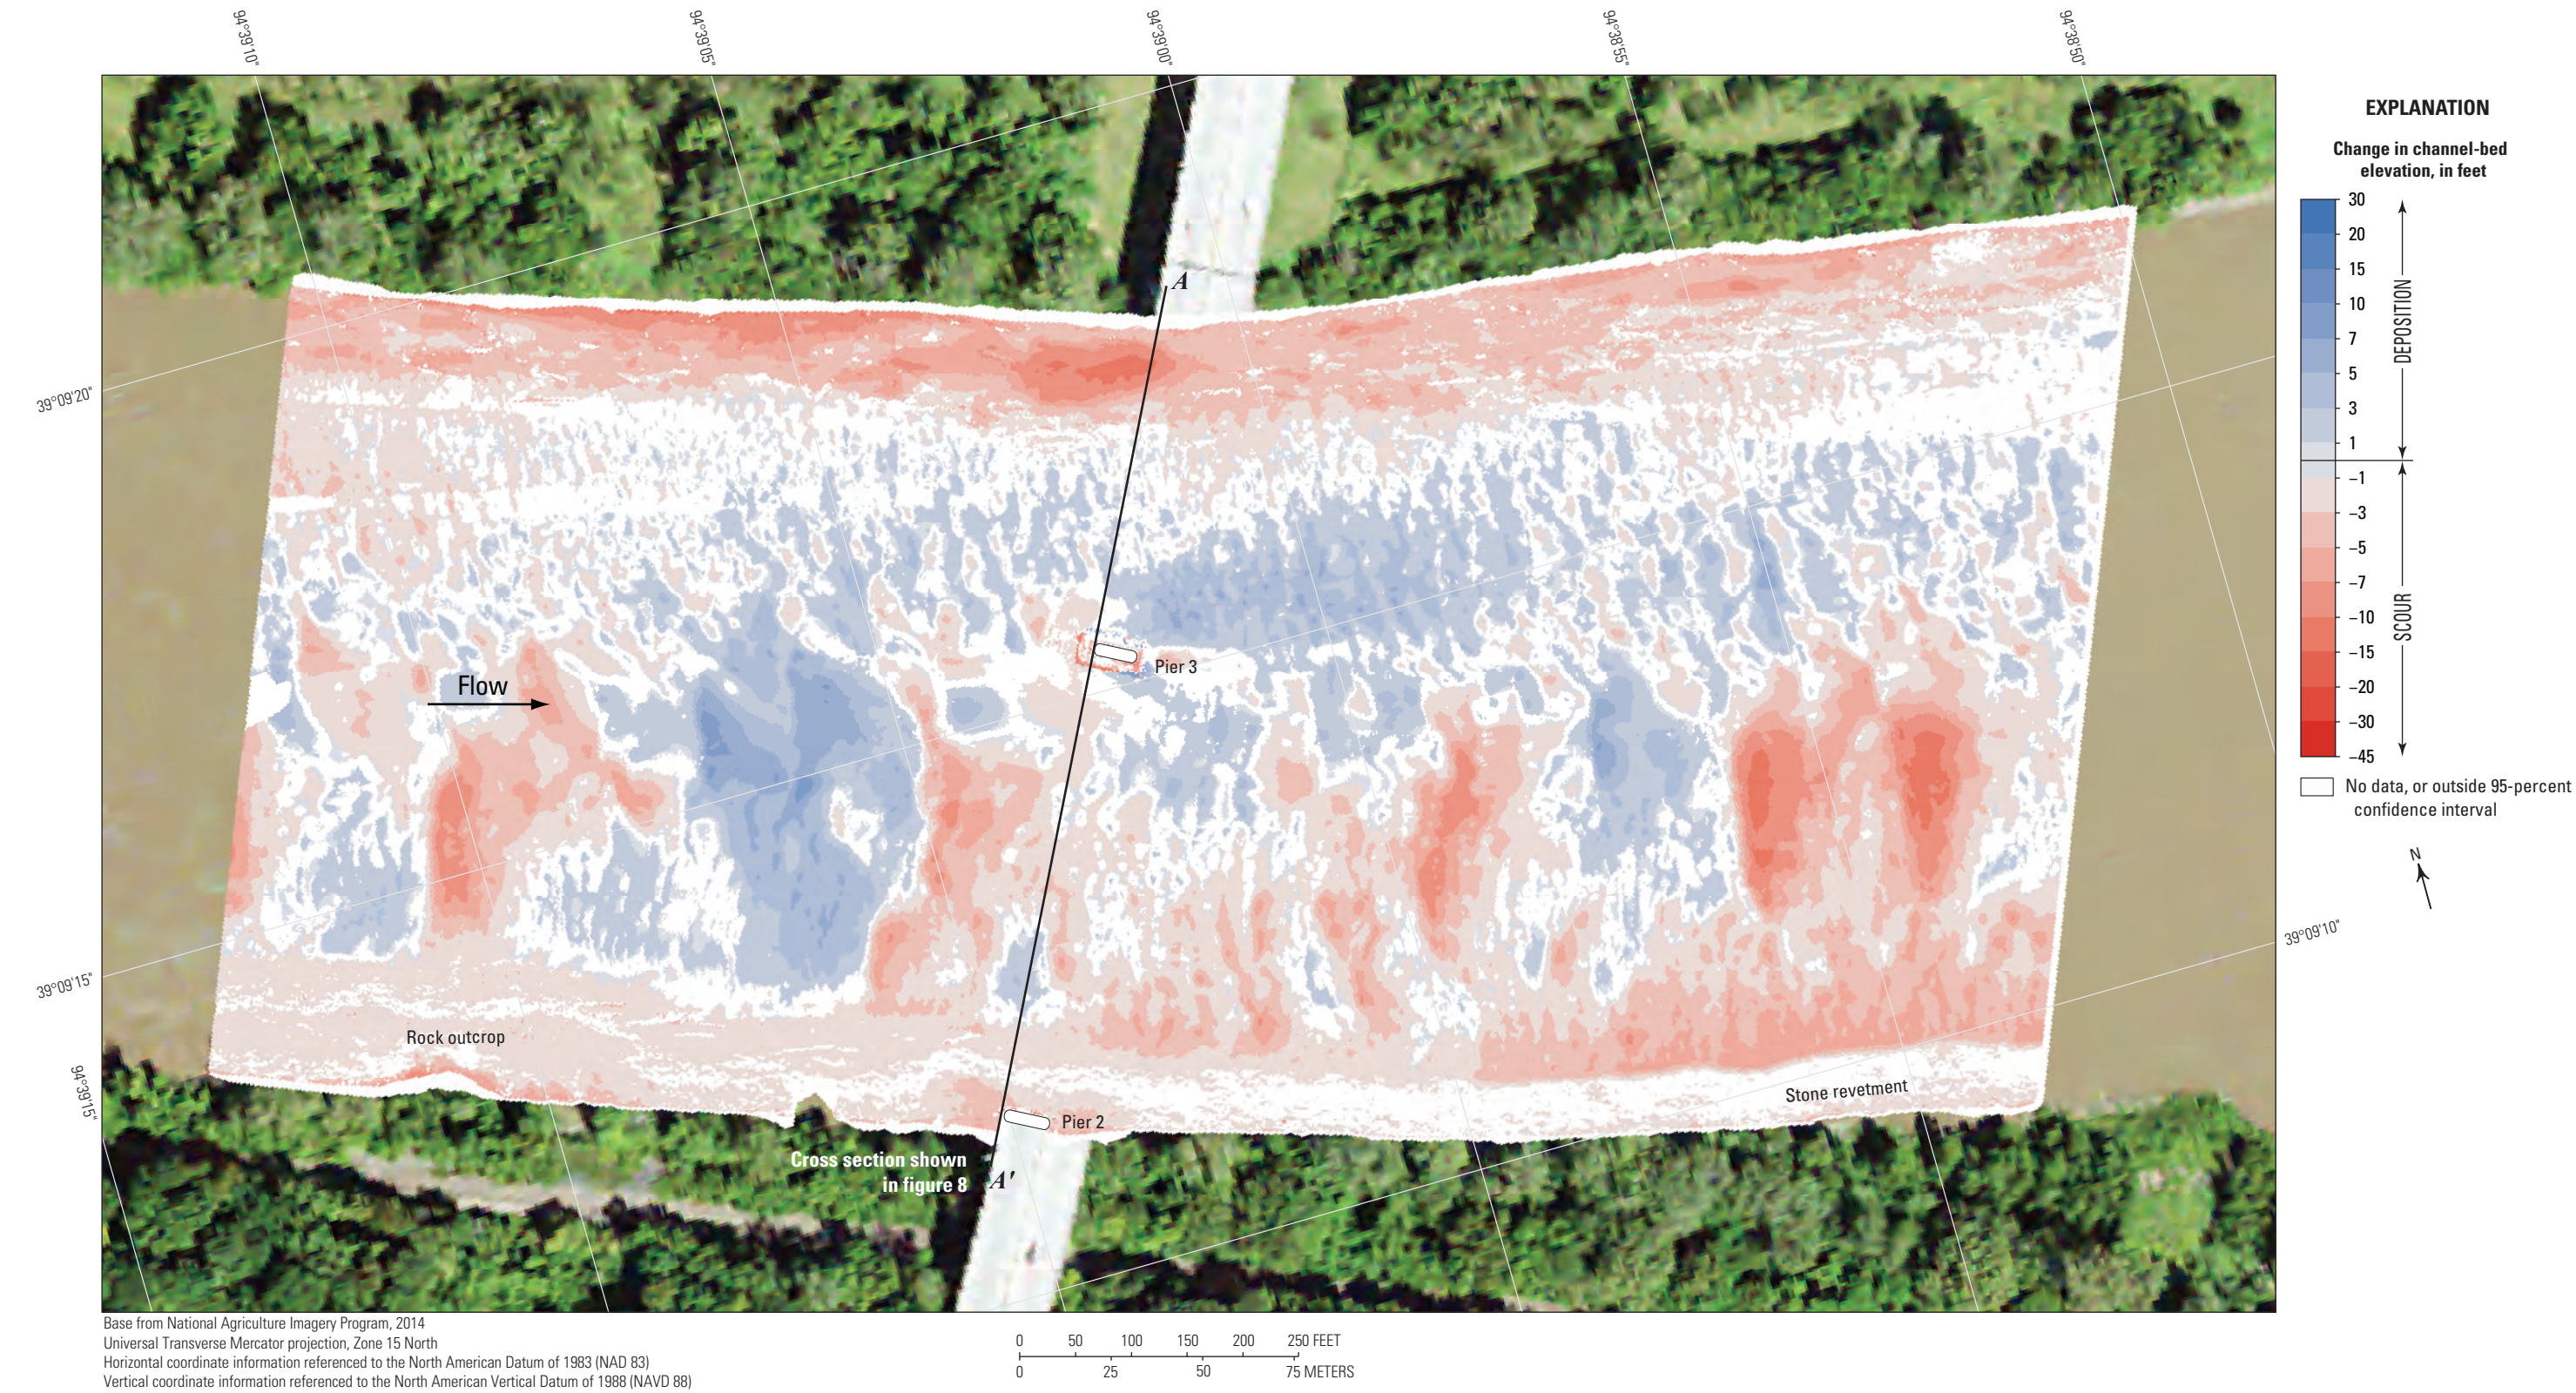
Figure 9. Difference between surfaces created from bathymetric surveys of the Missouri River channel near structure A1800 on Interstate 635 in Kansas City, Missouri, on August 13, 2019, and June 2, 2015.

the reach, scour is dominant (fig. 9). The average difference between the bathymetric surfaces (the statistical mean value of the gridded raster surface [fig. 9] created from the difference between the 2019 and 2015 gridded raster bathymetric surfaces) was -1.59 ft (table 7), indicating moderate channel degradation between the 2015 and 2019 surveys. The net volume of cut in the reach from 2015 to 2019 was about $72,900$ cubic yards (yd^3), and the net volume of fill was about $20,900$ yd^3 , resulting in a net loss of about $52,000$ yd^3 of sediment between 2015 and 2019. The cross sections from the two surveys along the upstream face of the bridge are not substantially different from one another for most of the cross section, except near the left bank where the 2019 section is substantially lower than all the previous sections (fig. 8). The frequency distribution of bed elevations in 2019 also was similar to 2015 but with a higher percentage of cells at lower channel-bed elevations (fig. 7). The scour hole near pier 3 was of a very similar shape in 2019 and 2015 (fig. 8), as evidenced by the overall area of “no data” or minimal change around the pier (fig. 9). The rock outcrop on the right (south) bank showed signs of minor scour upstream from the bridge (fig. 9). Although rock ultimately is an erodible material, its rate of erosion is substantially slower than that of sand and silt (Arneson and others, 2012). The stone revetment on the downstream right (south) bank showed no signs of substantial change (fig. 9). Substantial deposition or scour apparent at the faces of the pier footing results from minor horizontal positional variances between the surveys (see “Uncertainty Estimation” section).

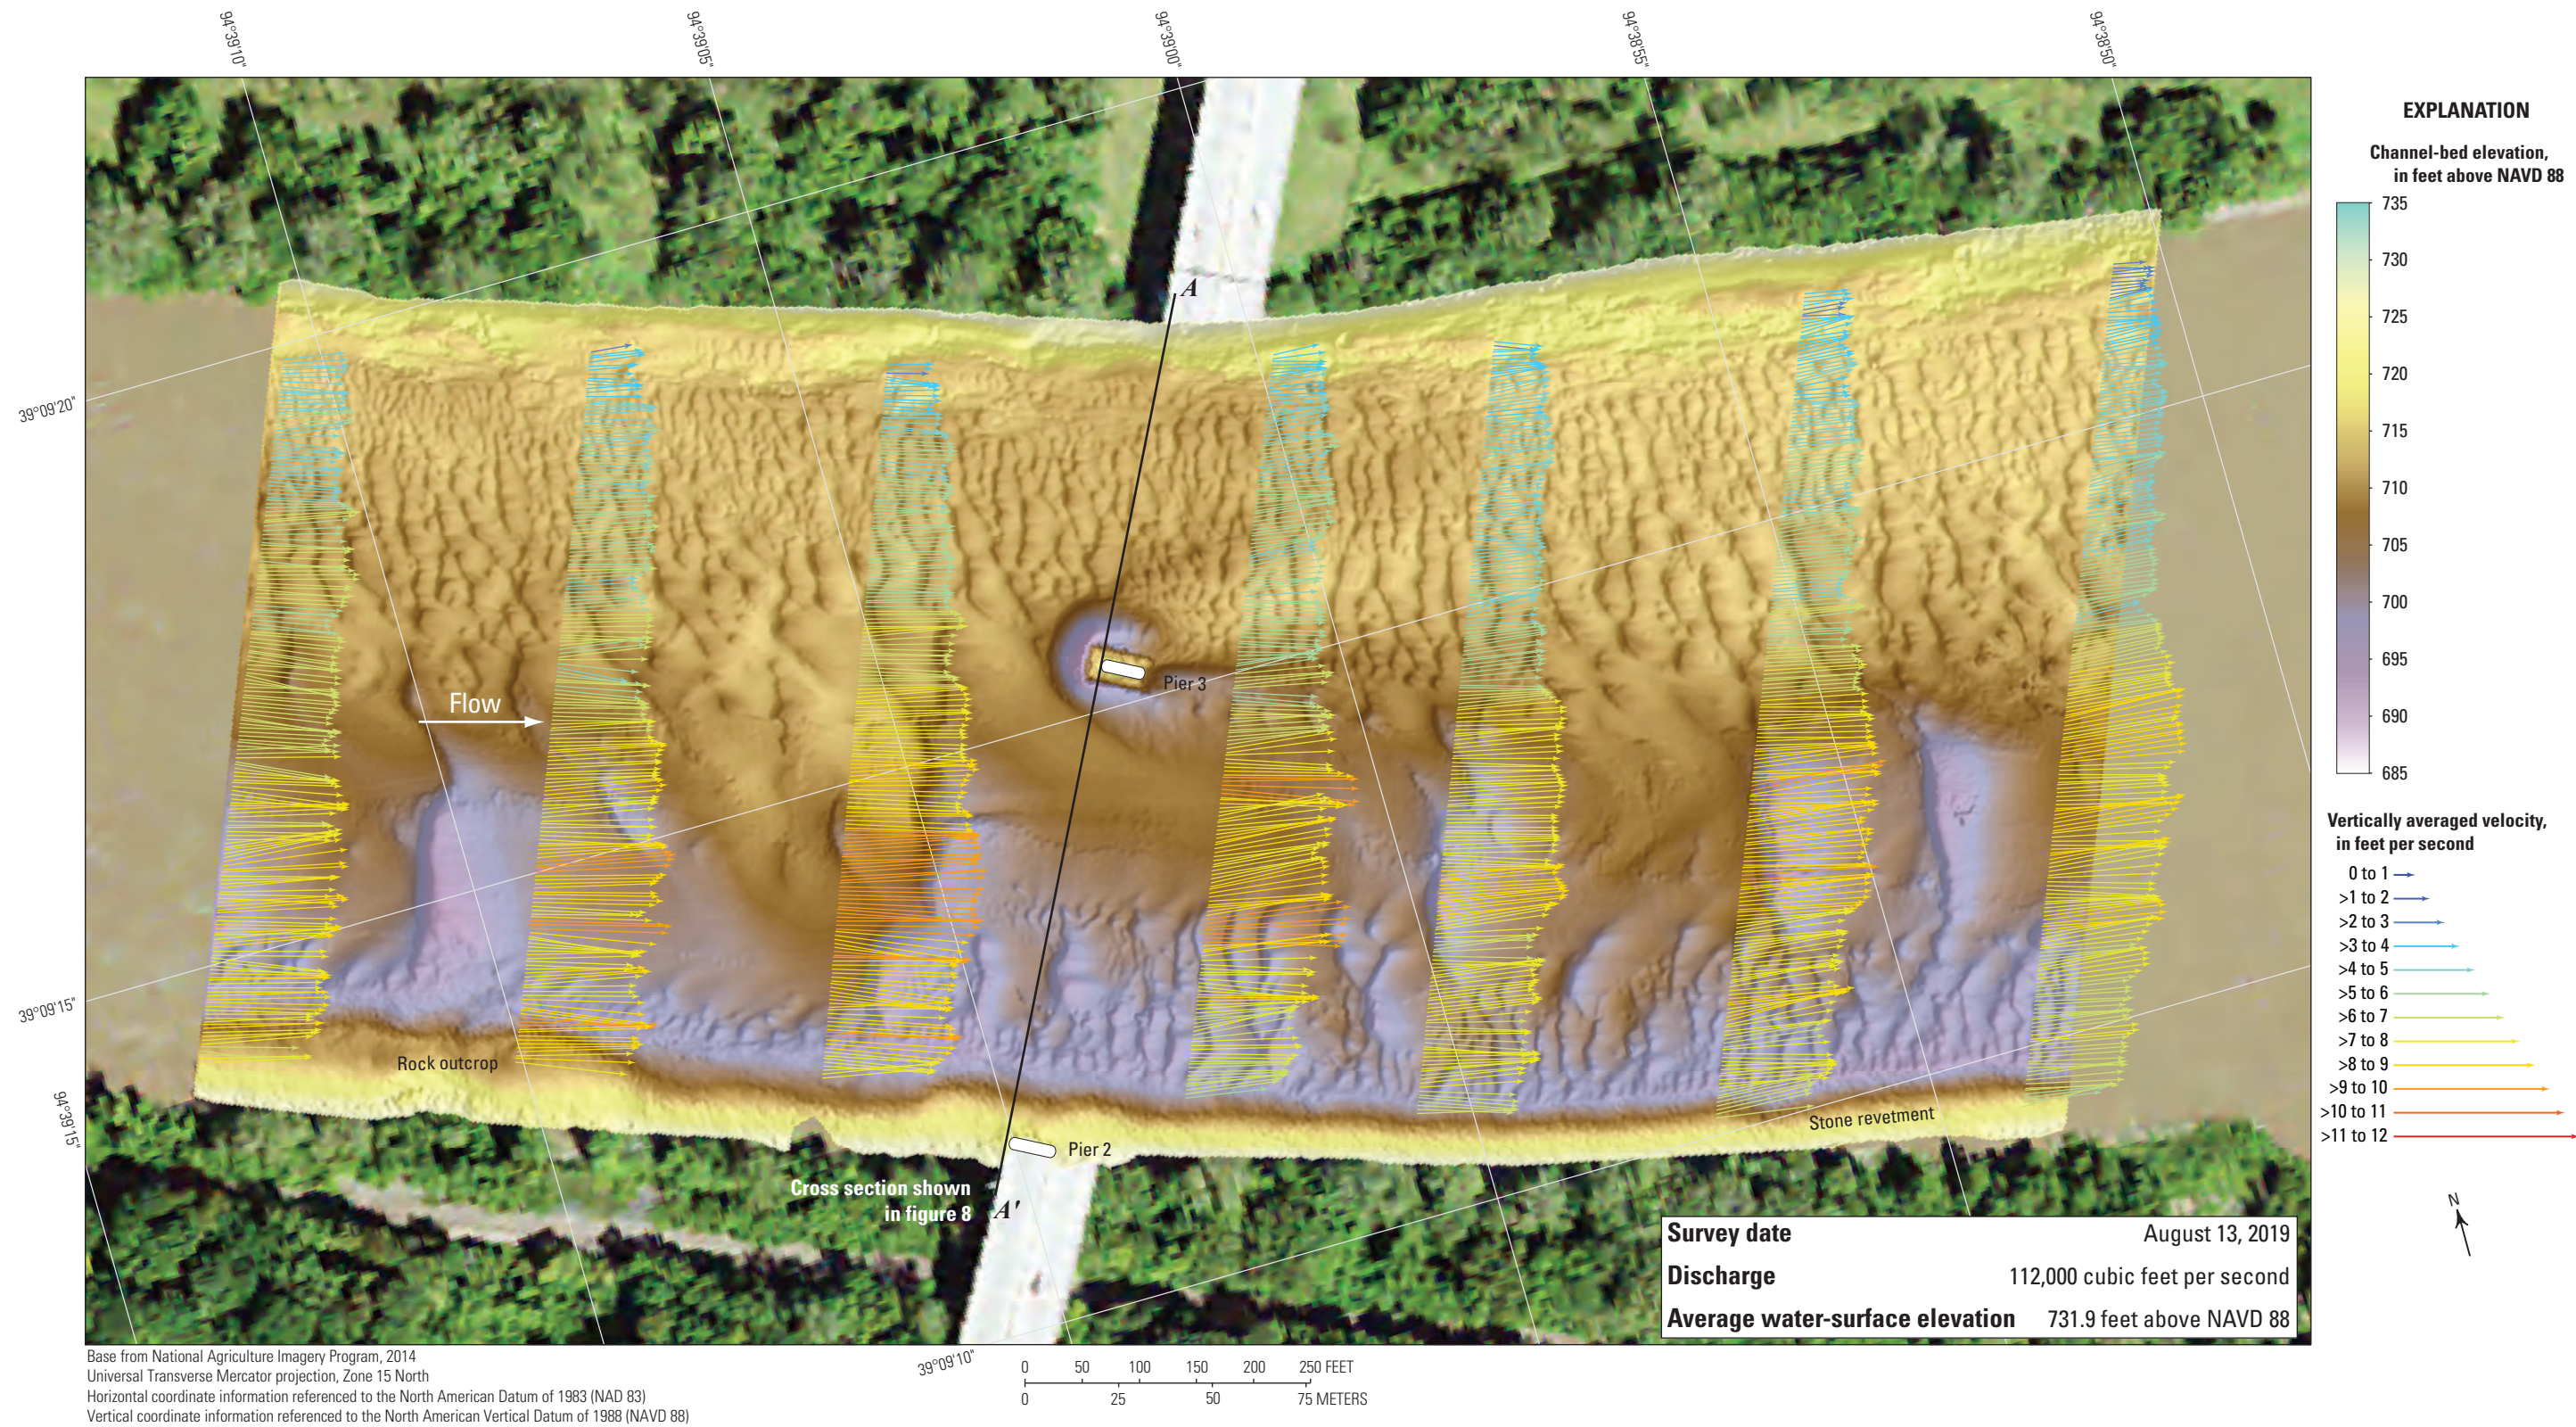
The vertically averaged velocity vectors indicate mostly uniform flow throughout the reach (fig. 12). A maximum velocity of about 11 feet per second (ft/s) was present in the thalweg immediately upstream from the bridge, and a minimum of 3 ft/s was present along the inside of the bend on the left (north) bank (fig. 12). The wake vortices downstream from pier 3 were not pronounced and seemed to be no greater than the general nonuniformity of flow observed in the channel (fig. 12). Minor turbulence was present in all the sections (fig. 12).

Figure 12. Bathymetry and vertically averaged velocities of the Missouri River channel near structure A1800 on Interstate 635 in Kansas City, Missouri, on August 13, 2019.

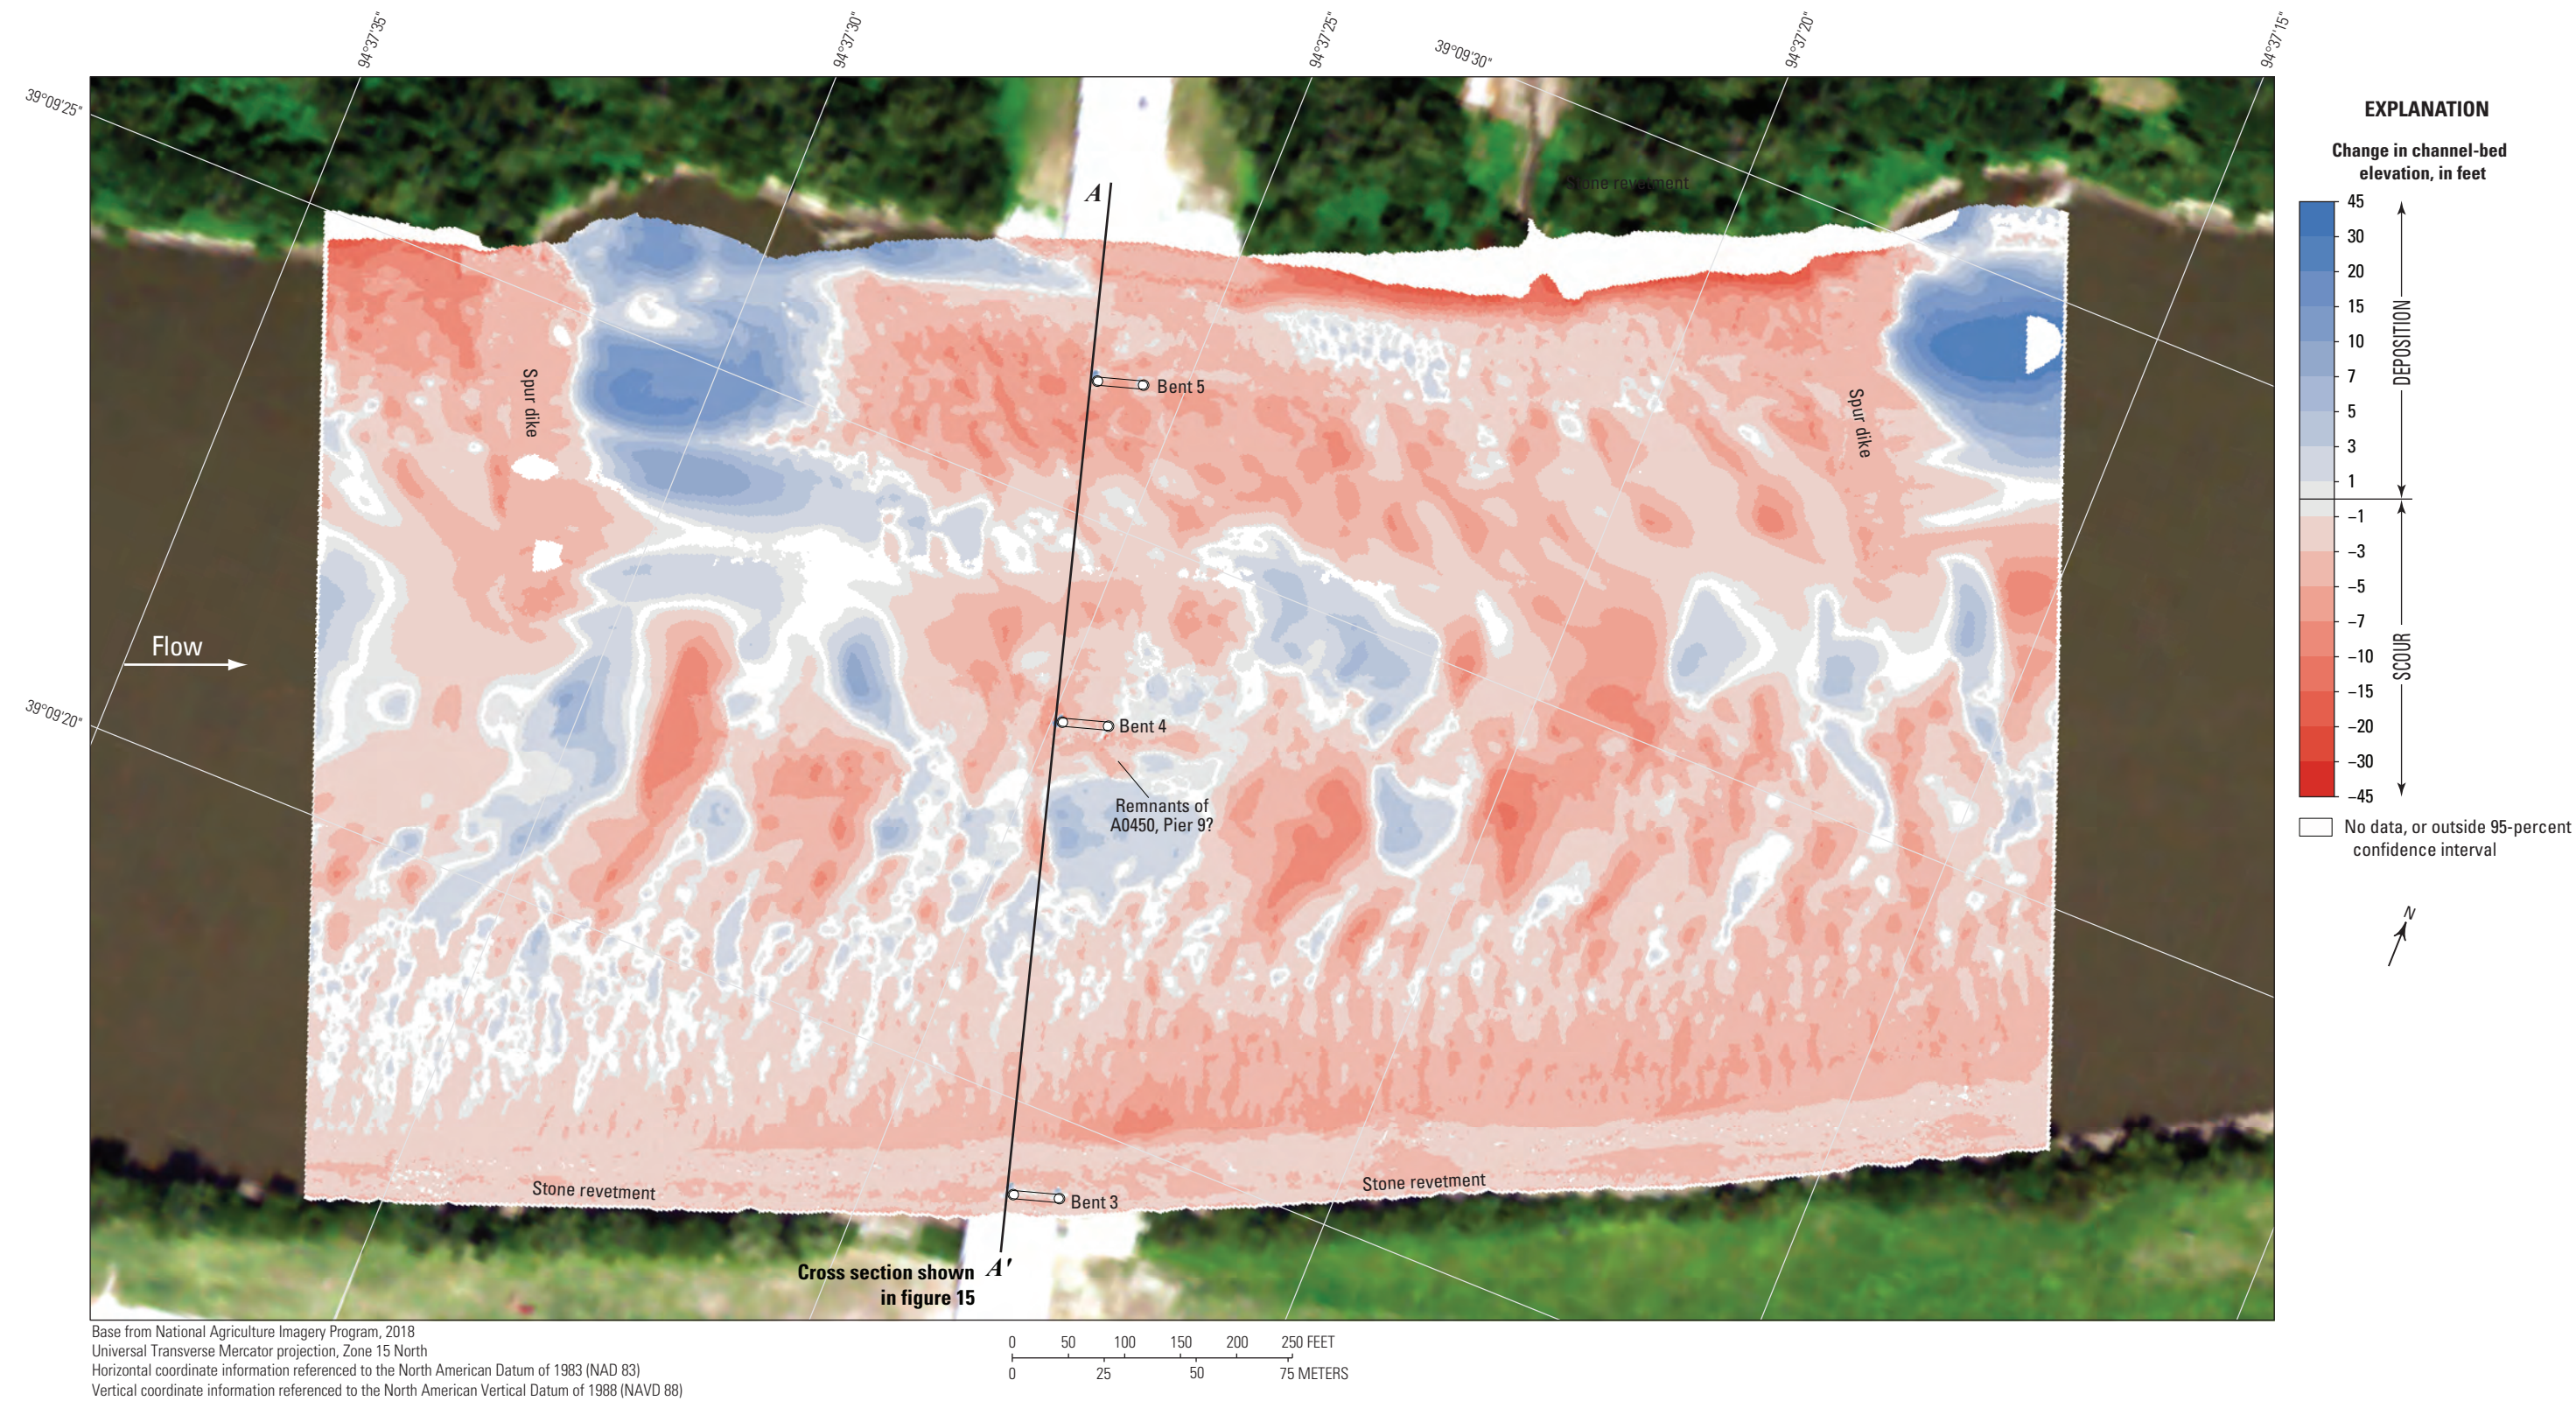
from 2017 to 2019 in the DoD map, except downstream from the spur dikes and in the troughs of dunes present in the 2017 survey (Huizinga, 2020a; [fig. 16](#)). The average difference between the bathymetric surfaces was -1.90 ft ([table 7](#)), indicating moderate channel degradation between the 2017 and 2019 surveys. The net volume of cut in the reach from 2017 to 2019 was about 119,600 yd³, and the net volume of fill was about 33,900 yd³, resulting in a net loss of about 85,700 yd³ of sediment between 2017 and 2019. The cross sections from the two surveys along the upstream face of the bridge indicate a nearly uniform lowering of about 5 ft for most of the cross section ([fig. 15](#)). The frequency distribution of bed elevations in 2019 was similar in shape to 2017 but with a higher percentage of cells at lower channel-bed elevations ([fig. 14](#)). The scour holes near main channel bents 4 and 5 were of a very similar shape in 2019 and 2017 ([fig. 15](#)), as evidenced by the overall area of similar change around the bents in the DoD map ([fig. 16](#)). The stone revetment on the right (south) bank also showed signs of nearly uniform minor scour ([fig. 16](#)).

Figure 16. Difference between surfaces created from bathymetric surveys of the Missouri River channel near structure A8340 on U.S. Highway 69 in Kansas City, Missouri, on August 13, 2019, and May 22, 2017.

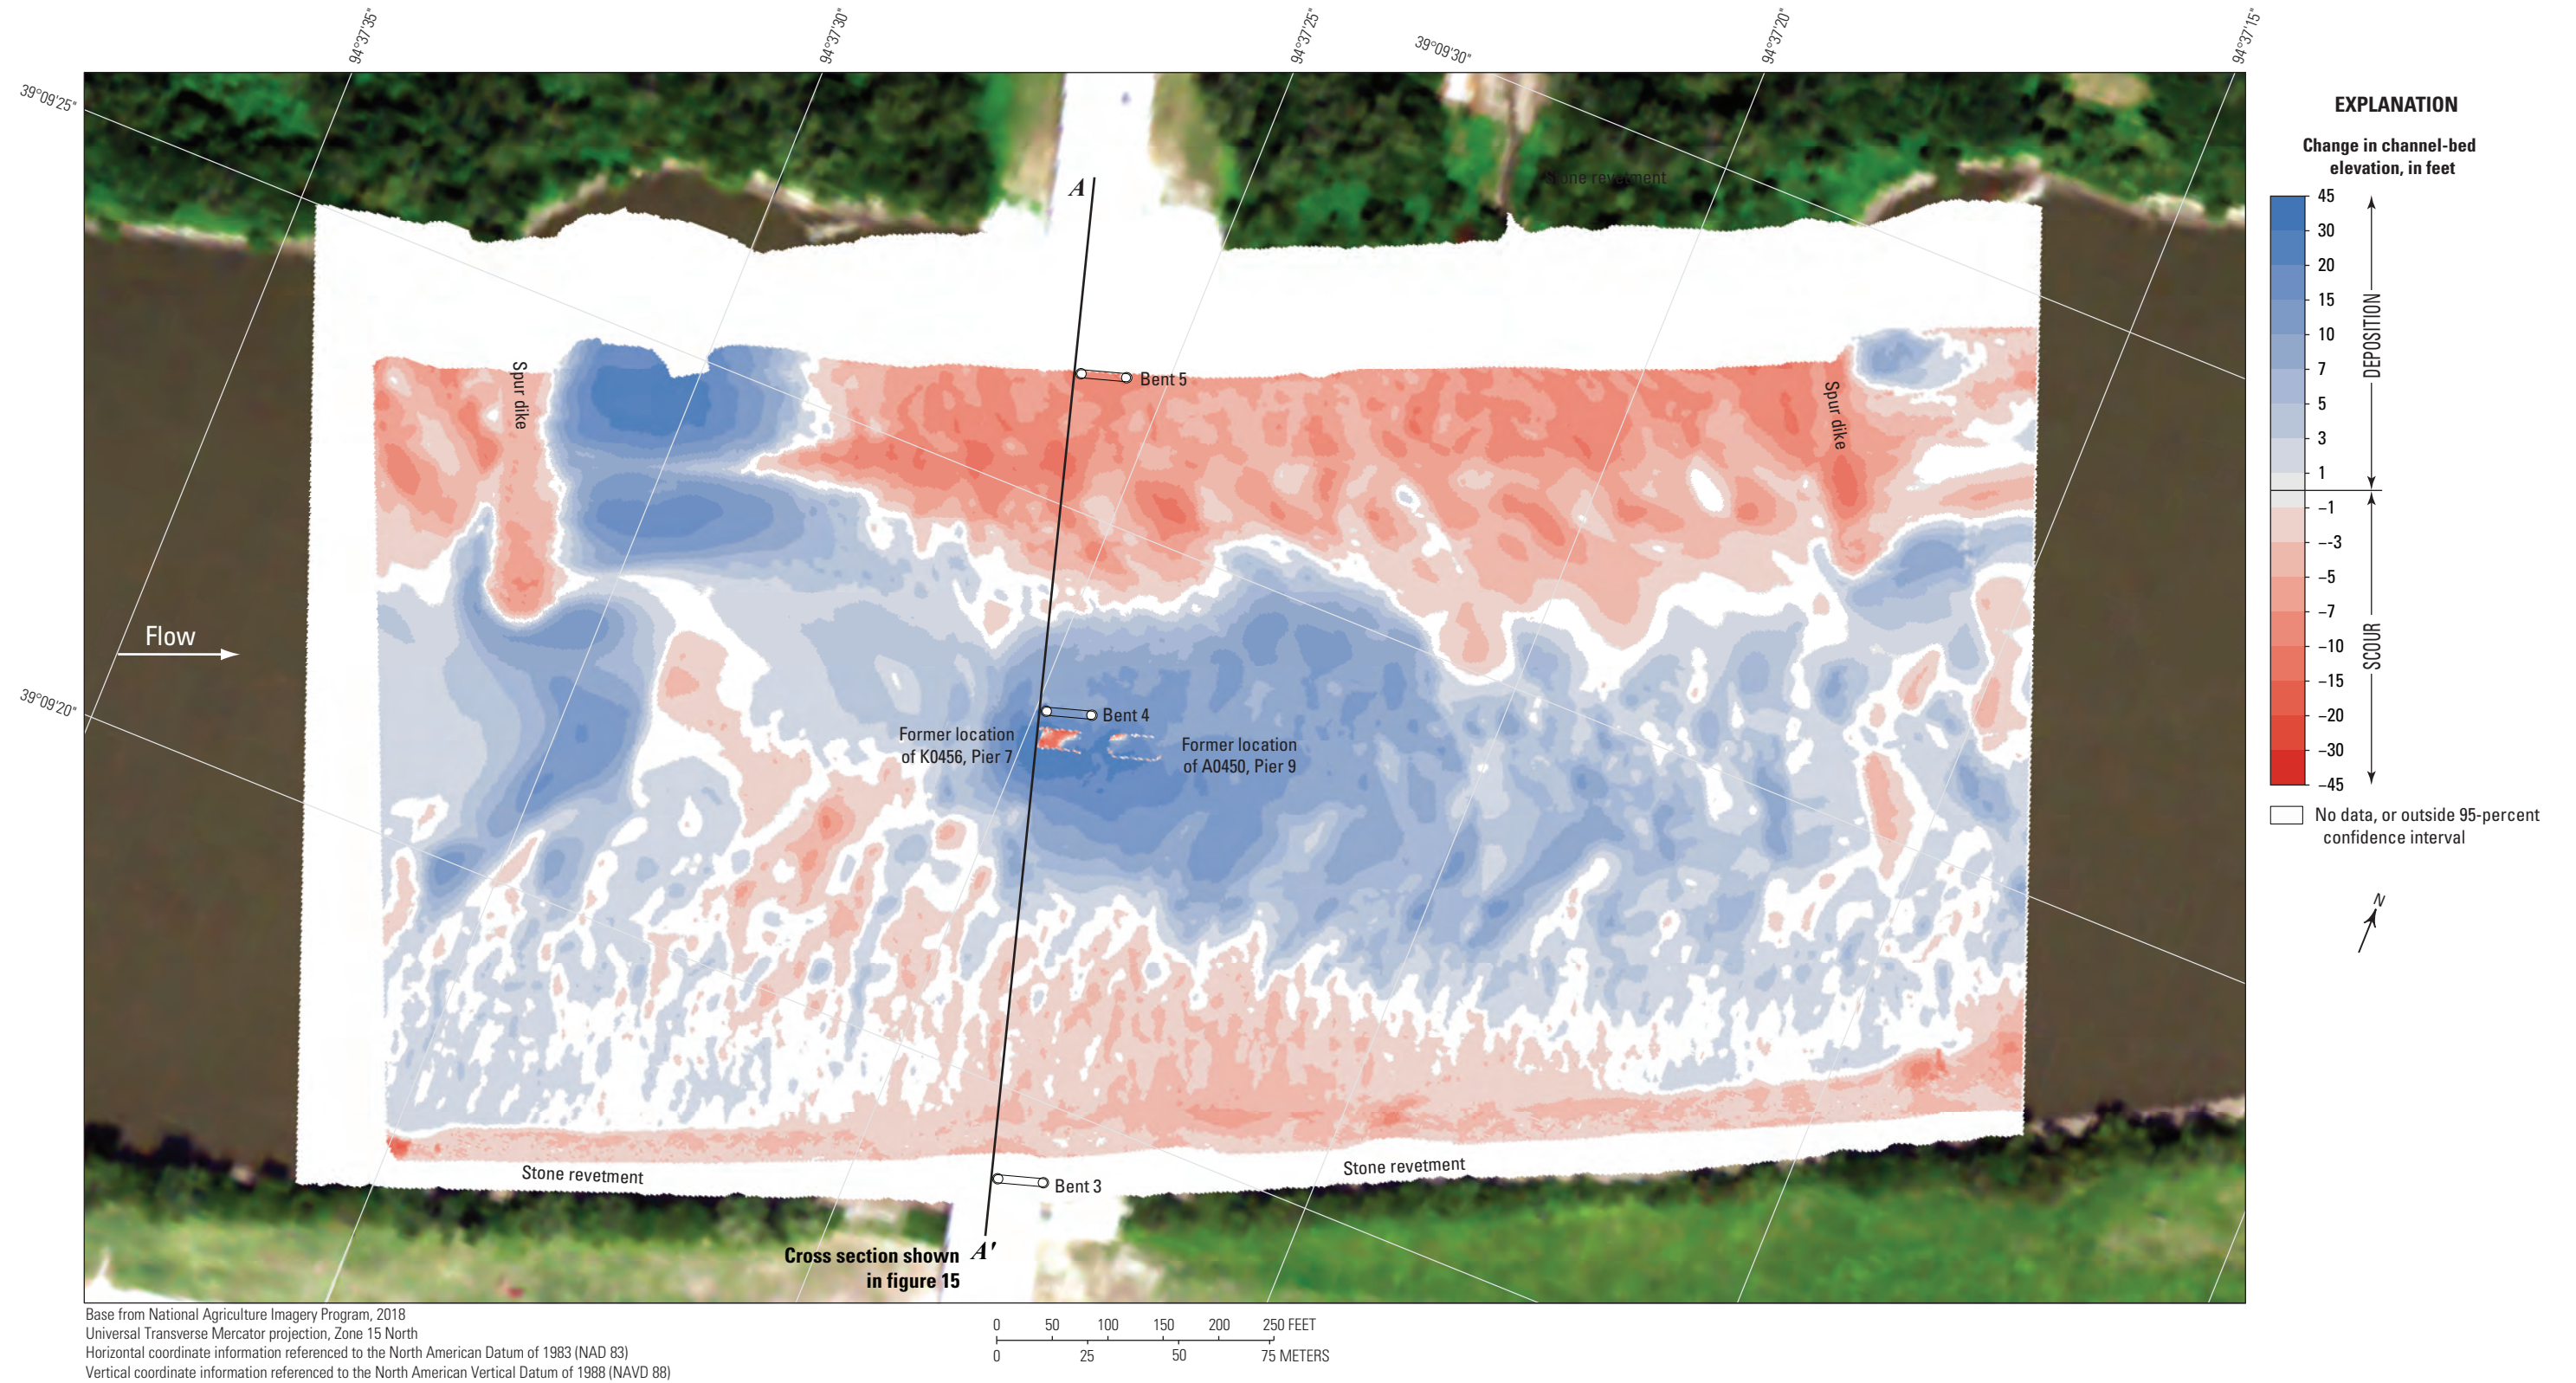
between bents 3 and 4 (fig. 15). The frequency distribution of bed elevations in 2010 was somewhat unique compared to the other surveys, but the 2019 distribution was similar to 2010, except with a lower percentage of cells at a lower channel-bed elevation than 2010 (fig. 14). As noted in the previous paragraph, the differences in the frequency distribution of bed elevations in 2017 and 2019 from 2011 and 2010 (fig. 14) likely are a direct result of the new bridge bents, which are designed to be more hydrodynamic and less scour-inducing than the old bridge piers. As with all the DoD maps for this site, stone revetment on the right (south) bank also showed signs of nearly uniform minor scour (fig. 18).

Figure 18. Difference between surfaces created from bathymetric surveys of the Missouri River channel near structure A8340 on U.S. Highway 69 in Kansas City, Missouri, on August 13, 2019, and March 15, 2010.
