Bathymetric and Velocimetric Surveys at Highway Bridges Crossing the Missouri River near Kansas City, Missouri, August 2019, August 2020, and October 2020

Scientific Investigations Report 2021–5098

By Richard J. Huizinga

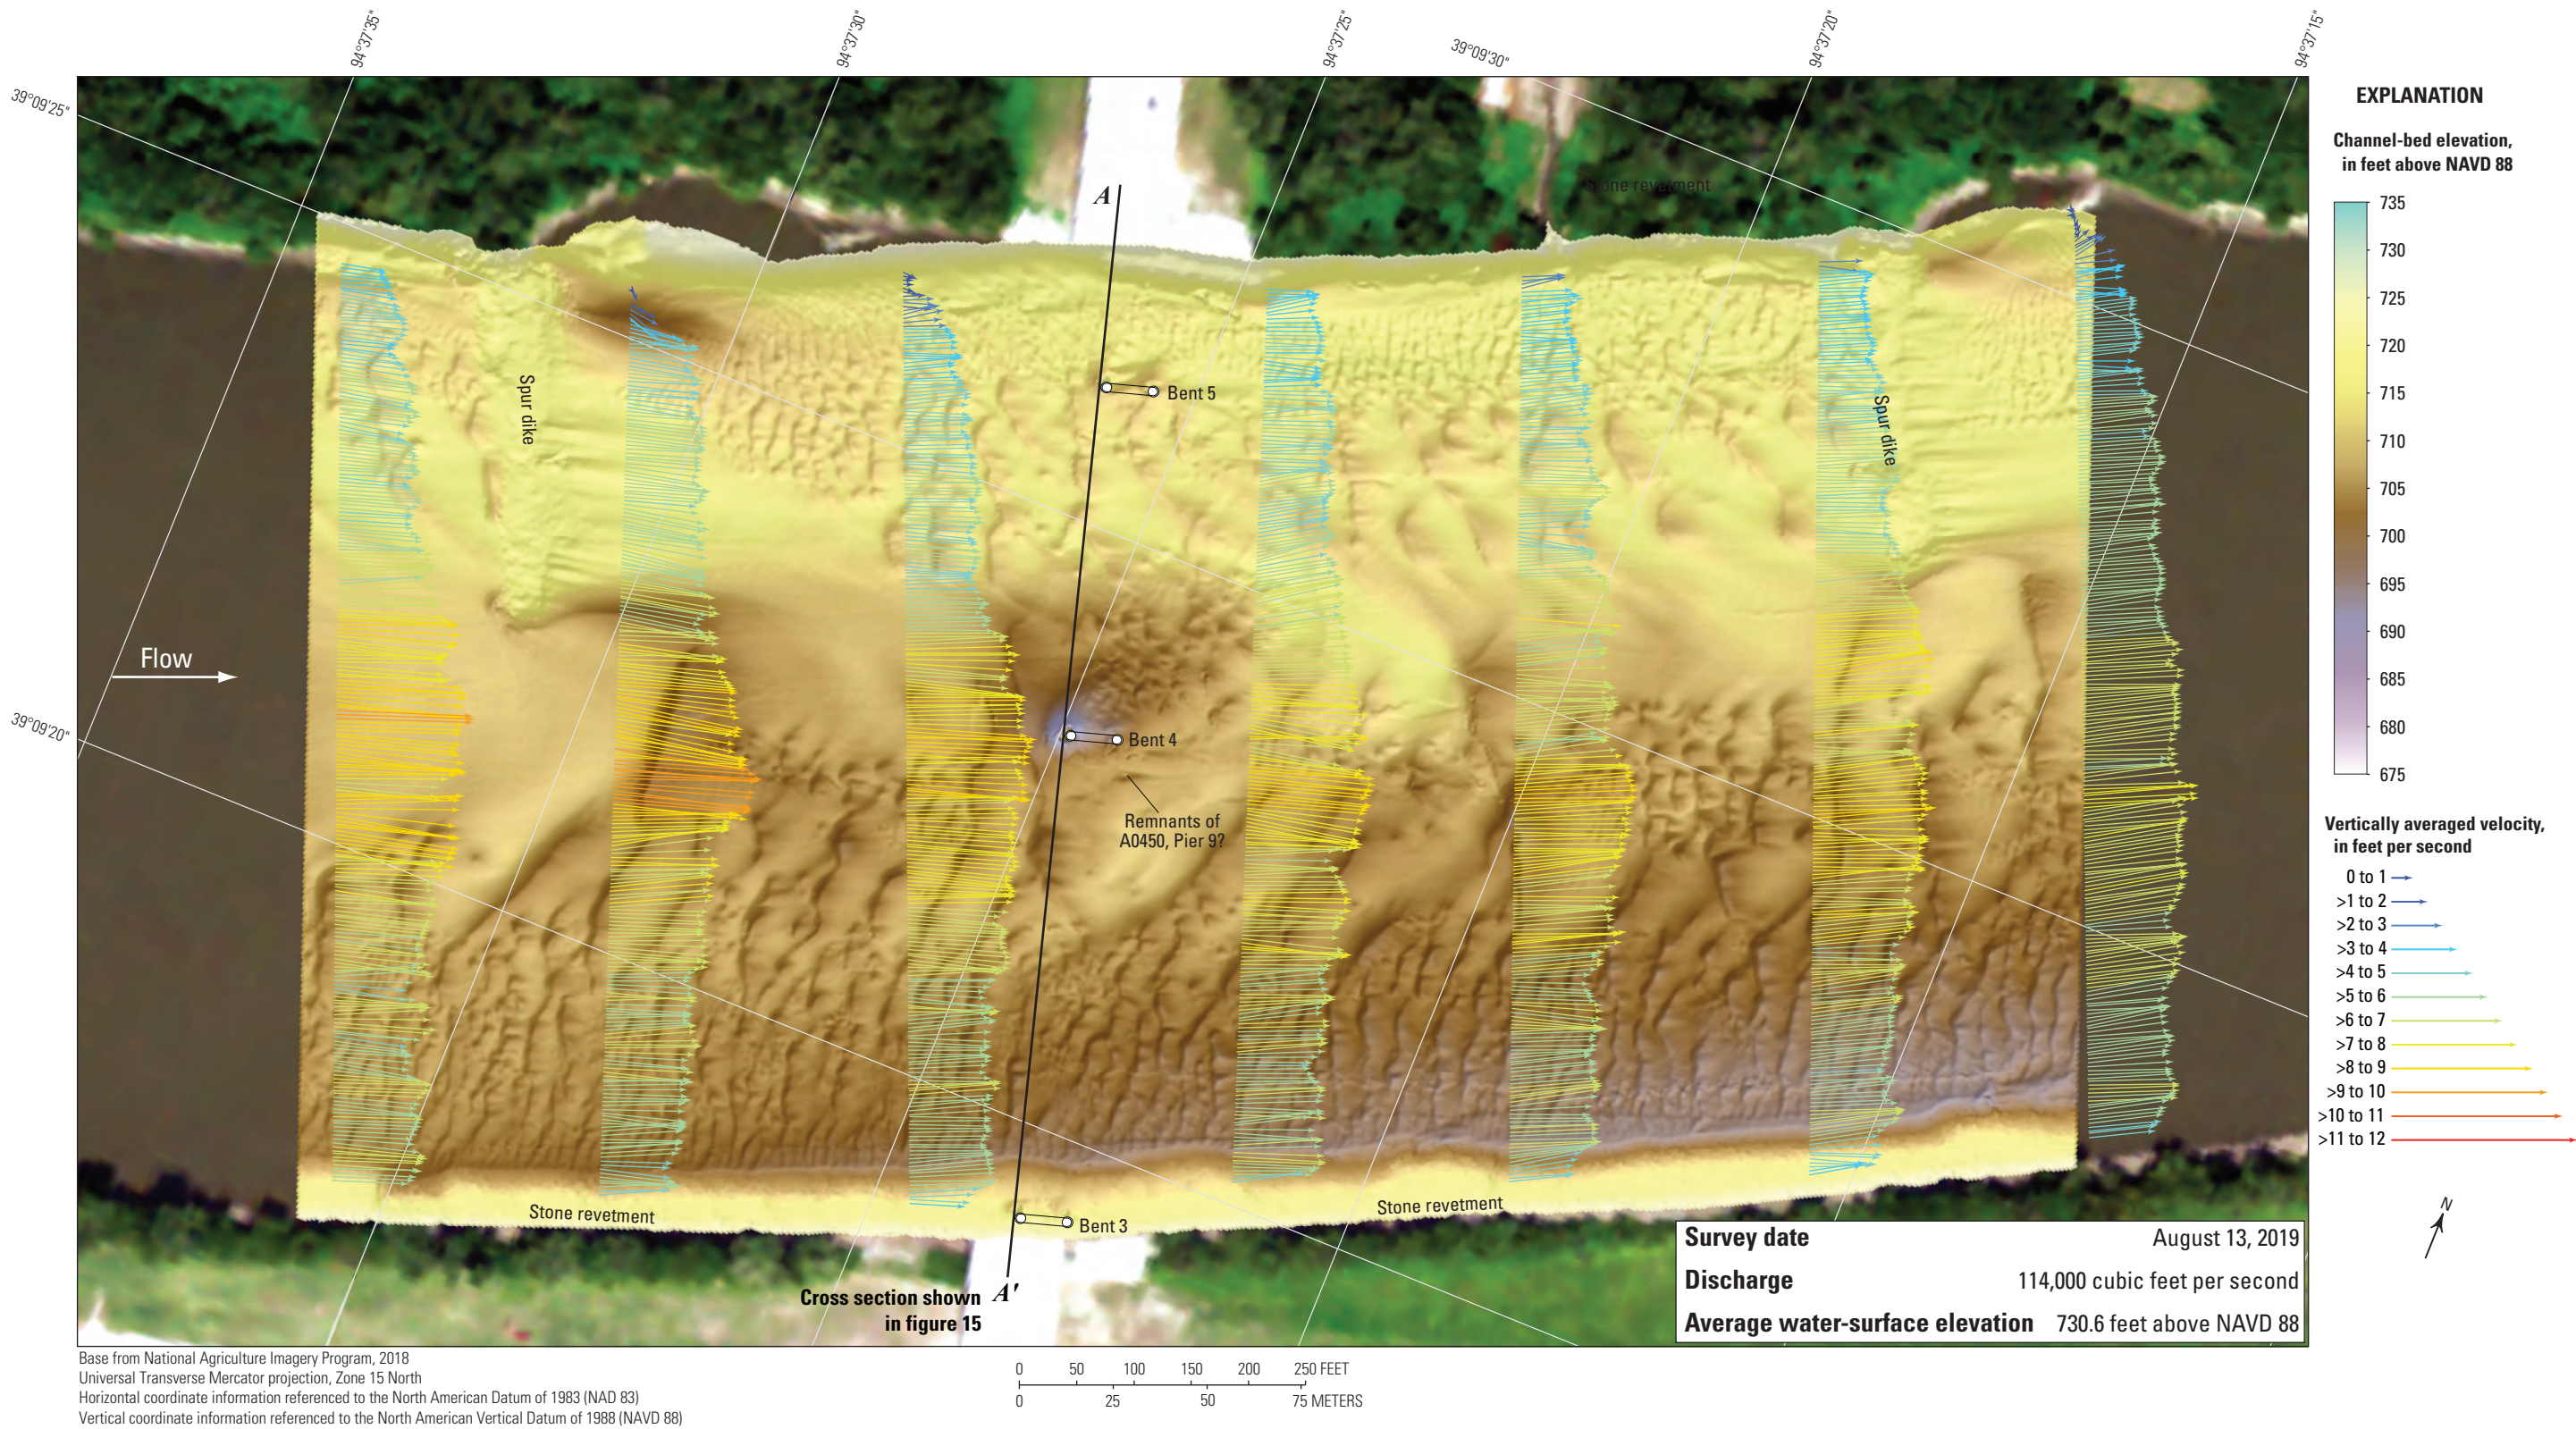
The vertically averaged velocity vectors indicate mostly uniform flow throughout the reach (fig. 19). A maximum velocity of about 10 ft/s was present in the upstream middle of the channel, and a minimum velocity of about 1 ft/s was present with flow reversal downstream from the various spur dikes in the reach (fig. 19). Minimal effect on the velocity was observed downstream from bent 4 (fig. 19), indicating the new pier design is appropriately hydrodynamic. Minor turbulence was present in all the sections (fig. 19).

Figure 19. Bathymetry and vertically averaged velocities of the Missouri River channel near structure A8340 on U.S. Highway 69 in Kansas City, Missouri, on August 13, 2019.

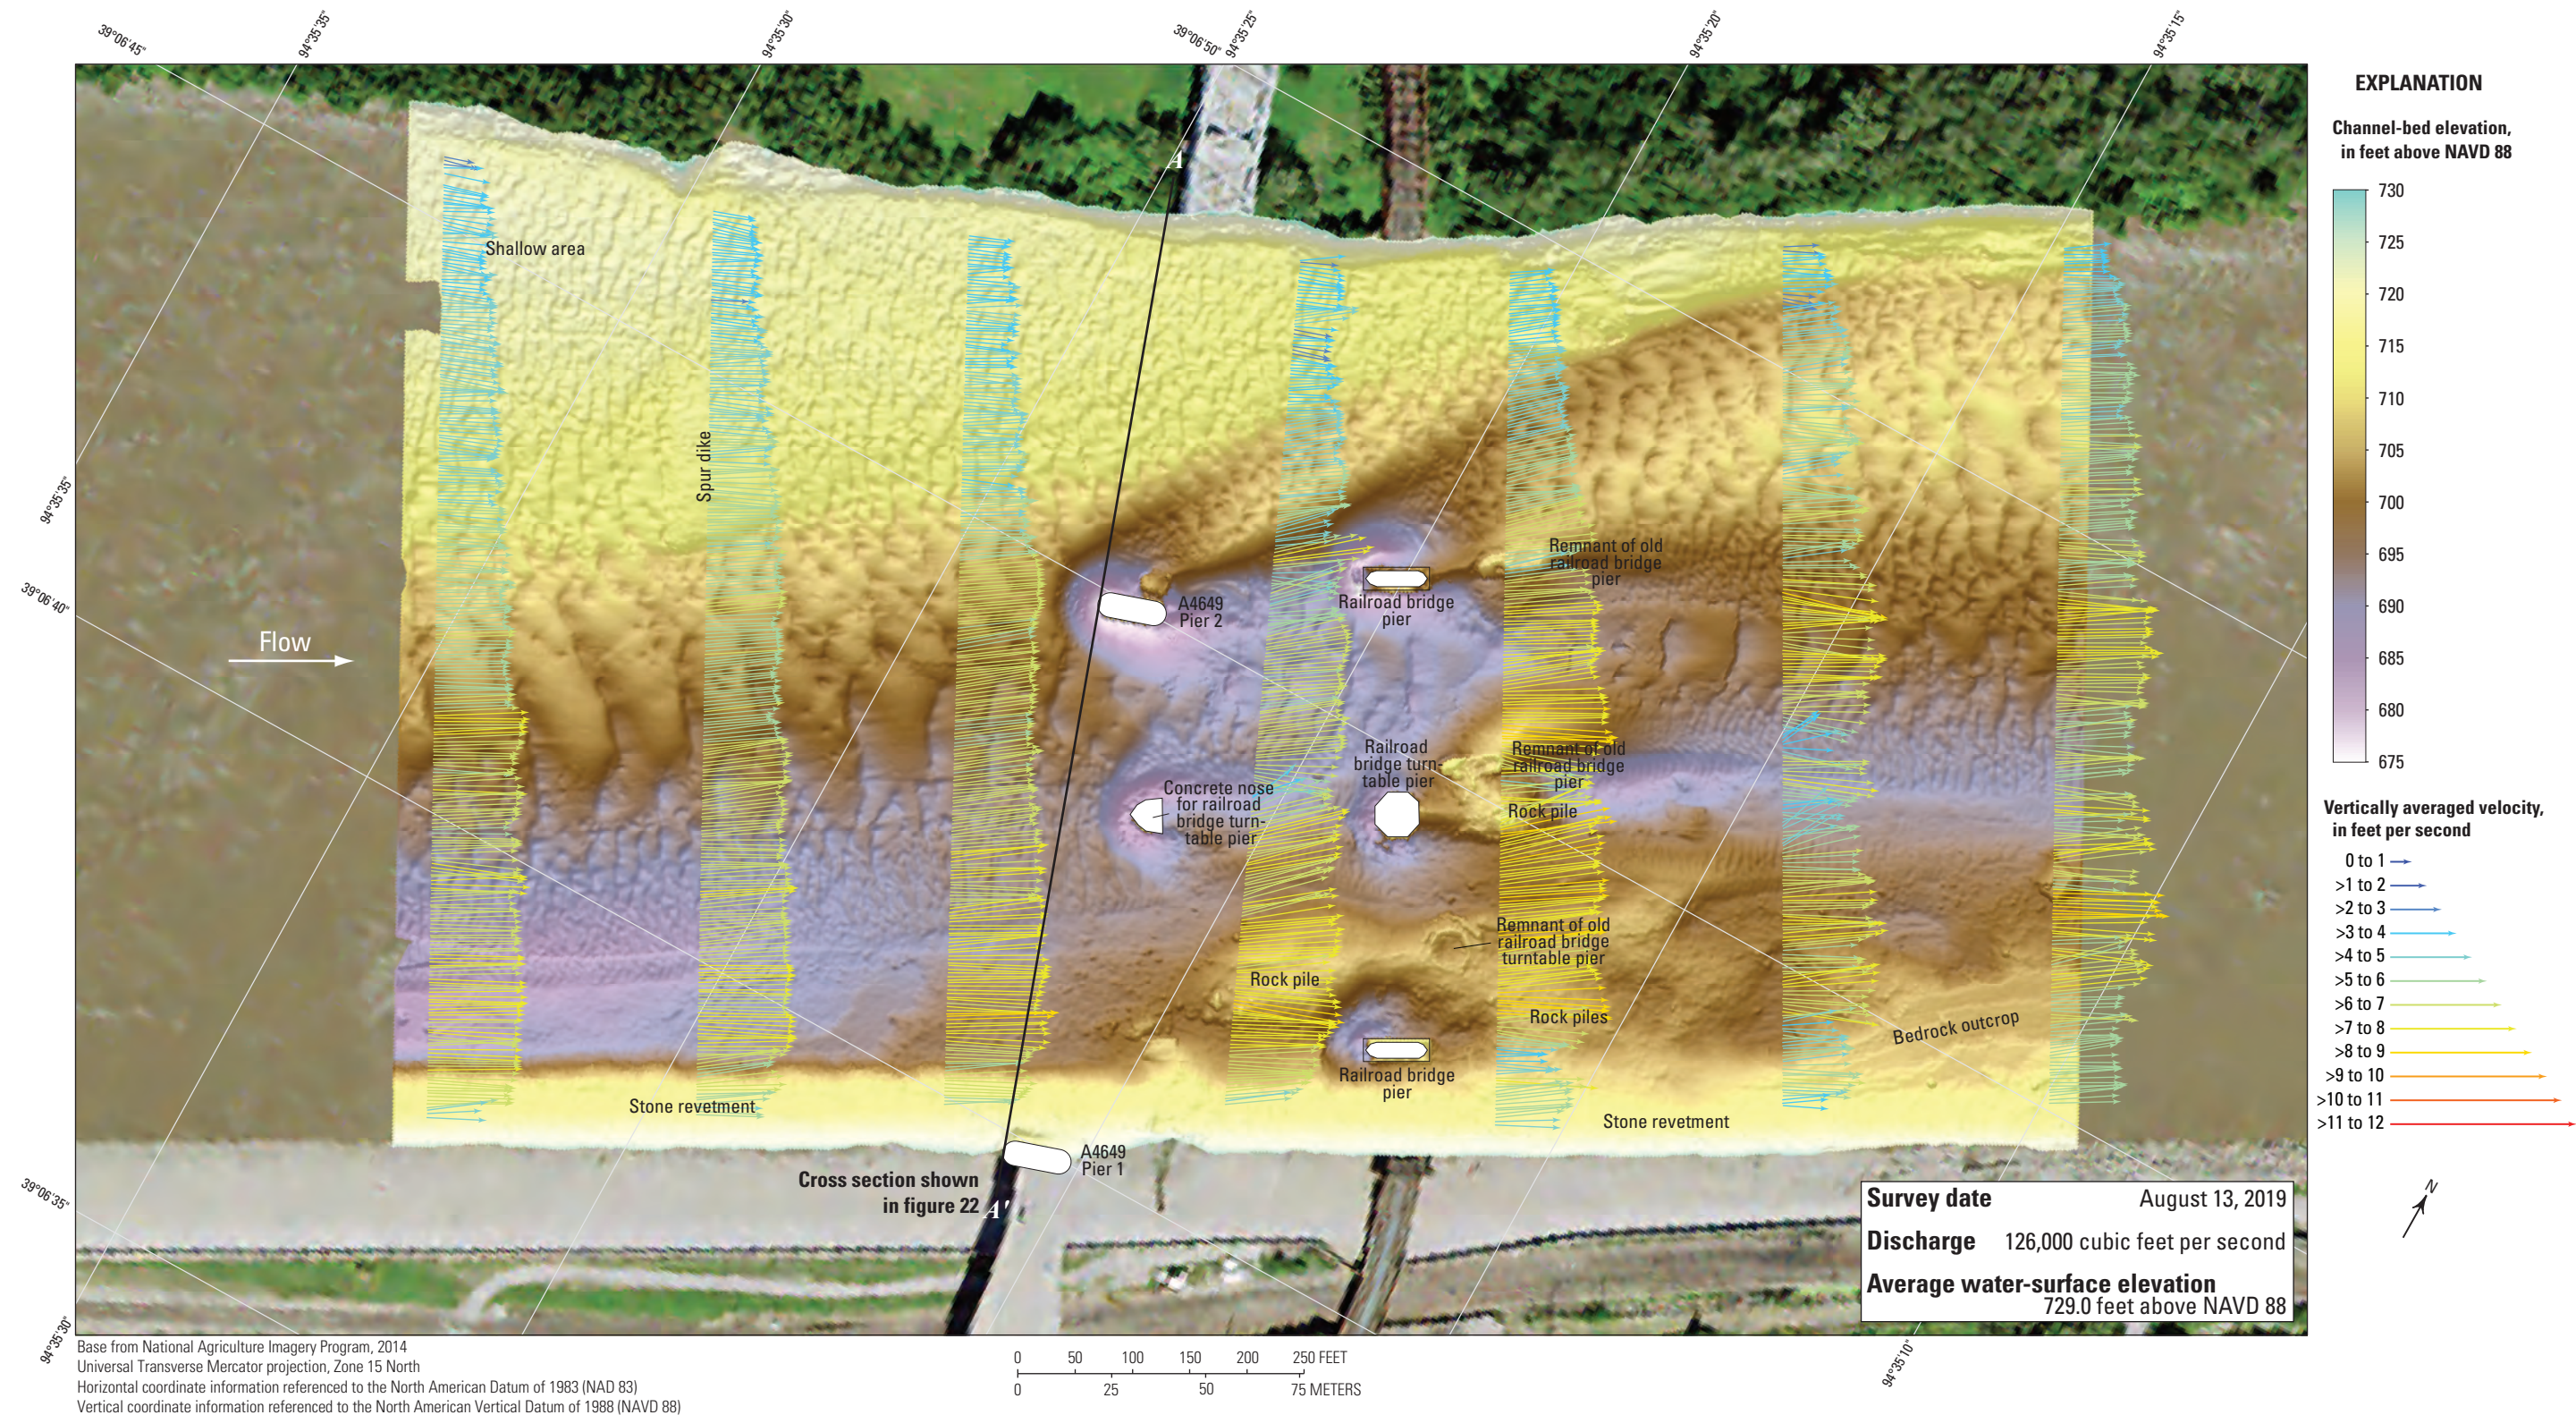
the right (south) bank, particularly near the bridges (fig. 26). Exceptions to uniform conditions include diagonal flows across the channel near structure A4649 (fig. 26), which may help explain the shift in the channel thalweg towards the left (north) bank through the reach. Substantial turbulence also was observed between structure A4649 and the railroad bridge and downstream from the railroad bridge piers (fig. 26). The rock piles near the right bank also appear to create turbulence (fig. 26).

Figure 26. Bathymetry and vertically averaged velocities of the Missouri River channel near structure A4649 on U.S. Highway 169 in Kansas City, Missouri, on August 13, 2019.

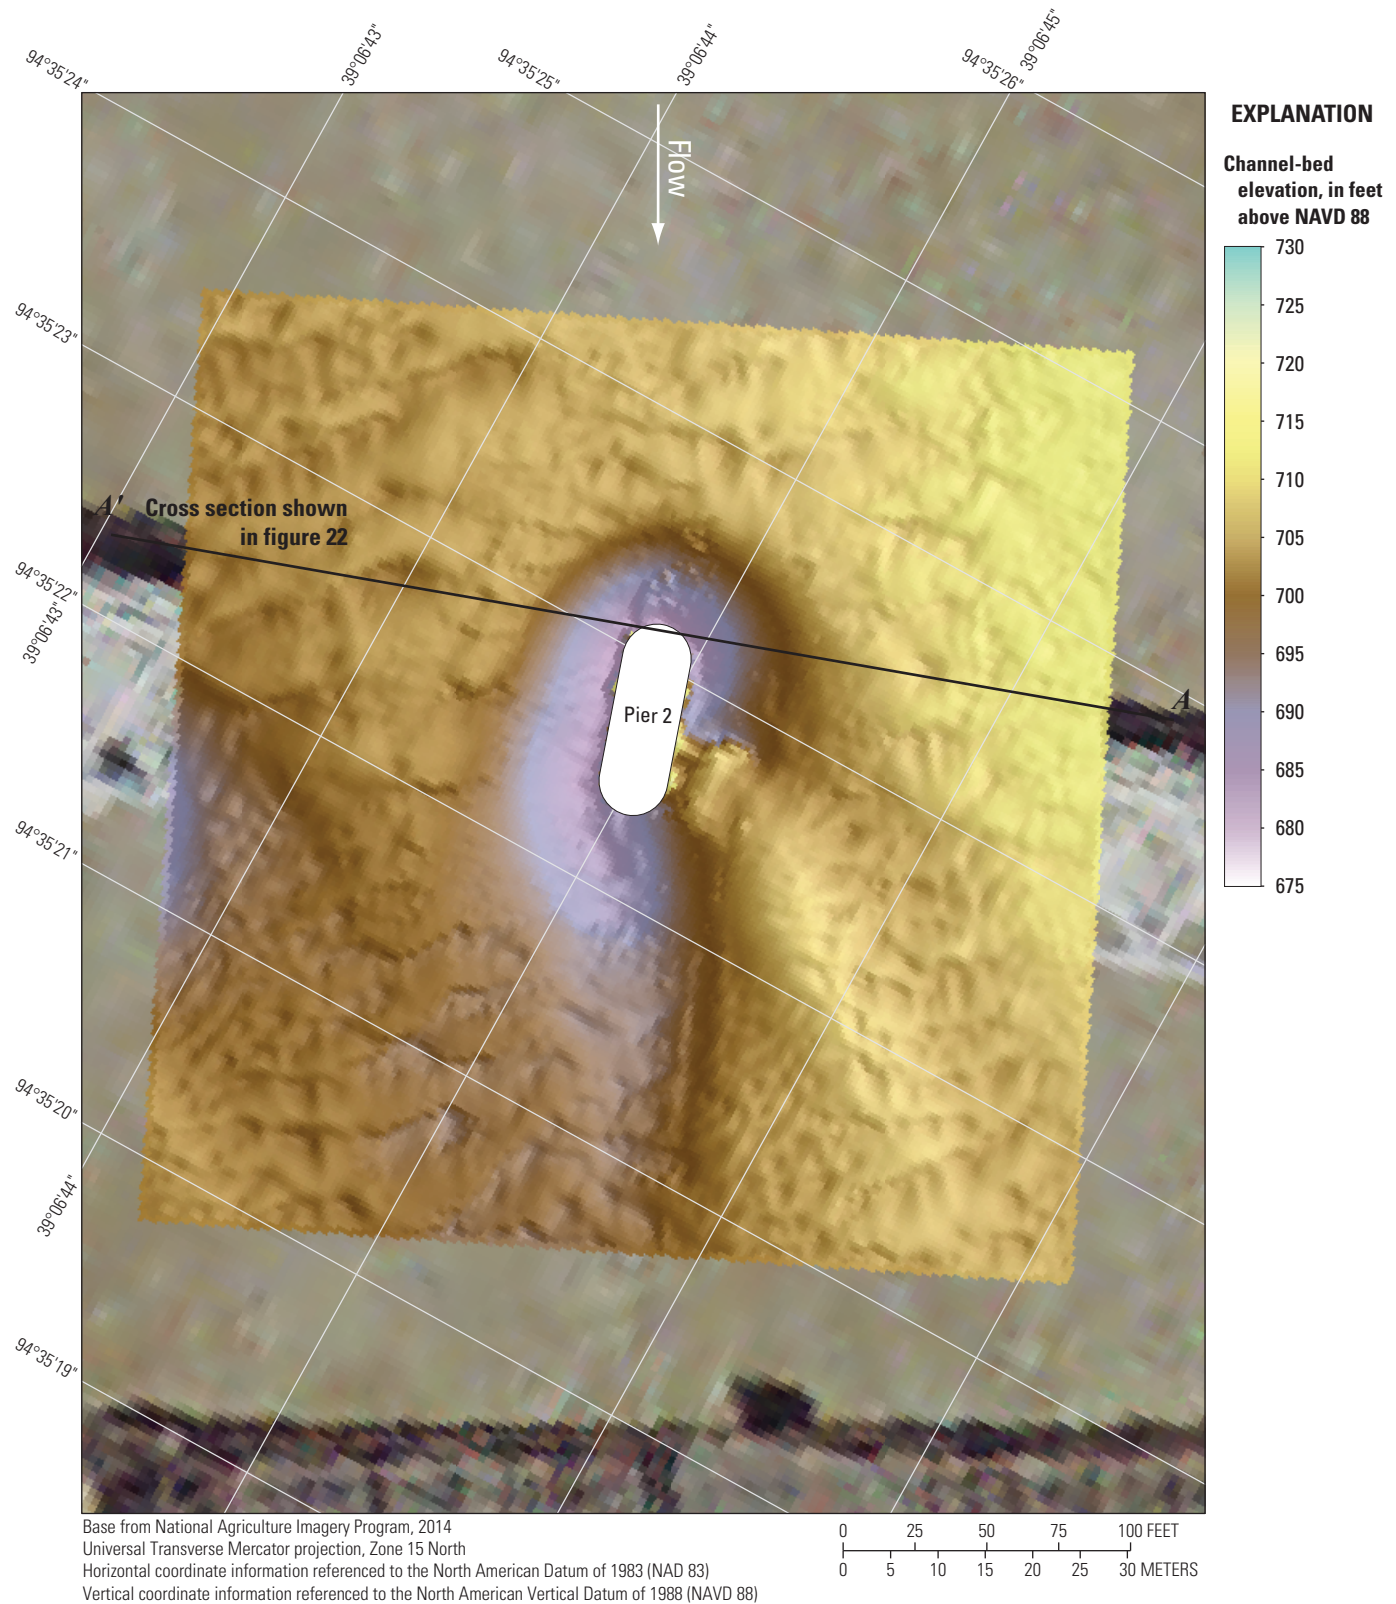
Figure 27. Bathymetric survey of the Missouri River channel near the main channel pier of structure A4649 on U.S. Highway 169 in Kansas City, Missouri, on August 17, 2020, before installation of scour countermeasures.

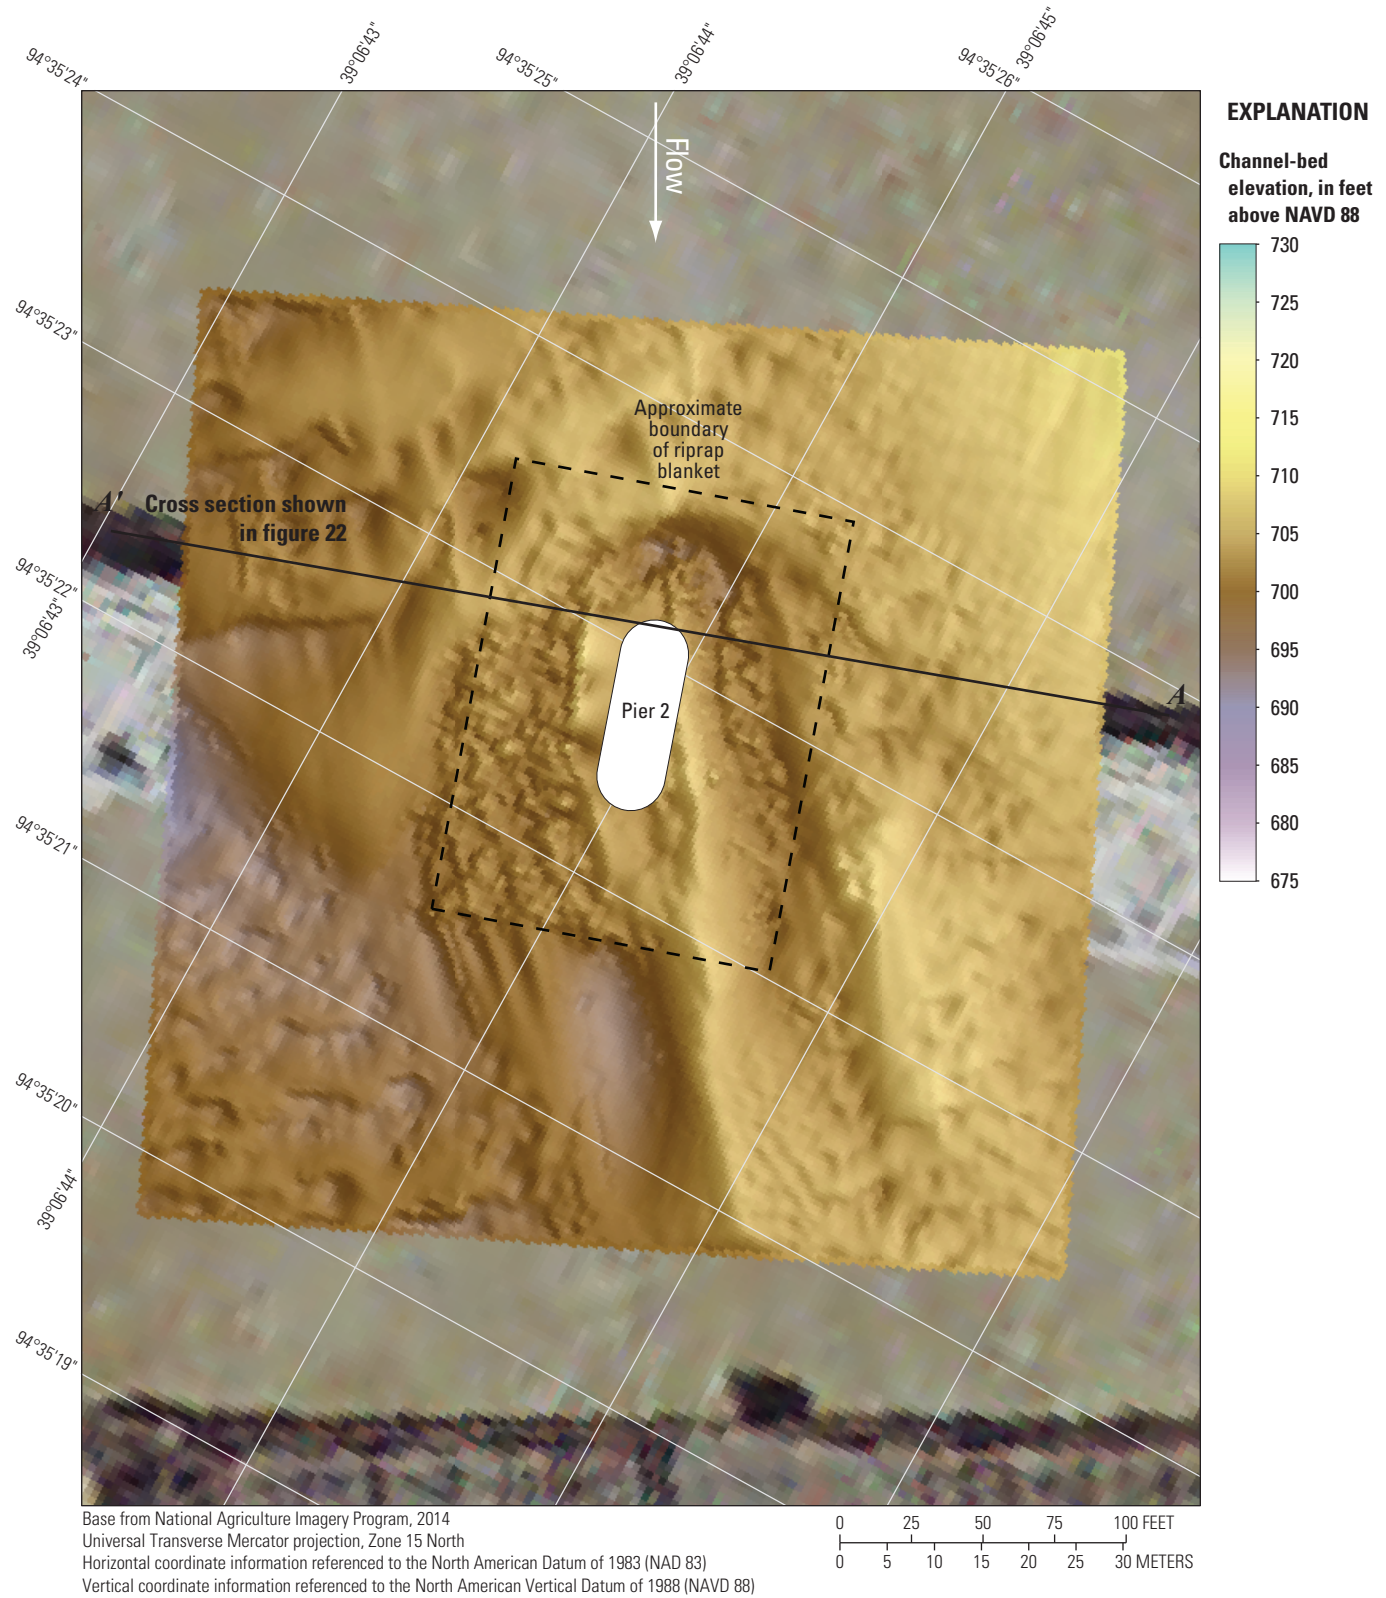
Figure 29. Bathymetric survey of the Missouri River channel near the main channel pier of structure A4649 on U.S. Highway 169 in Kansas City, Missouri, on October 23, 2020, after installation of scour countermeasures.

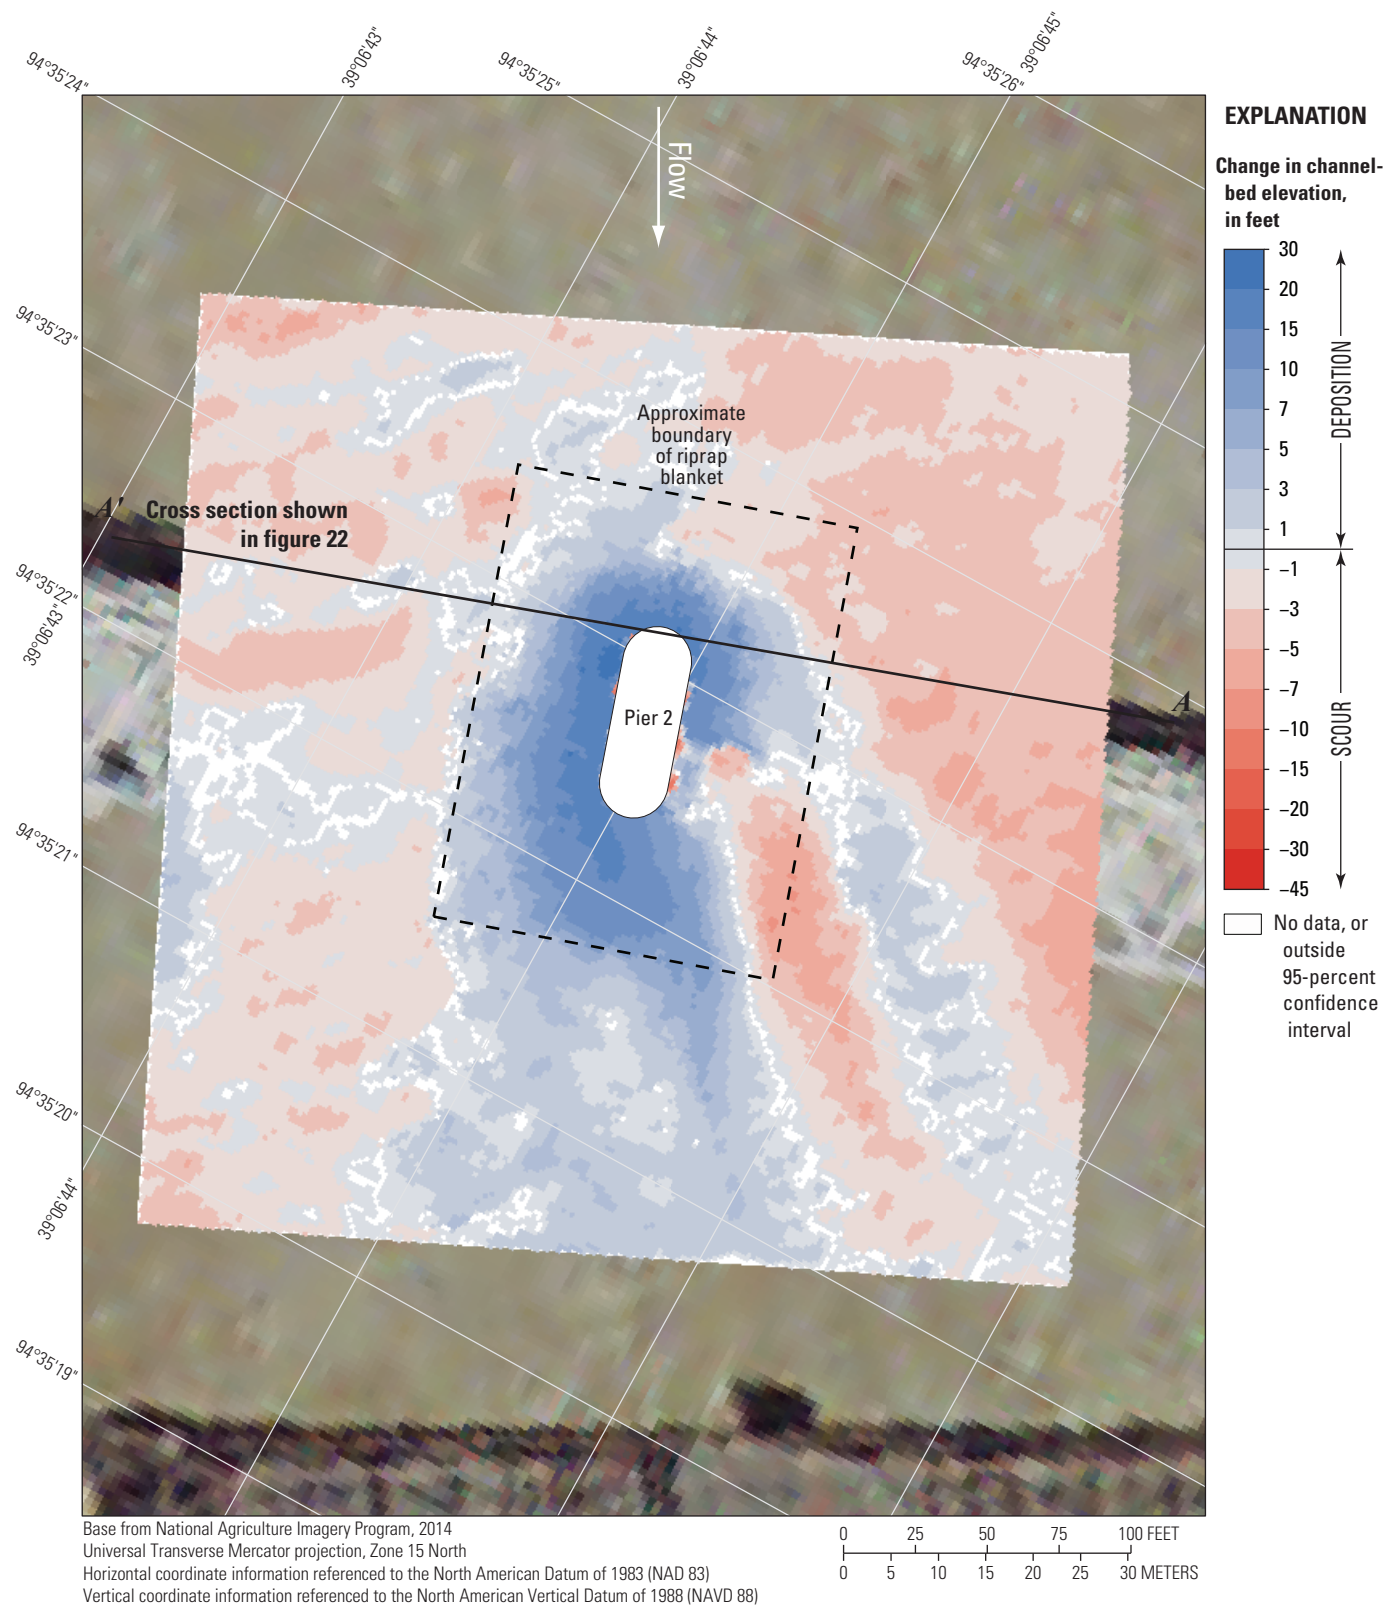
Figure 30. Difference between surfaces created from bathymetric surveys of the Missouri River channel near the main channel pier of structure A4649 on U.S. Highway 169 in Kansas City, Missouri, on August 17 and October 23, 2020, before and after installation of scour countermeasures.

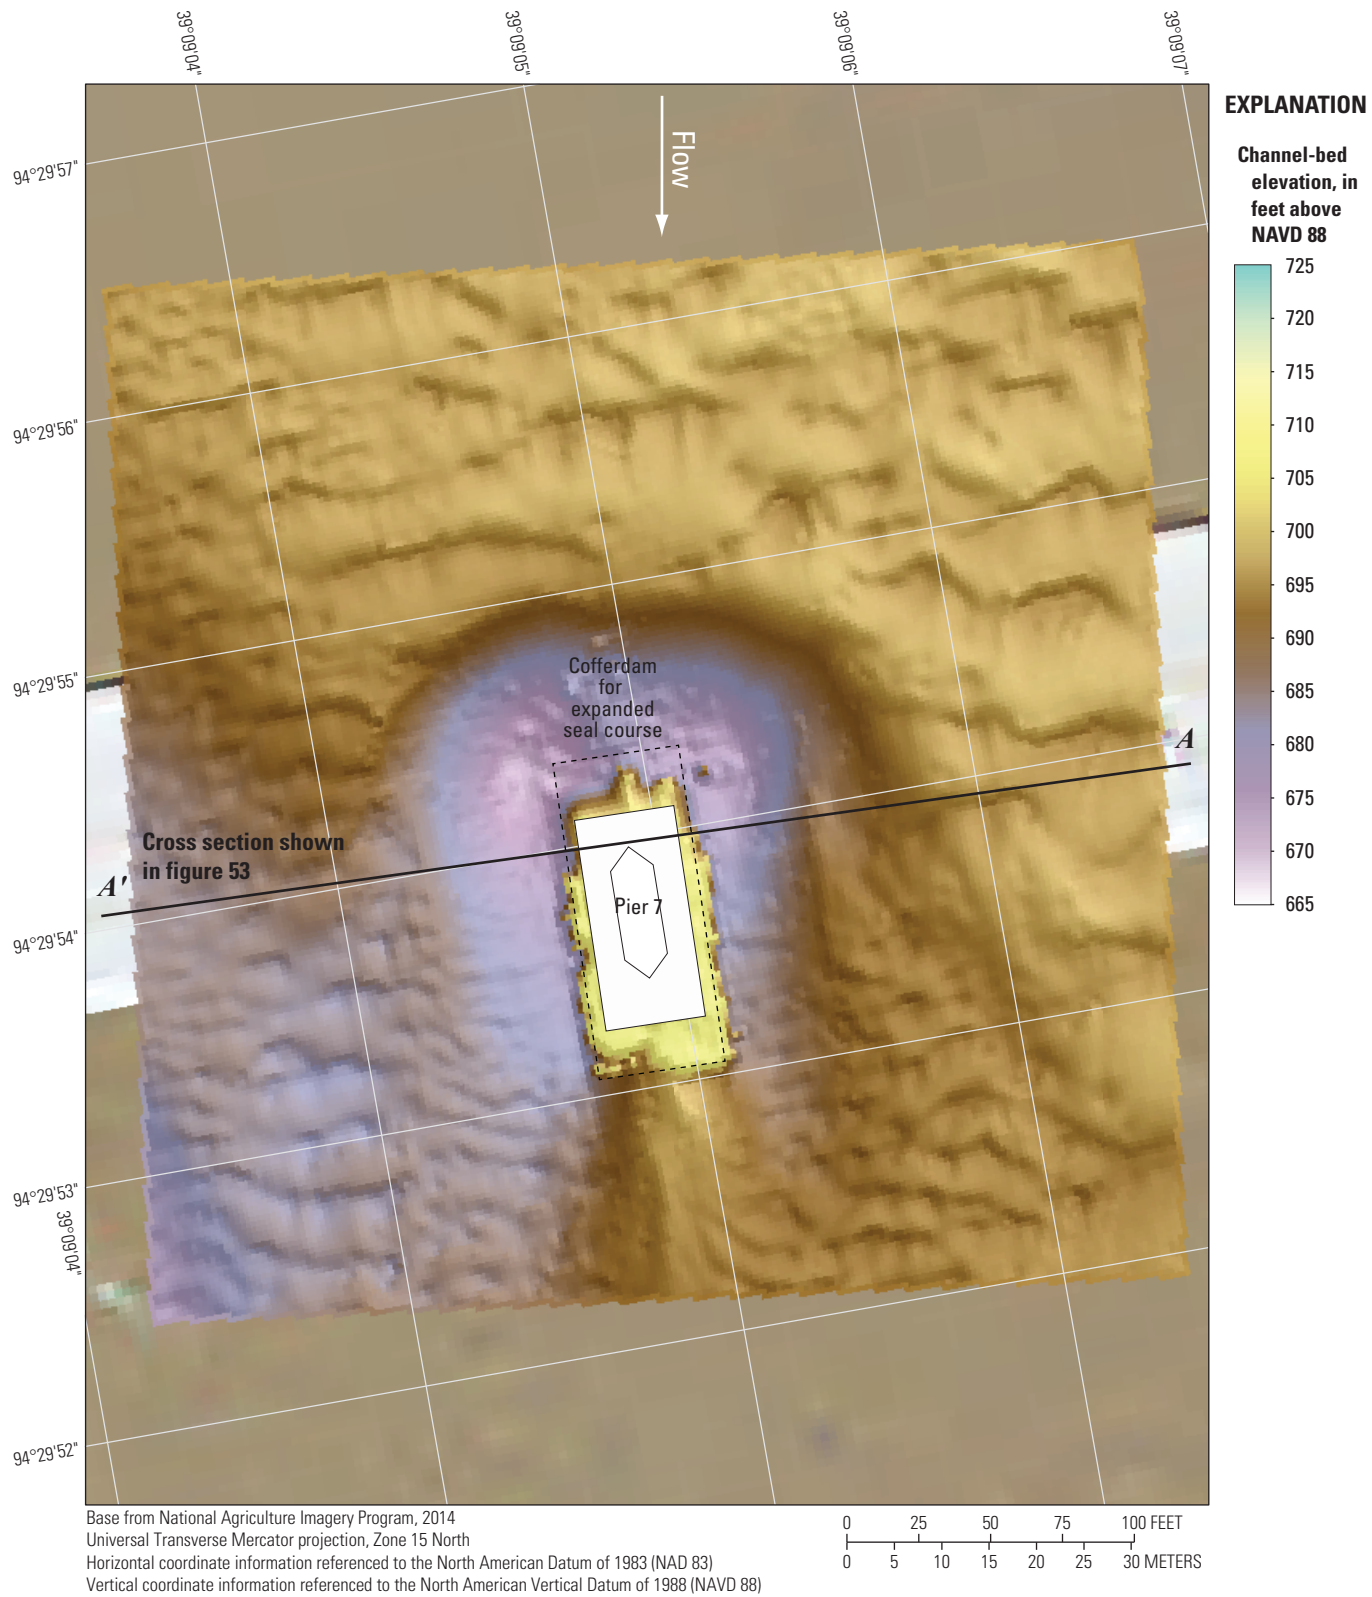
Figure 58. Bathymetric survey of the Missouri River channel near the main channel pier of structure A0767 on Interstate 435 in Kansas City, Missouri, on August 17, 2020, before installation of scour countermeasures.

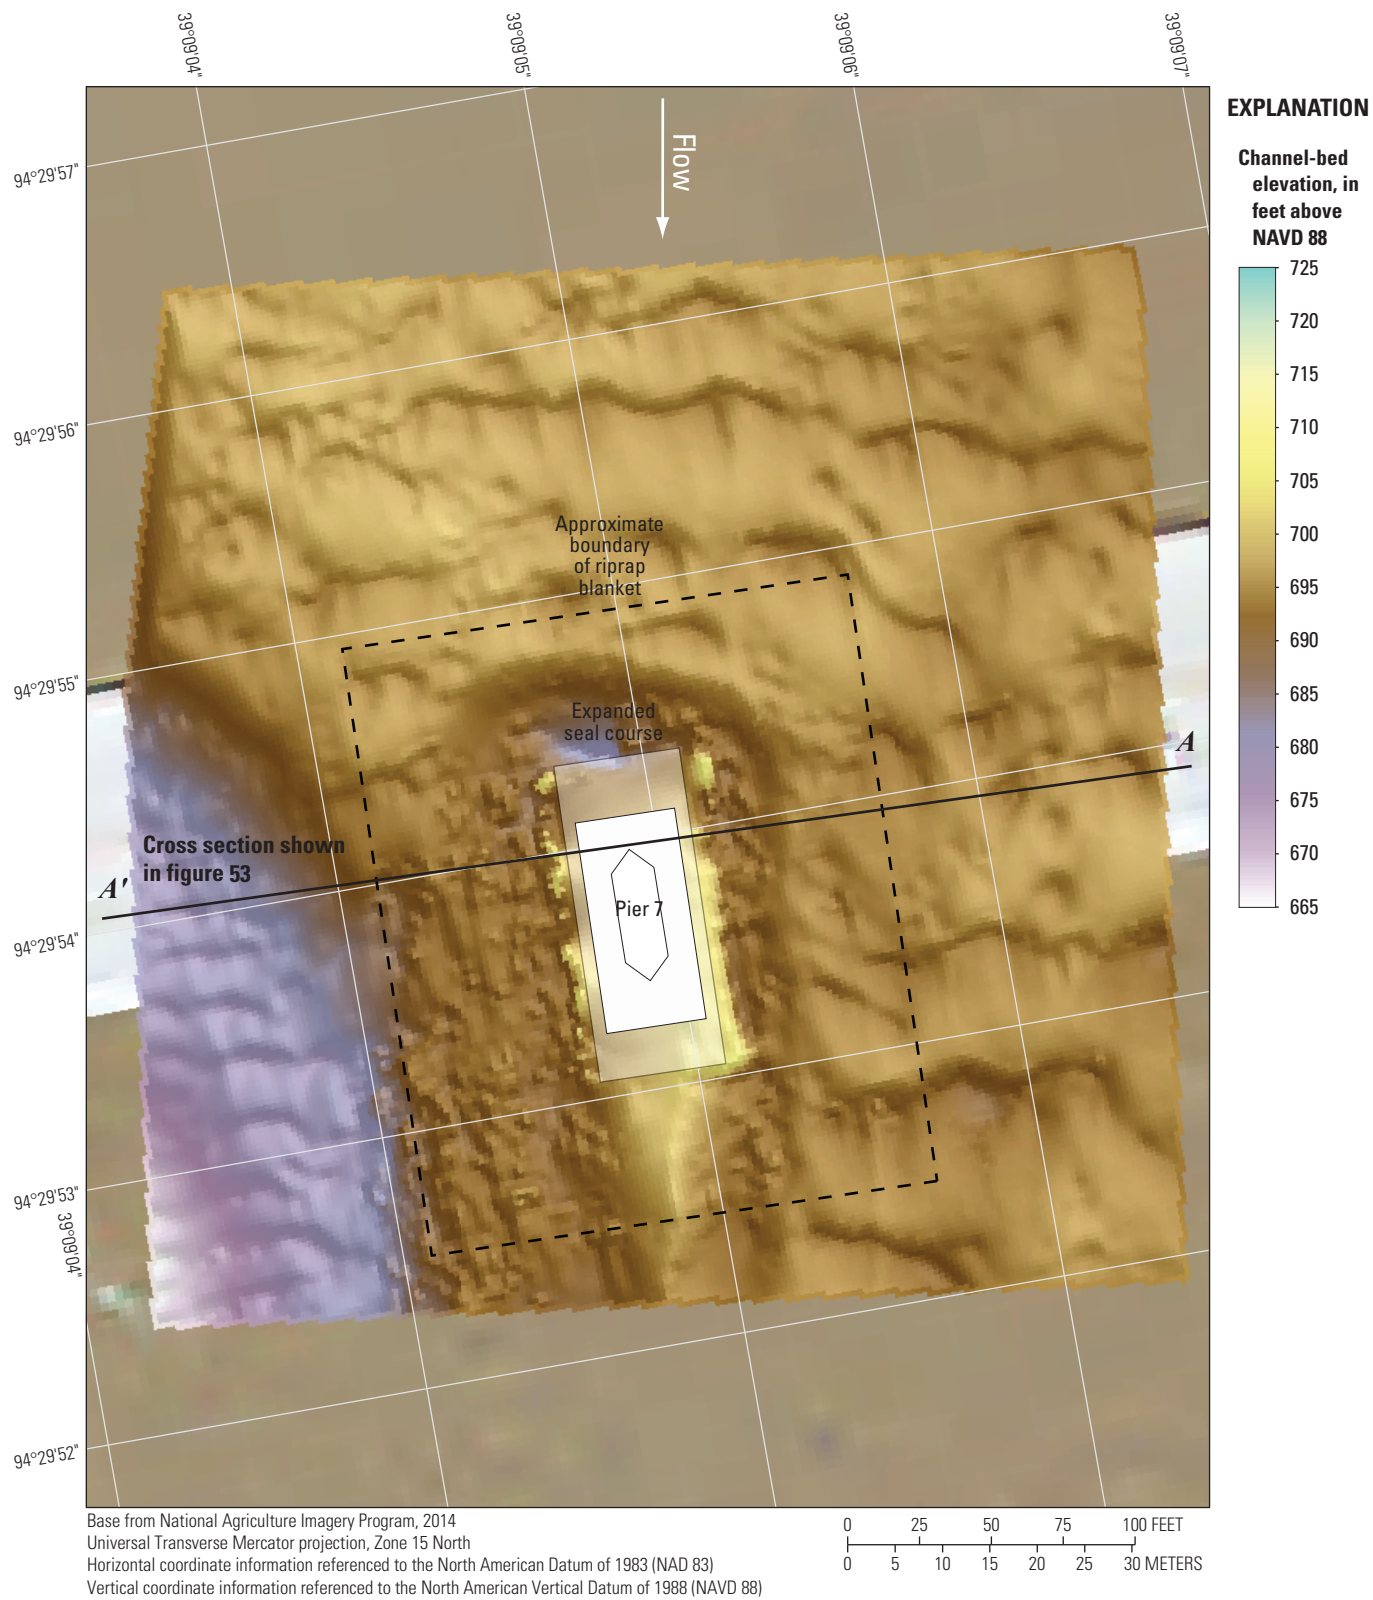
Figure 60. Bathymetric survey of the Missouri River channel near the main channel pier of structure A0767 on Interstate 435 in Kansas City, Missouri, on October 23, 2020, after installation of scour countermeasures.

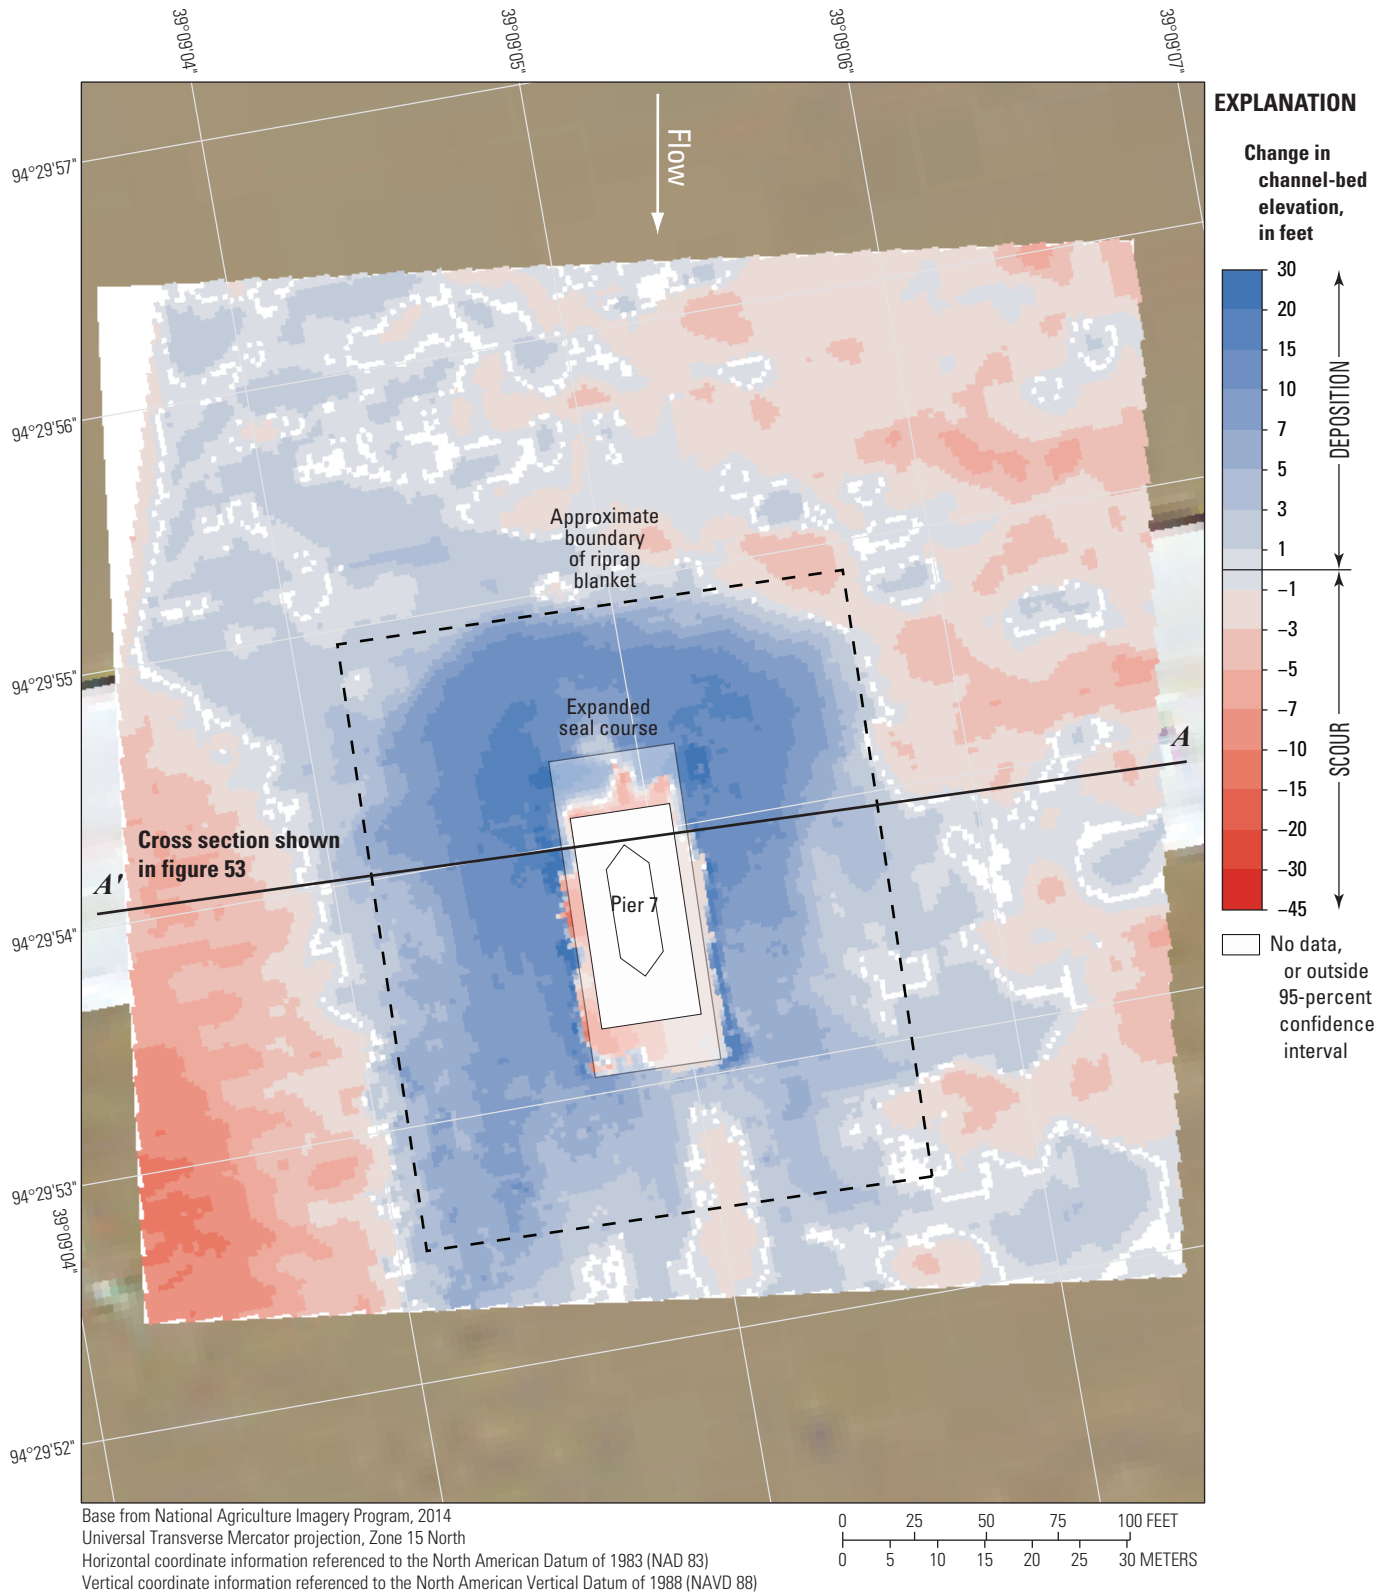
Figure 61. Difference between surfaces created from bathymetric surveys of the Missouri River channel near the main channel pier of structure A0767 on Interstate 435 in Kansas City, Missouri, on August 17 and October 23, 2020, before and after installation of scour countermeasures.
