Bathymetric and Velocimetric Surveys at Highway Bridges Crossing the Missouri and Mississippi Rivers on the Periphery of Missouri, June 13–22, 2022

Scientific Investigations Report 2024–5032

By Richard J. Huizinga

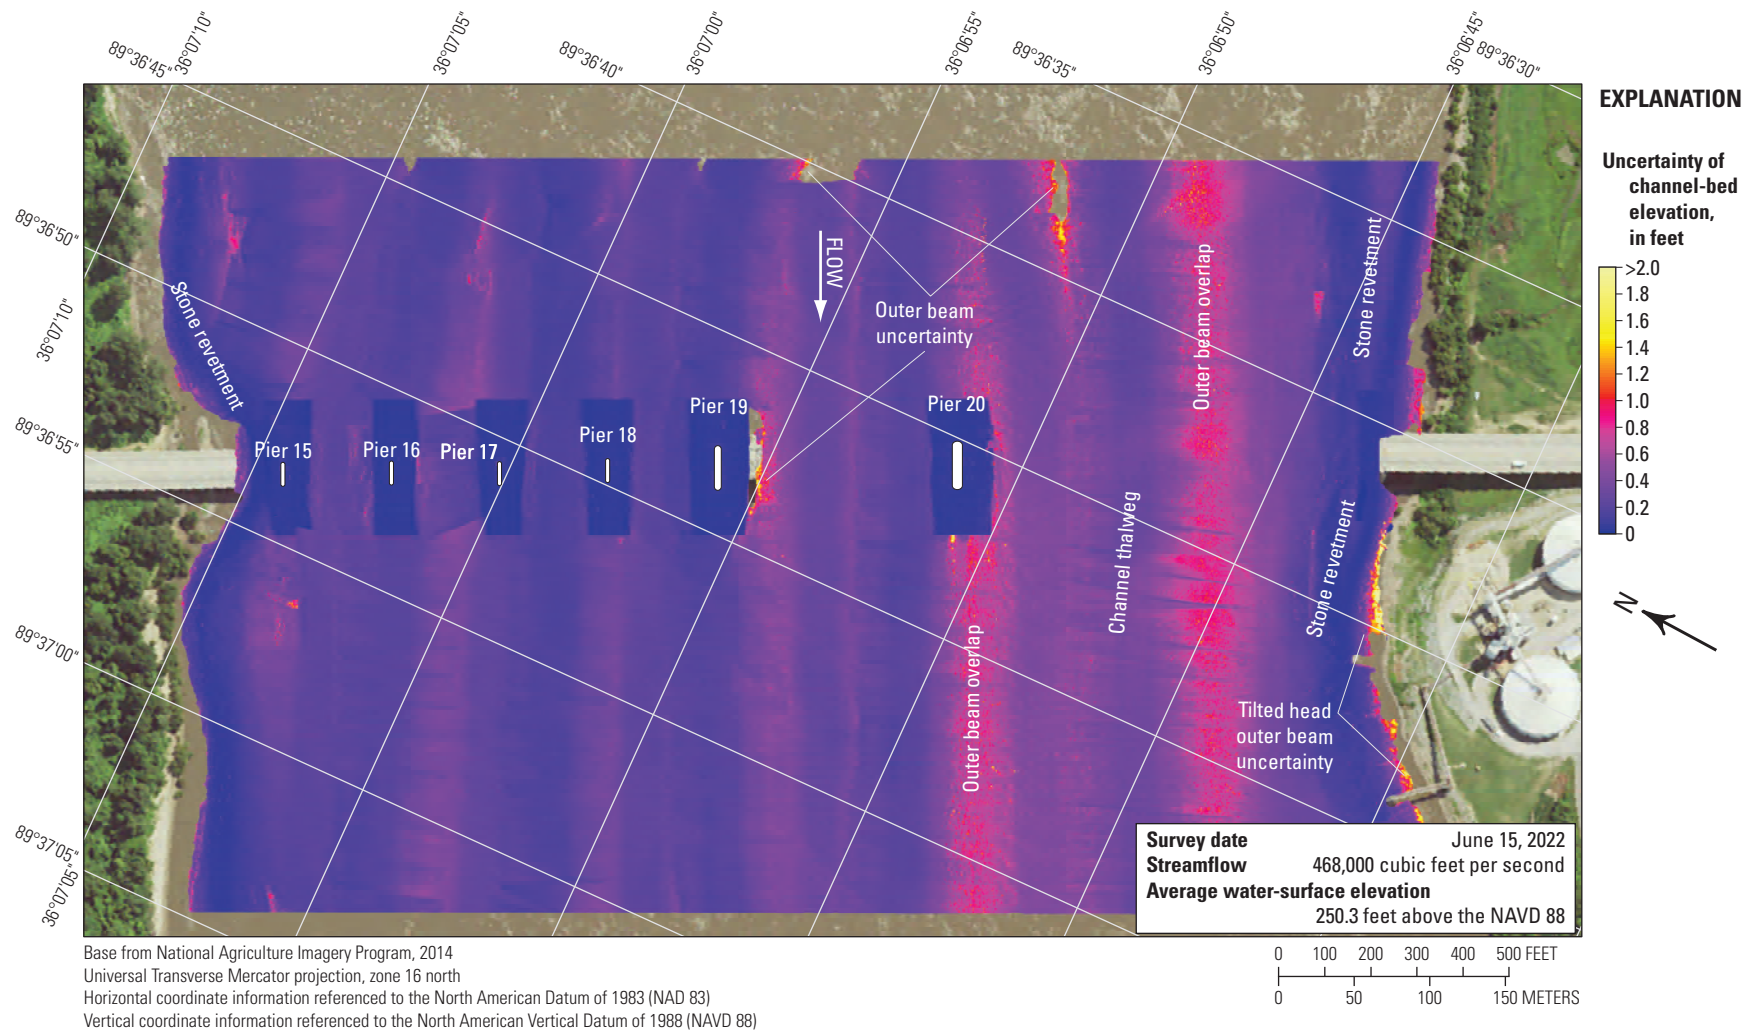
Figure 5. Uncertainty of gridded bathymetric data from the Mississippi River channel near structure A1700 on Interstate 155 near Caruthersville, Missouri.

The survey at structure A1700 on Interstate 155 near Caruthersville had one of the highest maximum values (6.56 ft) and the highest median value (0.26 ft) of gridded uncertainty, as well as a lower percentage of bathymetry points with a gridded uncertainty of less than the various thresholds (table 6). The survey at this site was obtained with relatively smooth longitudinal swaths (fig. 5), which was the case at nearly all the sites surveyed in this study. The primary anomalies at this site were observed near the outermost beams of adjacent swaths and along the banks and near the piers, where the MBES was used in an electronically tilted configuration to extend the potential coverage in these areas, resulting in higher uncertainty values. Generally, the magnitude and distribution of uncertainty observed at this site are representative of those observed at all the sites.

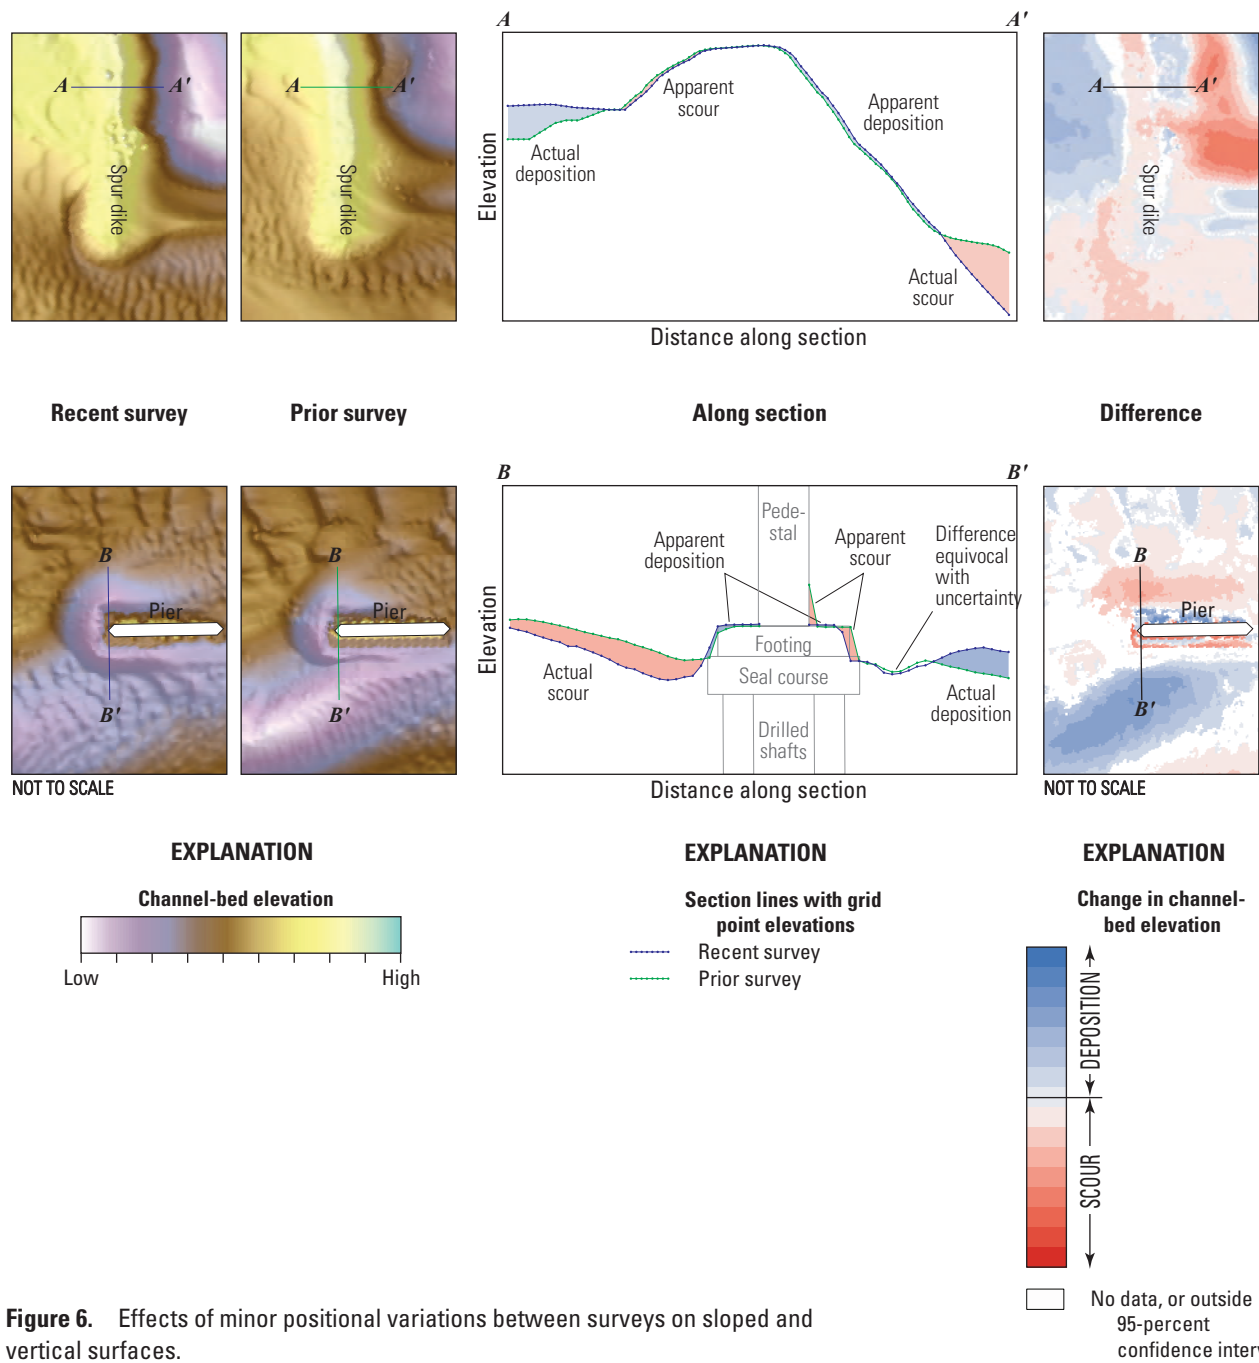
When calculating difference between two surveys near sloped or vertical features, small horizontal positional variations between the surveys can result in substantial calculated elevation differences. A schematic of this phenomenon is shown in [figure 6](#), where a position offset of one grid spacing (0.25 m) resulted in apparent deposition or scour on the opposing faces of a spur dike or the opposing sides of a pier. When deposition and scour are apparent on opposing faces of a feature in the following site-specific discussions and maps, the likely cause is a minor horizontal positional variance between the surveys.

Figure 6. Effects of minor positional variations between surveys on sloped and vertical surfaces.

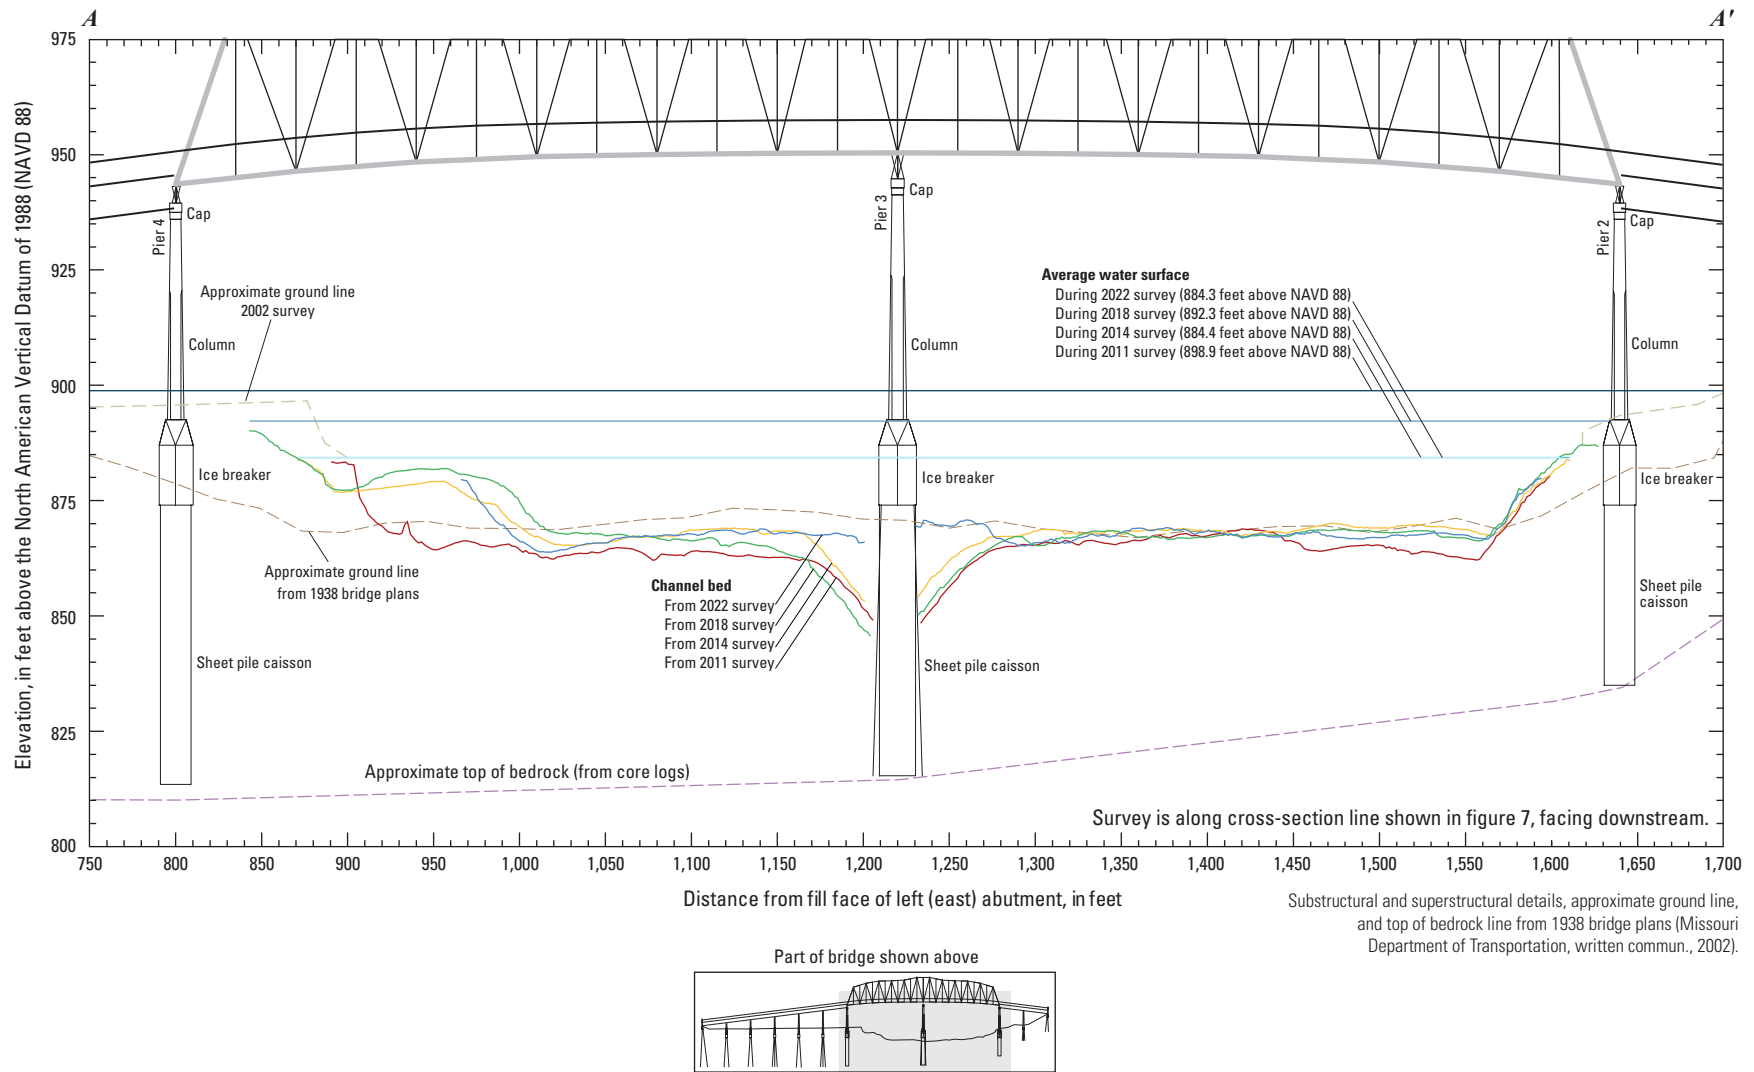
The scour hole that historically had been observed near pier 3 in previous surveys (refer to fig. 6 in Huizinga [2020e]) was conspicuously absent in the 2022 survey, having been mitigated by the apparent installation of a riprap blanket scour countermeasure around the pier sometime since the most-recent previous survey in 2018 (figs. 7, 1.1A, 1.1B). Information from bridge plans indicates that pier 3 is founded on sheet piling caissons on bedrock, with about 51 ft of bed material between the bottom of the scour hole and bedrock at the upstream face of the pier (fig. 9; difference between “Approximate minimum elevation in scour hole near pier/bent” and “Approximate elevation of bedrock near pier/bent” in table 7). The unique configuration of the sheet pile caissons and ice breaker of the pier are clearly seen in the shaded TIN images for pier 3 (fig. 1.1). The surveyed bed generally was similar to the most-recent previous multibeam surveys in 2014 and 2018, except near pier 3 where the riprap blanket scour countermeasures now exist (fig. 9).

Figure 9. Key features, substructural and superstructural details, and surveyed channel bed of structure L0098 on U.S. Highway 136 crossing the Missouri River at Brownville, Nebraska.

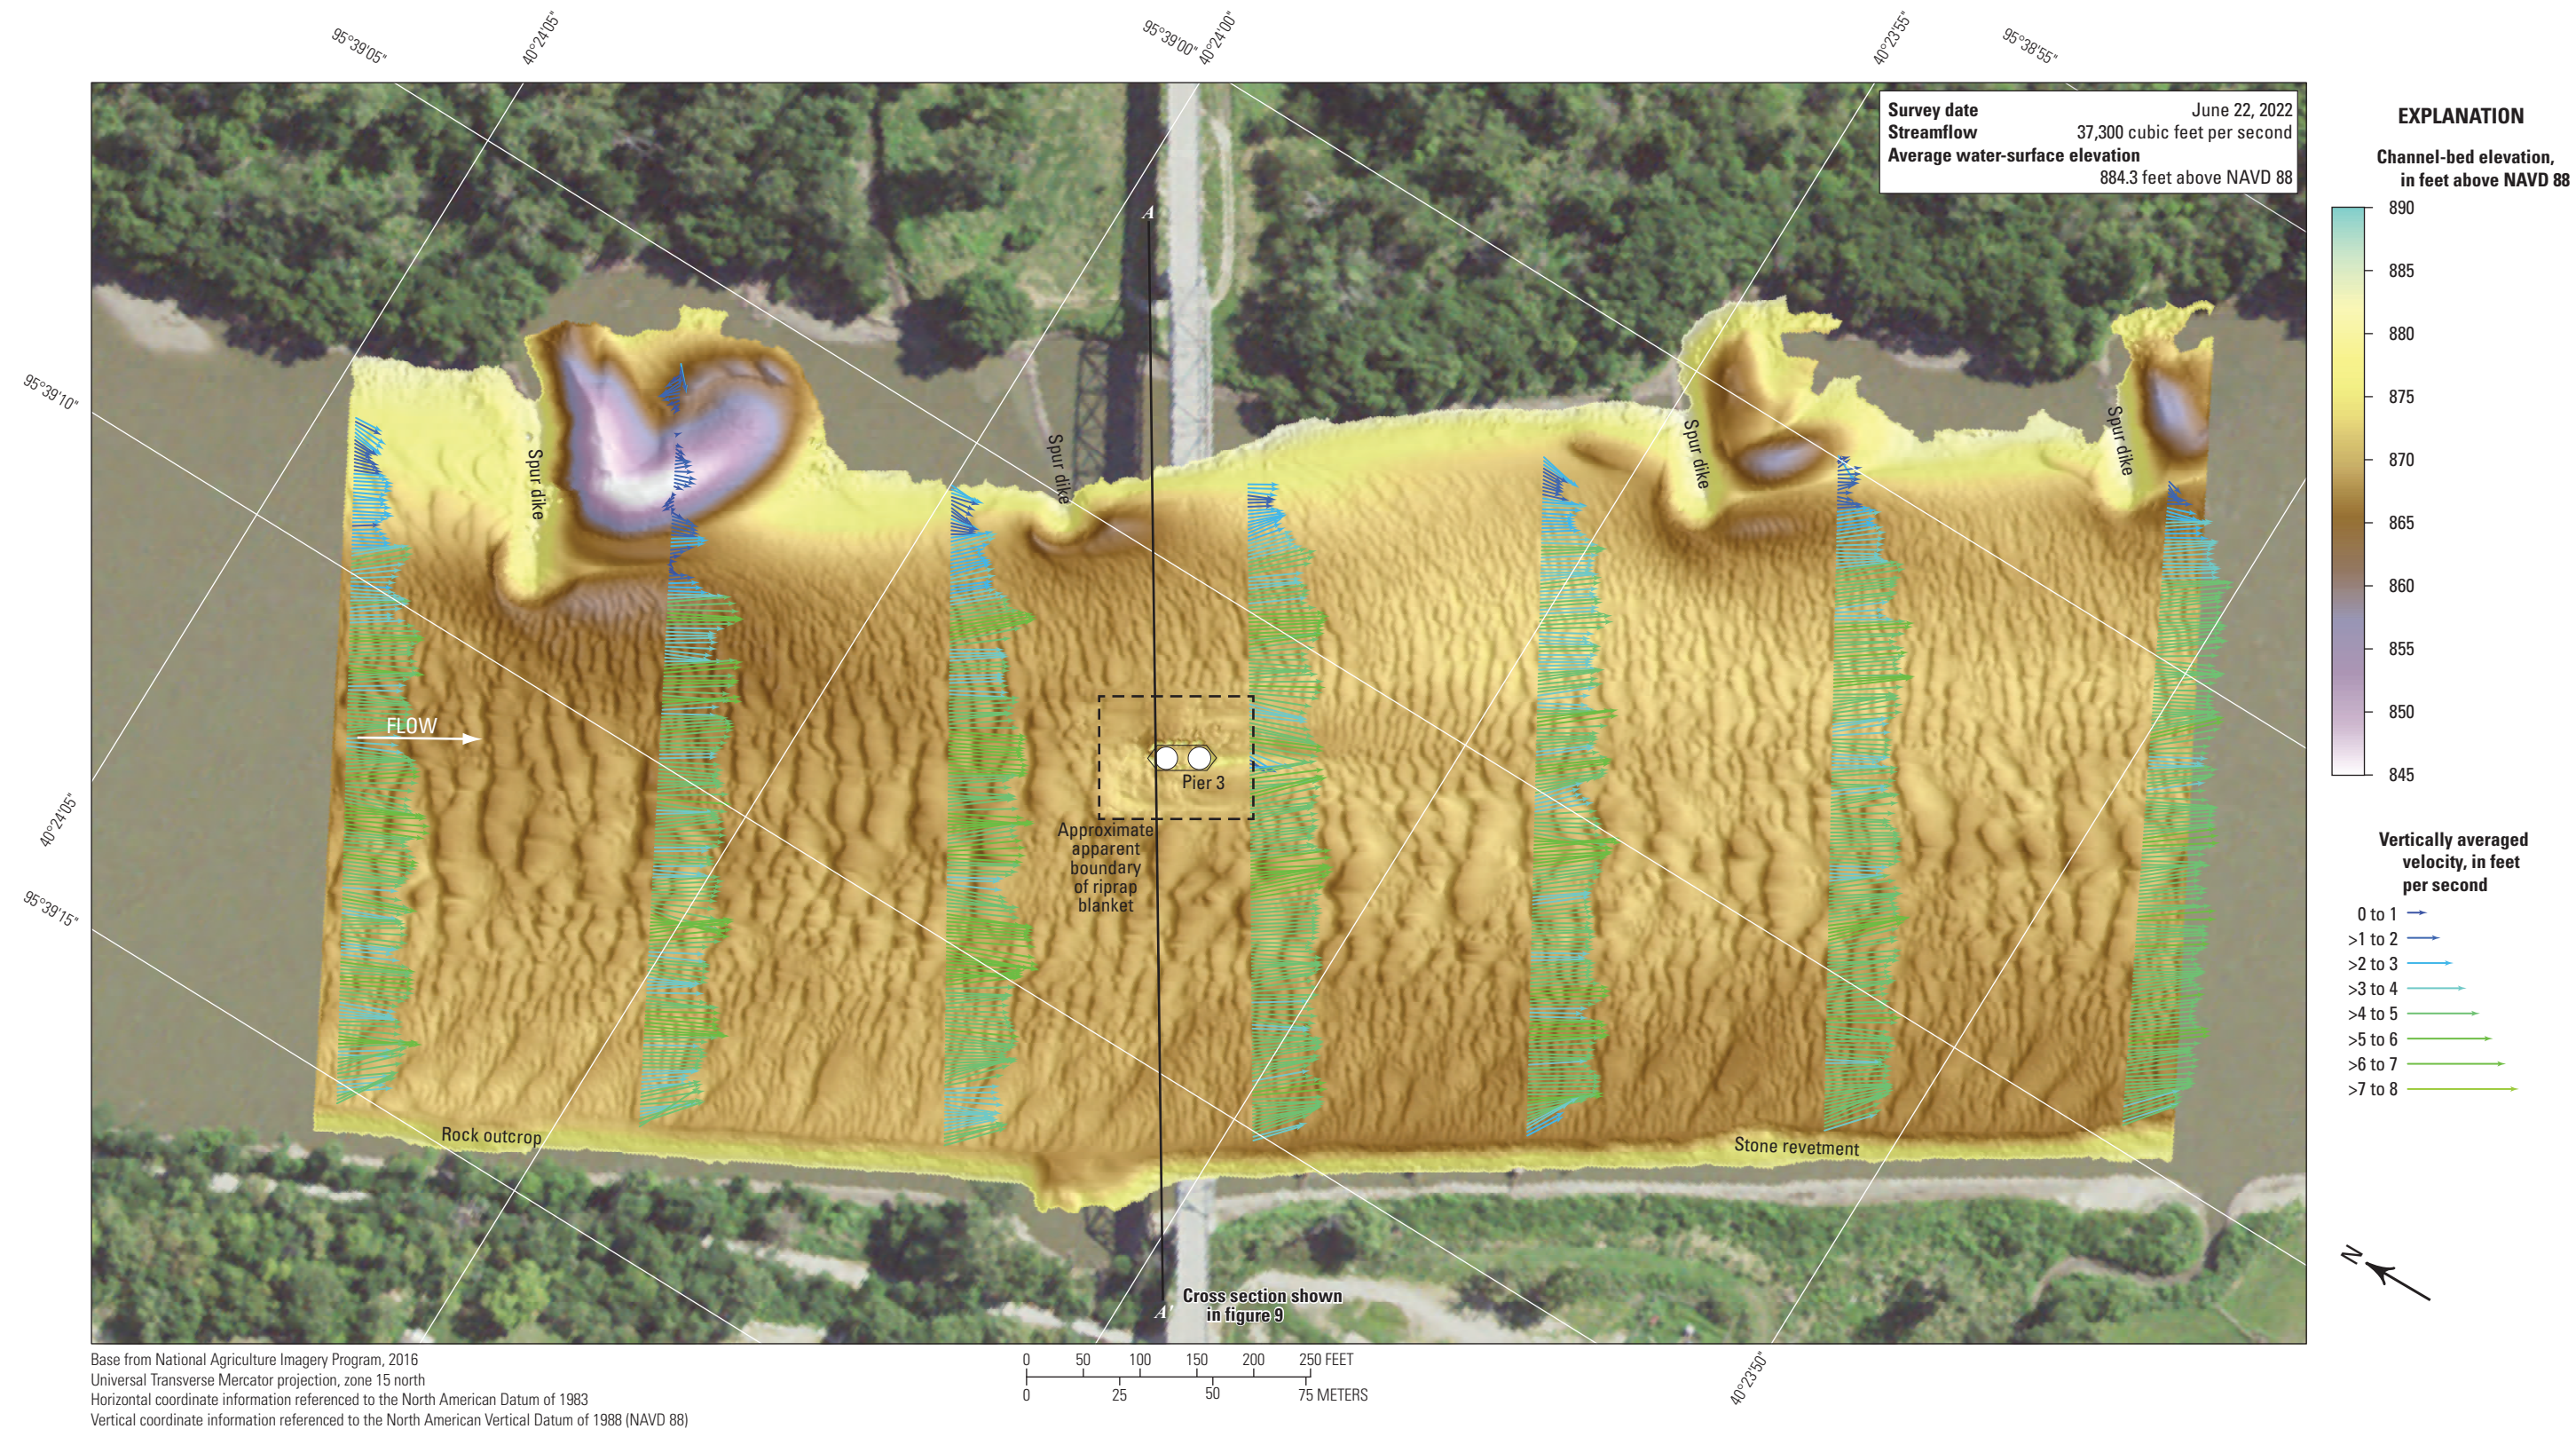
The vertically averaged velocity vectors indicated mostly uniform flow in the middle of the channel, with velocities ranging from about 4 to 7 feet per second (ft/s) except near the spur dikes on the left (east) bank where local lower velocities and turbulence were observed (fig. 13). The wake vortices downstream from the main channel pier were not pronounced and seemed to be no greater than the general nonuniformity of flow observed in the channel (fig. 13). Minor localized turbulence was present in all the sections (fig. 13).

Figure 13. Bathymetry and vertically averaged velocities of the Missouri River channel near structure L0098 on U.S. Highway 136 at Brownville, Nebraska.

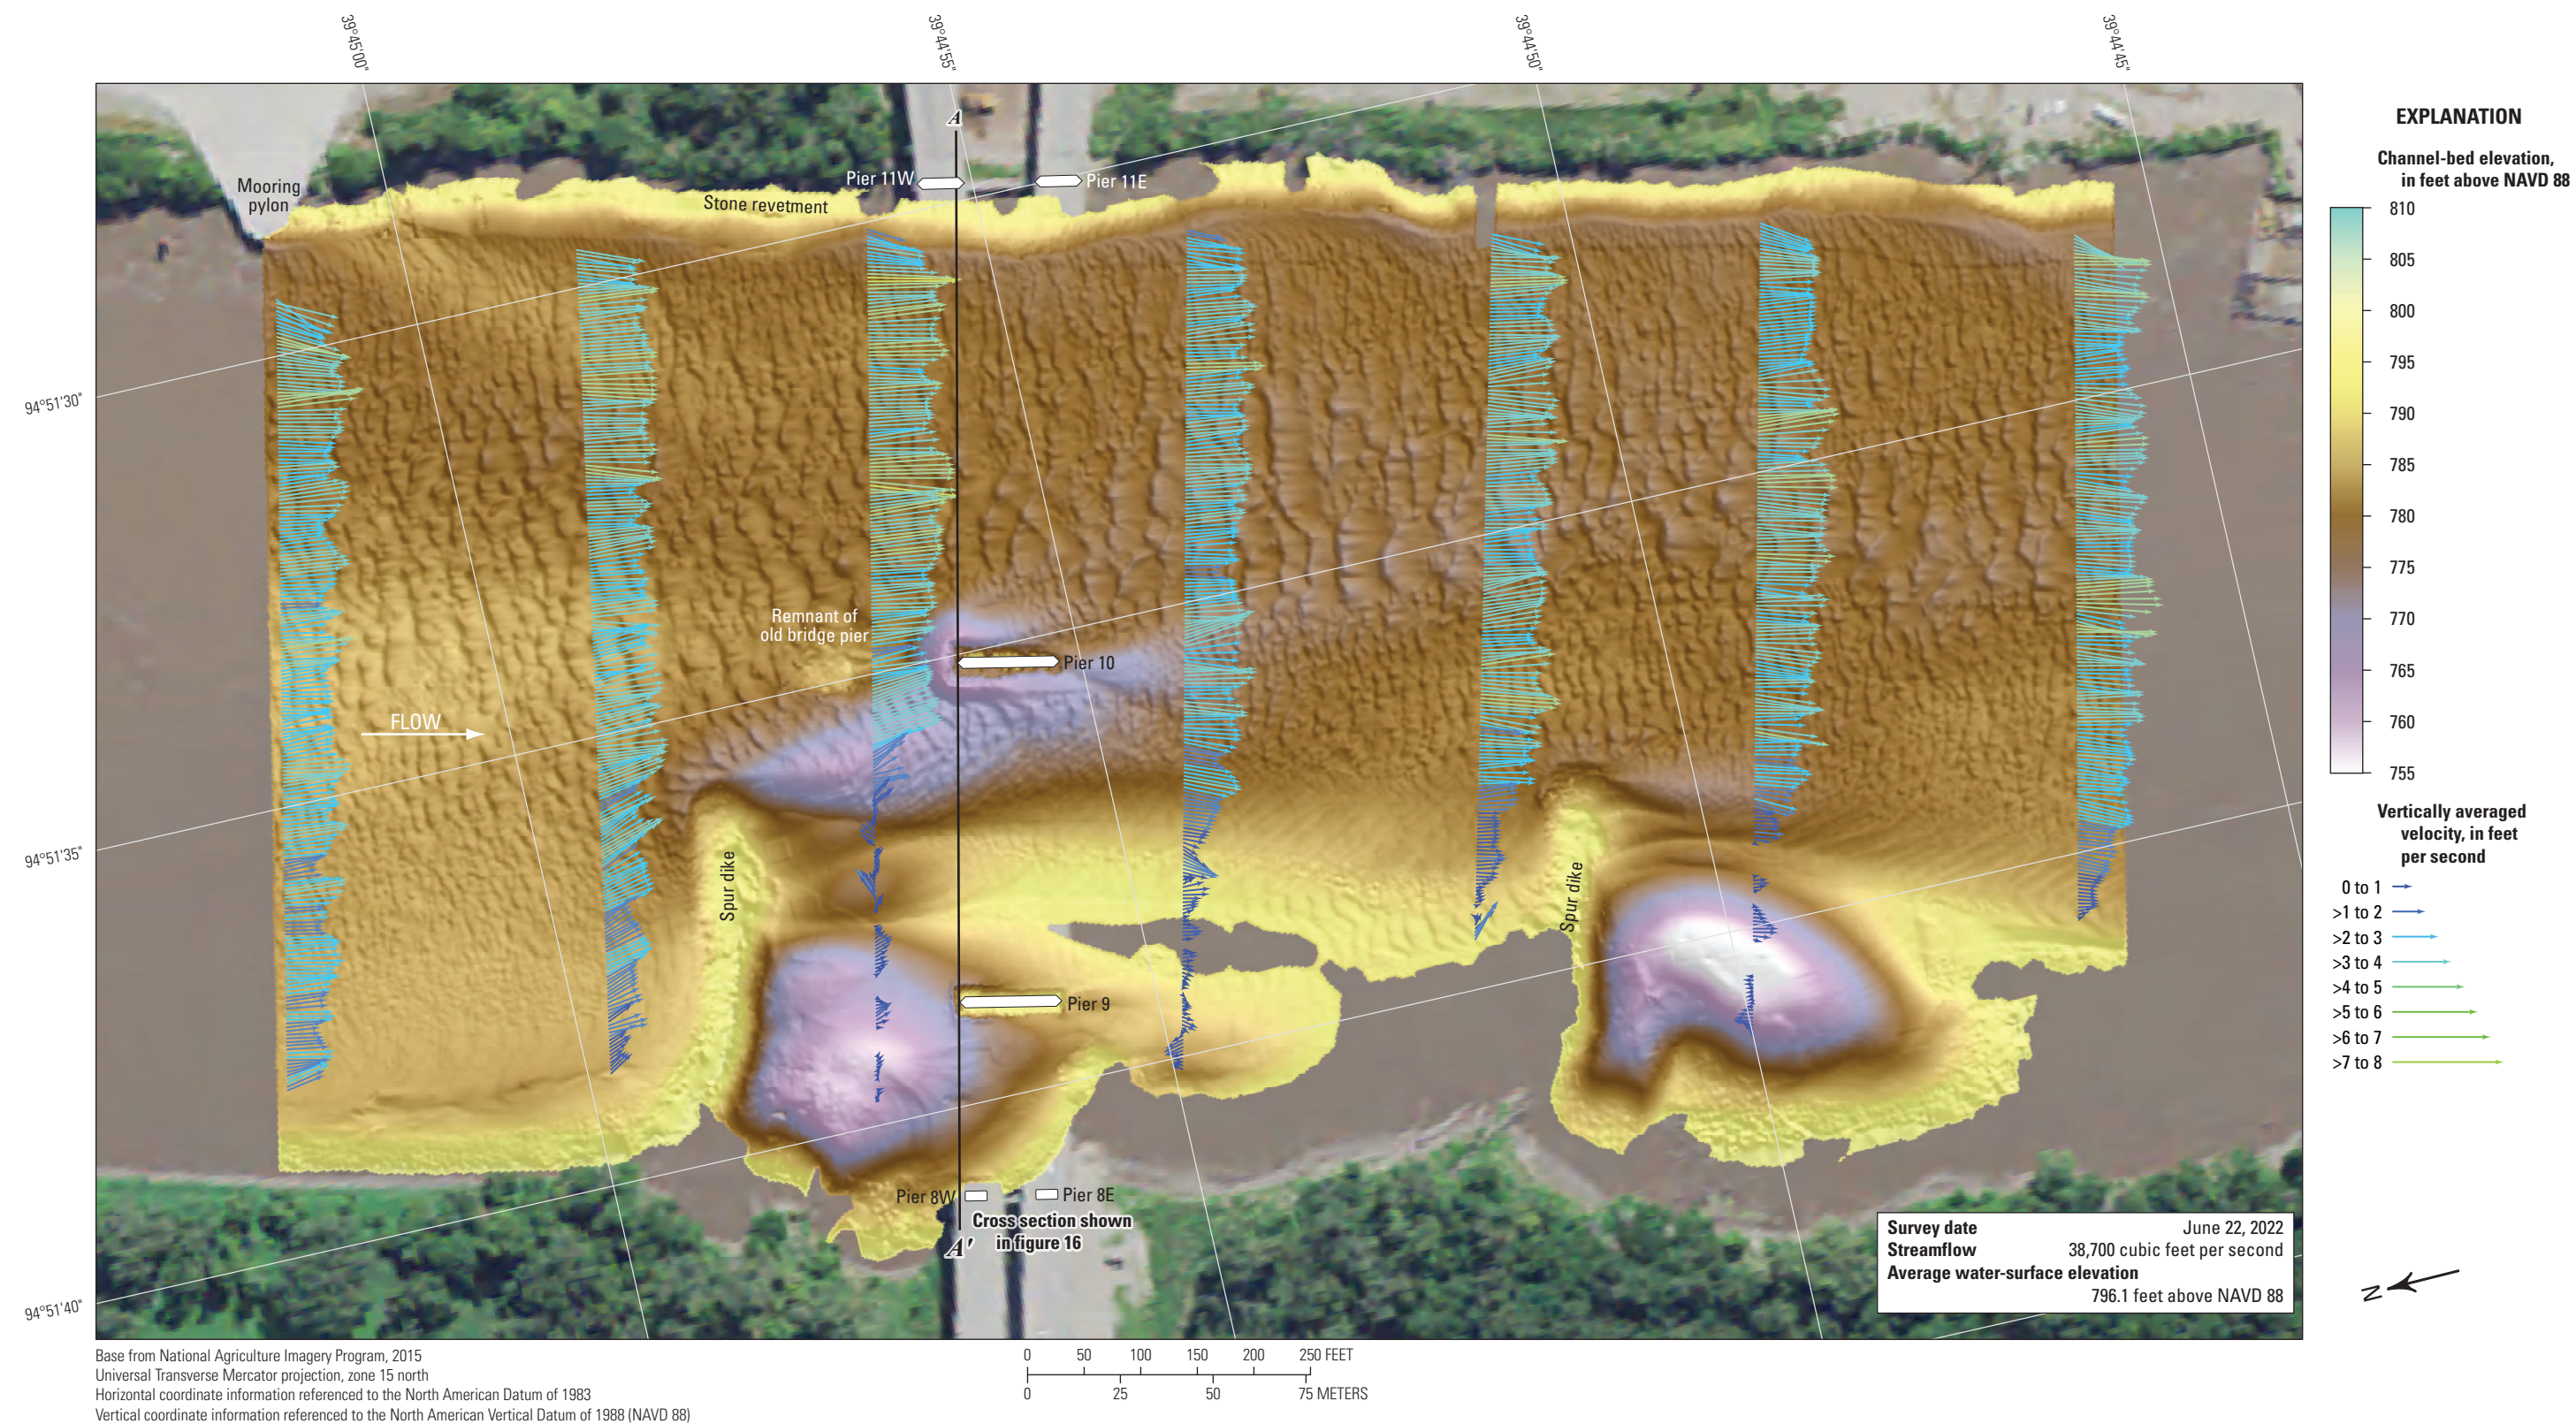
The vertically averaged velocity vectors indicate mostly uniform flow in the middle of the channel, with velocities ranging from about 3 to 8 ft/s (fig. 20). Local lower velocities and turbulence were observed downstream from the various spur dikes on the right (west) bank (fig. 20). Wake vortices were evident downstream from main channel pier 10 but were not pronounced and seemed to be no greater than the general nonuniformity of flow observed in the channel (fig. 20). Although aligned with primary flow in the channel, pier 10 is slightly skewed to approach flow because of the spur dike on the right (west) bank upstream, causing minor wake vortices and a defined deposition ridge downstream (fig. 20). Minor localized turbulence was present in all the sections (fig. 20).

Figure 20. Bathymetry and vertically averaged velocities of the Missouri River channel near dual bridge structure A3664 on U.S. Highway 36 at St. Joseph, Missouri.

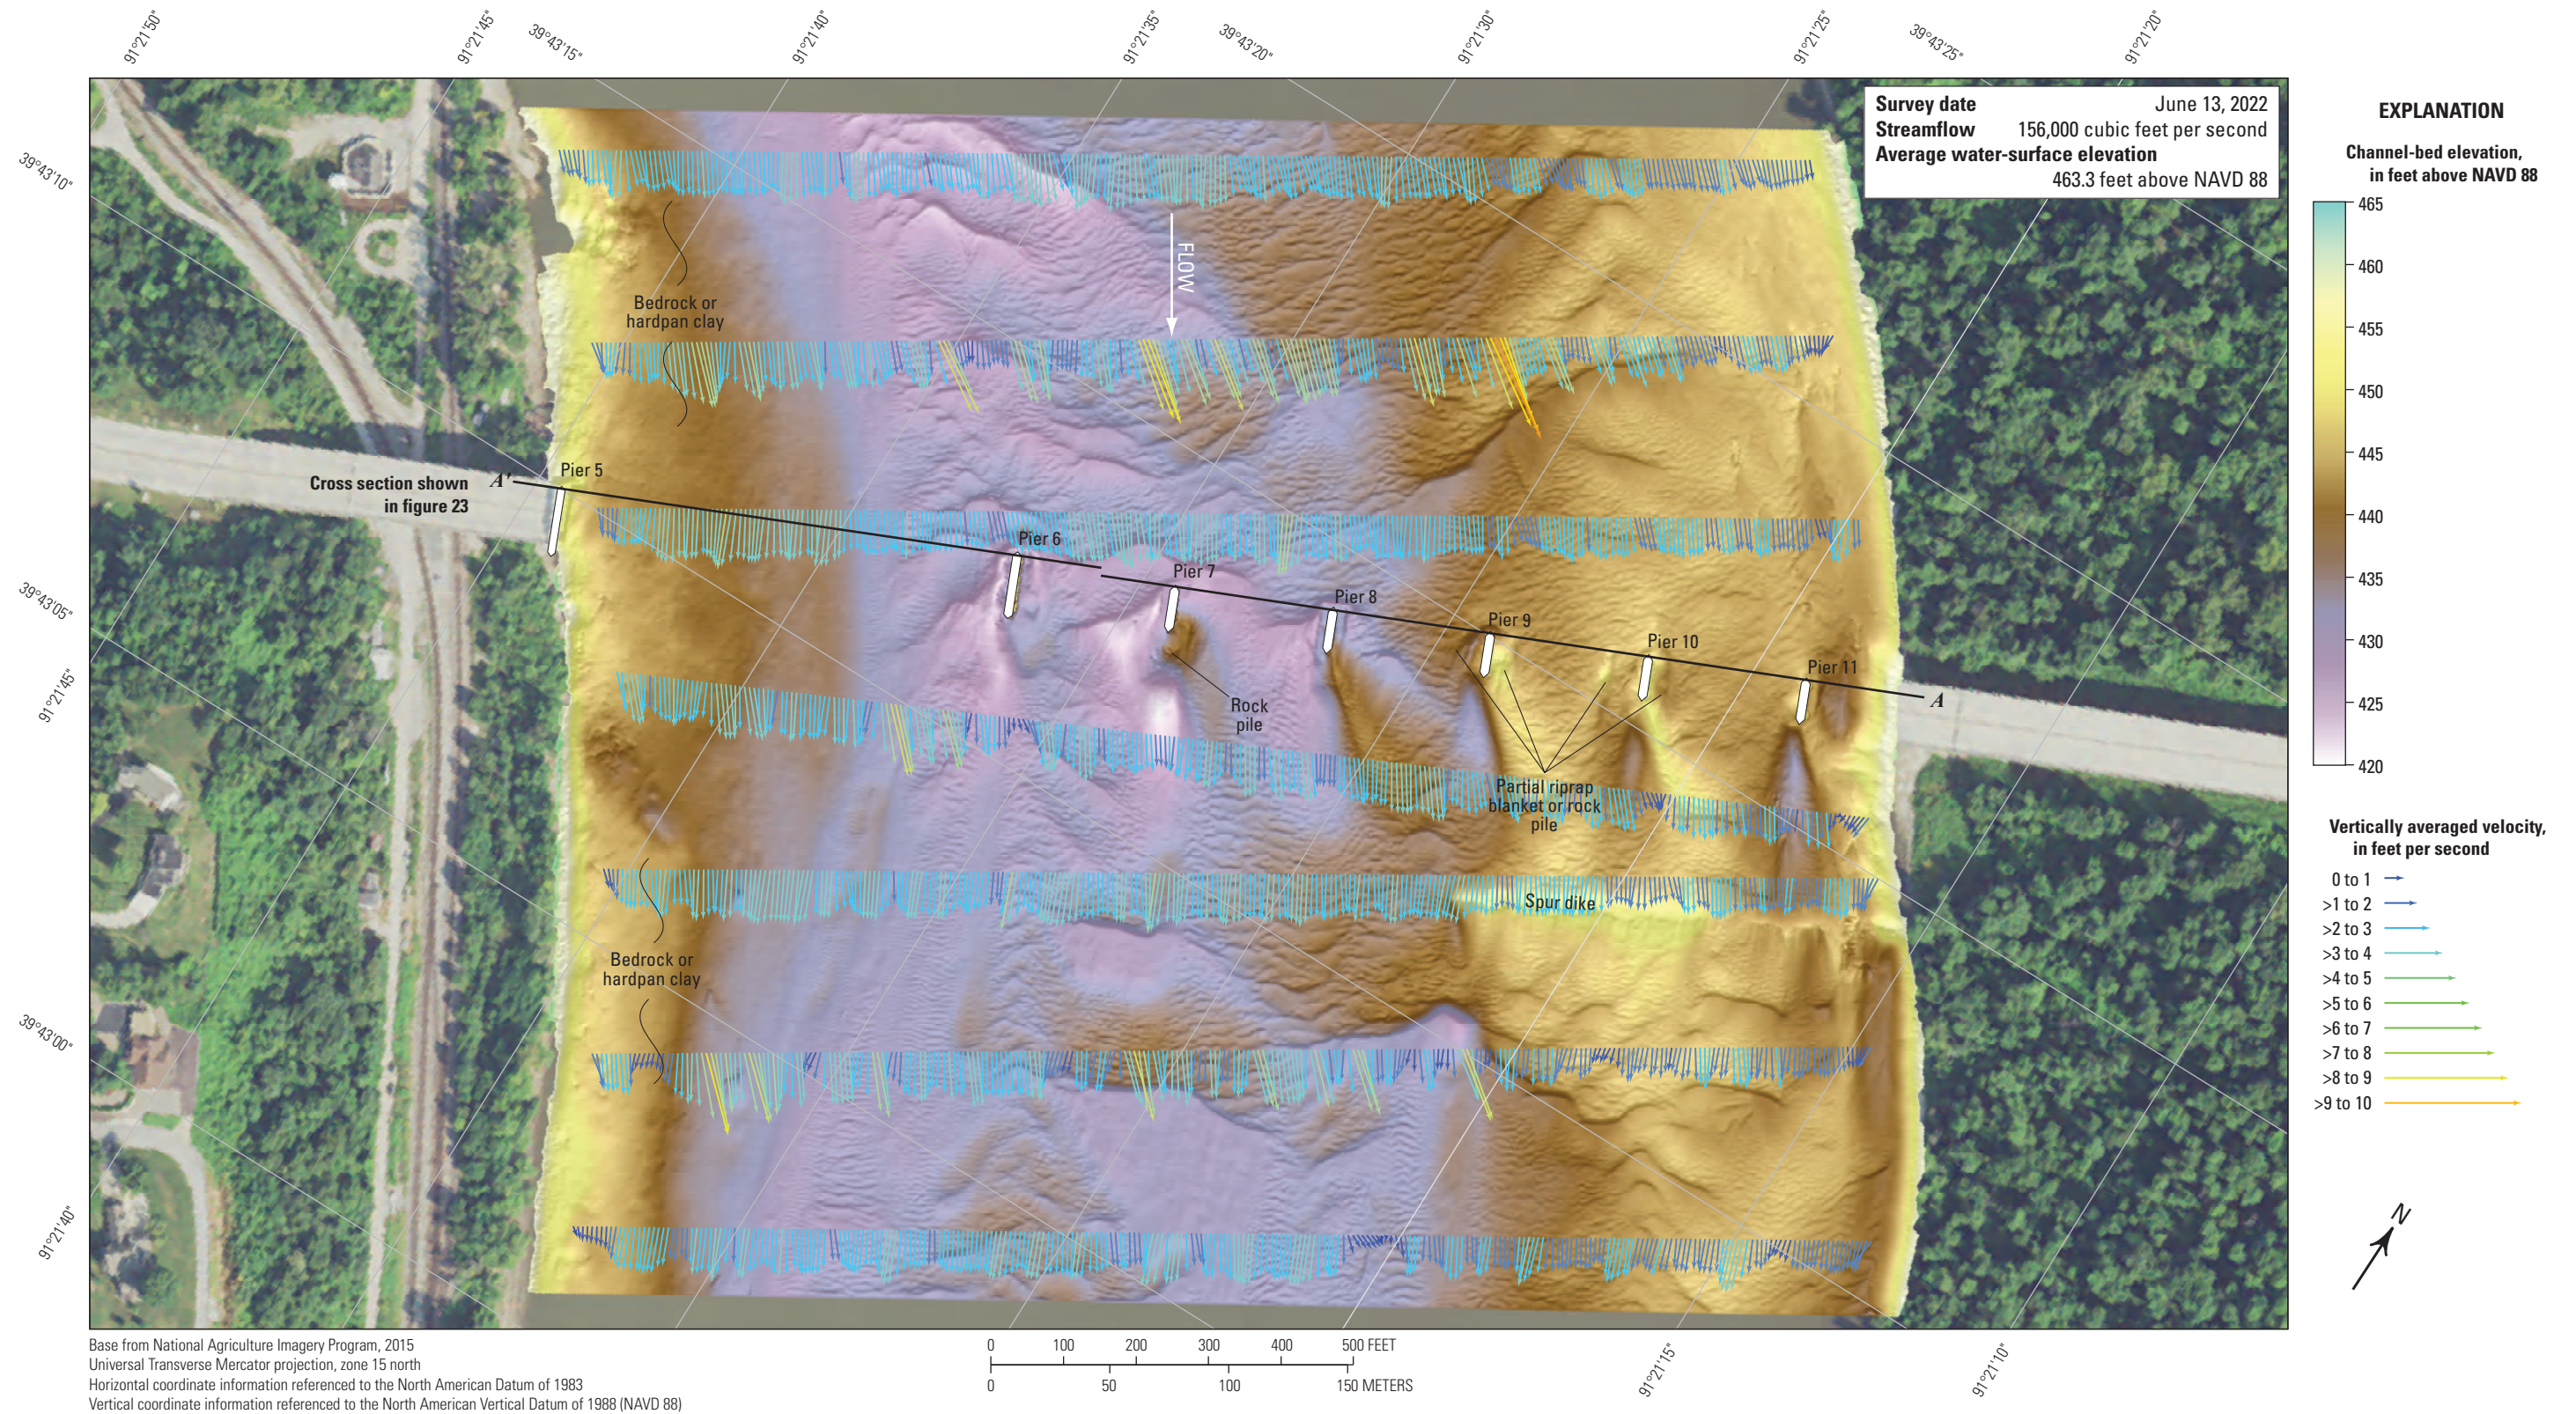
velocities and turbulence observed downstream from the piers and along the right (southwest) bank (fig. 26). All the piers were skewed to approach flow by 10 to 20 degrees (table 7), causing minor wake vortices and well-defined deposition ridges downstream (fig. 26). Additional flow disturbance may result from upwelling of flow caused by the numerous medium dune features present throughout the channel (Best, 2005; fig. 26).

Figure 26. Bathymetry and vertically averaged velocities of the Mississippi River channel near structure A5054 on Interstate 72 at Hannibal, Missouri.

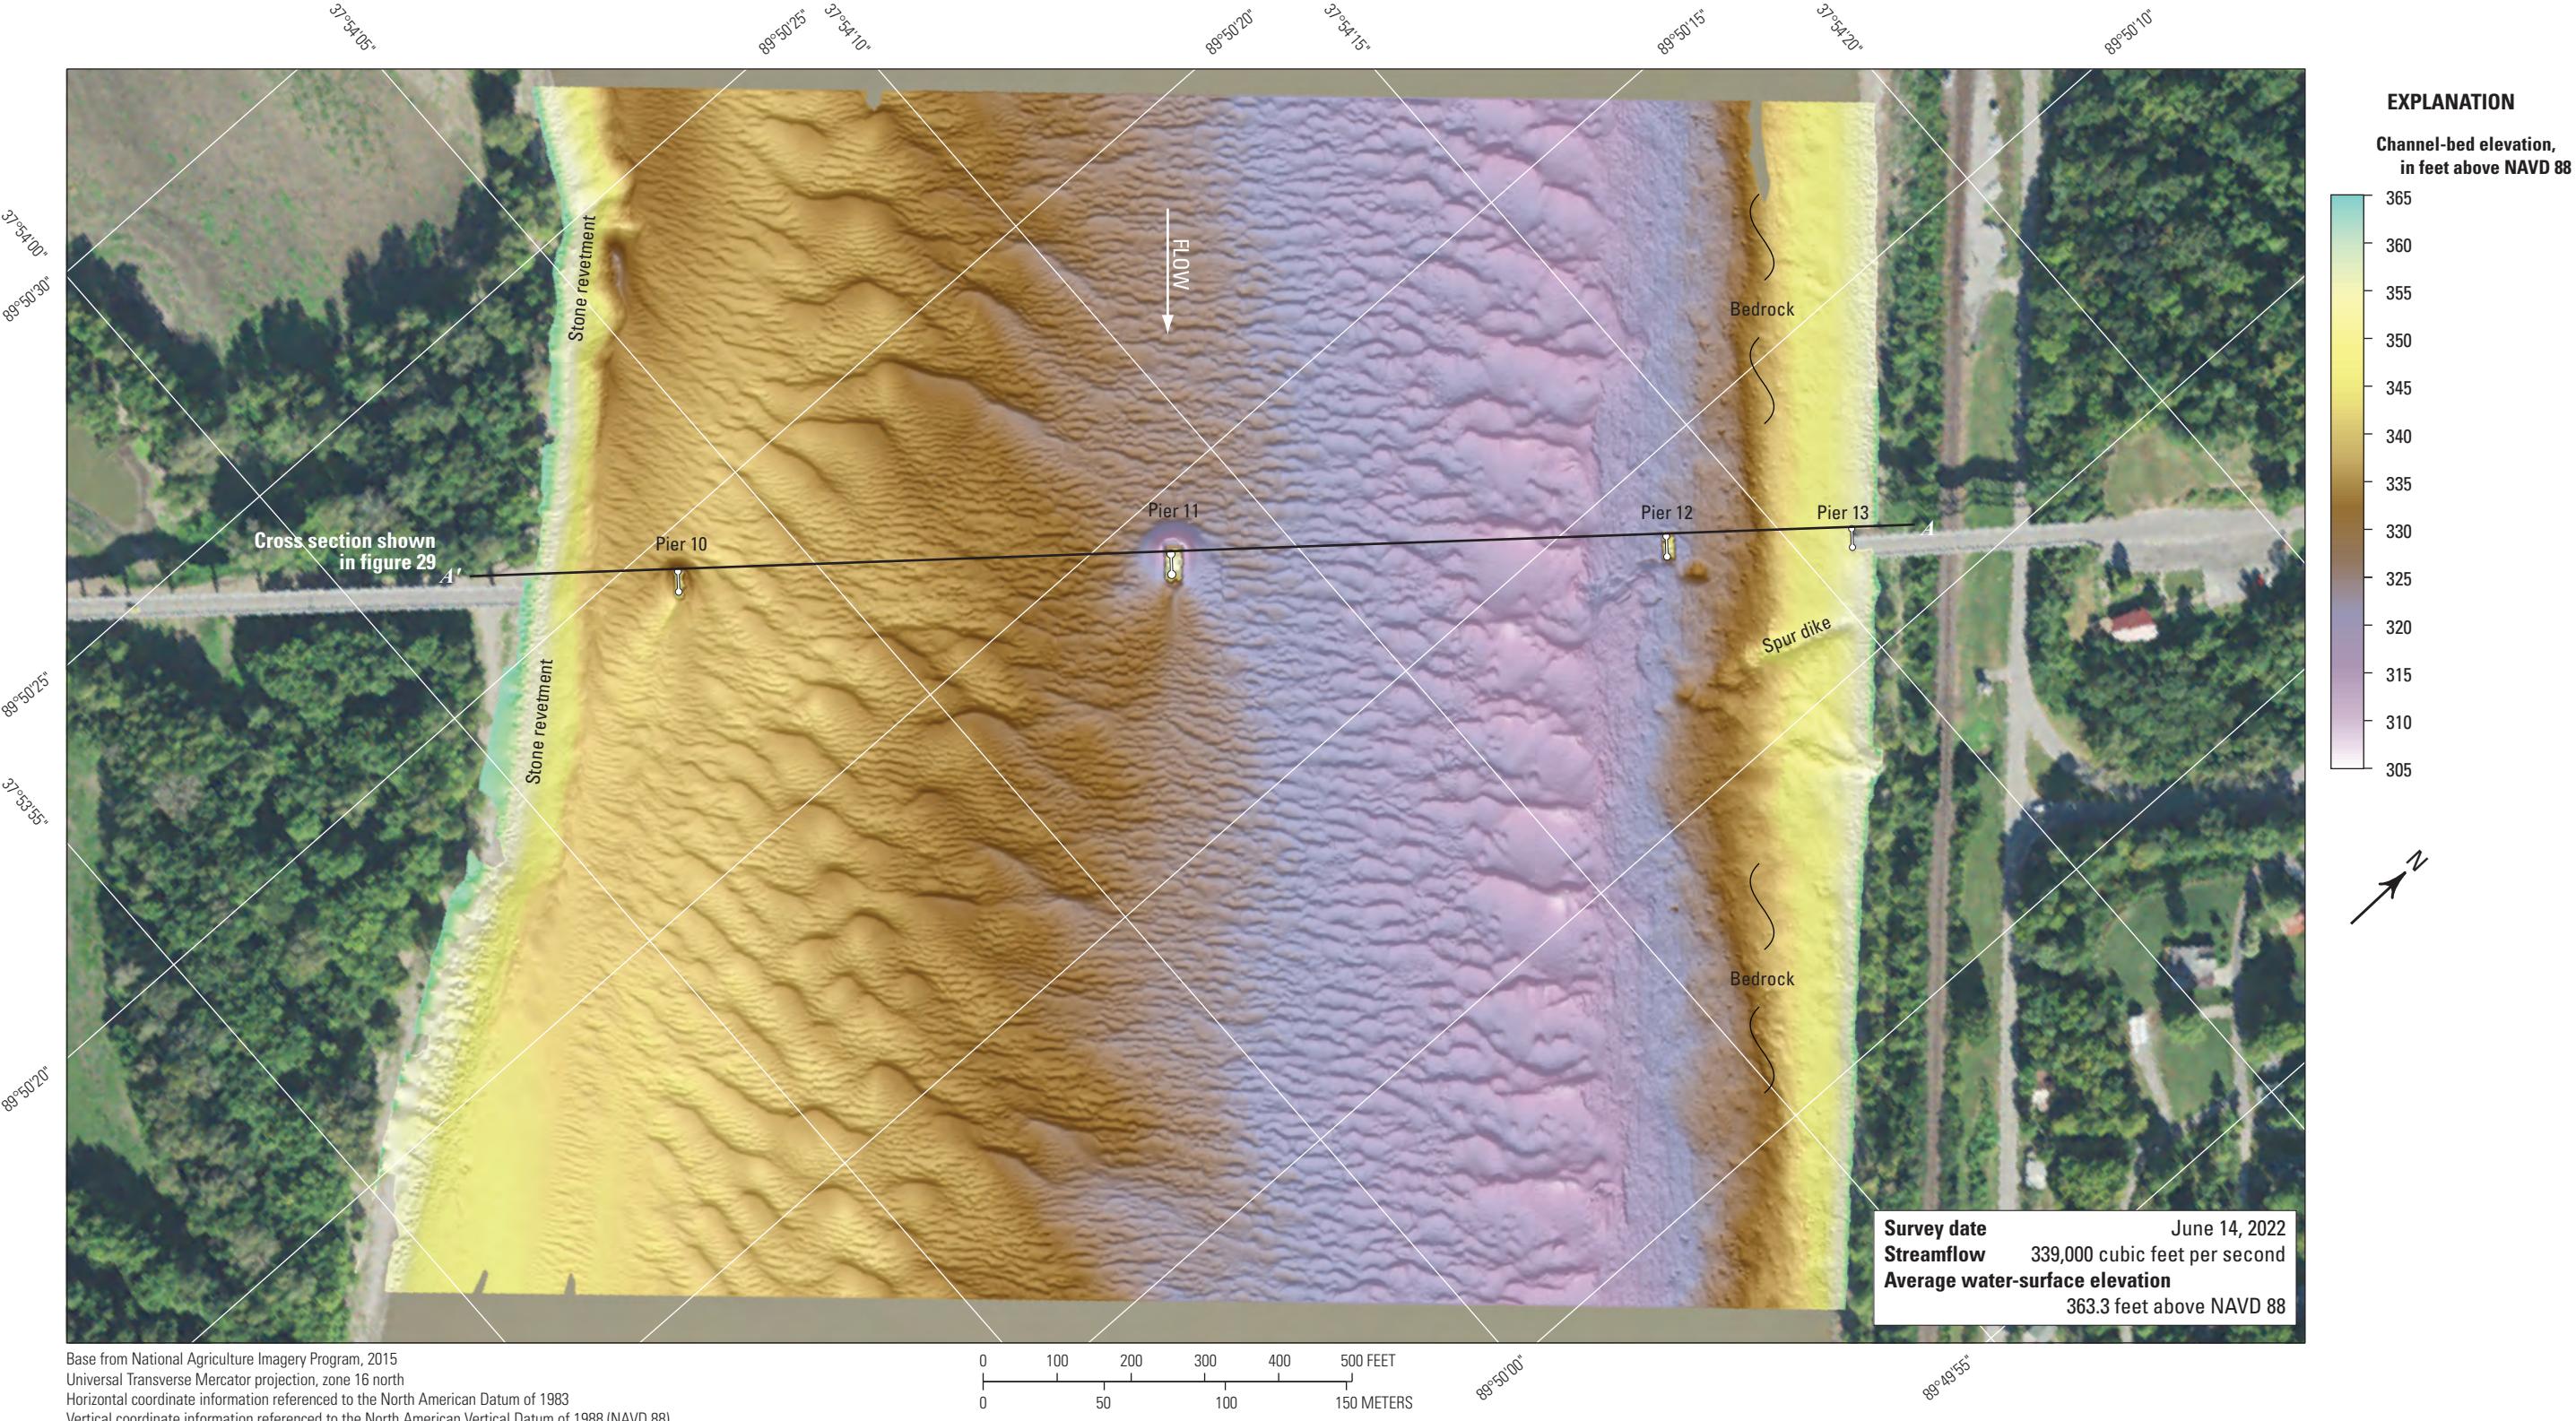
Near pier 11, a substantial scour hole had a minimum channel-bed elevation of about 309 ft ([table 7](#)), which is about 17 ft below the average channel elevation upstream from the pier ([figs. 27, 1.5D–E](#)). Information from bridge plans indicates that pier 11 is founded on a caisson on bedrock, having about 43 ft of bed material between the bottom of the scour hole and bedrock ([fig. 29](#); [table 7](#)); the top of the caisson is visible in the shaded TIN images ([fig. 1.5D–E](#)). Near pier 10, a moderate scour hole had a minimum channel-bed elevation of about 329 ft ([table 7](#)), which is about 8 ft below the average channel elevation upstream from the pier ([figs. 27, 29, 1.5F–G](#)). Pier 10 also is founded on a caisson on bedrock, having about 84 ft of bed material between the bottom of the scour hole and bedrock ([fig. 29](#); [table 7](#)). Pier 12 is founded on footings on the exposed bedrock on the right bank, with no apparent scour hole nearby ([figs. 27, 29, 1.5B–C](#); [table 7](#)). Pier 13 also is founded on footings on the exposed bedrock on the right bank and was near the surveyed water surface with no apparent scour hole nearby ([figs. 27, 29, 1.5A](#); [table 7](#)). In modern construction, bridge substructural elements usually are pinned or socketed to bedrock (Brown and others, 2018; American Association of State Highway Transportation Officials, 2020), but full exposure of usually buried substructural elements warrants special consideration and observation, particularly at an older bridge such as structure L0135 (built in 1940) even when designed to be exposed.

Figure 27. Bathymetric survey of the Mississippi River channel near structure L0135 on State Highway 51 at Chester, Illinois.
