Bathymetric and Velocimetric Surveys at Highway Bridges Crossing the Missouri and Mississippi Rivers on the Periphery of Missouri, June 13–22, 2022

Scientific Investigations Report 2024–5032

By Richard J. Huizinga

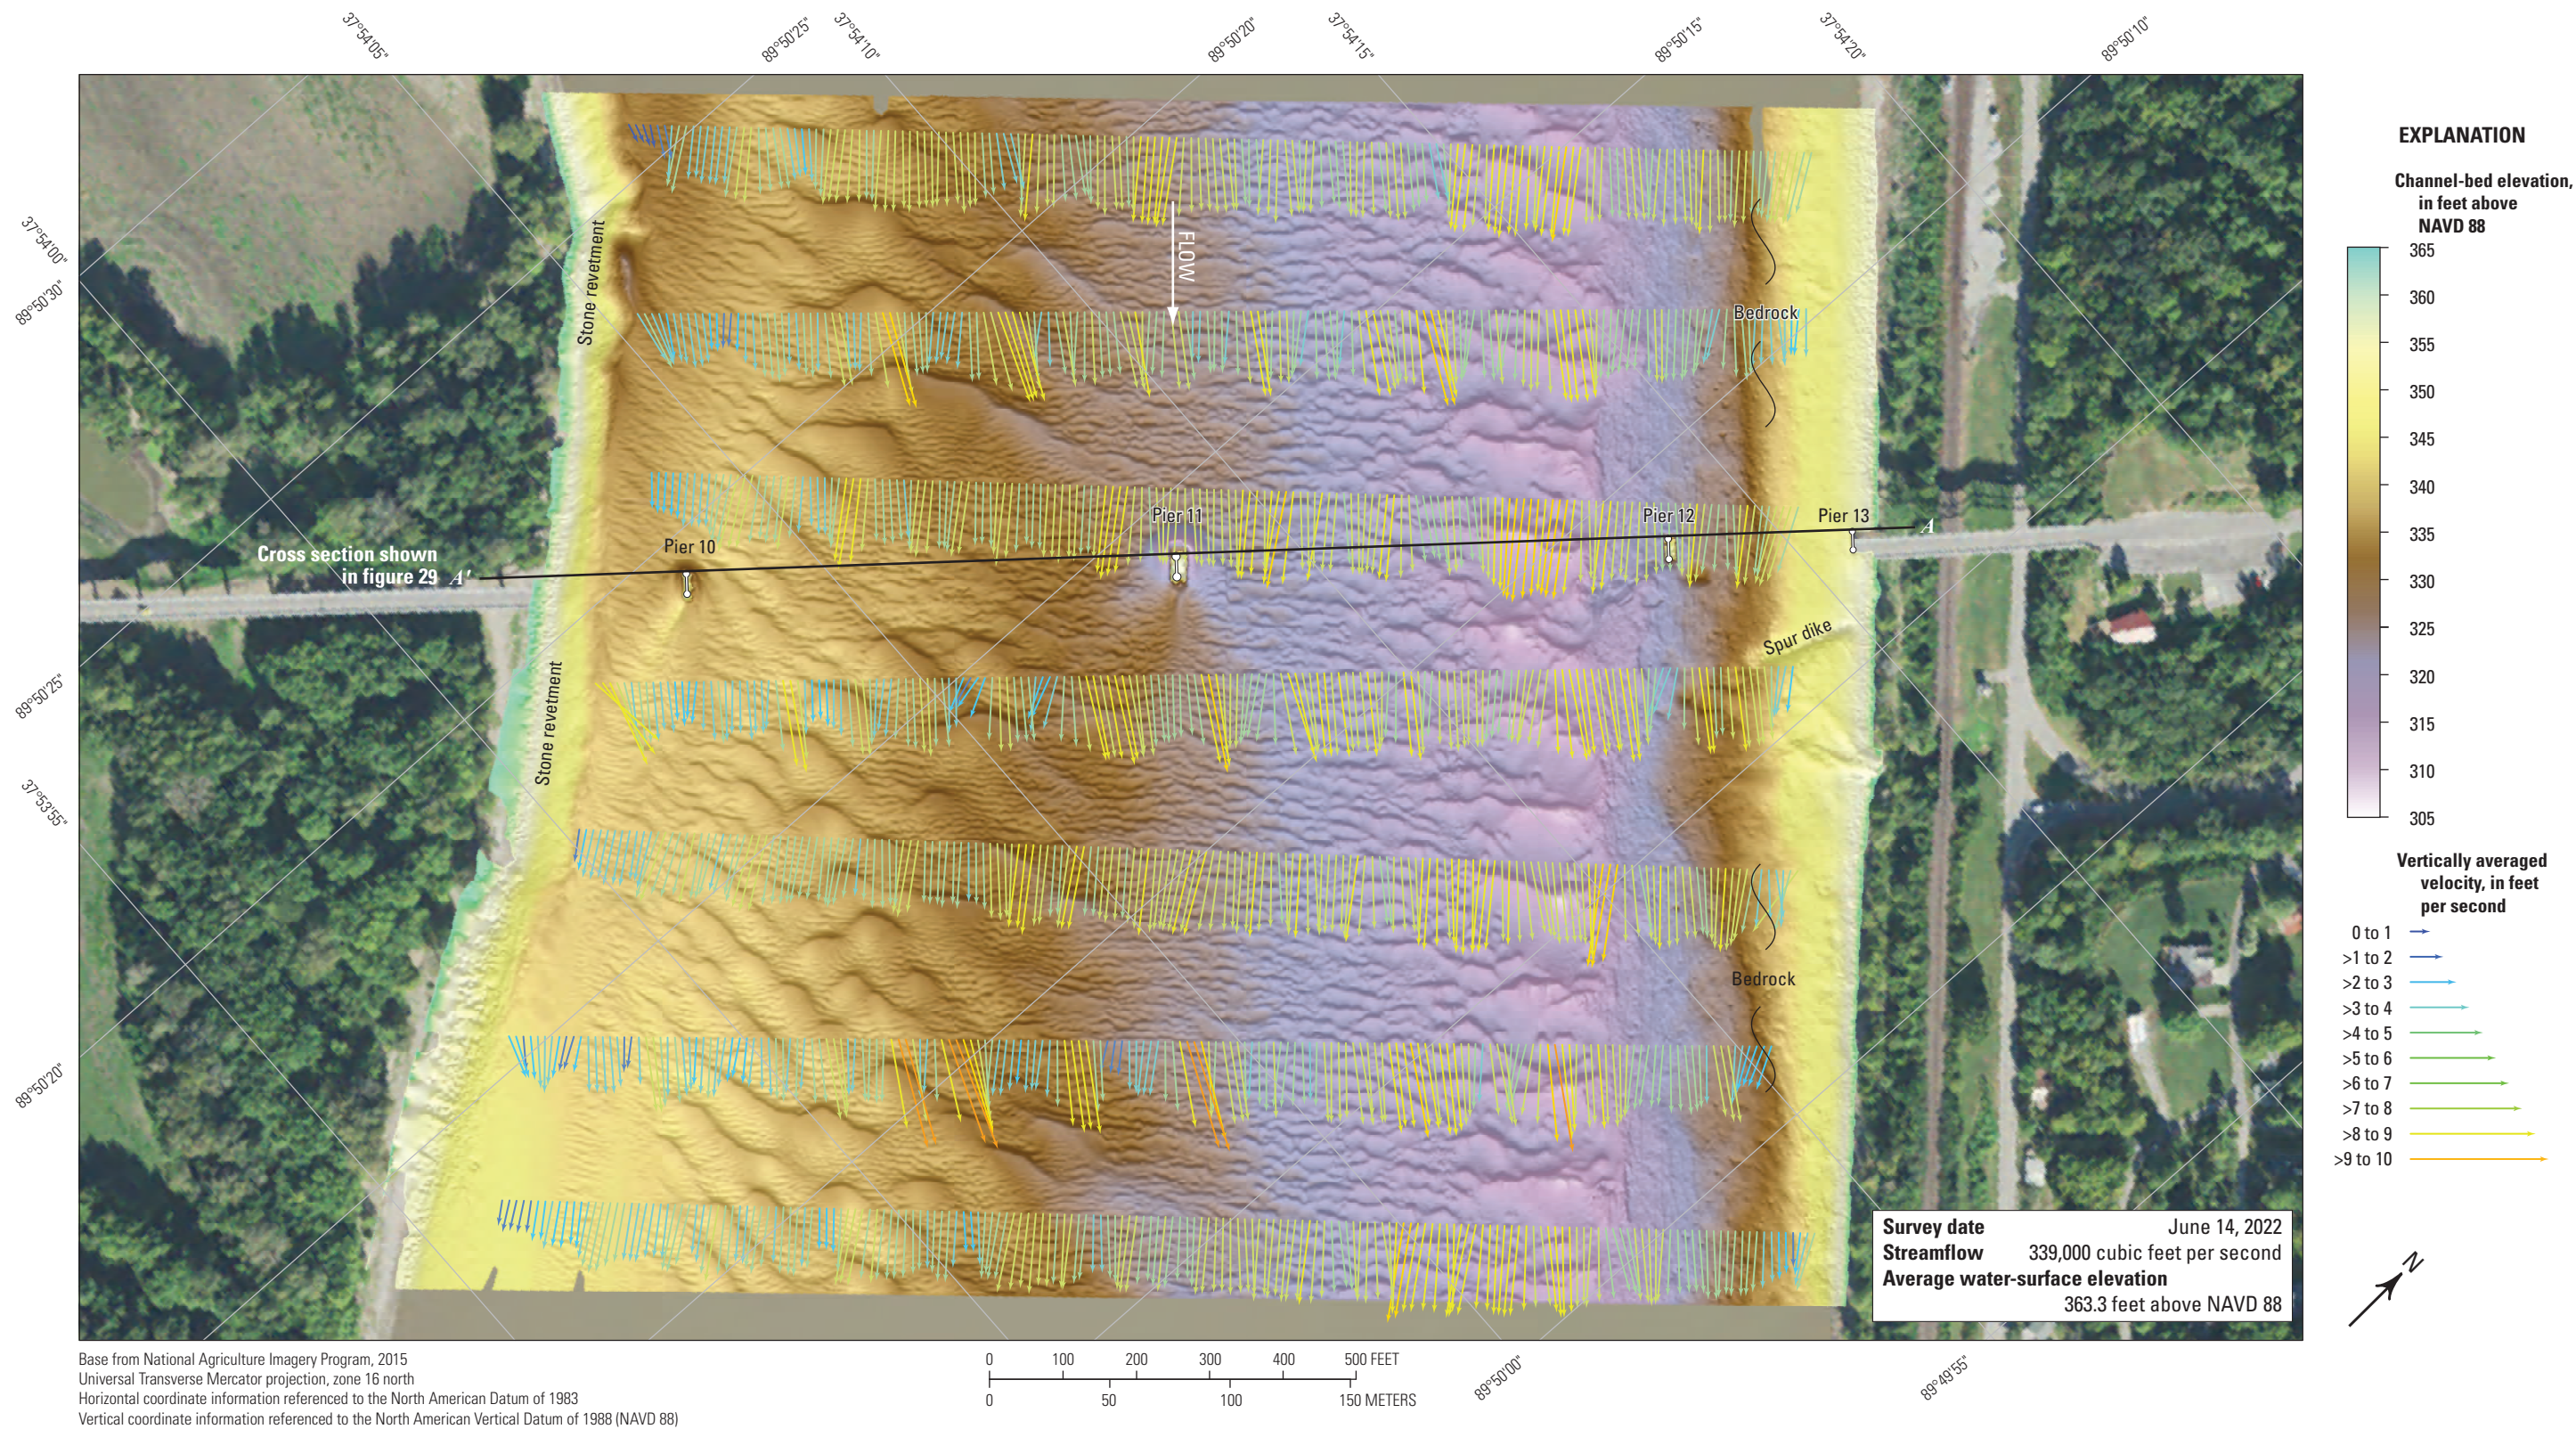
The vertically averaged velocity vectors indicate mostly uniform flow in the reach, but with localized flow disturbances in direction and magnitude in several of the sections (fig. 32). Velocities ranged from about 3 to 10 ft/s (fig. 32), with lower velocities and turbulence observed along the right (southwest) bank (fig. 32). Piers 11 and 12 were aligned with flow, as indicated by little to no turbulence observed downstream that

Figure 32. Bathymetry and vertically averaged velocities of the Mississippi River channel near structure L0135 on State Highway 51 at Chester, Illinois.

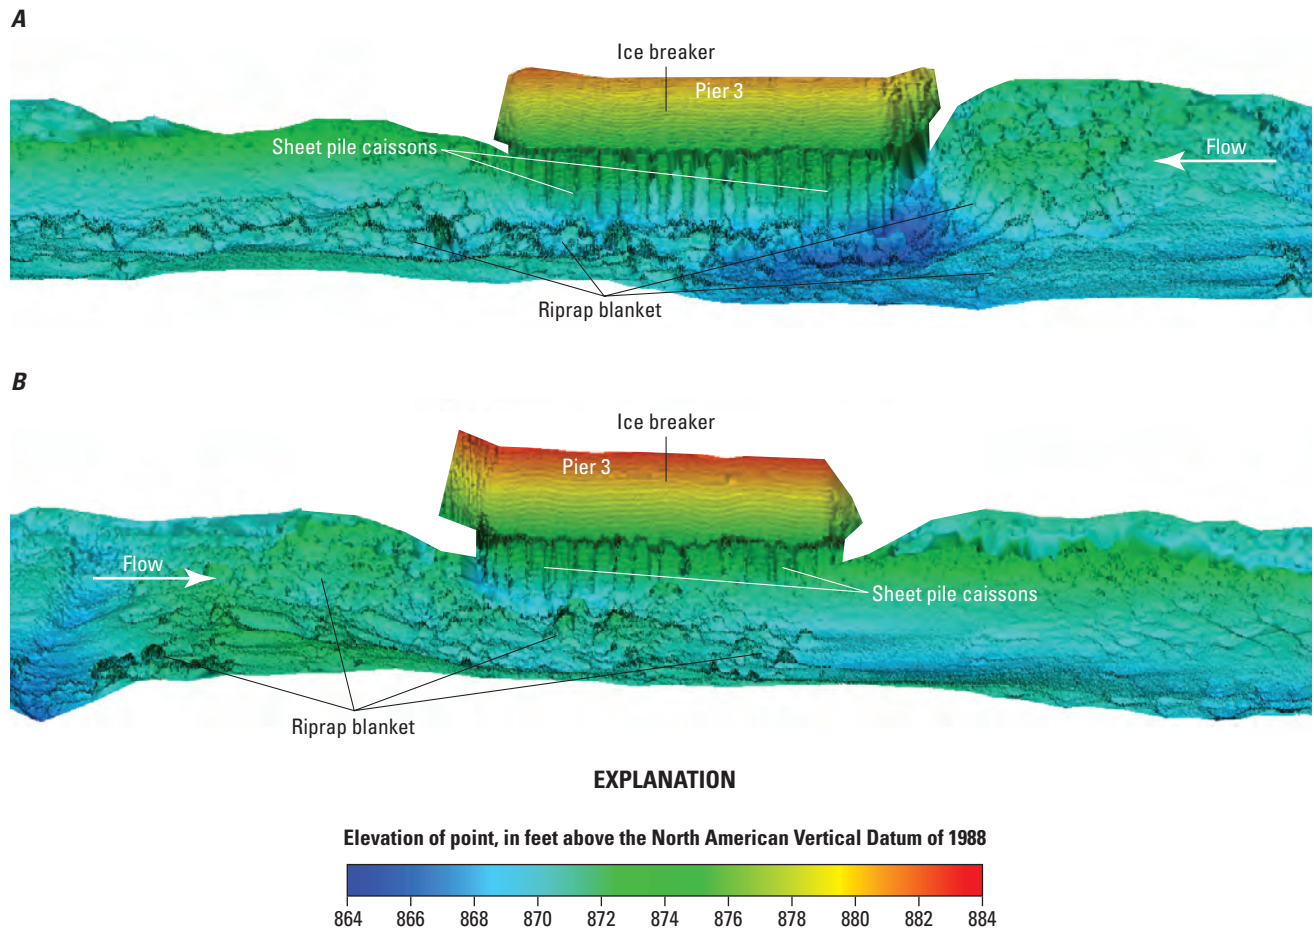
Figure 1.1. Shaded triangulated irregular network visualization of the channel bed and main channel pier of structure L0098 on U.S. Highway 136 over the Missouri River at Brownville, Nebraska. *A*, Left (northeast) side of pier 3. *B*, Right (southwest) side of pier 3.

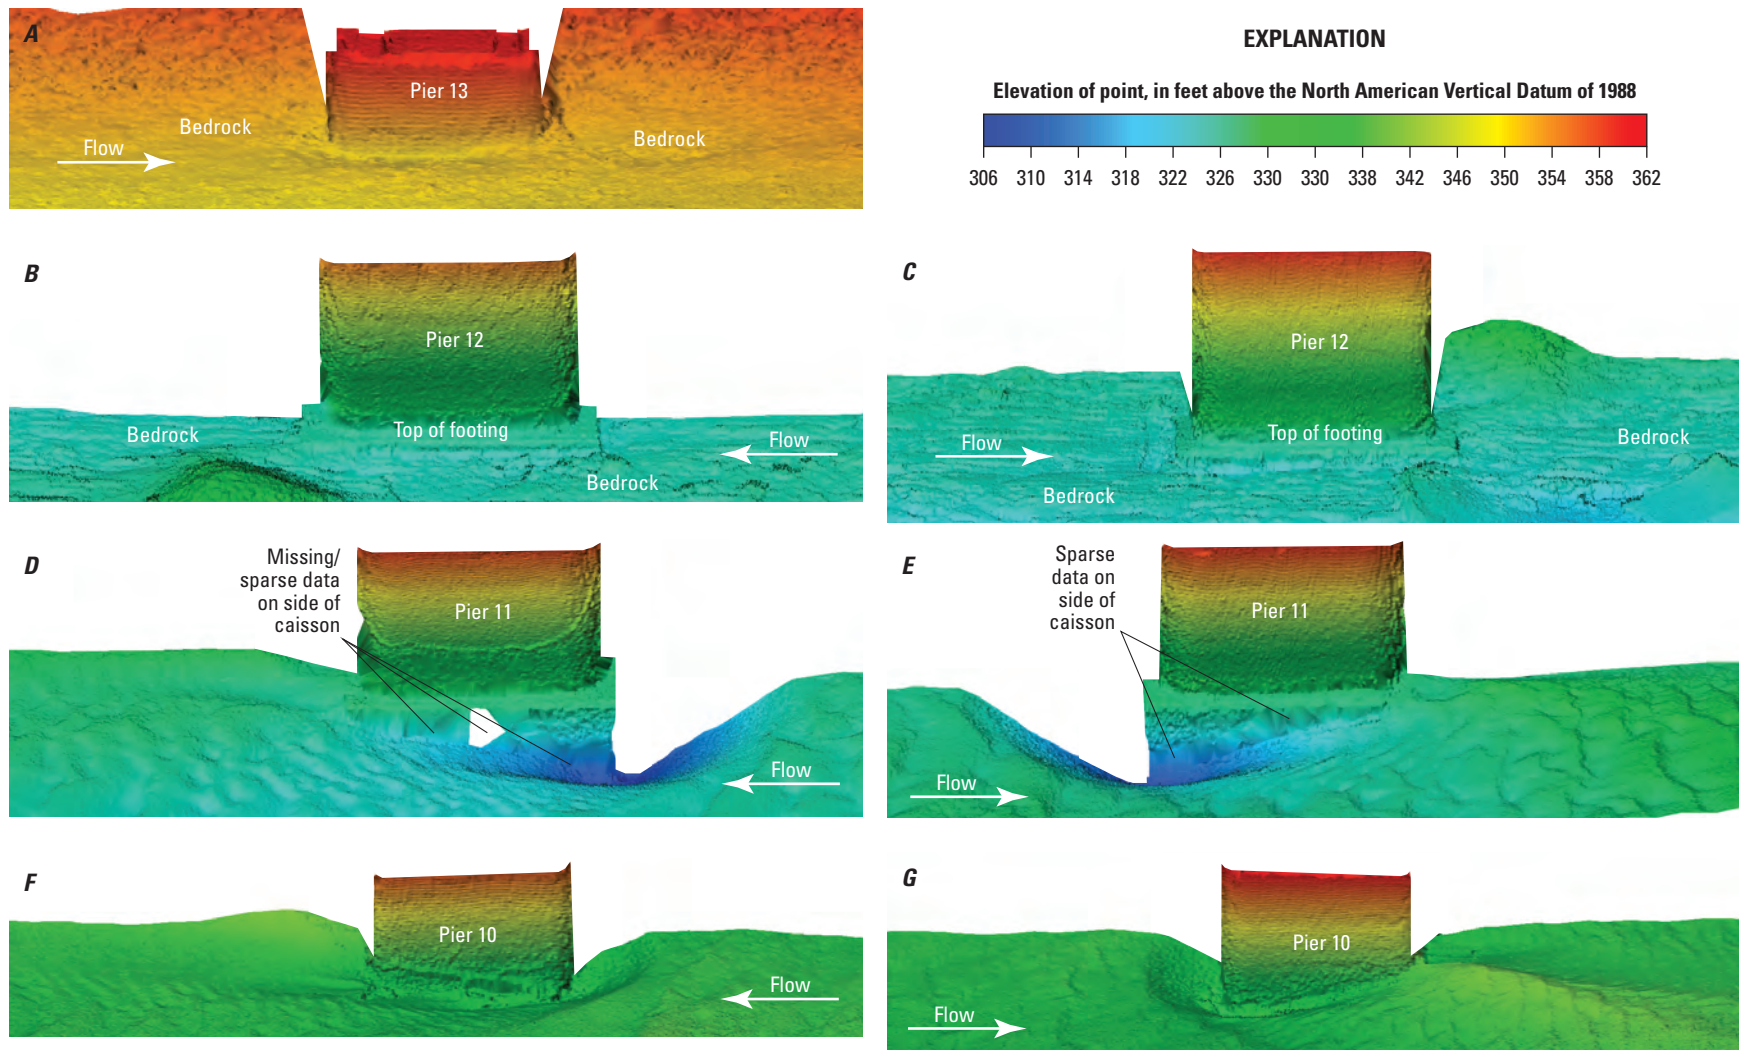
Figure 1.5. Shaded triangulated irregular network visualization of the channel bed and main channel piers of structure L0135 on State Highway 51 over the Mississippi River at Chester, Illinois. *A*, Right (southwest) side of pier 13. *B*, Left (northeast) side of pier 12. *C*, Right (southwest) side of pier 12. *D*, Left (northeast) side of pier 11. *E*, Right (southwest) side of pier 11. *F*, Left (northeast) side of pier 10. *G*, Right (southwest) side of pier 10.
