TEI-844

ENGINEERING GEOLOGY OF THE PROPOSED NUCLEAR POWER PLANT SITE ON
BODEGA HEAD, SONOMA COUNTY, CALIFORNIA

Julius Schlocker and Manuel G. Bonilla

December 1963

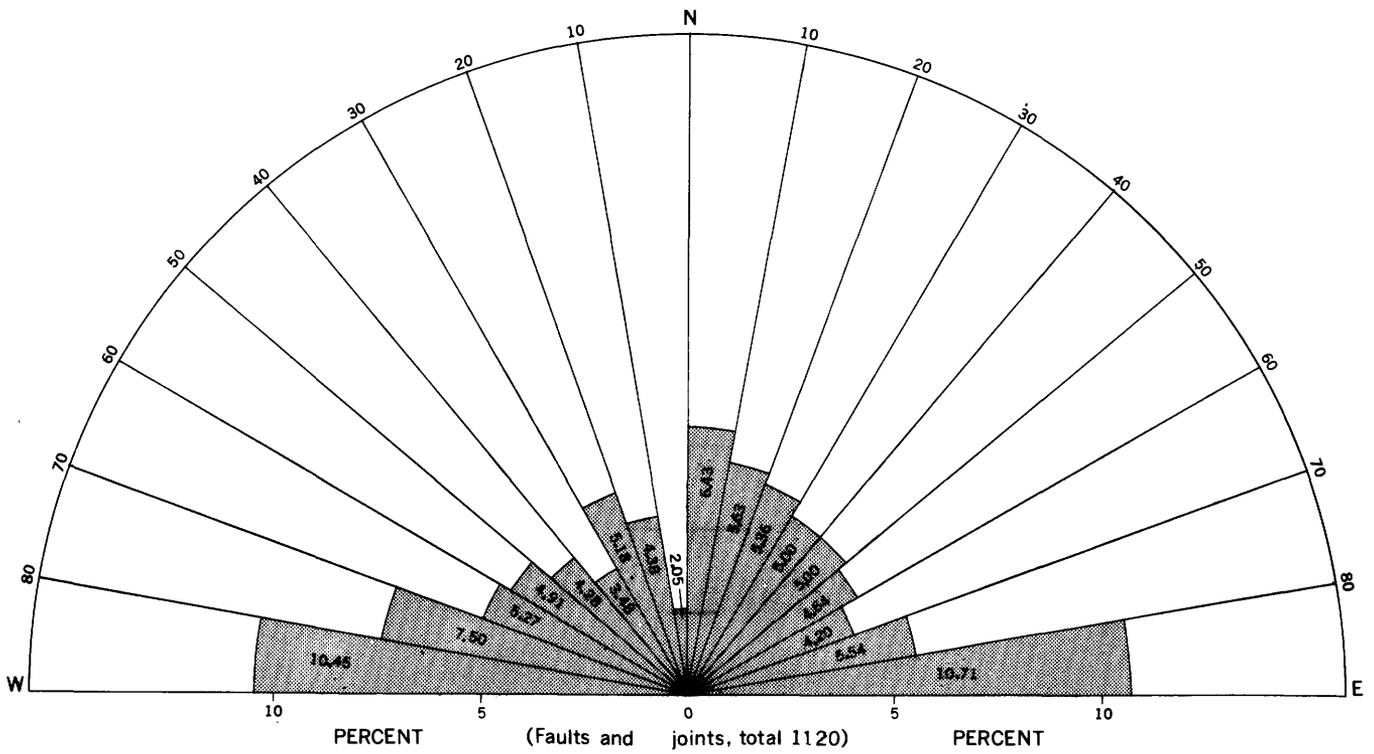
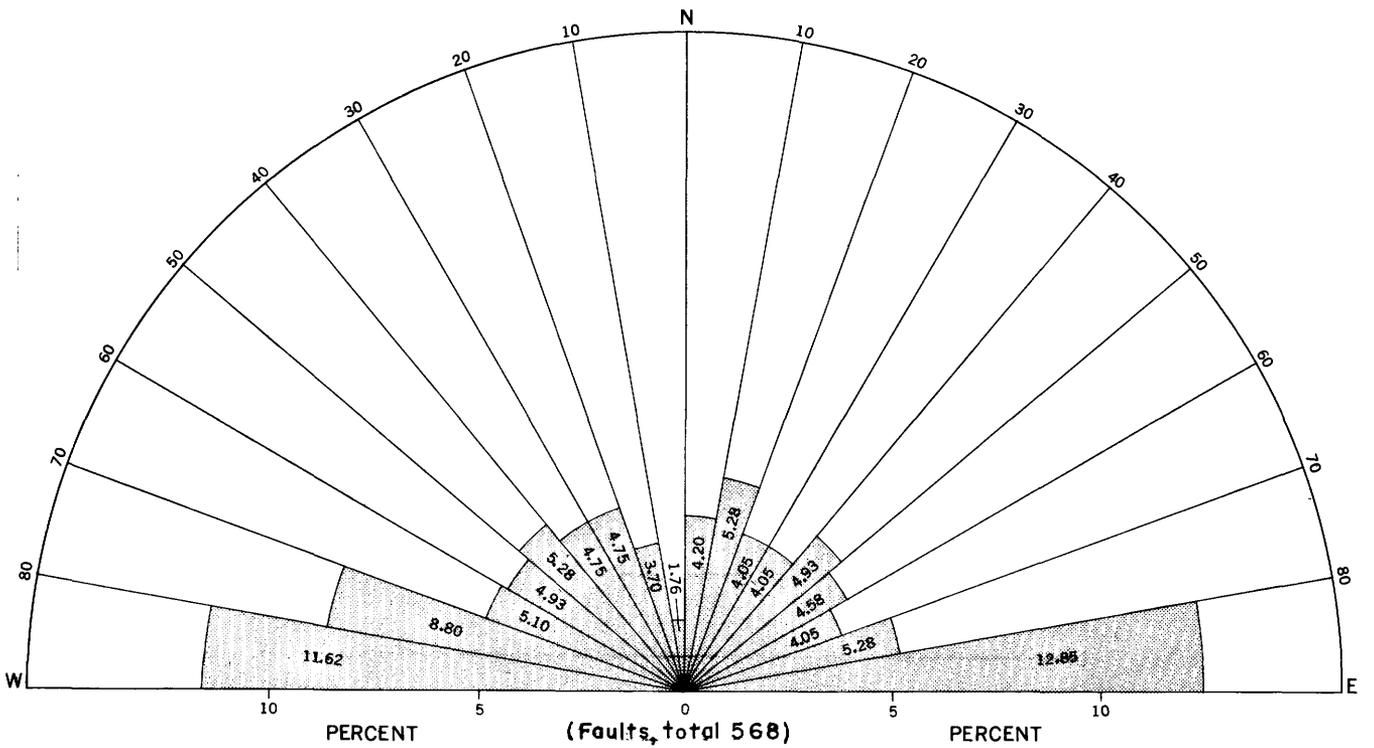
The orientation of faults and joints in the granitic rock exposed on the shaft wall is shown on plate 4 and in figures 1 and 2. Figure 1 shows the percentage of faults and joints having various strikes (bearings) grouped by 10 degree arcs. That is, all faults and joints whose strike is within the range N. 20° to 30° W. were considered as one group. One of the diagrams on figure 1 shows the distribution of 1,120 measurements made of the strike of faults and joints at all levels in the shaft. Thus if a fault or joint persists from one level

to a lower level its orientation was measured at each level. Use of repeated measurements on the same feature at several levels in figures 1 and 2 tends to weight the data in the direction of persistent, continuous features. Another diagram on figure 1 shows strike-frequency of only the faults included in the 1,120 measurements used in the other diagram. Both diagrams show that the predominant strike of faults and joints is in a narrow zone 10 degrees on either side of east-west and that the least-favored strike is between north and N. 10° W. The second most-favored strike is between N. 70° W. and N. 80° W. The average dip of all the fault and joint measurements is 63 degrees.

Figure 1. - Strike(bearing)-frequency diagrams of faults and joints observed in wall of reactor shaft, showing percent mapped within 10 degree intervals of strike. Includes repeated observations of faults and joints that persisted from level to level.

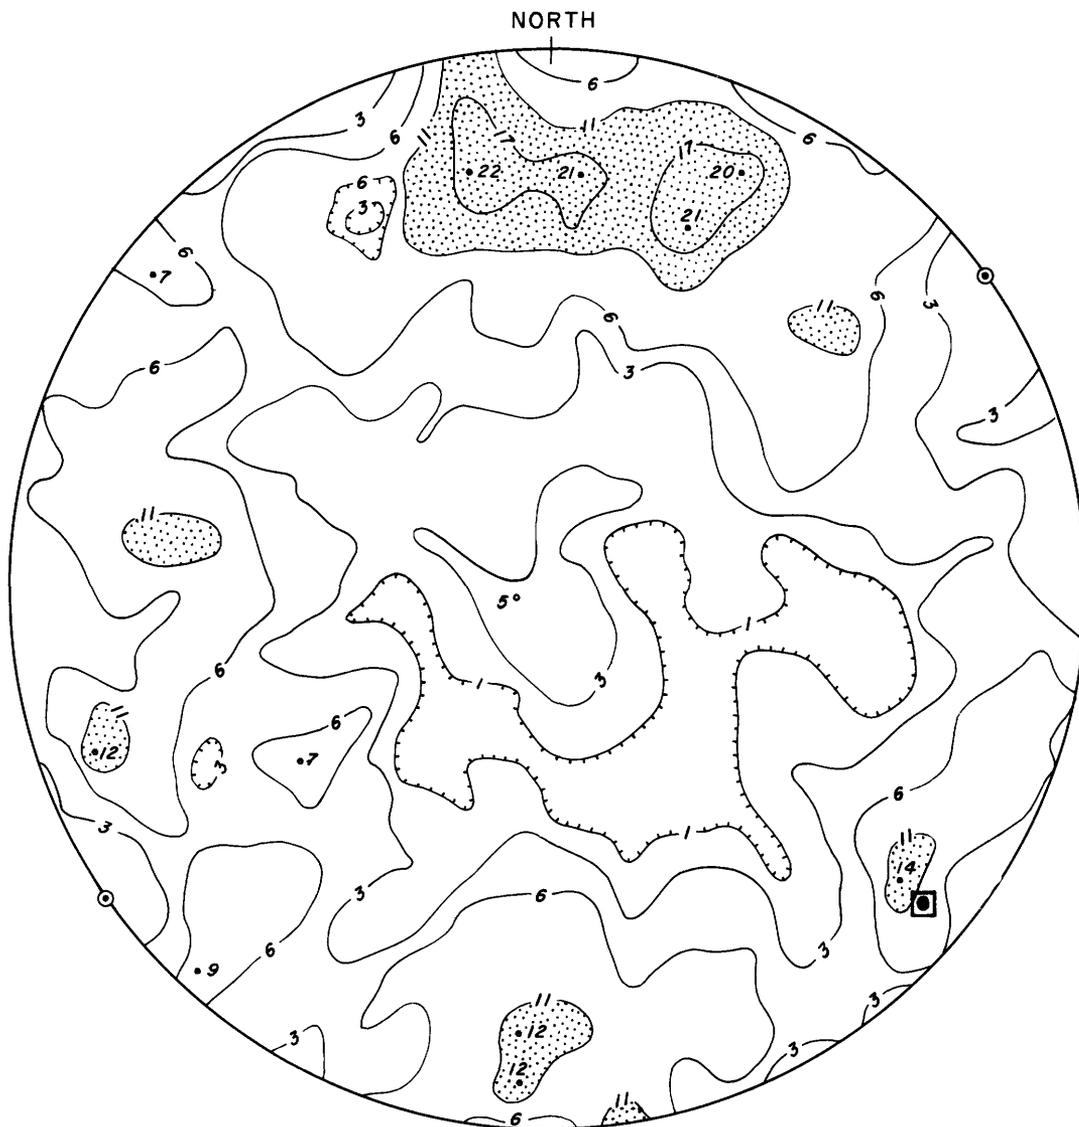
Figure 2.- DIAGRAM SHOWING ORIENTATION OF FAULTS

Figure 2 shows both dip and strike of the faults in the form of a contour map of the concentration of poles to the faults. A pole is a line drawn perpendicular to a fault plane. It confirms what is shown in figure 1 and, in addition, shows that the predominant dip direction of the west-trending faults is 50° to 75° S., but the general range is 65° N. to 45° S. Many fault surfaces seen in the wall bend in open curves through large angles. Slickensides or striations caused by relative movement on fault surfaces are common and generally plunge at large angles though on some faults they plunge at low-angles or are nearly horizontal.

Contour diagram of 568 poles of faults on wall of reactor shaft. Plotted on lower hemisphere of equal-area net. Includes repeated observations on faults that persist from level to level. Contoured on 1, 3, 6, 11, and 17 pole concentration intervals; unit area for counting poles is one percent.

⊙ indicates pole to San Andreas faultzone, which for this diagram is assumed to be vertical strike N37 W. ◻ indicates pole to Shaft fault, dip 77 degrees N. W., strike N 40 E.

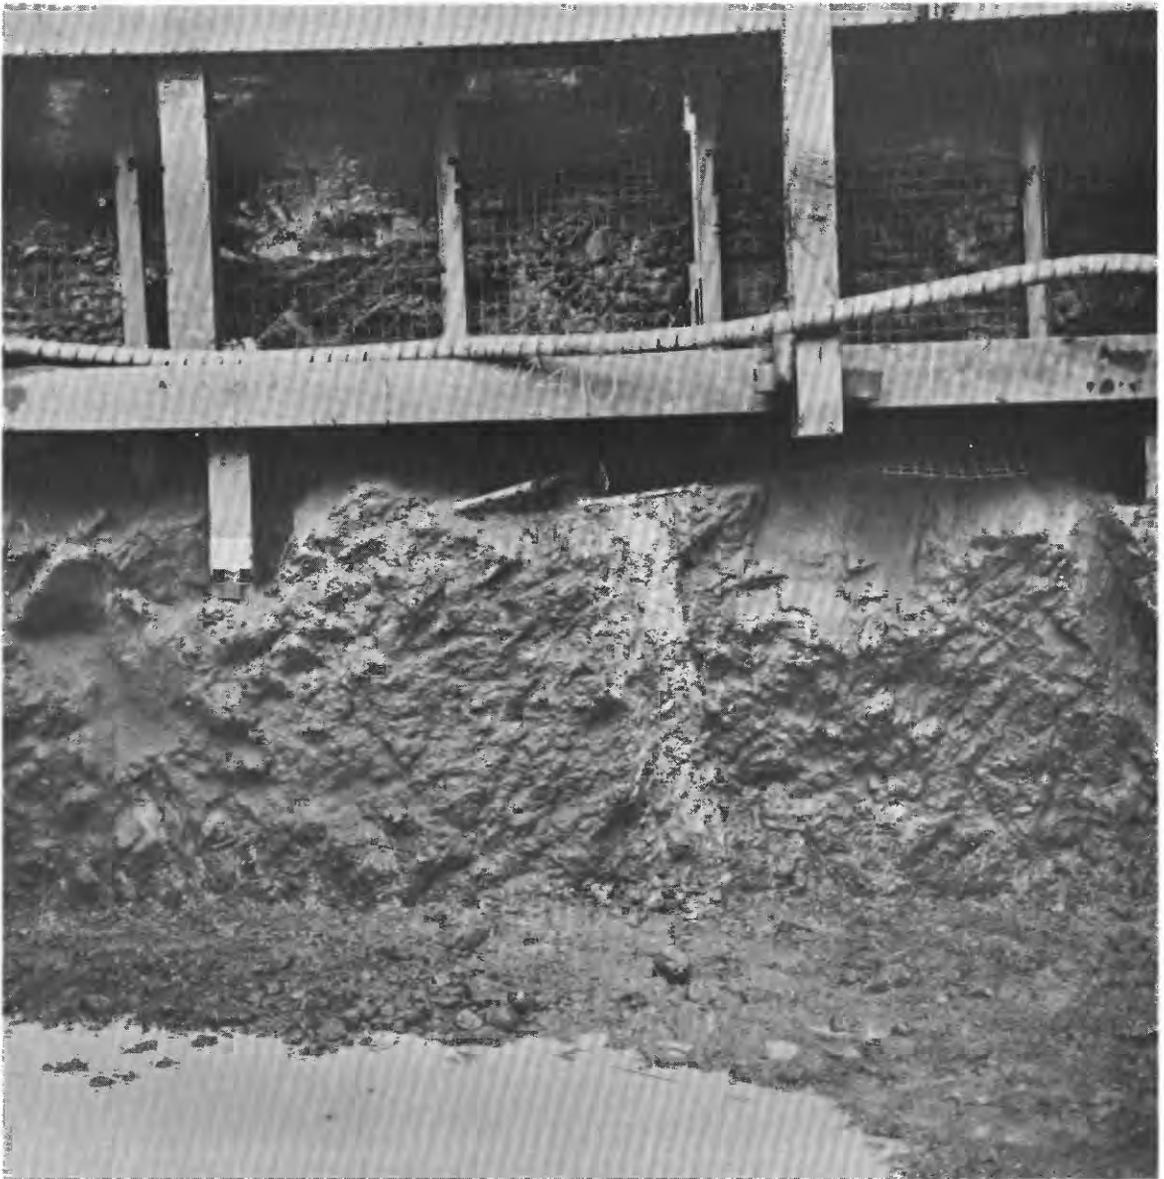
Fig. 3.--Shaft fault on south wall of shaft, elevation -75 feet.

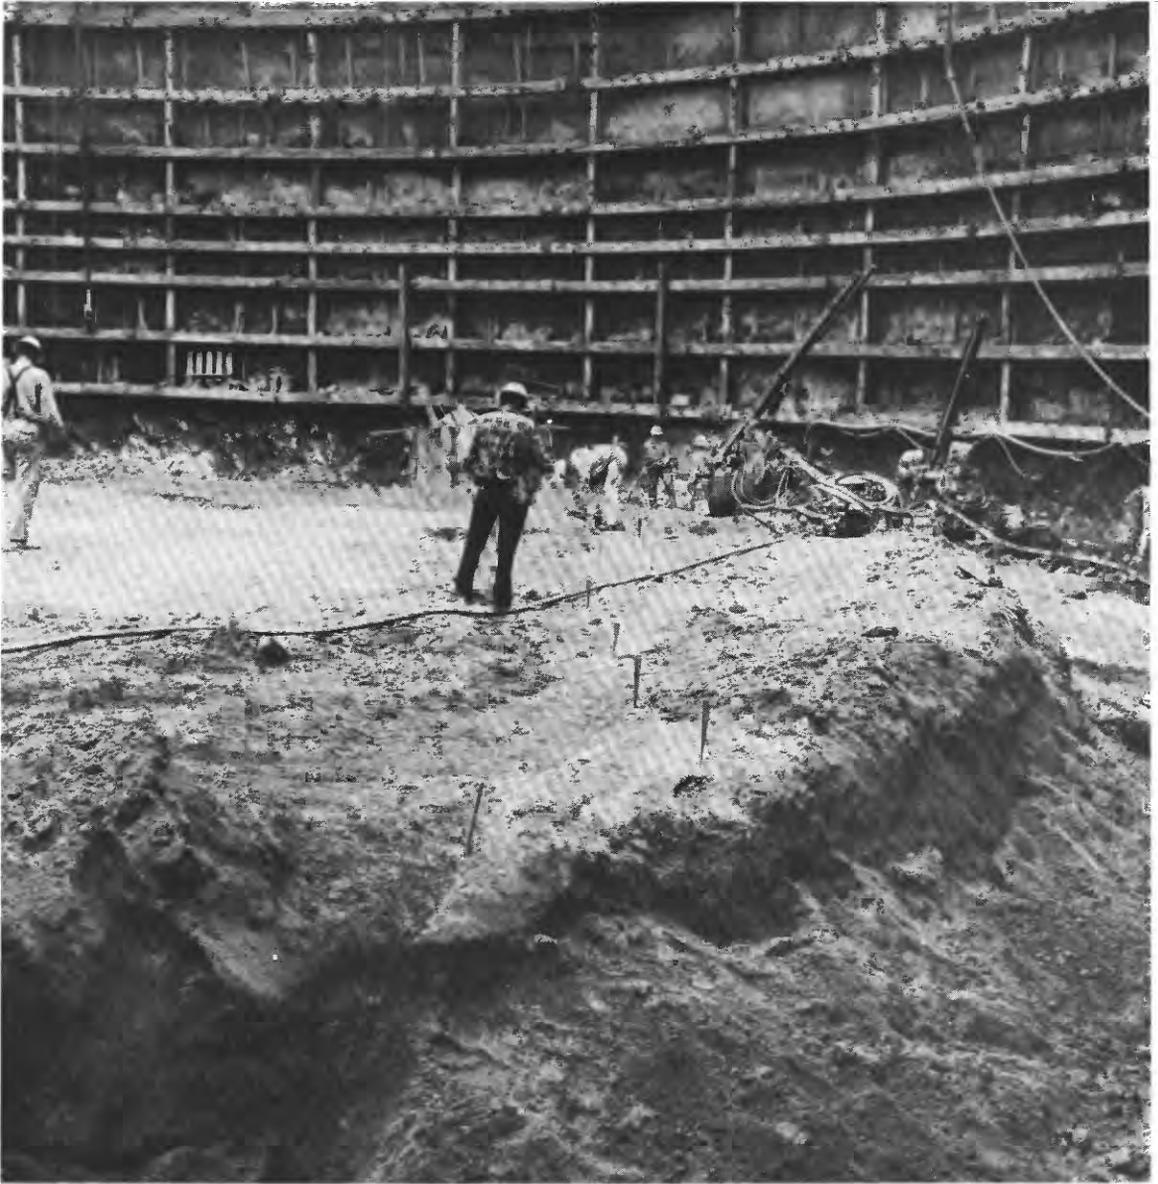
Fig. 4.--Shaft fault on floor of shaft, elevation -42 feet.

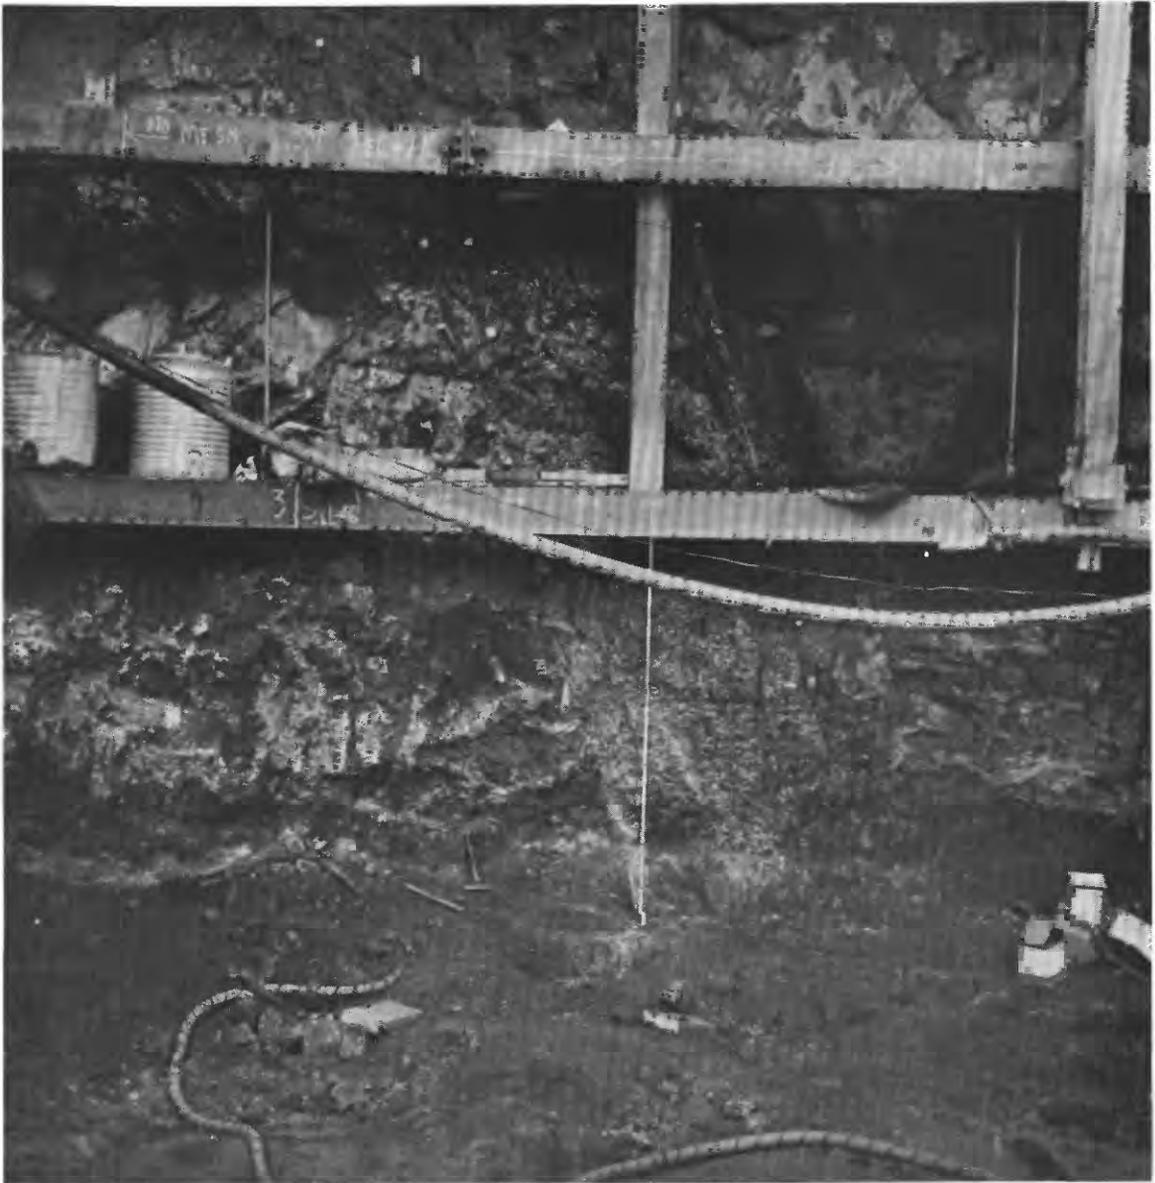
The well-developed fault zone on the south wall near elevation -55 (fig. 5) consists of numerous subparallel faults. On the north-east wall, however, the fault zone is not as well developed. At the floor (elevation -73) and for about 7 feet above, the zone consists of two faults separated by about 2 feet of fairly intact rock.

At this locality each fault is a gouge and breccia zone 1 to 2 inches wide. From elevation -55 to -51 the fault zone is a foot wide and made up of gouge and breccia. Between elevation -41 to -46, the fault was traced from the south wall to the northeast wall (pl. 3 and fig. 4). At this elevation the fault is 2 to 12 inches wide and consists of several intersecting and branching faults separated locally by breccia. Near elevation -24 between vertical control lines 25 and 26 the fault splays out into several branches about 5 feet below the top of the granitic rock (pl. 4). No rupture was seen in the overlying gravelly sandy clay.

Fig. 5.--Shaft fault in granitic rock on south wall of shaft,
elevation -41 to -51 feet.

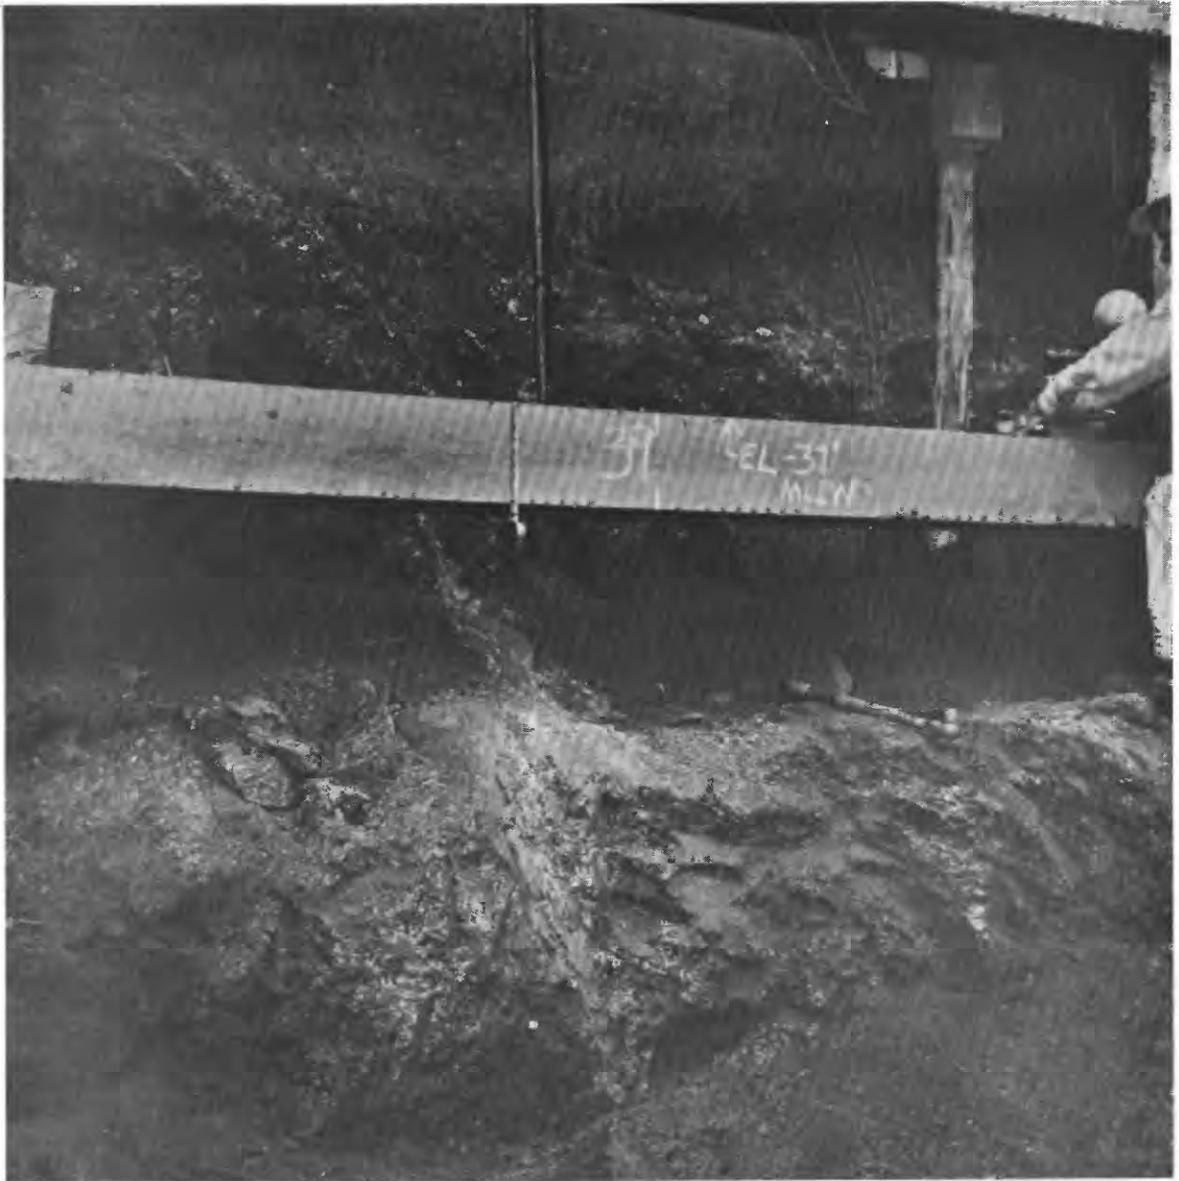
Fig. 6.--Shaft fault on south wall showing sediment lying on granitic bedrock.

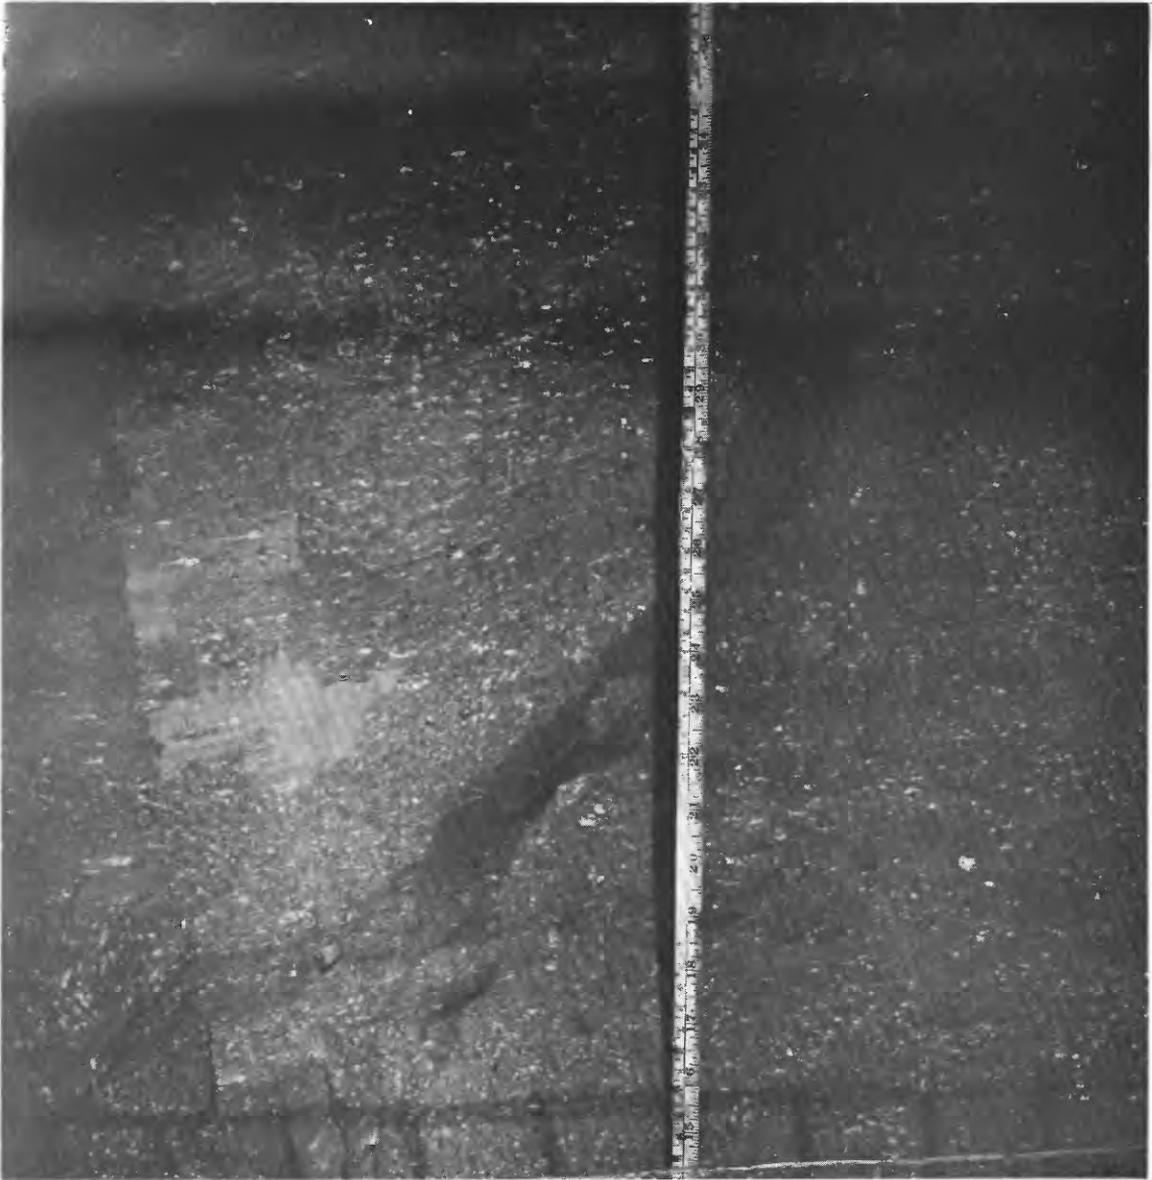
Fig. 7.--Shaft fault on south wall showing sand filling and variation in dip.

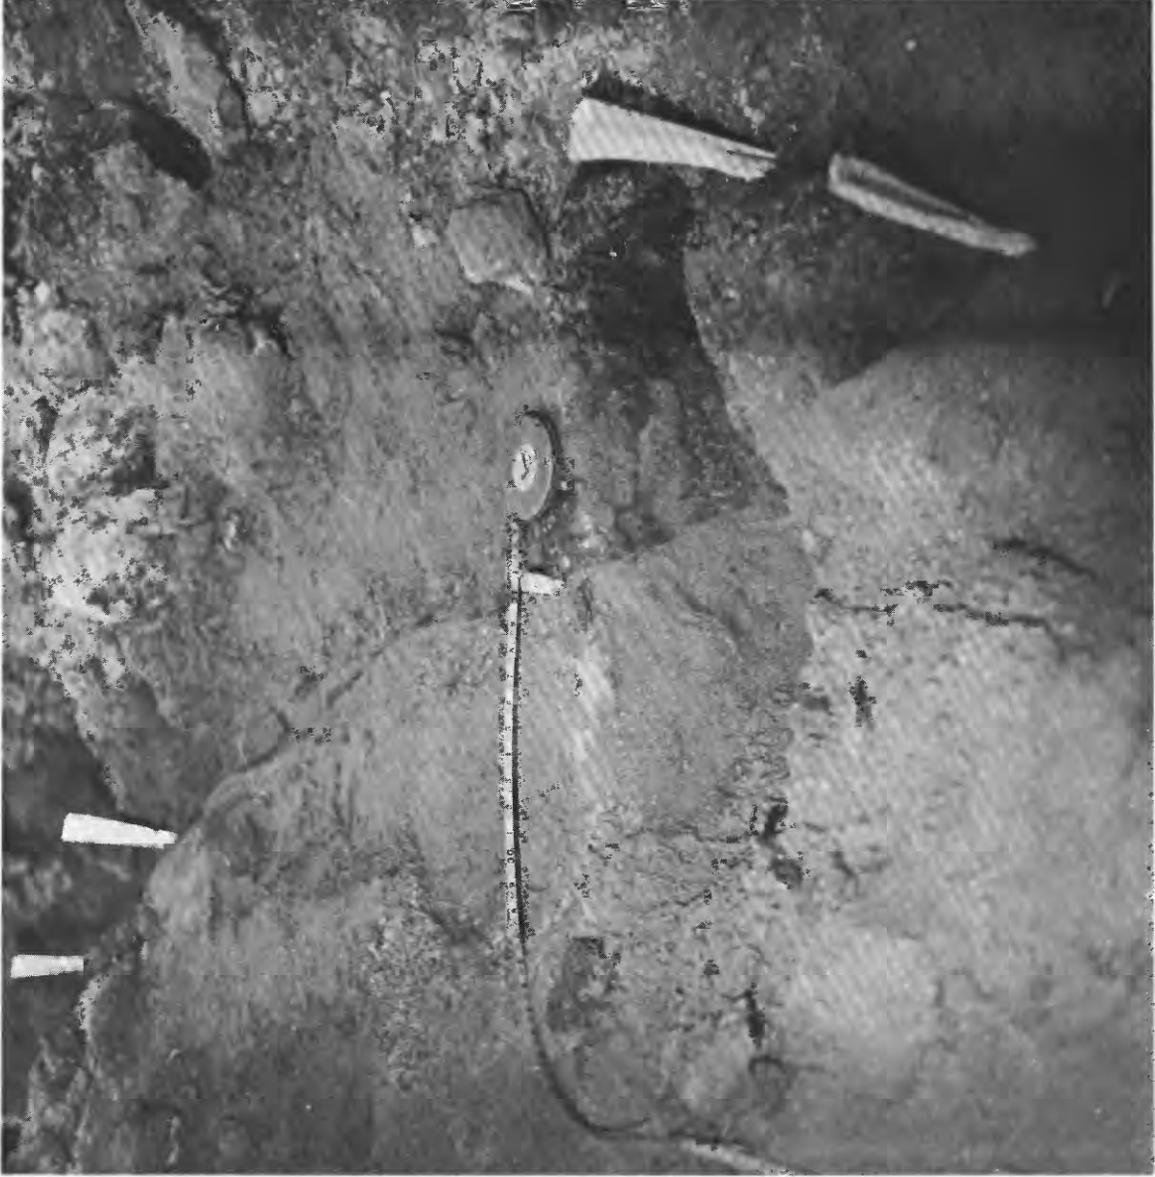
Fig. 8.--Shaft fault in floor of shaft, elevation -20 feet, showing dip and branches.

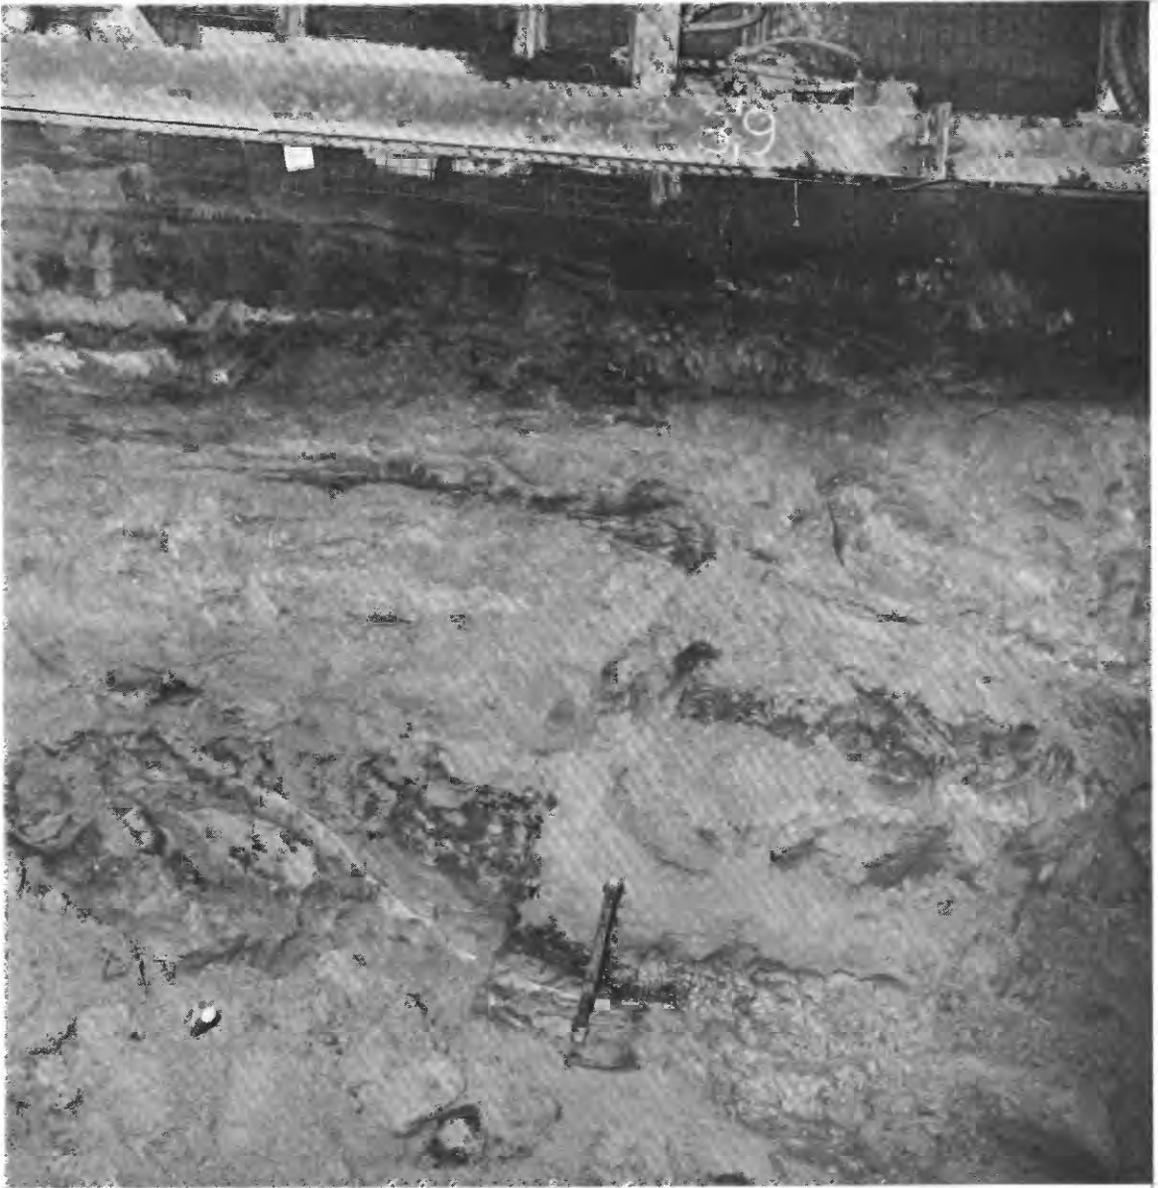
Fig. 9.--Shaft fault in sediment between elevation -13 and -20 feet showing 14-inch vertical separation.

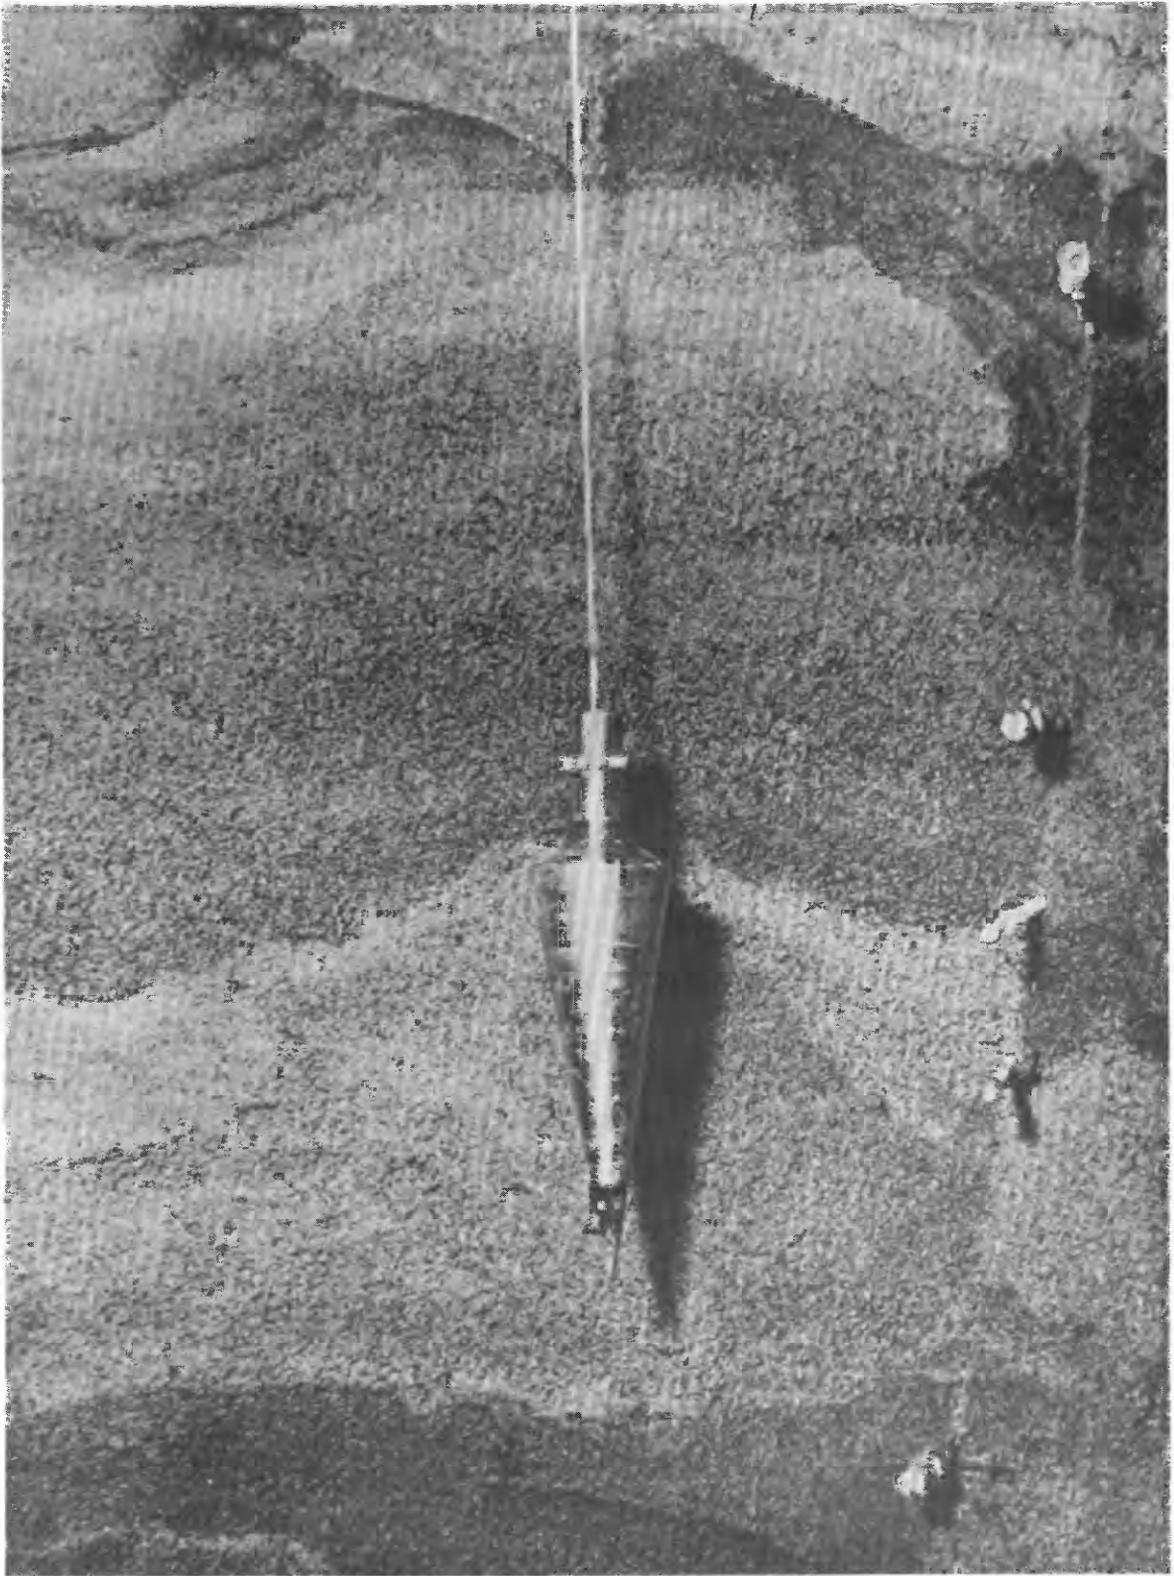
found about 9 feet to the east. It dips 70 to 85° eastward, strikes N. 35° E. to N. 42° E. and shows a vertical separation of about 1.8 inches, down on west (fig. 10). A fault believed to be this one (see plates 2 and 3) was found in an embankment to the southwest. It was traced upward to the elevation +25 feet and followed by bulldozer across this level to the asphalt drain at the base of the embankment below the elevation 55 feet bench. It was well developed where last seen near the asphalt drain 170 feet southwest of the shaft.

Fig. 10.--Shaft fault in exploratory trench 1, looking southwest.

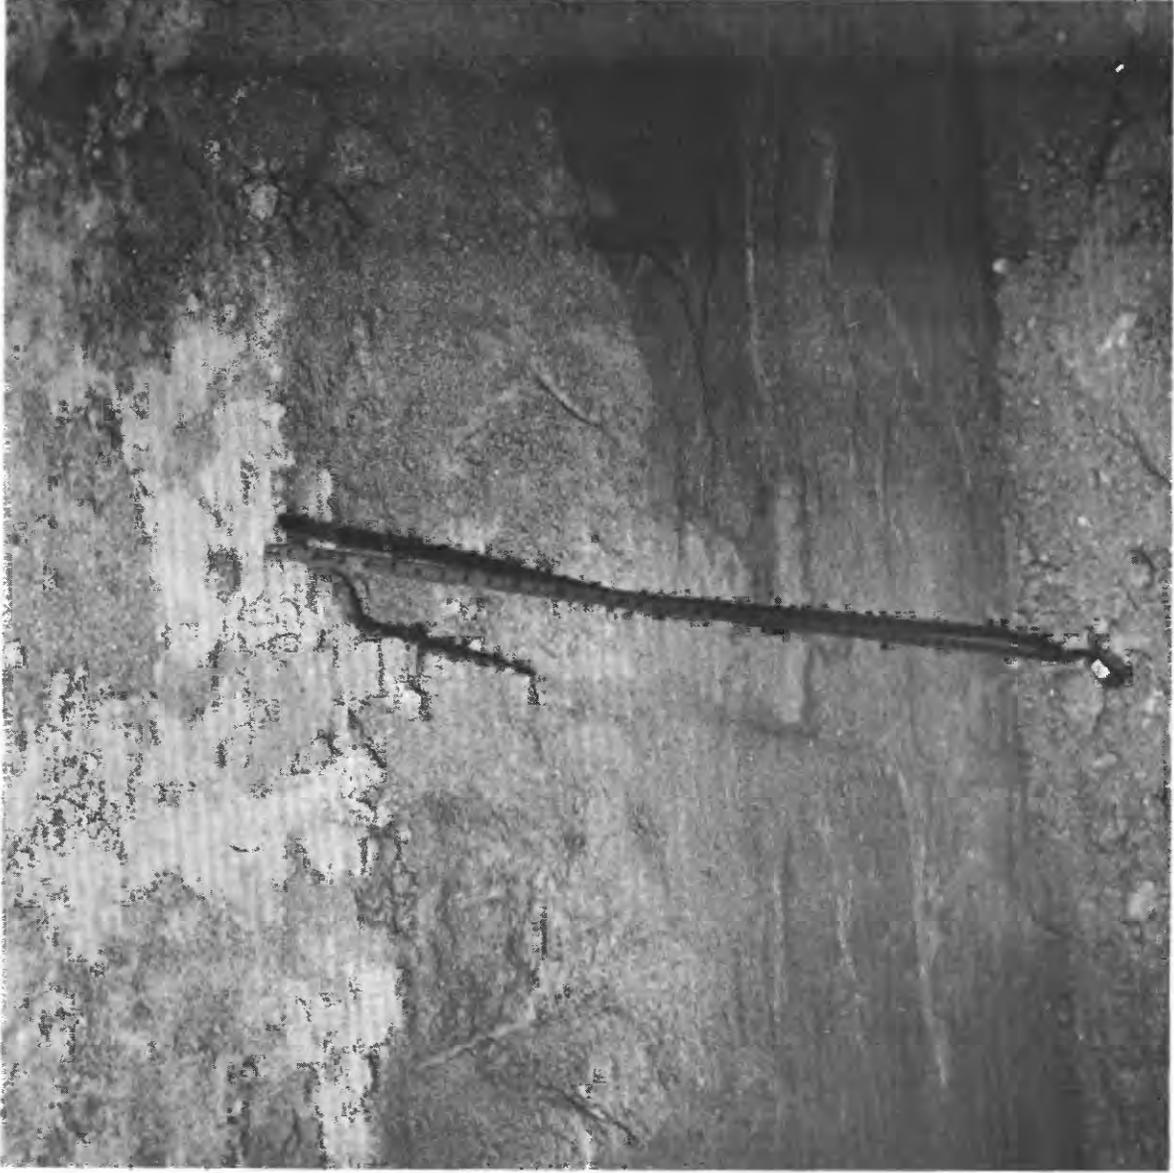
Fig. 11.--Shaft fault in exploratory trench 2, looking southwest.

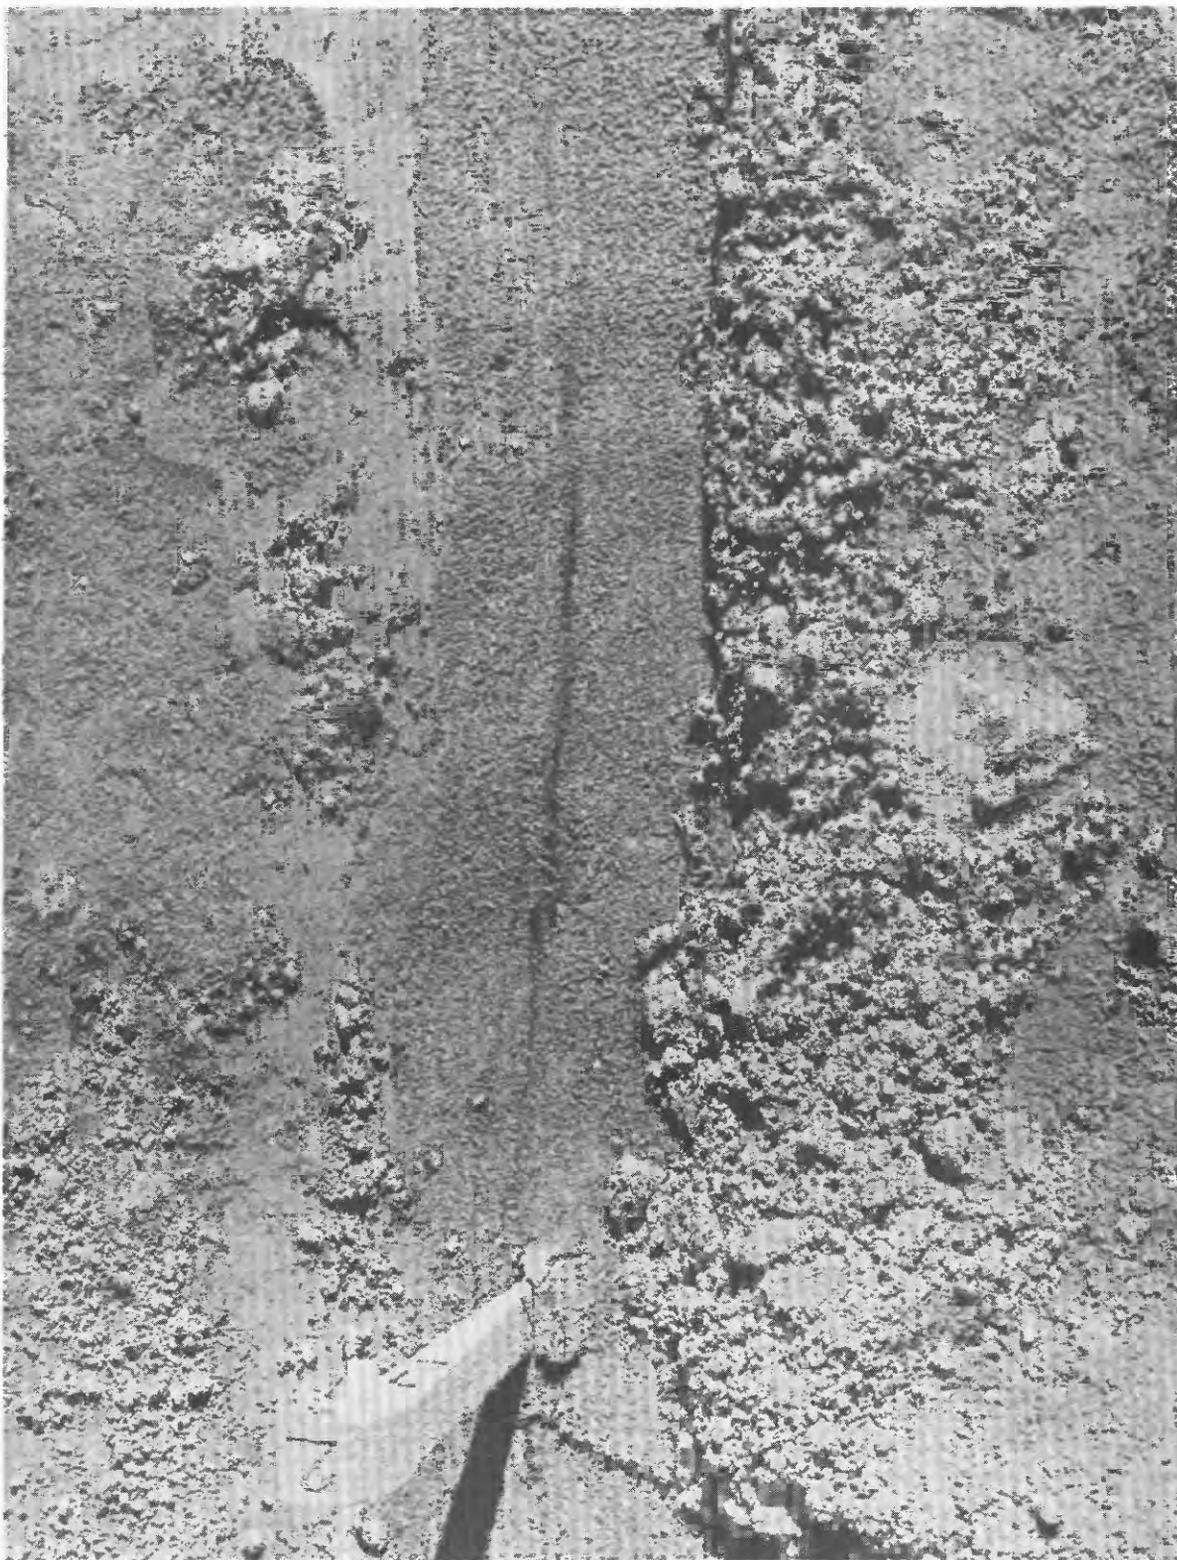
Fig. 12.--Close view of the Shaft fault on elevation 25 feet level.
