CHANNEL EROSION SURVEYS ALONG TAPS ROUTE, ALASKA, 1974

UNITED STATES DEPARTMENT OF THE INTERIOR
GEOLOGICAL SURVEY

Joseph M. Childers and Stanley H. Jones

OPEN-FILE REPORT

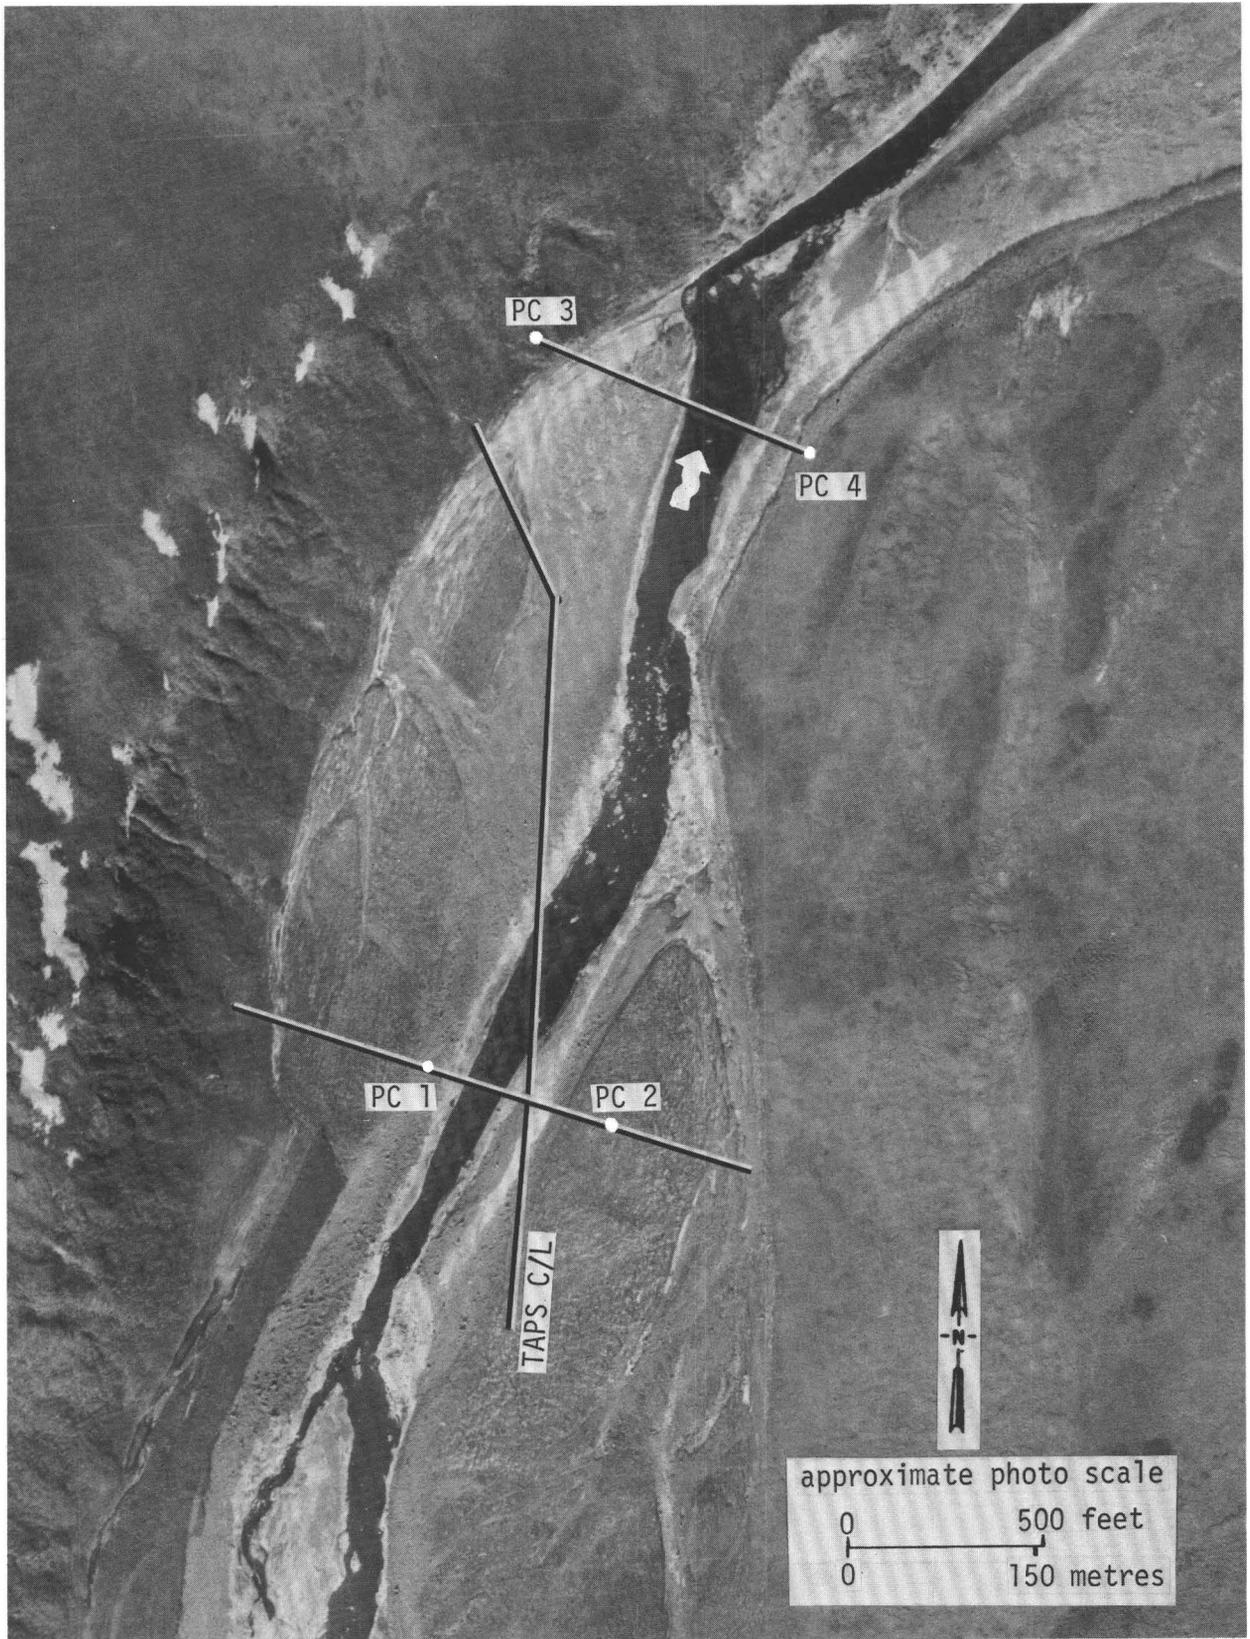
Figure 2. -- Sagavanirktok River near Sagwon, October 17, 1969. TOBIN RESEARCH INC.

Channel conditions.--High-altitude vertical aerial stereophotography (scale 1:24,000) was obtained October 17, 1969, (fig. 2) to document preconstruction topography of the site. Vertical aerial stereophotography (scale 1:6,000) taken August 24, 1974, (fig. 3) shows no significant channel erosion or construction activities have occurred in the proposed crossing reach since October 17, 1969. Three cross sections (fig. 4) were surveyed July 30, 1971, to define preconstruction ground profiles in the crossing reach. On September 6, 1974, a channel survey of the three cross sections found no significant lateral erosion.

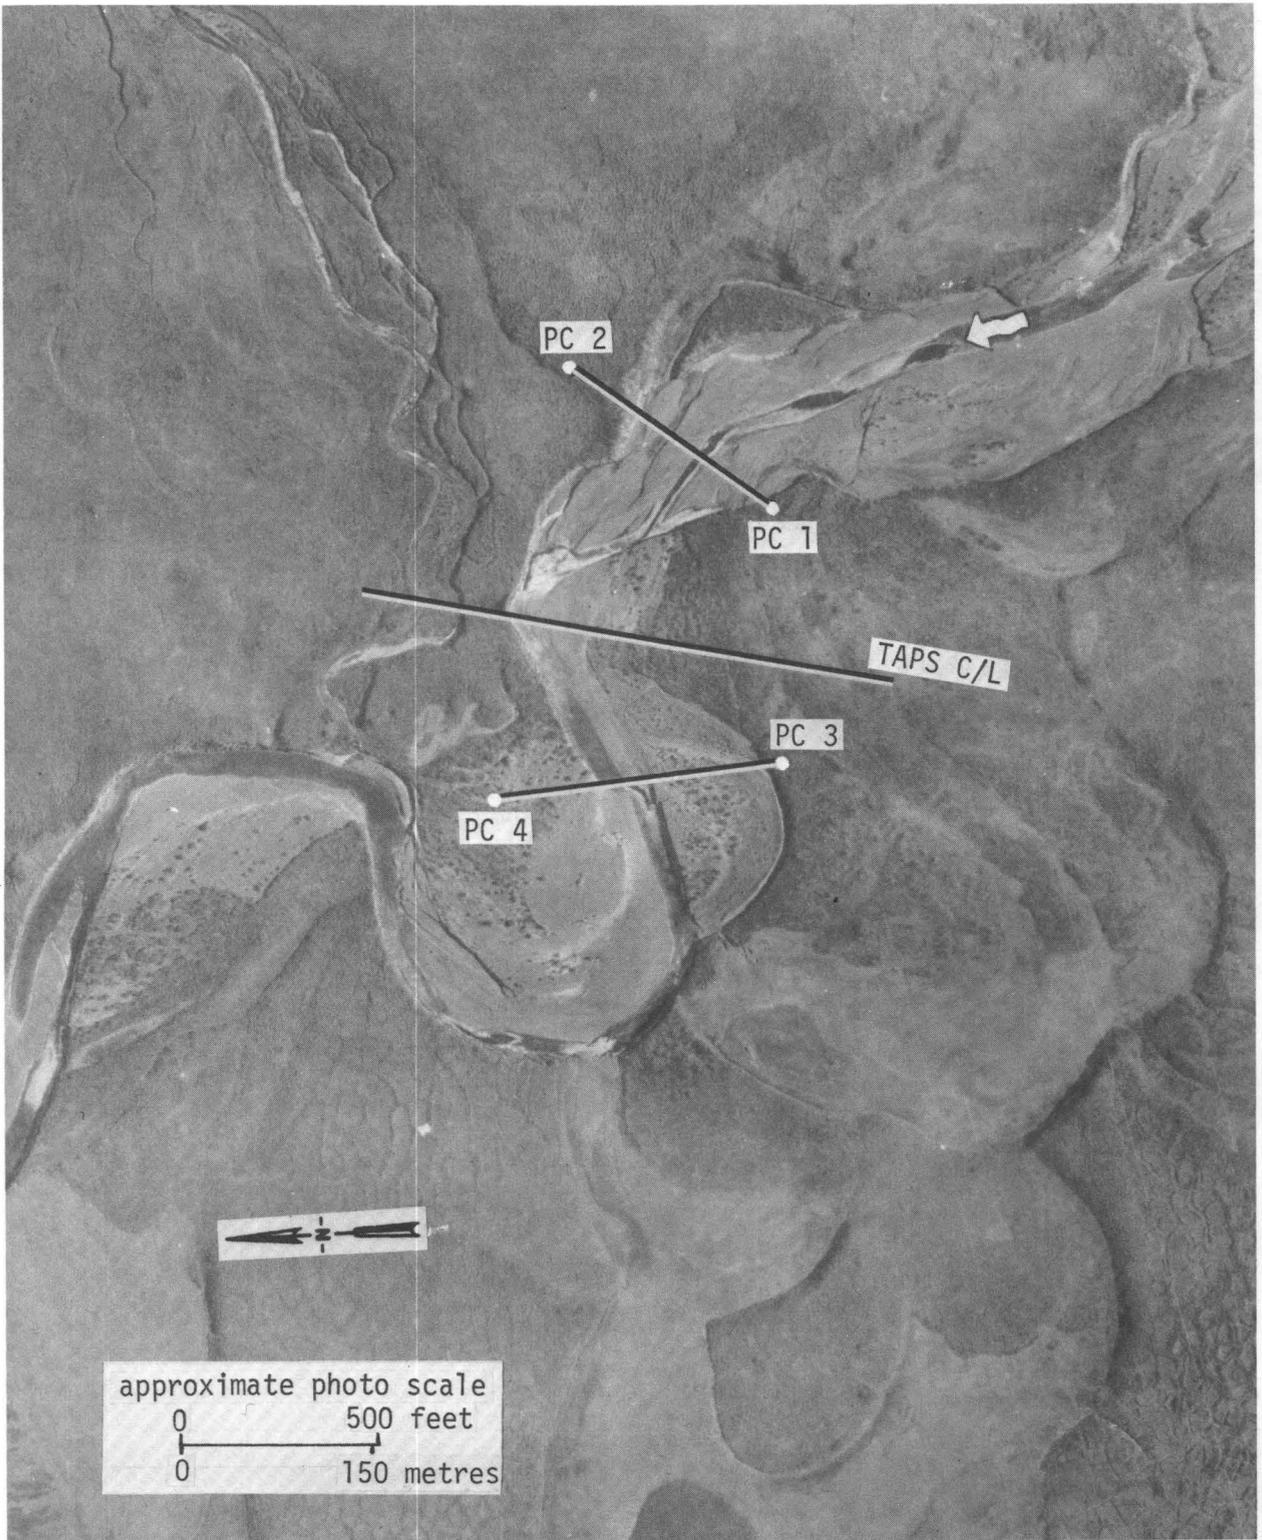
Figure 6. -- Atigun River near Galbraith Lake, October 17, 1969.
TOBIN RESEARCH INC.

Channel conditions.--High-altitude vertical aerial stereophotography (scale 1:24,000) was obtained October 17, 1969, (fig. 6) to document preconstruction topography at the site. Vertical aerial stereophotography (scale 1:6,000) taken August 24, 1974, (fig. 7) shows lateral bank erosion of 20 ft (6 m) along the right bank of the upstream section and a small overflow channel has developed along the left bank of the downstream section. No significant erosion has occurred in the TAPS centerline section. There was no construction activity in the crossing reach since October 17, 1969. Three cross sections (fig. 8) were surveyed July 31, 1971, to define preconstruction ground profiles in the crossing reach. On September 6, 1974, a channel survey of the three cross sections found 20 ft (6 m) of lateral bank erosion along the right bank of the upstream section and a small overflow channel about 4 ft (1 m) deep has developed along the left bank of the downstream section.

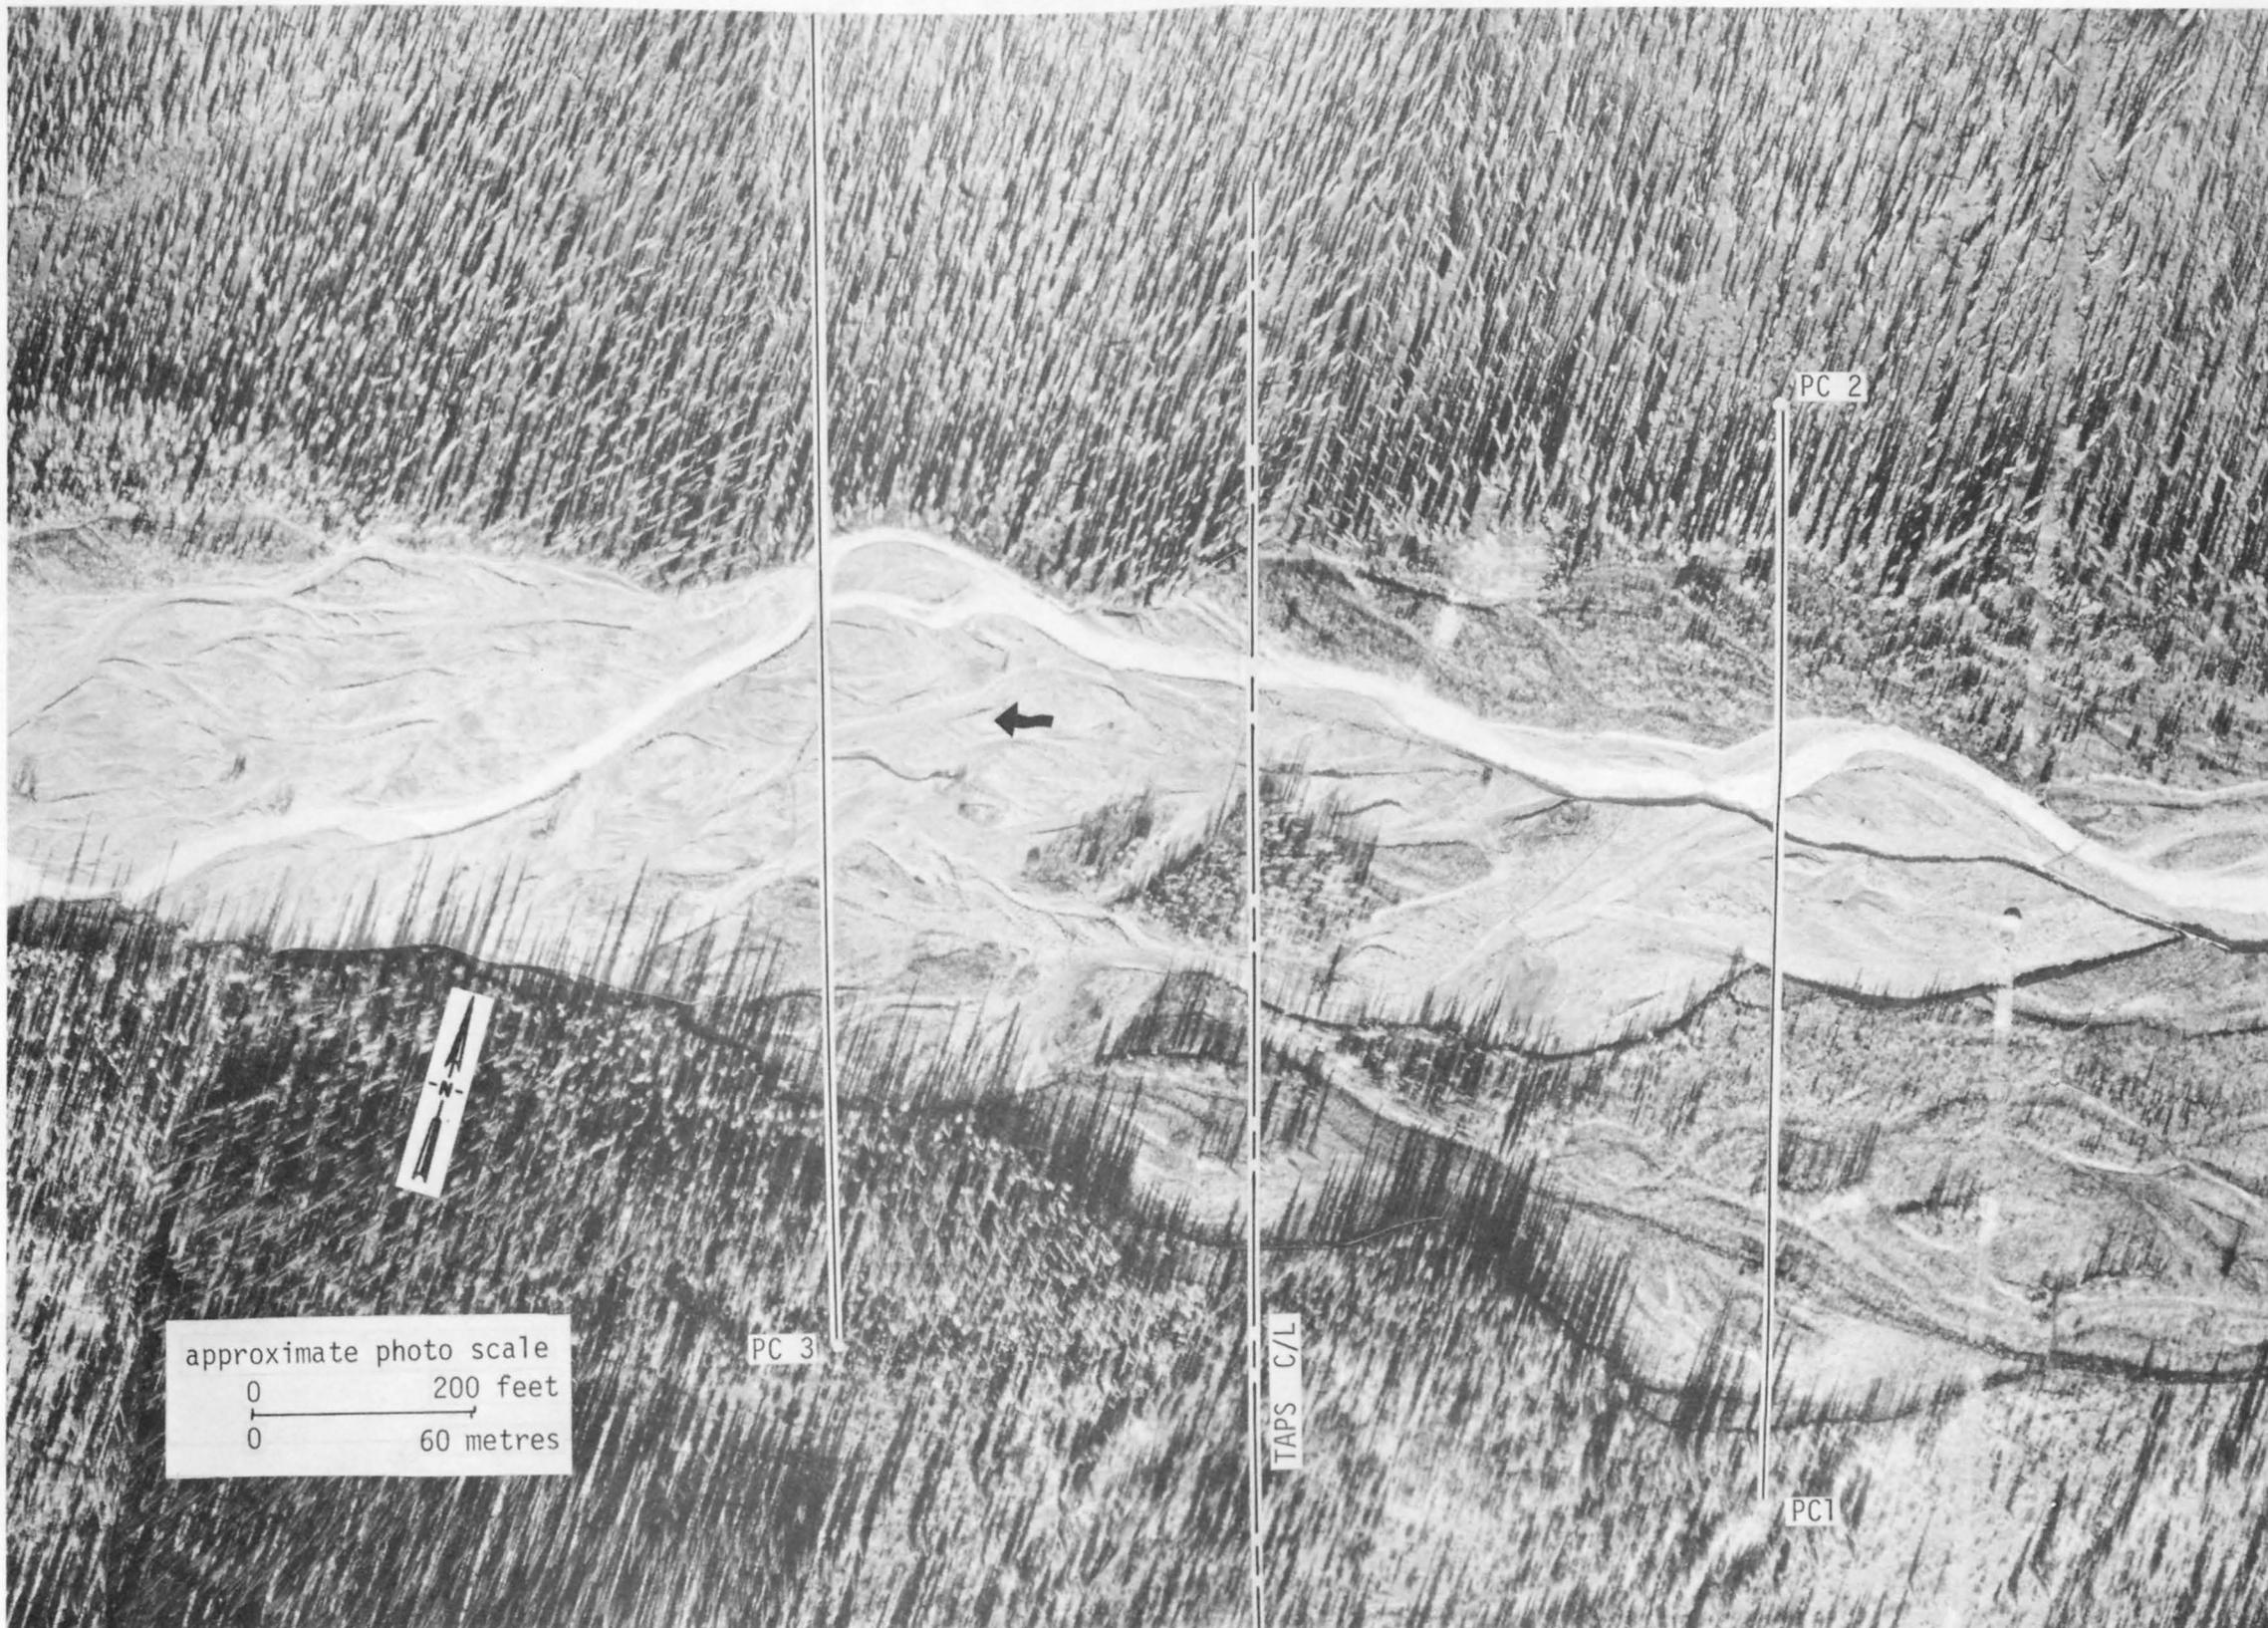
Figure 9. -- Snowden Creek near Dietrich Camp, September 28, 1971. WALKER-ALASKA INC.

Channel conditions.--Low-altitude vertical aerial stereophotography (scale 1:2,400) was obtained September 28, 1971, (fig. 9) to document preconstruction topography at the site. Vertical aerial stereophotography (scale 1:6,000) taken August 6, 1974, (figs. 10 and 11) shows significant change throughout the crossing reach. A large material-removal site is located in the stream channel and on the left bank of the flood fan at the pipeline crossing. A culvert and road fill have been installed across the Snowden Creek flood fan 800 ft (240 m) above the pipeline crossing. Three cross sections (fig. 12) were surveyed July 26, 1971, to define preconstruction ground profiles in the crossing reach. On September 5, 1974, a channel survey of the upstream and downstream sections (fig. 12) showed significant change. The upstream section shows about 20 ft (6 m) of lateral erosion along the left bank of the main channel. The downstream section shows about 20 ft (6 m) of lateral erosion along the right bank and a large quantity of flood-fan material removed from the left bank flood plain.

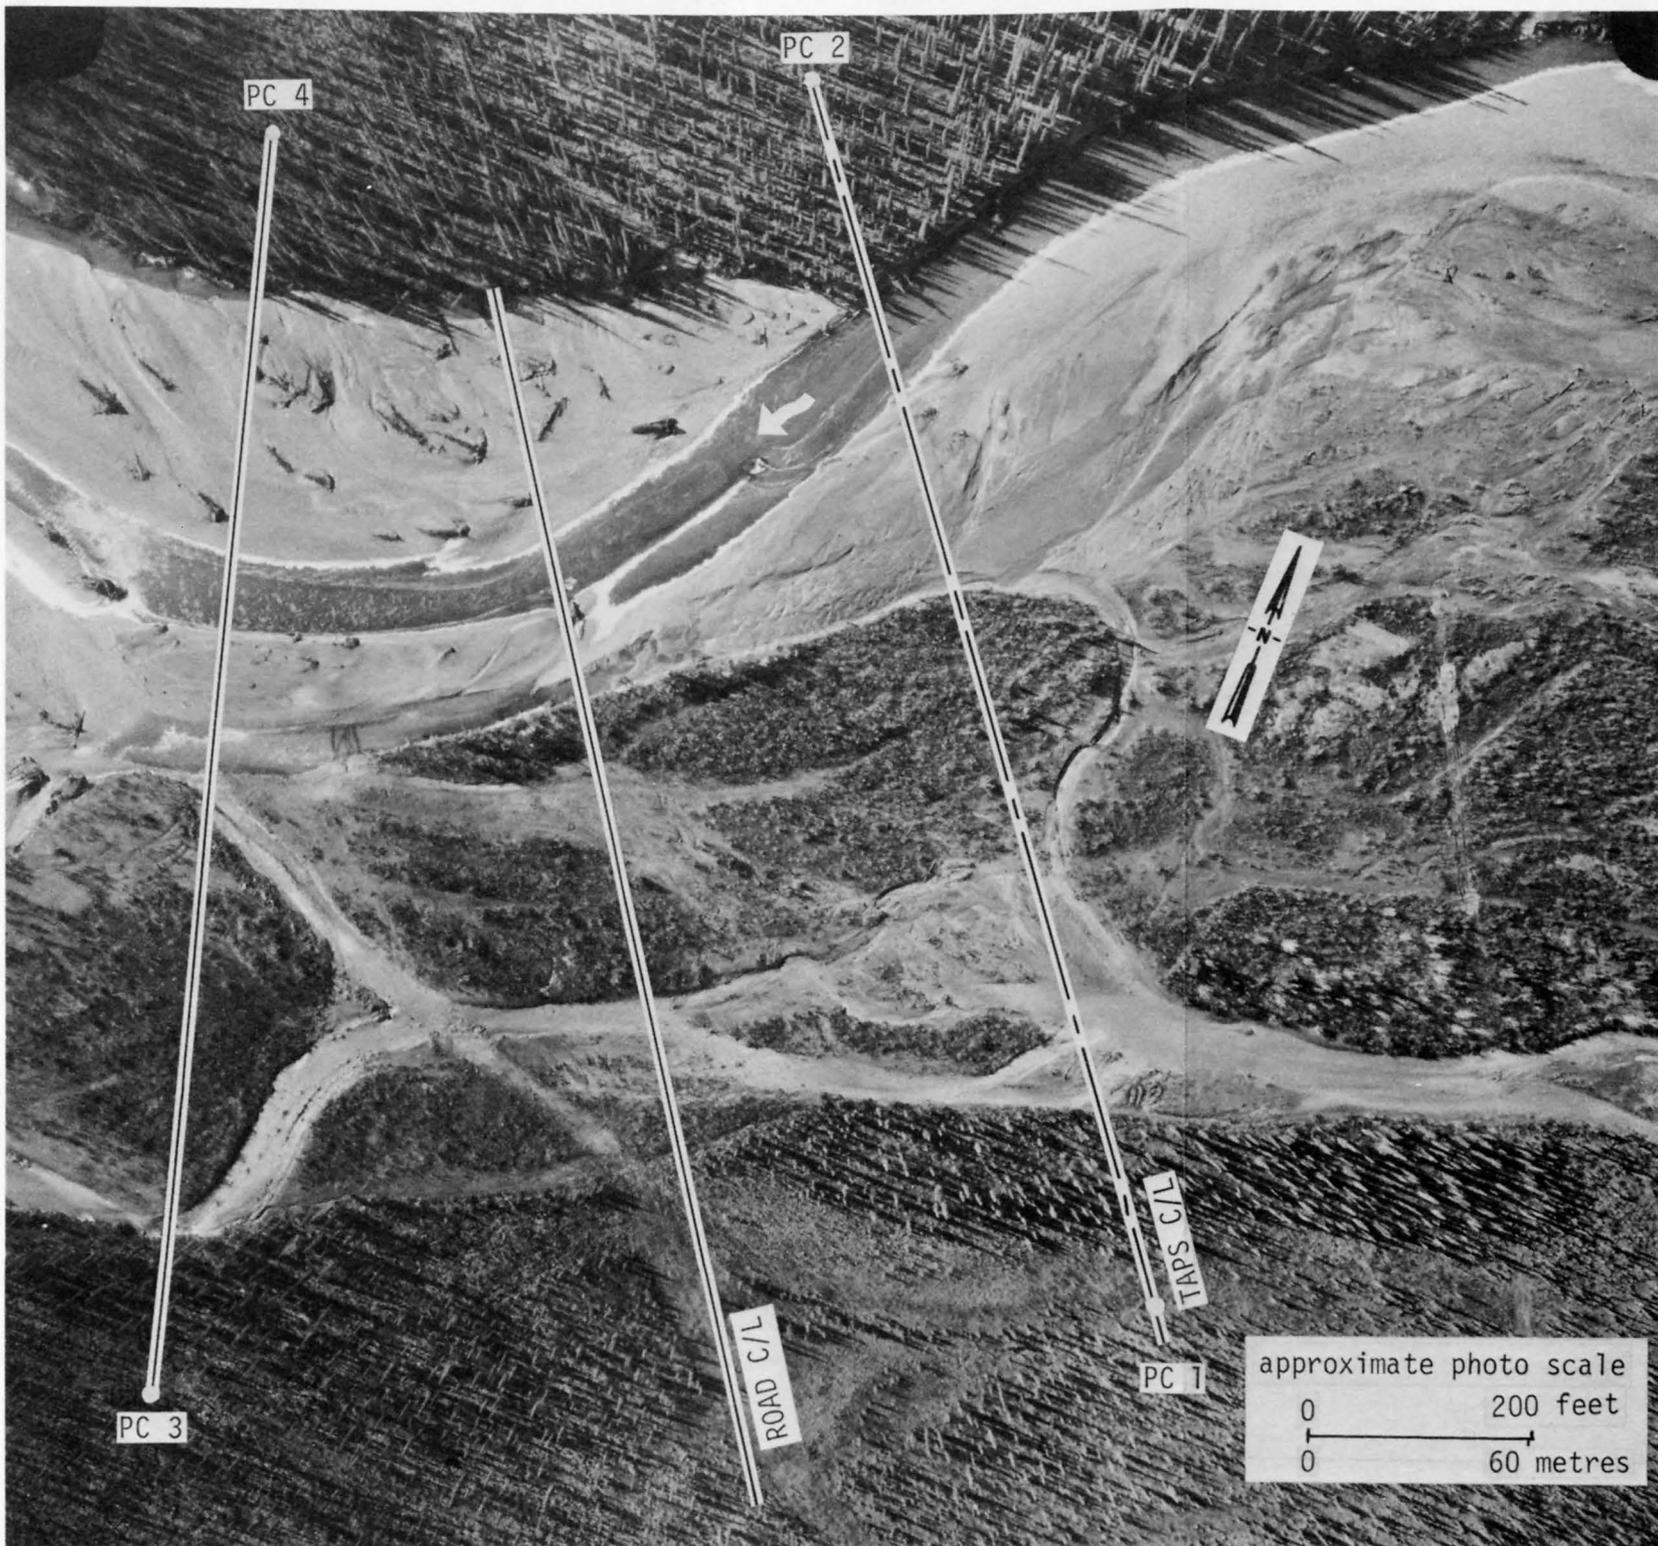
Figure 13. -- Dietrich River at Bettles River, September 28, 1971.
WALKER-ALASKA INC.

Channel conditions.--Low-altitude vertical aerial stereophotography (scale 1:2,400) was obtained September 28, 1971, (fig. 13) to document preconstruction topography at the site. Vertical aerial stereophotography (scale 1:6,000) taken August 6, 1974, (fig. 14) shows a bridge and roadway fill construction encroaching into the flood plain along the preconstruction road centerline section. The three cross sections (fig. 15) surveyed July 29, 1971, showed significant changes when they were resurveyed on September 5, 1974. The upstream section shows 10 ft (3 m) of lateral bank erosion. The preconstruction road centerline section was significantly changed by bridge and roadway fill construction encroaching into the flood plain. Although no overbank flooding occurred during the period July 29, 1971, through September 5, 1974, about 50 ft (15 m) of lateral erosion was detected in the main channel of the downstream section. The bridge upstream of this section has constricted the floodflow and concentrated streamflow in the main channel below the bridge.

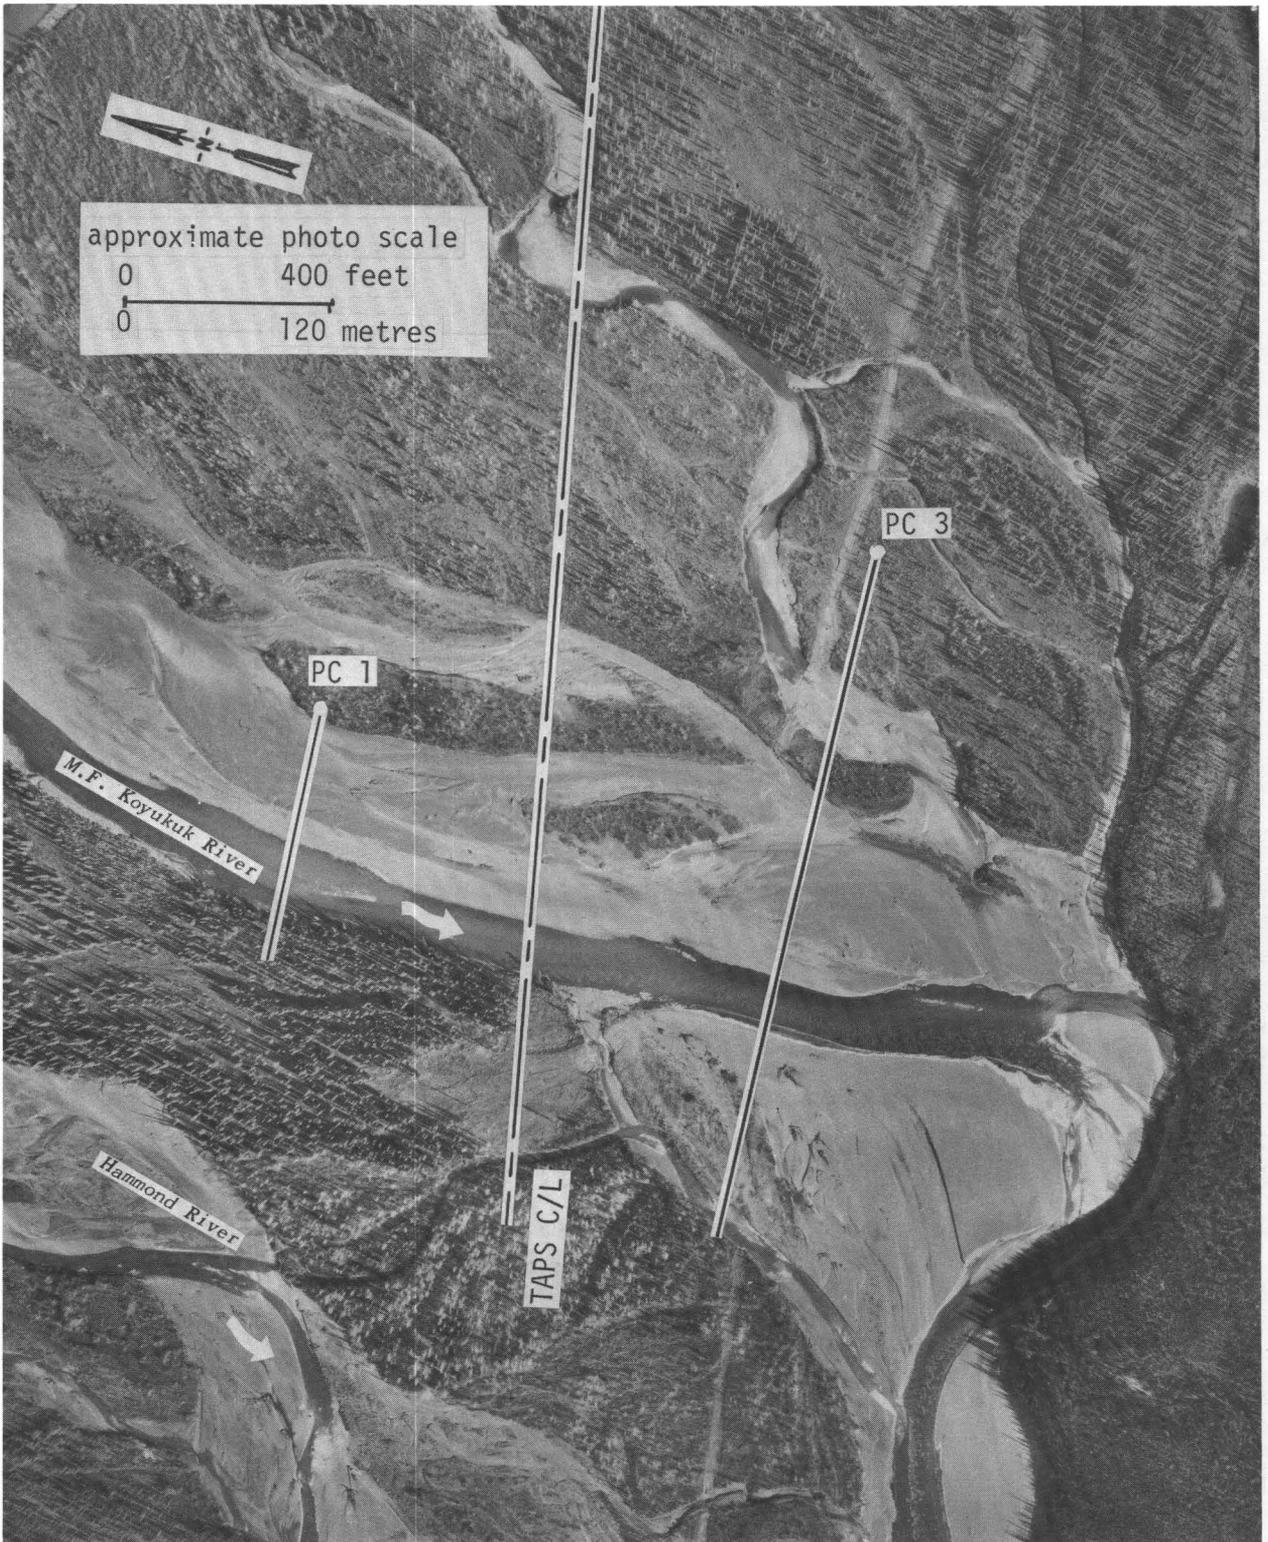
Figure 16. -- Middle Fork Koyukuk River at Hammond River, September 28, 1971.
WALKER-ALASKA INC.

Channel conditions.--Low-altitude vertical aerial stereophotography (scale 1:4,800) was obtained September 28, 1971, (fig. 16) to document preconstruction topography at the site. Vertical aerial strip photography (scale 1:6,000) taken September 1, 1974, (fig. 17) shows a bridge and roadway fill being constructed at the downstream cross section below the TAPS centerline cross section. The overflow channel on the far left bank of the TAPS centerline cross section has been diked off upstream at the material-removal site and by the road embankment. Three cross sections (fig. 18) were surveyed July 27, 1971, to define preconstruction ground profiles in the crossing reach. On September 5, 1974, a channel survey of the upstream cross section found no significant lateral erosion.

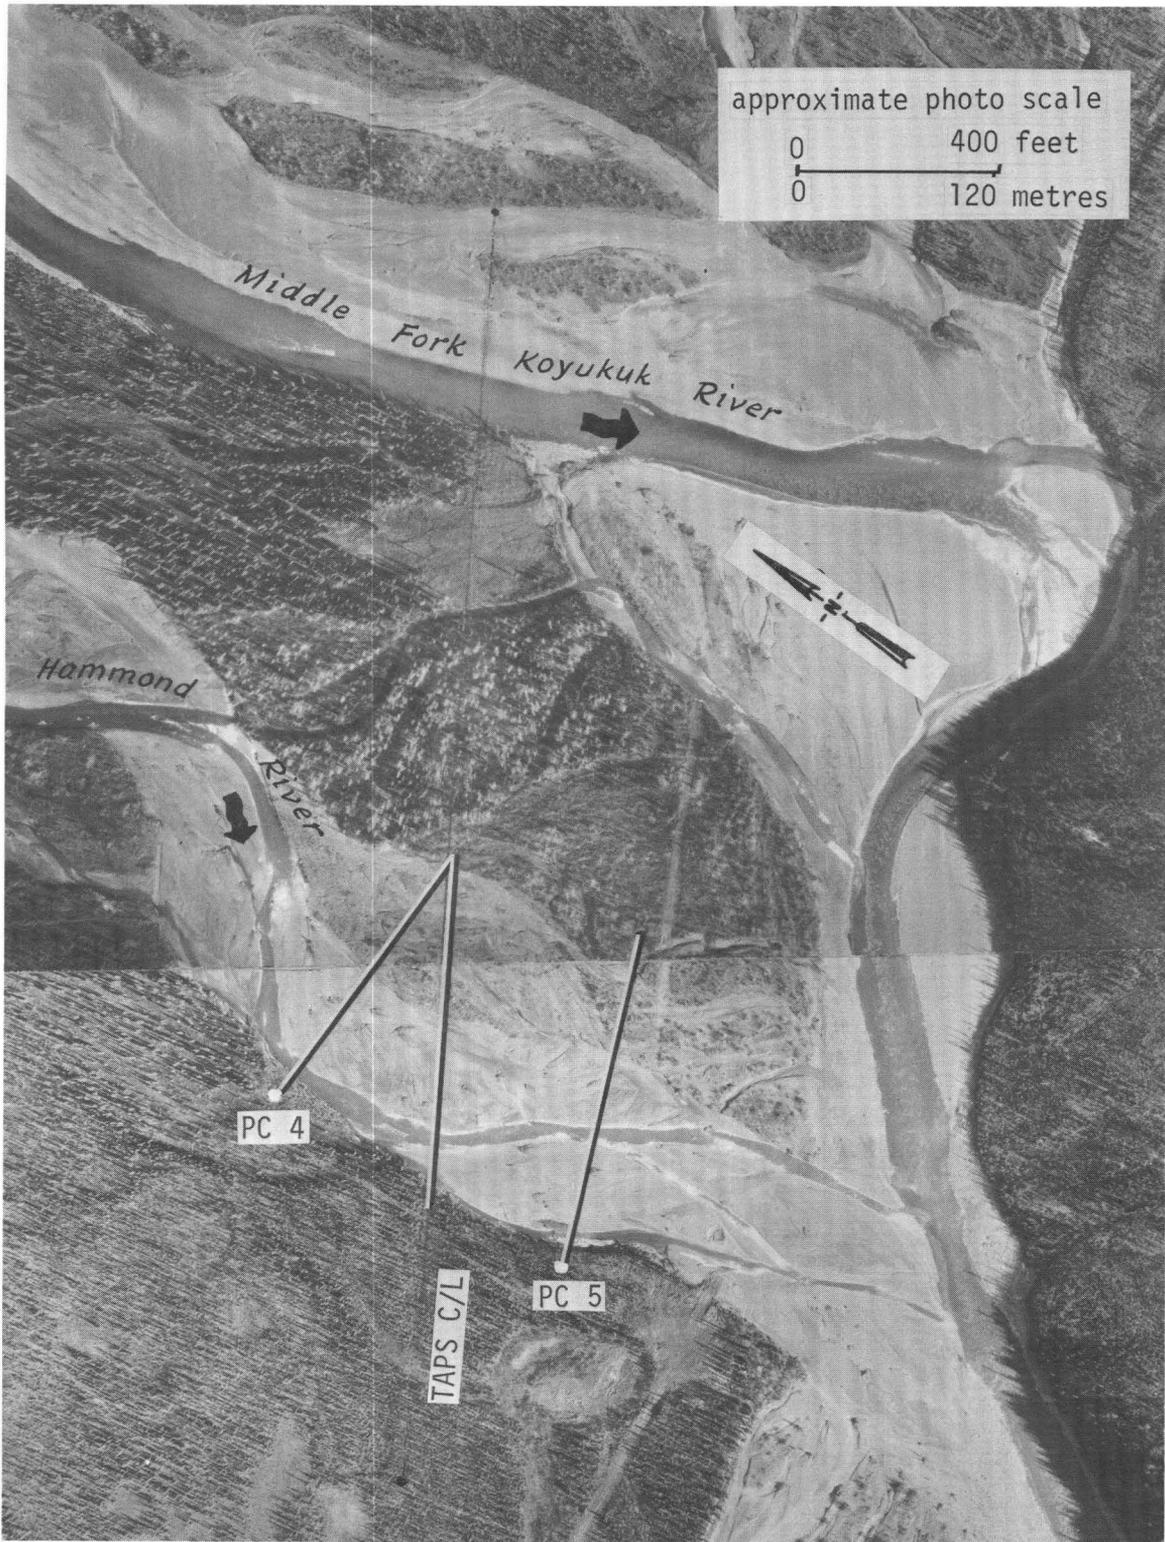
Figure 19. -- Hammond River near Wiseman, September 28, 1971.
WALKER-ALASKA INC.

Channel conditions.--Low-altitude vertical aerial stereophotography (scale 1:4,800) was obtained September 28, 1971, (fig. 19) to document preconstruction topography at the site. Vertical aerial strip photography (scale 1:6,000) taken September 1, 1974, (fig. 20) shows bridge and roadway fill being constructed near the downstream cross section below the TAPS centerline cross section. Three cross sections (fig. 21) were surveyed July 25, 1971, to define preconstruction ground profiles in the crossing reach. On September 5, 1974, a channel survey showed about 20 ft (6 m) of lateral bank erosion in the upstream section and 20 ft (6 m) of lateral bank erosion in the downstream section along the right bank. About 2 ft (0.6 m) of scour has occurred along the right cutbank in the upstream section.

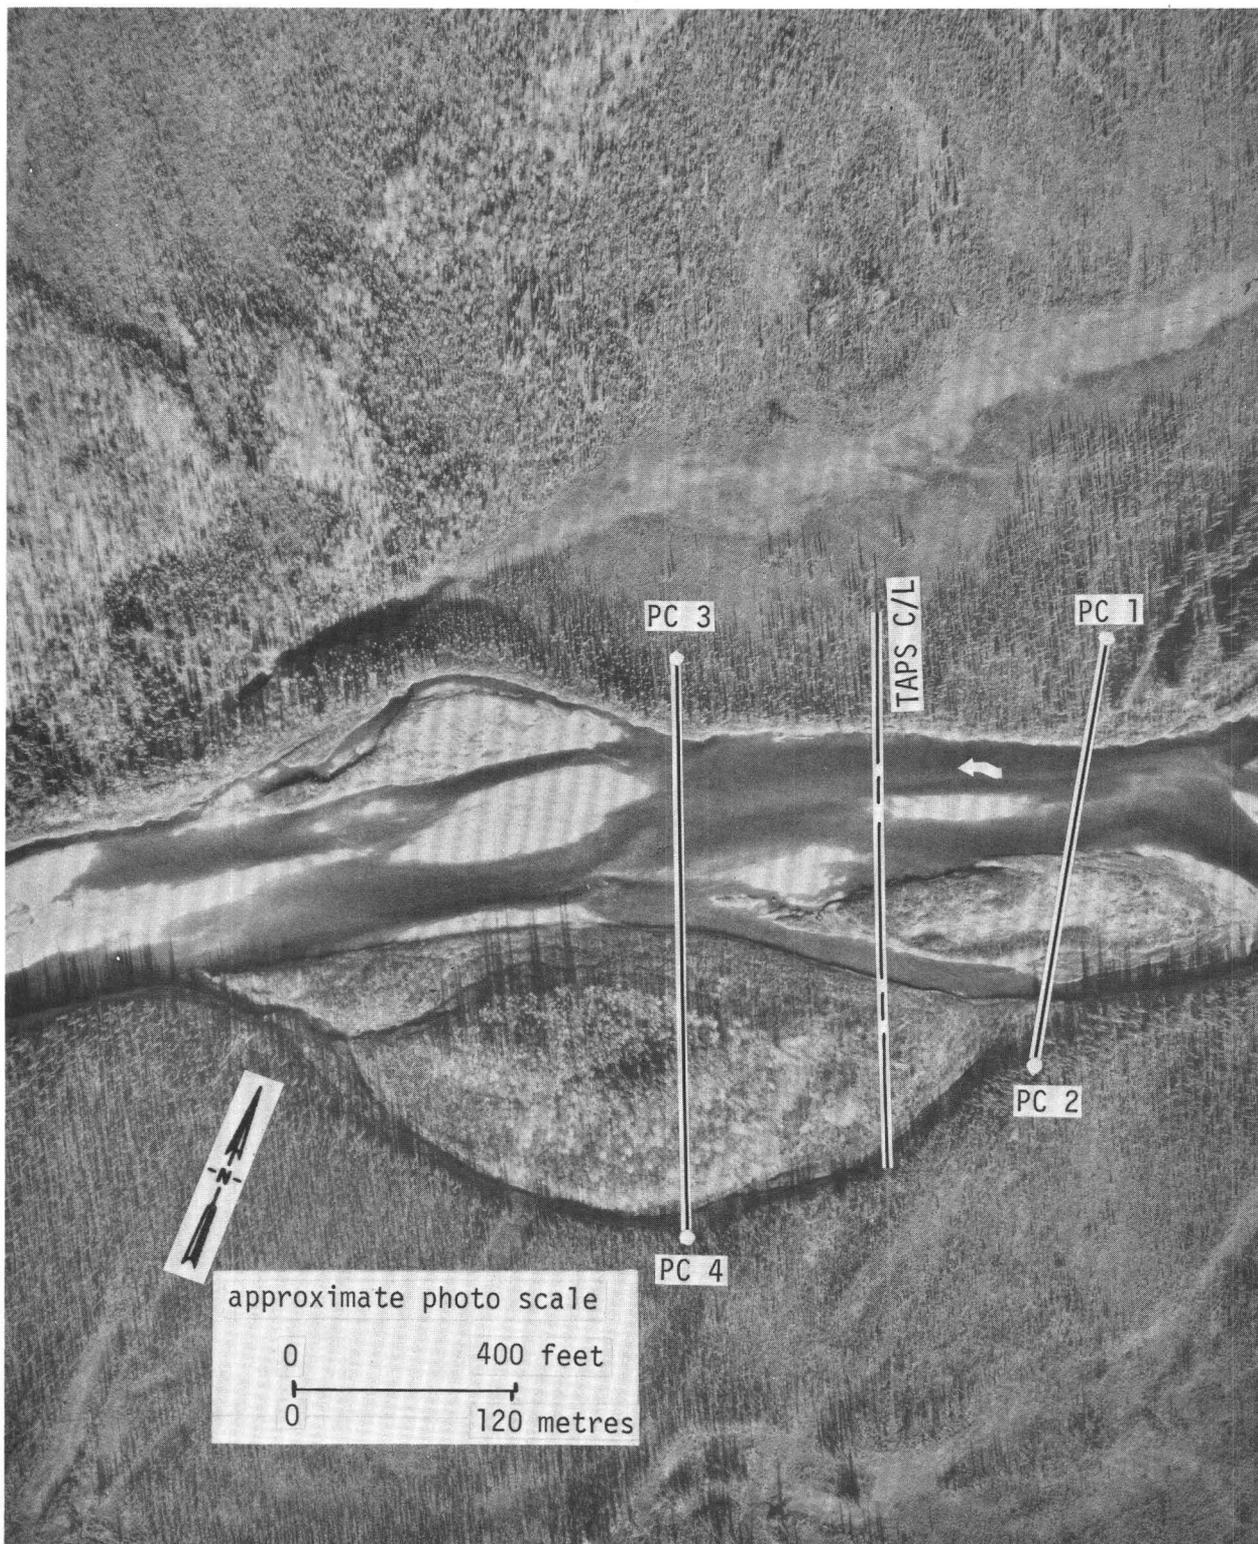
Figure 26. -- South Fork Koyukuk River near Wiseman, September 28, 1971.
WALKER-ALASKA INC.

Channel conditions.--Low-altitude vertical aerial stereophotography (scale 1:4,800) was obtained September 28, 1971, (fig. 26) to document preconstruction topography at the site. Vertical aerial stereophotography (scale 1:6,000) taken August 6, 1974, (fig. 27) shows no significant channel erosion or construction activities have occurred in the proposed crossing reach since September 28, 1971. Three cross sections (fig. 28) were surveyed July 22, 1971, and September 26, 1973, to define preconstruction ground profiles in the crossing reach. In September 1974 a channel survey of the three cross sections found no significant lateral erosion.

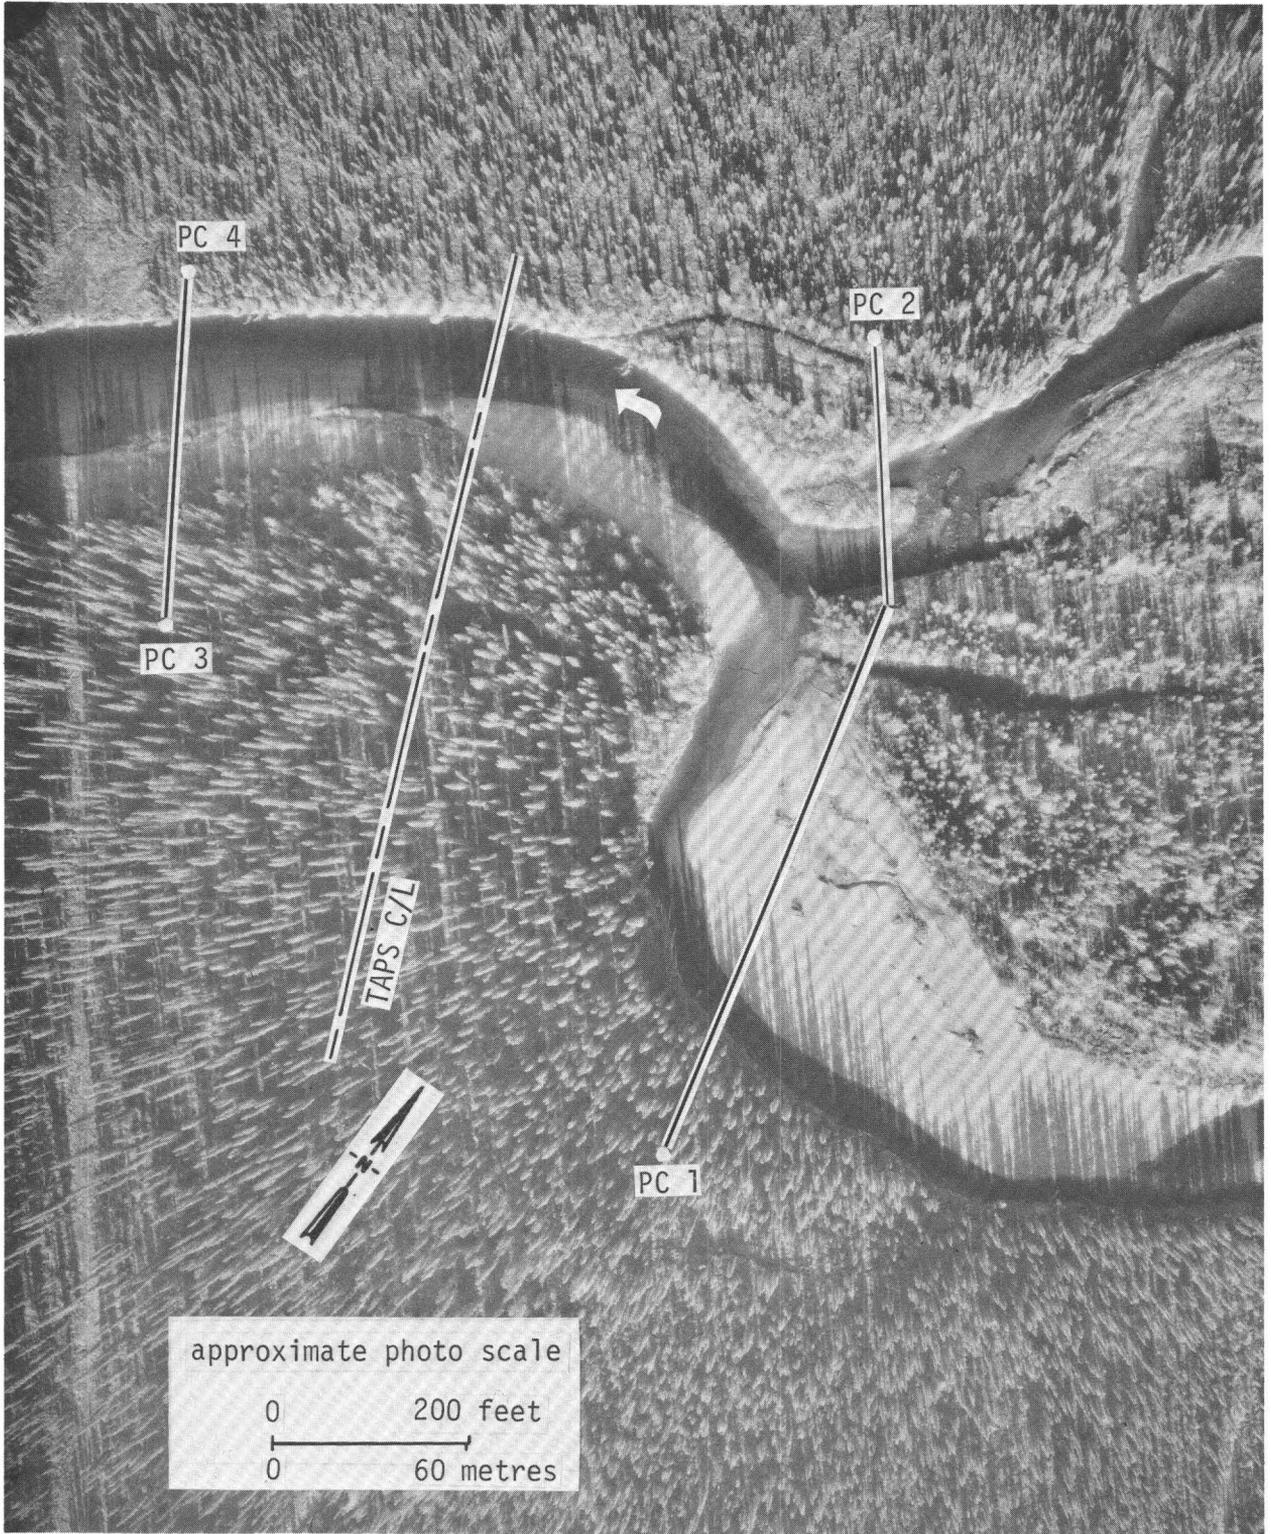
Figure 29. -- Jim River near Prospect Creek Camp, September 28, 1971.
WALKER-ALASKA INC.

Channel conditions.--Low-altitude vertical aerial stereophotography (scale 1:2,400) was obtained September 28, 1971, (fig. 29) to document preconstruction topography at the site. Vertical aerial stereophotography (scale 1:6,000) taken August 25, 1974, (fig. 30) shows bridge and road fill being constructed near the downstream cross section. The photographs show no significant lateral erosion. Three cross sections (fig. 31) were surveyed July 20, 1971, to define preconstruction ground profiles in the crossing reach. On September 1974 a channel survey of the preconstruction cross sections showed no significant change.

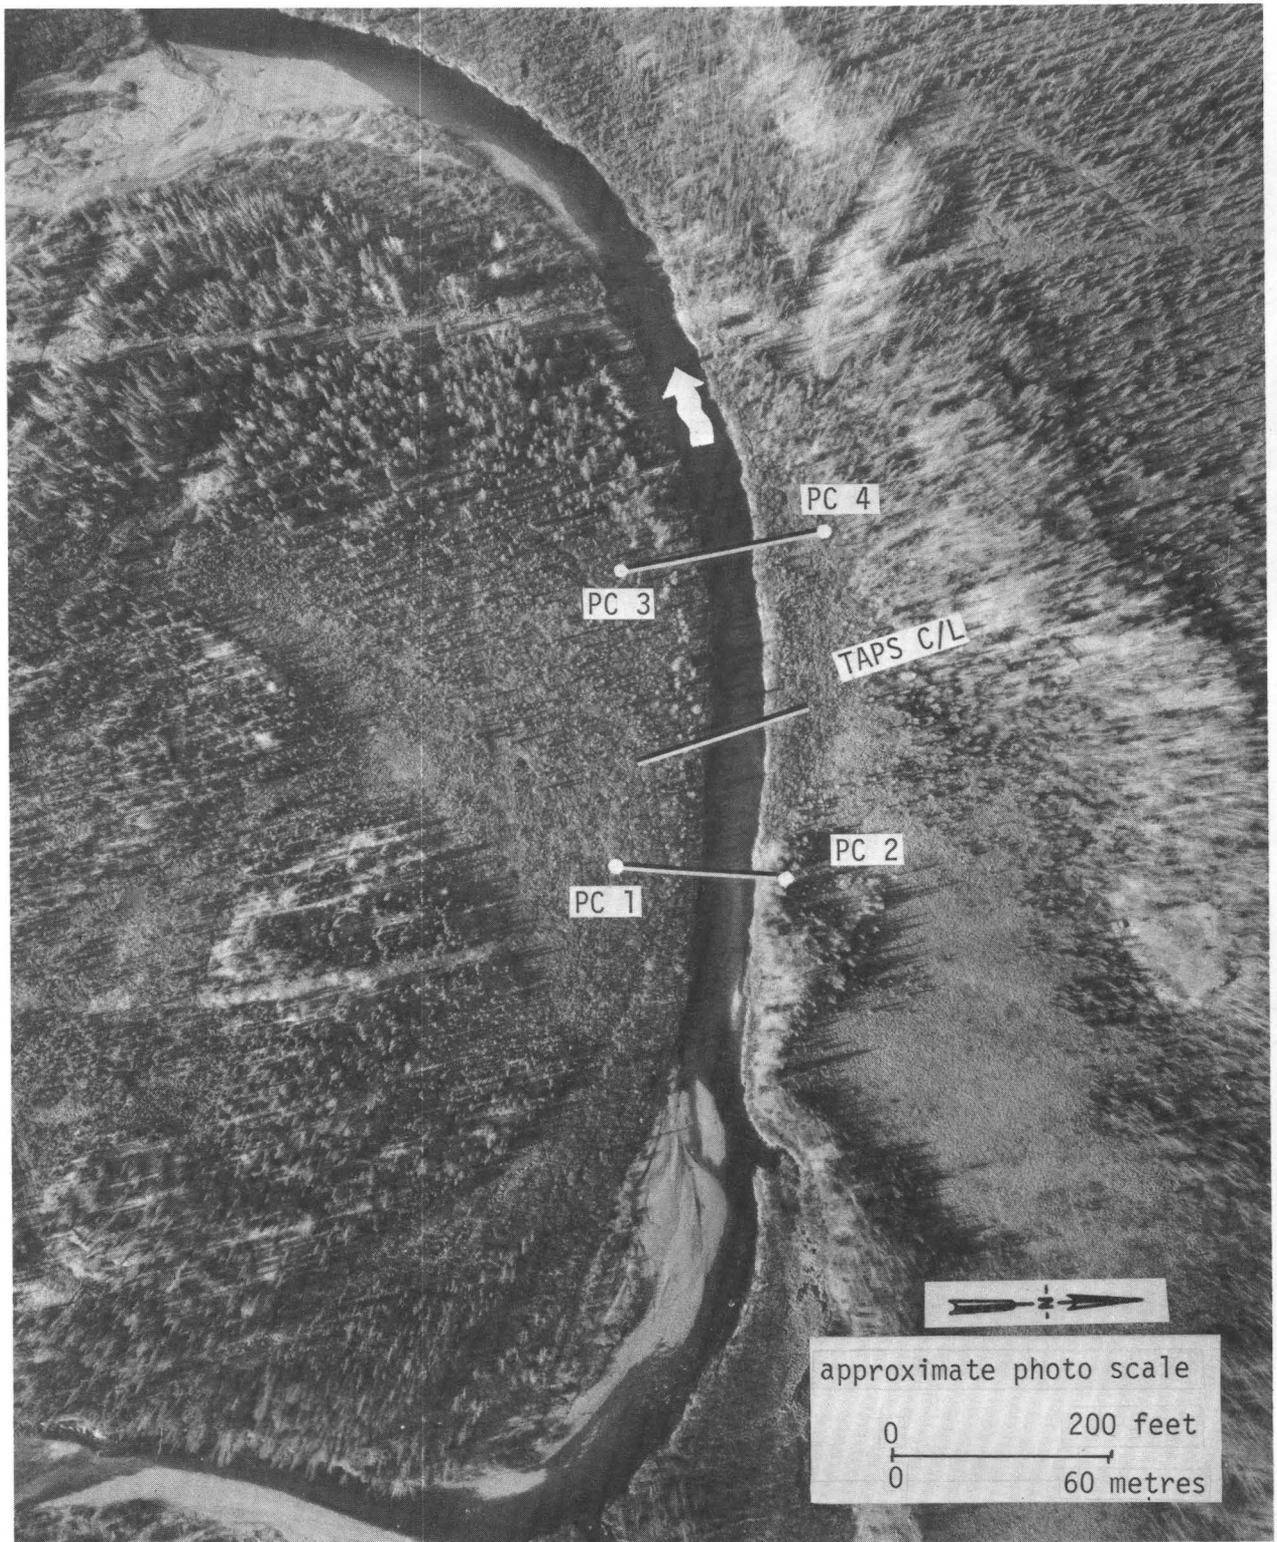
Figure 33. -- Prospect Creek near Prospect Creek Camp, September 28, 1971.
WALKER-ALASKA INC.

Channel conditions.--Low-altitude vertical aerial stereophotography (scale 1:2,400) was obtained September 28, 1971, (fig. 33) to document preconstruction topography at the site. Vertical aerial strip photography (scale 1:6,000) taken September 1, 1974, (figs. 34 and 35) shows a large gravel-removal site, roadway fill, and bridge about 500 ft (150 m) downstream of the TAPS centerline. The photographs show no significant lateral erosion. Three cross sections (fig. 36) were surveyed July 21, 1971, to define preconstruction ground profiles in the crossing reach. In September 1974 a channel survey of the preconstruction cross sections showed no significant erosion.
