CHANNEL EROSION SURVEYS ALONG TAPS ROUTE, ALASKA, 1974

UNITED STATES DEPARTMENT OF THE INTERIOR
GEOLOGICAL SURVEY

Joseph M. Childers and Stanley H. Jones

OPEN-FILE REPORT

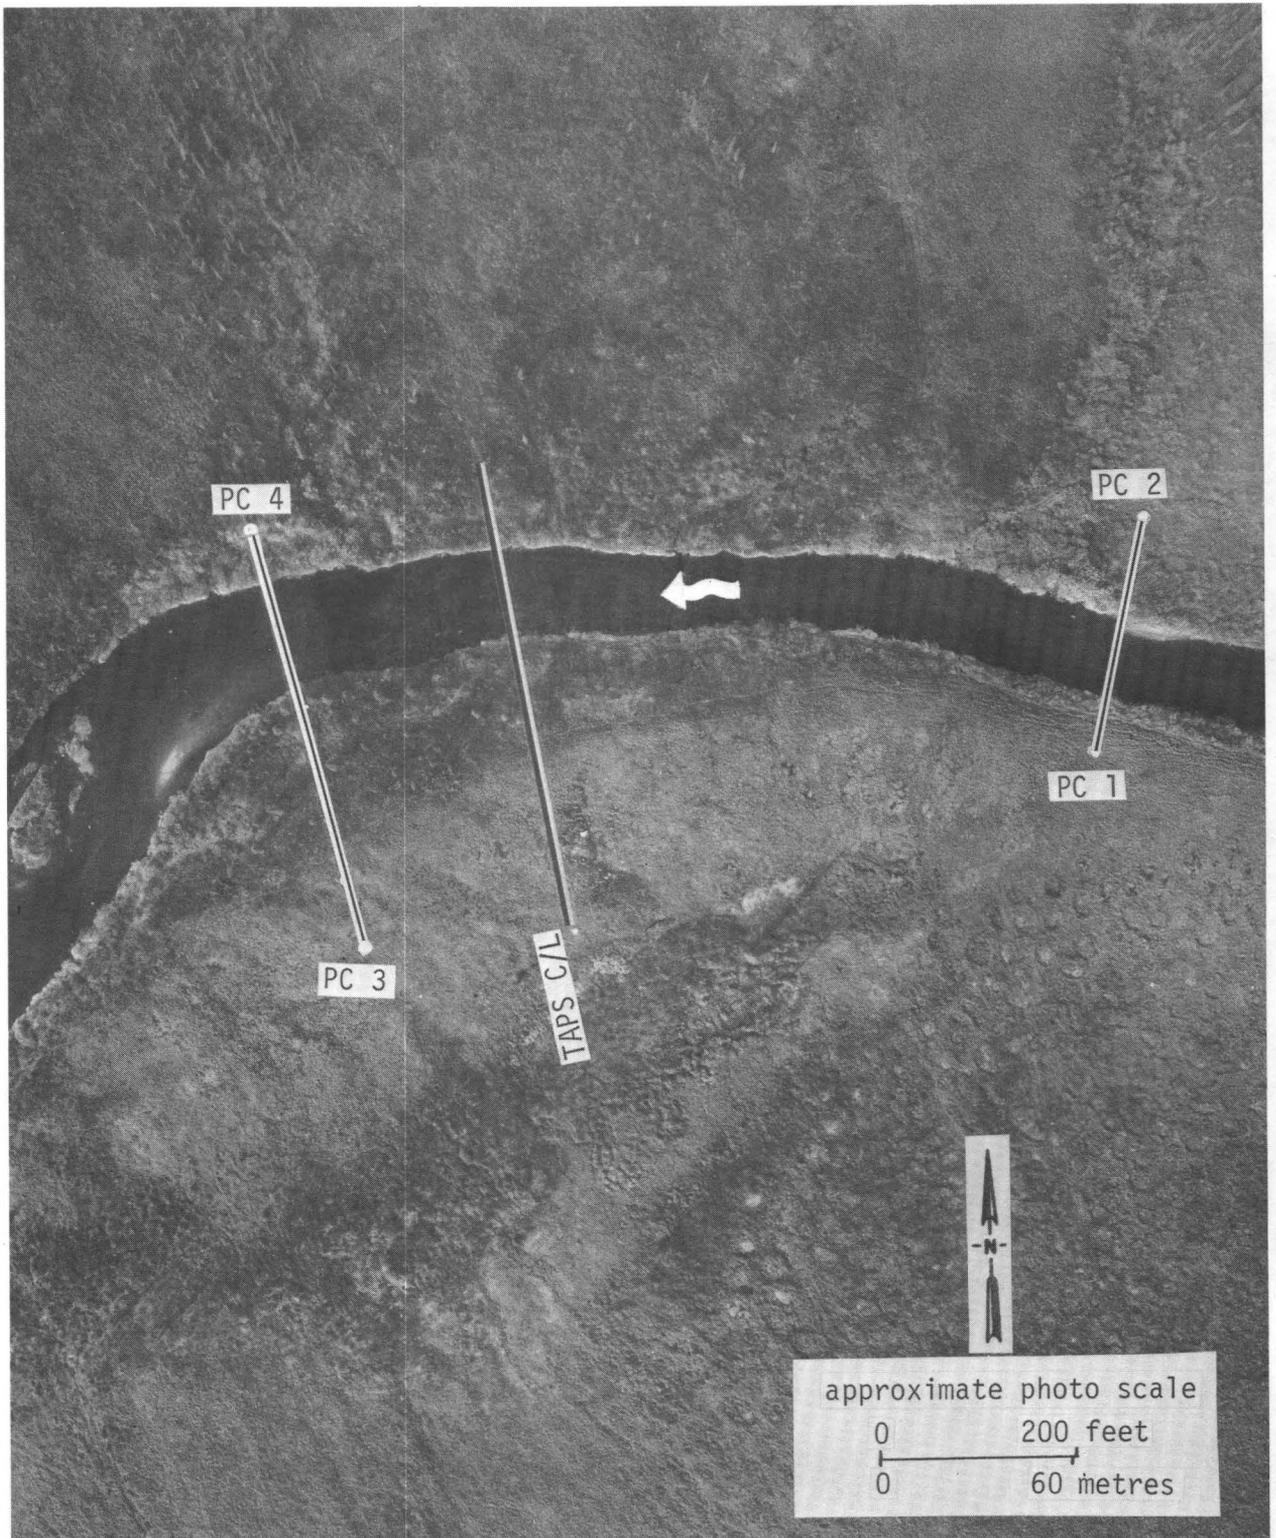
Figure 37. -- Kanuti River near Bettles, September 28, 1971.

Channel conditions.--Low-altitude vertical aerial stereophotography (scale 1:2,400) was obtained September 28, 1971, (fig. 37) to document preconstruction topography at the site. Vertical aerial stereophotography (scale 1:6,000) taken August 6, 1974, (fig. 38) shows a roadway and bridge constructed 300 ft (91 m) above the TAPS centerline. There was no significant erosion in the crossing reach. Three cross sections (fig. 39) were surveyed July 22, 1971, to define preconstruction ground profiles in the crossing reach. In September 1974 a channel survey of the preconstruction cross sections showed no significant erosion.

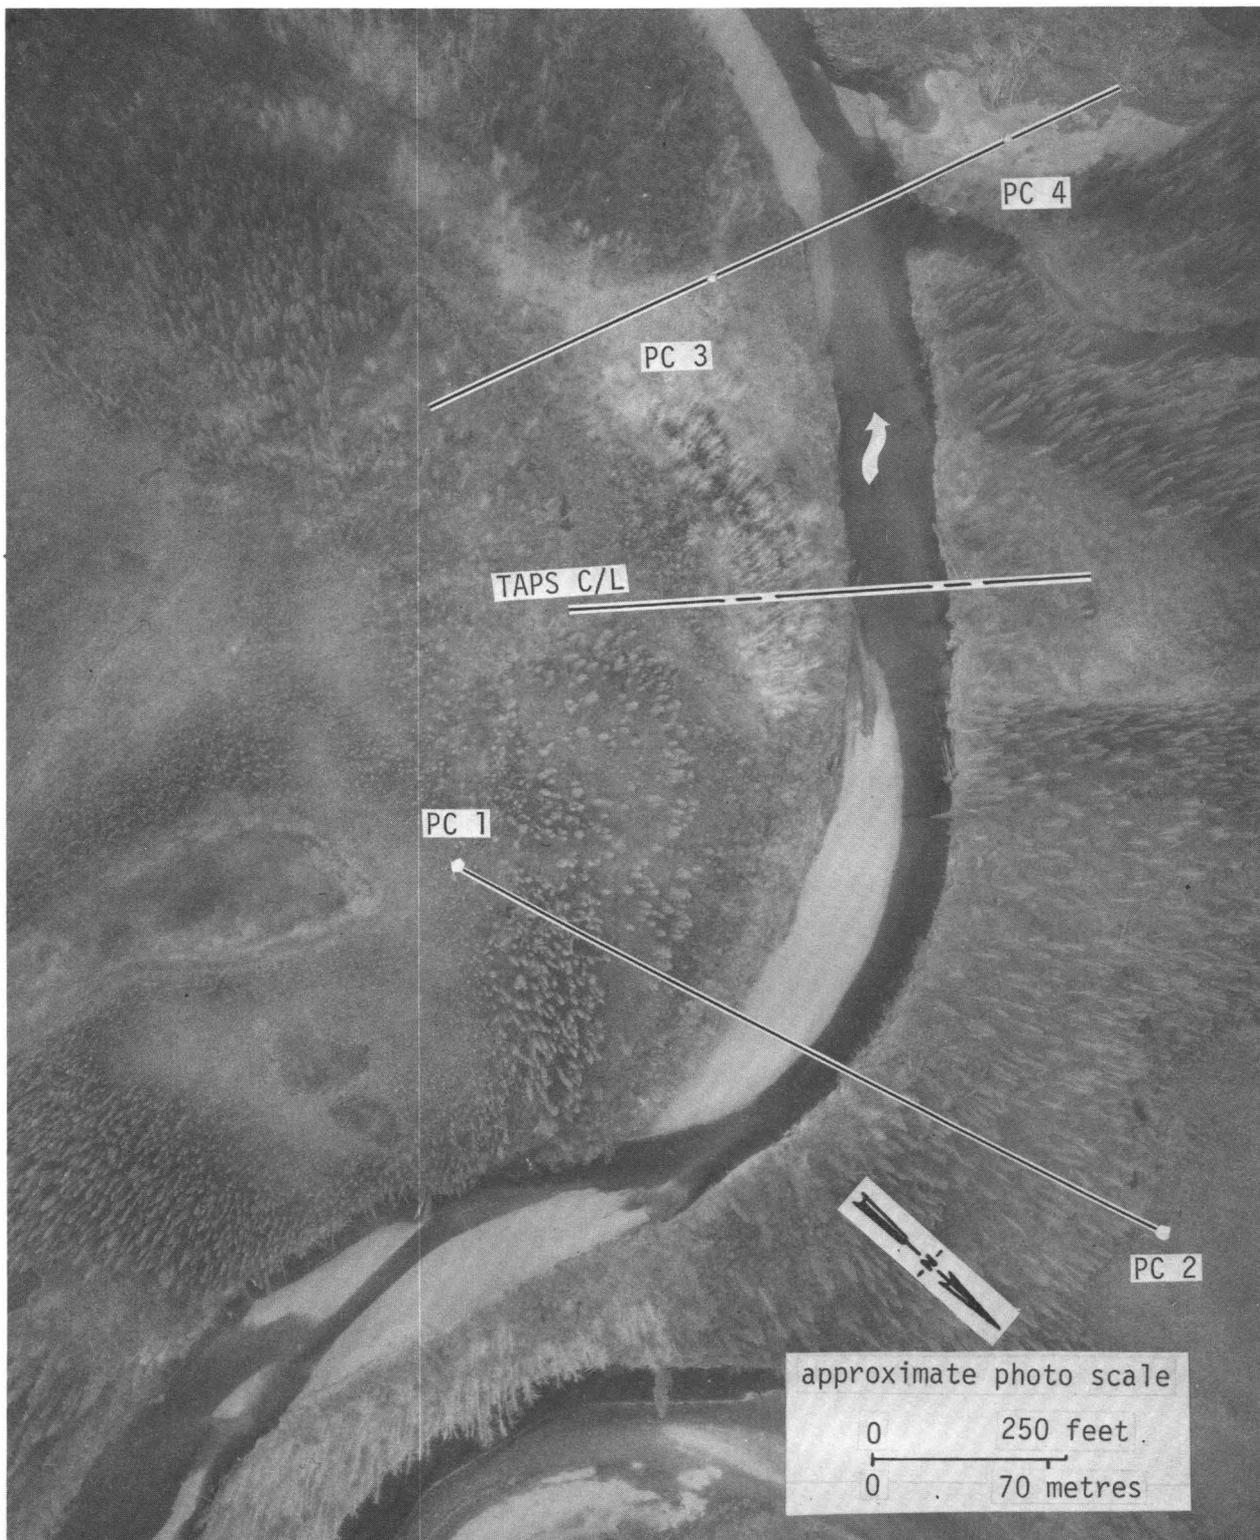
Figure 40. -- Hess Creek near Livengood, September 28, 1971.
WALKER-ALASKA INC.

Channel conditions.--Low-altitude vertical aerial stereophotography (scale 1:2,400) was obtained September 28, 1971, (fig. 40) to document preconstruction topography at the site. Vertical aerial strip photography (scale 1:6,000) taken September 1, 1974, (fig. 41) shows no significant channel erosion or construction activities have occurred in the proposed crossing reach since August 3, 1971. Three cross sections (fig. 42) were surveyed August 3, 1971, to define preconstruction ground profiles in the crossing reach. In September 1974 a channel survey of the three cross sections found 5 ft (2 m) of lateral bank erosion in the upstream section.

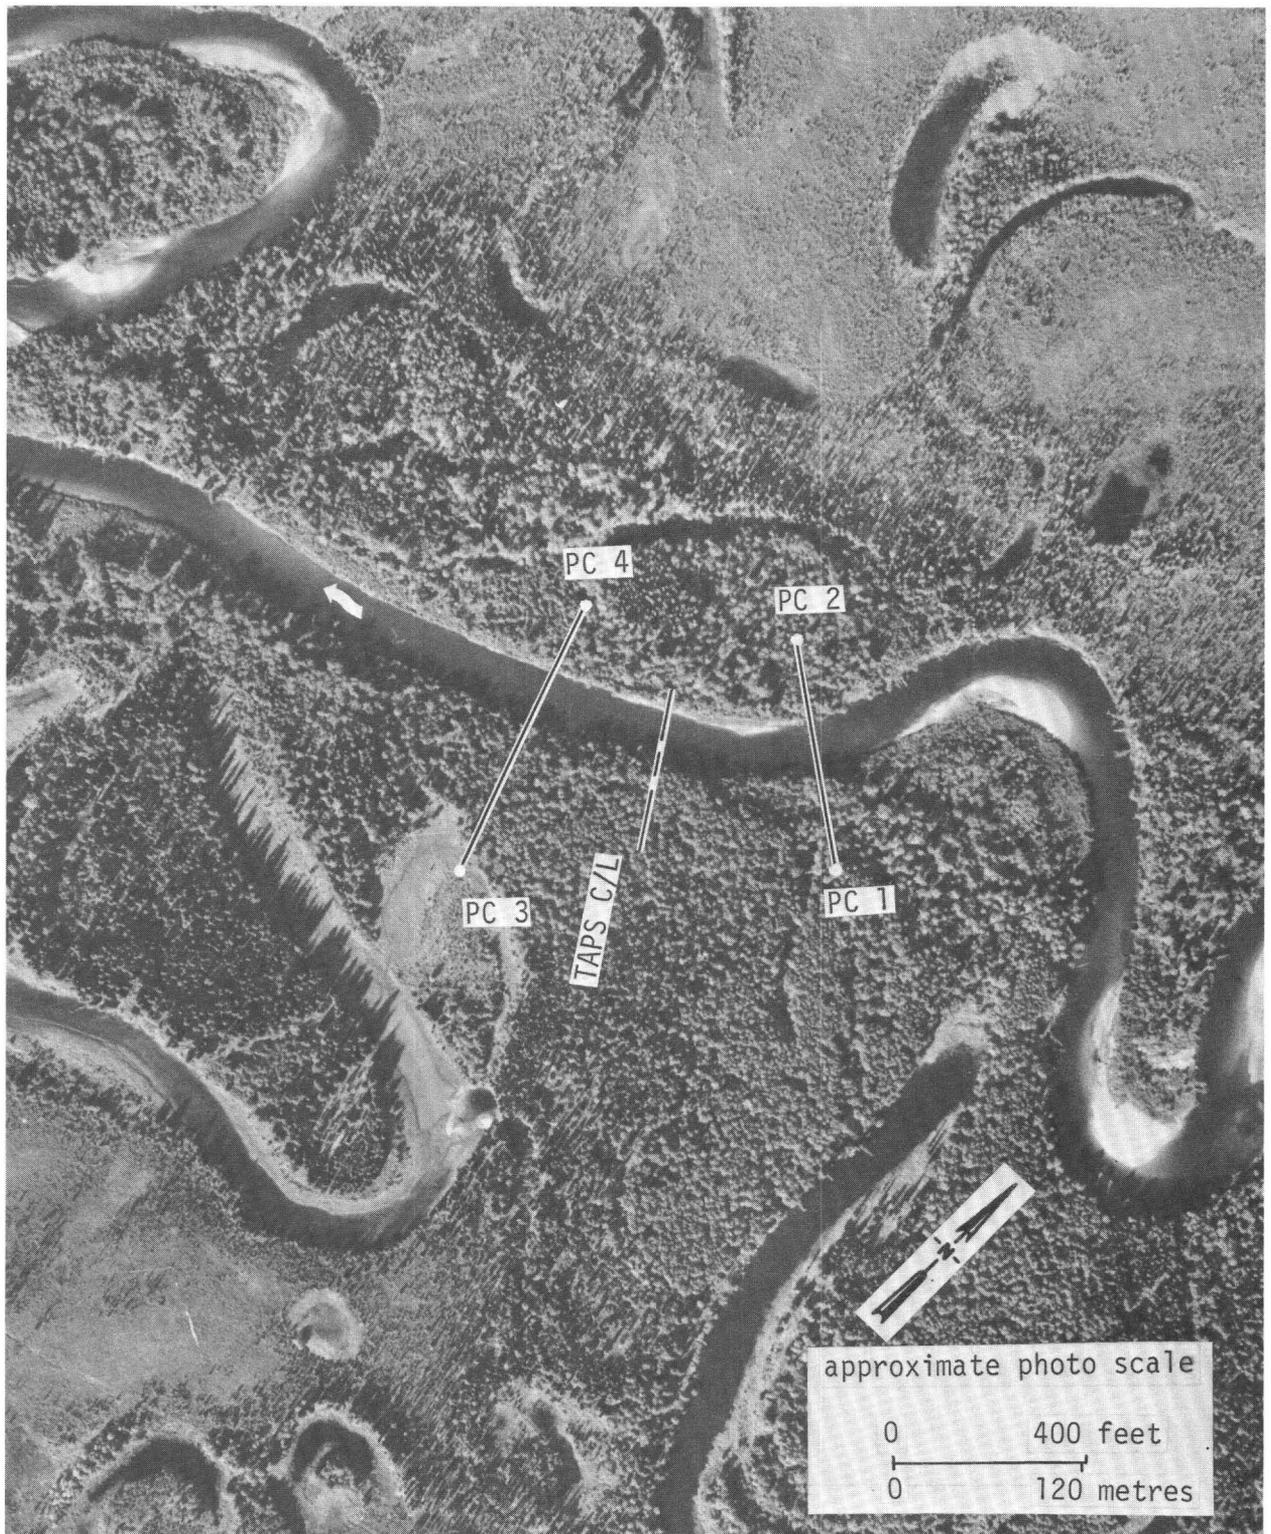
Figure 44. -- Chatanika River near Olnes, August 18, 1969.
BUREAU OF LAND MANAGEMENT

Channel conditions.--High-altitude vertical aerial stereophotography (scale 1:15,840) was obtained August 18, 1969, (fig. 44) to document preconstruction topography at the site. Vertical aerial strip photography (scale 1:6,000) taken September 4, 1974, (fig. 45) shows no significant channel erosion or construction activities have occurred in the proposed crossing reach since August 18, 1969. Three cross sections (fig. 46) were surveyed August 3, 1971, to define preconstruction ground profiles in the crossing reach. In June 1974 a channel survey of measurements from photograph control points found no significant lateral erosion.

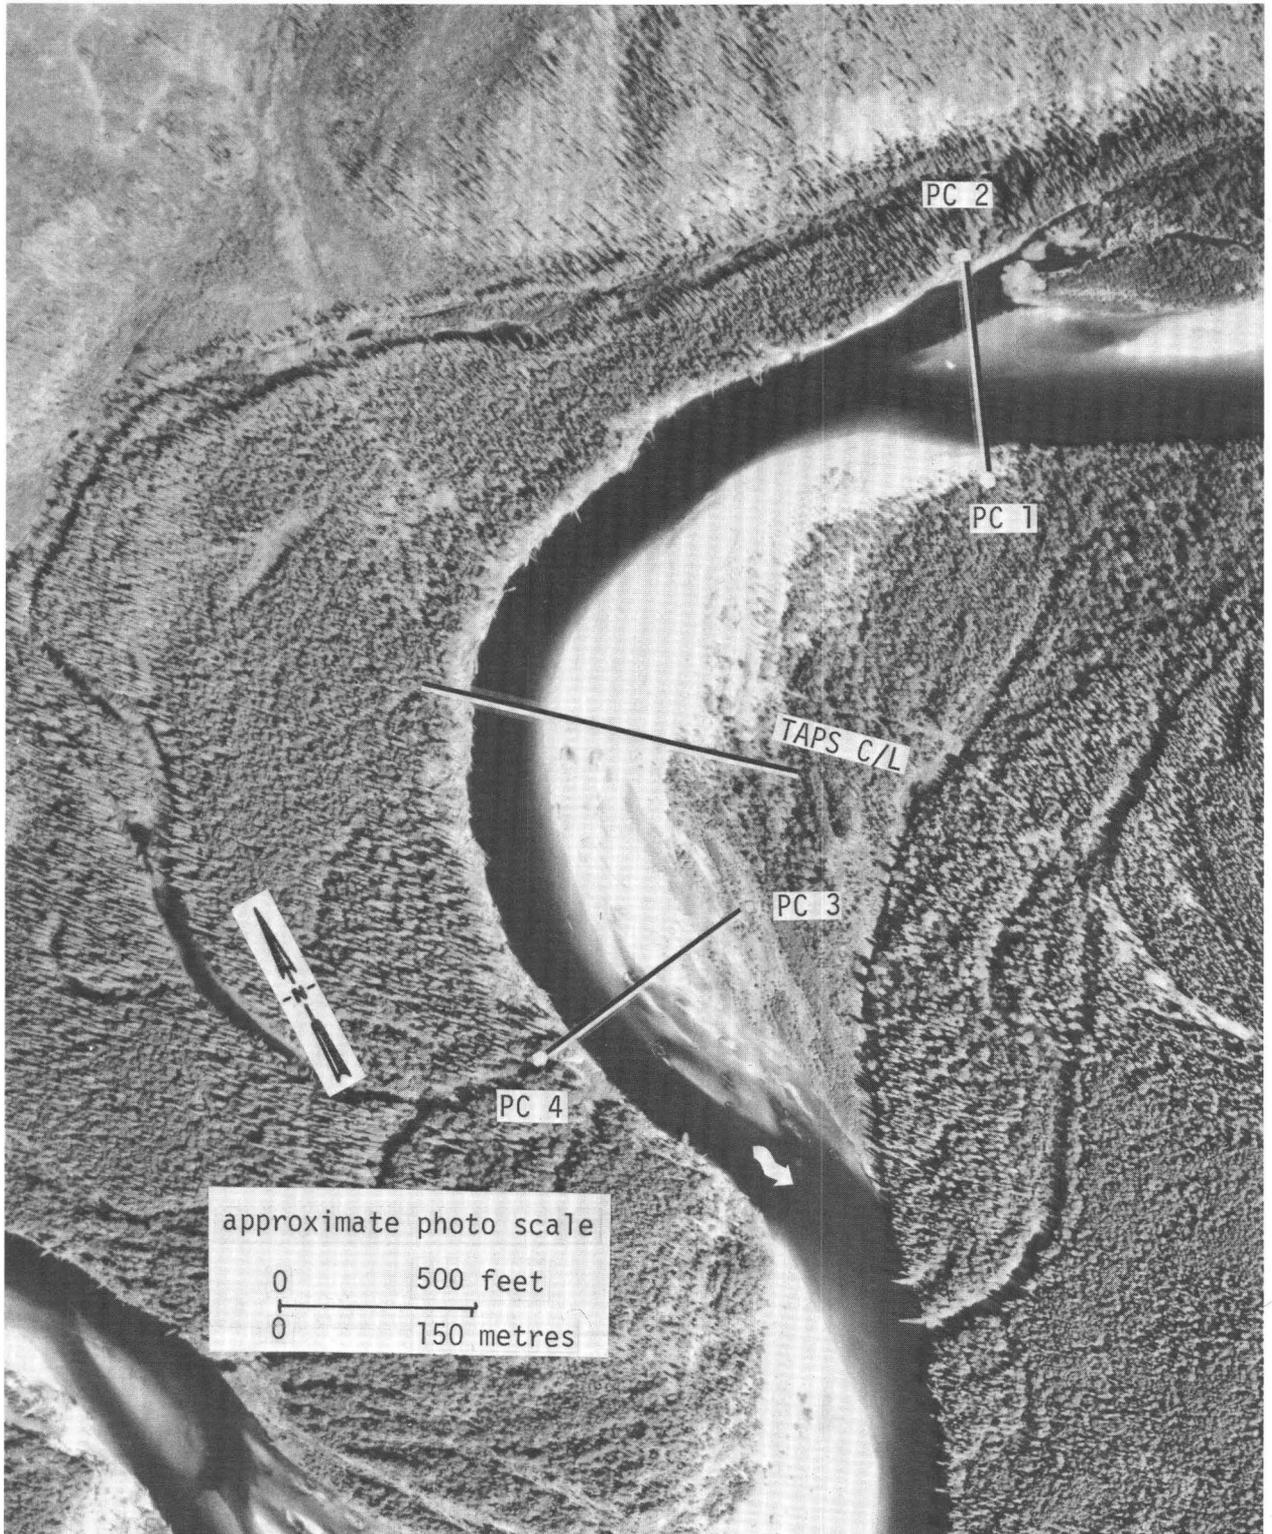
Figure 47. -- Salcha River near Salchaket, August 14, 1969.
TOBIN RESEARCH INC.

Channel conditions.--High-altitude vertical aerial stereophotography (scale 1:24,000) was obtained August 14, 1969, (fig. 47) to document preconstruction topography at the site. Vertical aerial strip photography (scale 1:6,000) taken August 31, 1974, (fig. 48) shows no significant channel erosion or construction activities have occurred in the proposed crossing reach since August 14, 1969. Three cross sections (fig. 49) were surveyed August 5, 1971, to define preconstruction ground profiles in the crossing reach. On September 16, 1974, a channel survey of the three cross sections found no significant lateral erosion.

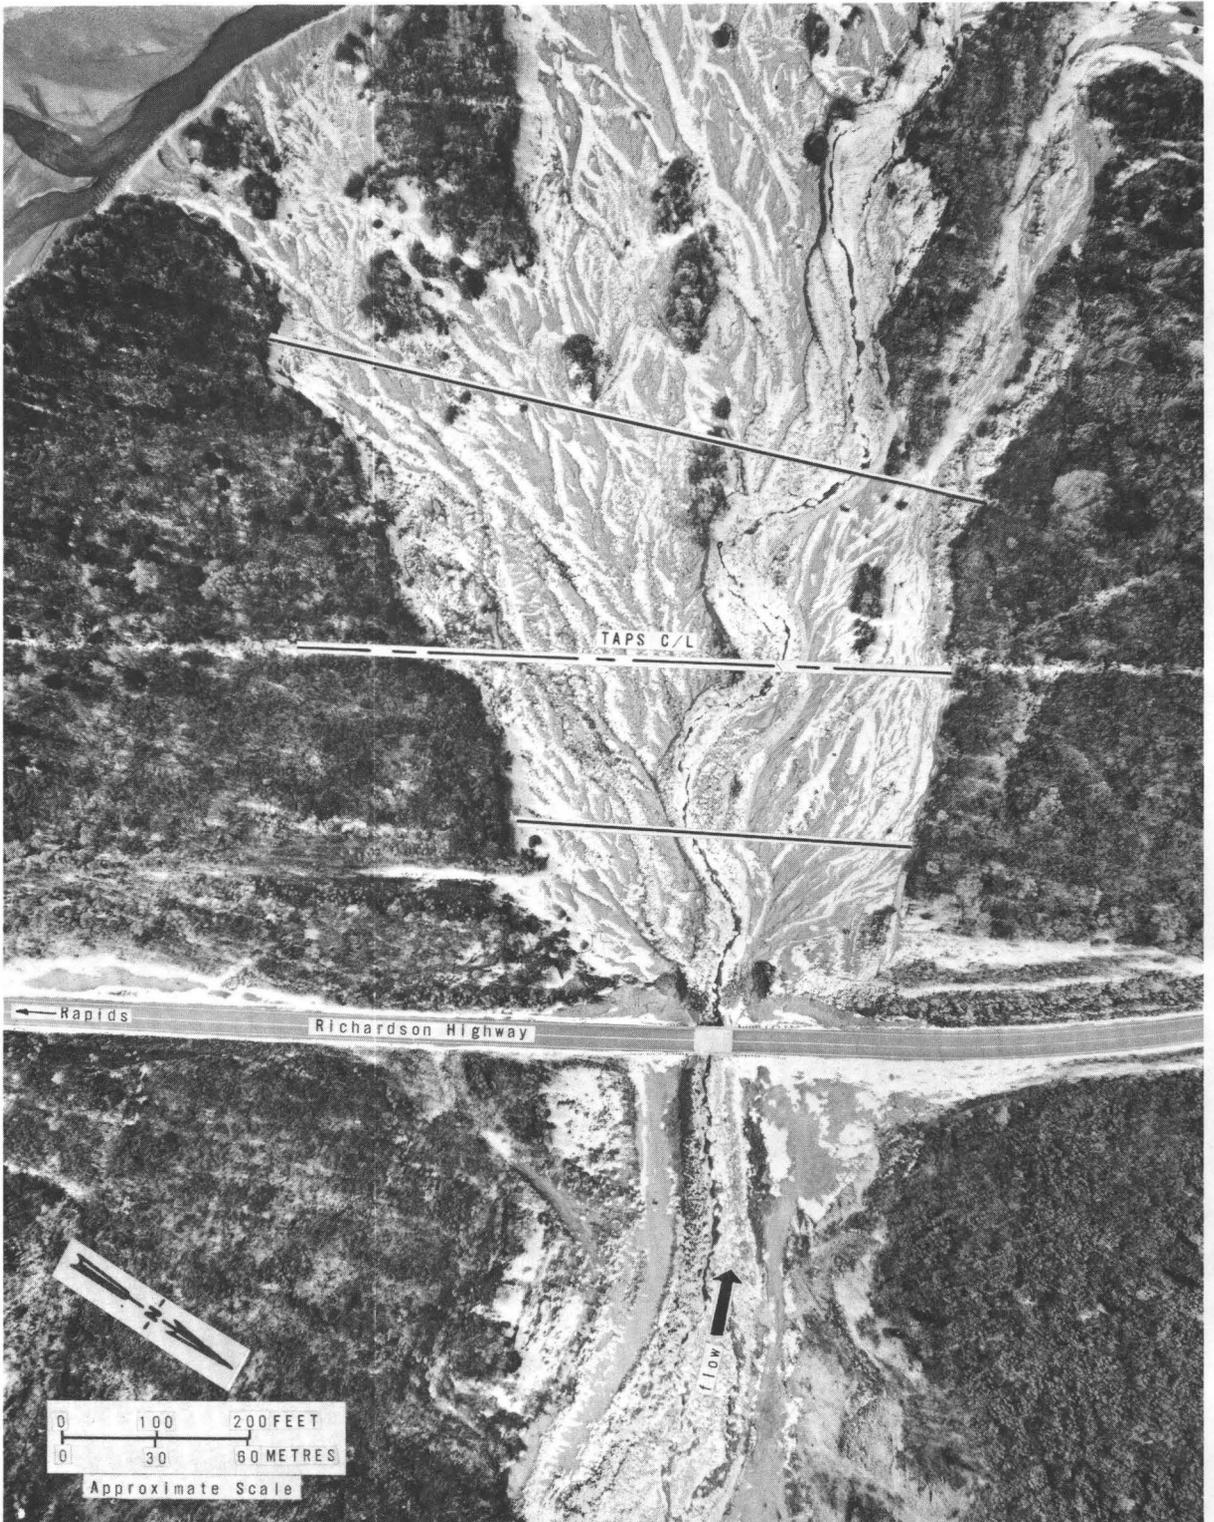
Figure 51. -- Flood Creek near Rapids, September 23, 1972.
NORTH PACIFIC AERIAL SURVEYS

Channel conditions.--Low-altitude vertical aerial stereophotography (scale 1:2,400) was obtained September 23, 1972, (fig. 51) to document preconstruction topography at the site. Vertical aerial strip photography (scale 1:6,000) taken August 31, 1974, (fig. 52) shows no significant channel erosion or construction activities have occurred in the crossing reach since September 23, 1972. Three cross sections (fig. 53) were surveyed in September 1972 to define preconstruction ground profiles in the crossing reach. In September 1974 a channel survey of the three cross sections found no significant lateral erosion.

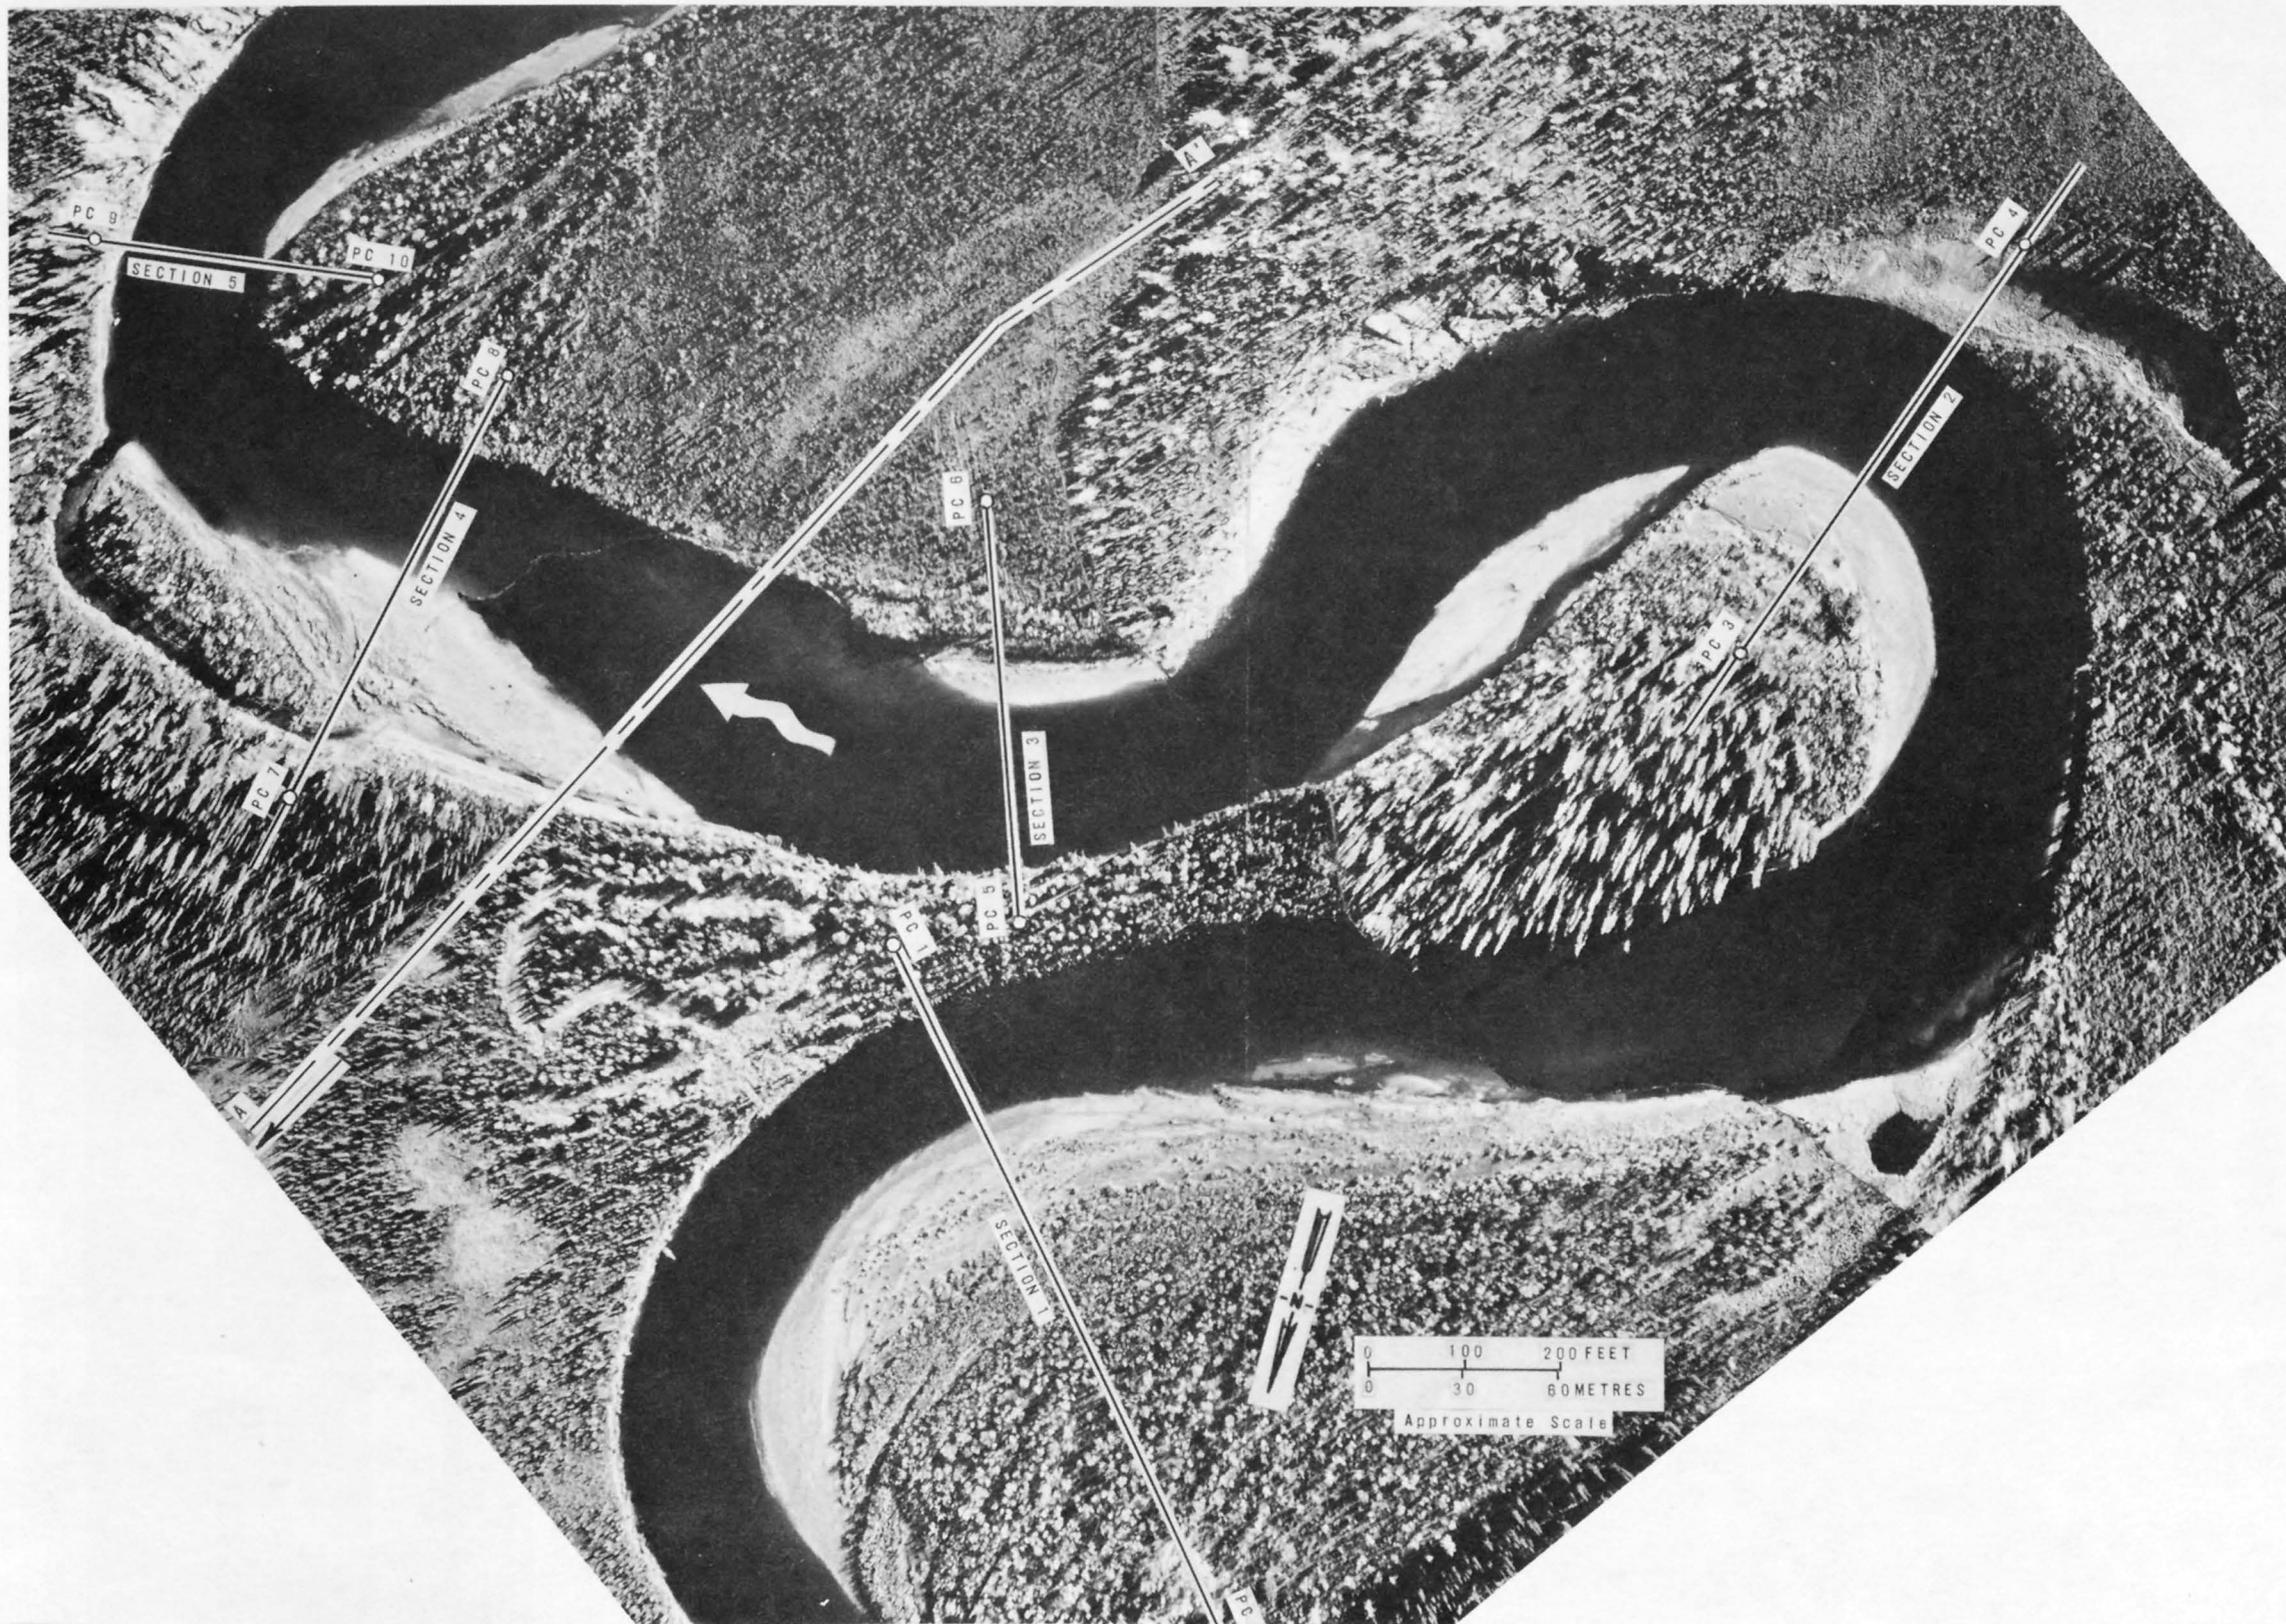
Figure 54. -- Gulkana River near Sourdough, September 23, 1972. NORTH PACIFIC AERIAL SURVEYS

Channel conditions.--Low-altitude vertical aerial stereophotography (scale 1:2,400) was obtained September 23, 1972, (fig. 54) to document preconstruction topography at the site. Vertical aerial strip photography (scale 1:6,000) taken August 31, 1974, (fig. 55) shows no significant channel erosion or construction activities have occurred in the crossing reach since September 23, 1972. Six cross sections (fig. 56) were surveyed May 15, 1973, to define preconstruction ground profiles in the crossing reach. On May 23, 1974, a channel erosion survey was made at a stream-flow discharge of 6,430 ft³/s (182 m³/s), gage height, 6.72 ft (205 m) at gaging station just downstream from Sourdough Creek, to determine maximum streambed scour at the cross sections.

The survey found 15 ft (5 m) of lateral bank erosion along the right bank of section 4 and along the left bank of section 5. Two feet (0.6 m) of scour was measured.

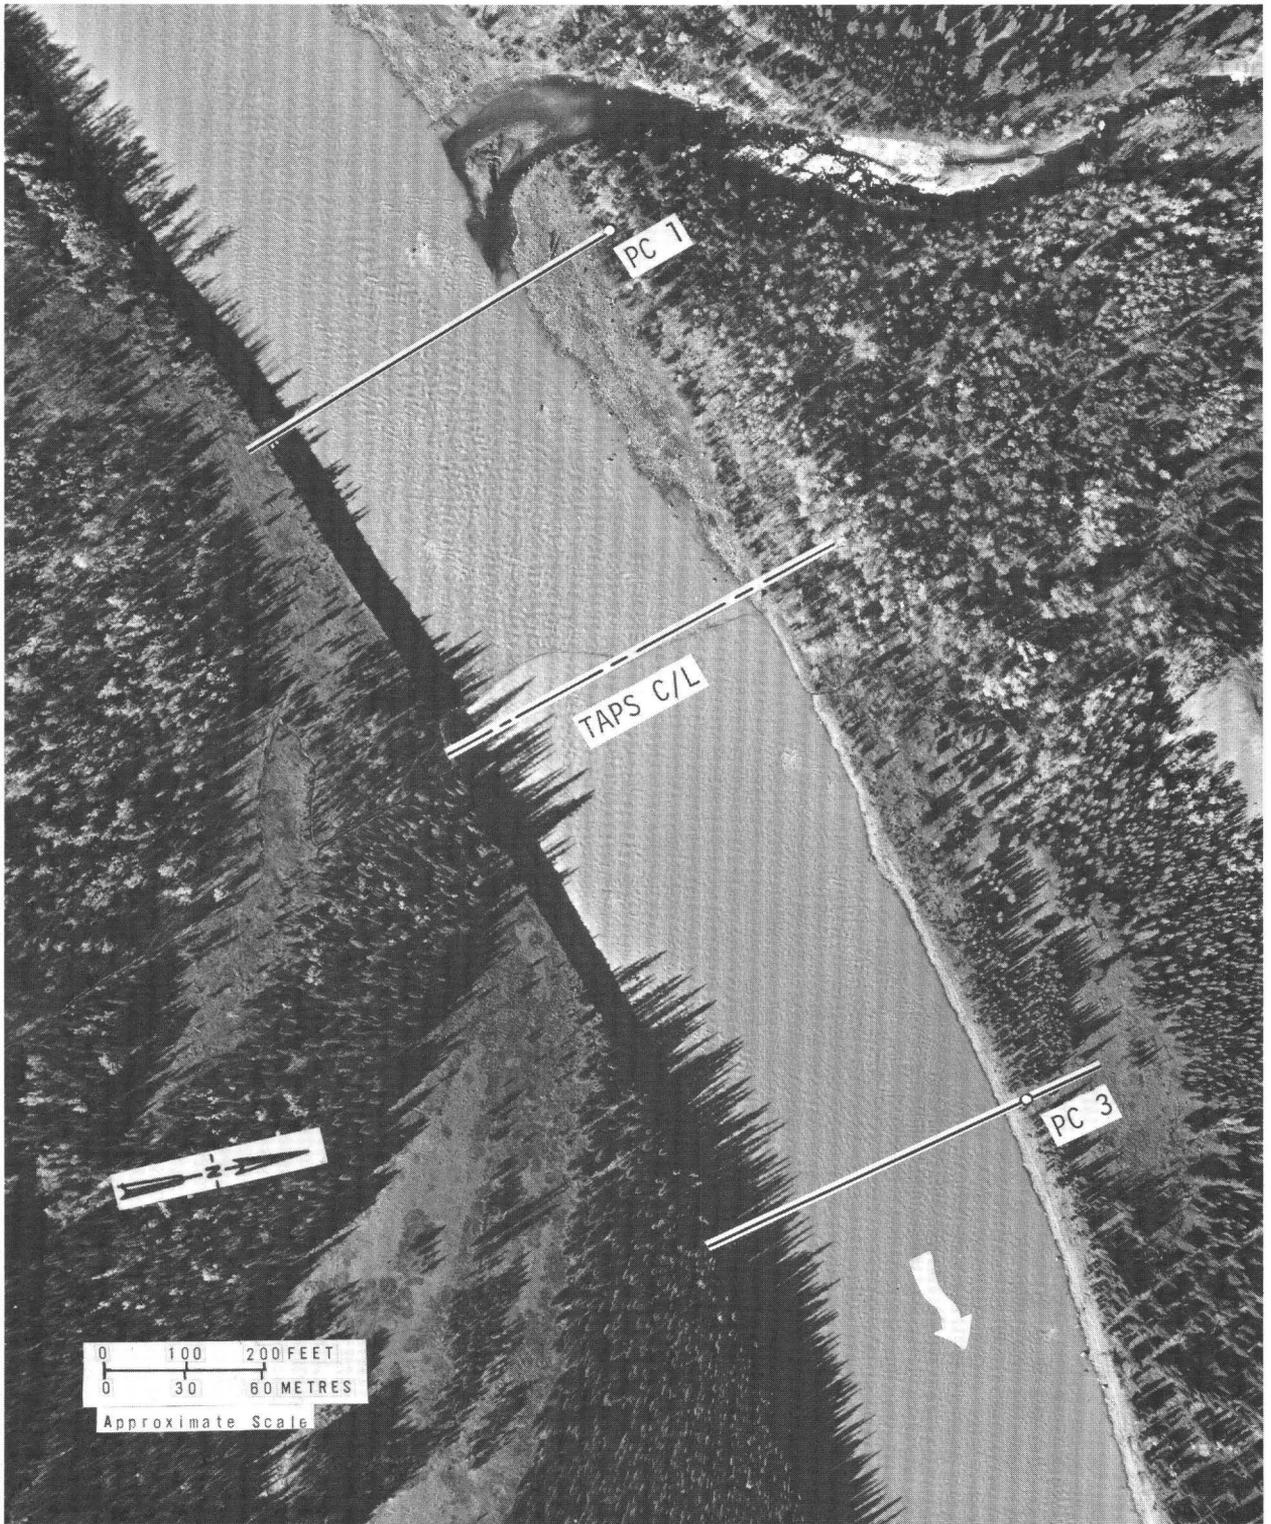
Figure 58. -- Tazlina River near Glennallen, September 23, 1972.
NORTH PACIFIC AERIAL SURVEYS

Channel conditions.--Low-altitude vertical aerial stereophotography (scale 1:2,400) was obtained September 23, 1972, (fig. 58) to document preconstruction topography of the site. Vertical aerial strip photography (scale 1:6,000) taken August 31, 1974, (fig. 59) shows no significant channel erosion or construction activities have occurred in the proposed crossing reach since September 23, 1972. Three cross sections (fig. 60) were surveyed September 22, 1973, to define preconstruction ground profiles in the crossing reach. On September 18, 1974, a channel survey of the original cross sections following the flood of August 15, 1974, shows 1 ft (0.3 m) of general scour in the crossing reach. There were no construction activities at the crossing.

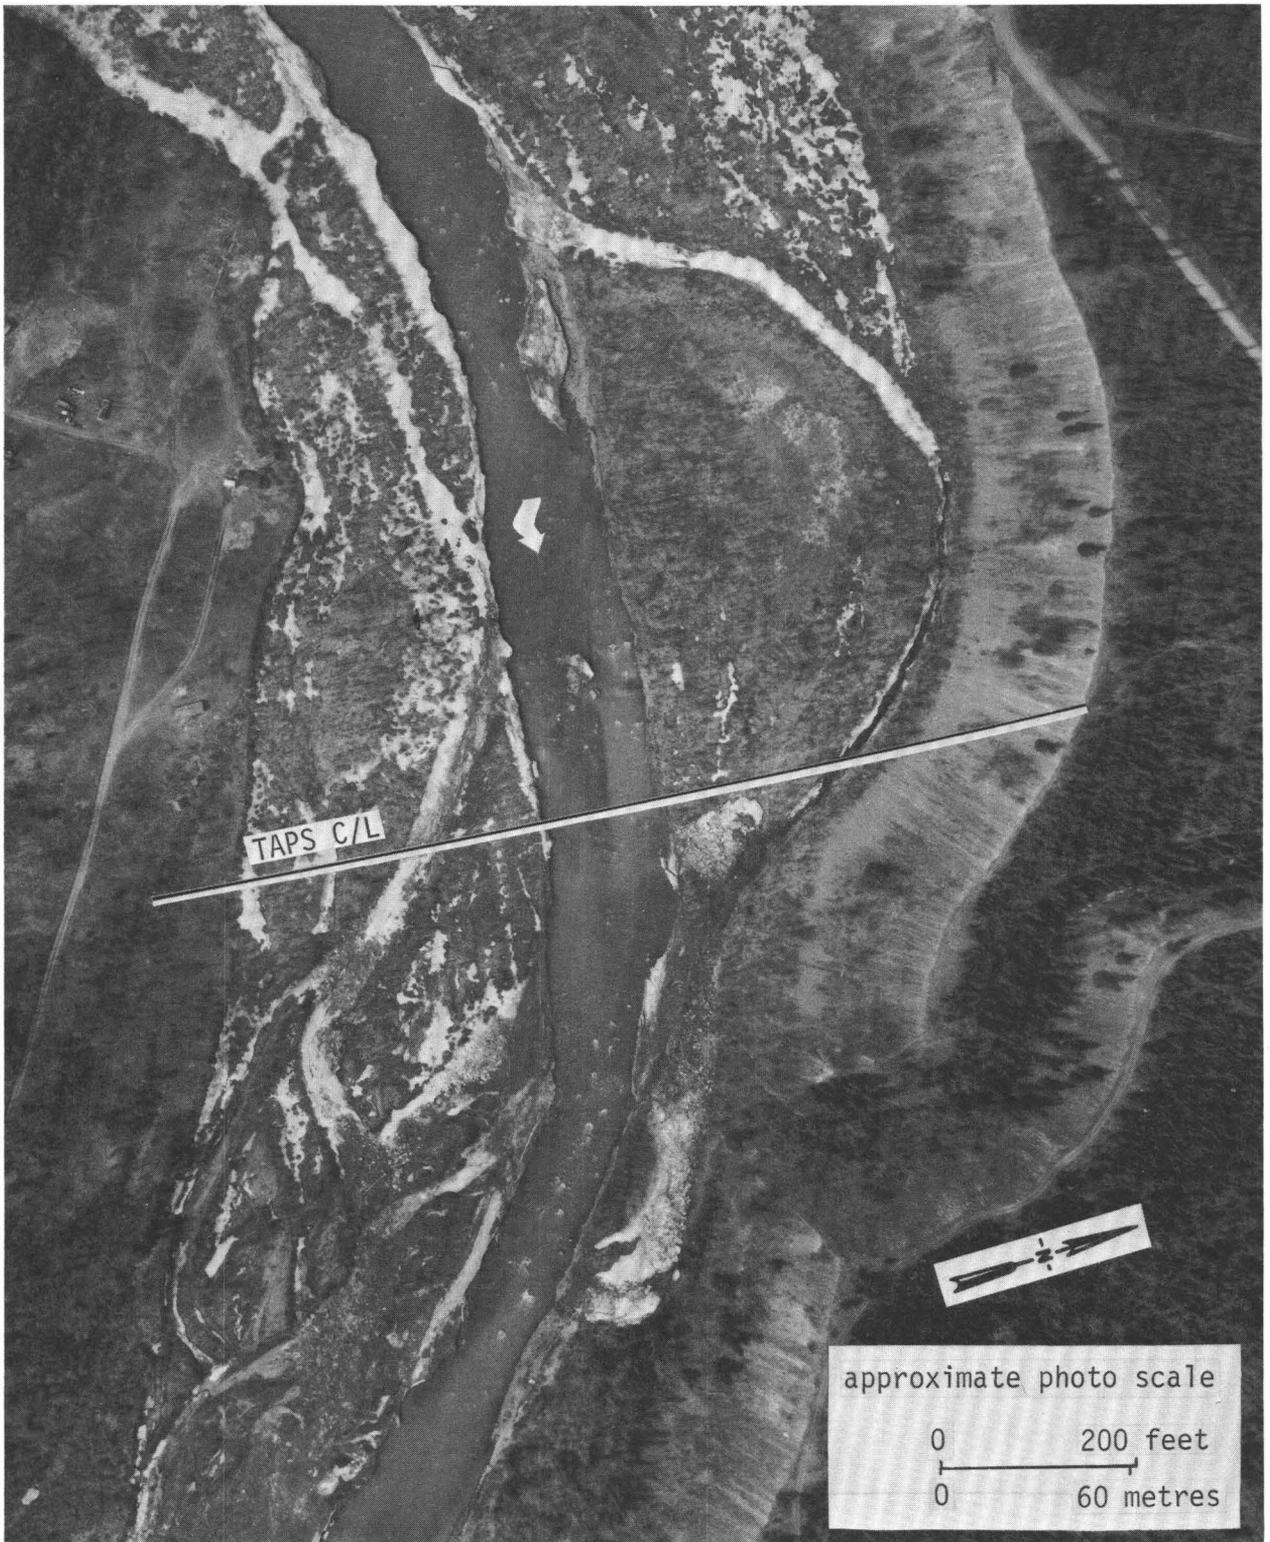
Figure 64. -- Klutina River near Copper Center, May 22, 1973.
ALYESKA PIPELINE SERVICE CO.-AIR PHOTO TECH.

Channel conditions.--Low-altitude vertical aerial stereophotography (scale 1:6,000) was obtained May 22, 1973, (fig. 64) to document preconstruction topography at the site. Vertical aerial strip photography (scale 1:6,000) taken August 31, 1974, (fig. 65) shows no significant channel erosion or construction activities have occurred in the crossing reach since May 22, 1973. The TAPS centerline section surveyed by Alyeska Pipeline Service Company on August 14, 1970, is shown in figure 66.
