# COASTAL FLOOD OF FEBRUARY 7, 1978 IN MAINE, MASSACHUSETTS, AND NEW HAMPSHIRE

WATER - RESOURCES INVESTIGATIONS 79-61

By Russell A. Gadoury

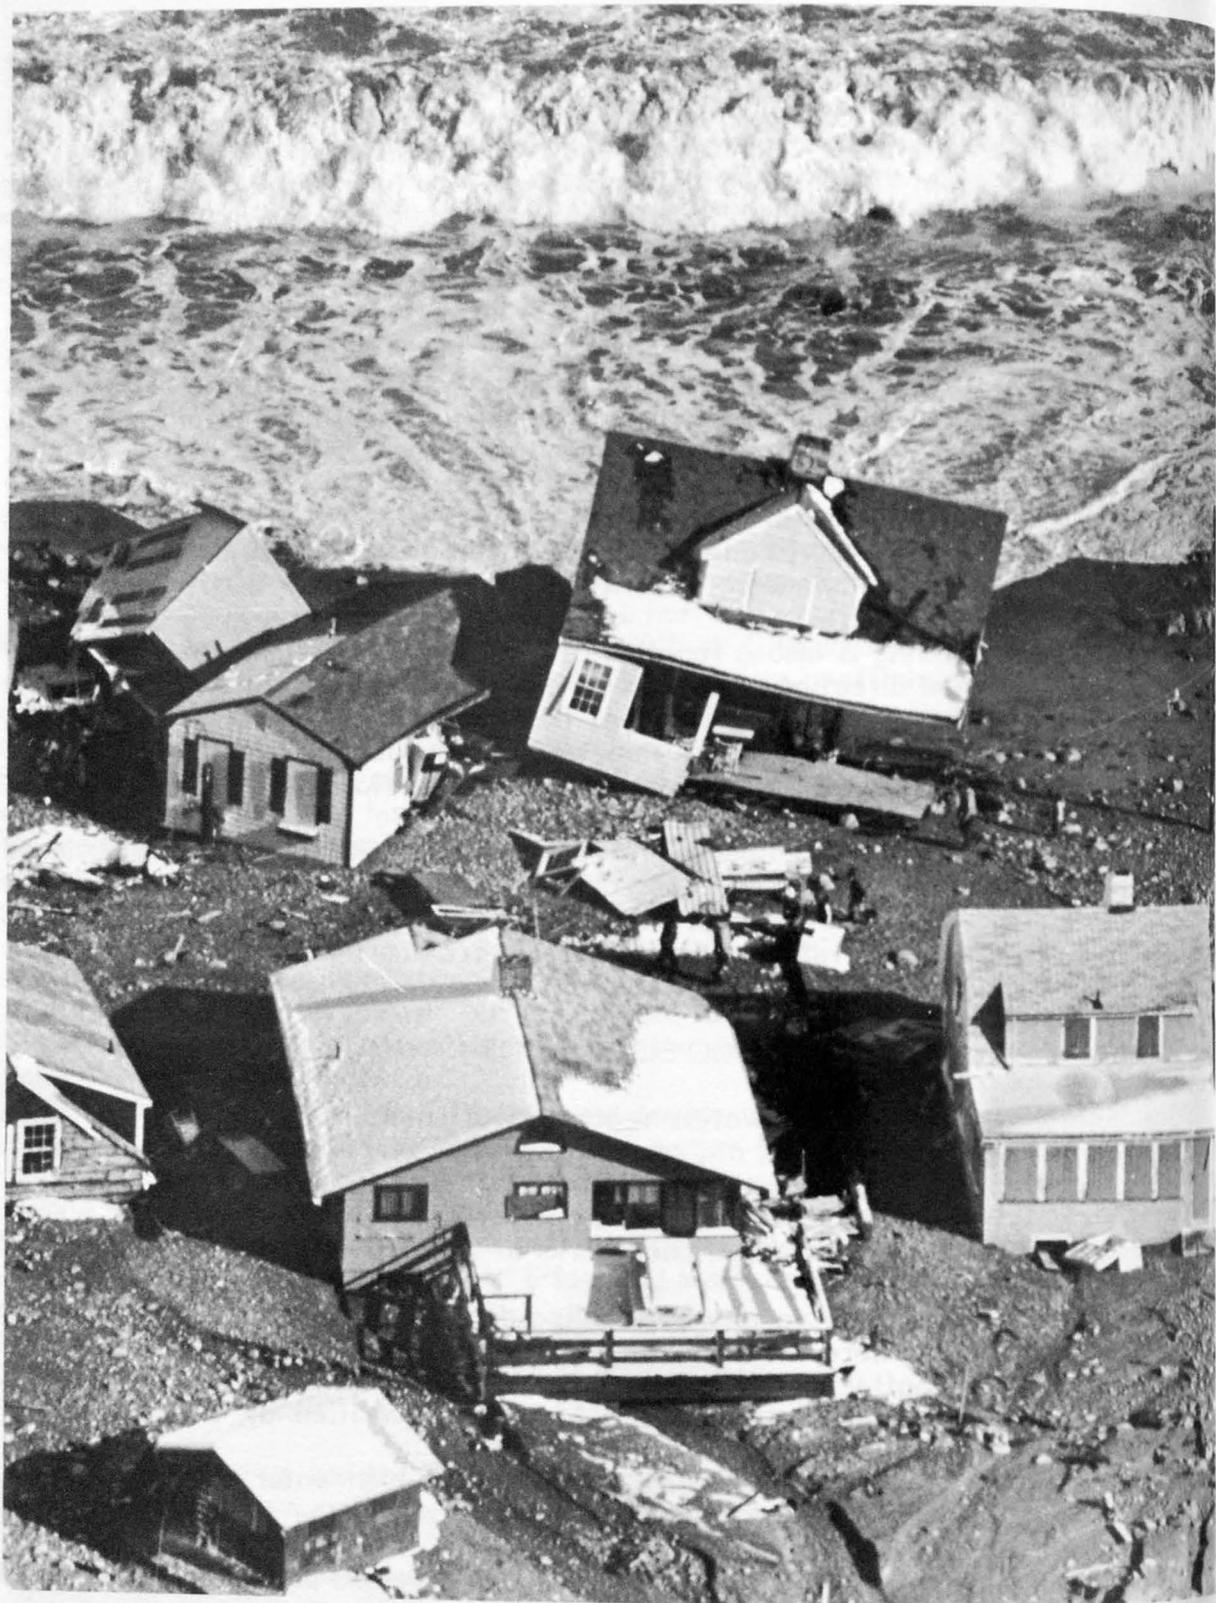
Figure 1.--Waves reduced these houses along the Scituate-Marshfield, Mass., shoreline to tangled wreckage (photograph by Kevin Cole, Boston Herald American)

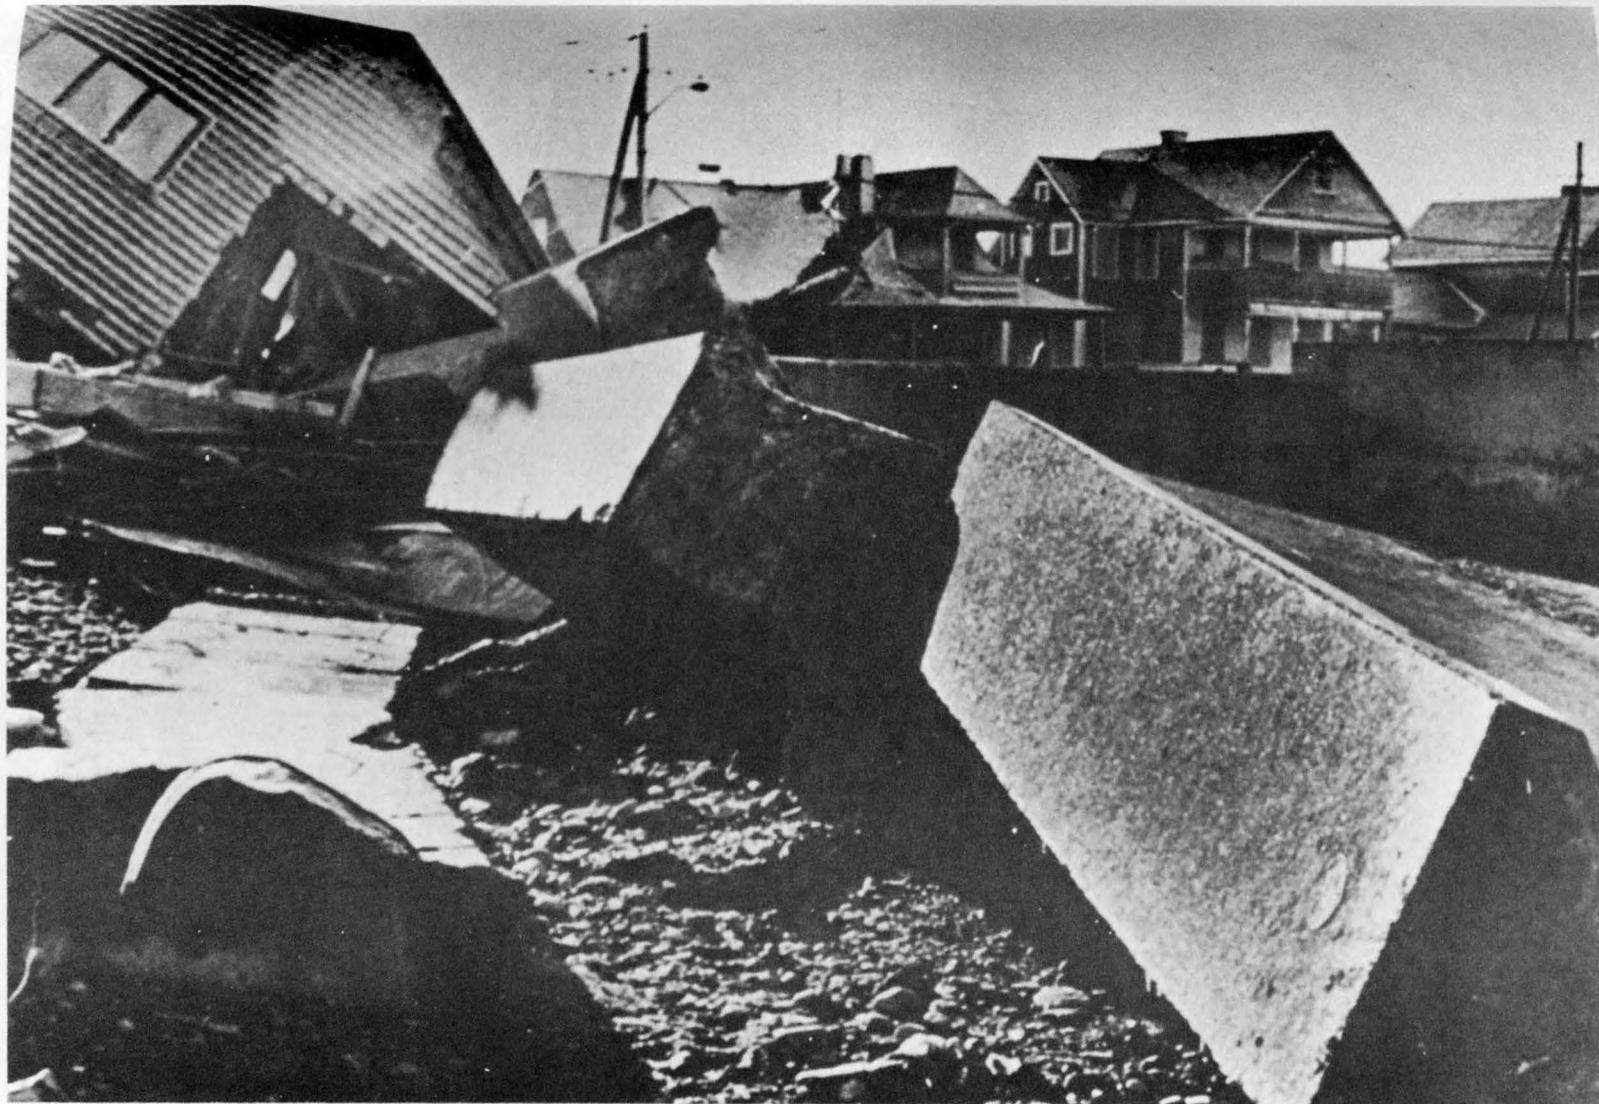
Figure 2.--Portions of the North Scituate Beach seawall in Massachusetts were destroyed by pounding surf (photograph courtesy of The Boston Globe)

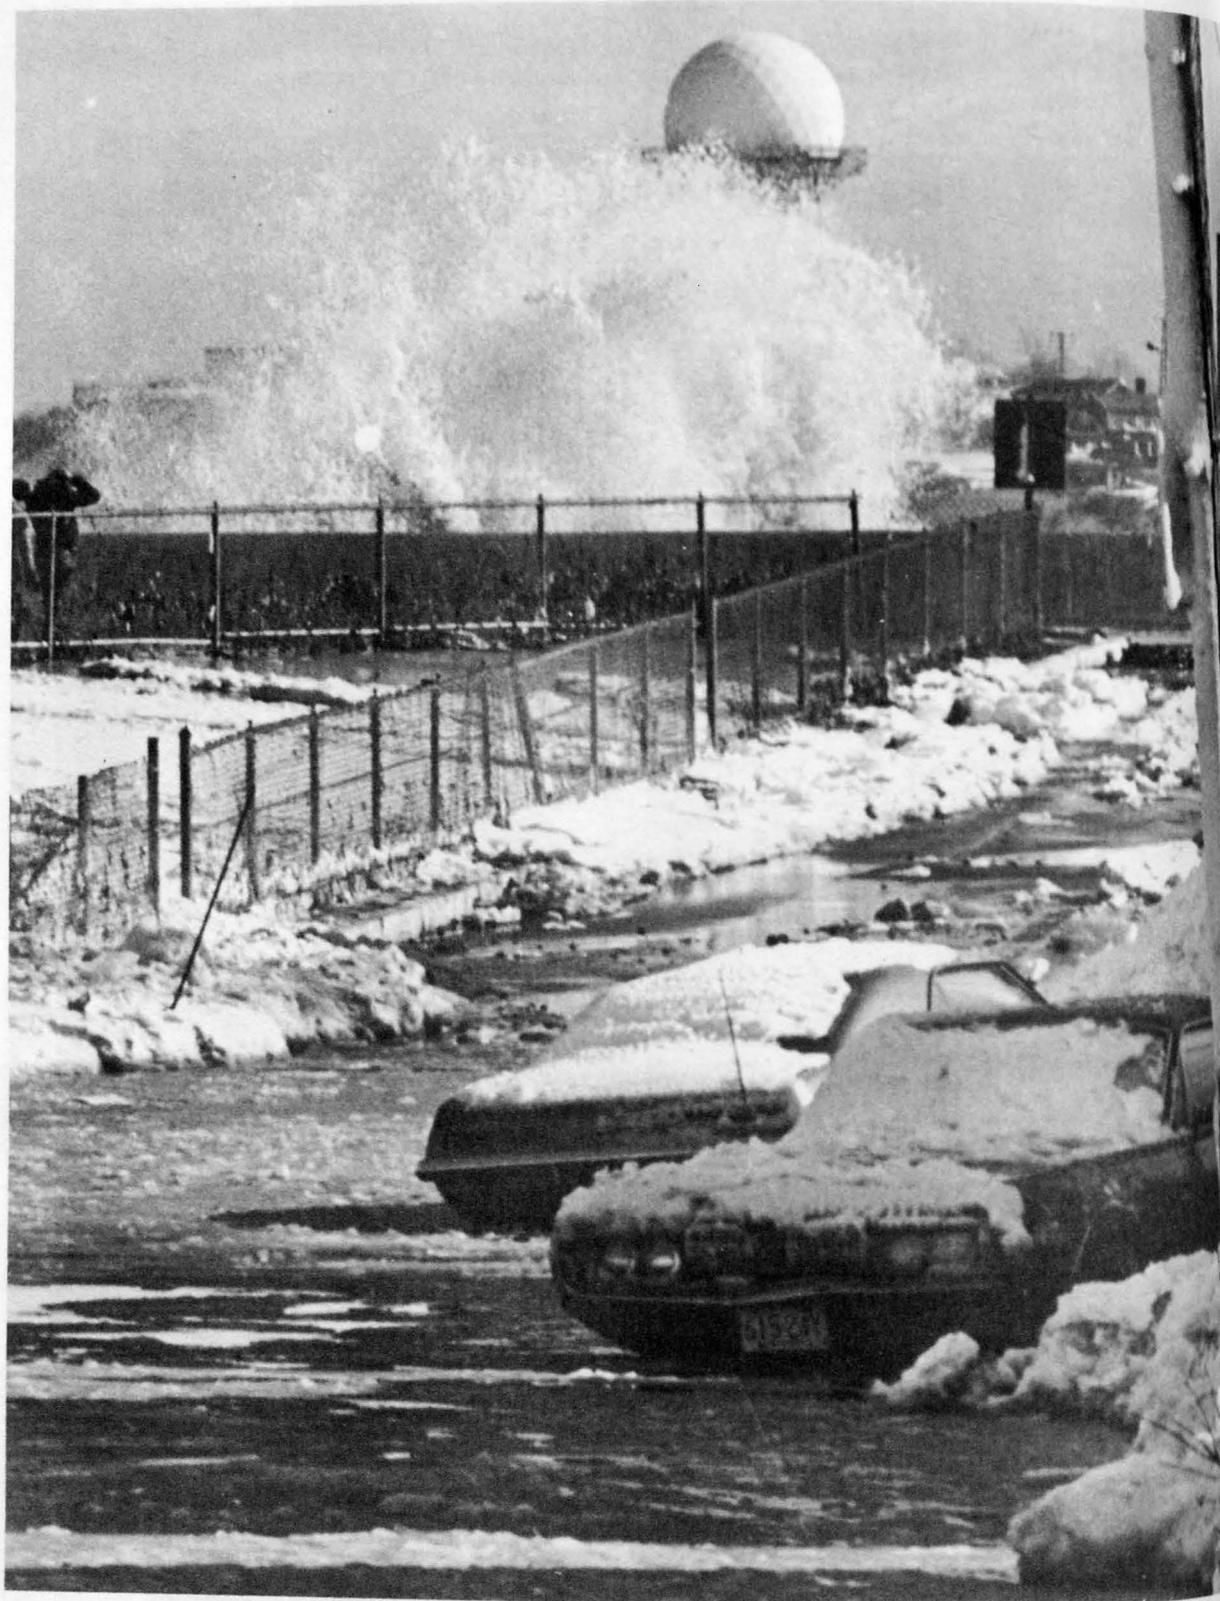
Figure 3.--Water from waves overtopping the seawall runs down Leverett Avenue in Revere, Mass. (photograph courtesy of The Boston Globe)

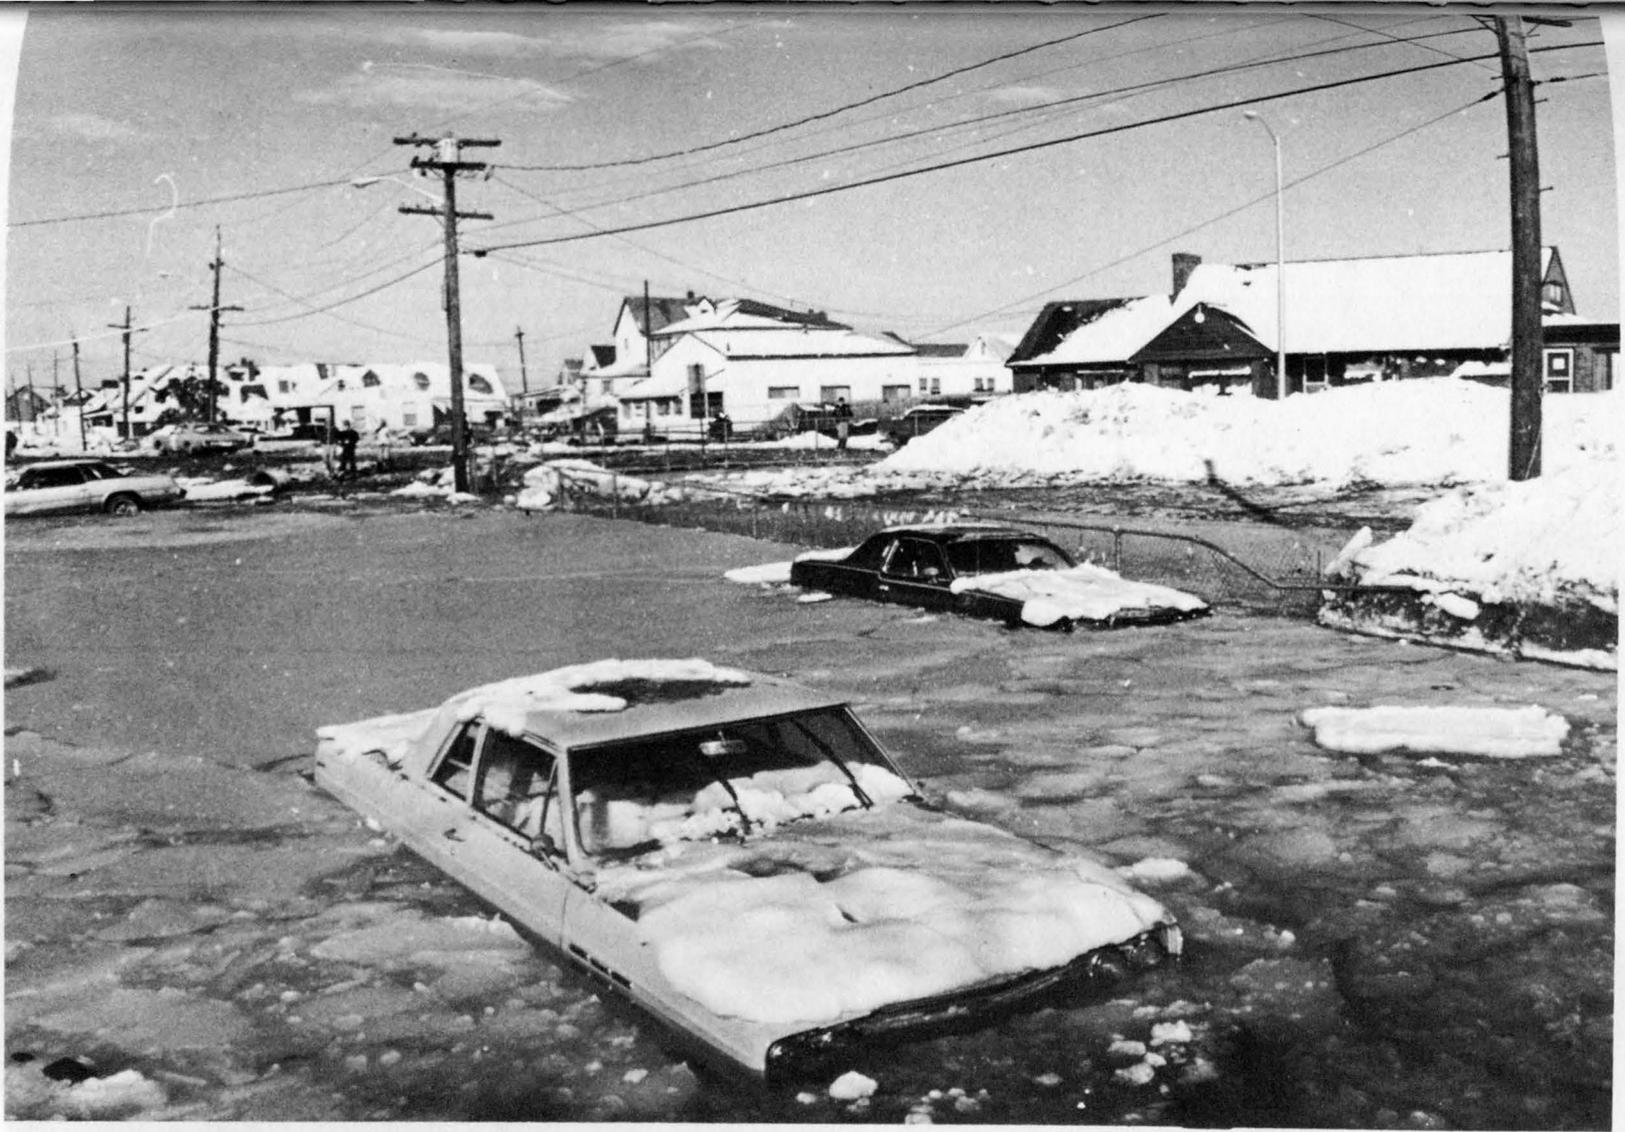
Figure 4.--Winthrop Drive, in the Beachmont section of Revere, Mass., was flooded by waves and tidal surge that overflowed the seawall (photograph courtesy of The Boston Globe)

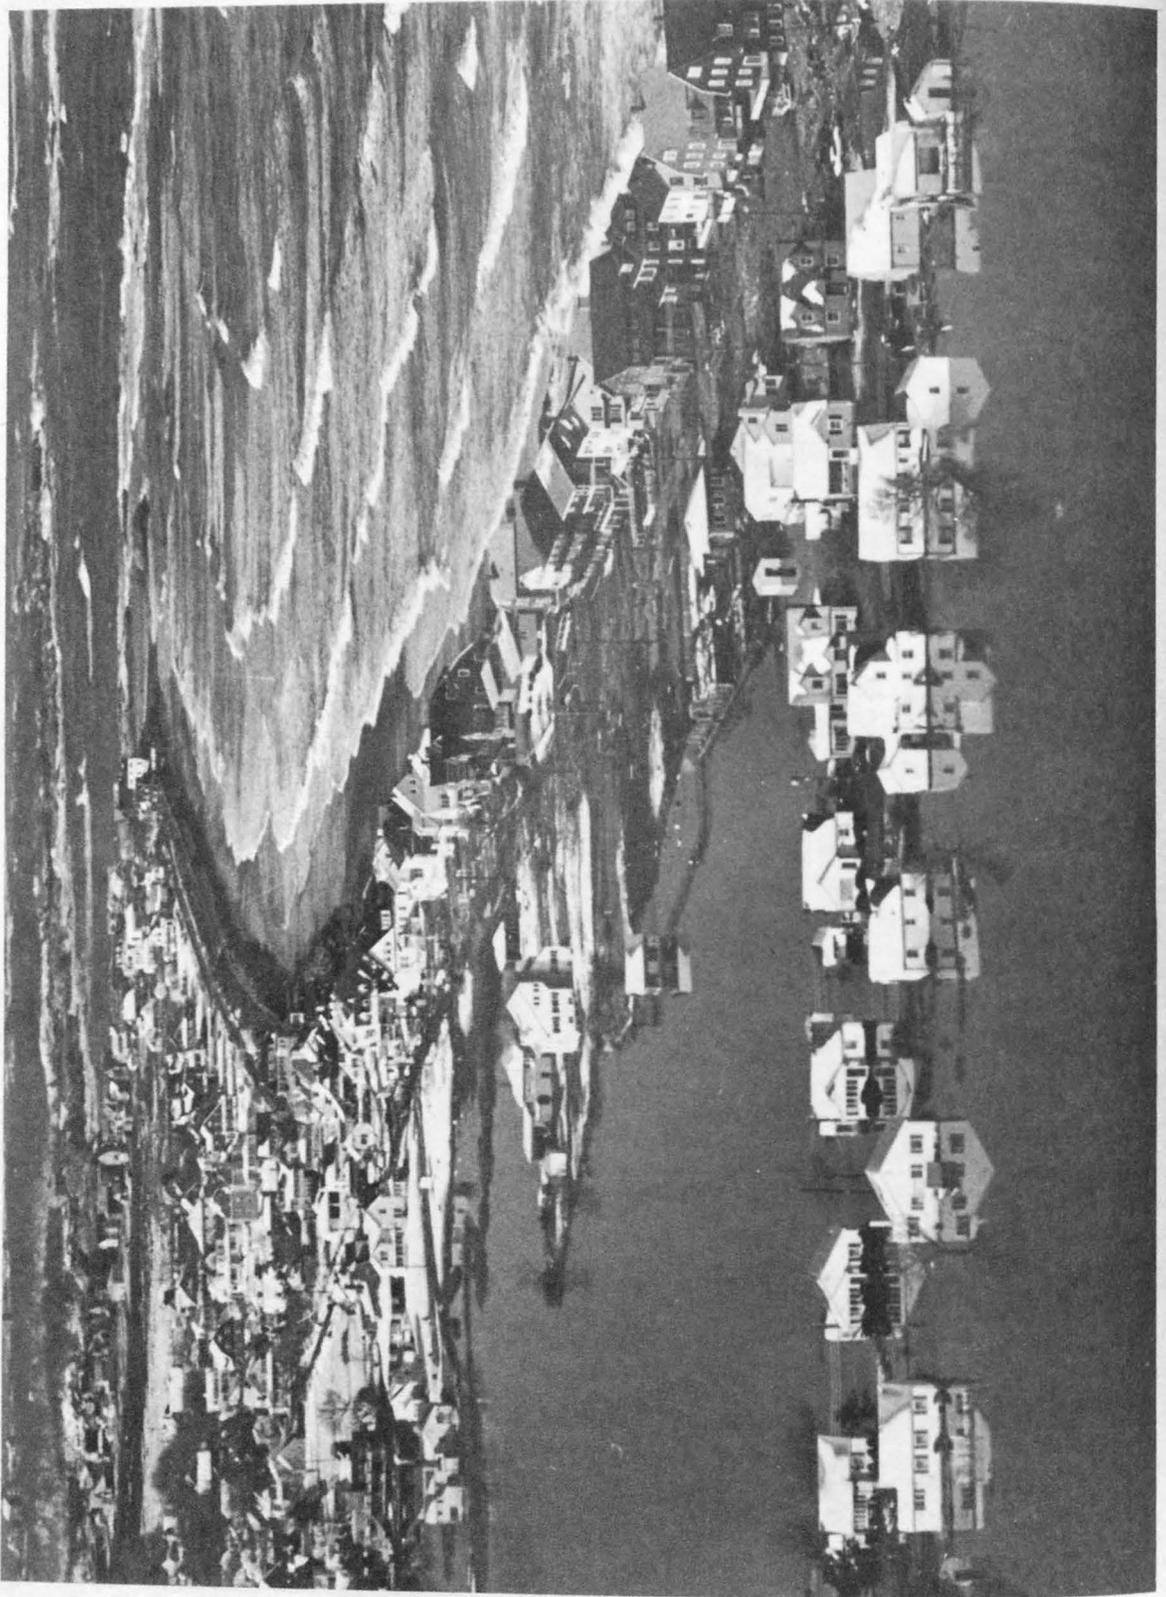
Figure 5.—Floodwaters overtopped the seawall and rock barrier in North Scituate, Mass., and raised the level of Musquashcut Pond, resulting in inundation of homes along Seagate Circle in foreground (photograph by Kevin Cole, Boston Herald American)

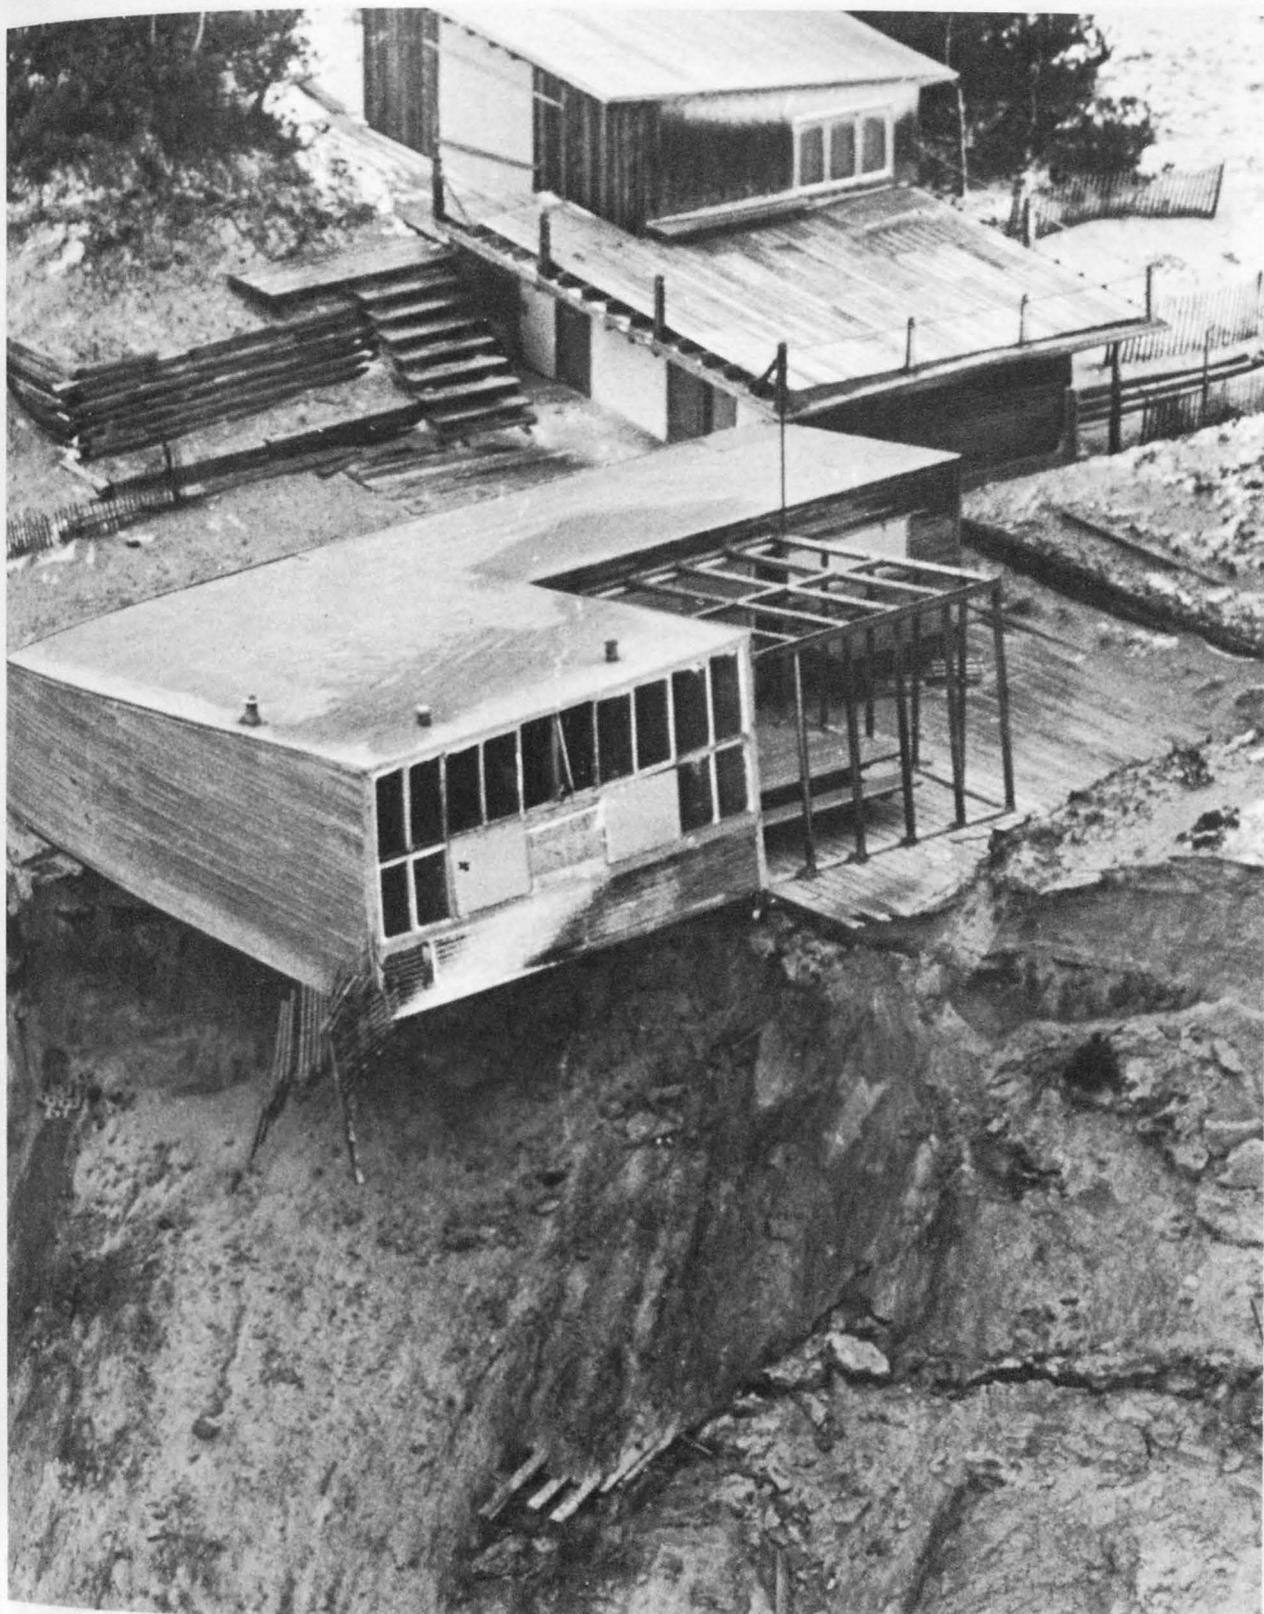
Damage in areas not protected by seawalls, dikes, or dunes can be caused by plunging waves and wave bores at normally unaffected elevations. Once a wave has broken, the onshore rush of water, called a bore, will continue up the beach. Waves may overwash natural protective barriers. Erosion of the barriers may destroy, or render unsafe, structures thereon (fig. 6).

Figure 6.—Dunes on Cape Cod in Brewster, Mass., were eroded by the storm. The foreground structure suffered severe damage. The home in the background is not necessarily safe because the dune slope has not yet stabilized  
(photograph by Kevin Cole, Boston Herald American)

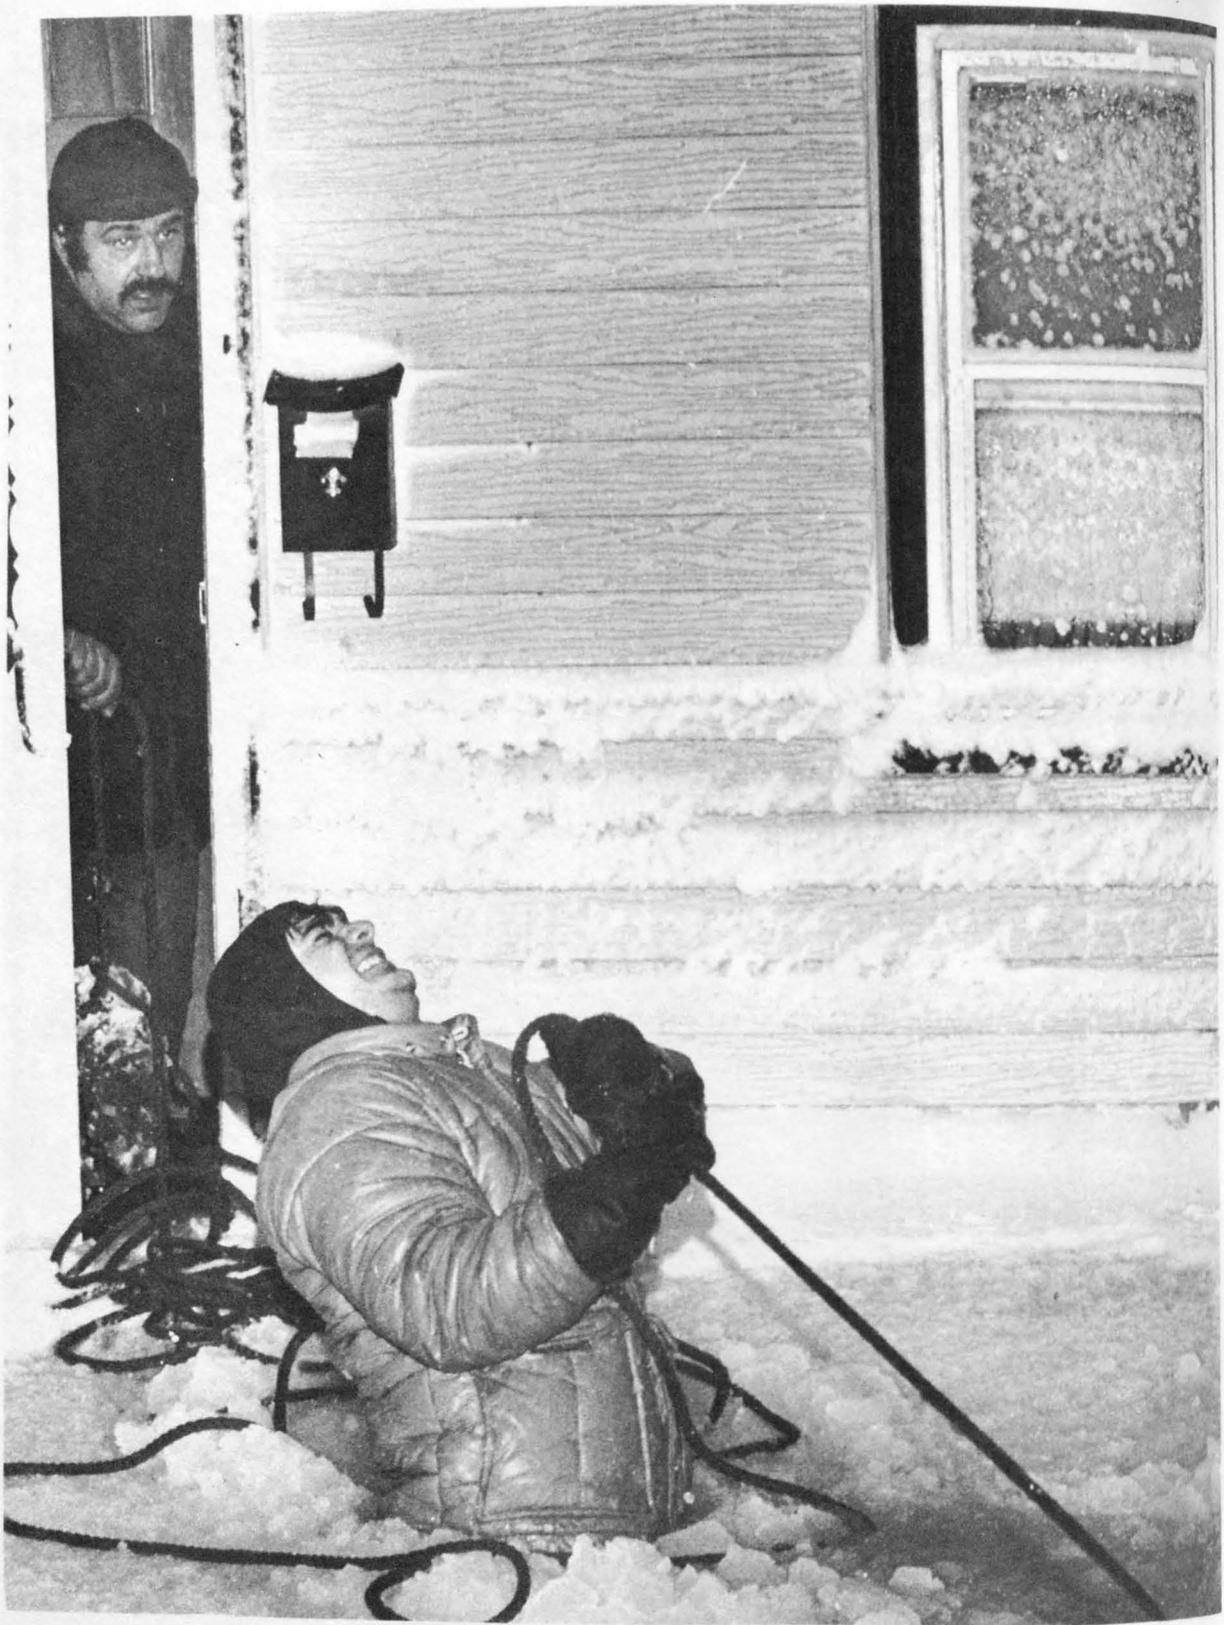
The highest levels that floodwaters reach can often be detected from evidence such as a line of debris, trash, salt, oil, or snow (fig. 7). Determination of the elevation of these marks can readily be made by spirit-leveling from points of known elevation. Most floodmarks given herein were identified by personnel of the U.S. Geological Survey during the week after the flood. Additional marks in selected estuaries were identified the following week.

Figure 7.--Rescue worker struggles to haul evacuation boat to the front door of this home in Revere, Mass. Note the excellent high-water mark just above the window sill level (photograph by Paul Benoit, Boston Herald American)

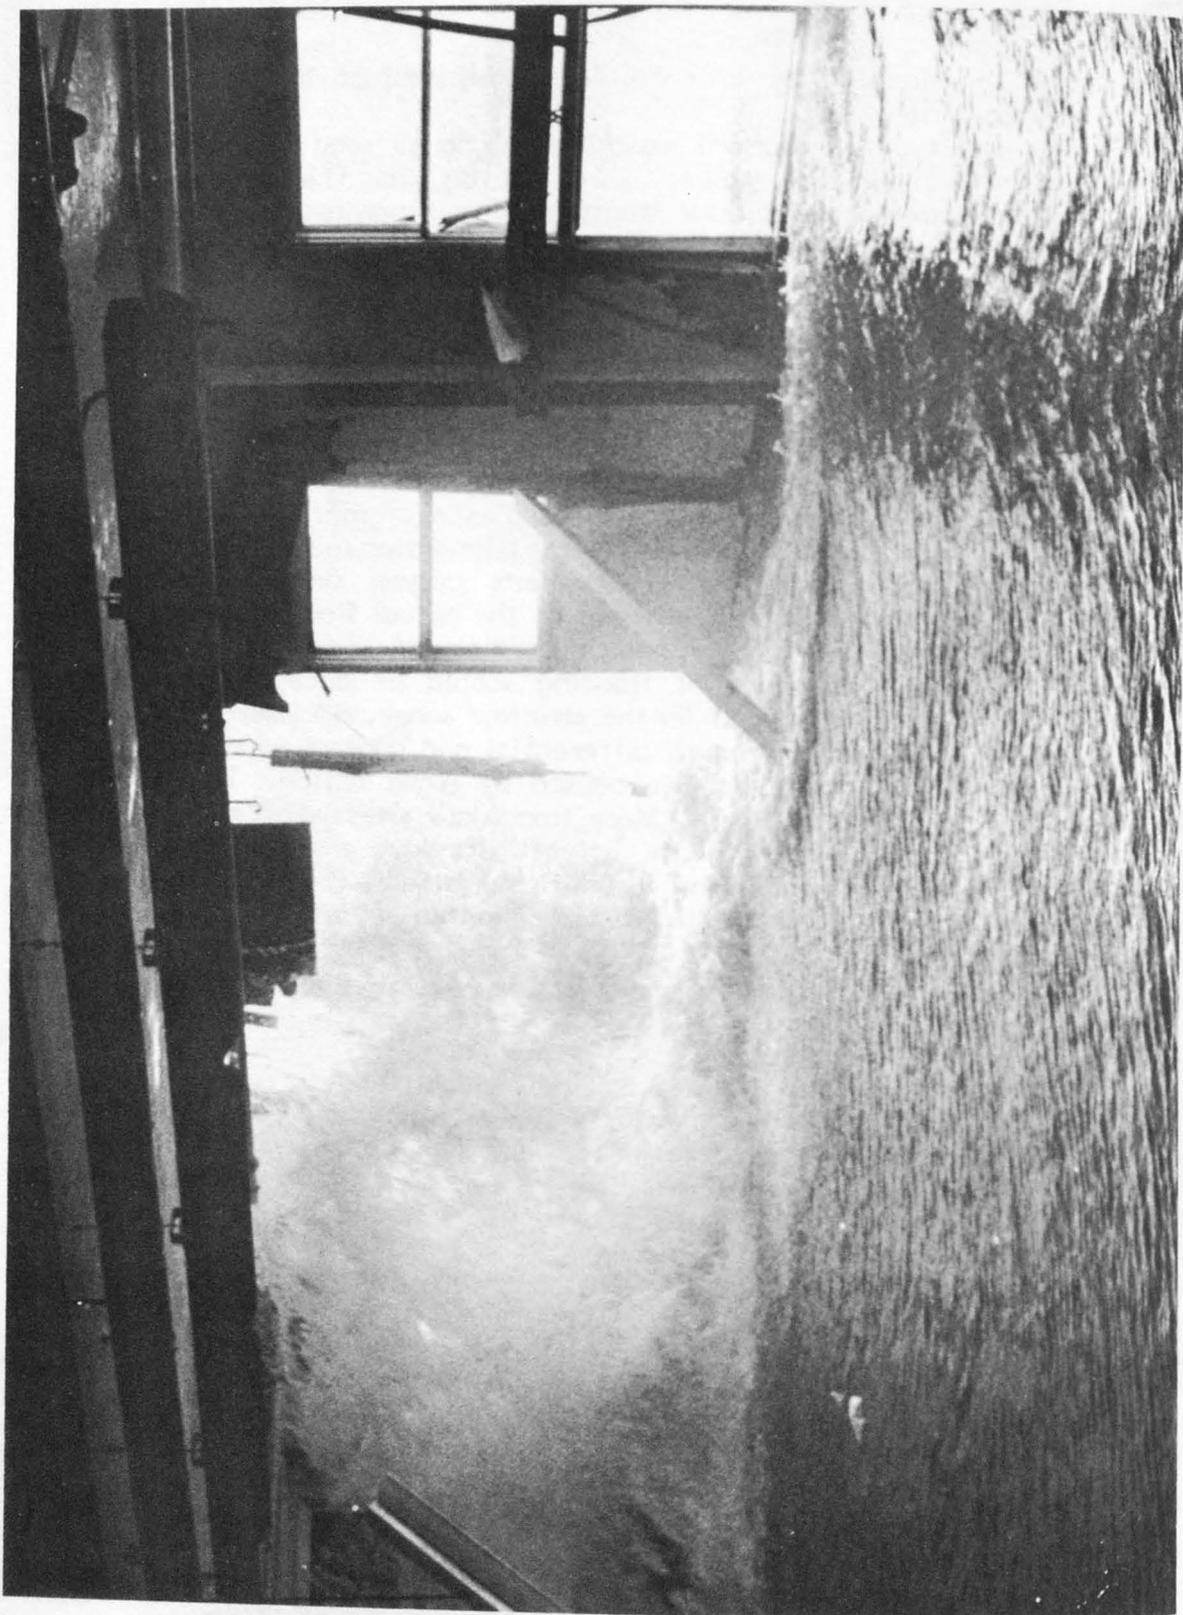
Figure 8.—Water pours through Ted Hood's sail loft in Marblehead, Mass. Waves were violent outside the building, but excellent stillwater elevations could be obtained inside the building.
