DEBRIS FLOW HAZARD ASSESSMENT FOR THE OREGON CAVES NATIONAL MONUMENT

U.S. GEOLOGICAL SURVEY
Water Resources Investigations Report 83-4100

Prepared in cooperation with
NATIONAL PARK SERVICE

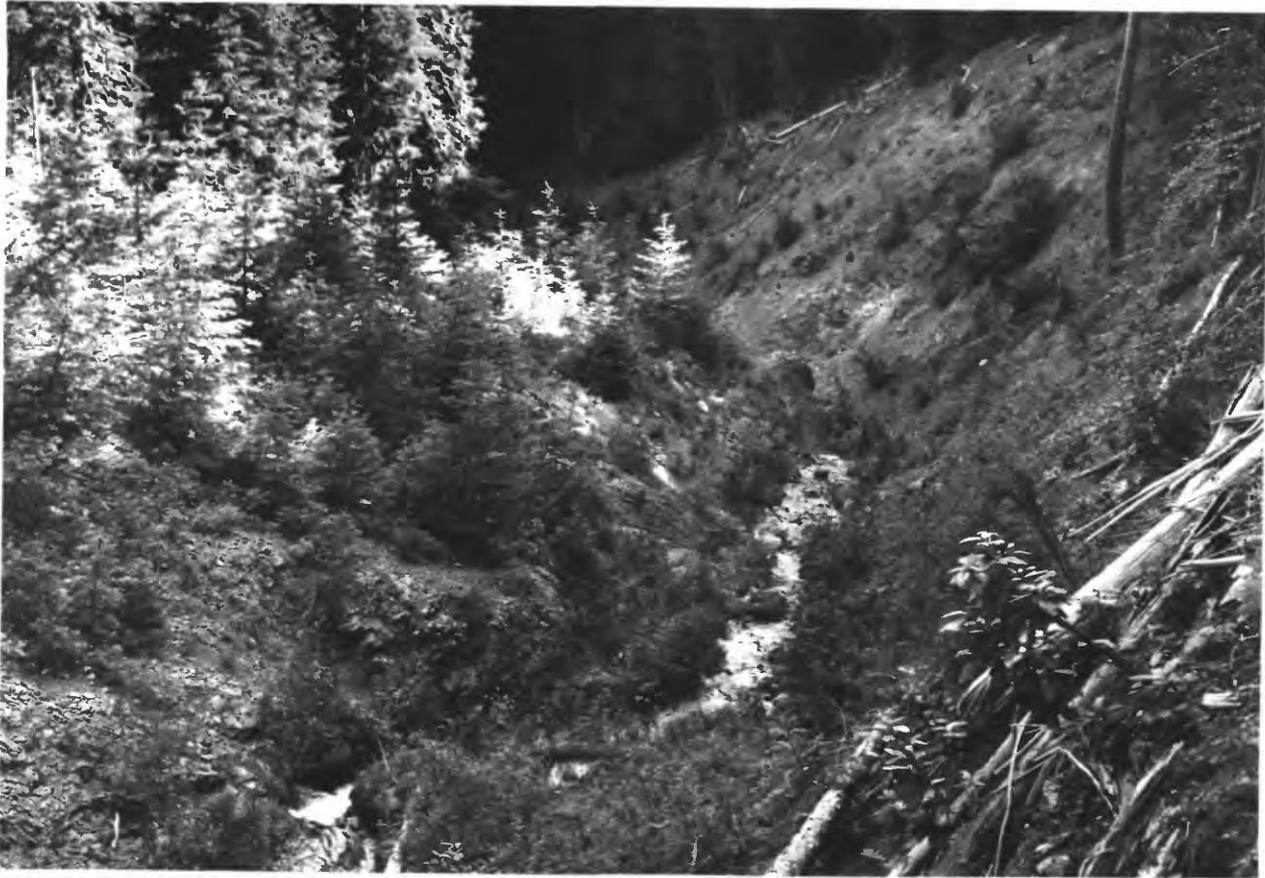
Figure 2. — Debris-flow scar in No Name Creek channel. Streamflow was about 1.5 cubic feet per second when the picture was taken.

The source of the debris flow is evidenced by a scar 130 feet downslope from the highest of three crossings of Lake Mountain Trail on the north-facing slope of the drainage. The zone of depletion is about 250 ft long and 6.0 ft deep near the crown (measured normal to the sloping terrain).

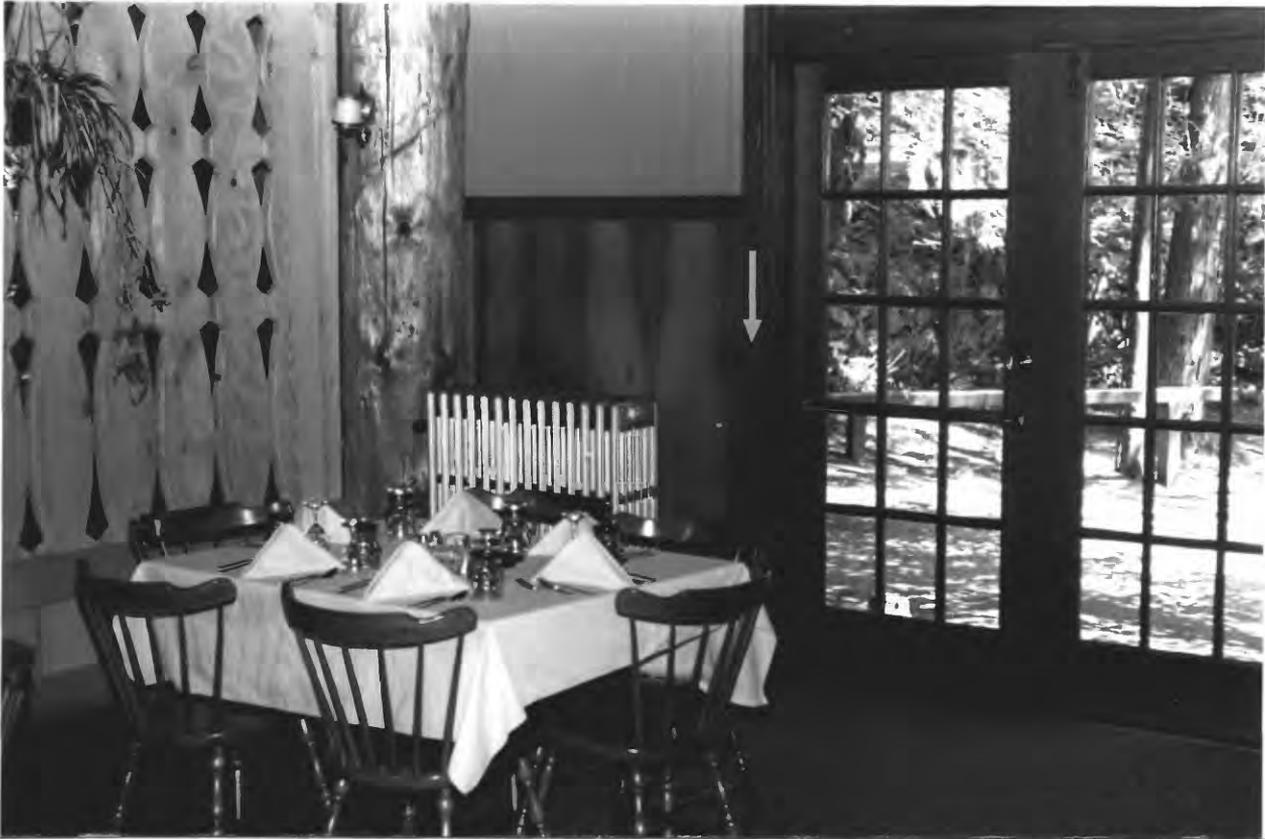
Figure 3. — Mud line in dining-room on third floor. Point of arrow is 54 inches above the floor.

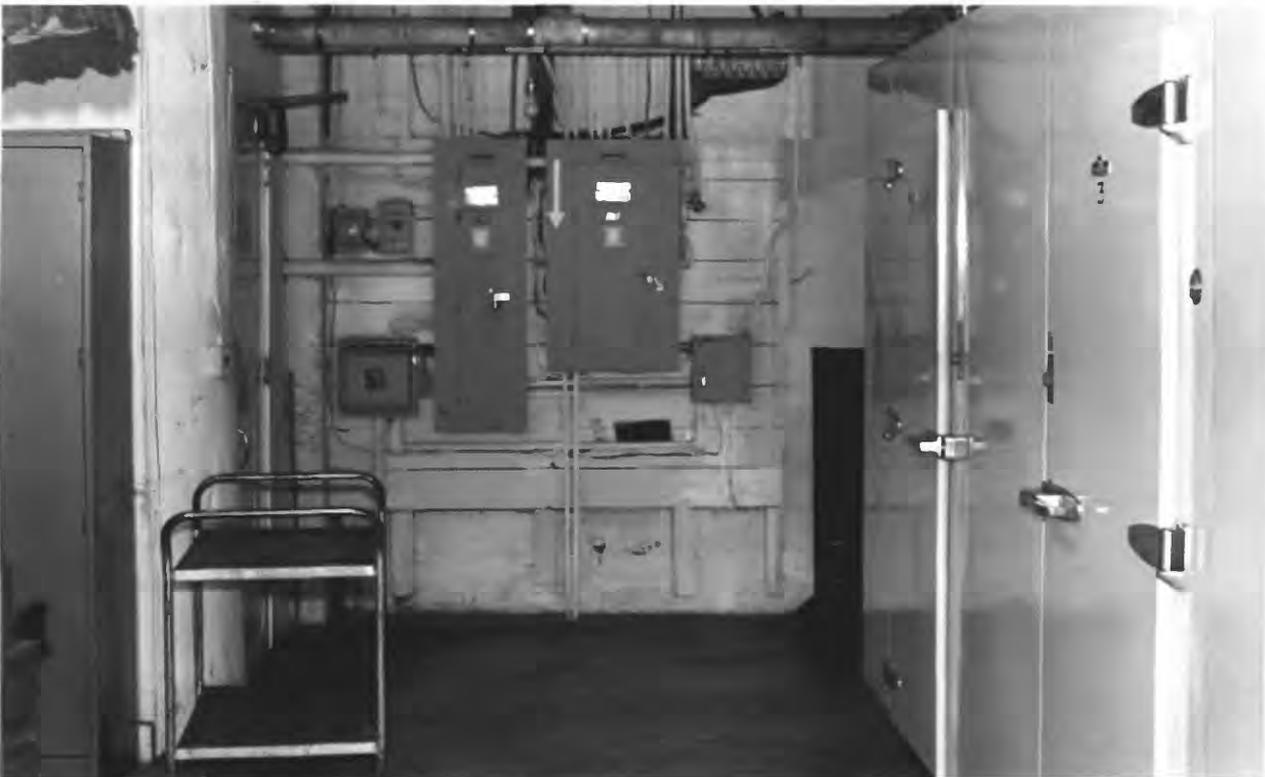
Figure 4. — Mud line in electrical switch box on second floor. Point of arrow is 67 inches above the floor.

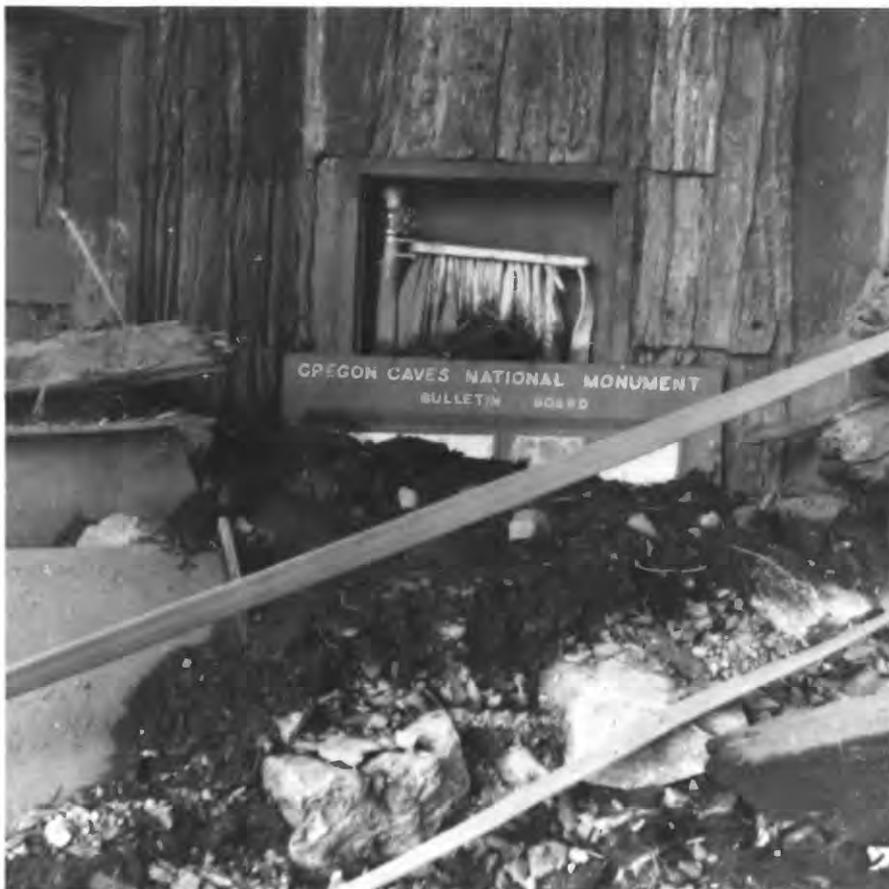
An estimated 1,800 yd³ of material was deposited in the area between the chalet and the chateau. The estimate is based on a sketched map of the debris deposit drawn by Warren Johnson (Park Engineer, NPS), photographs of the debris before removal, and the configuration of the terrain surveyed in July 1982. Seventeen trees were extracted from the debris; one was 70 ft long. Figures 5 and 6 show the damage in the breezeway area of the chalet and the deposits of material during cleanup operations. About 5,200 yd³ of material was removed from the area. Damage to NPS facilities, roads, and trails, exceeded \$82,000; restoration of the privately-owned concession cost \$100,000.

Figure 5. — Debris deposit in breezeway at the chalet. Photo courtesy of the NPS, date unknown.

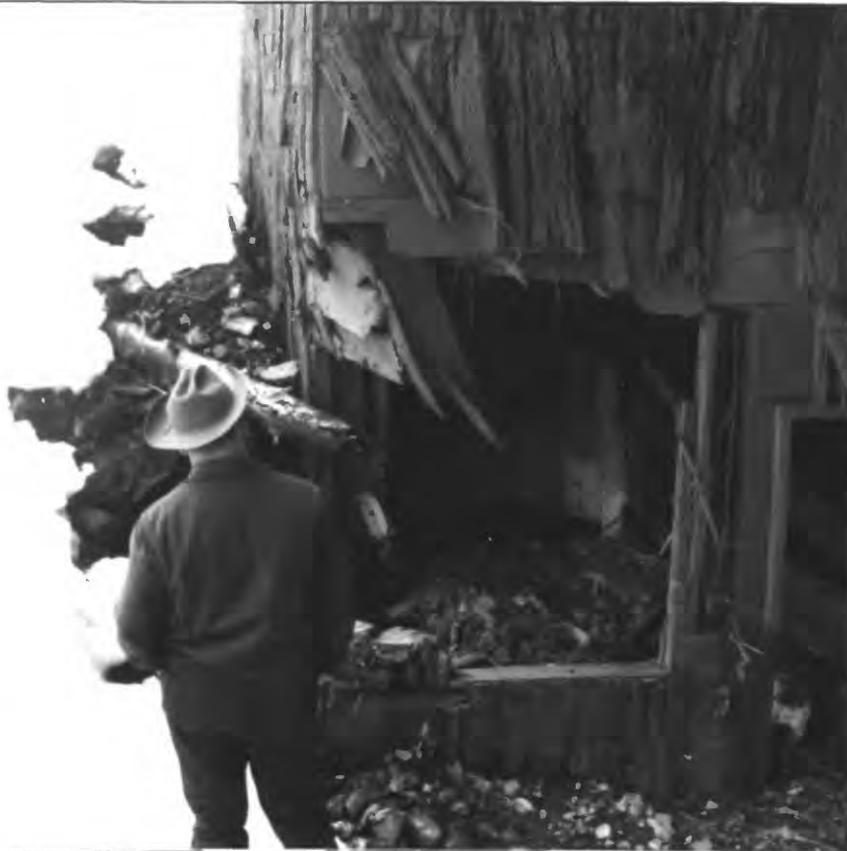
Figure 6. -- Debris damage at the upslope corner of the chalet breezeway.
