EVALUATION OF HYDROLOGIC PROCESSES AFFECTING SOIL MOVEMENT
IN THE HAGERMAN FAUNA AREA, HAGERMAN, IDAHO

By H. W. Young

Water-Resources Investigations Report 84-4137

Prepared in cooperation with the
U.S. BUREAU OF LAND MANAGEMENT

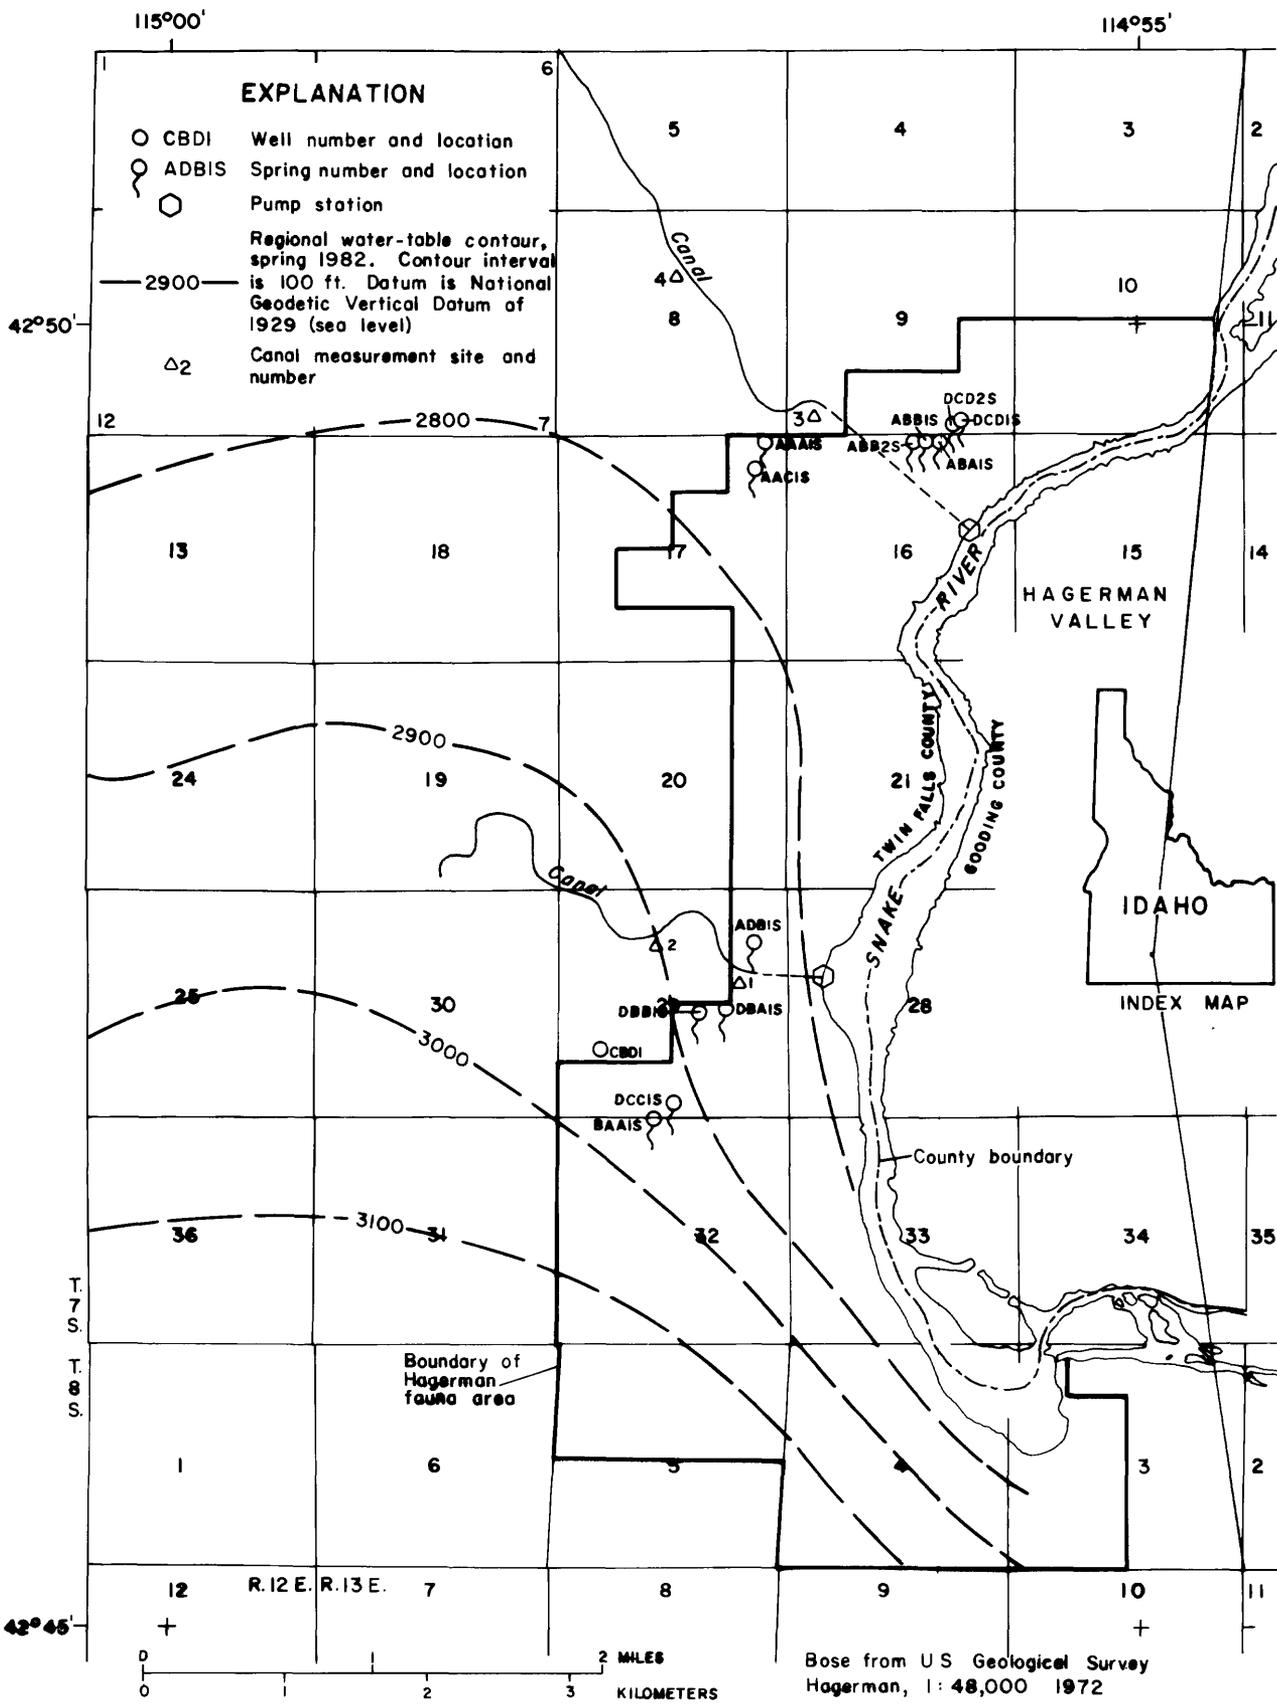
Figure 1.--Regional water-table contours and locations of data-collection sites.

Water-table contours for the regional aquifer system in the vicinity of the fauna area are shown in figure 1. Altitude of the water table in the regional aquifer ranges from about 2,800 to 2,900 ft above sea level. The springs discharge at altitudes generally between about 3,100 and 3,200 ft, which indicates the source of the springs is a minor aquifer perched above the regional water table (fig. 1).

Prior to development of farmlands on the plateau and construction of two irrigation canals supplied by water pumped from the Snake River and lifted to the canyon rim (fig. 1), the springs and seeps on the canyon slope did not exist. Therefore, the principal source of recharge to the perched aquifer that feeds the springs and seeps is probably seepage losses from the canals. Other possible sources of recharge include infiltration of applied irrigation water and precipitation.

<u>Site No.</u>	<u>Discharge, in cubic feet per second</u>
1	52.1
2	50.4
Estimated loss per mile is 3.3 ft ³ /s, or 6 percent	
3	71.5
4	66.9
Estimated loss per mile is 4.6 ft ³ /s, or 6 percent

Assuming a 120-day irrigation season, annual canal losses for a 1-mi reach near the fauna area total about 1,900 acre-ft.

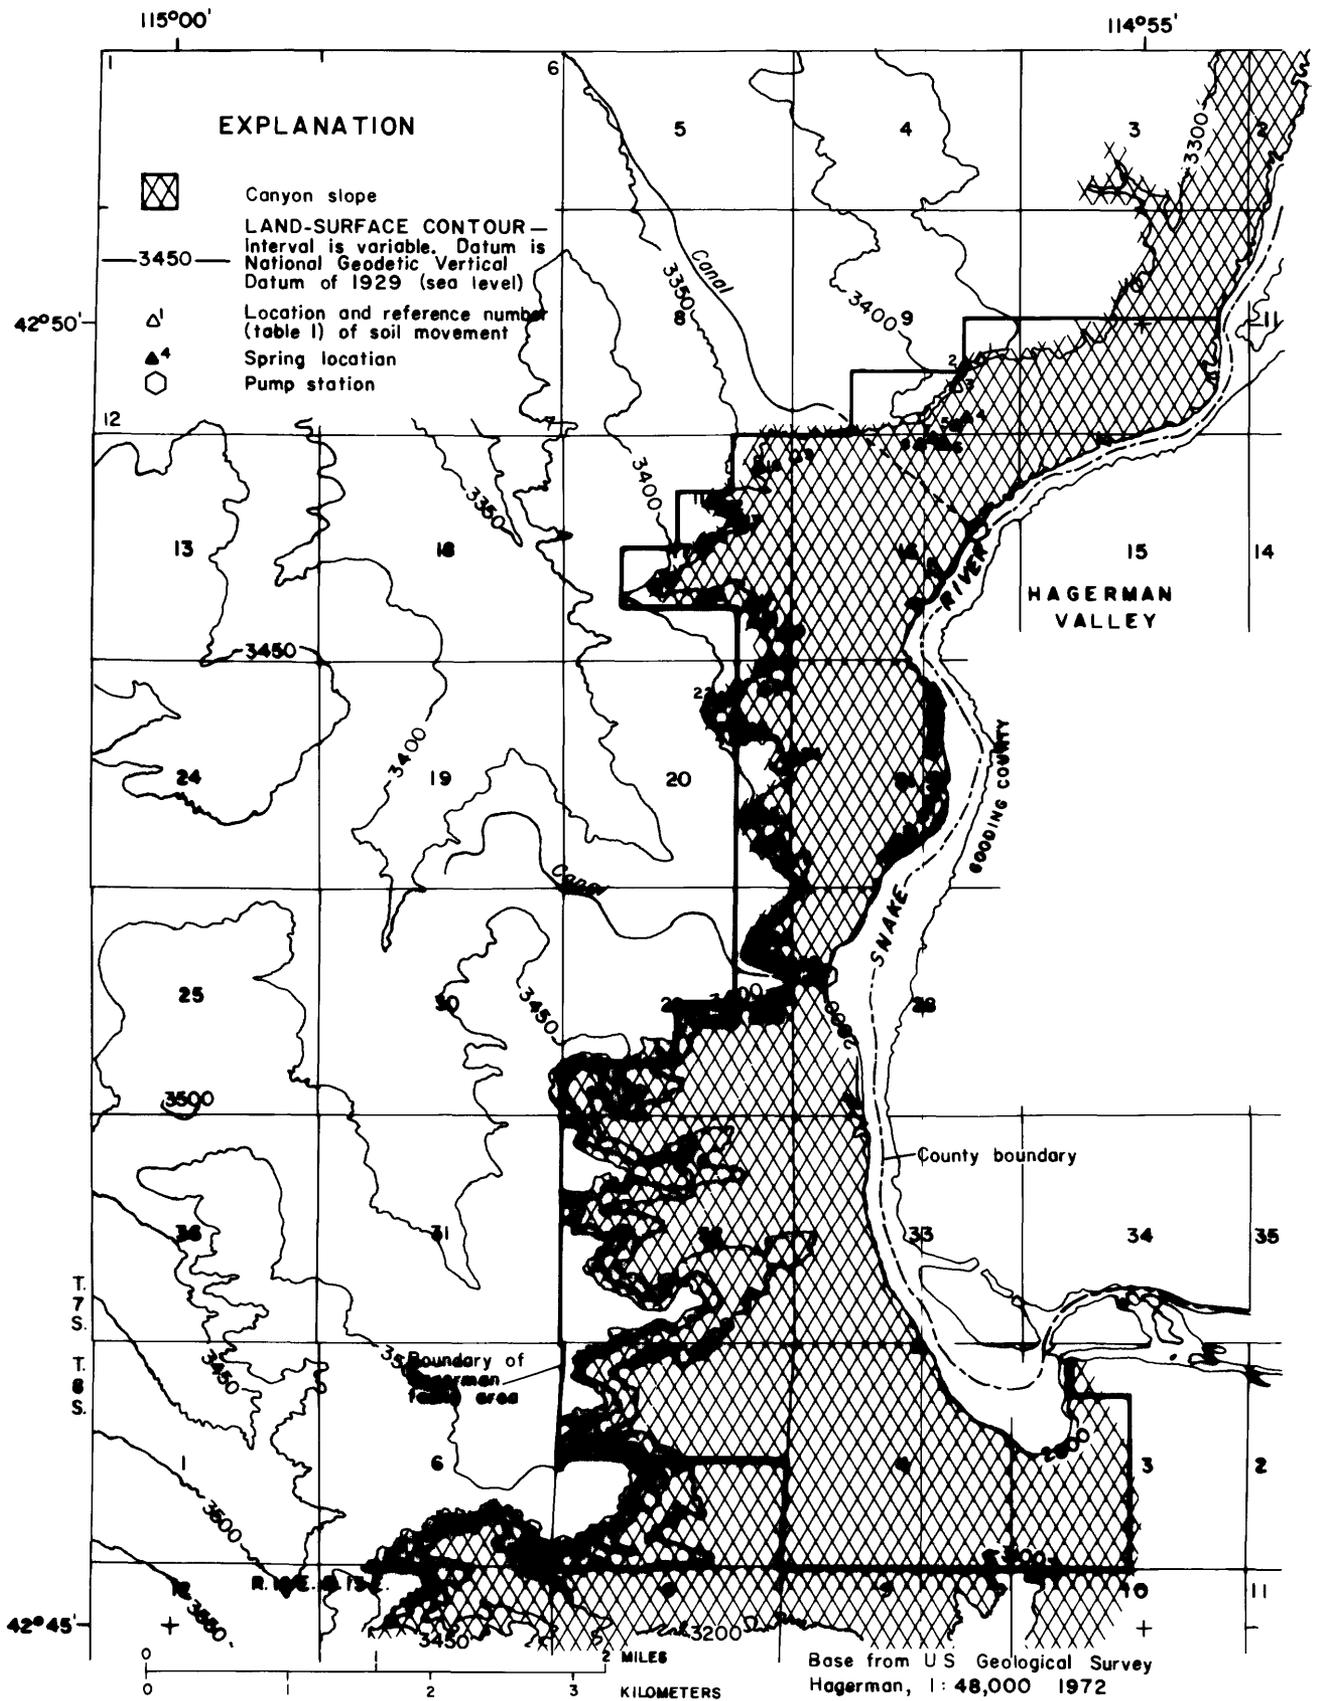
Figure 4.--Sites of major soil movement.

Soil movement in the fauna area is the result of erosion from surface-water runoff and ground-water discharge from springs and seeps. Presently, 22 sites have been affected by surface-water runoff and 11 sites have been affected by ground-water discharge. Sites of major soil movement are shown in figure 4, and descriptions and probable cause(s) are given in table 1.

Site number (location shown in fig. 4)	Description of soil movement	Cause(s) of soil movement	Site number (location shown in fig. 4)	Description of soil movement	Cause(s) of soil movement
1	Gully erosion	Irrigation runoff. Broken mainline in sprinkler system; pipe has been repaired	14	Gully erosion	Irrigation and natural runoff. Powerline access road acts as a collector
2	do.	Natural drainage. Irrigation and natural runoff	15	do.	Irrigation and natural runoff
3	Gully erosion, large washouts	Irrigation runoff. Most erosion occurs when valve in main sprinkler line is opened to flush system	16	do.	Do.
4	Soil slump or creep below springs. Soil creep has filled natural channel. Springs have cut new channels through slumping material	Ground-water discharge. Springs have saturated material below vents	17	do.	Do.
5	do.	Do.	18	do.	Irrigation runoff. Most erosion occurs when valve in main sprinkler line is opened to flush system

6	Soil slump or creep below spring, gully erosion below spring	Ground-water discharge. Spring has saturated material below basalt outcrop. Some gully erosion below spring due to surface-water runoff	19	do.	Natural runoff, possibly some irrigation runoff
7	do.	Do.	20	do.	Irrigation and natural runoff; access road to Snake River acts as a collector
8	Soil slump or creep below springs. Large gully erosion below springs	Ground-water discharge. Springs have saturated material below basalt outcrop. Most of the large gullies due to surface-water runoff	21	do.	Irrigation and natural runoff
9	Gully erosion	Irrigation runoff. Most erosion occurs when valve in main sprinkler line is opened to flush system. A pipe under road collects irrigation runoff, which adds to surface-water runoff	22	do.	Irrigation and natural runoff; road along edge of field acts as a collector
10	Soil slump or creep below spring, some gully erosion below spring	Ground-water discharge. Spring has saturated material below vent. Some movement due to gully erosion from surface-water runoff	23	do.	Irrigation and natural runoff

11	do.	Do.	24	do.	Do.
12	Gully erosion	Irrigation runoff. Most erosion occurs when valve in main sprinkler line is opened to flush system. Some erosion due to natural and irrigation runoff	25	do.	Do.
13	do.	Irrigation and natural runoff	26	do.	Do.
			27	do.	Do.
			28	do.	Do.
			29	Soil slump or creep; some gully erosion	Ground-water discharge. Springs have saturated material below vents. Some movement due to gully erosion from surface-water runoff
			30	Gully erosion	Natural runoff; probably enhanced by roads around communication relay station, which act as a collector
			31	Soil slump or creep	Ground-water discharge; seeps have saturated material below vents
			32	do.	Do.
			33	do.	Ground-water discharge; seeps have saturated material below vents. Leakage from valve in sprinkler line may add to saturation of material near slump

1. Lining or otherwise treating the two irrigation canals to reduce seepage losses would eliminate the principal source of recharge to the perched aquifer.
2. Eliminating the practice of flushing irrigation sprinkler systems adjacent to the canyon rim would halt the severe erosion in areas below the valves.
3. Constructing berms and cross dips on all roads in and adjacent to the fauna area would reduce the rate of erosion from surface-water runoff.

4. Establishing an uncultivated strip of land between irrigated farmland and the canyon rim would reduce the amount of surface-water runoff and hence reduce soil erosion.

Implementing corrective measure 1 would reduce soil movement that is the result of ground-water discharge at 11 sites. Implementing corrective measures 2, 3, and 4 would reduce soil movement that is the result of surface-water runoff at 22 sites.
