INFLOW TO A CRACK IN PLAYA DEPOSITS OF YUCCA LAKE,
NEVADA TEST SITE, NYE COUNTY, NEVADA

By Gene C. Doty and F. E. Rush

U.S. GEOLOGICAL SURVEY

Water-Resources Investigations Report 84-4296

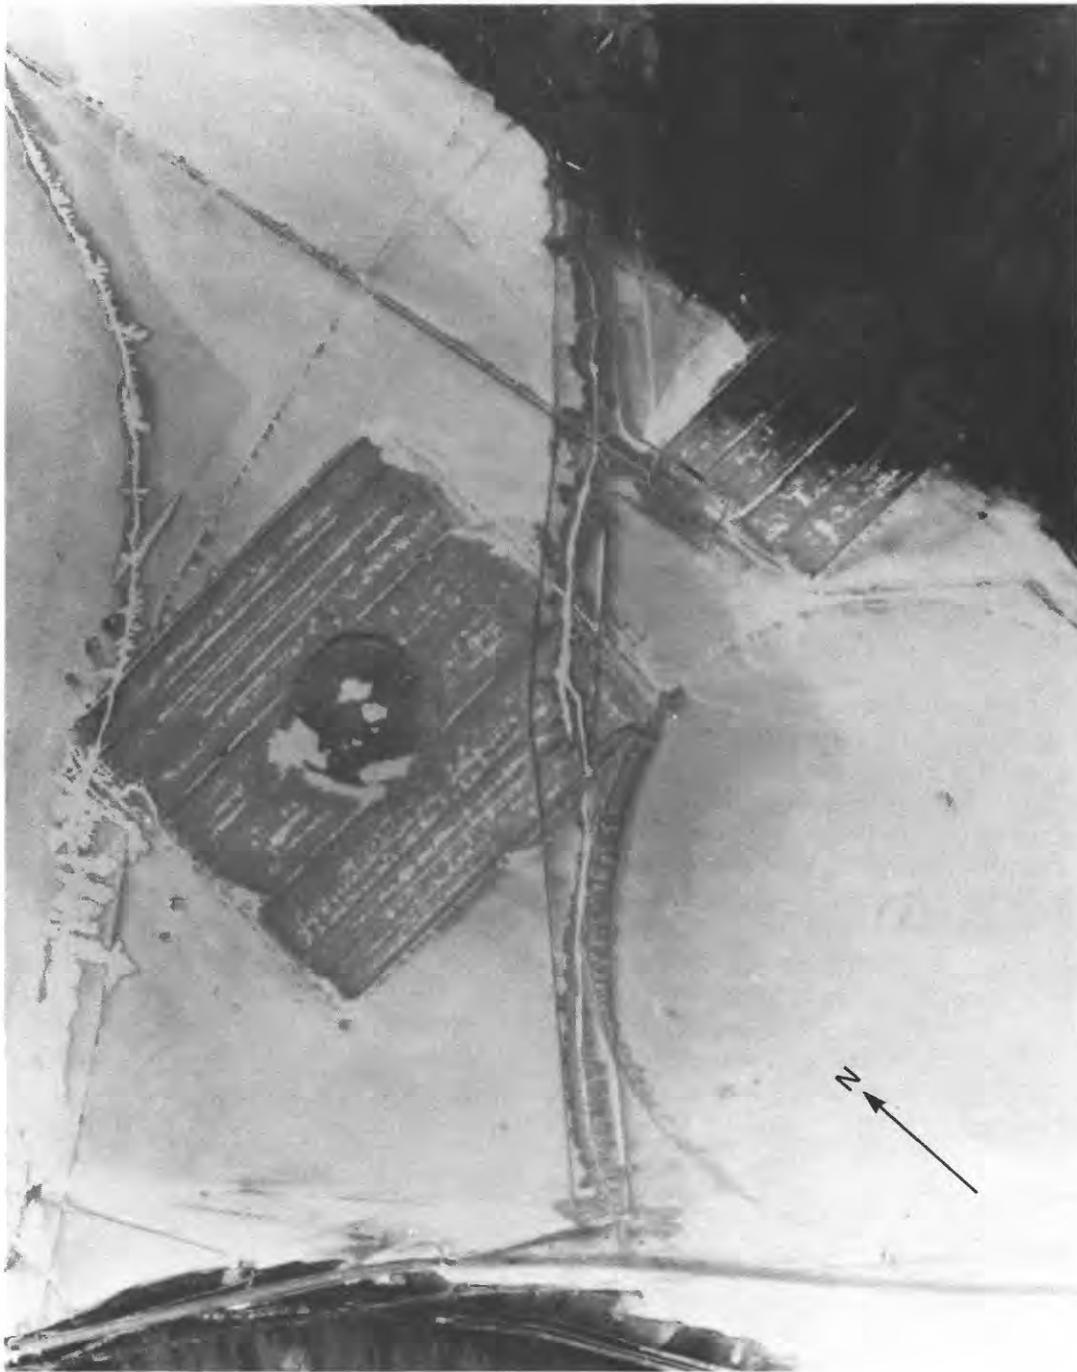
Figure 3.--Vertical aerial photograph (1973) of the southern part of Yucca Lake playa showing the cracks that opened in 1960 (left) and in 1969 (center). (Circular pattern at right and rectangular areas are remnants of testing operations; various straight lines are buried pipes, fences, or cables.)

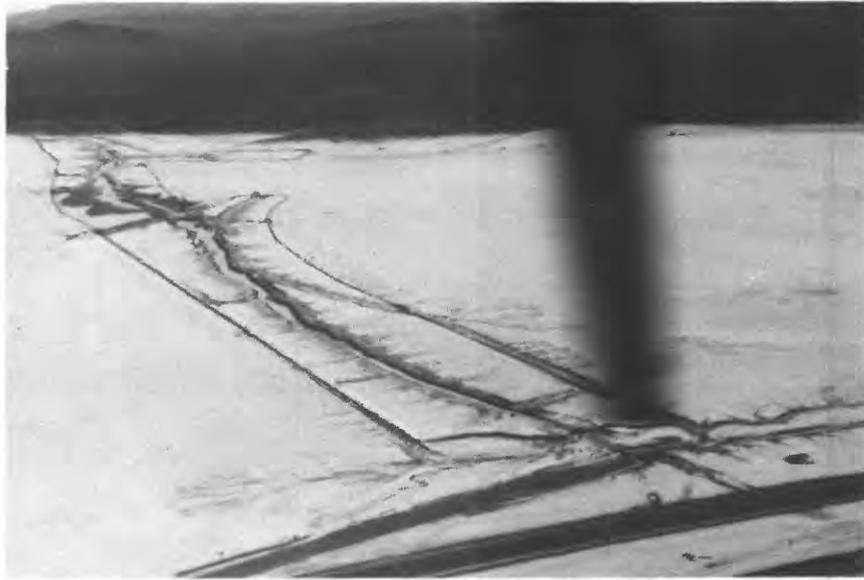
Figure 4.--Northeasterly view of the 1969 crack showing erosion of drainageways along the berm and into the crack, May 1982. (Dark shadow at right side of view is blade of helicopter rotor; paved road is in lower right of photograph; crack is partly filled with water.)

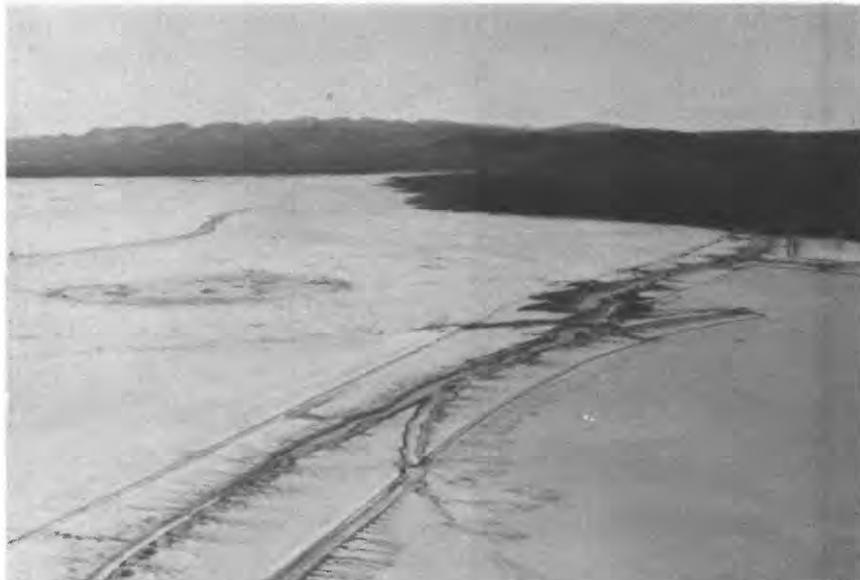
Figure 5.--Northerly view of the 1969 crack showing erosion along the circular test-pattern perimeter inside of the berm. [Deepest erosion (more than 16 feet) occurred near flume 2, right center of photograph; note trace of 1960 crack in upper left of photograph.]

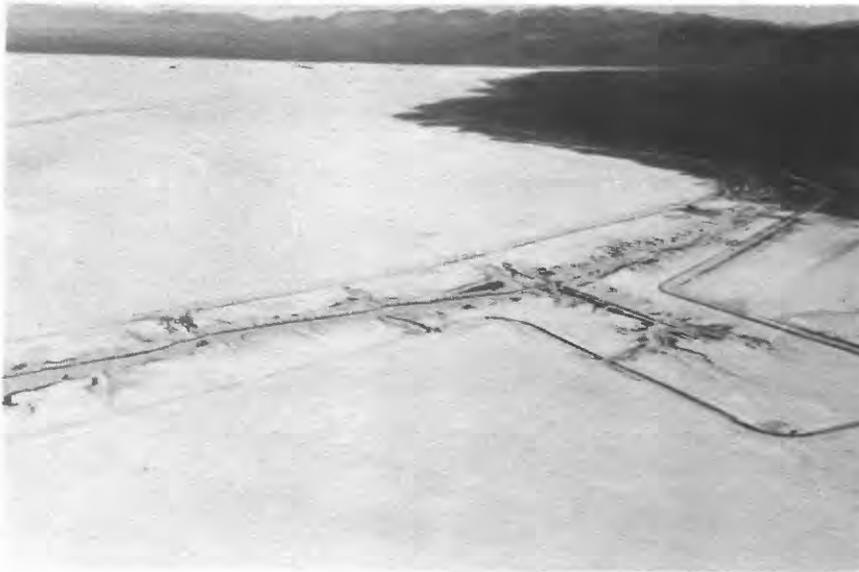
Figure 6.--Northwesterly view of the 1969 crack showing erosion along the buried water line from well C inside of the berm.

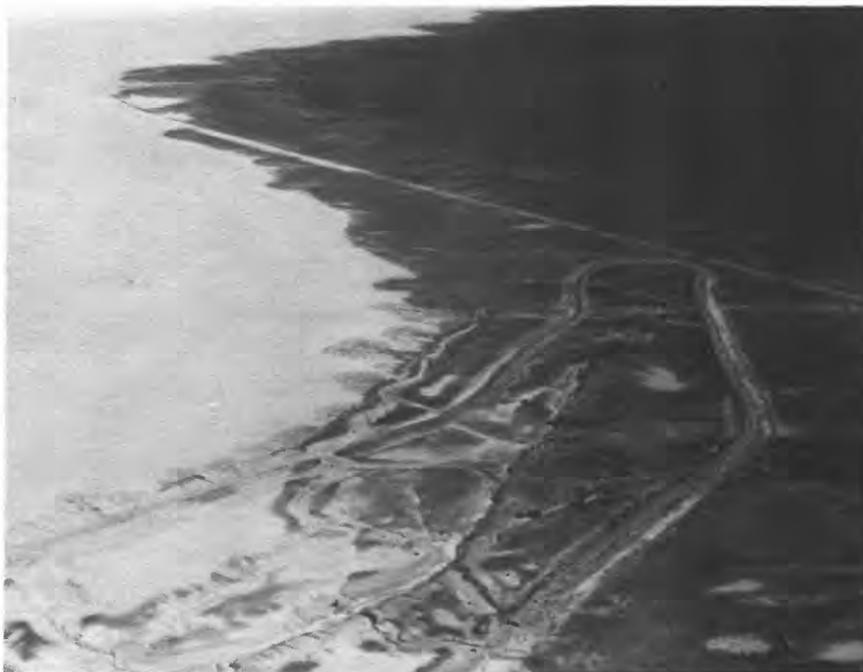
Figure 7.--Northerly view of the 1969 crack showing the 1978 extension (center above berm). (Although the 1978 extension and older part of the crack appear parallel, they are slightly divergent.)

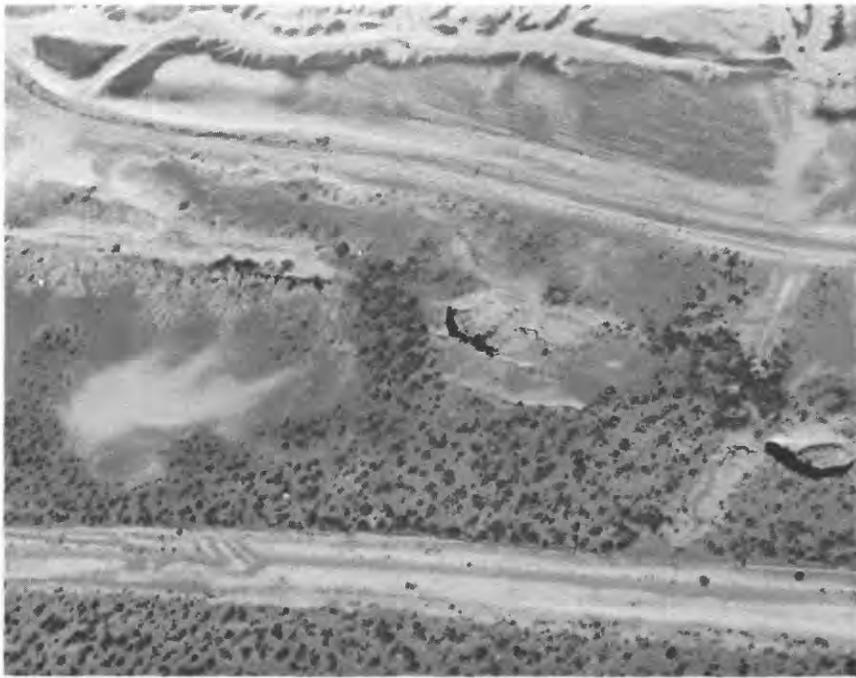
Figure 8.--Oblique aerial photograph looking northwestward along the northeastern end of the 1969 crack showing collapse sinks inside of the berm (right center). (Trace of the 1978 extension is along the top of the photograph. Sink at right collapsed first and is about 9 feet deep; sink to left is about 6 feet deep.)

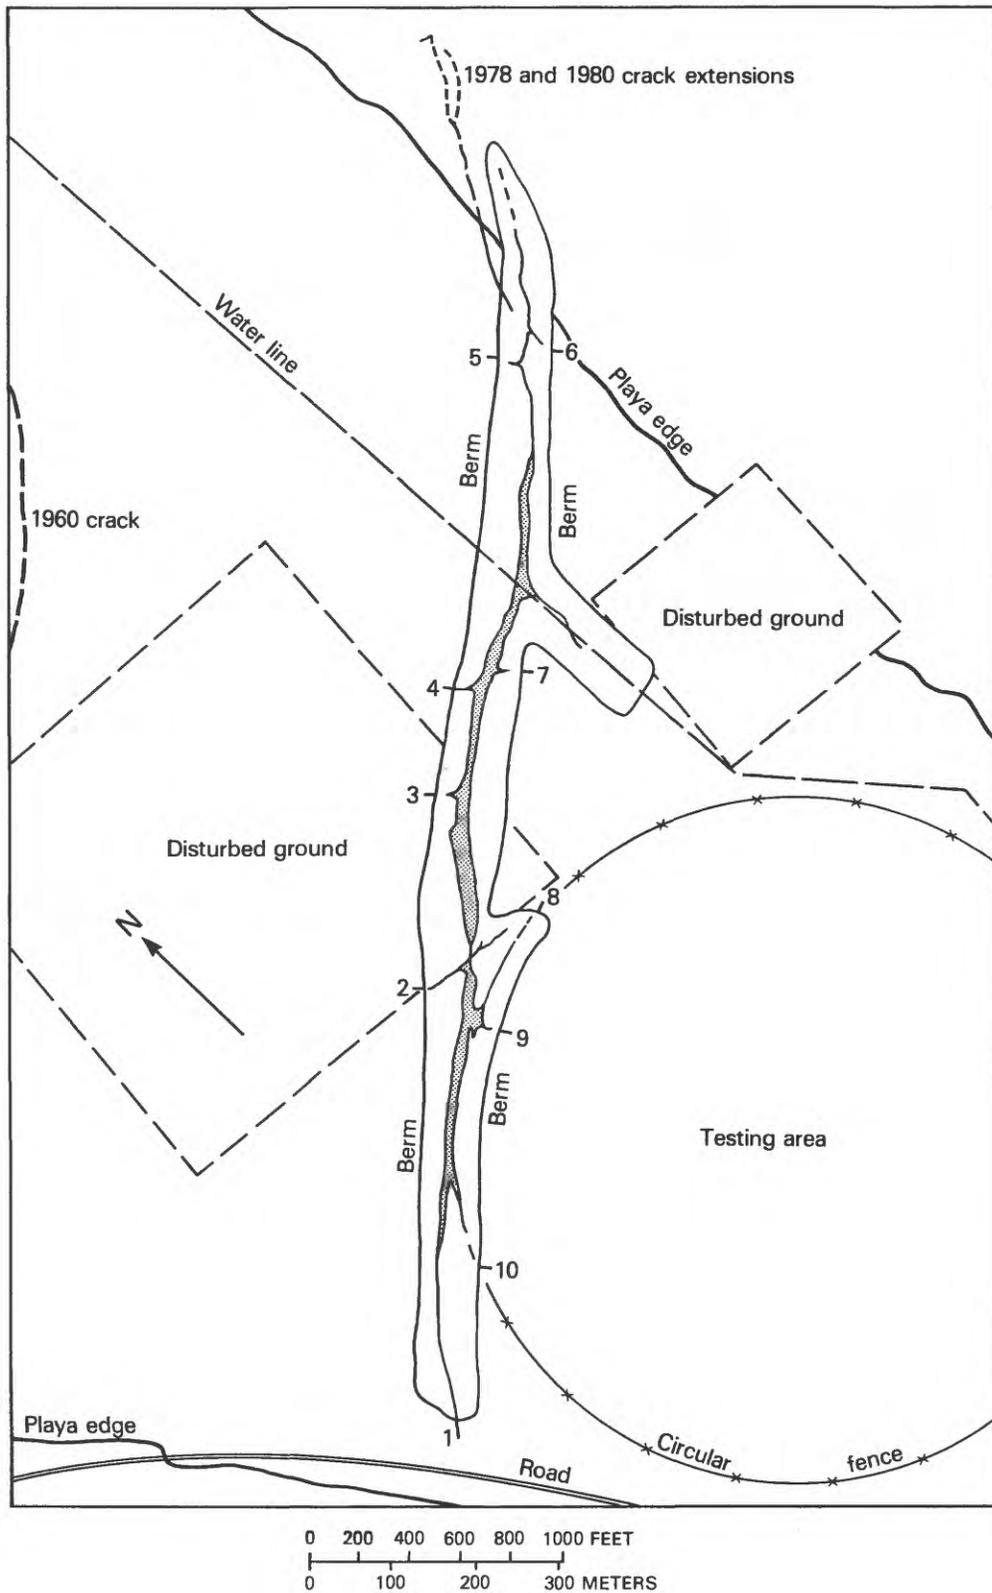
Figure 9.--Sketch of eroded 1969 crack showing 1978 and 1980 extensions, berm, and location of flumes. (Numbers along berm refer to flumes listed in table 1.)

Of the three dimensions of the crack, only one was known with any degree of certainty--the lateral extent of the crack. As shown in figure 9, the crack was about 5,800 ft long at land surface. For purposes of calculation, the length at depth is assumed to be the same. The width and depth can only be speculated. If the crack averaged 1 in. in width, the computed average depth would have been about 2,000 ft. If the crack had a narrower average width and the length estimate remained unchanged, then the computed average depth would be proportionally larger. According to information presented by Winograd and Thordarson (1975, pl. 2), the depth to bedrock (base of alluvial valley fill) probably is less than 1,500 ft beneath the area of the crack. Therefore, it is possible that the crack could extend to that contact.
