GEOMORPHIC RESPONSE TO CHANNEL MODIFICATIONS OF SKUNA RIVER AT THE STATE HIGHWAY 9 CROSSING AT BRUCE, CALHOUN COUNTY, MISSISSIPPI

by K. Van Wilson, Jr. and D. Phil Turnipseed

U.S. GEOLOGICAL SURVEY
Water-Resources Investigations Report 94-4000

Prepared in cooperation with the
MISSISSIPPI DEPARTMENT OF TRANSPORTATION

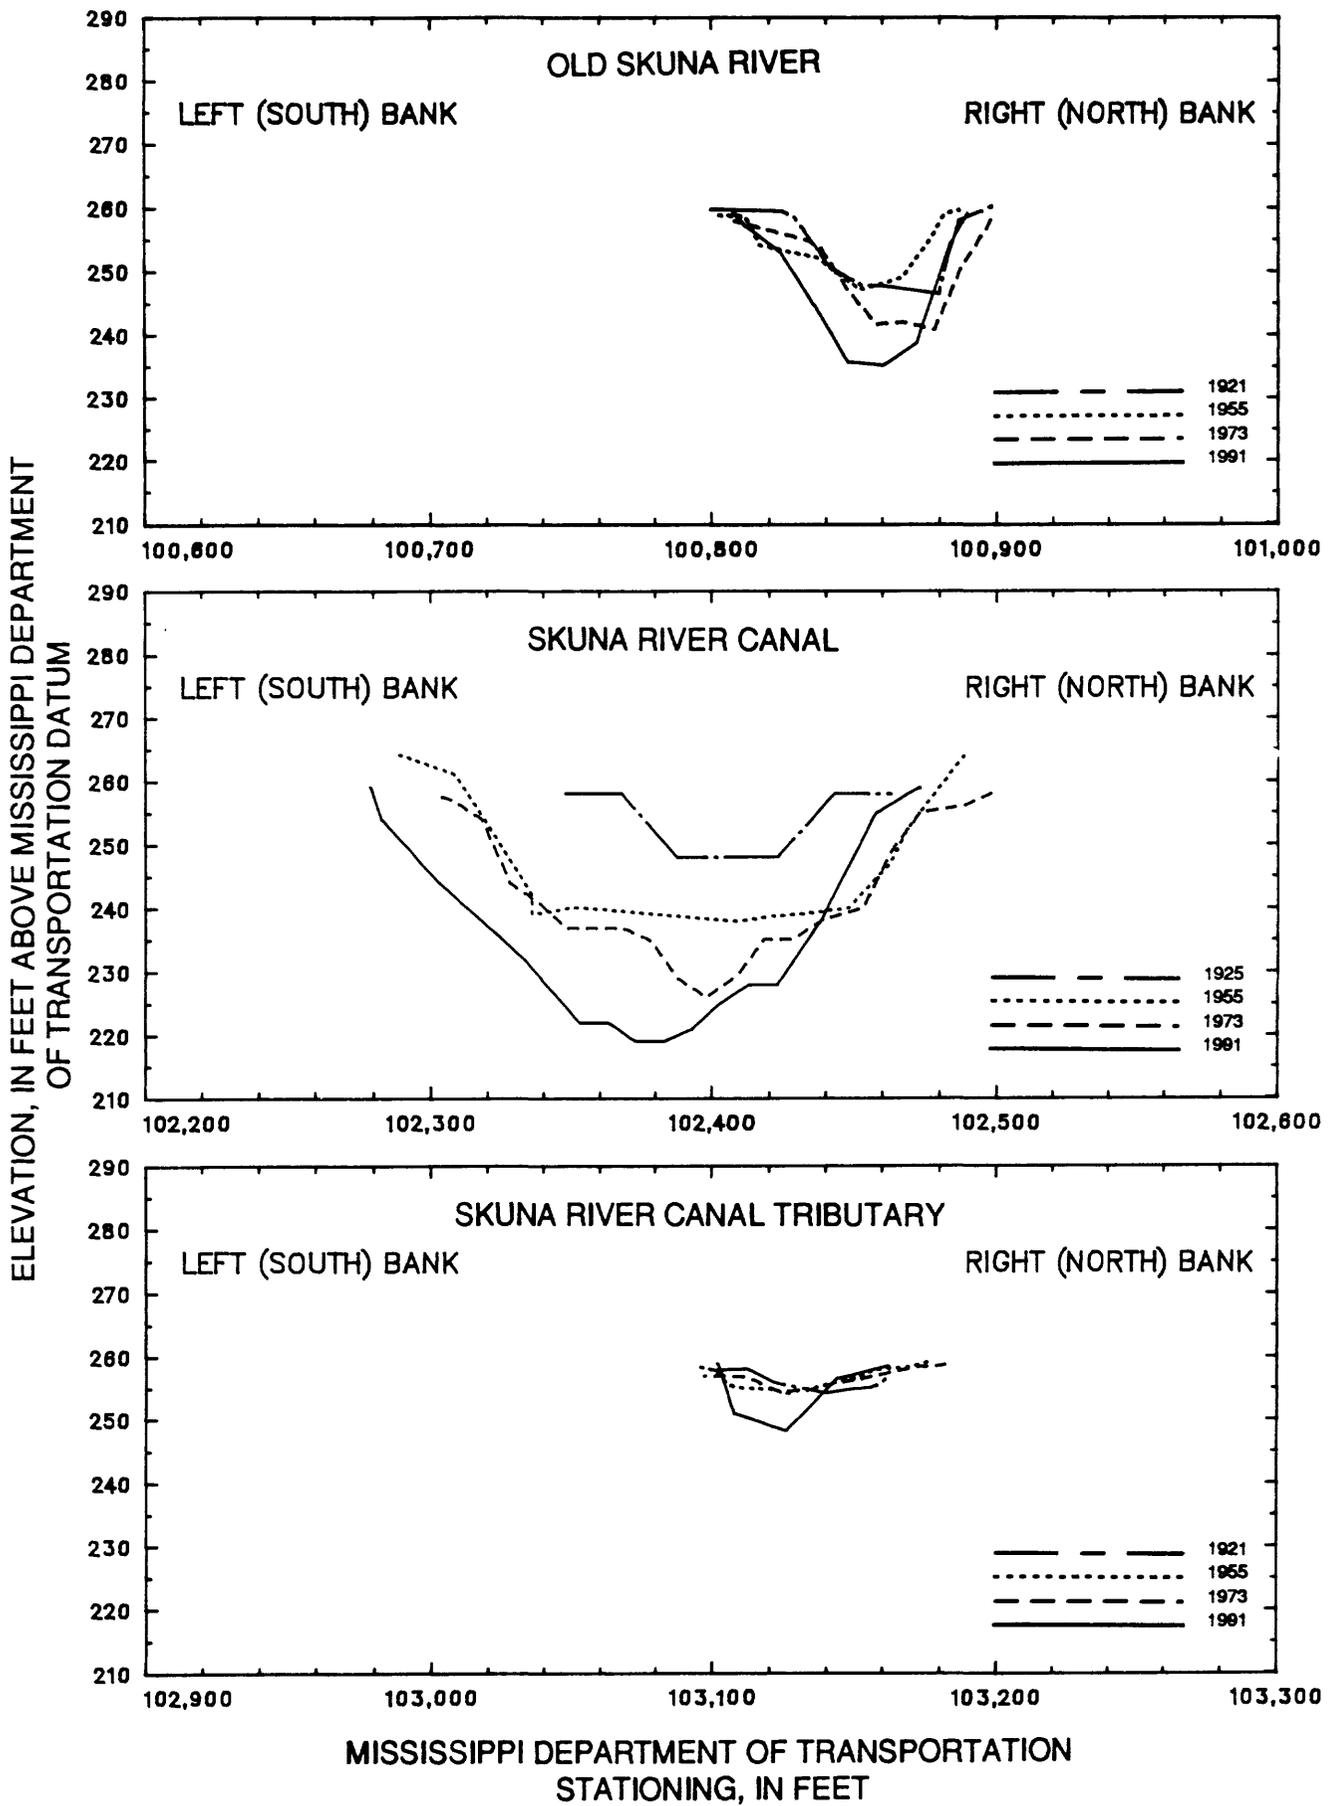
Channel cross sections at the State Highway 9 bridges crossing Old Skuna River, Skuna River Canal, and Skuna River Canal tributary indicate these streams have responded to channel modifications by bed lowering (scour and degradation) and bank

widening (fig. 2). The 1921, 1925, and 1955 sections in figure 2 were surveyed during low-flow conditions, but the 1973 and 1991 sections were determined from soundings taken during discharge measurements made by the USGS. The discharge for the 1973 and 1991 measurements had recurrence intervals between 5 and 10 years. The canal scoured and degraded as much as 29 ft from 1925 to 1991. Old Skuna River Canal and Skuna River Canal tributary scoured and degraded as much as 11 ft and 6 ft, respectively, from 1921 to 1991. The channels at these bridges widened because of unstable banks caused by scour and degradation.

Figure 2.--Channel cross sections at the State Highway 9 bridges crossing Old Skuna River, Skuna River Canal, and Skuna River Canal tributary at Bruce, Mississippi.

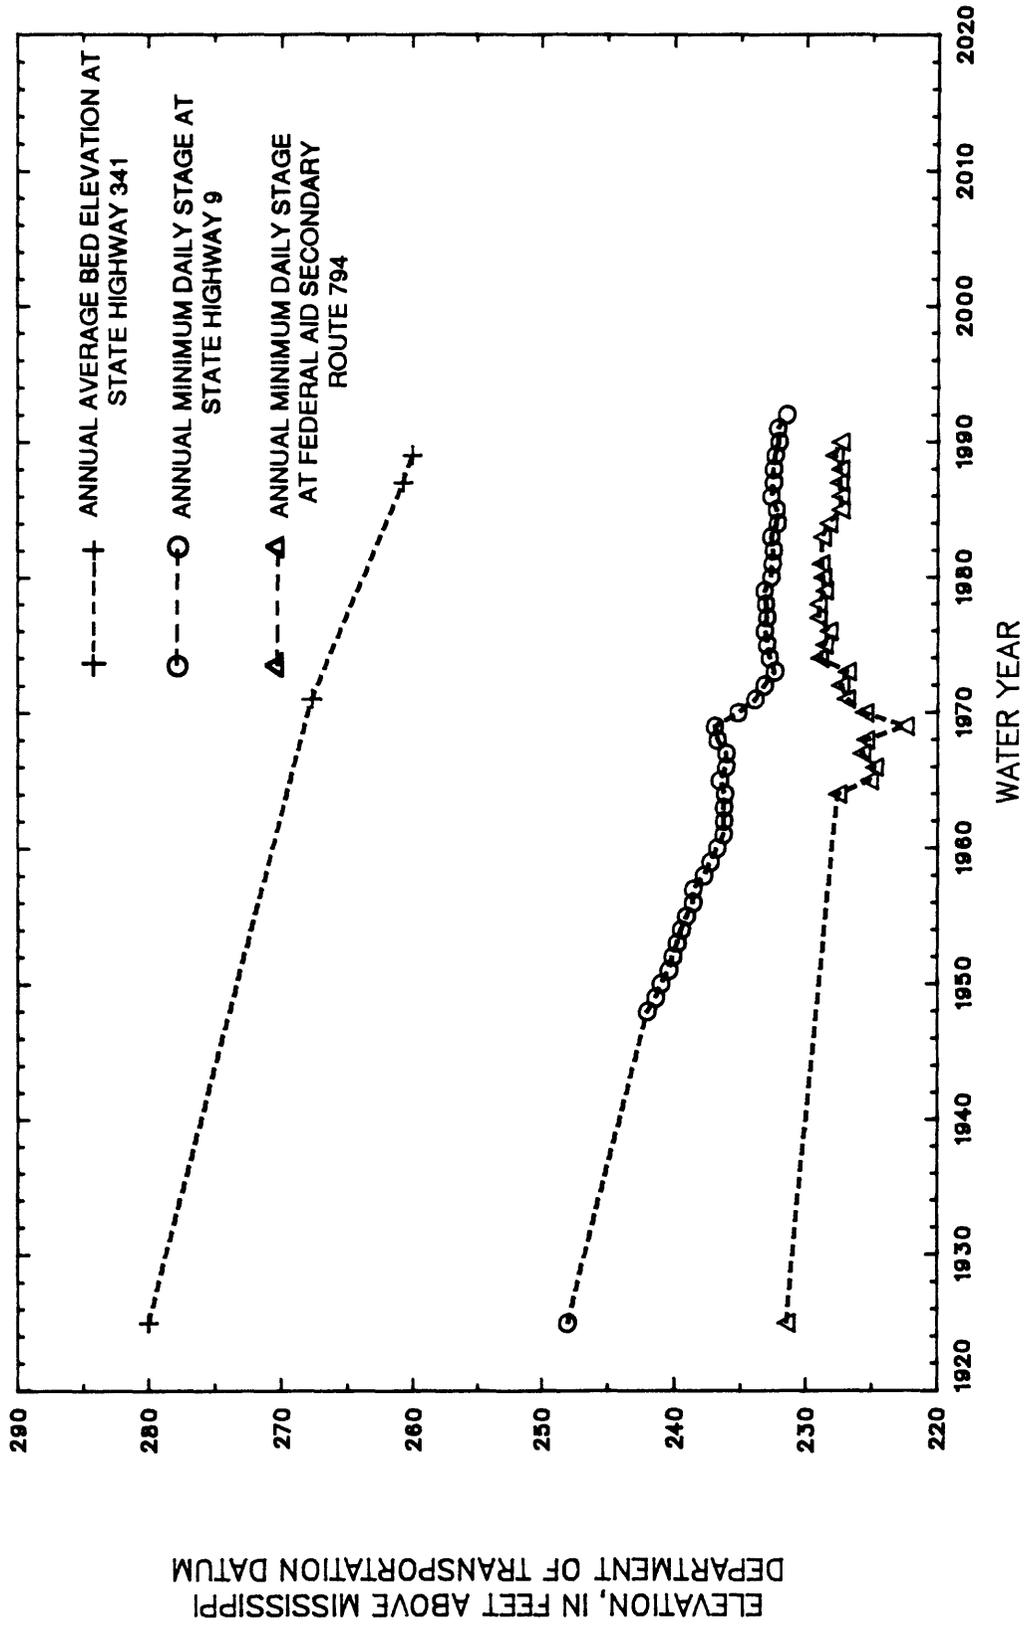
The channel bed of Skuna River Canal degraded about 4 ft from 1925 to 1990 at the Federal Aid Secondary Route 794, 16.5 ft from 1925 to 1992 at State Highway 9, and about 20 ft from 1925 to 1989 at State Highway 341 (fig. 3). The degradation was determined from design-bed elevations estimated from Loosascoona River Drainage District No. 2 plans, minimum-stage data from the COE gage at Federal Aid Secondary Route 794 and the USGS gage at State Highway 9, and average bed elevations obtained at State Highway 341.

Figure 3.--Channel-bed elevation for Skuna River Canal at Federal Aid Secondary Route 794, State Highway 9, and State Highway 341.

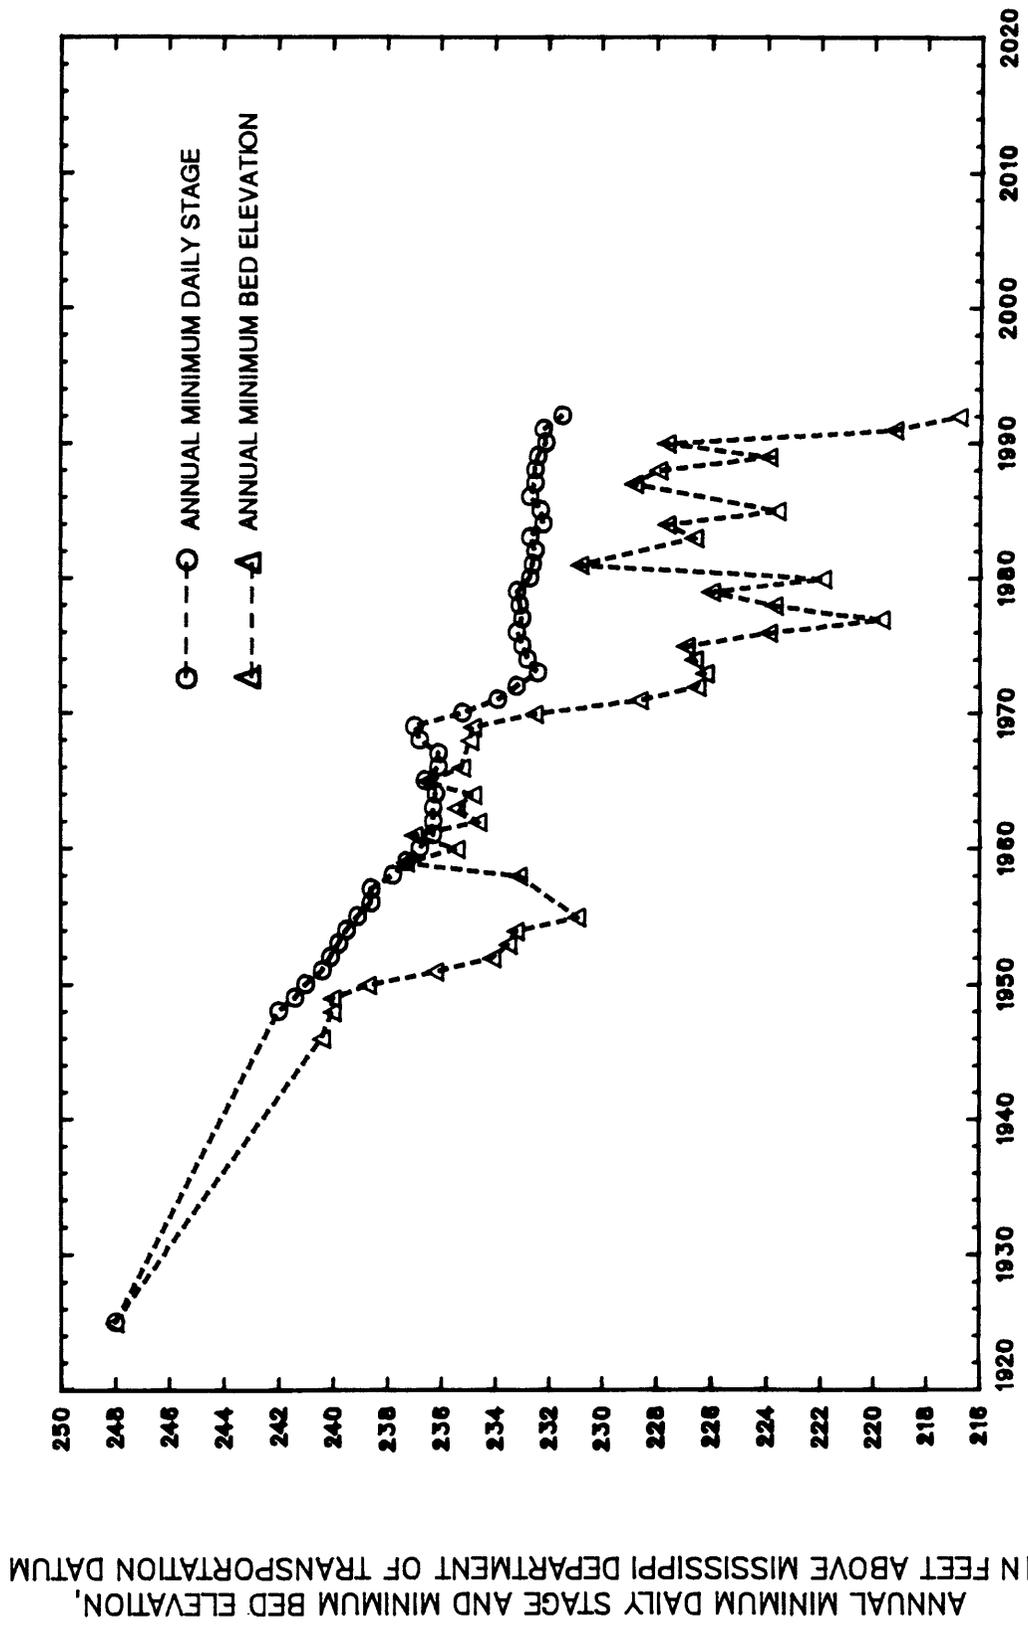
The available annual minimum daily stages and minimum-bed elevations between 1925 and 1992 at State Highway 9 are shown in figure 4. Minimum channel-bed elevations at State Highway 9 are affected by local and constriction scour. Local and constriction scour are in addition to the ongoing degradation process and, therefore, are not representative of a typical channel reach. Minimum-bed elevations were computed by obtaining maximum flow depths from discharge measurements made at either the upstream or downstream side of the State Highway 9 bridge. The minimum-bed elevations at the bridge give an indication of the total scour occurring at the bridge, but do not sufficiently describe the degradation patterns for a typical channel reach of the canal. Therefore, the minimum-stage data were used for channel-gradation analyses. Generally, specific-gage data (using the water-surface elevation at a selected discharge) are used for channel-gradation analyses instead of minimum-stage data. However, minimum-stage data were used in this report because of the ease of obtaining the information. The minimum stages do not appear to be

Figure 4.--Annual minimum daily stage and minimum bed elevation for Skuna River Canal at State Highway 9 at Bruce, Mississippi.

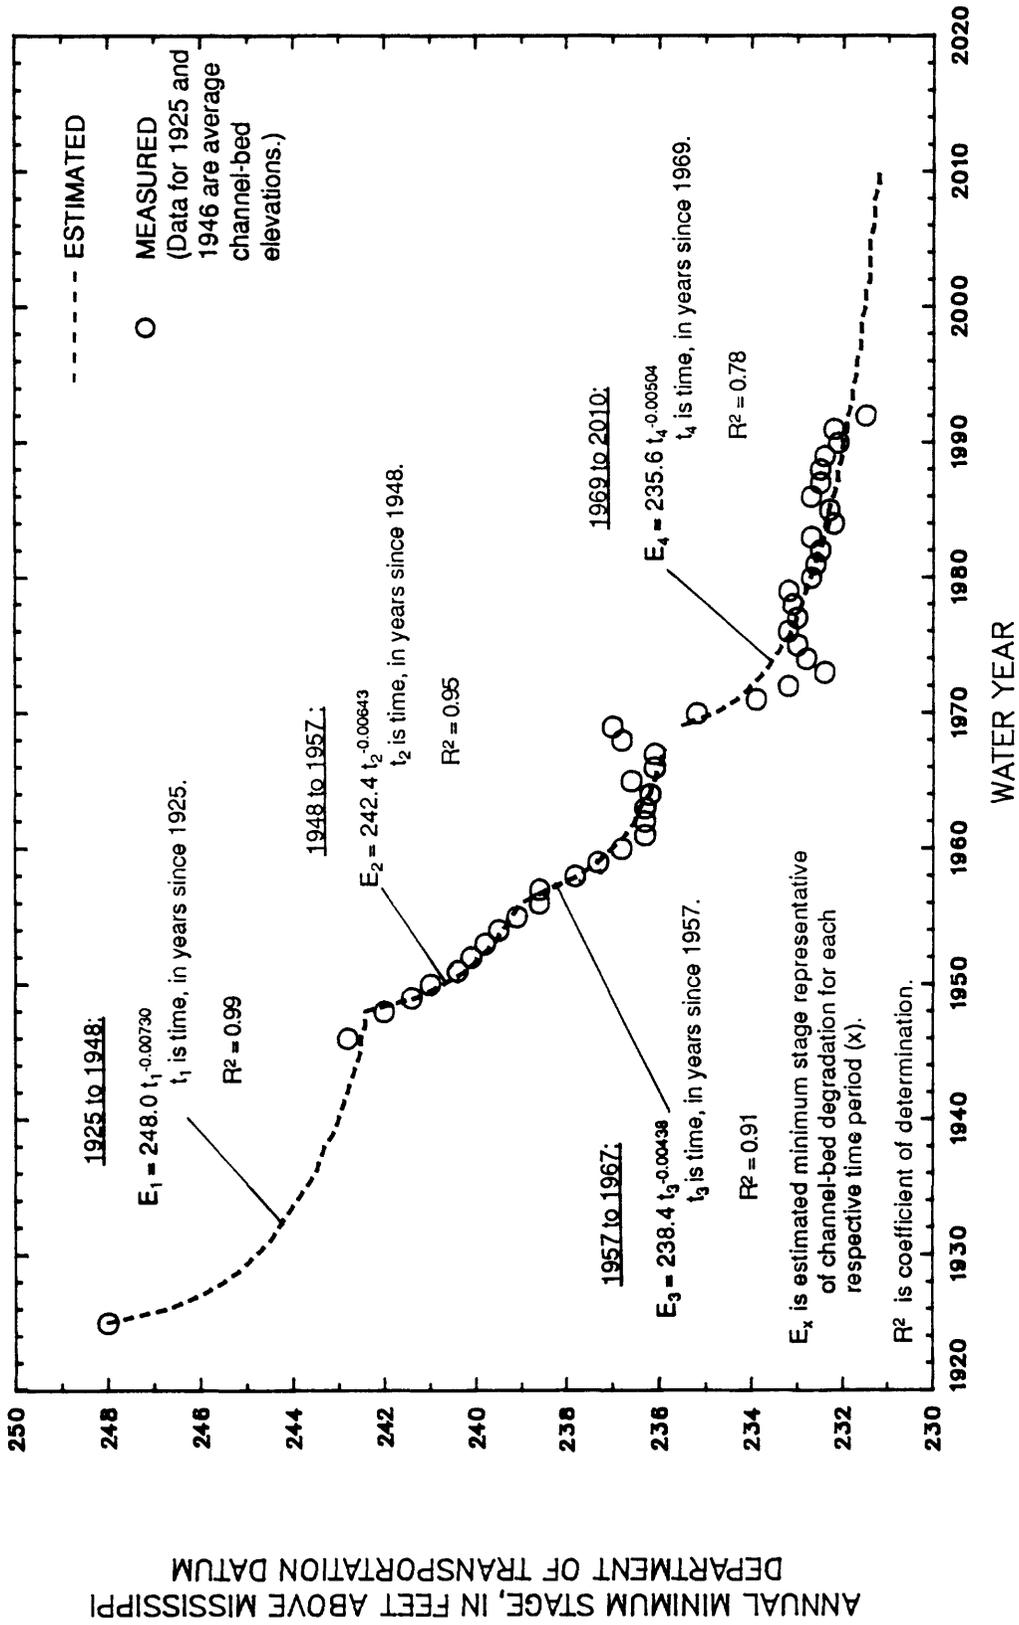
Log-linear relations were computed for the periods 1925-48, 1948-57, 1957-67, and 1969-2010 (fig. 6). On the basis of the log-linear relation for 1969-2010, about 1 ft of additional degradation will occur by 2010. Prior to 1948, the channel bed was mostly composed of silt and clay; after about 1948, degradation lowered the bed below an elevation of 243 ft where sand exists, according to the soil borings of bank material (table 1). The relation of available bed elevations and minimum stages with time

Figure 6.--Estimated patterns of channel-bed degradation on Skuna River Canal at State Highway 9 at Bruce, Mississippi.

indicated a break in the degradation process in 1948, which probably is due to the different channel-bed material. Therefore, the period 1925-57 was subdivided into the sub-periods 1925-48 and 1948-57. The time periods of 1957-67 and 1969-2010 were chosen because of the modifications done in 1957 and 1967-68, respectively.

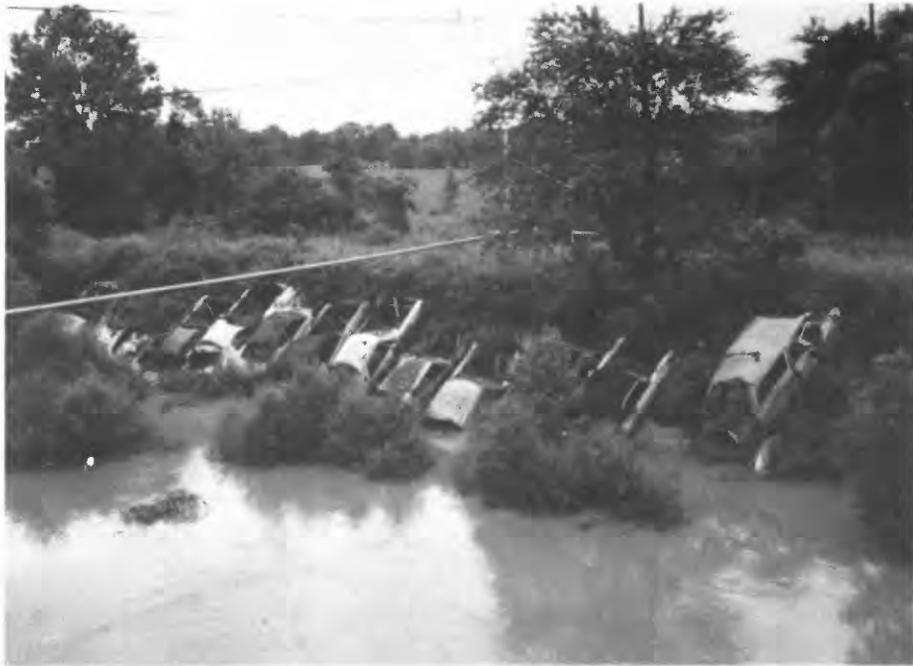
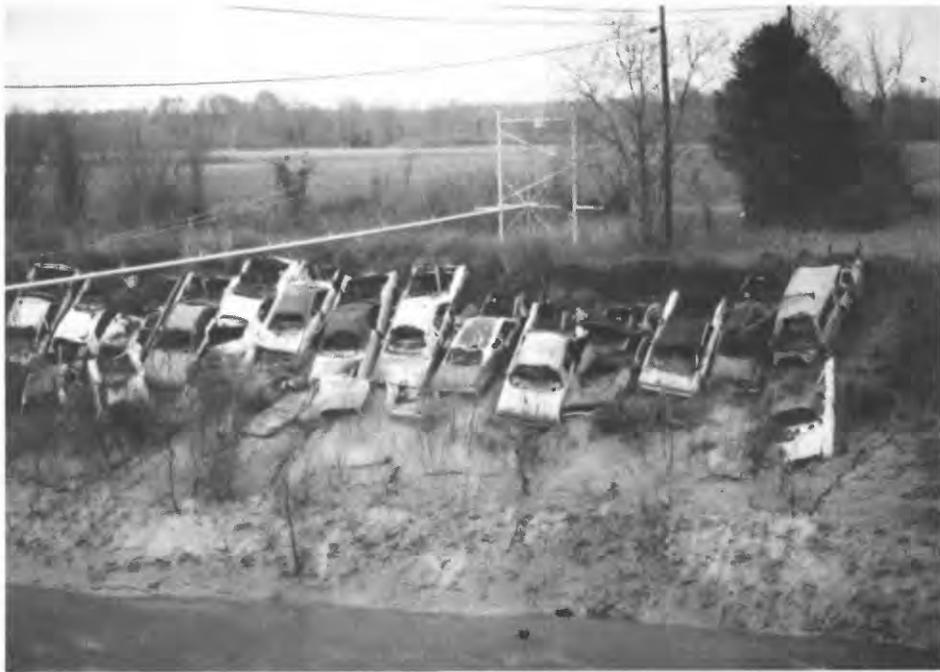
June 15, 1989 (Stage is 249.4 feet above Mississippi Department of Transportation Datum.)

March 23, 1989 (Stage is 234.6 feet above Mississippi Department of Transportation Datum.)

Figure 9.--Old car bodies on the upstream left (south) bank of Skuna River Canal at State Highway 9 at Bruce, Mississippi.

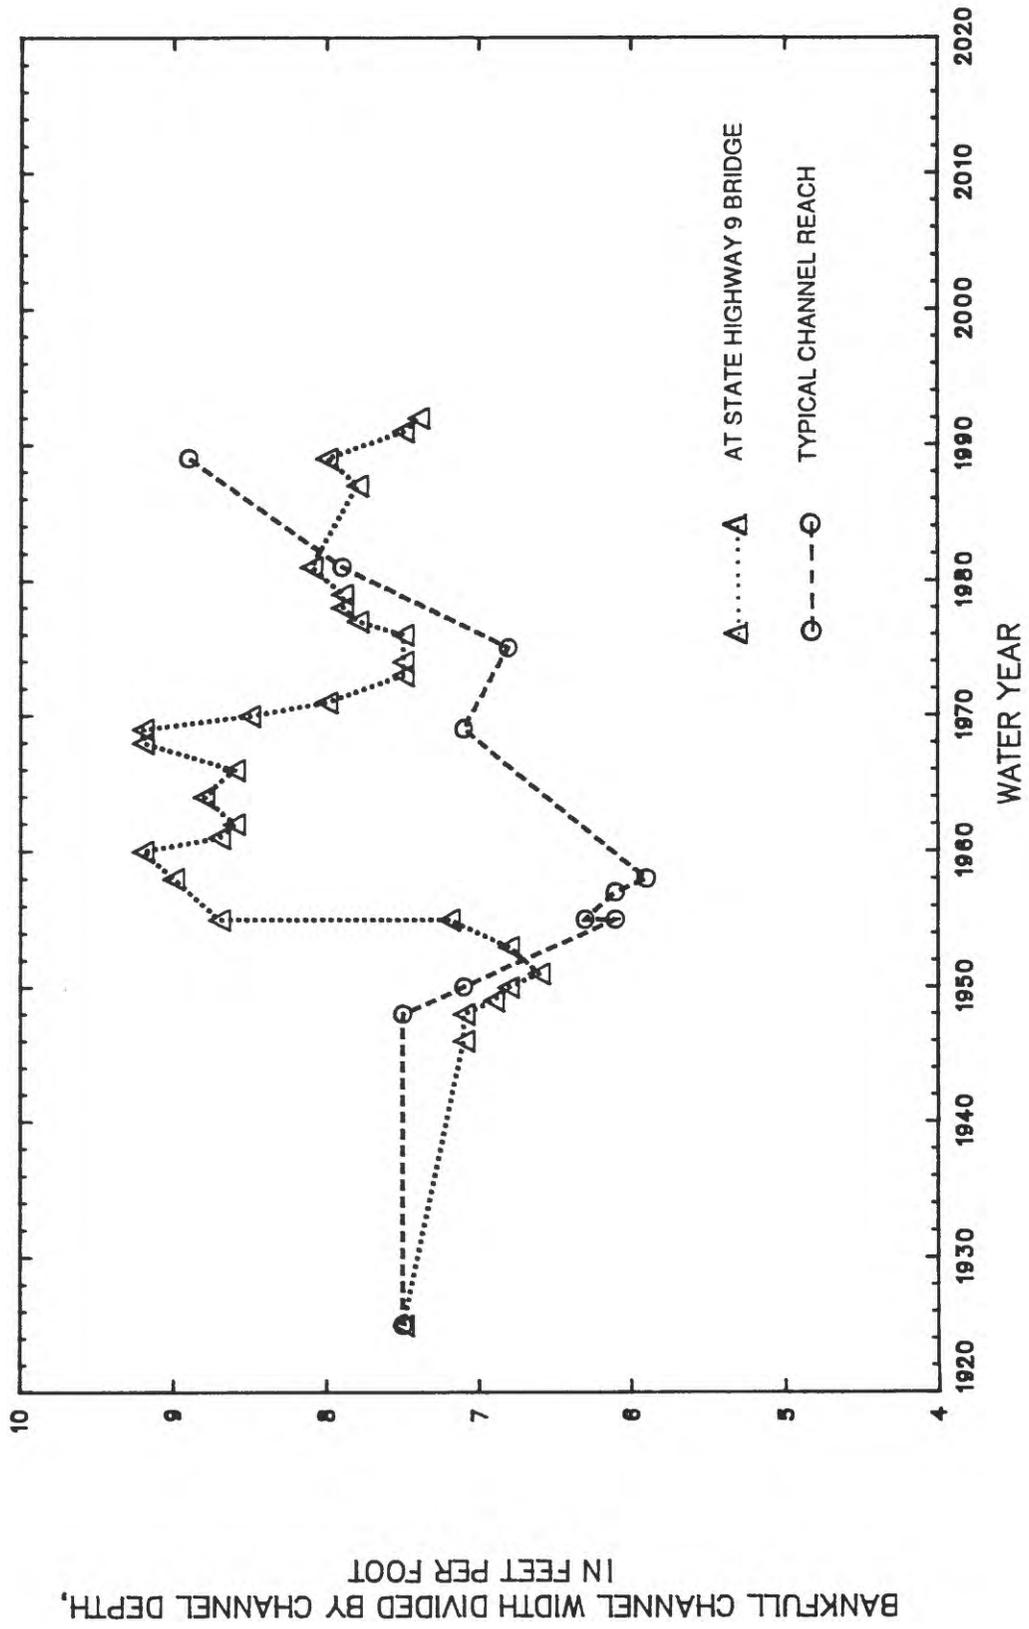
The channel widths and depths were used to compute **W/D** for the typical channel reach of Skuna River Canal in the vicinity of State Highway 9 (fig. 10). A trend reversal of **W/D** can indicate a change in the channel adjustment process. Simon and Hupp (1986a, 1991), in a study of West Tennessee streams, and Schumm and others (1984), in a study of northwestern Mississippi streams, used **W/D** to analyze channel adjustment processes. The measured **W/D** for the canal typically decreased from 7.5 to 5.9 from 1925 to 1958, increased to 7.1 in 1969, decreased from 7.1 to 6.8 in 1975 and increased to 8.9 in 1989 (fig. 10). From 1969 to 1975, width and depth increased 20 ft and 4 ft, respectively; from 1975 to 1989, width increased 58 ft, but depth only increased 0.6 ft. The widening process from 1975 to 1989 apparently did not depend as much on depth as it did prior to 1969. The bankfull channel width-depth ratio has been increasing since 1975, which indicates the canal has been widening more than degrading since 1975. Although the channel is not degrading significantly, the channel is widening due to bank failures caused by steep high banks and by lateral erosion undercutting the banks. Using the degradation and widening log-linear relations for the time period 1969-2010,

Figure 10.--Bankfull channel width divided by channel depth for Skuna River Canal at State Highway 9 at Bruce, Mississippi.

the projected W/D for 2010 is about 8.7. Schumm and others (1984) developed a regional relation of W/D with drainage area for quasi-equilibrium channel reaches of northwestern Mississippi streams. Using the regional relation (Schumm and others, 1984) at the canal (drainage area of 254 mi²), the W/D for quasi-equilibrium channel conditions is about 11.0. The projected depth of 26.8 ft for 2010 multiplied by 11.0 results in a width of about 295 ft, which suggests about 70 ft (rounded to nearest 10 ft) of additional widening will occur before the canal width reaches quasi-equilibrium. Quasi-equilibrium will probably be attained after 2010 if the widening processes follow the normal pattern of diminishing with time.

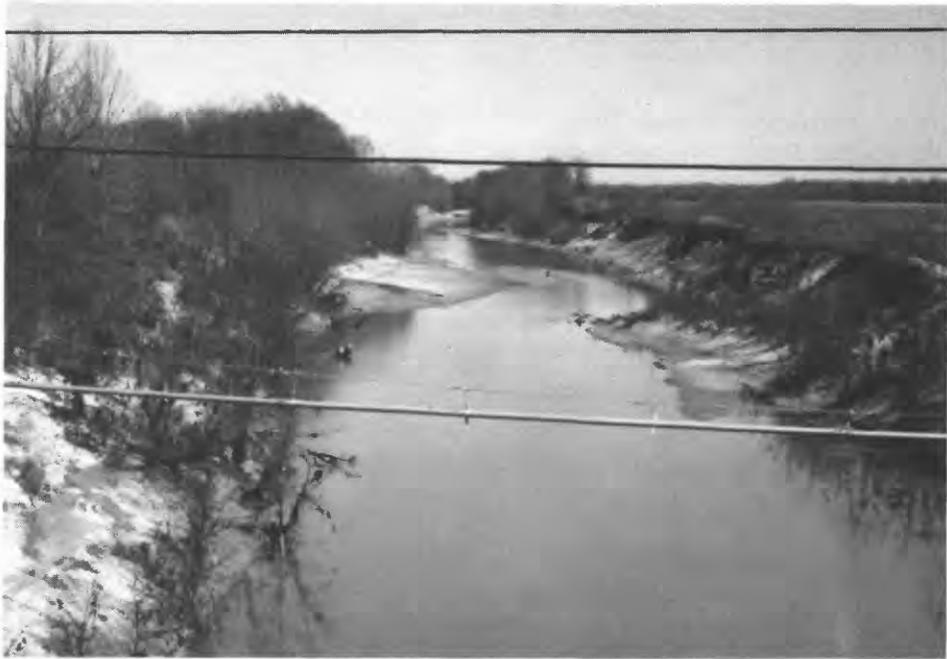
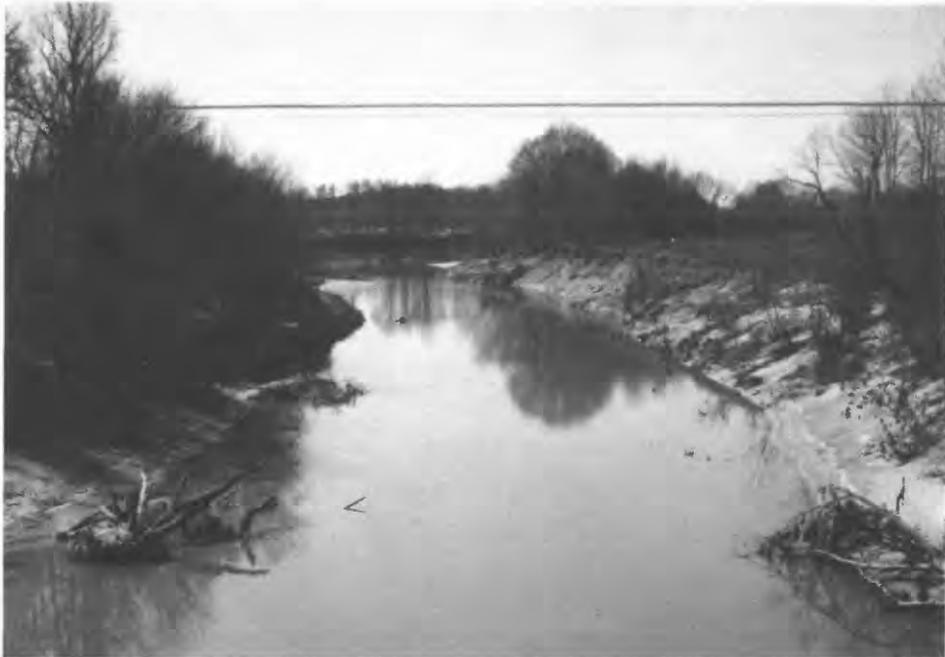
Figure 11.--Views upstream and downstream of the State Highway 9 crossing of Skuna River Canal at Bruce, Mississippi, February 20, 1992.

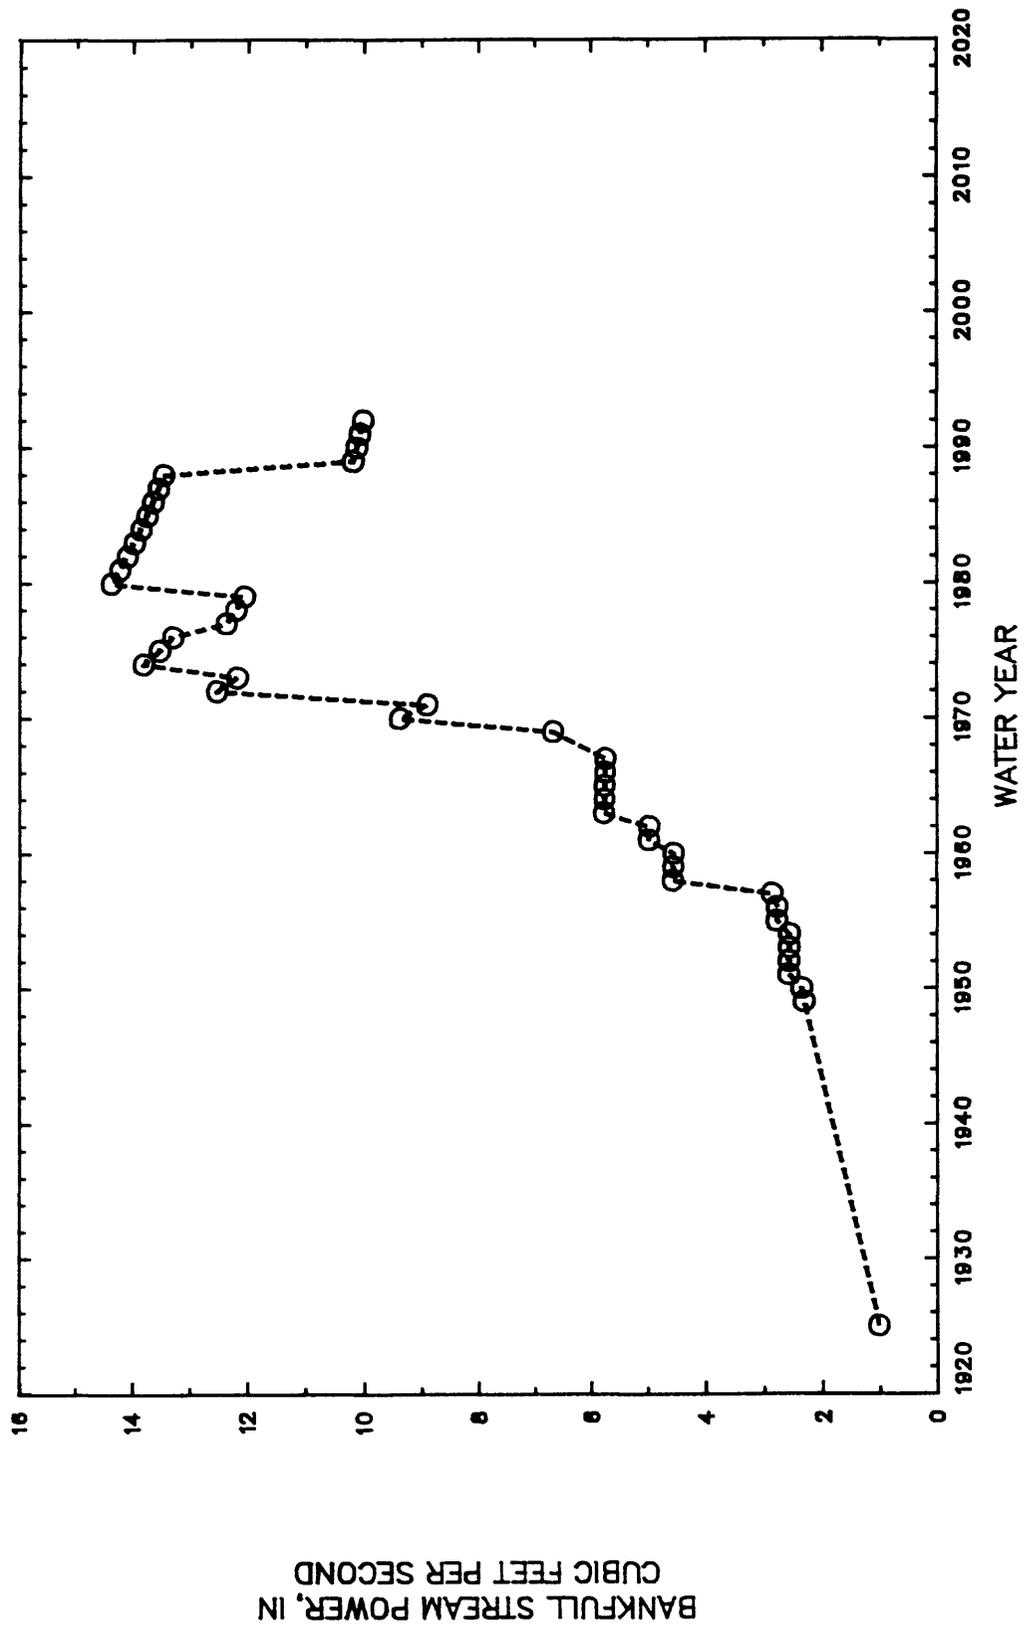
As previously described, bankfull stream power is dependent on the bankfull discharge and slope, which have changed significantly since 1925 (fig. 16). Due to degradation and widening in response to channel modifications, the bankfull stream power has increased about 880 percent from 1925 to 1992, when bankfull discharge increased about 1,450 percent and channel slope decreased about 34 percent. Stream power increased about 126 percent from 1925 to 1949, increased about 24 percent from 1949 to 1957, and increased about 132 percent from 1957 to 1969. For the period 1969-92, stream power reached a maximum of 14.4 ft³/s in 1980, but since 1980, the stream power has decreased about 31 percent to 10.0 ft³/s, possibly indicating channel adjustment processes have progressed upstream.

Figure 16.--Bankfull stream power for Skuna River Canal at State Highway 9 at Bruce, Mississippi.

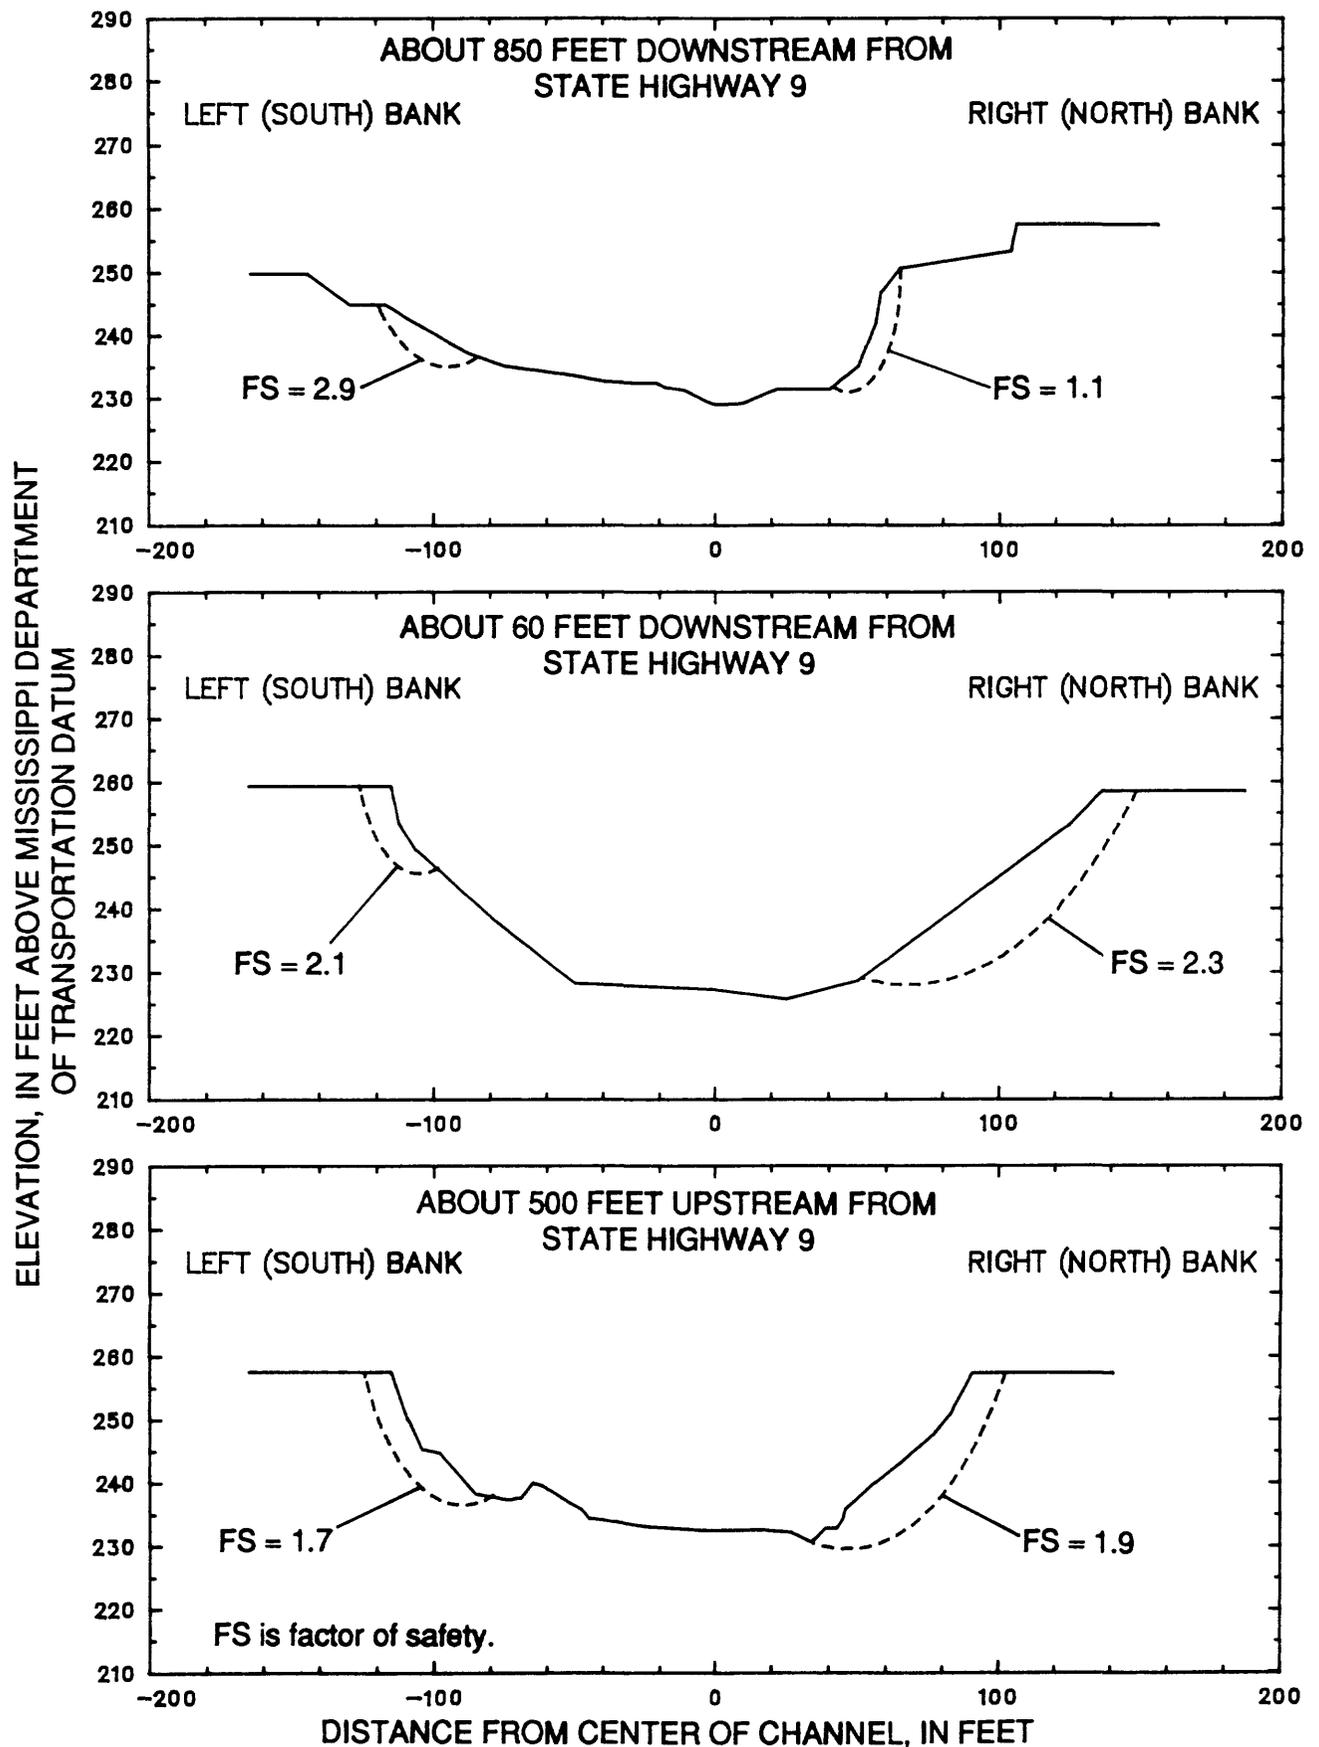
Analyses of both planar and rotational bank failures indicated that rotational bank failures were more likely to occur. Using streambank classification schemes of Taylor (1948) and Lohnes and Handy (1968), bank angles greater than 60 degrees are considered steep banks and angles less than or equal to 60 degrees are considered gently sloping banks. According to Osman and Thorne (1988) and Simon and Hupp (1991), steep bank slopes generally fail along a more planar surface; whereas, gently sloping banks generally fail along a curvilinear or rotational failure surface. Factors of safety and bank-failure block widths are presented in table 5. For saturated conditions (soil condition 2, table 5), failure block widths were as much as 11 ft for Skuna River Canal (fig. 17) and as much as 4 ft for Old Skuna River (fig. 18), and factors of safety ranged from 1.1 to 2.9 for Skuna River Canal and 1.0 to 1.5 for Old Skuna River. The computed failure-block widths compared reasonably well with failure-block widths observed in the field. For Skuna River Canal, the analyses indicate the left (south) bank 850 ft downstream from State Highway 9 is the most stable, and the right bank 850 ft downstream is the most unstable. For Old Skuna River, the right (north) bank is more stable than the left bank at 130 ft upstream from State Highway 9.

The results from the UTEXAS2 computer program indicate possible tension cracks forming in the upper part of all banks analyzed, except for the left bank of the canal 850 ft downstream from State Highway 9. When tension cracks occur at the top of cohesive banks, the shear strength of the bank material is reduced, which causes the bank to be more susceptible to failure. No tension cracks have recently been observed at this site; however, to estimate the effects of possible tension cracks, a tension crack depth of 5 ft was used (soil condition 3, table 5). The factors of safety for Skuna River Canal were decreased to 1.3, 1.1, and 0.8 for the cross sections located 500 ft upstream, 60 ft downstream, and 850 ft downstream, respectively. The factor of safety for Old Skuna River was decreased to 0.5 for the cross section located 130 ft upstream. The most significant reduction of the factor of safety was from 2.1 to 1.1 at the left bank located 60 ft downstream from State Highway 9. The possible formation of tension cracks in the upper part of the streambank greatly affects the stability of the streambank. Thorne and others (1981) determined tension cracks play an important role in controlling the stability, critical mode of failure, and limiting height of steep streambanks in northwestern Mississippi.

Figure 17.--Cross sections showing critical failure surfaces for saturated channel banks on Skuna River Canal in the vicinity of State Highway 9 at Bruce, Mississippi, 1989.

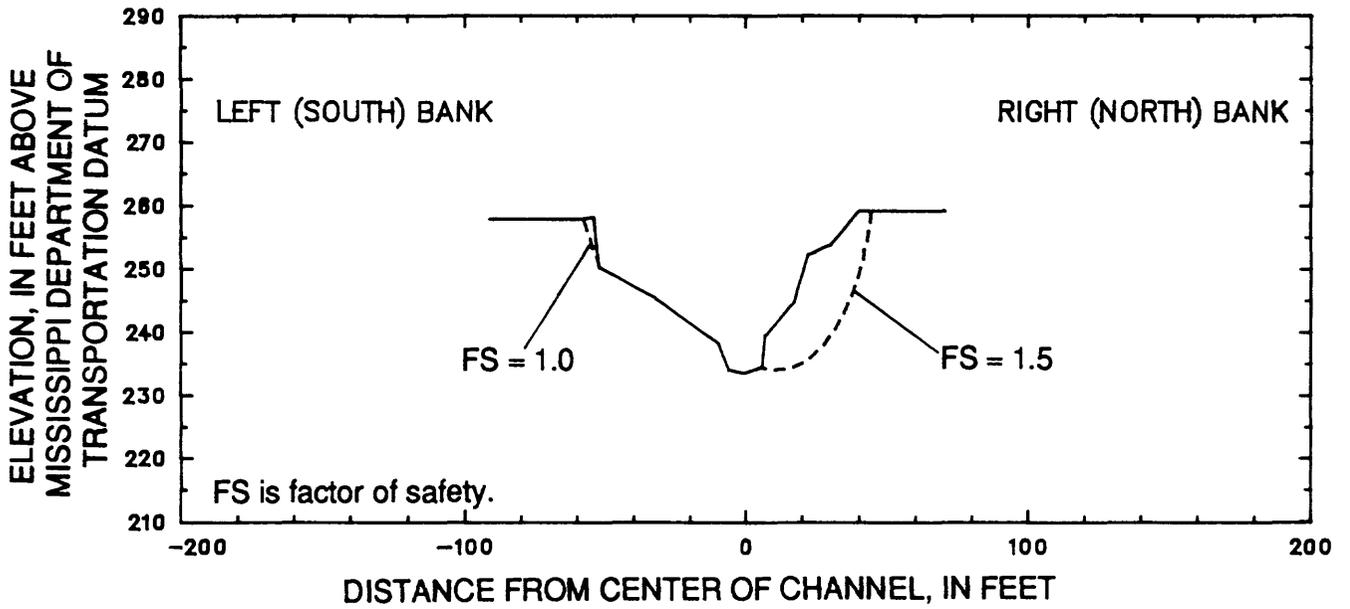
Figure 18.--Cross section showing critical failure surfaces for saturated channel banks on Old Skuna River about 130 feet upstream from State Highway 9 at Bruce, Mississippi, 1989.
