EROSION ASSESSMENT AT THE PETROGLYPH NATIONAL MONUMENT AREA, ALBUQUERQUE, NEW MEXICO

U.S. GEOLOGICAL SURVEY

Water-Resources Investigations Report 94-4205

Prepared in cooperation with the
NATIONAL PARK SERVICE

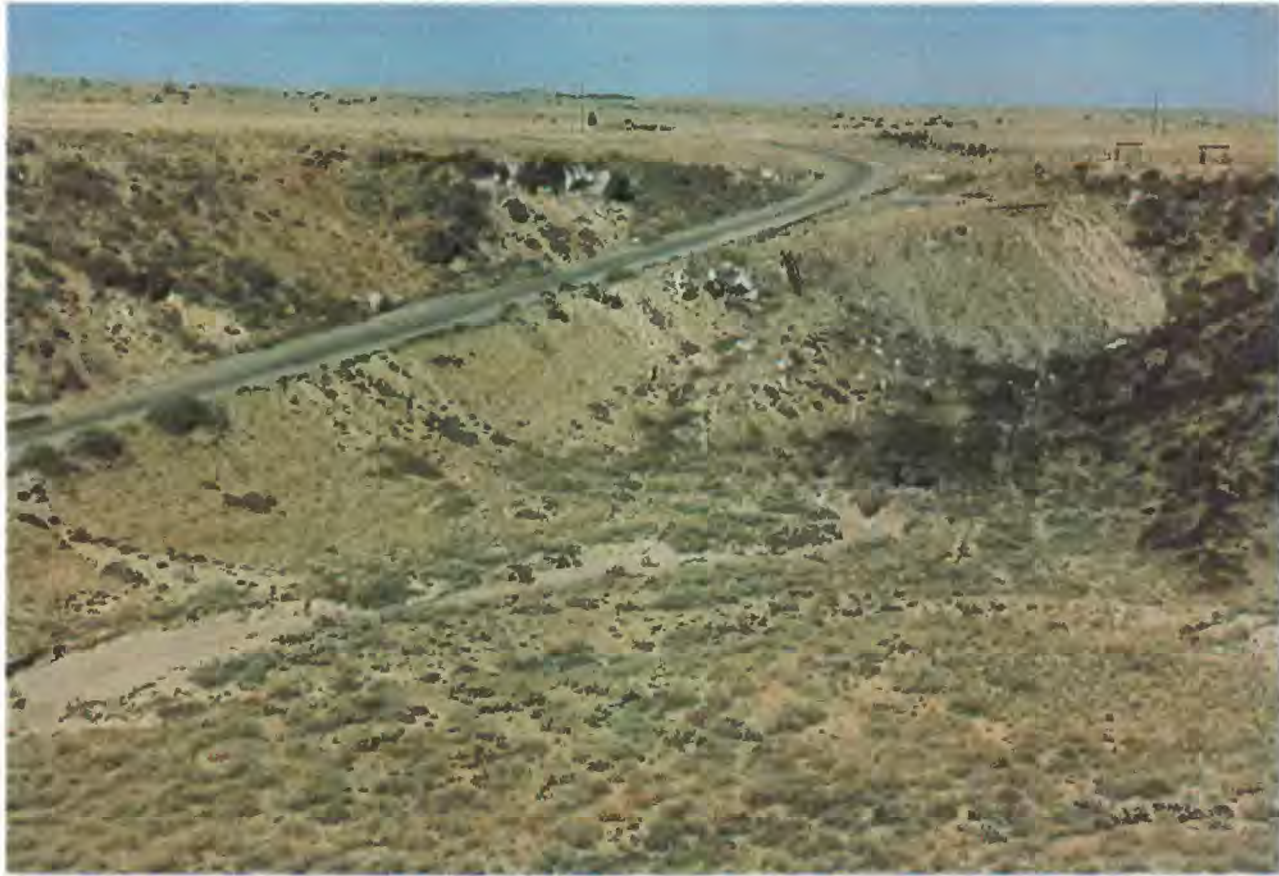
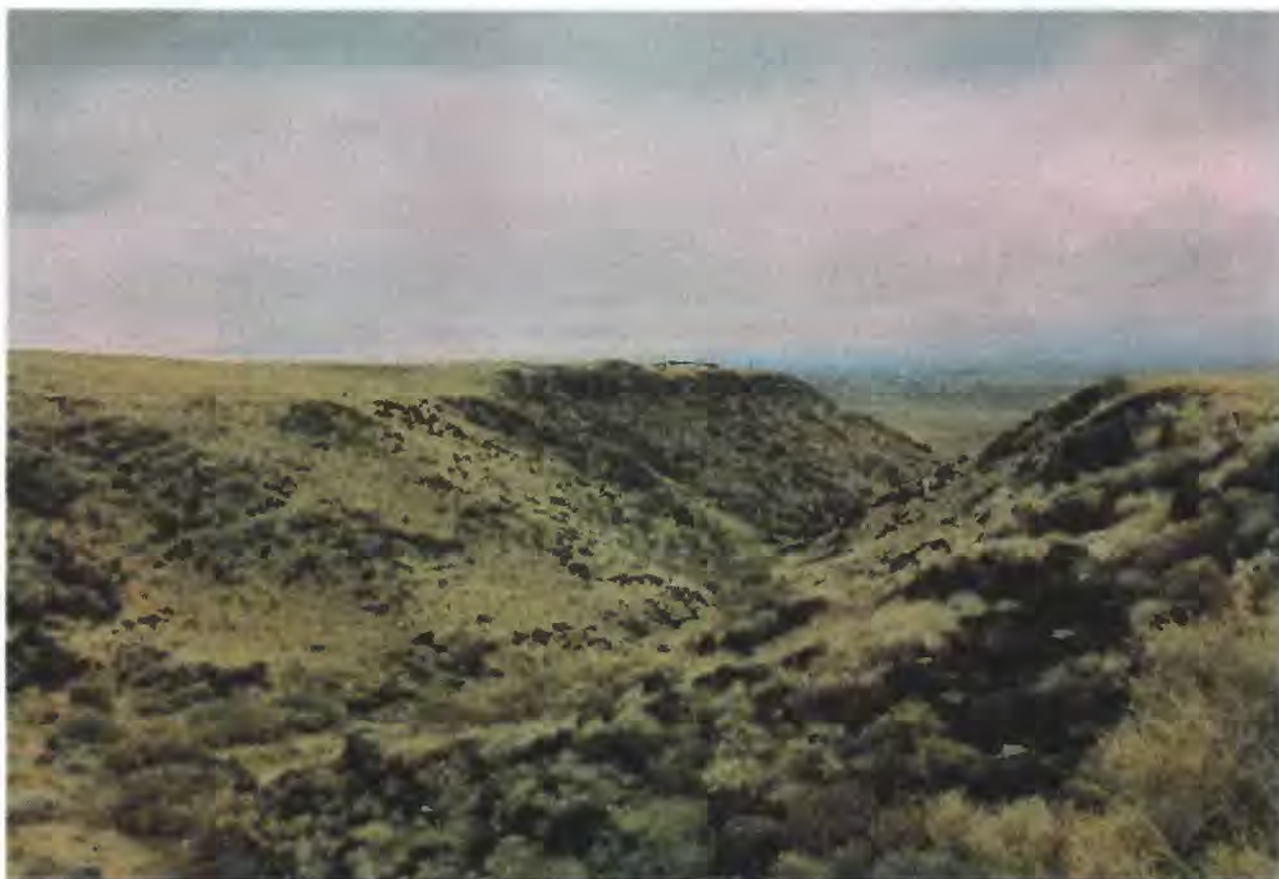
In the West Mesa escarpment there may be a relation between gully density and vegetative cover. The northern areas of the escarpment have less dense vegetative cover than the southern areas and a higher occurrence of gullies (figs. 7 and 8). Of the 50 gullies identified, 37 gullies, or about 75 percent, are located in the northern area of the escarpment between escarpment mile 0 and mile 9 (fig. 7). Housing communities are adjacent to and downgradient from the northern areas of the escarpment. Local residents use the foot and bike trails to reach the top of the mesa. Many of the gullies described in table 1 are located on these trails. Foot and bike traffic on the vegetation in northern parts of the escarpment might be decreasing the vegetative cover and promoting gullying. The number of gullies per square mile decreases slightly around escarpment mile 9; however, the density of gullies decreases even more around escarpment mile 12 (fig. 7). Mile 12 is south of the Marsh Peninsula (fig. 1) where there are fewer housing subdivisions.

Figure 8.--Contrasts in vegetation density from the northern to the southern areas of the escarpment. (A) Low vegetation density in the La Boca Negra Arroyo Canyon (site 43). (B) High vegetation density in the Rinconada Canyon area (site 81). (See figure 5 for location and table 1 for detailed characteristics.)

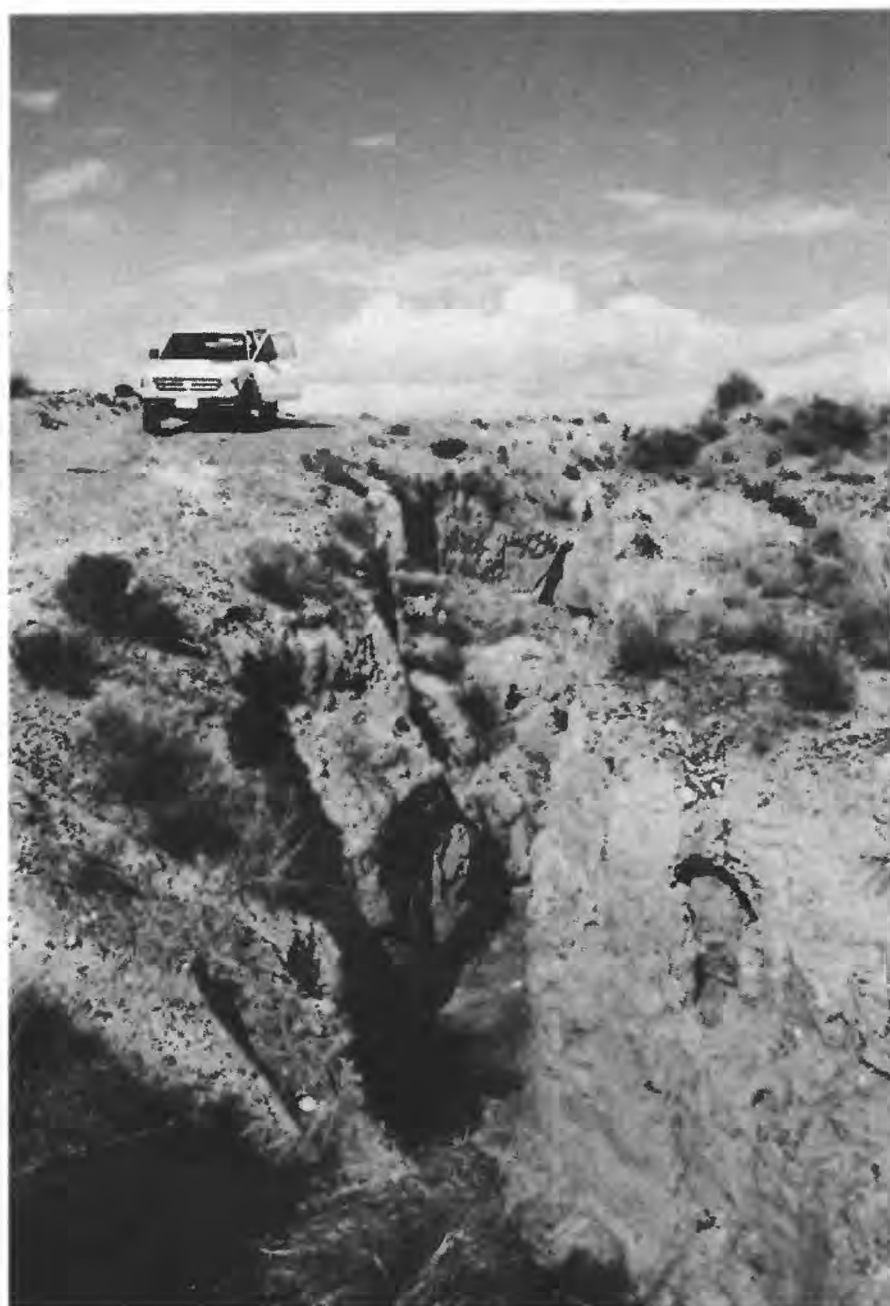
The northern areas of the escarpment also have a denser network of dirt roads near the edge of the mesa than the southern areas. Rills and gullies in these dirt roads indicate that the roads channel surface flow (fig. 9). During a storm, runoff down these dirt roads can overtop low points in the road and spill over the edge of the mesa, which often is close to the roads. Thirty of the 50 gullies were identified as being connected by surface drainage to these mesa roads. Therefore, observations suggest that the dirt roads channel surface runoff, causing erosion in the road bed and delivery of surface runoff over the mesa that can incise into the unconsolidated material found at the escarpment.

Figure 9.--Gullying near a dirt road at the Petroglyph National Monument, site 102.

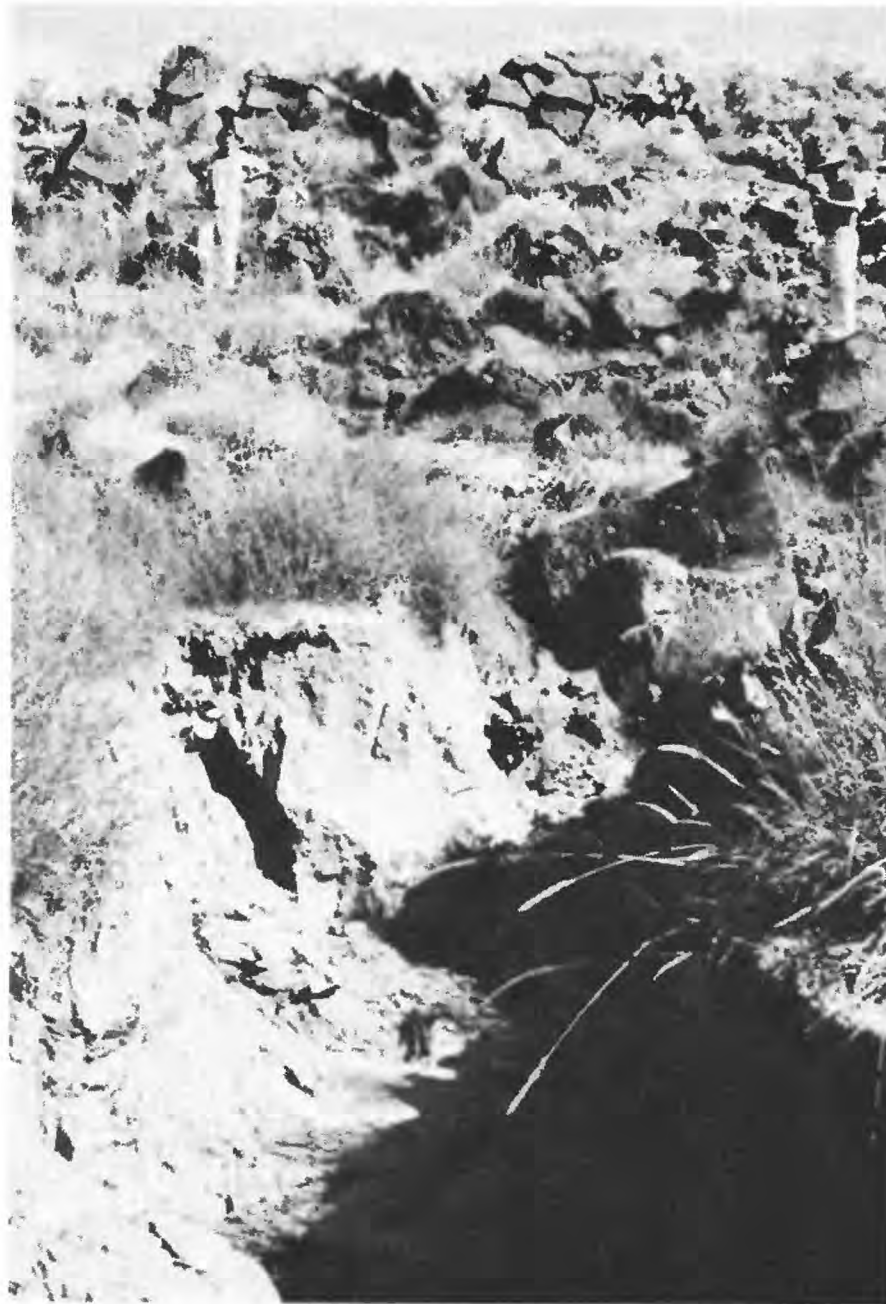
The gully at site 1 (fig. 6) in Piedras Marcadas Canyon is approximately 300 feet long (fig. 10). Nineteen cross sections were surveyed and two cross sections, 12 and 19, had elevation-reference marks emplaced for the purpose of resurveys (fig. 11). The lower reaches of the gully, from cross sections 1 to 5, have a relatively flat slope and a poorly defined channel. From cross section 6 to 16 the gully is incised into a loamy-sandy soil, and an active headcut is located upgradient from cross section 13. Cross section 14 is at the mouth of a tributary gully on the left bank and cross section 15 is at a tributary on the right bank. Upgradient from cross section 15 to just downgradient from cross section 19, the gully loses its form. Gullying is absent in this portion of the drainage because soils are lacking and bedrock and boulder outcroppings line the hillslope. On top of the mesa, at cross section 19, the gully is again incised into a loamy-sandy soil. A longitudinal profile of the gully (fig. 12A) shows an increase in gully gradient in an upstream direction. Width-to-depth ratios along the profile indicate a general widening in a downstream direction (fig. 12B). Reaches that are further downstream and away from the headcut might be closer to obtaining a new equilibrium condition than reaches immediately downstream from the headcut. Gully 1 was assigned an erosion classification of Class II (fig. 6; table 1).

Figure 10.--Gully viewed upstream at site 1. [See figure 5 for location and table 1 for detailed characteristics.]

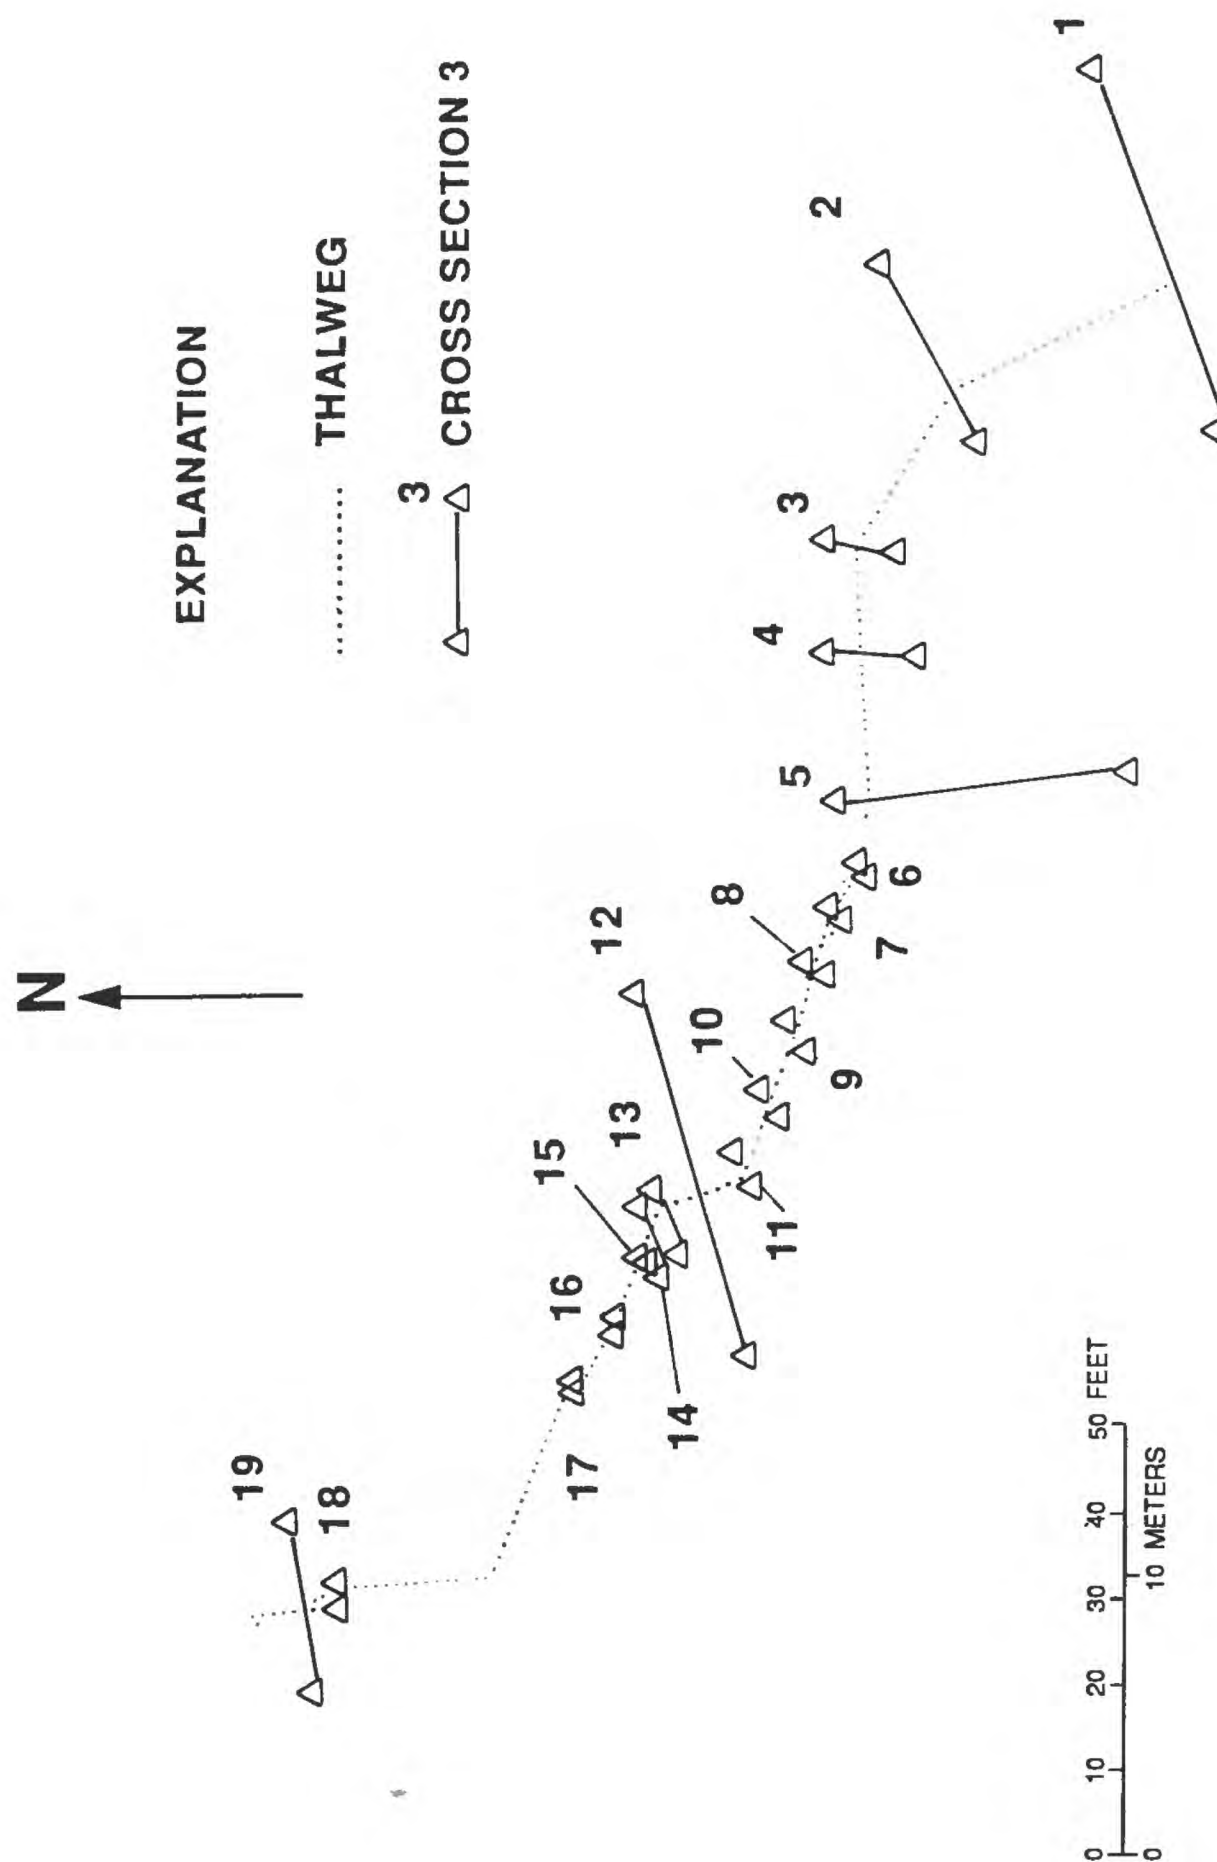
Figure 11.--Main gully channel and surveyed cross sections for site 1. [See figure 5 for location and table 1 for detailed characteristics.]

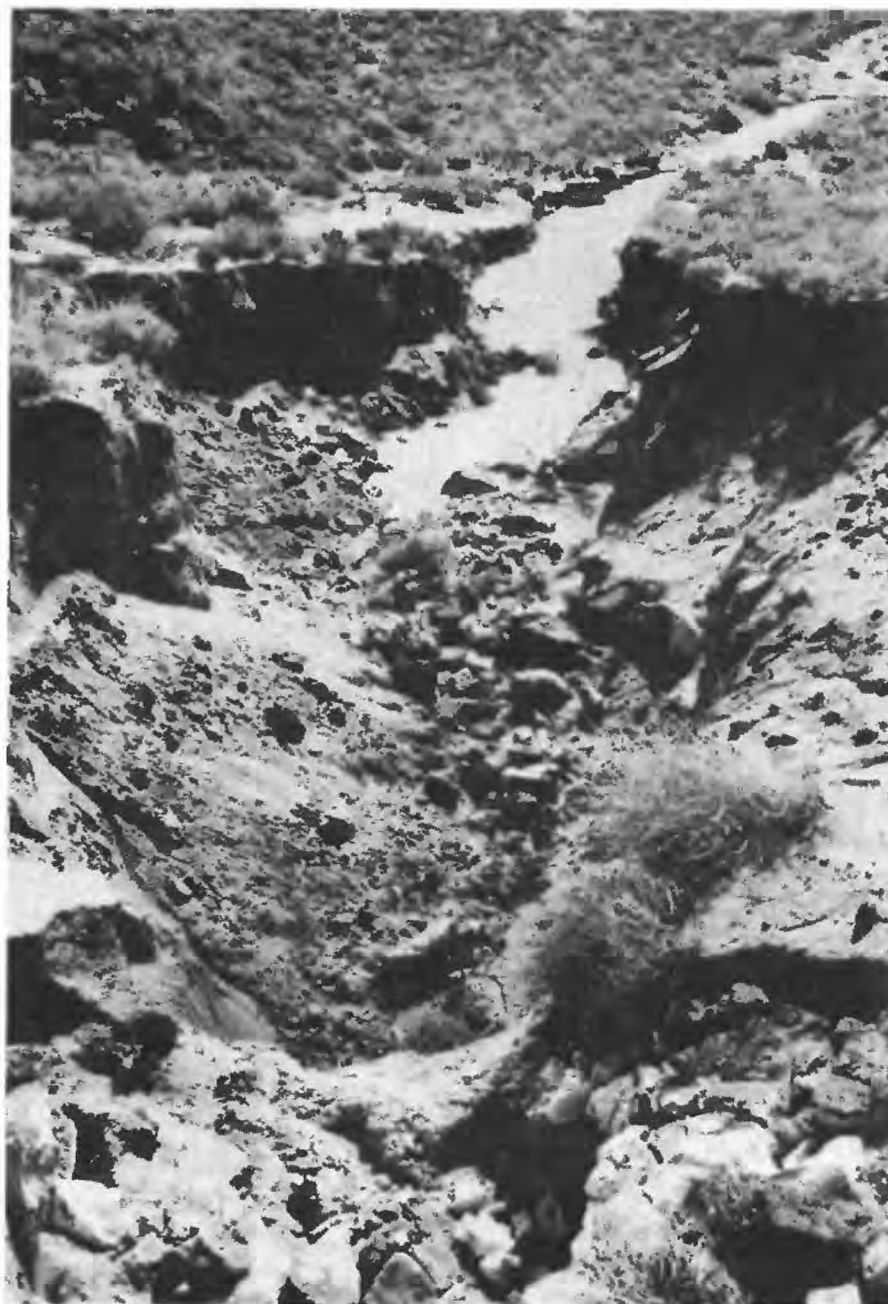
The gully at site 2 (fig. 6) is immediately east of site 1. This gully had the most incision of any gully observed in the study area and was assigned an erosion classification of Class IV. A gully at site 2 viewed downstream is shown in figure 13. The gully is approximately 300 feet long. Ten cross sections were surveyed in the main gully and a tributary that enters the gully from the left bank (fig. 14). At three of these cross sections, 3, 8, and 9, elevation-reference marks were established. The longitudinal profile of the gully indicates a gradual decrease in gradient downstream from the headcut below cross section 10 (fig. 15A). In a similar fashion to gully 1, width-to-depth ratios increase downstream from the headcut (fig. 15B).

Although a gully was observed at site 2 before the summer of 1991, monument officials observed that the gully eroded appreciably during the summer of 1991 (Larry Beal, National Park Service, oral commun., 1992). Runoff from the Paradise Hills area is routed into the monument by means of a 1,500-foot Paradise Hills trench. Heavy runoff during the summer probably flowed down the trench, spread onto the dirt roads, and further eroded gully 2.

Figure 13.--Gully viewed downstream at site 2. [See figure 5 for location and table 1 for detailed characteristics.]

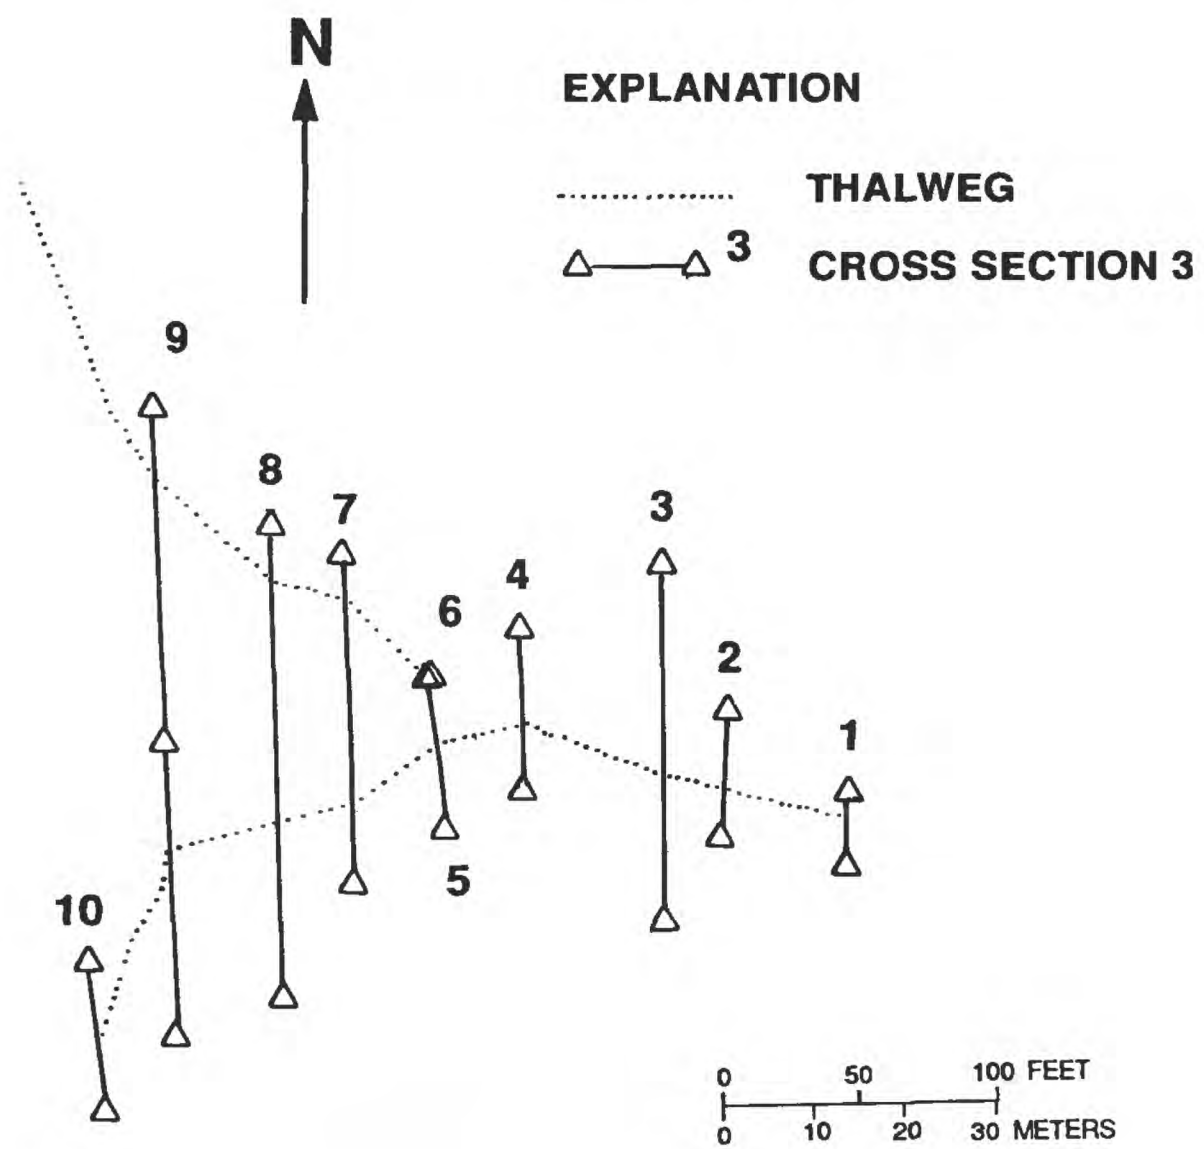
Figure 14.--Main gully channel and surveyed cross sections for site 2. [See figure 5 for location and table 1 for detailed characteristics.]

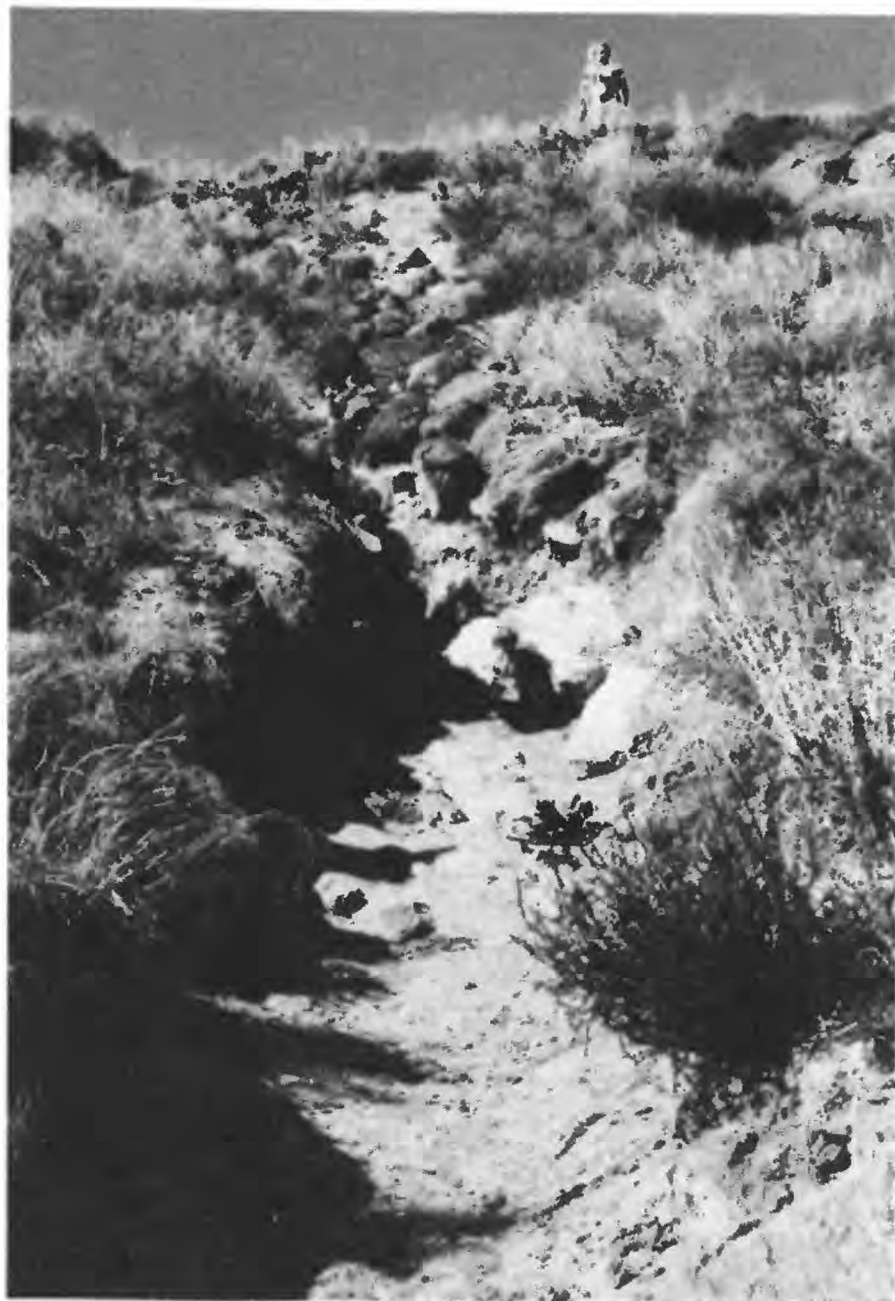
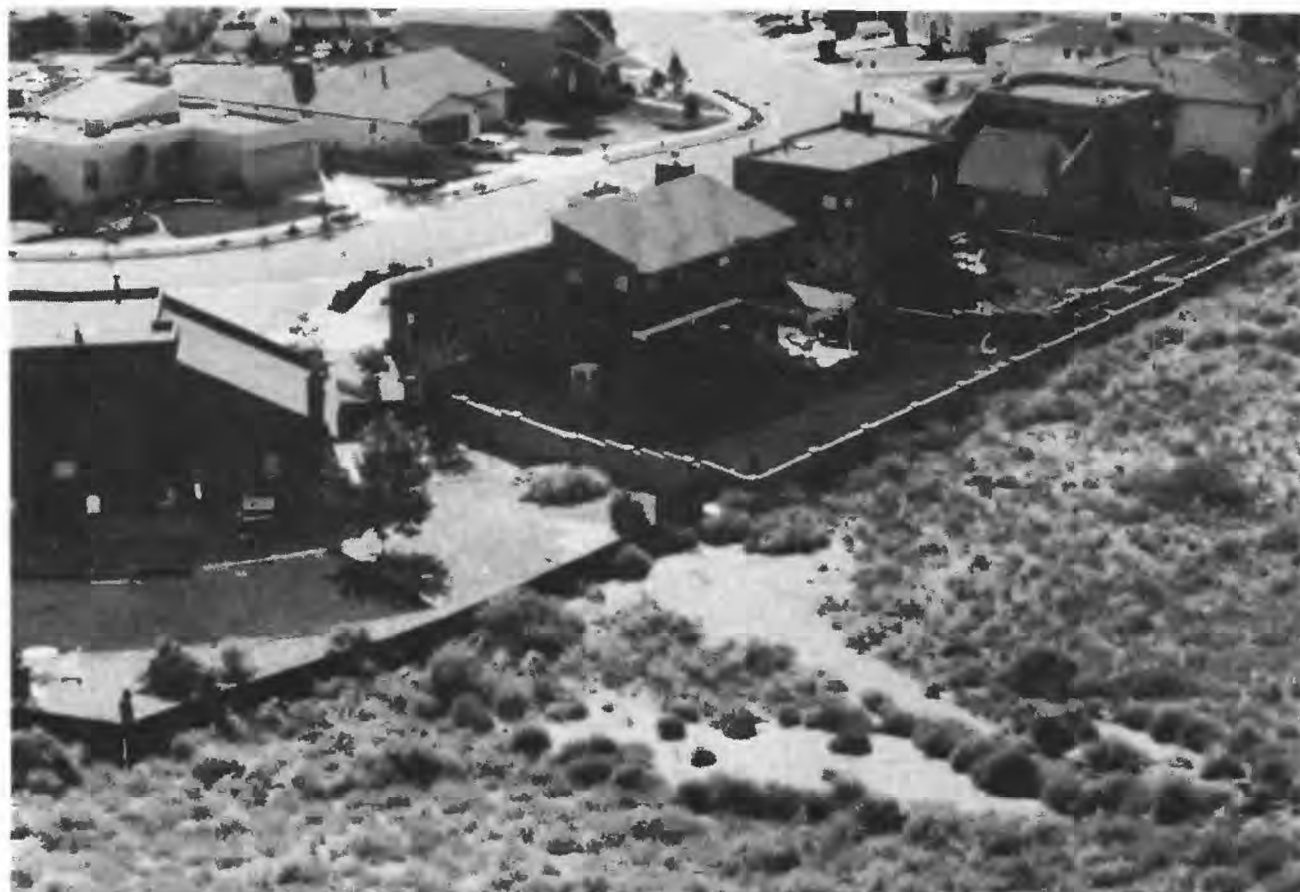
The gully at site 32 (fig. 16A) is approximately one-half mile north of the monument (fig. 6). Several houses are immediately below the gully. As figure 16B indicates, the gully is depositing sediment into the backyard of one of the nearby residences. Nine cross sections were surveyed in this gully (fig. 17). At three of these cross sections, 3, 8, and 9, elevation-reference marks were established for future surveys (fig. 17). An active headcut is located in the gully downgradient from cross section 7. The longitudinal profile of the gully indicates a lowering of slope below the headcut (fig. 18A). Immediately below the headcut, the channel is relatively deep. Width-to-depth ratios generally increase above the headcut and at a distance downstream from the headcut (fig. 18B). These changes in width-to-depth ratios in this gully are slightly different than those observed in the other surveyed gullies. Eventually, as the headcut moves further upstream, the depth will increase, which will cause the width-to-depth ratio to decrease.

Figure 16.--(A) Gully viewed upstream at site 32. (B) Deposition from gully at site 32.
[See figure 5 for location and table 1 for detailed characteristics.]

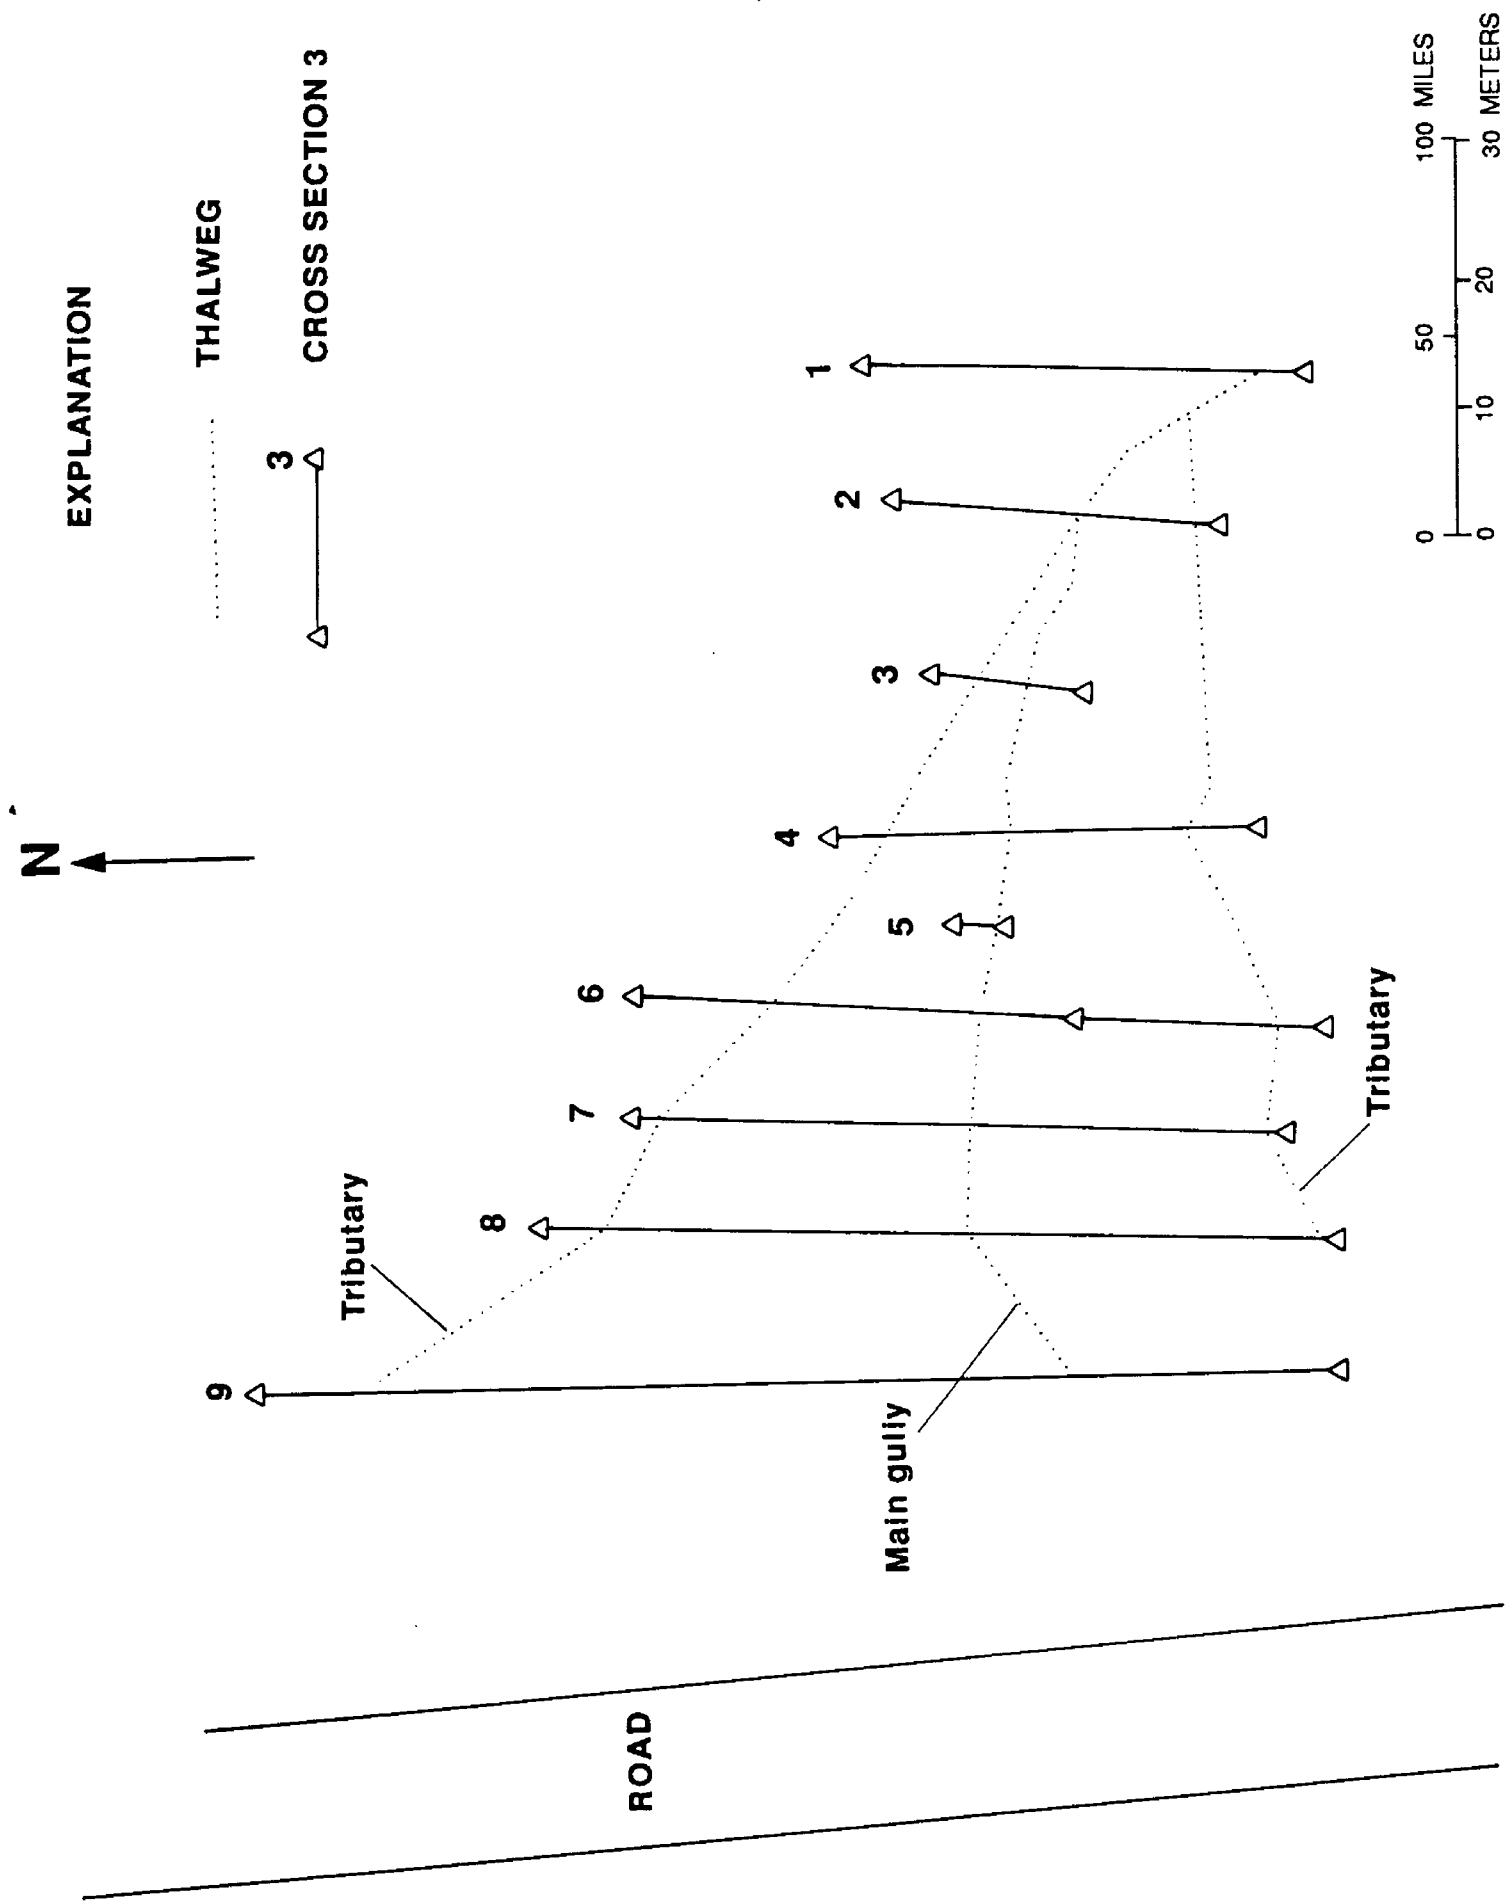
Figure 17.--Main gully channel and surveyed cross sections for site 32. [See figure 5 for location and table 1 for detailed characteristics.]
