# Hydrogeology and Deformation of Sandbars in Response to Fluctuations in Flow of the Colorado River in the Grand Canyon, Arizona

U.S. GEOLOGICAL SURVEY  
Water-Resources Investigations Report 95—4010

Prepared in cooperation with the  
BUREAU OF RECLAMATION

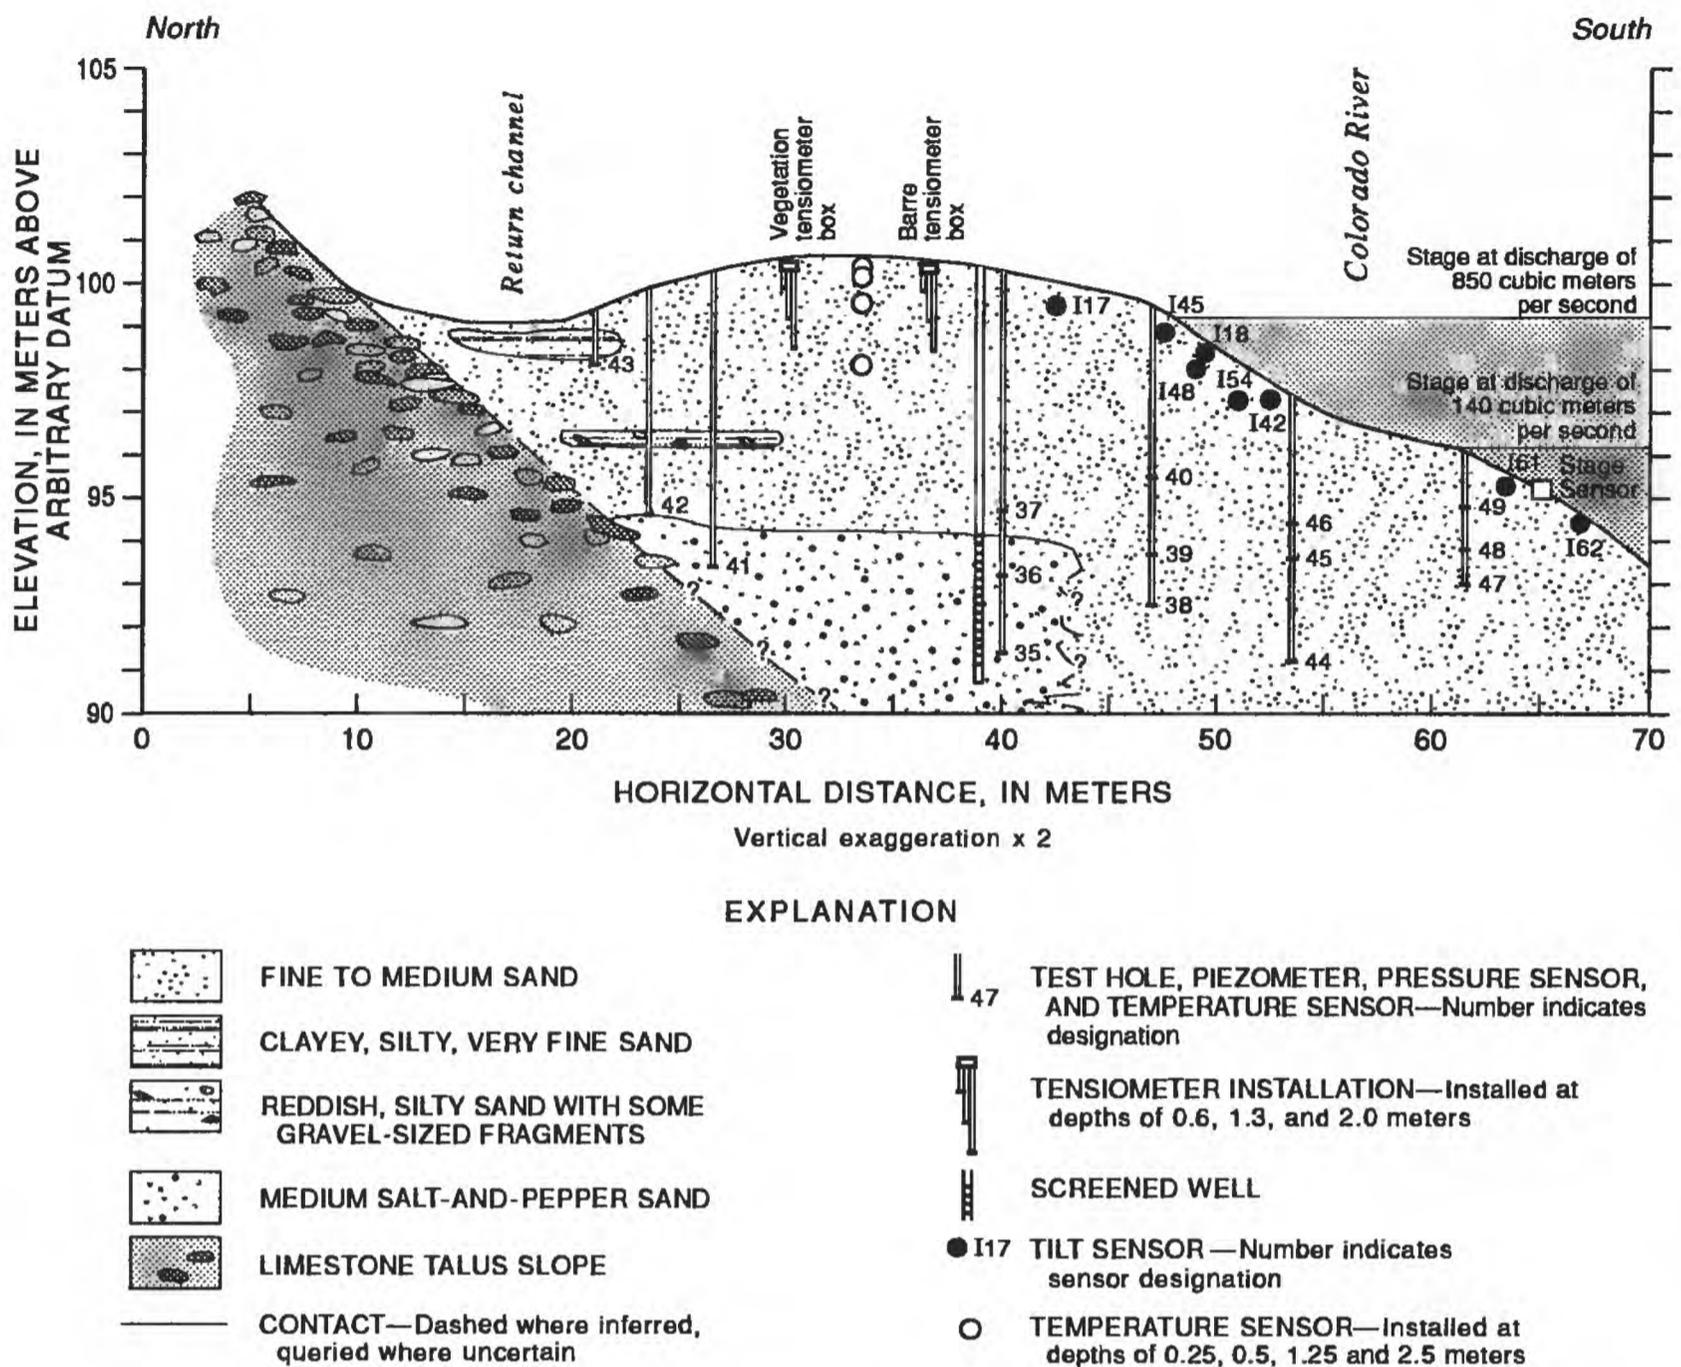
Figure 3. Geologic section and location of sensors at sandbar 43.1L, opposite Anasazi Bridge.

Sandbar 43.1L (fig. 3) consisted of homogeneous fine to medium sand overlying medium salt-and-pepper sand at a depth of 6 m. The back boundary was talus with a narrow, deep return channel underlain by a thin, clayey silty sand. A

second reddish, silty sand with some gravel occurred at a depth of about 4 m in the back of the sandbar. The zone of fluctuating river stage was a steeply sloping face that exhibited rill erosion, slumping, and fissuring.

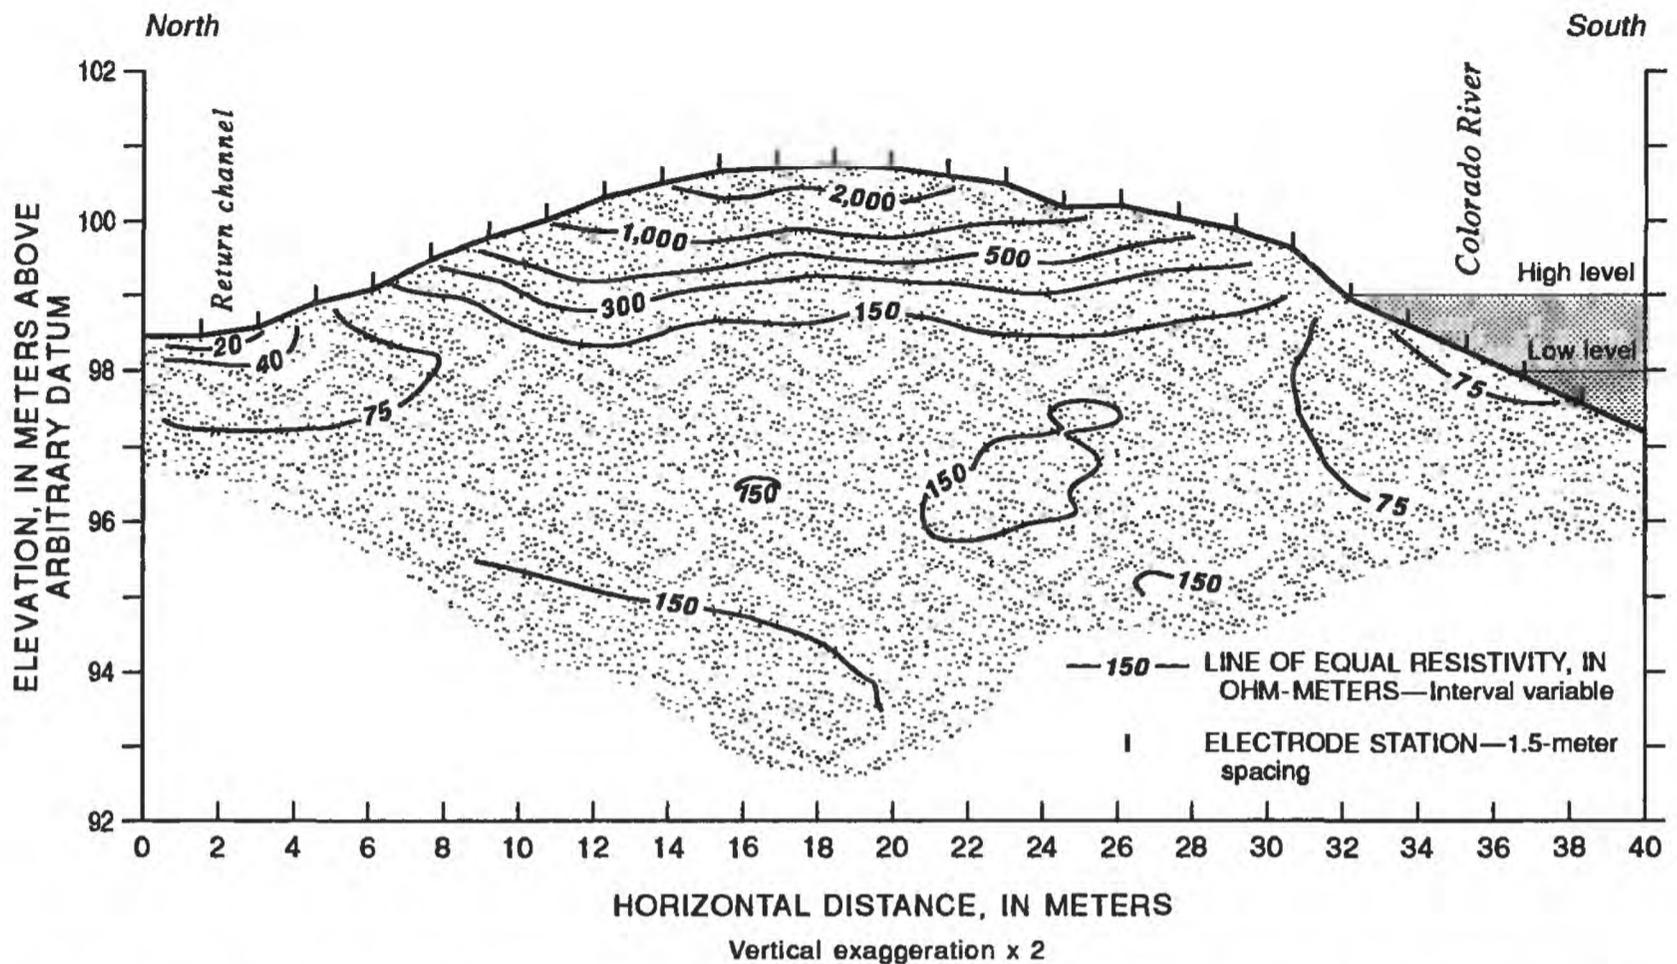
**Figure 4.** Modified logarithmic pseudosection of apparent resistivity referenced to land surface at sandbar 43.1L, opposite Anasazi Bridge, August 1991.

Apparent resistivities ranged from 50 to more than 2,000 ohm-meters ( $\Omega$ -m). The high apparent

resistivities were related to the dry-sand part of the sandbar that underlay approximately 18 m of the line. Data from the central part of the line were block-averaged and modeled using one-dimensional methods. Modeling results indicated that the dry sand had a true resistivity of about 3,800  $\Omega$ -m and a thickness of about 1.6 m (fig. 5, table 1). This thickness correlated well with the elevation of the dry-sand part of the sandbar above the average stage of the river during the measurement period. Low apparent resistivities occurred on both ends of the line where electrodes were either occasionally submerged in the river or in the return channel. Apparent resistivities in these areas ranged from 40 to 50  $\Omega$ -m, suggesting that the river-water resistivity was not any greater than

50  $\Omega$ -m. (A resistivity of 50  $\Omega$ -m is equivalent to an electrical conductivity of 200  $\mu$ S/cm.) Resistivity values of about 40  $\Omega$ -m occurred in the return channel. These resistivity values probably were lower than the river water because of the clay content in the sediments underlying the return channel or greater dissolved solids in the stagnant return-channel water.

The low apparent near-surface resistivities at the ends of the line also were reflected in the middle layer, for which modeling suggested a true resistivity of  $50 \pm 20$   $\Omega$ -m and a thickness of  $8.5 \pm 4.0$  m. The middle layer was inferred to represent saturated sand and the overlying capillary zone.

Modeling yielded a higher true resistivity for the third layer that may represent electrical bedrock. The maximum depth penetrated by any of the piezometers was approximately 10 m. Bedrock was not encountered nor was there any significant change observed in grain size that might indicate penetration of a basal gravel or talus. On the basis of the resistivity data, bedrock may have been just

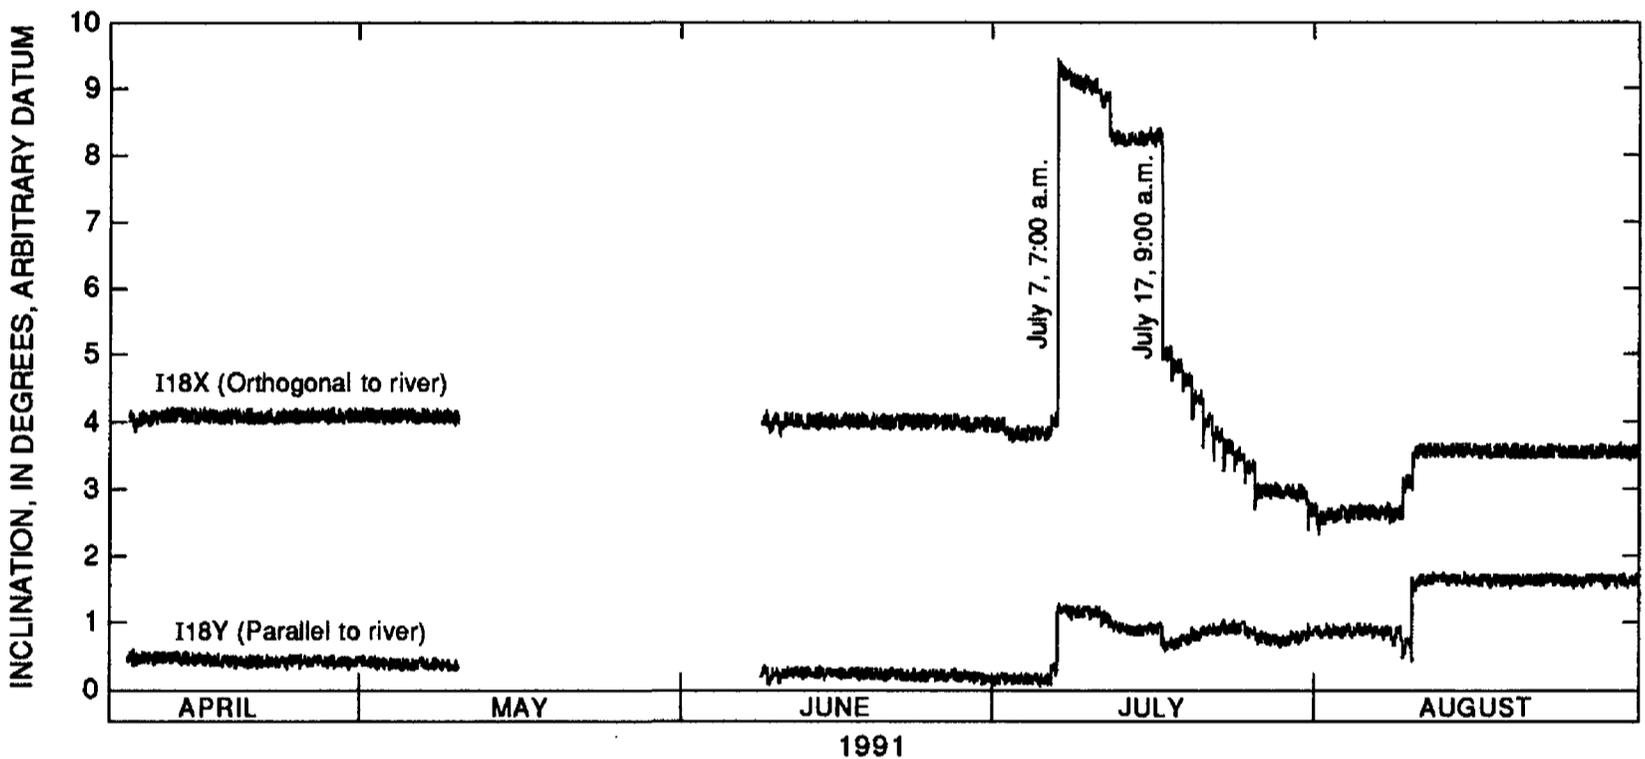
Figure 6. Tilt for sensor I18 at sandbar 43.1L, opposite Anasazi Bridge, April 8 through August 31, 1991.

At sandbar 43.1L, a sequence of tilts occurred from July 7, 1991, through July 17, 1991 (fig. 6). The tilts were at least five times greater in the  $x$  tilt sensor, which is oriented orthogonal to the river, than in the  $y$  tilt sensor, which is oriented parallel to the river. The major tilts were preceded by tilt of  $-0.1^\circ$  toward the river (along the  $x$  axis) on the morning of July 2, and tilt of  $0.1^\circ$  toward the river

on the evening of July 6. At 8:00 a.m. on July 7, tilt of  $5.5^\circ$  occurred toward the river. At 9:00 a.m. on July 12, tilt of  $-0.5^\circ$  occurred; and at 9:00 a.m. on July 17, an additional tilt of  $-3.3^\circ$  occurred. These major tilts were followed by continued negative tilt in the  $x$  sensor from July 18 to July 26, punctuated with daily spikes of about  $-0.4^\circ$  that occurred in the morning. With the single exception of the precursor positive tilt on July 6, all of the sudden tilts occurred on downward limbs of the hydrographs (figs. 7-11)

when the effective stress (intergranular stress) in the sandbar face was increasing. The hypothesis suggested by this sequence of tilts is slumping or rotational failure, in which tilt sensor I18 was within a slump block during the major upward tilt on July 7, followed by several occurrences of creep. An alternative hypothesis is slumping with tilt sensor I18 within the slump block on July 7 followed by slumping with tilt sensor I18 outside

the slump block on subsequent tilts. The sensor may have had a tendency to realign itself in a preferred orientation or may have been affected by the cable connecting the sensor to the datalogger, in spite of efforts to prevent such problems. The slope failure was shallow because none of the nearby tilt sensors—I17, I45, I48, or I54—(fig. 3) exhibited any tilt during April to July 1991. Tilt sensor I42 failed in April 1991. The probable cause of slope

failure on this sandbar was oversteepening of the lower part of the slope in the zone of fluctuating river stage. This conclusion was supported by evidence of rill erosion in daily photographs taken automatically from the opposite bank (Cluer, 1991). Rilling was enhanced during fluctuating weekend low flows (fig. 7). Rilling was intense after about 1.5 days during research steady low flows.

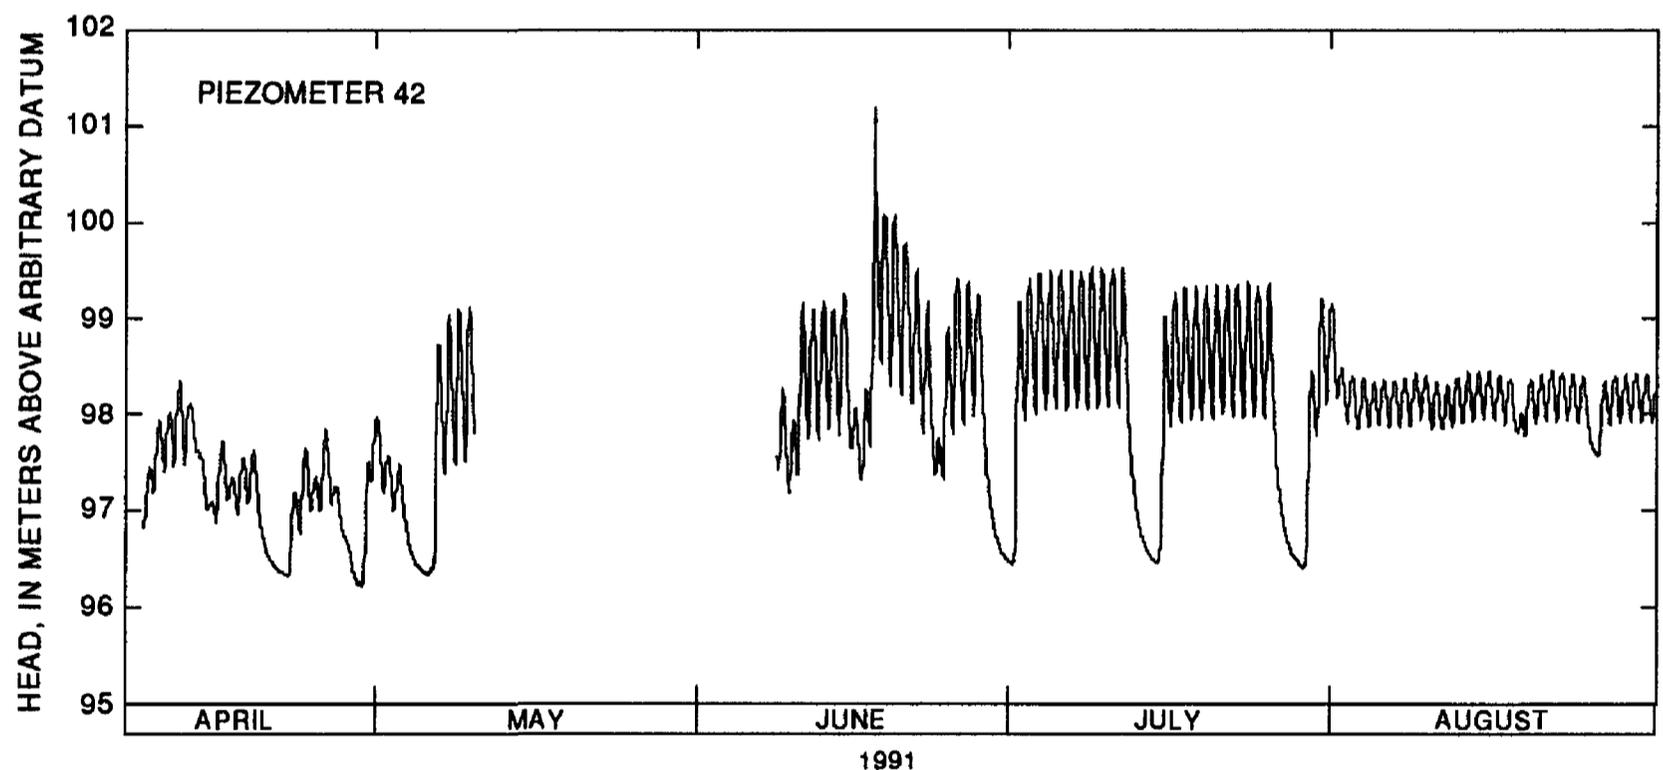
**Figure 11.** Water level in piezometer 42 at sandbar 43.1L, opposite Anasazi Bridge, April 8 through August 31, 1991.

Attenuation of water-level fluctuation from the front to the back of sandbar 43.1L was evident at piezometers 46, 40, 37, and 42 (figs. 9–11). From piezometer 46 to piezometer 42, the attenuation of fluctuating July flows was 30 percent over a distance of 30 m. The particularly high water level in piezometer 42 beginning on June 17, 1991, (fig. 11) may have been caused by hydraulic

connection to an upstream part of the return channel or overpressurization by a process such as temporary sealing of a zone accompanied by swelling of clays. Piezometer 42 exhibited no evidence for movement or failure throughout its record.

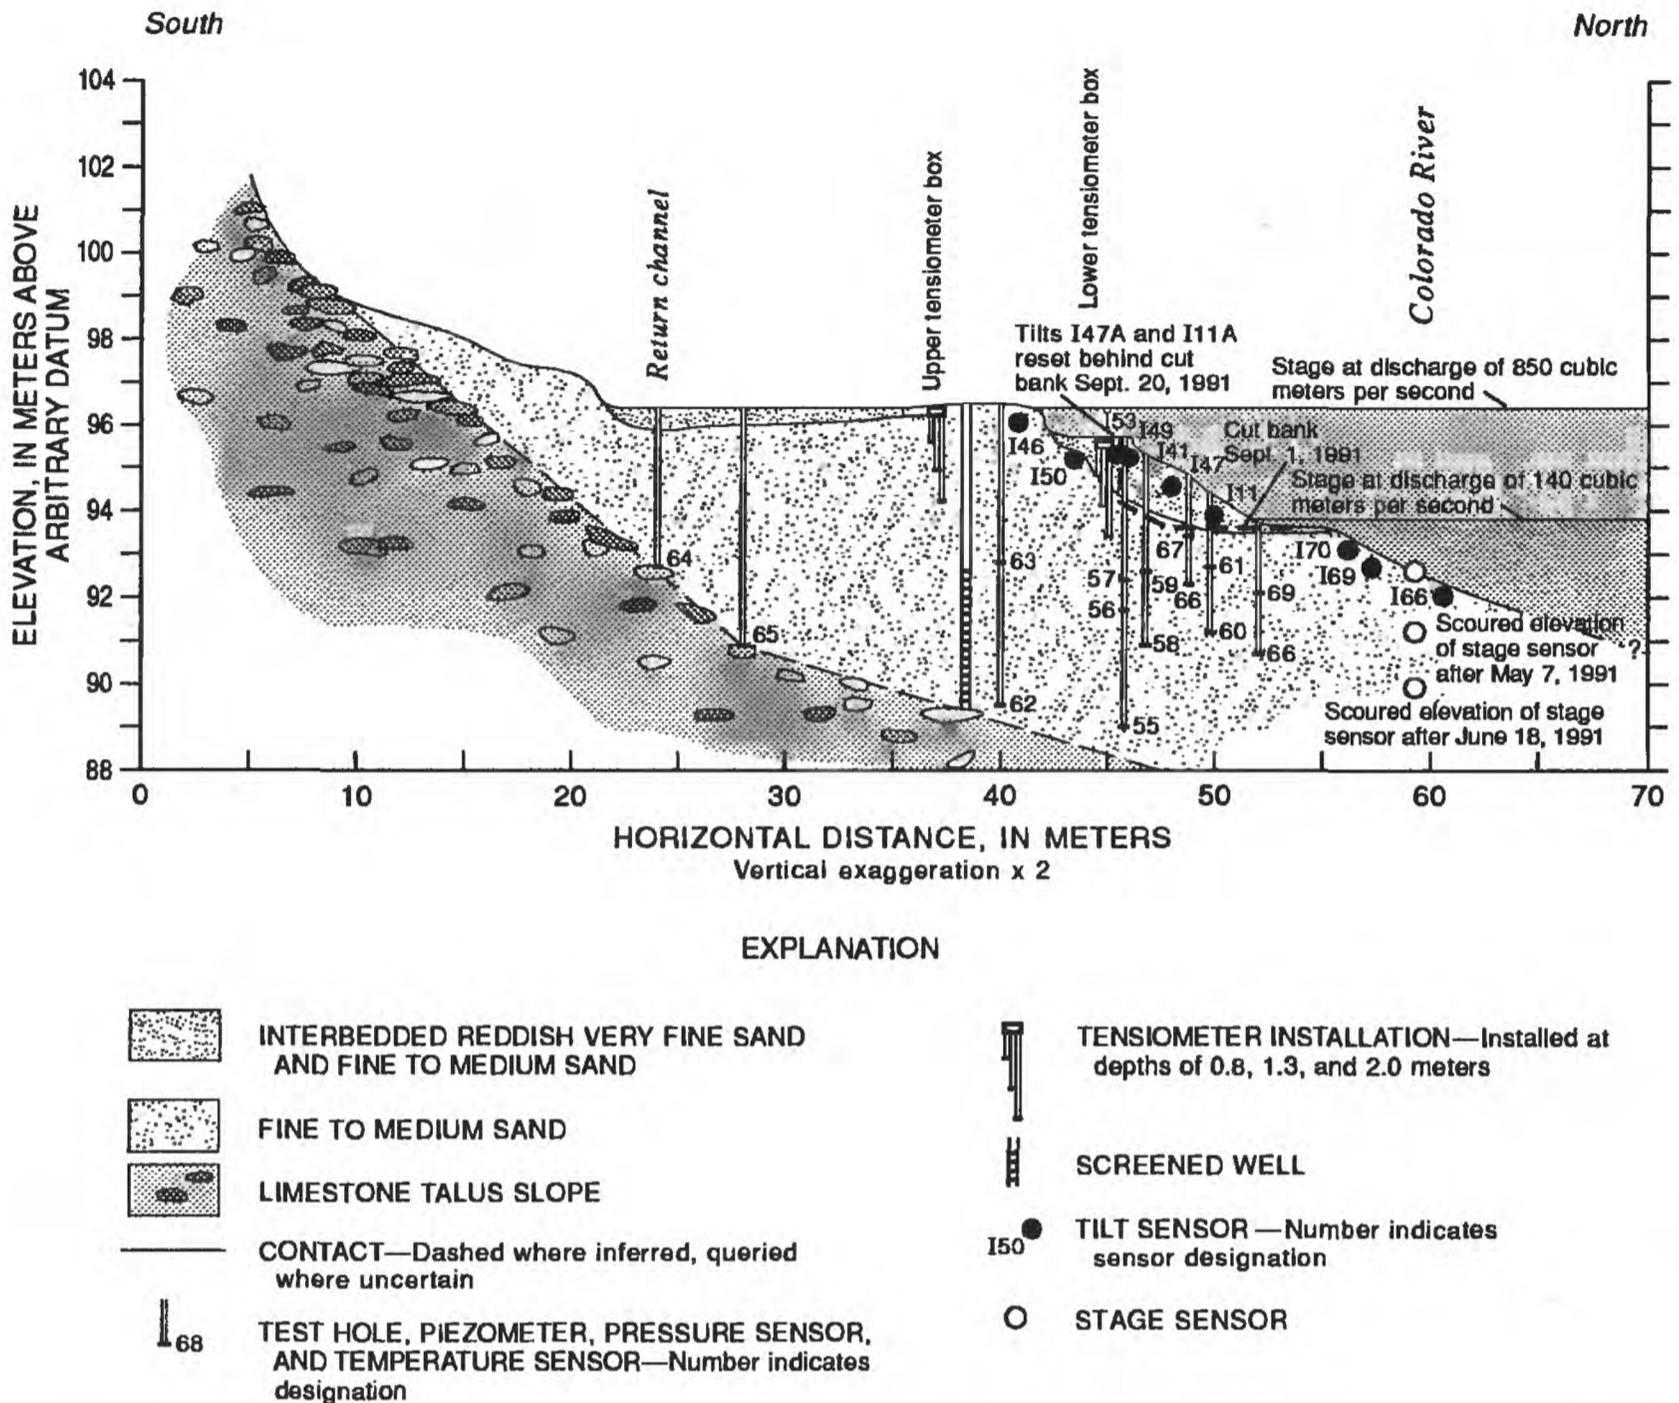
**Figure 12.** Geologic section and location of sensors at sandbar 172.3L, downstream from the mouth of National Canyon.

Sandbar 172.3L (fig. 12) consisted of inter-layered fine to medium sand and silty, very fine sand. The back boundary was talus abutted by a broad shallow return channel underlain by silty fine sand. The zone of fluctuating river stage was a steeply sloping face with a bench that was underlain by reddish, silty, very fine sand interlayered with fine to medium sand. This sandbar exhibited rill erosion, slumping, and fissuring.

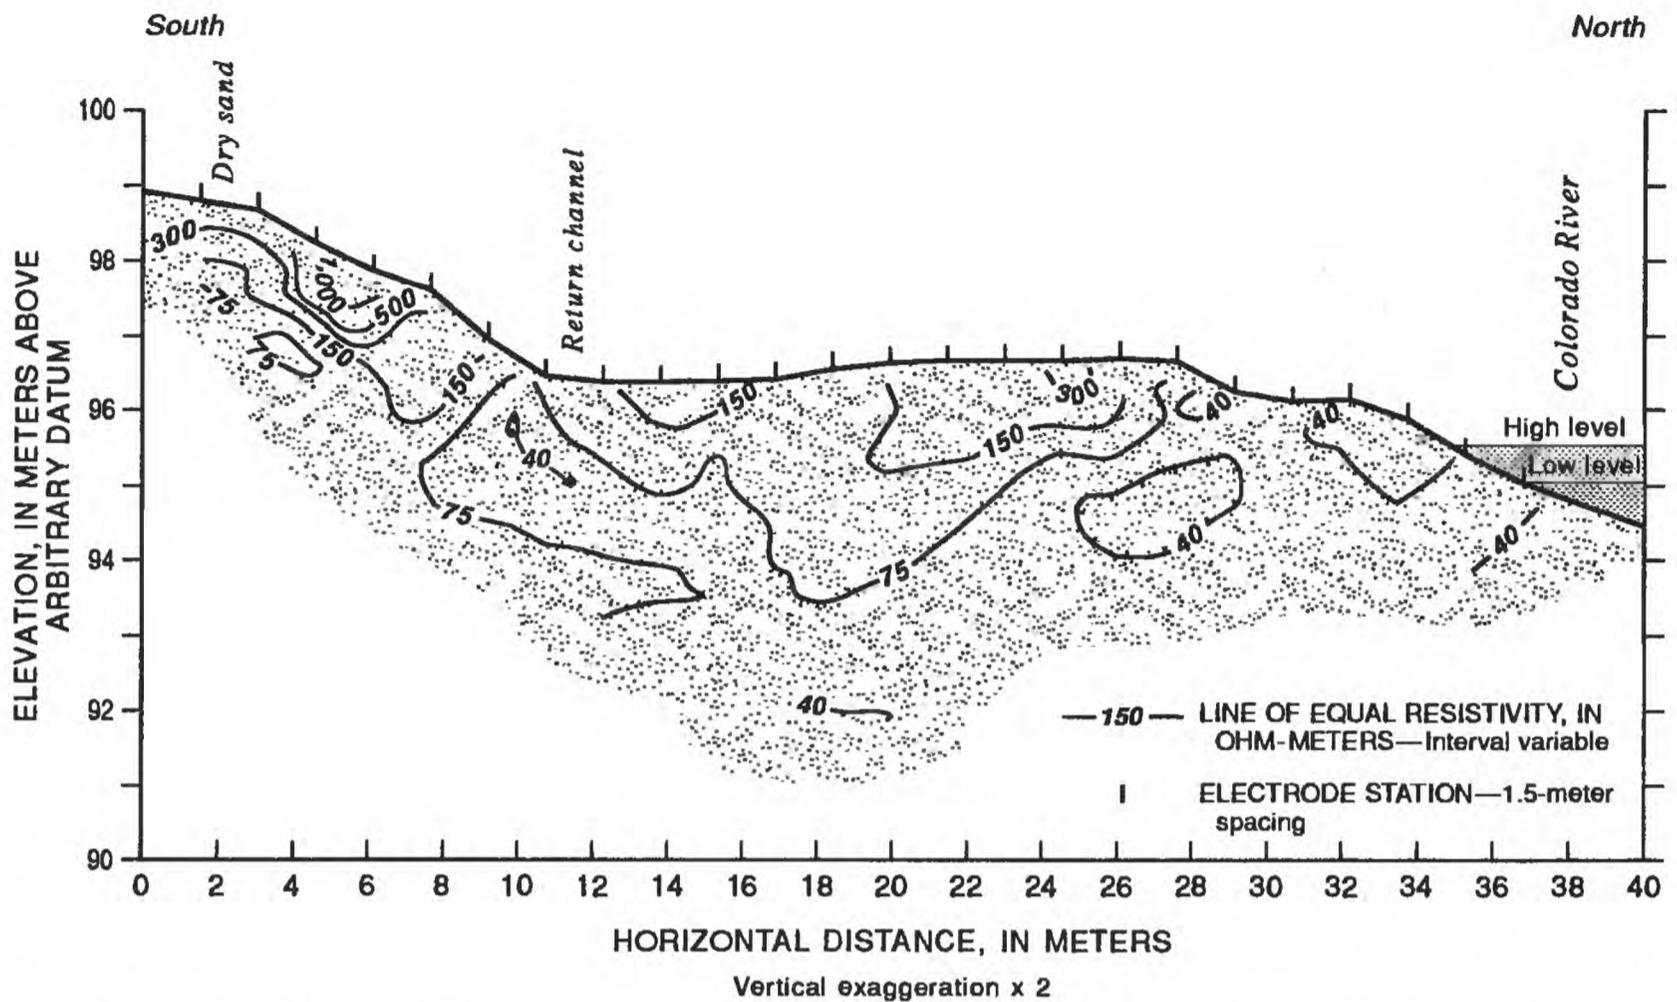
**Figure 13.** Modified logarithmic pseudosection of apparent resistivity referenced to land surface at sandbar 172.3L, downstream from the mouth of National Canyon, August 1991.

Apparent resistivities ranged from 25  $\Omega$ -m to greater than 1,000  $\Omega$ -m. The highest values were associated with dry sand at the south end of the line and near the top of the sandbar. Although the central part of the line was well vegetated and had a higher percentage of silt and clay, the associated apparent resistivities were greater than 100  $\Omega$ -m. A decrease in apparent resistivity with increasing spacing in the central part of the line suggested a more conductive lower horizon, but effects caused by surface topography or perhaps lateral changes in porosity or permeability masked the deeper effects. Drilling encountered obstacles at depths ranging

from 4 to 7 m. If bedrock had been present at these shallow depths, a significant increase in apparent resistivity should have occurred at wider electrode spacings. A generally decreasing trend as a function of increasing spacing suggested that bedrock was not detected and that the obstacles encountered during drilling were probably talus blocks rather than in-place bedrock. Depth to bedrock appeared to be greater than 20 m.

The two most salient features in the apparent resistivity pseudosection were the two lows associated with sharp changes in topography. The low near the return channel was likely restricted to changes in topography. The low beneath the bench on the sandbar face appeared to be related to a combination of changes in topography and subsurface lithology. The inferred subsurface change may have been caused by a facies change or a zone of increased porosity.

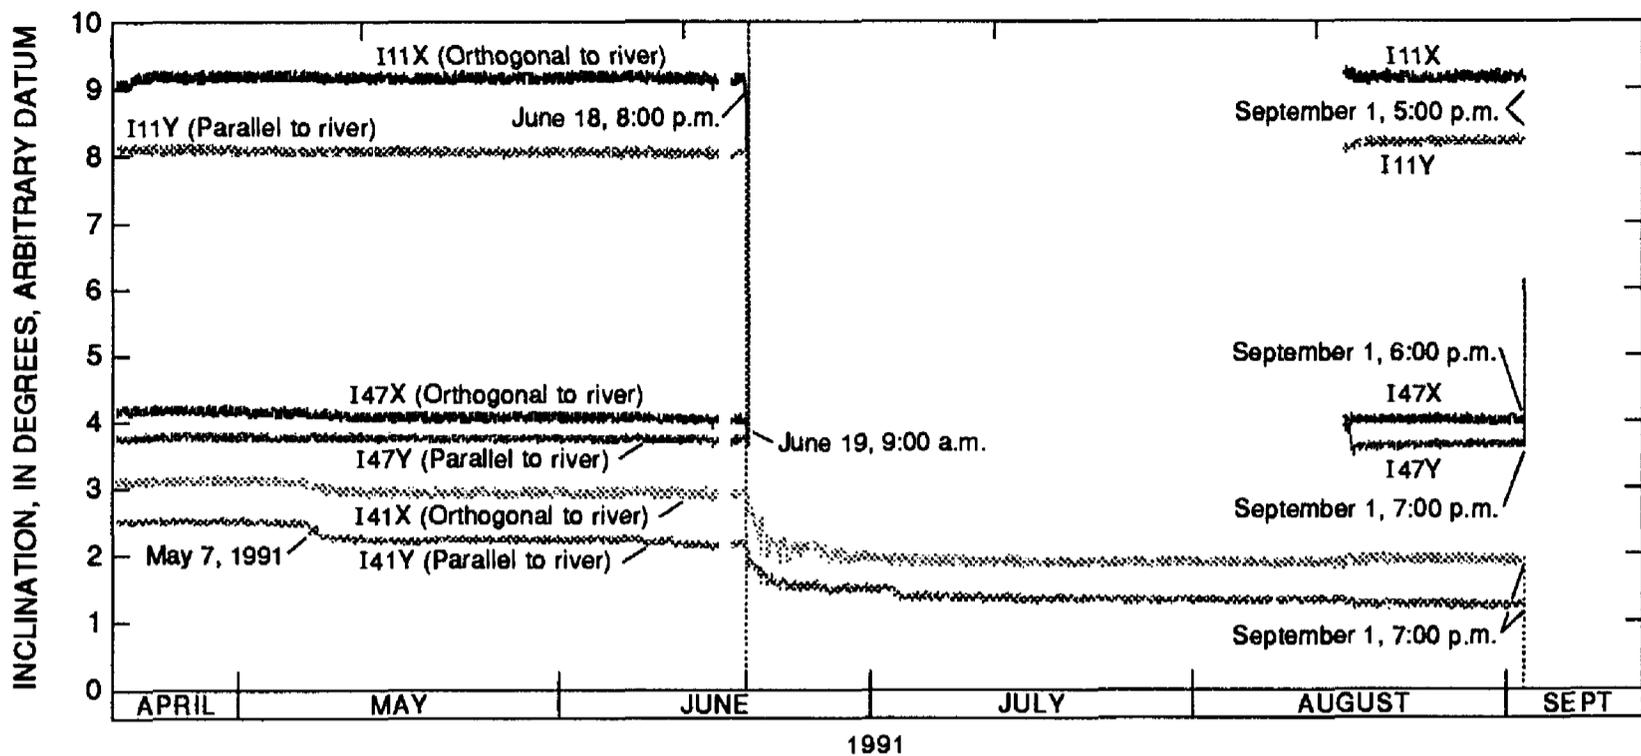
**Figure 14.** Tilt for sensor I18, I41, and I47 at sandbar 172.3L, downstream from the mouth of National Canyon, April 19 through September 12, 1991.

Several tilts occurred at sandbar 172.3L. At this sandbar, the tilts documented by tilt sensors occurred on the rising limb of a hydrograph and probably were all related to scour. Major scour accompanied by tilt began about 11:00 p.m. April 17 and lasted until about 1:30 a.m. April 18, 1991. This scour was observed by the crew installing the sensors before sensors were operational in the sandbar. In this scour event, which also occurred on the rising limb of the hydrograph, a large sand peninsula in the upstream end of the eddy was completely eroded. Scour events documented by tilt sensors and daily photographs taken automatically by a camera on the opposite bank include May 7, 1991, at about 7:30 p.m.; May 13, 1991; June 18, 1991, about 7:30 p.m.; and September 1, 1991. Minor tilting of  $-0.3^\circ$  in both axes of tilt sensor I41 occurred in the 2 days following the May 7 tilt (fig. 14). No other tilt sensors exhibited any tilt during this period.

On June 18, tilt sensor I11 went off scale at  $\pm 12^\circ$  about 8:00 p.m. Sensors I41 and I47 tilted about 9:00 a.m. on June 19. Sensor I41 tilted  $-1.1^\circ$  in the  $x$ -axis and  $-0.7^\circ$  in the  $y$ -axis in the 5 days following June 18. The succession of tilts from sensors in the river to sensors farther into the sandbar indicated failure by scour. On September 1, 1991, the entire face of sandbar 172.3L was scoured. Tilt sensor I11 went off scale

at  $\pm 12^\circ$  about 5:00 p.m., followed by sensors I41 and I47 at 7:00 p.m.

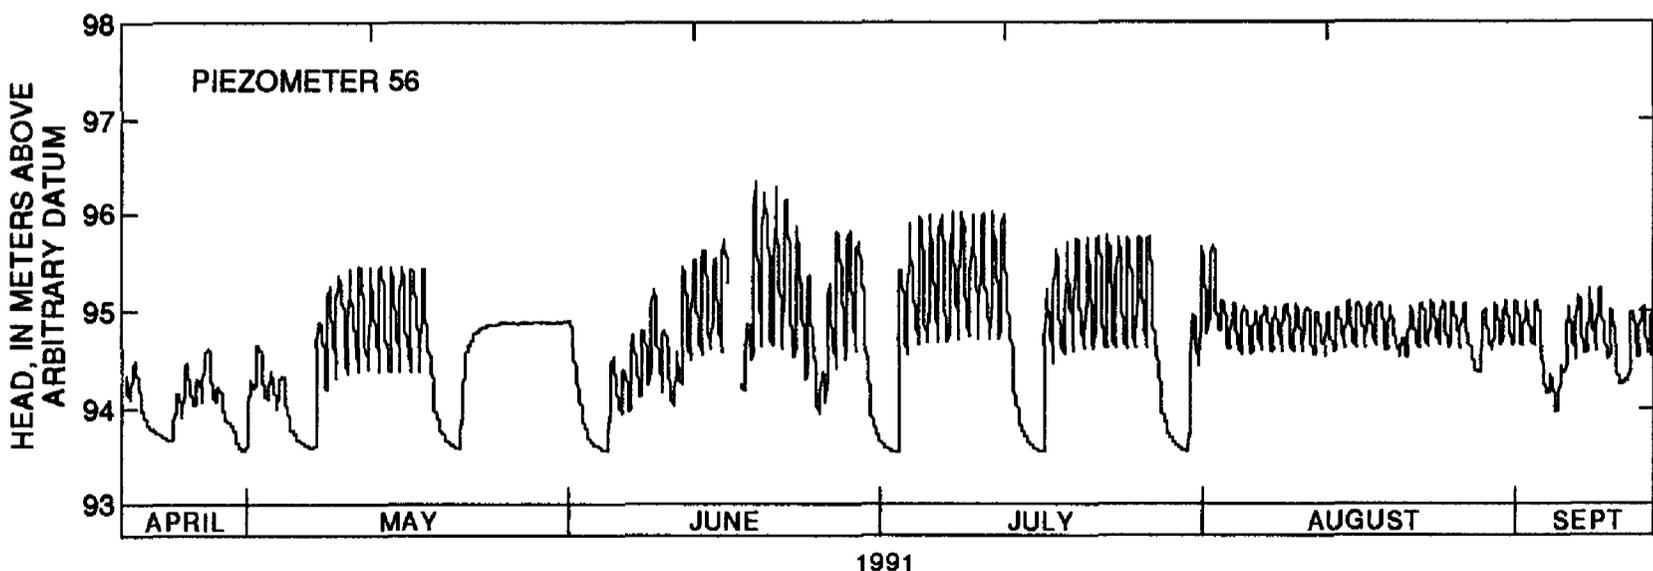
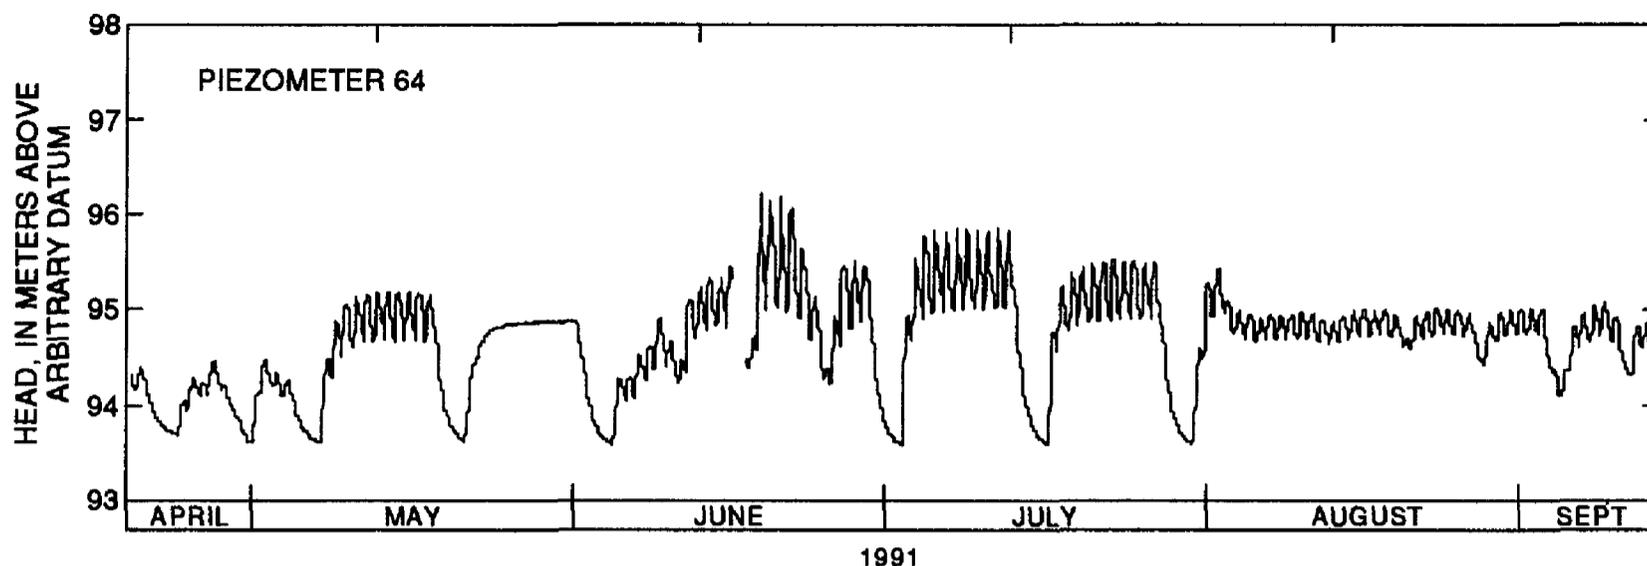
At sandbar 172.3L, attenuation of water-level fluctuation was about 30 percent from the stage sensor to piezometer 56 and 65 percent from the stage sensor to piezometer 64 over a distance of 35 m (figs. 15–17). Water-level fluctuations were less attenuated at piezometer 56 after the June 18, 1991, scour that deepened the stage sensor. The stage sensor was scoured and buried successively 1.3 m and 1.8 m on May 7 and June 18, 1991. The change in attenuation from the stage sensor to piezometer 56 probably was caused by the

combination of scour removing low-permeability material near piezometer 56 and burial reducing water-level fluctuations at the stage sensor.
