# Geomorphic Effects of Overflow Dams on the Lower Neosho River, Kansas

—Kyle E. Juracek

*The purpose of this report is to characterize the geomorphic (channel-changing) effects of overflow dams on the lower Neosho River channel in southeastern Kansas. Specifically, the report describes the types, upstream and downstream extents, and stability of the geomorphic effects in relation to site-specific, human-caused and natural conditions that may affect the channel's response to the overflow dams.*

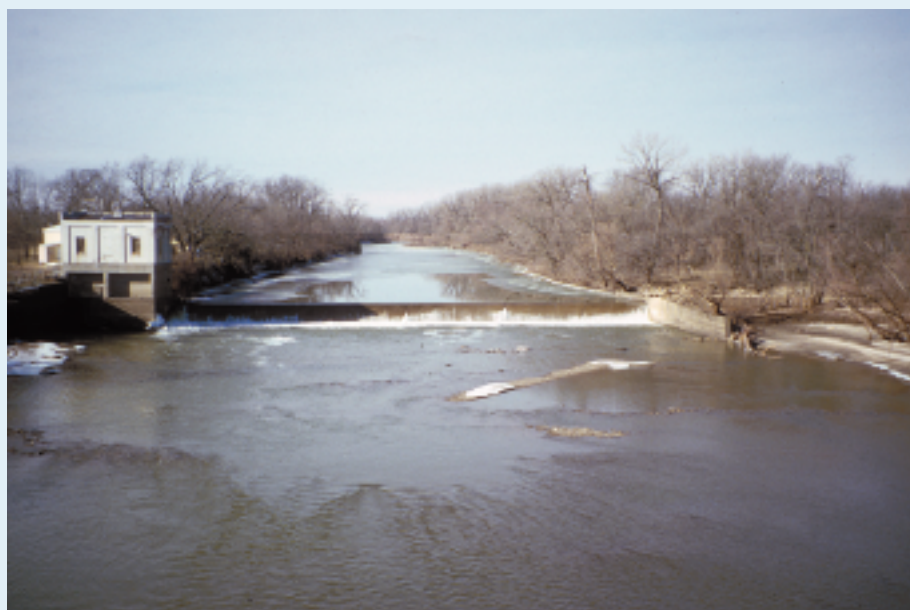
Figure 1. Overflow dam at Neosho Falls, Kansas (location shown in figure 2).

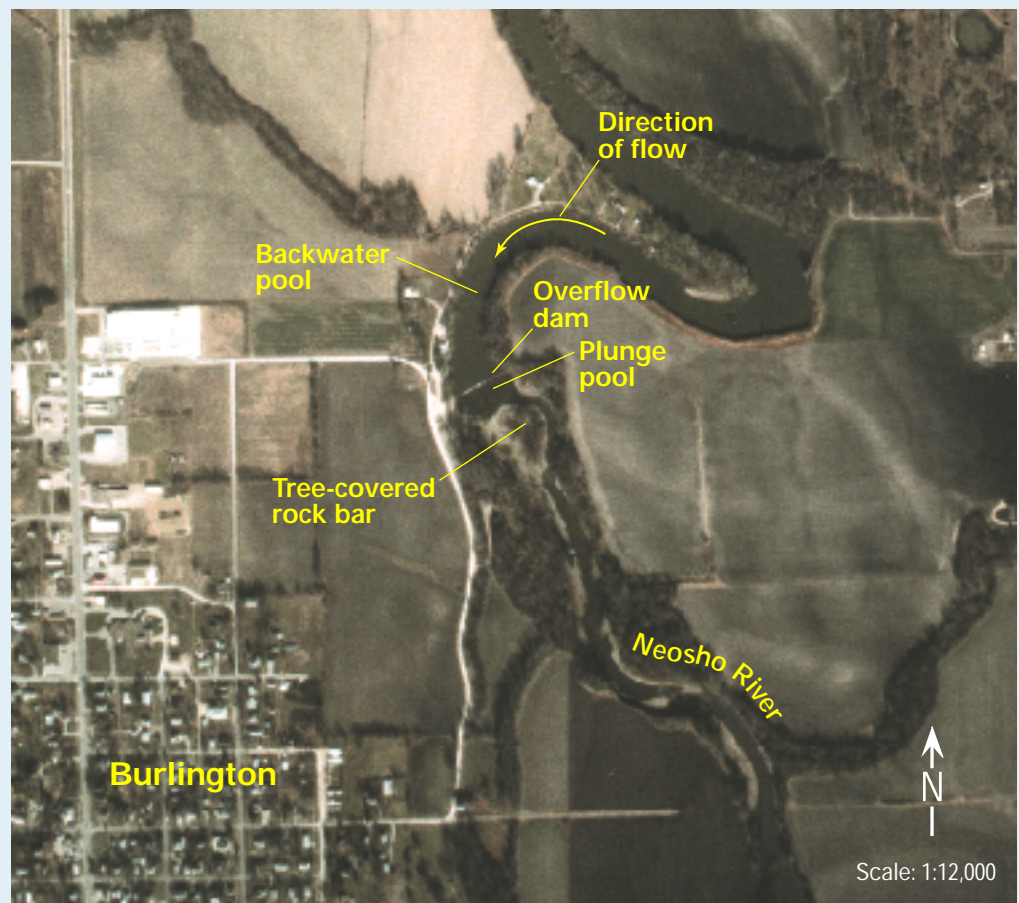
Figure 4. Leaf-off aerial photograph (scale 1:12,000) of the lower Neosho River channel near Burlington, Kansas, December 1990. Photograph from U.S. Department of Agriculture's Farm Service Agency.

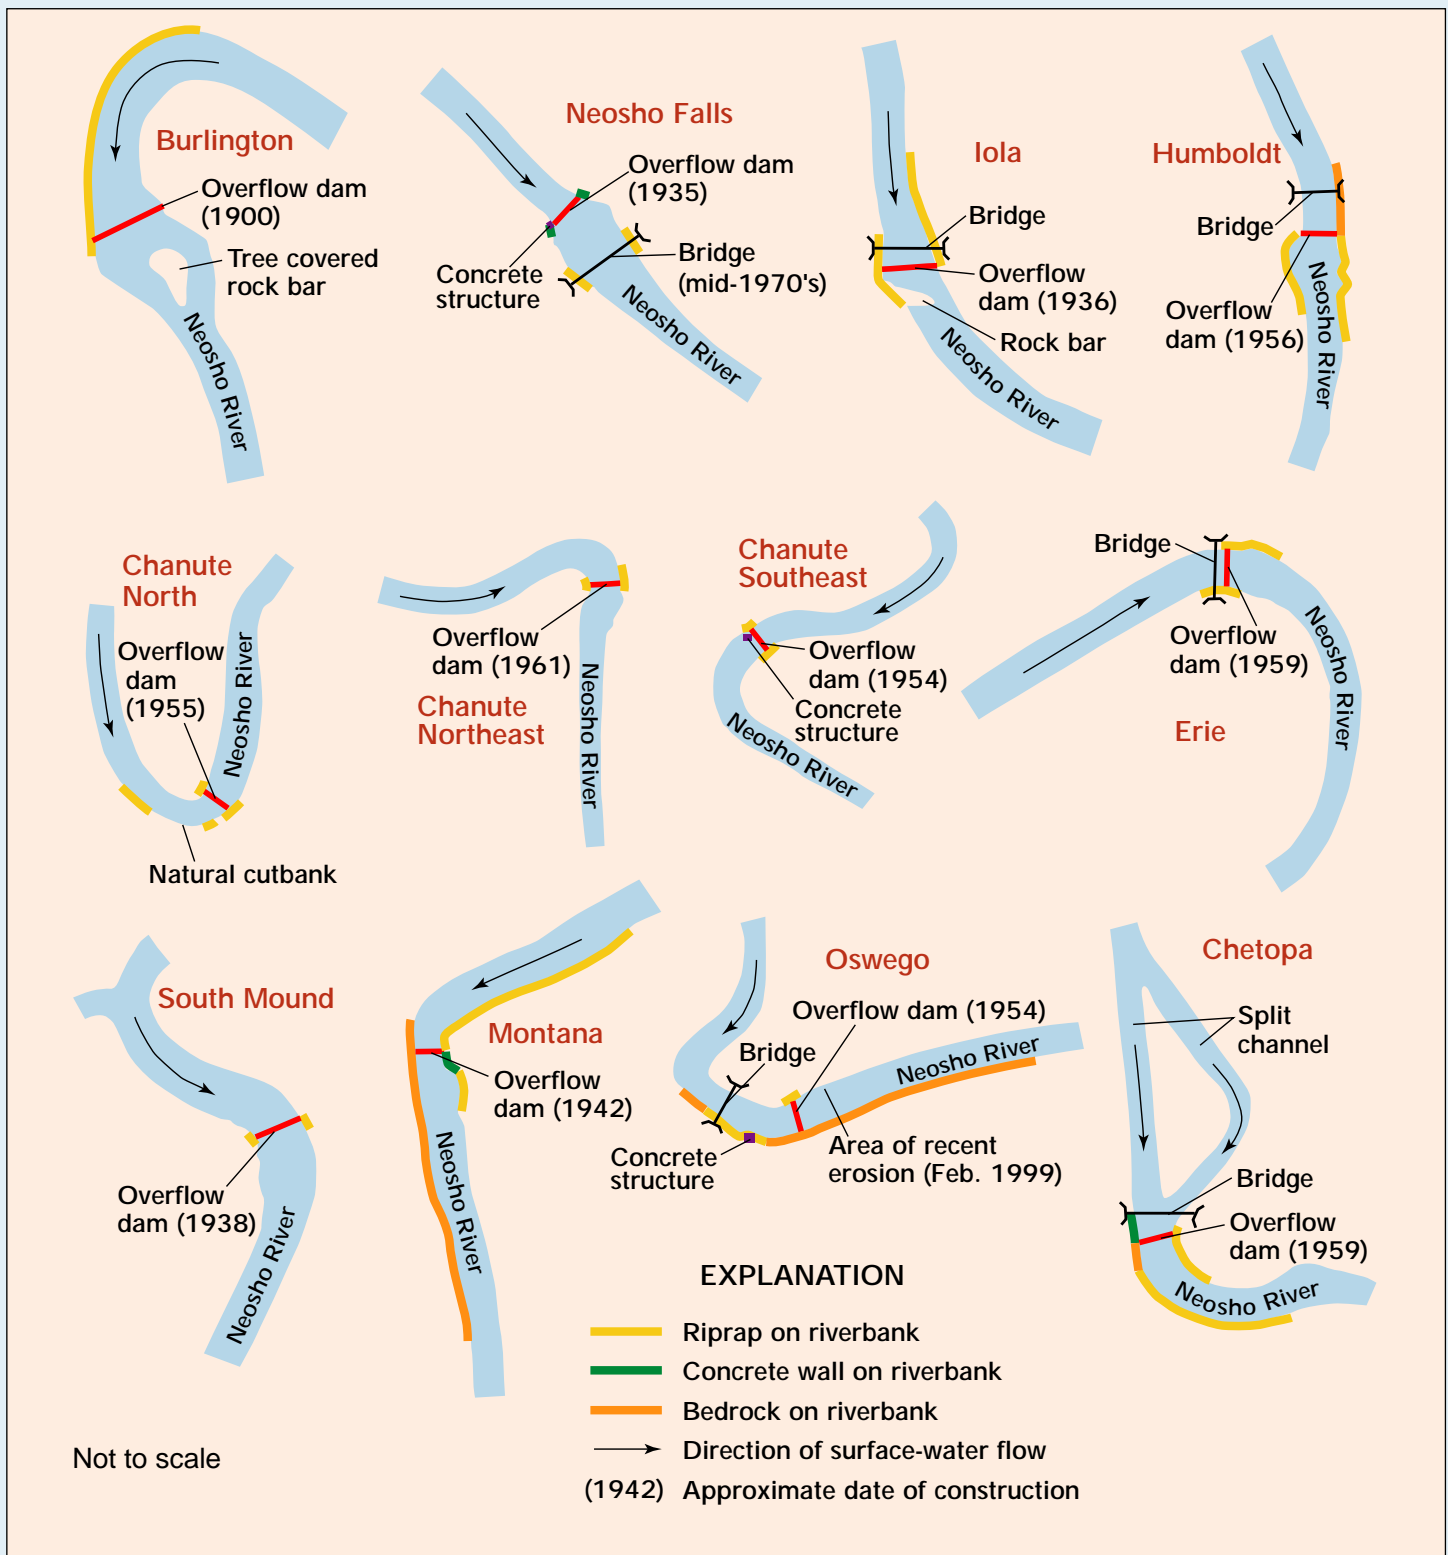
Results of the aerial-photograph analyses indicate that the geomorphic effects of the overflow dams appear to be limited to a short reach of river channel located immediately downstream from the dams. This geomorphic-response zone typically is confined to the first 1,000 feet downstream from the dams. Within the geomorphic-response zone at each site, channel widening has occurred to some degree (fig. 5), except

Figure 5. Shapes of the Neosho River channel, human-caused and natural conditions, and evidence of channel widening downstream from the 12 overflow dam sites. Location of dam sites shown in figure 2.

observed at the Humboldt, Chantue Northeast, Erie, and South Mound sites (fig. 5). At Humboldt and Erie, both banks were stabilized with riprap at some undetermined date. However, the shapes of the channel indicate that considerable bank

erosion had occurred before the riprap was added. At the South Mound site, the rapidly migrating channel eroded around the dam on the right bank in 1995. It appears that, unless stabilized, the channel eventually will completely bypass

At some locations, such as the Montana and Chetopa sites, channel change in the geomorphic-response zone has been limited by some combination of riprap, concrete wall, and bedrock (fig. 5). The widening evident on the left bank downstream from the concrete wall at the Montana site appears to be the result of the original construction design rather than a reaction to bank erosion. At Chetopa, the riprap on the cutbank side (right bank) of the channel

immediately downstream from the dam may have diverted the bank erosion to the opposite bank, resulting in the widening evident on the left bank farther downstream (fig. 5). Onsite inspection indicated at least some bank erosion immediately downstream from riprap at all 12 sites.

The effects of the overflow dam at the Chanute North site appear to be indeterminate due to riprap and the location of the dam with respect to the natural cutbank (right bank) (fig. 5). Given that maximum erosion tends to occur on the outer bank just downstream from the apex of a channel meander, the erosion observed on the right bank downstream from that dam may be due simply to normal cutbank erosion. At this and other sites, the control afforded by the dam and associated riprap may be inhibiting channel migration.

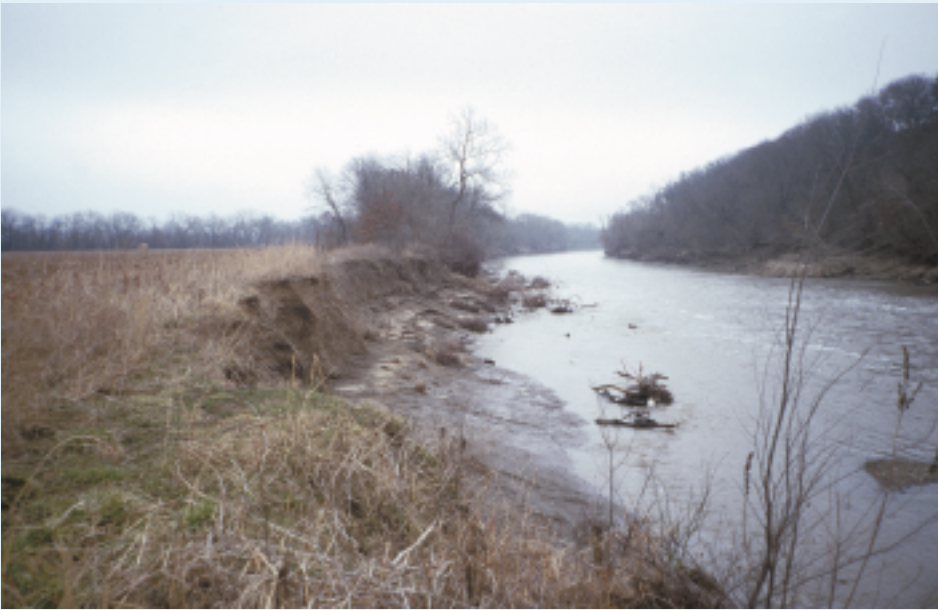
**Figure 6.** Erosion on left bank of Neosho River just downstream from riprap at Oswego overflow dam. Location of Oswego overflow dam shown in figure 2.

Otherwise, channel widening at this site is minimal. The 1991 aerial photograph showed only a slight widening of the channel in the response zone at Oswego. However, recent onsite inspection (February 1999) discovered rapid left-bank erosion in progress within the response zone (fig. 6). The erosion at this site had removed all tree cover along the affected bank and was advancing into cropland.

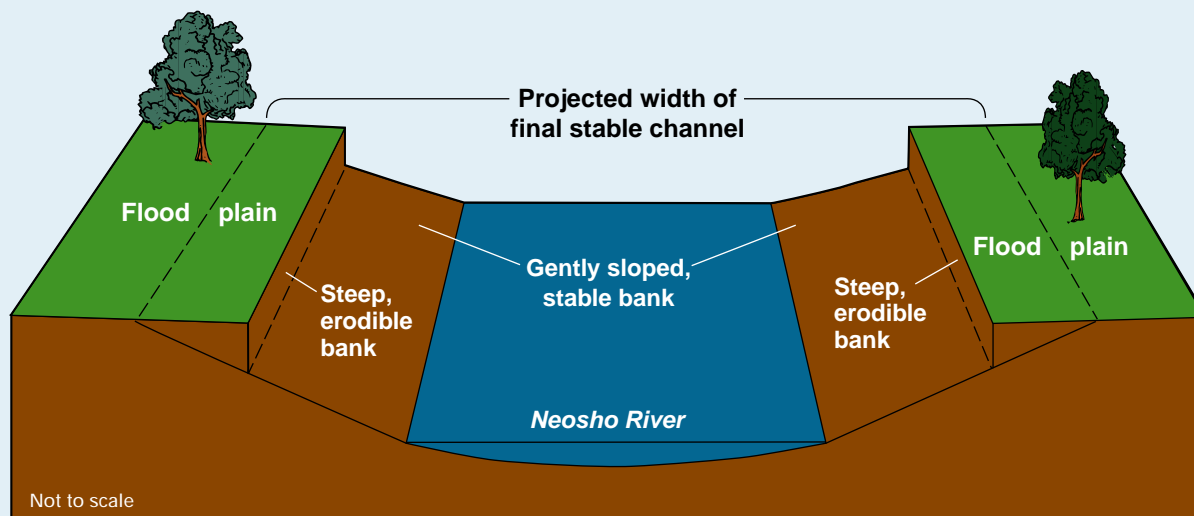
that, where not inhibited by riprap, concrete wall, or bedrock, channel changes at several dam sites are in progress. Typically at these sites, steep erodible banks are being replaced by gentle, stable banks within the response zone (fig. 7). The steep erodible banks appear to consist mostly of silt, whereas the gentle, stable banks appear to consist mostly of coarser grained sand and gravel. These channel changes were particularly evident at Neosho Falls. Eventually, where site conditions permit, the channel within the response zone may evolve into an approximately stable form characterized by a larger bankfull channel width and gentler bank slopes compared to the channel immediately upstream and downstream from the response zone.

Figure 7. Channel change within the geomorphic-response zone.
