CONTRIBUTIONS TO THE HYDROLOGY OF THE UNITED STATES, 1926

GEOLOGY OF NO. 3 RESERVOIR SITE OF THE CARLSBAD IRRIGATION PROJECT, NEW MEXICO, WITH RESPECT TO WATER-TIGHTNESS

By OSCAR E. MEINZER, B. COLEMAN RENICK, and KIRK BRYAN

SUMMARY OF CONCLUSIONS AND RECOMMENDATIONS

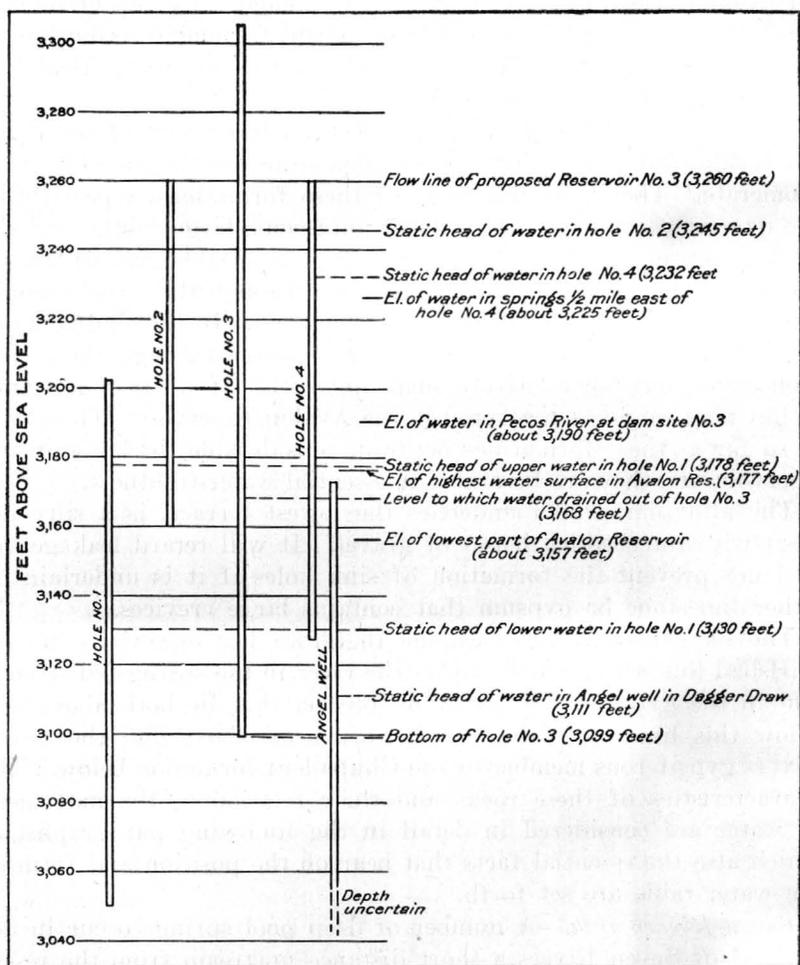
FIGURE 2.—Water levels in test holes drilled in 1925, in relation to other water levels in or near the No. 3 reservoir site of the Carlsbad irrigation project, New Mexico

In order to obtain more definite information as to the ground-water conditions at the dam site a test hole (No. 1, pp. 30-33, pl. 1, figs. 1 and 2) was drilled in 1925 at an elevation of 3,202 feet. It extends to a depth of 152 feet. The first ground water was struck between depths of 24 and 26 feet and stood 24.5 feet below the surface, or at an elevation of about 3,176 feet, which is 10 to 15 feet below the river level at the dam site. Water struck at some greater depth in this hole, probably between 74 and 76 feet, was found to have a static head 72 feet below the surface, or at an elevation of 3,130 feet, which is about 60 feet below the river level at the dam site.

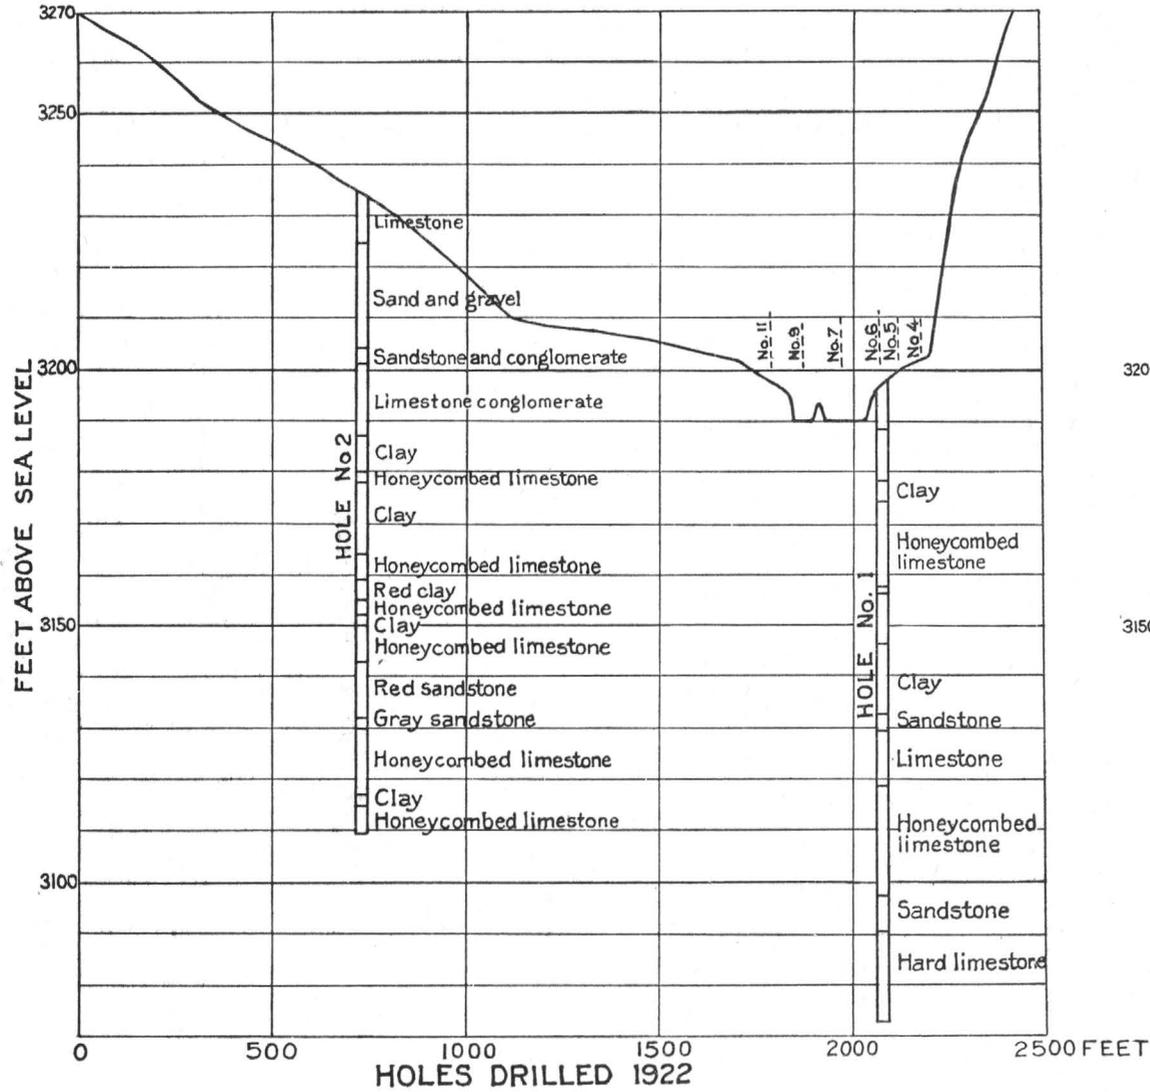
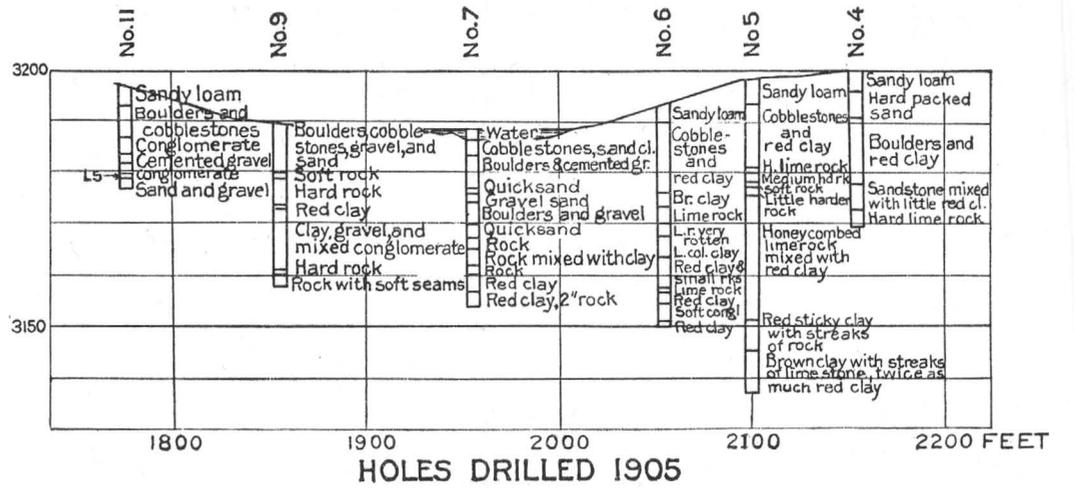
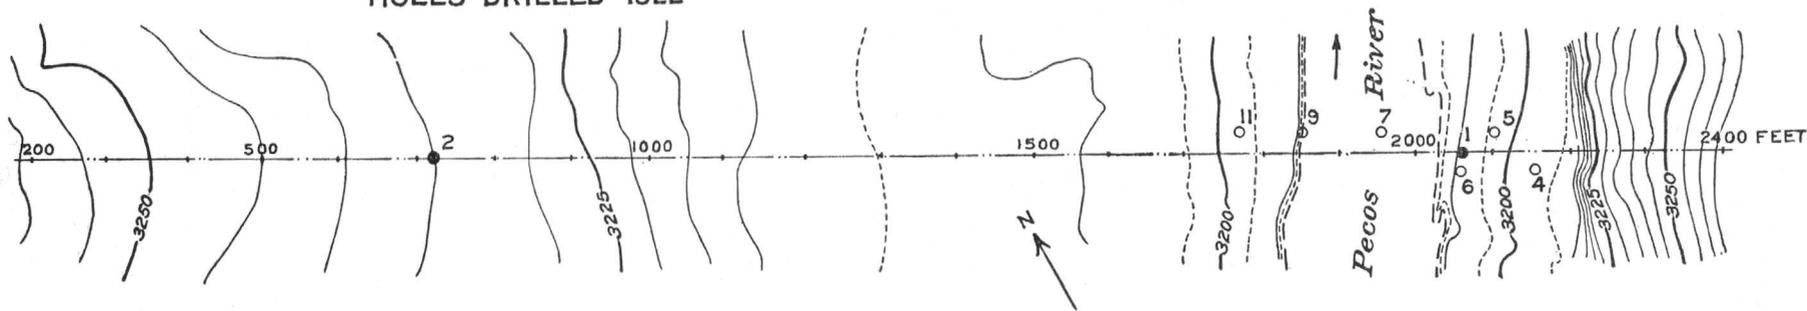
TOPOGRAPHY ALONG LINE OF PROPOSED DAM AT NO. 3 DAM SITE OF THE CARLSBAD IRRIGATION PROJECT, NEW MEXICO, AND LOGS OF TEST HOLES DRILLED IN 1905 AND 1922

It is obvious from a consideration of this log that the hole penetrated alluvium and possibly part of the limestone conglomerate for 42 feet. The lower part of this material is sufficiently impervious to prevent downward seepage from the river and to support the perched water table having a water level of 24 feet 6 inches that is described below, under the tests. Below 42 feet the hole entered the Carlsbad limestone, which for 64 feet is weathered and apparently contains caverns full of clay. The cavernous condition of the limestone explains the discrepancies in the logs of adjacent holes drilled in 1905 and 1922 (shown diagrammatically in pl. 2). Below 106 feet the Carlsbad limestone is but little affected by solution and doubtless forms the tight floor which supports the water table that, as shown in the tests, has a level of 72 feet below the surface. The cavernous condition of the upper part of the limestone at this place would be a menace to the reservoir, for when it was full the movement of water through this area would be greatly increased. The easily eroded clay would be readily washed out of these caverns, leaving large openings for the passage of water under the dam.
