UNITED STATES DEPARTMENT OF THE INTERIOR

**FLOODS OF
OHIO AND MISSISSIPPI RIVERS
JANUARY-FEBRUARY 1937**

GEOLOGICAL SURVEY WATER-SUPPLY PAPER 838

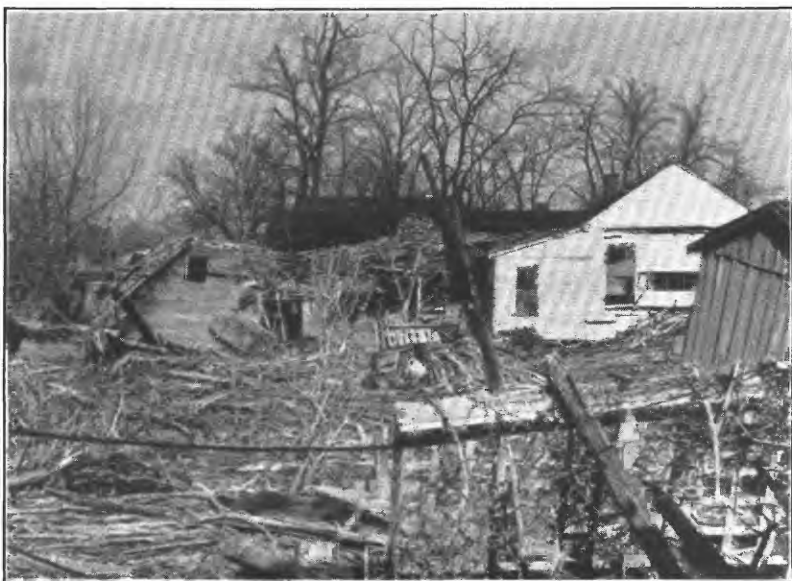
A. FLOOD WRECKAGE AT UNIONTOWN, KY.

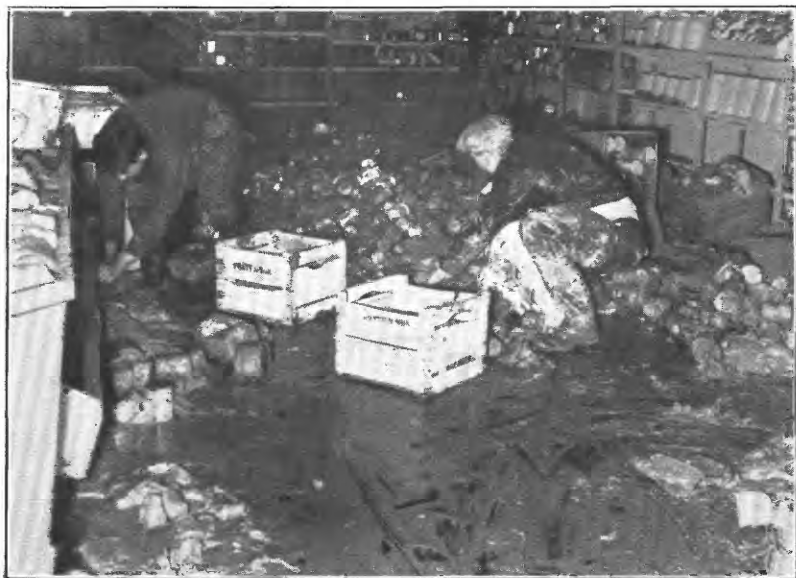
B. CLEANING UP AFTER THE FLOOD.

Interior of a store in Evansville, Ind. Only one of thousands of such scenes.

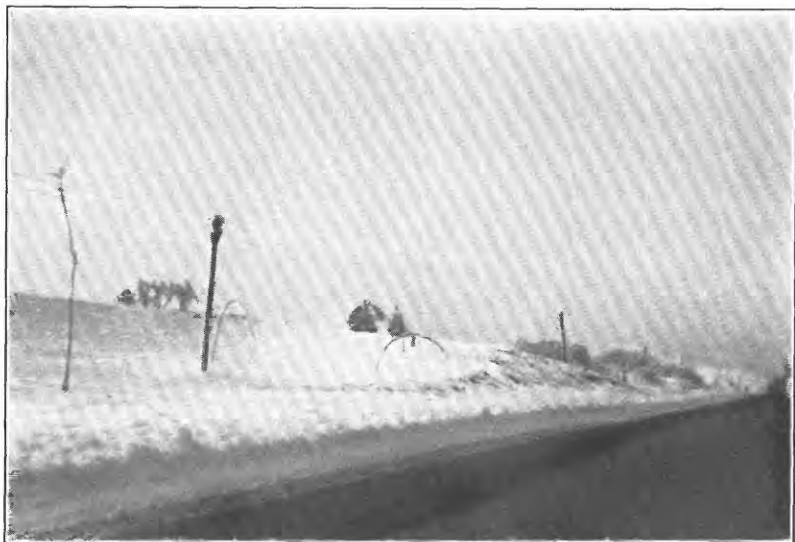
A. SCENE AFTER ICE STORM WHICH DISRUPTED TELEPHONE COMMUNICATION IN SOUTHERN ILLINOIS, JANUARY 26, 1937.

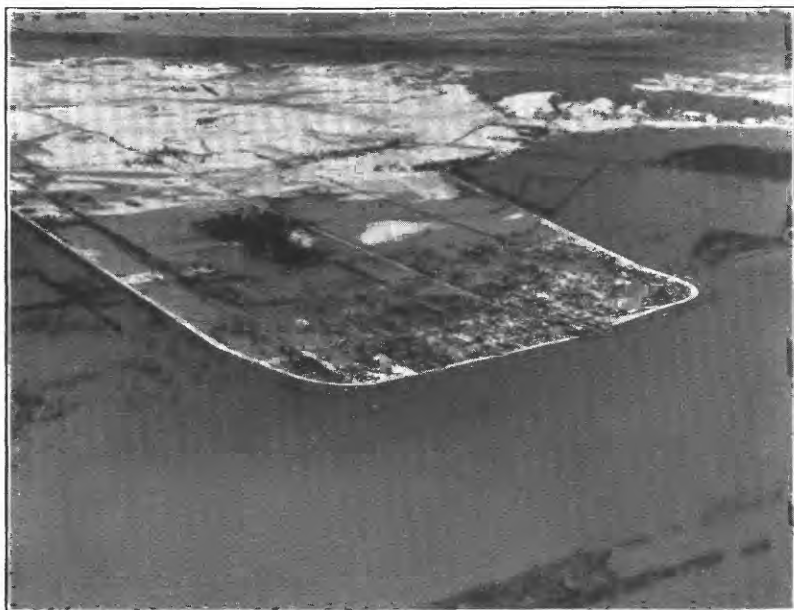
A. PRIOR TO OVERTOPPING OF THE LEVEE, JANUARY 25, 1937.
Official photograph, United States Army Air Corps.

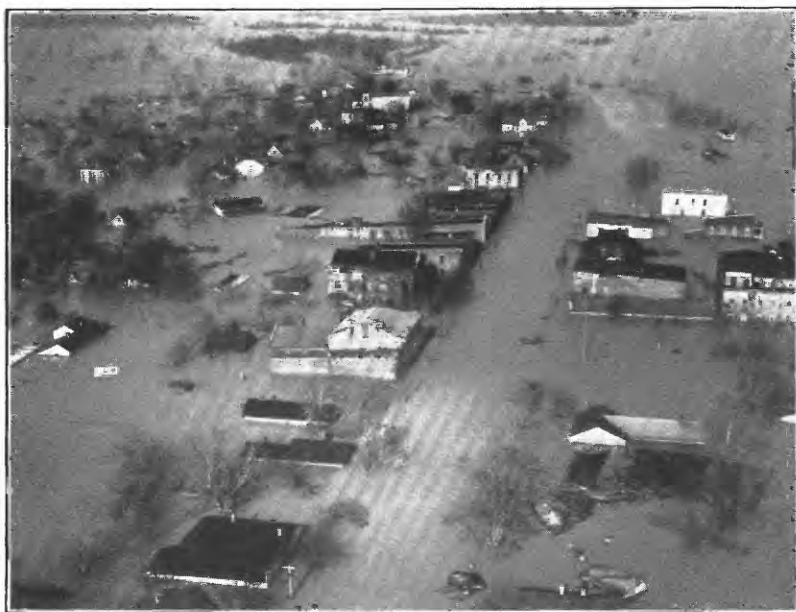
B. SUBSEQUENT TO OVERTOPPING OF THE LEVEE.
Official photograph, United States Army Air Corps.
OHIO RIVER AT SHAWNEETOWN, ILL.

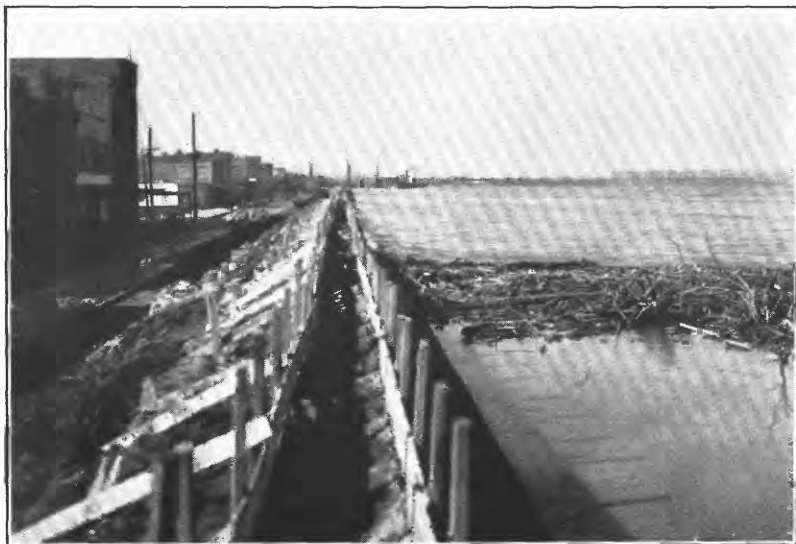
A. LOOKING NORTH ALONG THE OHIO RIVER AT THE LEVEE, FEBRUARY 4, 1937.

LEVEE ALONG OHIO RIVER AT CAIRO, ILL., SHOWING THE EMERGENCY
EMBANKMENT FOR PROTECTION AGAINST OVERTOPPING.

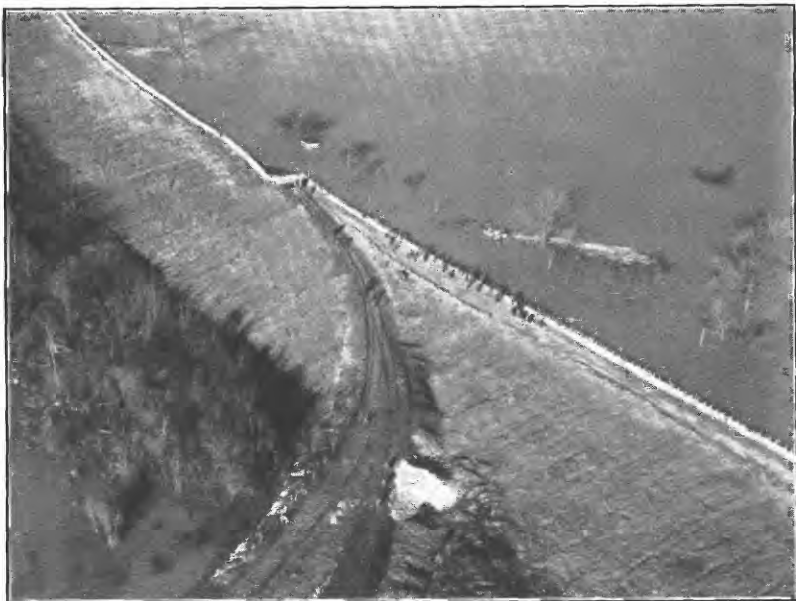
B. VIEW OF RIVER FRONT, FEBRUARY 5, 1937.

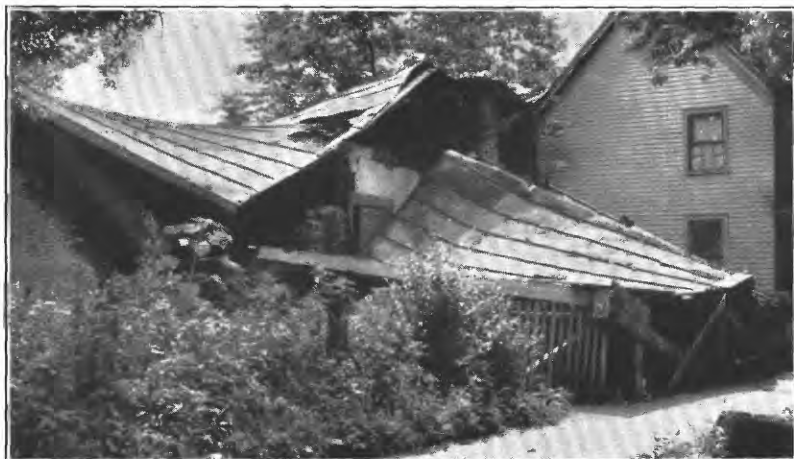
A. BRICK HOUSE, NEW RICHMOND, CLERMONT COUNTY, OHIO, DESTROYED BY FLOOD OF JANUARY 1937.

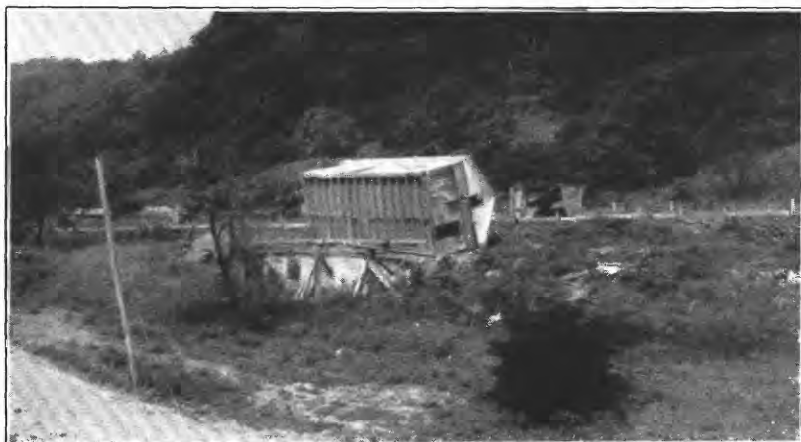
B. HOUSE EAST OF BUENA VISTA, ADAMS COUNTY, OHIO, TORN FROM FOUNDATION AND OVERTURNED BY FLOOD OF JANUARY 1937.

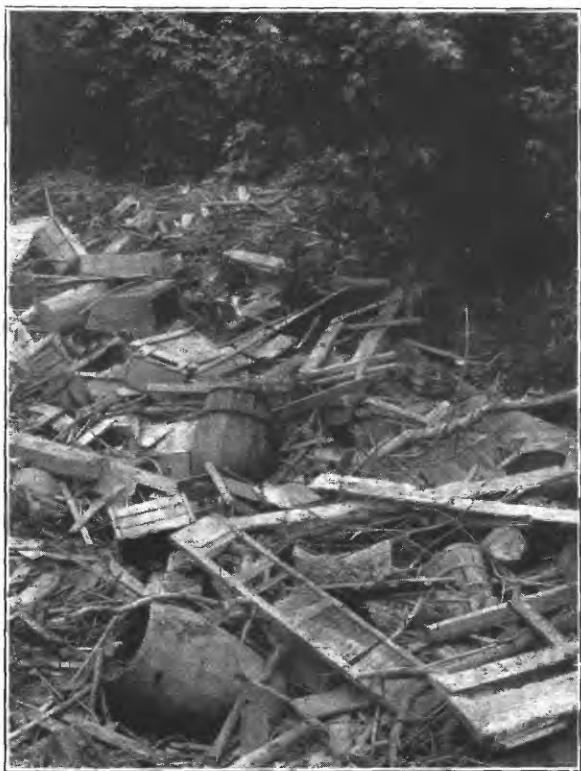
A. FLOOD DEBRIS NEAR BELLEVUE, CAMPBELL COUNTY, KY

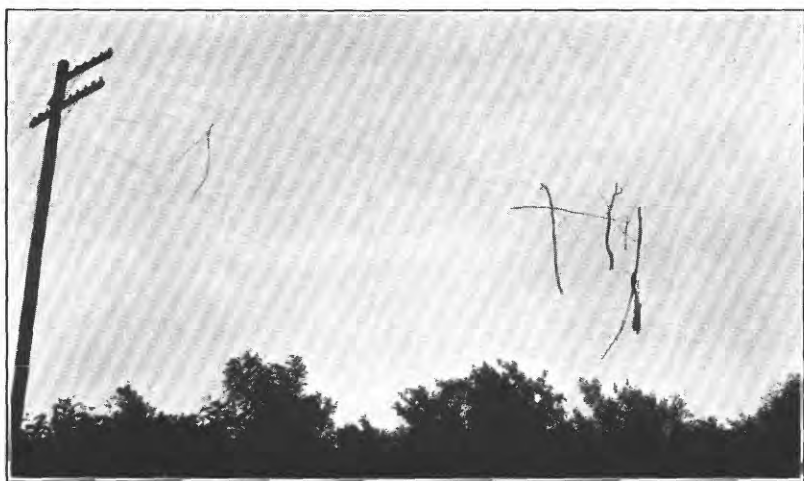
B. FLOOD DEBRIS ABOVE U. S. HIGHWAY 41 NEAR EVANSVILLE,
VANDENBERG COUNTY, IND.

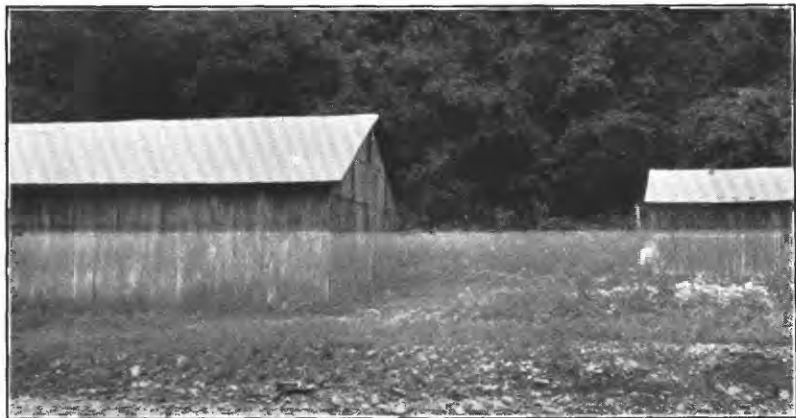
A. WATER-MARKED BARN AND SHED IN CAMP SPRING HOLLOW, MASON COUNTY, KY., ABOUT 1½ MILES FROM THE OHIO RIVER SPRINGDALE QUADRANGLE.

Height of water indicated by light tint.

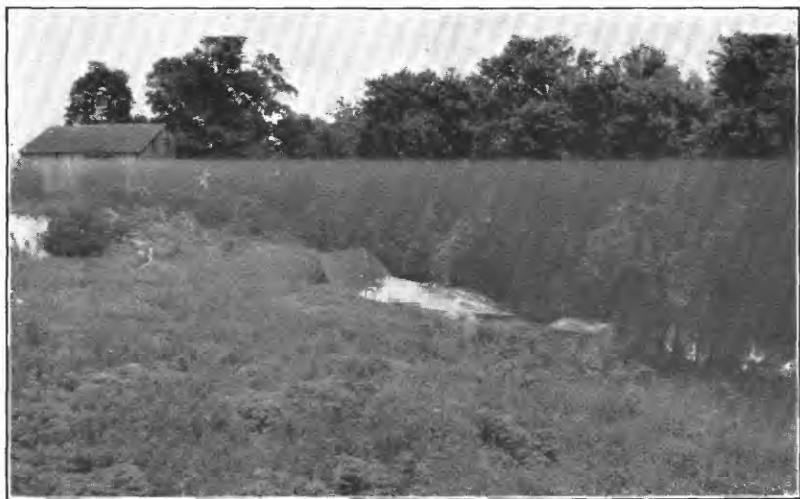
B. WATER-MARKED BARN ON BLUFF ABOVE TWELVEMILE CREEK, ON THE WEST SIDE OF NEW RICHMOND, OHIO, AND ON THE SAME TERRACE WITH THE TOWN.

Collapsed sheds in middle ground. Height of water indicated by light tint.

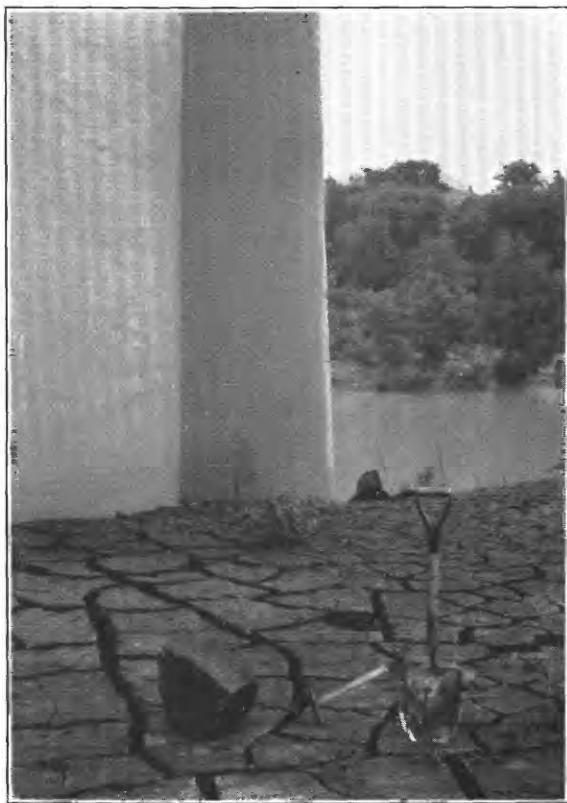
A. FLOOD DEPOSIT BENEATH LOWER BRIDGE OVER LICKING CREEK, NEAR MOUTH AT NEWPORT, KY.

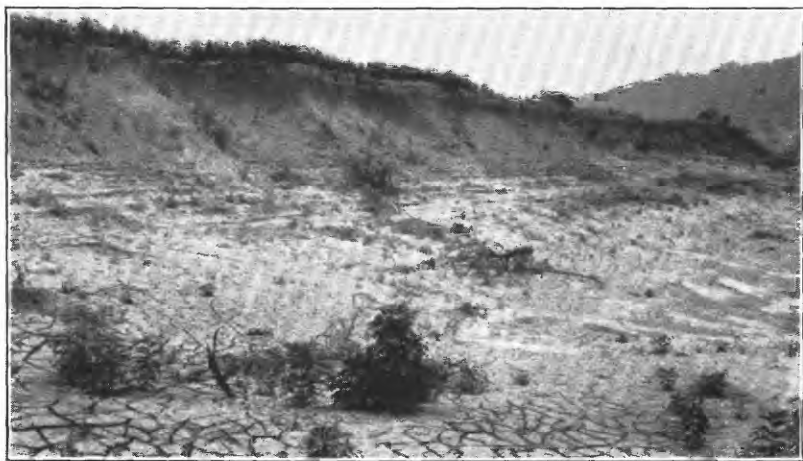
B. FLOOD DEPOSIT AND WATER-MARKED BLUFF NEAR KENTUCKY END OF AURORA FERRY, LAWRENCEBURG QUADRANGLE.

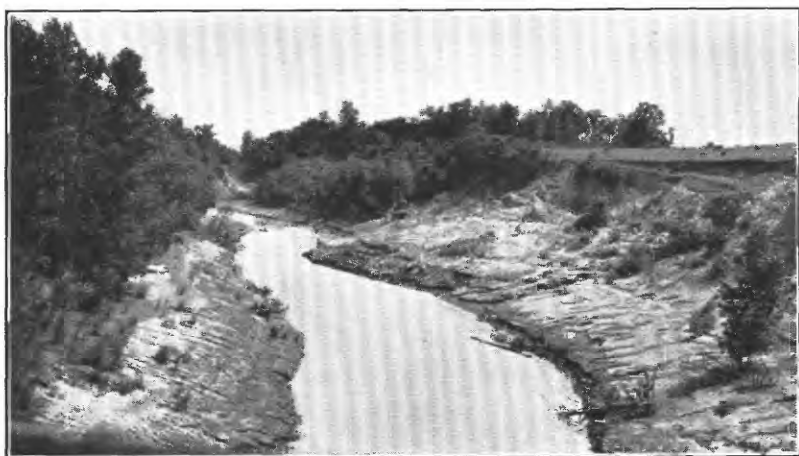
B. GENERAL VIEW.

Shows recent landslip a little below sky line at right.

FLOOD DEPOSITS ALONG POST CREEK CUTOFF, JUST SOUTH OF
BRIDGE ON ILLINOIS STATE HIGHWAY 37, LA CENTRE QUAD-
RANGLE.
