# A GEOLOGIC STUDY OF THE MADDEN DAM PROJECT, ALHAJUELA, CANAL ZONE

By FRANK REEVES and CLYDE P. ROSS

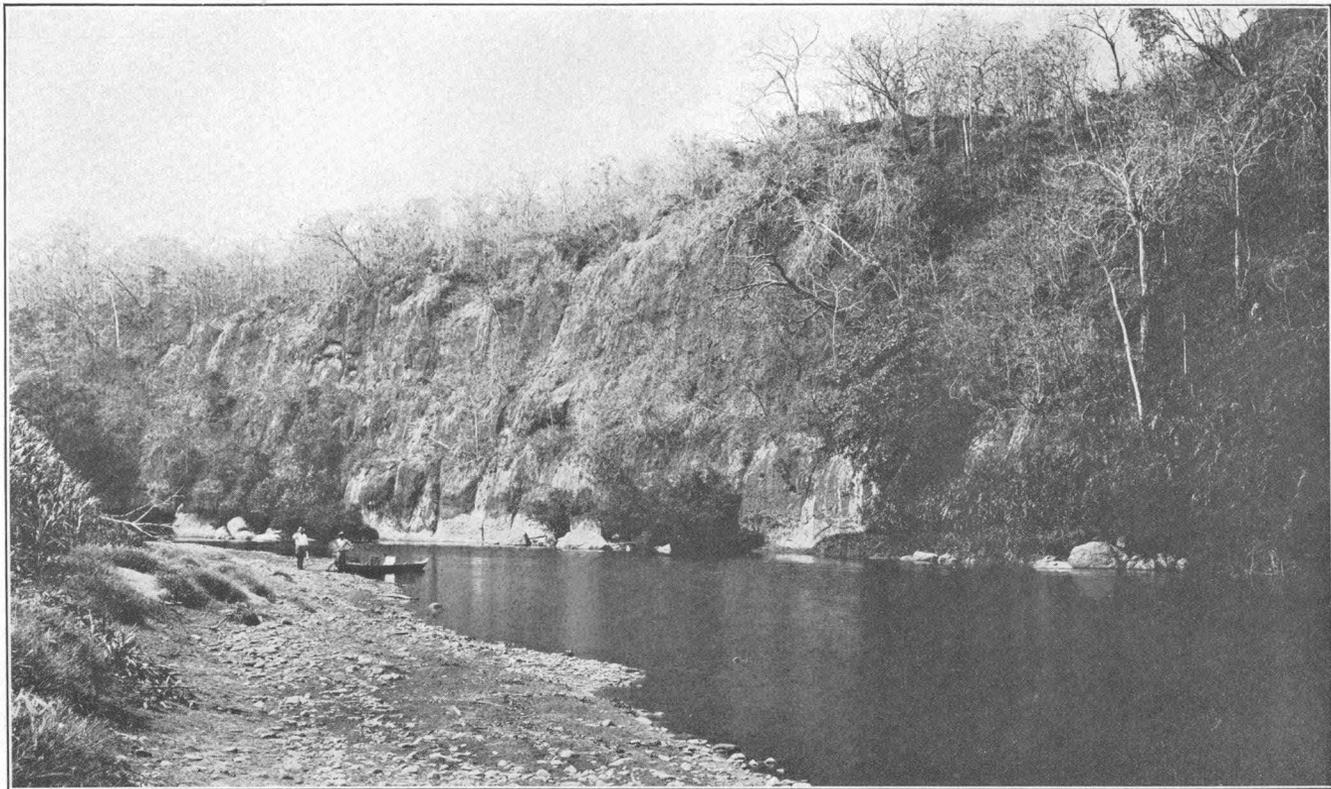
CLIFF ON THE NORTH SIDE OF THE DIKE RIDGE ABOVE DAM SITE 1  
Shows massive Gatun (?) formation, with slight solution on joints.

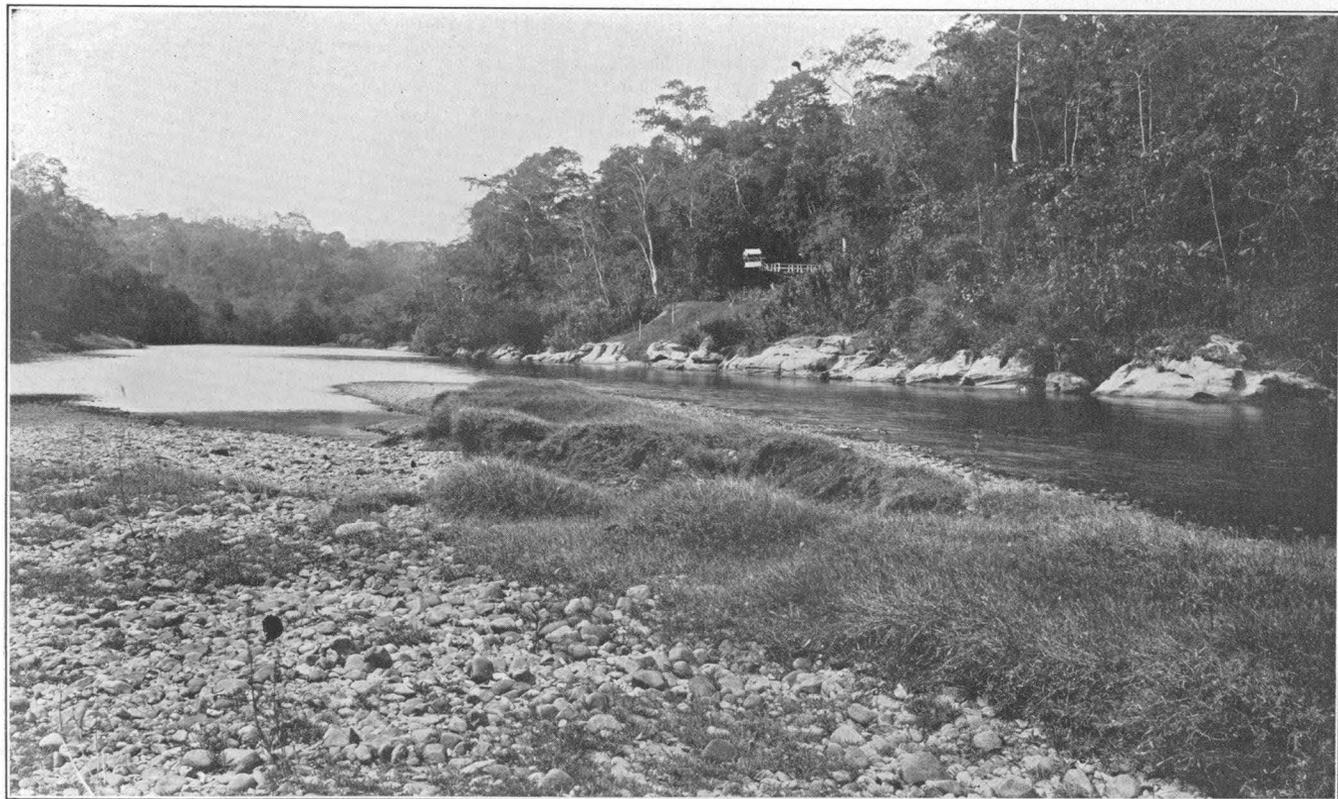
THE RIGHT BANK OF THE RIO CHAGRES, LOOKING DOWN THE CALLE LARGA STRETCH

Shows characteristics of the Caimito (?) formation—fairly distinct bedding and solution along joints.

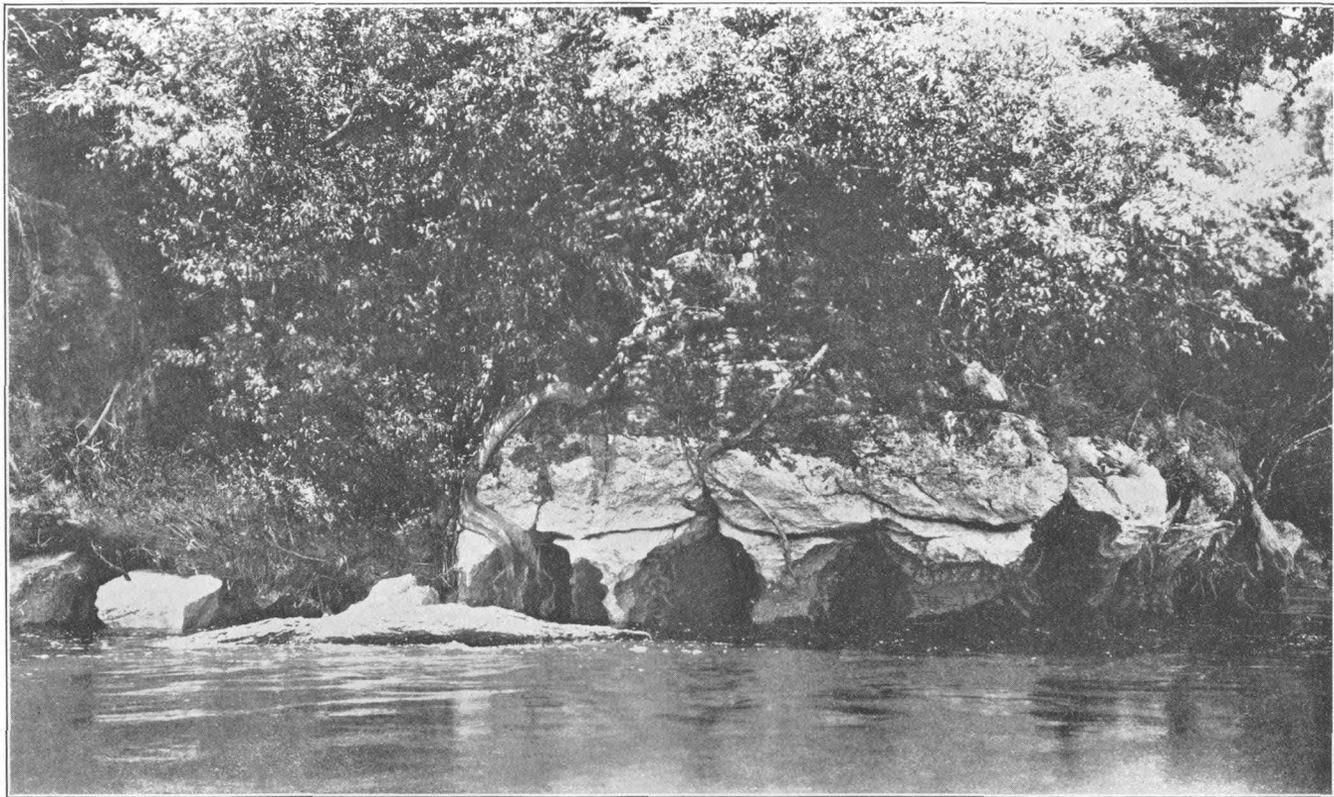
CLOSER VIEW ON THE RIO CHAGRES AT THE SAME LOCALITY AS PLATE 8

Shows undercutting and solution on joints.

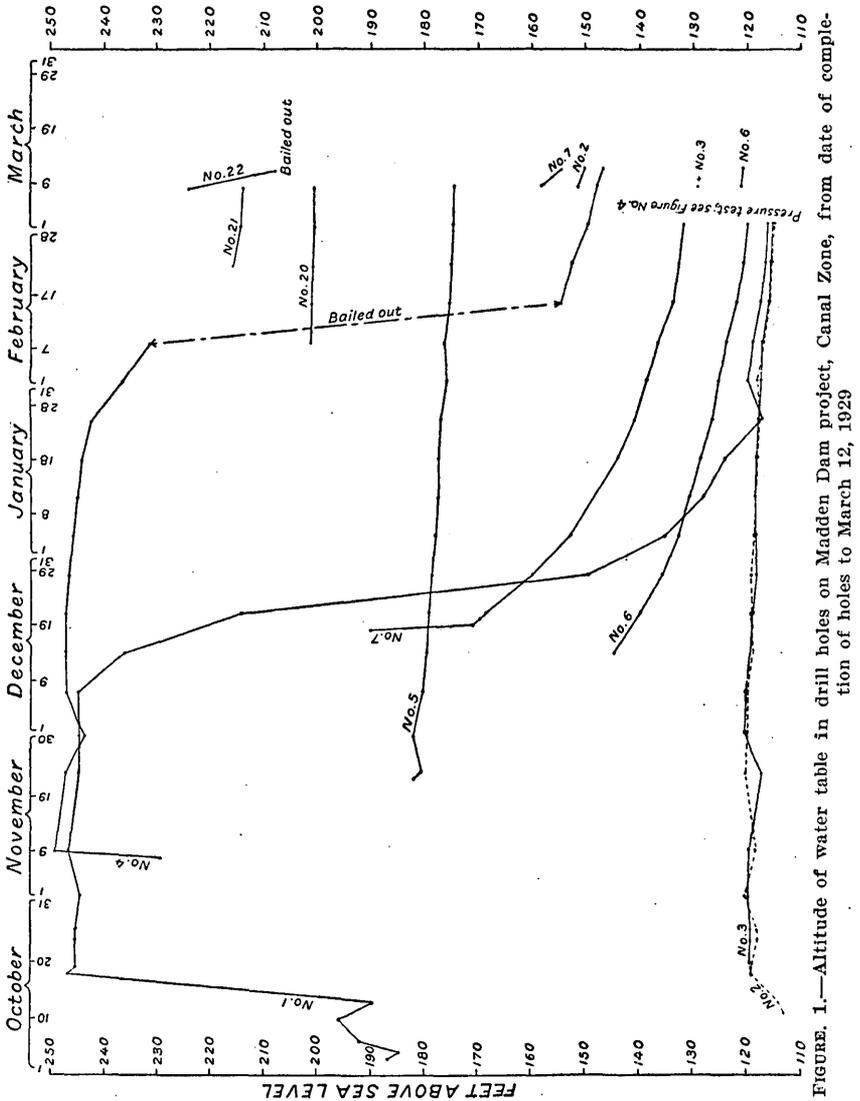
FIGURE 1.—Altitude of water table in drill holes on Madden Dam project, Canal Zone, from date of completion of holes to March 12, 1929

coupled with observations on springs, indicate that the dry-season water table on the Madronal ridge in holes 21 and 22 is above the 200-foot level, which in itself is indicative that sink holes and solution channels in this area do not extend to a very great depth.

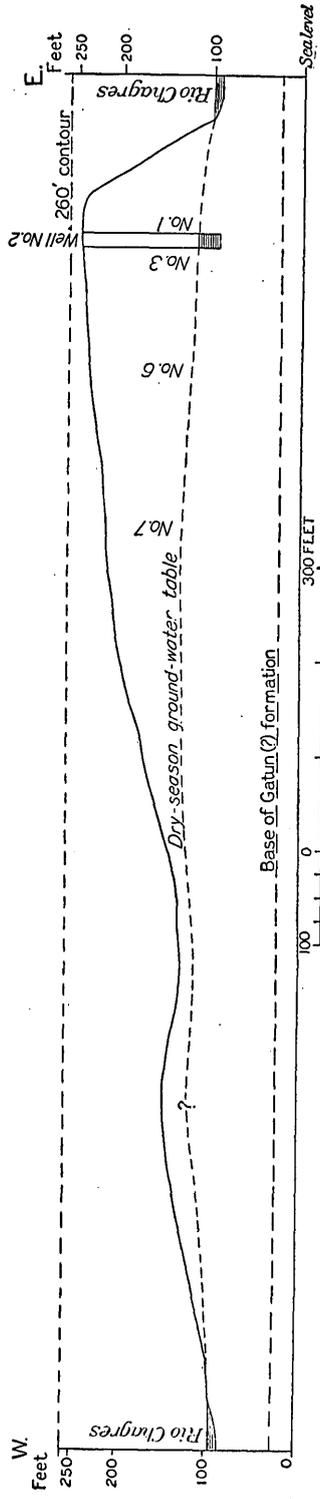
The results of the measurements of the holes east of the dam site along the ridge herein called the dike ridge (see pl. 6) are somewhat variable. Holes 2, 3, 5, and 6 show a gradual and not very large drop in altitude of the water level from the time they were drilled, during the wet season, up to March 16, 1929. Although there was a slight continued fall in some of the holes throughout the period of dry weather, the water table on this date stood at essentially the ground-water level of the dry season. It appears that the water level in Nos. 1 and 7 when first measured was abnormally high, but it later became adjusted, and on March 16 the level was essentially that of the dry-season water table. Hole 4, for a considerable period, showed a disproportionately high water level as compared with neighboring holes. On February 14, 1929, it was bailed out to an altitude of 154.1 feet, 77 feet below its previous level. The next day it had recovered only 0.6 foot, and thereafter the level of the water fell regularly until the observation on February 23. The water in holes on the ridge east of the Quebrada Madronal when similarly bailed out came back promptly to approximately the former level. Apparently the former high water level in hole 4 was due to some abnormal condition—possibly, at least in part, to puddling

FIGURE 2.—Profile across dike ridge on Madden Dam project. Hole 2 is on the profile; other numbers show relative position of holes not on profile

The low altitude of the dry-season water table in the holes along the dike ridge results from the proximity of the holes to the river bluff, which here has a sheer drop of 140 to 150 feet, and from the narrowness of the ridge. (See fig. 2.) An examination of the positions of these holes as shown in Plate 6 and in section in Figure 2 and of the water-table data in Figure 1 indicates that the height of the water table above the Rio Chagres in the holes is approximately proportional to their distance from the stream. This fact is brought out also in the subjoined table. The water table in holes 6 and 7 is relatively lower than in the others, presumably because the river surrounds these holes on three sides. The form of the water table in this ridge indicates that the rock below the dry-season water table is uniform in texture and that drainage into the river takes place slowly through the pores of the rocks rather than along joints or solution channels. However, the sharp departure in the wet season from dry-season conditions and the erratic behavior in detail in many of the holes, as illustrated by Figure 1 and by the subsequent data, indicate that the observations in many of the holes do not record the position of a water table, in the ordinary sense, but merely that of relatively small bodies of water lying well above the true water table. These holes were originally located largely for the purpose of testing the water-tightness of the numerous vertical joints that cut the rock of the dike ridge, and consequently they are on or close to such points. It appears that the water present in the holes is in large part water which has penetrated the ridge through the joints and perhaps in part directly through the holes, rather than by permeating the whole mass of the rock. On this conception, at times when high-water levels are observed in particular holes, unfractured ground at comparable altitudes may be essentially dry a short distance away from such holes on the joints which feed them. The rapid fluctuations recorded during the rainy season of 1929 indicate that relatively free passage of water takes place locally in the ridge, and this can be attributed only to the existence of openings along joints above the dry-season water table. The erratic behavior of some holes may result from variation in the ease with which water can find its way into passages along individual joints at different times. The pressure tests proved that a small amount of mud in the water introduced into the holes had a large influence on the rapidity with which the holes would take water. It may well be that variations

The above discussion indicates that in places in the dike ridge above altitudes of 120 to 130 feet above sea level there are openings large enough to permit the passage of water, although the quantities involved under present conditions may be small. The principal danger suggested by such a condition is that some of the openings may be or become large enough to permit water to pass through them with sufficient velocity to erode and dissolve the rock and eventually to enlarge the opening greatly. If a dry specimen of the rock of the Gatun (?) formation is plunged into water a small amount of material immediately spalls off of it, illustrating its weakness under conditions of alternate wetting and drying such as would exist in the upper part of the ridge as a result of fluctuations in the level of the reservoir. It is believed that serious consideration should be given to the possibility of grouting the dike ridge to guard against the danger suggested.

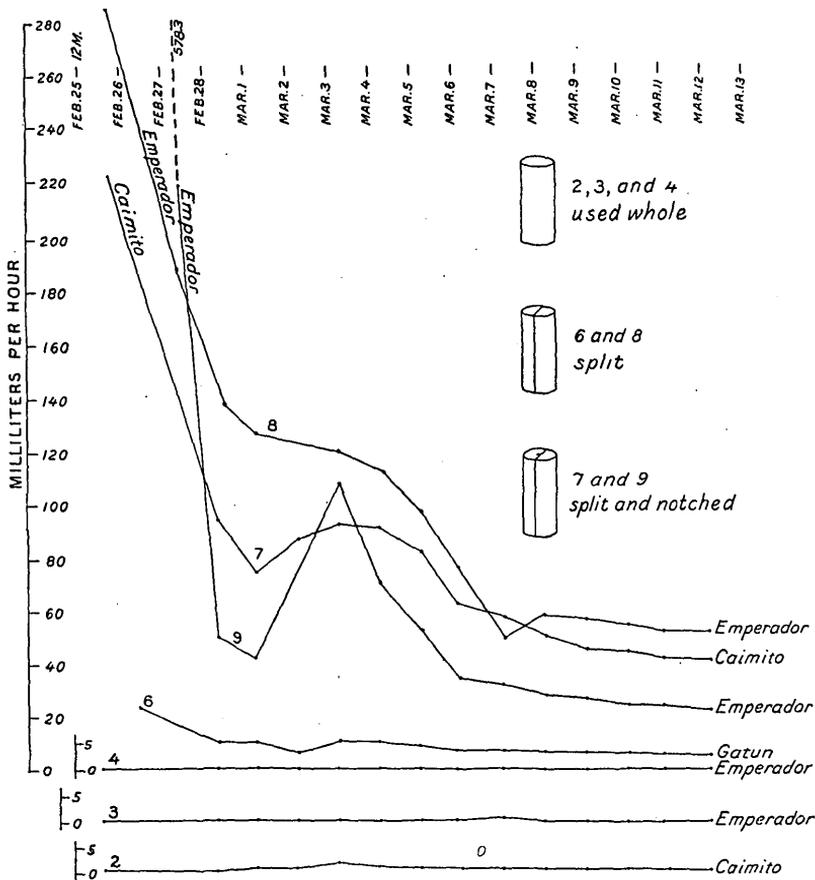
and 4, in which the flow was through the pores of the rocks; (2) that there was a slight decrease through core 6; and (3) that through cores 7, 8, and 9 the rate of flow decreased rapidly during the first four days of the test, increased for a few days, and decreased uniformly during the remainder of the test.

The cause of the fluctuation in flow through cores 7, 8, and 9 is not known, nor can any definite explanation be given for the de-

FIGURE 3.—Results of solution tests on cores of rocks of Madden Dam project

crease in flow through cores 6, 7, 8, and 9 throughout the period of the test. Polished sections of the cores showed evidence of solution that was decreasingly active through the cores from the intake end. It is possible that this decrease was due in part to chemical precipitation of calcite dissolved out of the cores at the end of high pressure and deposited toward the end of low pressure.

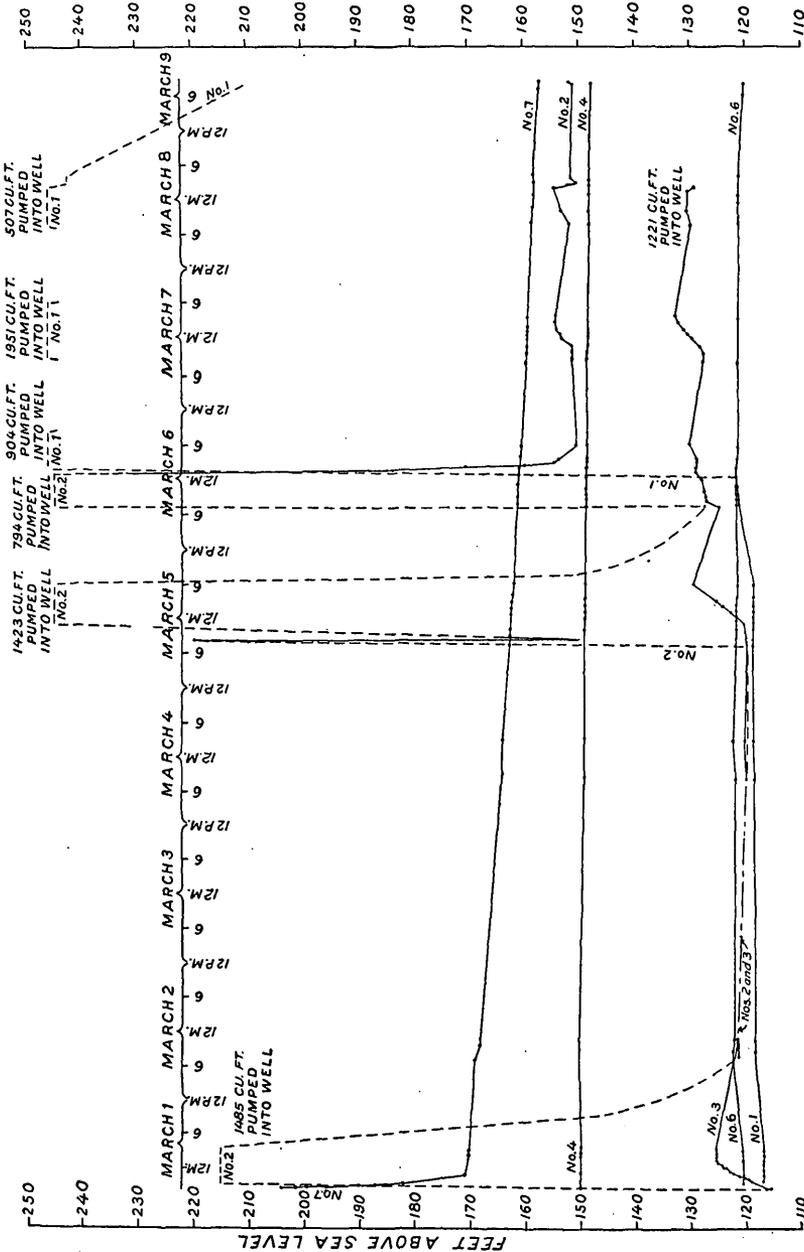
The pressure tests on drill holes 7, 2, 1, and 3 were initiated to determine to what extent, if any, water will leak through the dike ridge along joints and solution channels. (See fig. 4.) The amount of water forced into these holes was as follows: No. 7, 1,413 cubic feet; No. 2, 3,702 cubic feet; No. 1, 3,362 cubic feet; No. 3, 1,221 cubic feet. The pressure gage while the water was forced into the holes read from 0 to 50 pounds to the square inch; the rate of intake ranged from 1 to 4 cubic feet a minute. Although the amount of water that could be forced into the wells with the apparatus available was

probably insufficient to form a basis for definite conclusions, it appears improbable that the ridge will leak water to any great extent, for only three slight seepages, aggregating about 2 gallons

FIGURE 4.—Water table in wells on dike ridge during period of pressure tests on wells 1, 2, 3, and 7, Madden Dam project

a minute, occurred in the river bluff during the pressure tests, and these appeared only in joints that showed visible signs of being widened by former seepages. Along most of the joints, which had

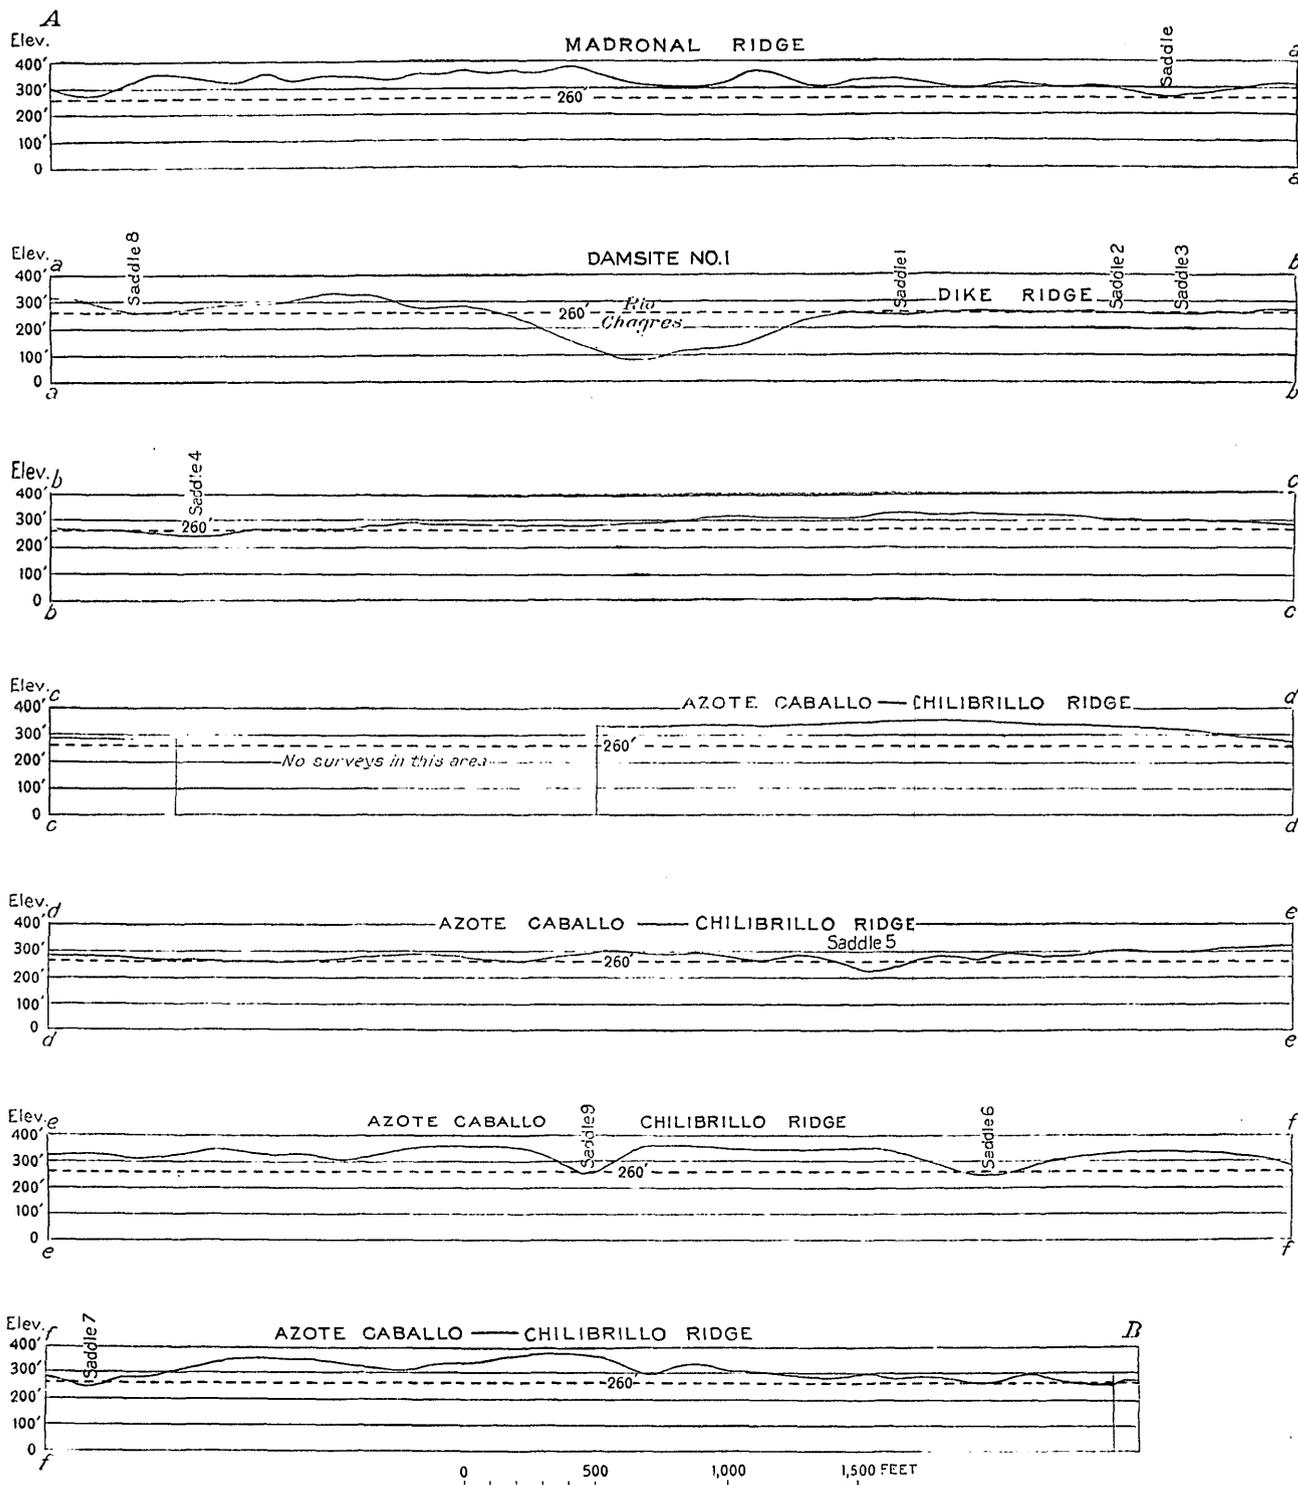
PROFILE ALONG CRESTS EXTENDING SOUTH AND EAST ALONG THE RIDGE ABOVE THE QUEBRADA MADRONAL TO AND ACROSS DAM SITE 1, THENCE ALONG THE DIKE RIDGE AND THE RIDGE ABOVE THE RIO AZOTE CABALLO

The weakness of the rocks along the ridge above the Azote Caballo River and the numerous saddles there make the question of the maximum height of water a serious one. It is probably unsafe to assume that an unprotected natural ridge of such rocks extending 25 feet above high-water line would be proof against breach by the water of the reservoir. In places where the slope on the reservoir side is steep and there is possibility of undercutting with consequent slumping an even greater height would be unsafe, if left unprotected.

It is recommended that no water be permitted to spill through the low saddle where small diamond-drill hole 5 is situated, this being the weakest of all the saddles. Nor is it advisable to spill water through the saddles on the Madronal Ridge unless aprons are constructed to carry the water down to the Quebrada Madronal. It is also inadvisable to permit spillage through any of the saddles along the ridge above the Azote Caballo River except in rare emergencies or after taking great precautions against cutting. The saddle dams should be built somewhat higher than the main dam, and most of them should be so built that weirs or other openings through them would be operative only in exceptional floods. If any of the saddles are used for spillage other than during such floods, the saddles situated in the Gatun (?) formation should be selected for this purpose.
