REPORT ON GEOLOGIC RECONNAISSANCE OF THE
CLARK FORK - KOOTENAI RIVER
DEVELOPMENT PLAN

LINCOLN AND SANDERS COUNTIES,
MONTANA

Charles E. Erdmann

June 1945

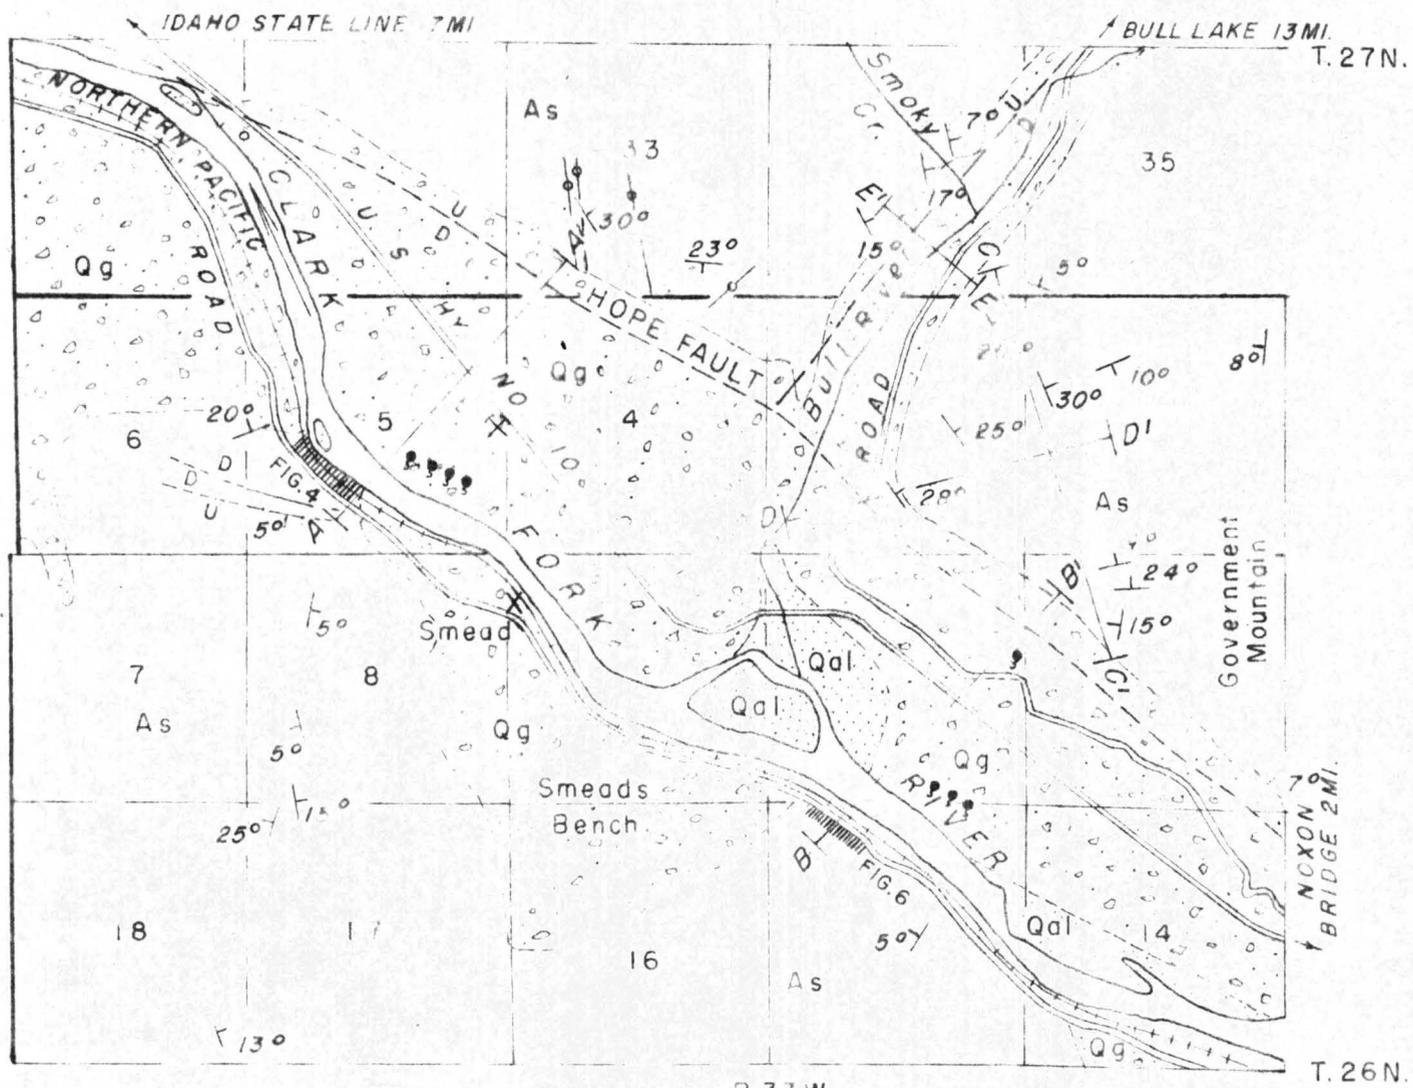
FIG. 2

Geologic structure: Dip of beds. The dips shown on Fig. 2 are those observed by Gibson, and they indicate considerable variation in regional structure due to folding and subsequent faulting. Locally, on the dam axis, the dip is comparatively simple. The beds in the right abutment dip 22° N. 22° E., with a tendency to steepen to the northeast. A little farther east, however, a reversal takes place, and it appears that the right abutment terminates in an asymmetric syncline with the steep limb on the west. The strike of this feature is to the

Dam section: Only one dam section is available at this locality. This prospective axis has a bearing of about N. 41° E., through a point about 600 feet south of the northeast corner of sec. 5, T. 26 N., R. 33 W. Line A-A', Fig. 2, and Fig. 3. Structural conditions in the left bank limit the breadth of this section to about 250 feet either side of the axis. Width of open valley at the critical elevation of 2,365 feet is about 5,650 feet, but a length of about 850 feet will be required for a dike or cutoff to obtain a secure right abutment. The total length of crest will thus be about 6,500 feet. Excess elevation above 2,365 is available in both abutments.

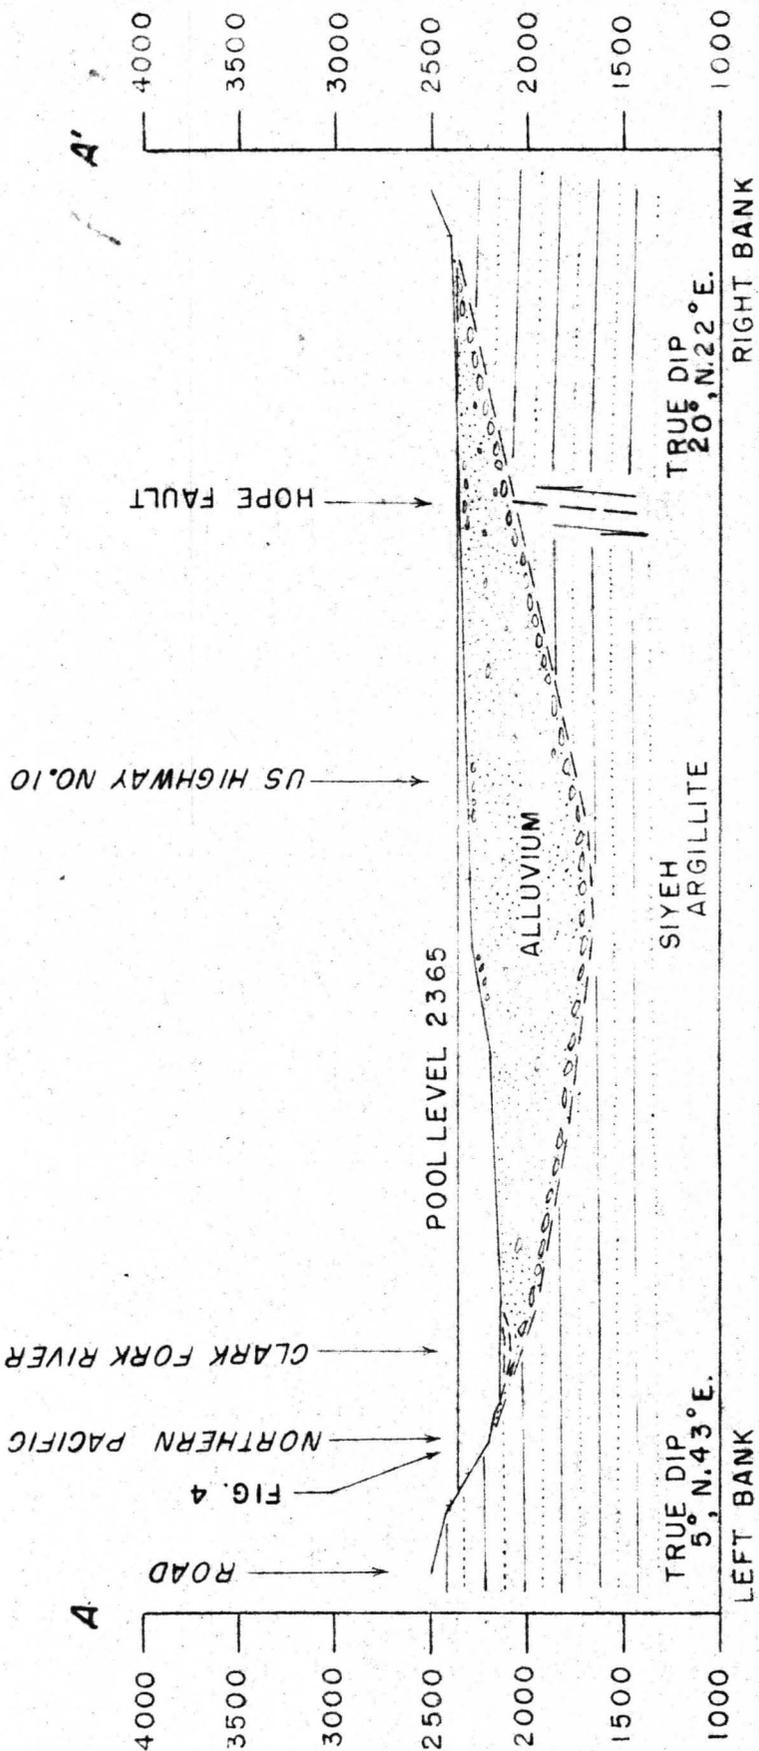
RECONNAISSANCE GEOLOGIC CROSS SECTION
SMEAD DAM SITE

Character and depth of valley fill: Information on this topic is not available. However, from the general history of the valley, one may conclude that a number of types of deposits are present, and that the fill is deep. It is quite possible that the bottom of the valley is occupied by till. Boulder trains that make small riffles suggest that the upper part of this deposit has been reworked by the stream. Following the till came lacustrine silts and sands, during the existence of glacial Lake Missoula, and then, during the waning stages of the lake, the fluvio-glacial outwash deposits. Only those at altitude 2,500 feet or lower may be considered as indigenous to the prospective dam site. Sorting is poor in some facies of the Bull River delta, and at the State gravel pit in NW $\frac{1}{4}$ SW $\frac{1}{4}$ sec. 4, T. 26 N., R. 33 W., there is no marked segregation of the material by size, although most of the pebbles are less than an inch in diameter. Occasional lenses of clay are interbedded in the gravel, and some water wells have reported "quicksand". Topographic conditions suggest that the delta may make the upper 200-250 feet of the valley fill. The total thickness of fill indicated in Fig. 3, is about 600 feet.

Height and length of possible dam: Assuming that the unsound character of the foundation and left abutment can be overcome, in order to fulfill requirements of the Clark Fork - Kootenai project, a dam at Smead site would have a minimum height above river surface of about 226 feet, and a crest length of at least 6,500 feet. However, height above foundation would add considerable footage to the elevation of the structure, and if a cutoff were carried into sound rock in the left abutment, an additional 1,000 feet might be added to the length. Obviously, a very large dam is required for Smead site, and more specific dimensions cannot be given until additional information is available. Furthermore, the nature of the defects indicate a broad base flexible dam.

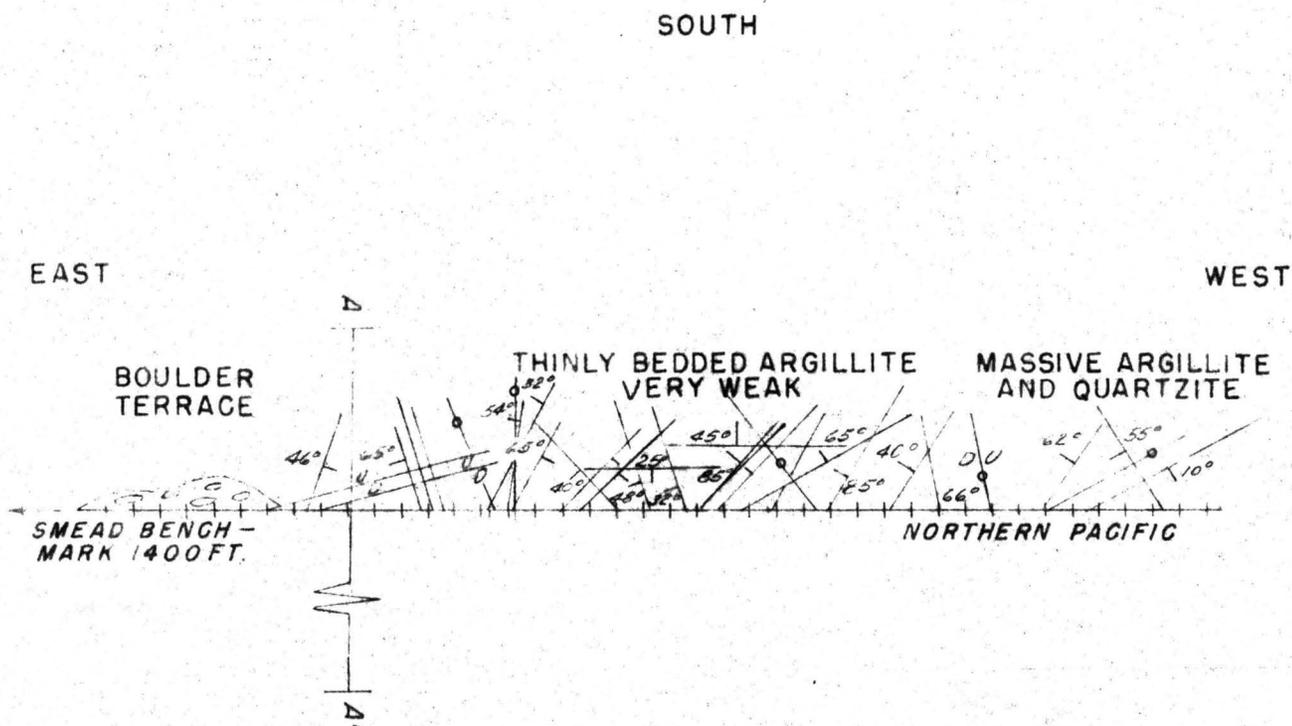
SMEAD DAM SITE AREA
PLAN VIEW OF SOUTH ABUTMENT
SHOWING MINOR FAULTS
TRAVERSE ALONG RAILWAY
Scale 1:12000

The fault pattern of the lower part of the left abutment is illustrated diagrammatically in Figure 4. Their mechanics are unknown, but the probability is that they are of tectonic origin. Farther up the slope to the southwest are several faults (Fig. 2) of probable landslide origin. The minor stress involved in such surficial movements seems inadequate to originate such a complex fracture pattern, but no doubt it has emphasized the fractures by loosening and opening them up as the slumped mass tended to rotate.

The position of the dam section across the shatter zone of the left abutment is shown in Fig. 4 by the line A-A'. The general character of the tectonic faults may be illustrated by a description of the attitude of a small group that cut the wall of the railway cut 700 to 850 feet west of line A-A'. Seven hundred feet west of the line of section, there are two faults. The stronger strikes S. 28° W., and dips 32° SE. The crush zone accompanying this fault consists of 10 to 12 inches of breccia; if gouge clay was ever present, it has been washed out. The second fault strikes S. 22° E., and is vertical. Gouge along it is only 2 or 3 inches thick.

Forty-eight feet farther west another fault strikes S. 10° W., and dips 54° E. Gouge on this fault is 10 inches thick.

Returning again to the line of the prospective dam section, A-A', in Fig. 4: the abutment zone is cut by two closely spaced parallel faults that strike S. 75° W., and dip northwest. These fractures are later than the sequence just described, and are part of a frequent series of normal or gravity faults that extend at least 1,000 feet back (southwest) from the left bank of the river. They are believed, on the basis of topographic evidence, to be of landslide origin; and probably the sliding took place shortly after the deglaciation of the valley, when the beds were thoroughly saturated with water and the slope of the valley wall greatly oversteepened. Two of the upper members of this set are shown on Figure 2. The most southerly fault in sec. 5 may be the sole fault or basal fault of the slumped zone. Its strike is N. 75° W., and dips northeast, but the amount of dip could not be observed. The vertical displacement of this fault is about 165 feet. Another step

The net result has been to translate a mass of highly fractured, thin argillaceous rocks forward and downward over more dense massive strata. The combination of thin beds, with a closely spaced fracture pattern, and thin fault slices cutting the older faults in the slumped blocks nearly at right angles, has been most effective in reducing the strength and continuity of the rock in the left abutment. The sole fault probably completely severs the shattered ground from the unfaulted terrane in the north part of sec. 8. The entire area is highly permeable and weak in both a geologic and engineering sense, and must be regarded as a potential landslide mass.

Taken as a whole, the entire left abutment spur is a thoroughly shattered, structurally weak, highly permeable, potential landslide mass that is geologically unsound and wholly unsuited to serve as the abutment of a dam. No doubt local remedial measures could be taken to reduce the permeability where the formation appears to be unbroken, but there is no continuity of strength within the area, and immunity from future sliding cannot be guaranteed. Hence, if movement did occur, the old fractures would be reopened and new ones

7. These unfavorable features and consequences are of such magnitude that they will be very difficult and expensive to overcome by engineering skill.
8. It is recommended that further consideration of Smead dam site be postponed until the possibilities of an alternative upstream site can be investigated.

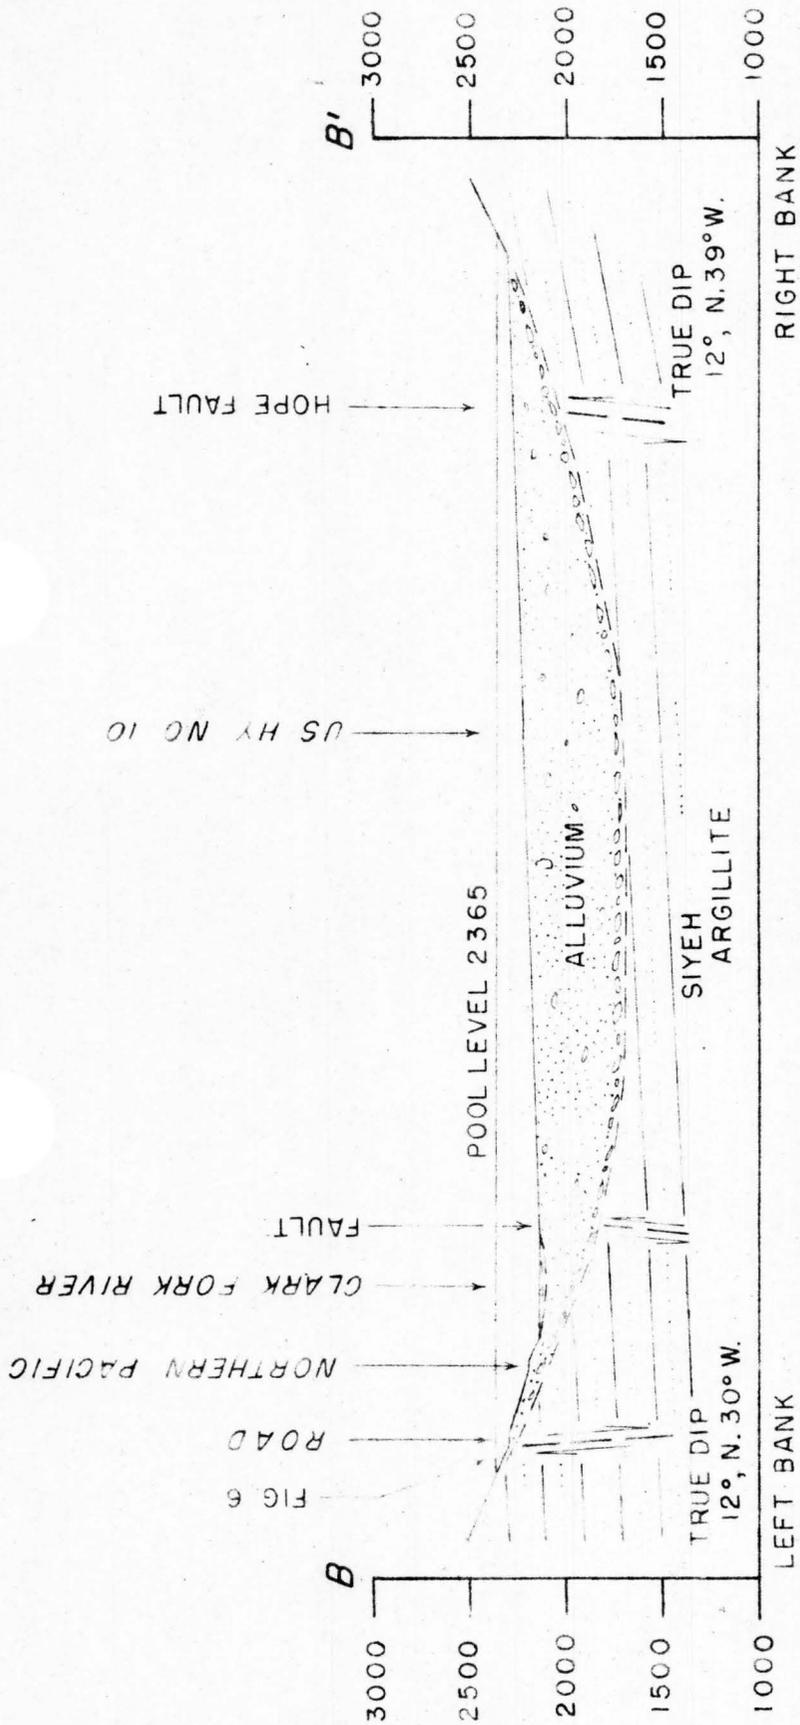
RECONNAISSANCE GEOLOGIC CROSS SECTION
 CHIMNEY ROCK DAM SITE

Valley profile: A general description of Clark Fork Valley has been given in the introduction of this report. A cross-section at low elevations is given in Fig. 5. Comparison with the profile at Smead dam site shows two significant differences: (1) the left abutment consists of the glaciated wall of the younger, inner valley of the river, and is a much higher and more massive feature than the left abutment at Smead dam site. (2) the northeast end of the axis crosses the valley upstream from the Bull River delta. Hence, although the width of the valley floor is about the same as at Smead dam site, it is lower, flatter, and does not contain so much alluvial fill.

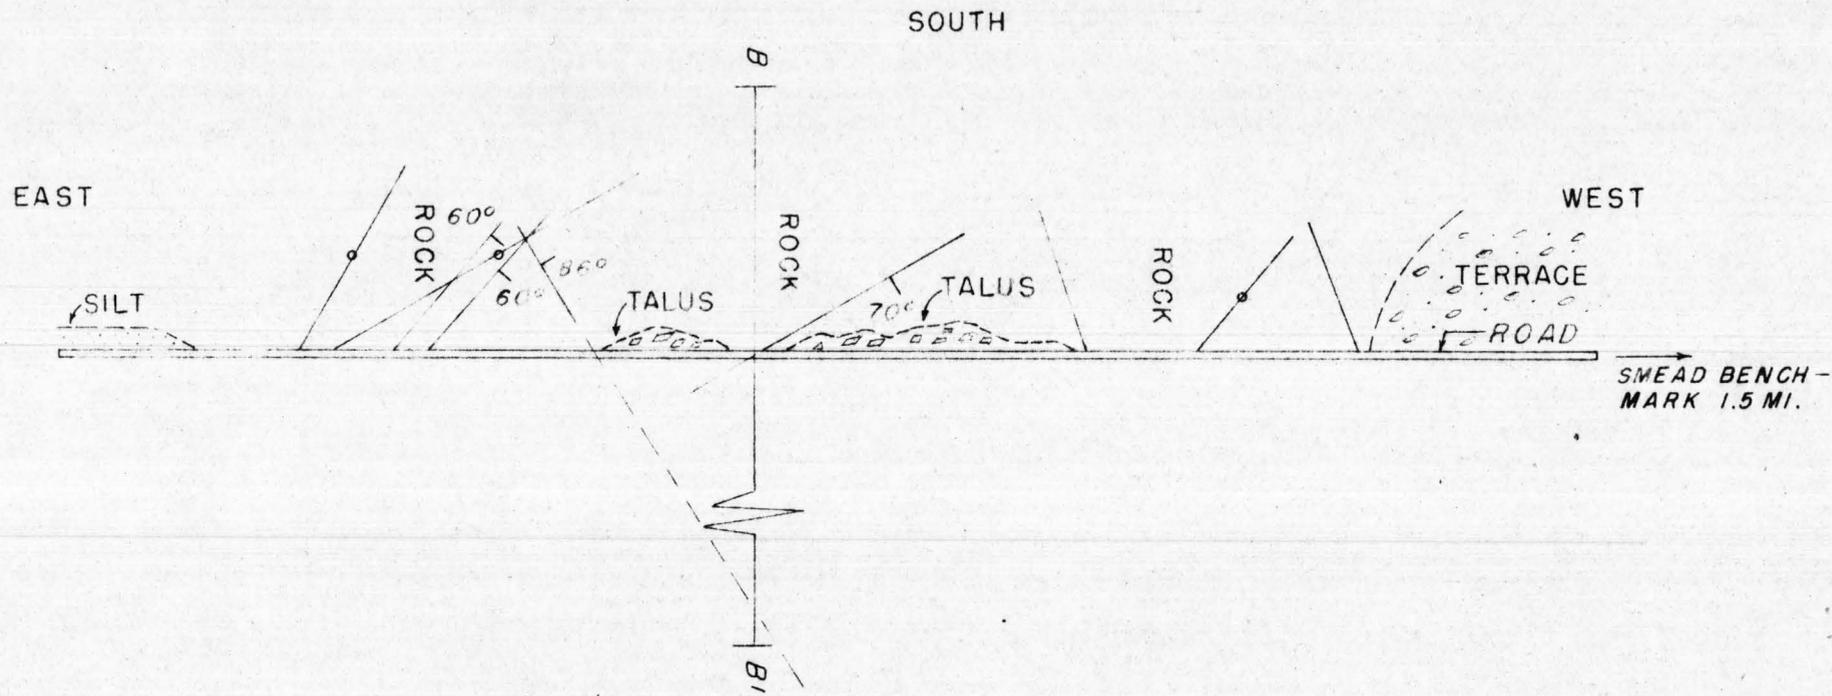
CHIMNEY ROCK DAM SITE
PLAN VIEW OF MAJOR JOINTS IN
SOUTH ABUTMENT
 TRAVERSE ALONG COUNTY ROAD
 Scale 1:12000

Joints. Joints in this area are of two general types: bedding and tectonic. In the cliffs of the left bank the rock has a marked tendency to cleave into rough prismatic blocks 3 to 10 feet on a side. Occasionally a major joint has been etched out by differential erosion into deep, narrow gashes. Viewed from the valley floor, they appear as minor faults, but their true character is evident when they are seen from the top of the cliffs. A plan view of these major joints is given in Fig. 6. This illustration should be compared with Fig. 4, which shows a plan view

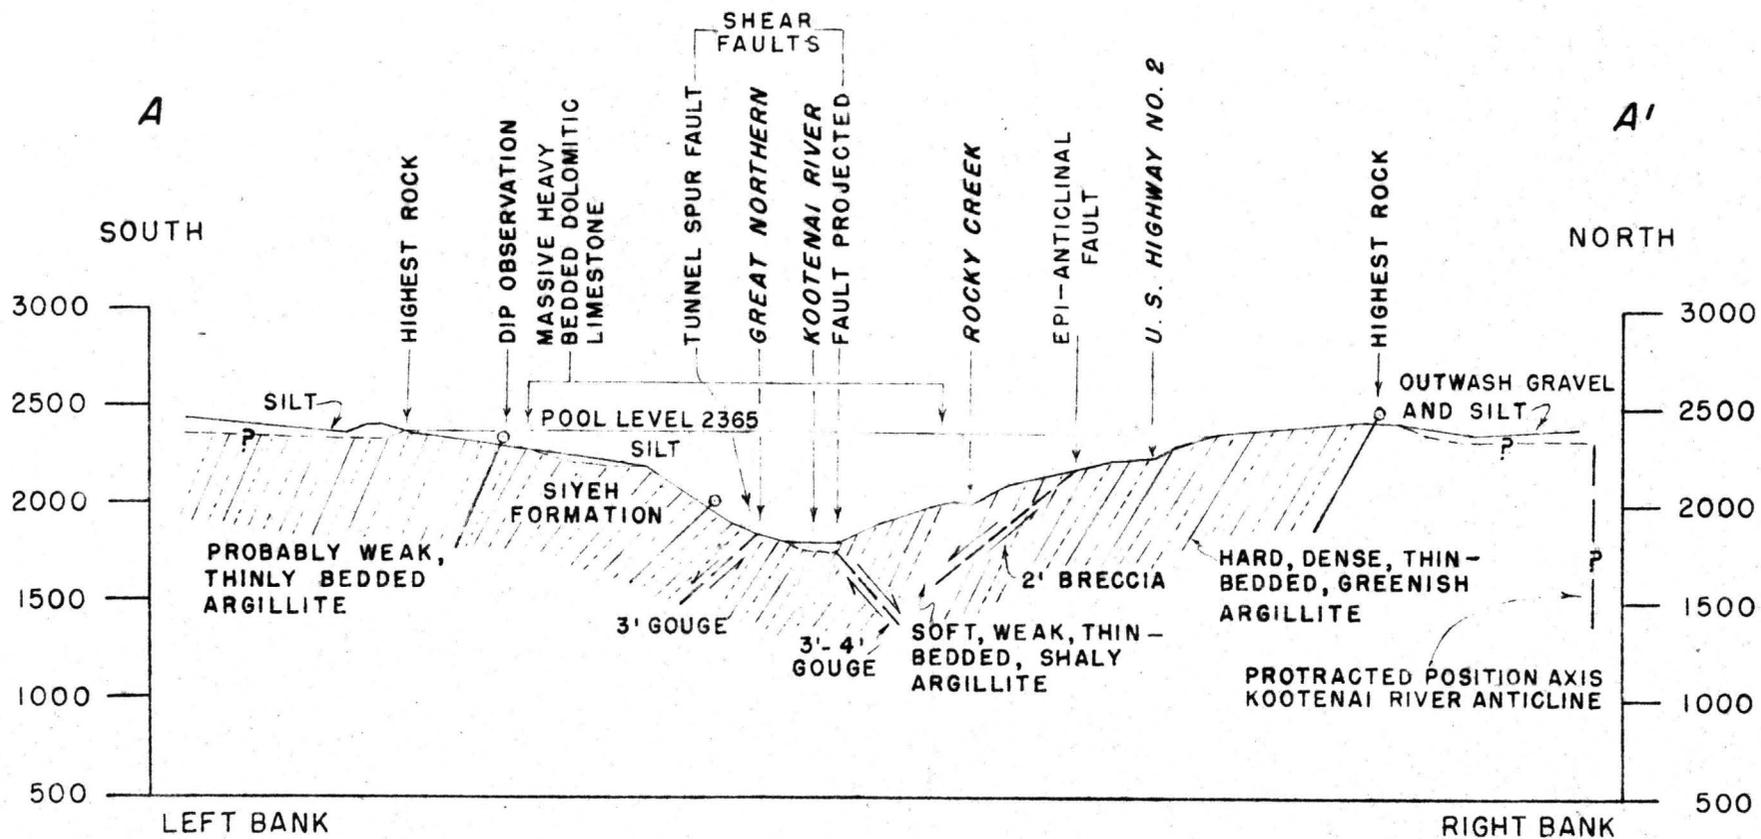
RECONNAISSANCE GEOLOGIC CROSS SECTION
TUNNEL NO. 8 DAM SITE
 SEC. 21 & 28, T. 33N., R. 34W.
 LINCOLN COUNTY, MONTANA
 Scale 1:12000

Valley profile: The inner gorge of Kootenai River at Tunnel No. 8 has been described in Water Supply Paper 866-A, and a profile (Fig. 1-B) from river surface (1,817 feet) to altitude 2,200 feet is given on page 27 of that report. In the present study, topography was carried up to altitude 2,440 feet on the right bank, and to altitude 2,500 feet on the left bank. In order to secure the narrowest width of profile above altitude 2,300 feet the bearing of the new high profile (Fig. 11, this report) has been changed somewhat from that given in Fig. 1-B (W.S.P. 866-A). Hence, there is some variation in the character of the two profiles below elevation 2,200. The apparent bench at elevation 2,000 on the right bank in Fig. 12 results from the line of section paralleling a contour in the small re-entrant valley of Rocky Creek. Width of valley at elevation 2,200 in Fig. 1-B is about 1,480 feet, whereas in Fig. 12 it is about 2,300 feet.

Above altitude 2,200 valley width increases rapidly. This results from a broad terrace on either side between the elevations of 2,200 and 2,300 feet. From the rear of this terrace the ground rises gently on to the old, broad, high-level valley of Kootenai River. This feature is especially well developed on the right bank, where it extends back at elevations close to 2,400 feet for a mile or a mile and a half. Its surface is covered with fluvio-glacial outwash and glacial lake silt, and it rises gradually on to a constructional surface at altitude 2,500 that is also of considerable local extent.

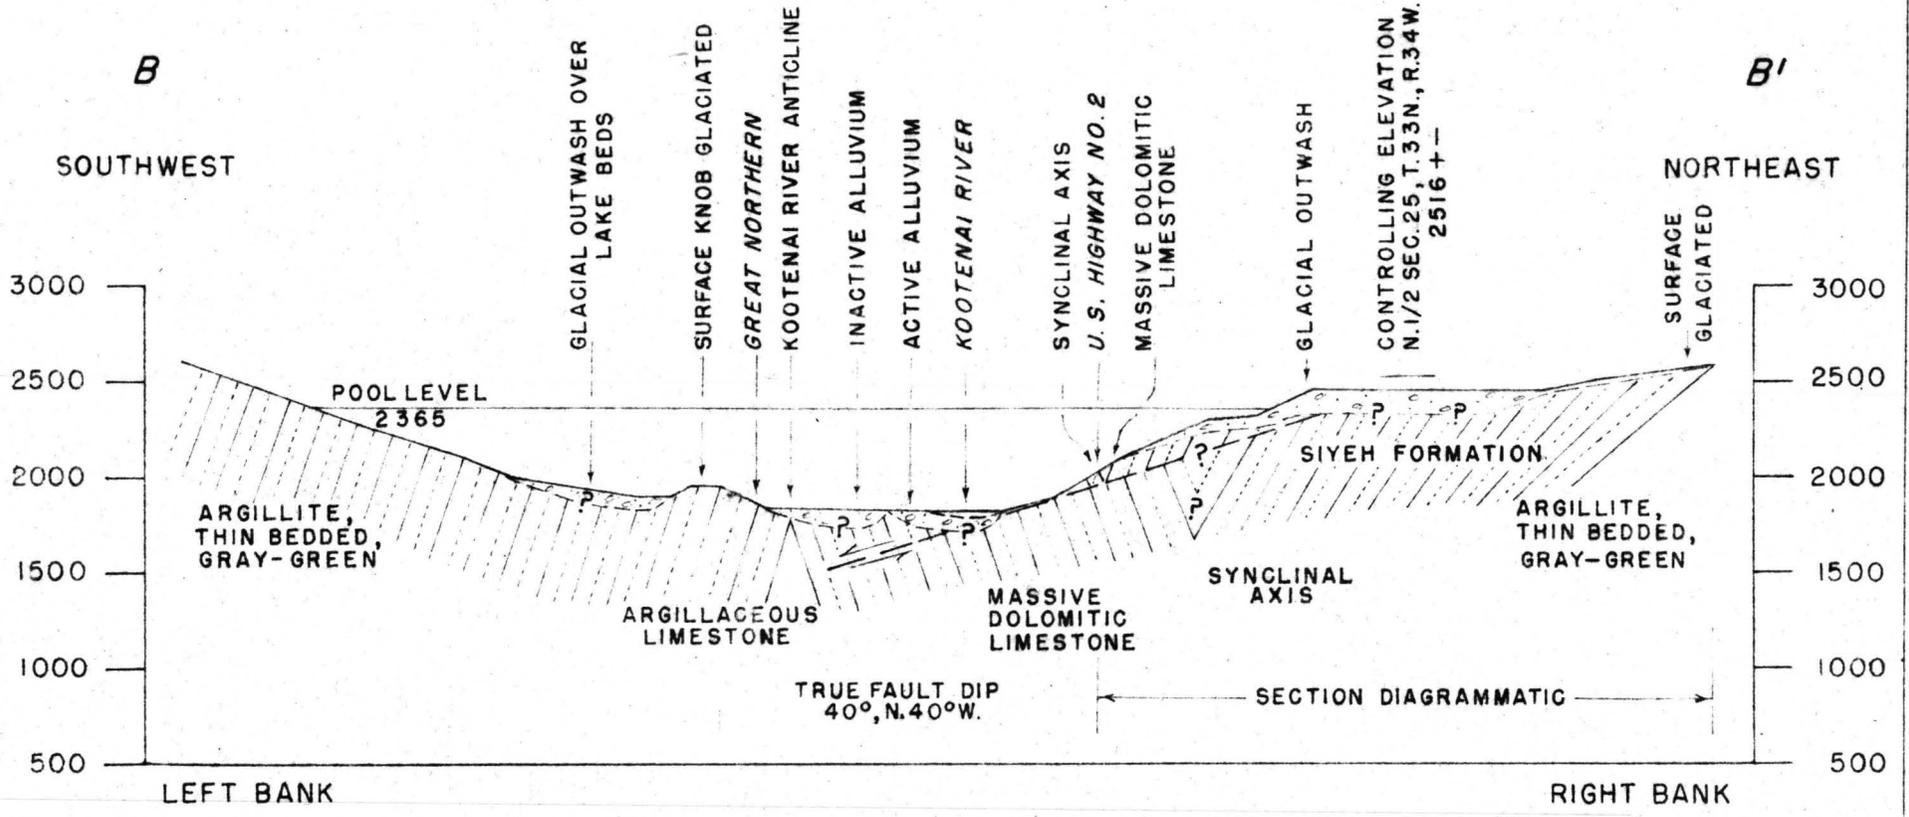
RECONNAISSANCE GEOLOGIC CROSS SECTION
 STAR CREEK DAM SITE
 SEC. 4 & 5, T. 32 N., R. 34 W.
 LINCOLN COUNTY, MONTANA
 Scale 1:12000

Only those from elevation 2,500 to river level are shown on Fig. 13, and the scale of the topography is inadequate to portray most of the narrow rock cut benches. The highest level of filling is marked by glacial outwash on the right bank at
