ICINGS ALONG THE TRANS-ALASKA PIPELINE ROUTE

By Charles E. Sloan, Chester Zenone,  
and Lawrence R. Mayo

Open-File Report 75-87

Anchorage, Alaska  
1975

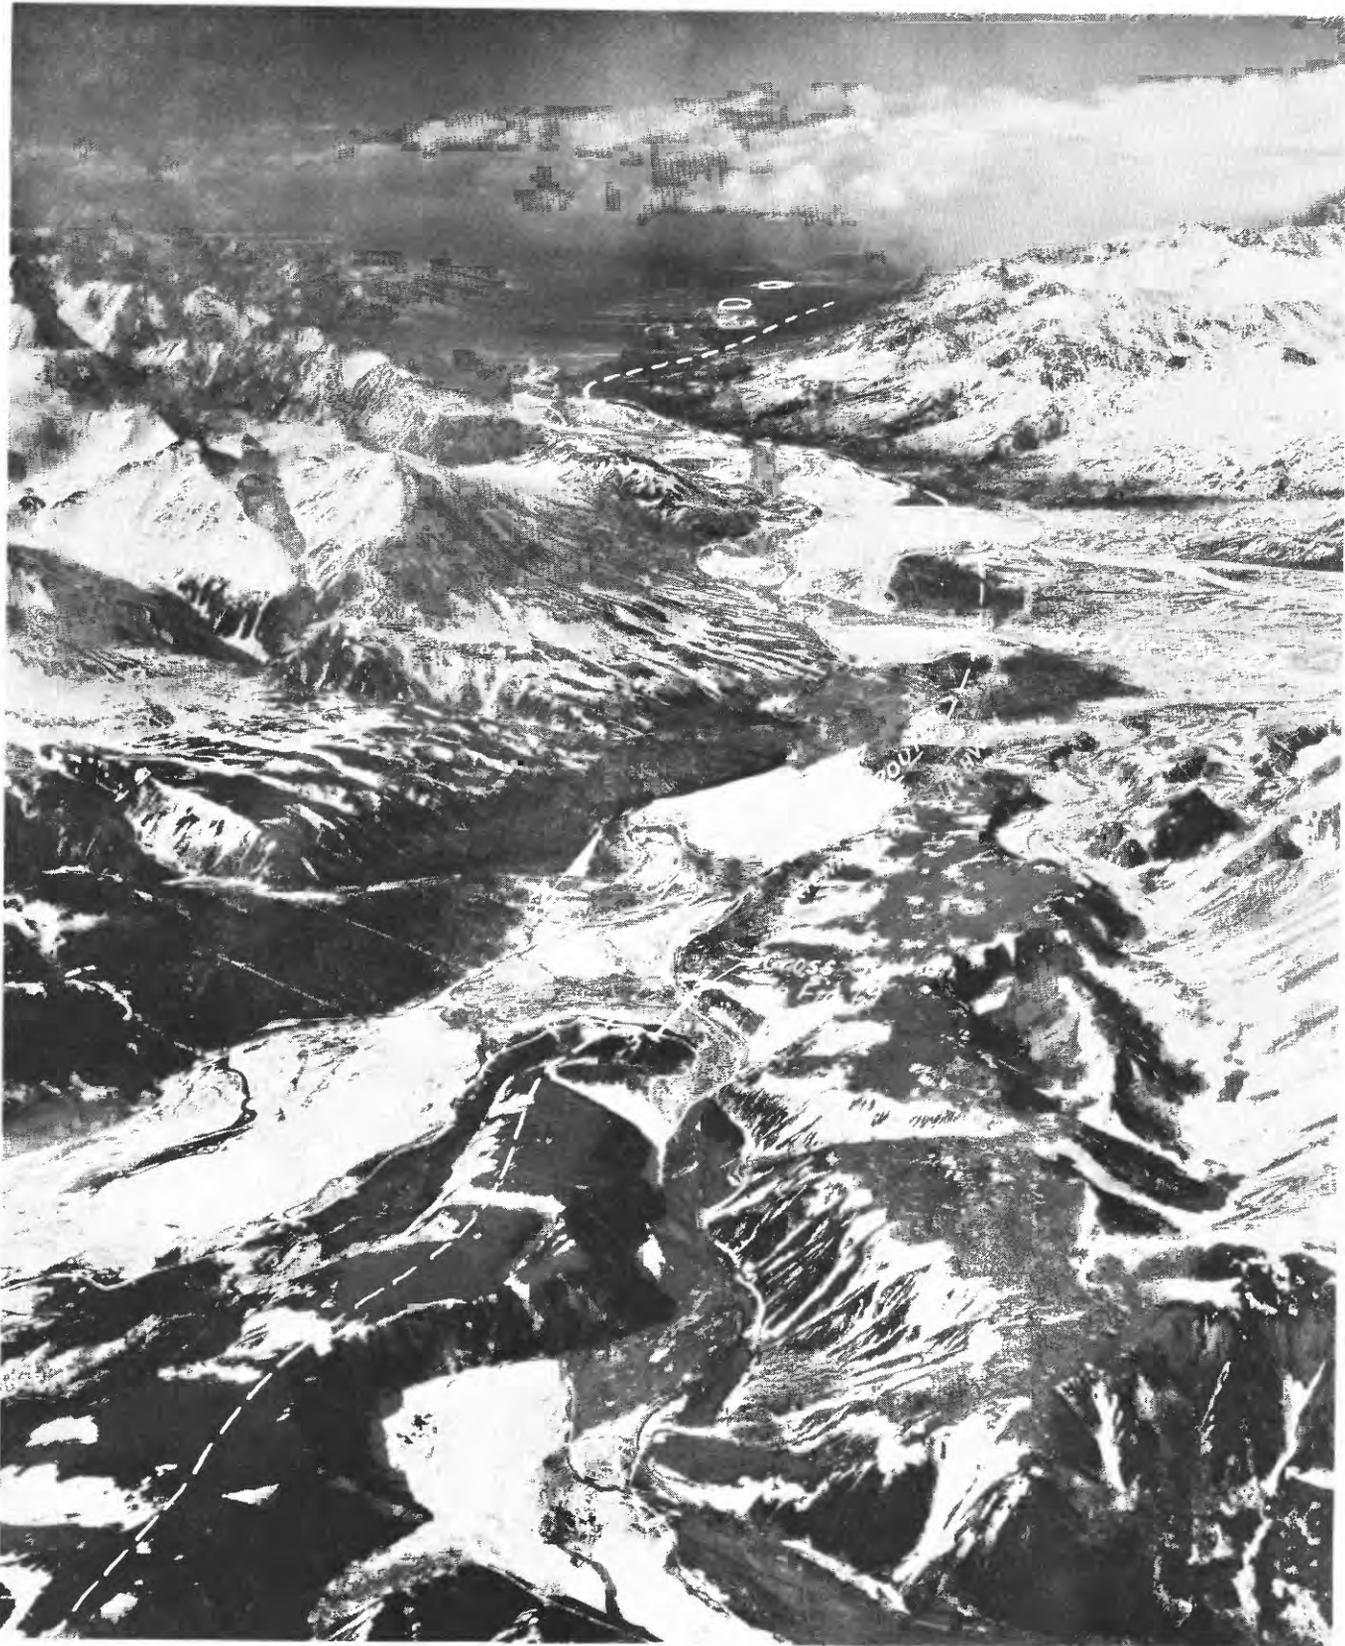
Figure 2.--Flood-plain icings on the Delta River and tributaries.  
View north along the pipeline route, May 22, 1972.

Small hillside and channel icings occur along the pipeline route between Donnelly Dome and Black Rapids (fig. 24). South of Black Rapids the pipeline route is in the active flood plain of the Delta River where extensive icings form annually (cover photograph; figs. 2, 25, and 26). The toes of several steep alluvial fans, including those of Boulder, Flood, and Trims Creeks, are crossed in this reach. The pipeline route also crosses the site of a large icing in Phelan Creek and site of another icing on the fan of McCallum Creek (fig. 27).

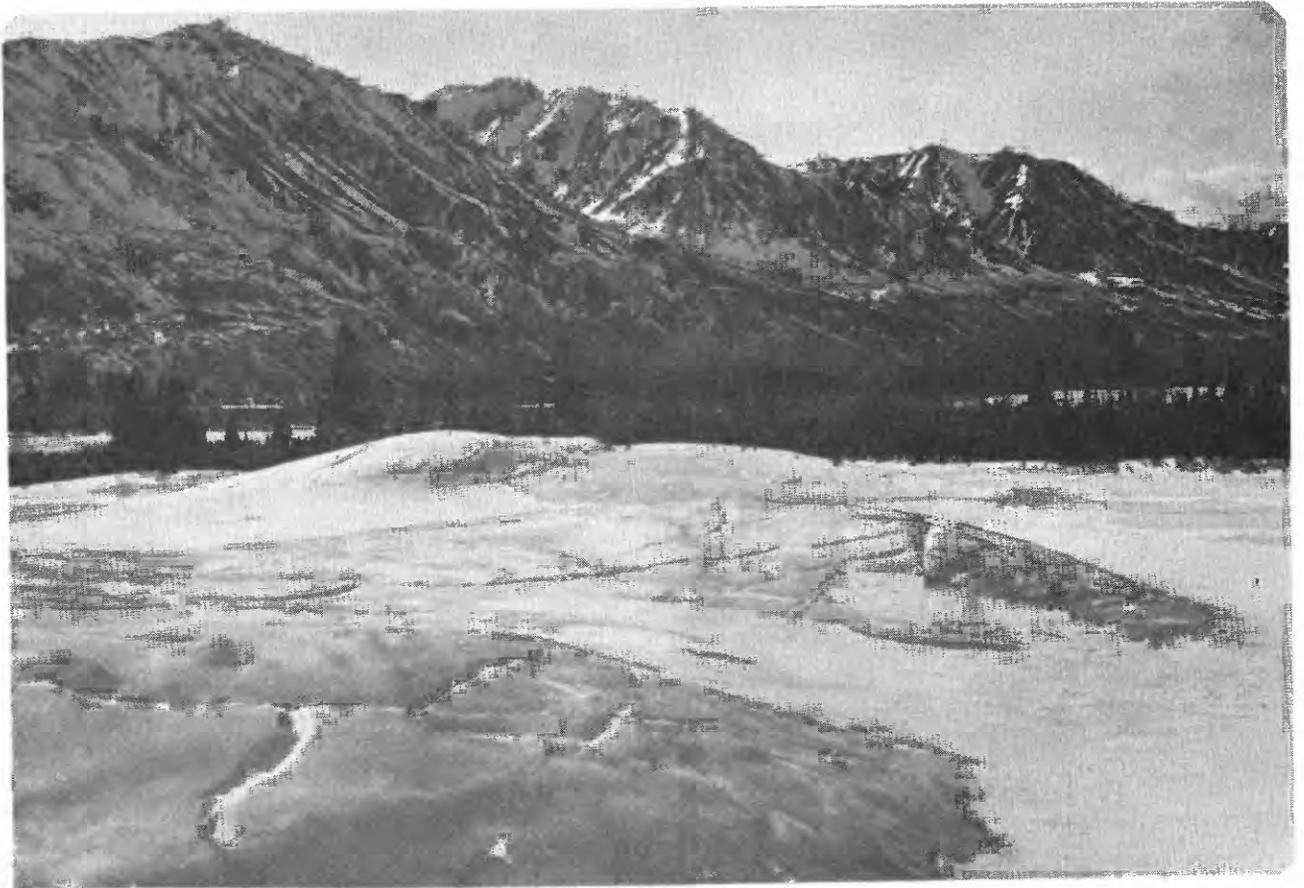
Icing mounds or hummocks are uplifted ice ridges, broad humps, or smaller conical domes (fig. 3) that are common features on large icings. As ice freezes downward, pockets of water may become isolated. The volume expansion that results from the freezing process in these pockets sharply increases the hydrostatic pressure. High hydrostatic pressure produces the uplifted area, which then cracks; the pressure is relieved as water bleeds out through radial or circular cracks. Occasionally, relief of pressure can occur suddenly and explosively, resulting in displaced and shattered blocks of ice (figs. 4 and 5). Such explosive events may be related to the release of entrapped gases.

Figure 3.--Icing mounds on Trims Creek near pipeline crossing,  
Delta River valley, April 18, 1974.

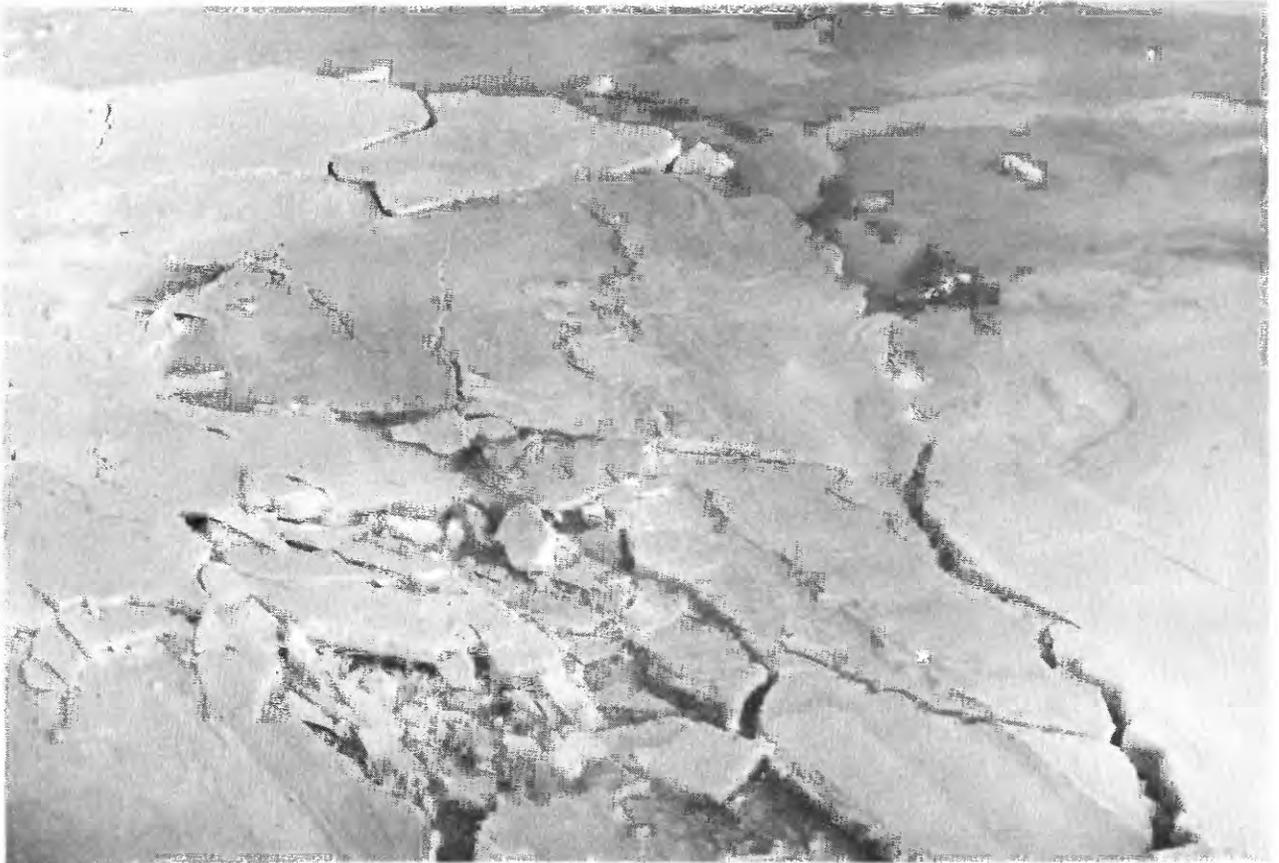
Figure 4.--Fractured icing mound on Dietrich River approximately 2 miles (3.2 km) downstream from confluence with Big Jim River, March 15, 1972. Explosive force scattered ice blocks for tens of feet.

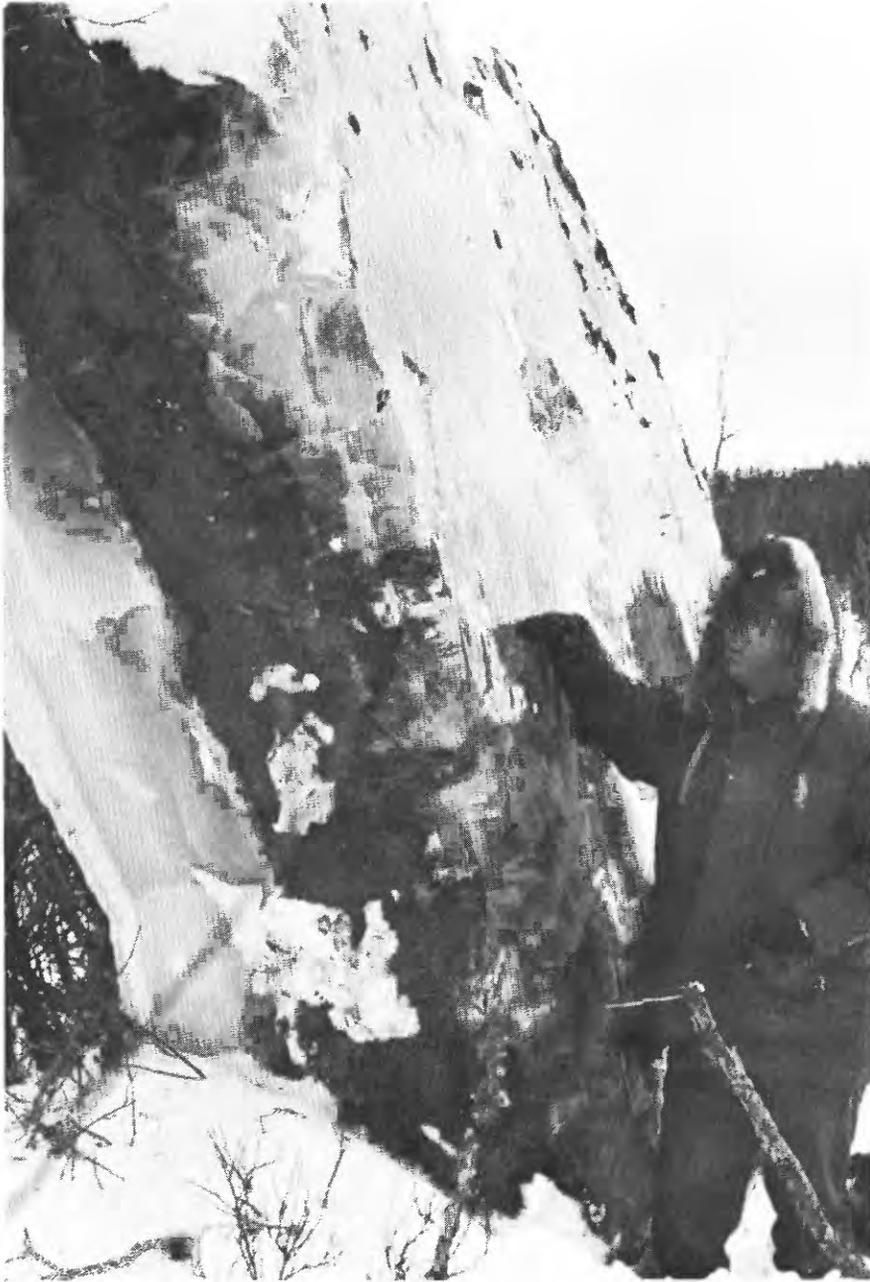
Figure 5.--Upheaved ice and soil block from exploded hillside icing mound north of Old Man camp in Fish Creek valley, March 21, 1974.

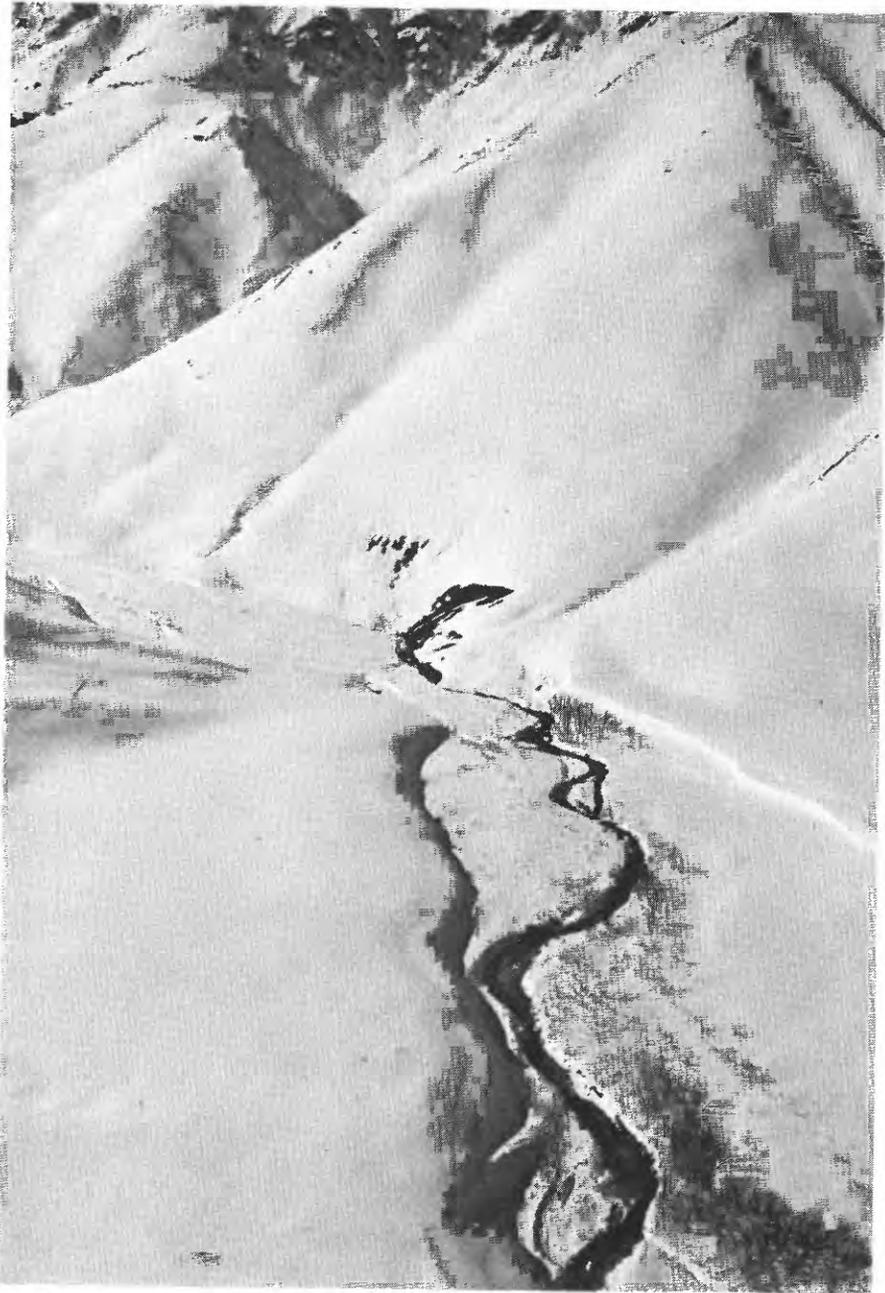
Large icings near the front of the Brooks Range are fed by springs discharging from carbonate bedrock directly to the river or alluvium in the river bed (fig. 6).

Figure 6.--Hillside spring in Brooks Range near Ivishak River, May 11, 1973. Balsam poplar are 30 to 40 feet (10 to 12 m) tall.

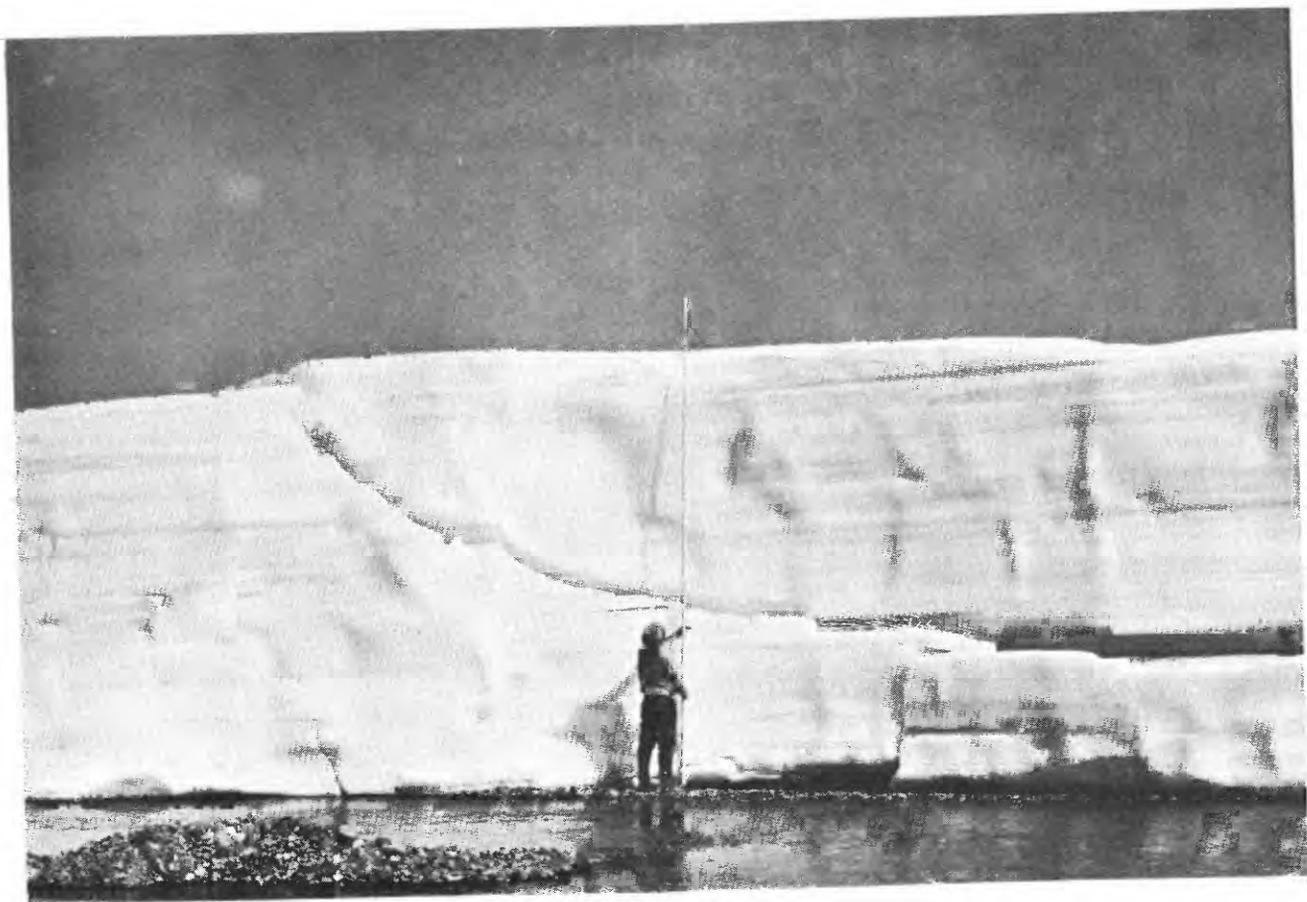
Figure 10.--Echooka River icing about 16 feet (5 m) thick, July 11, 1972.  
Layering in ice shows that numerous overflows make up the icing.

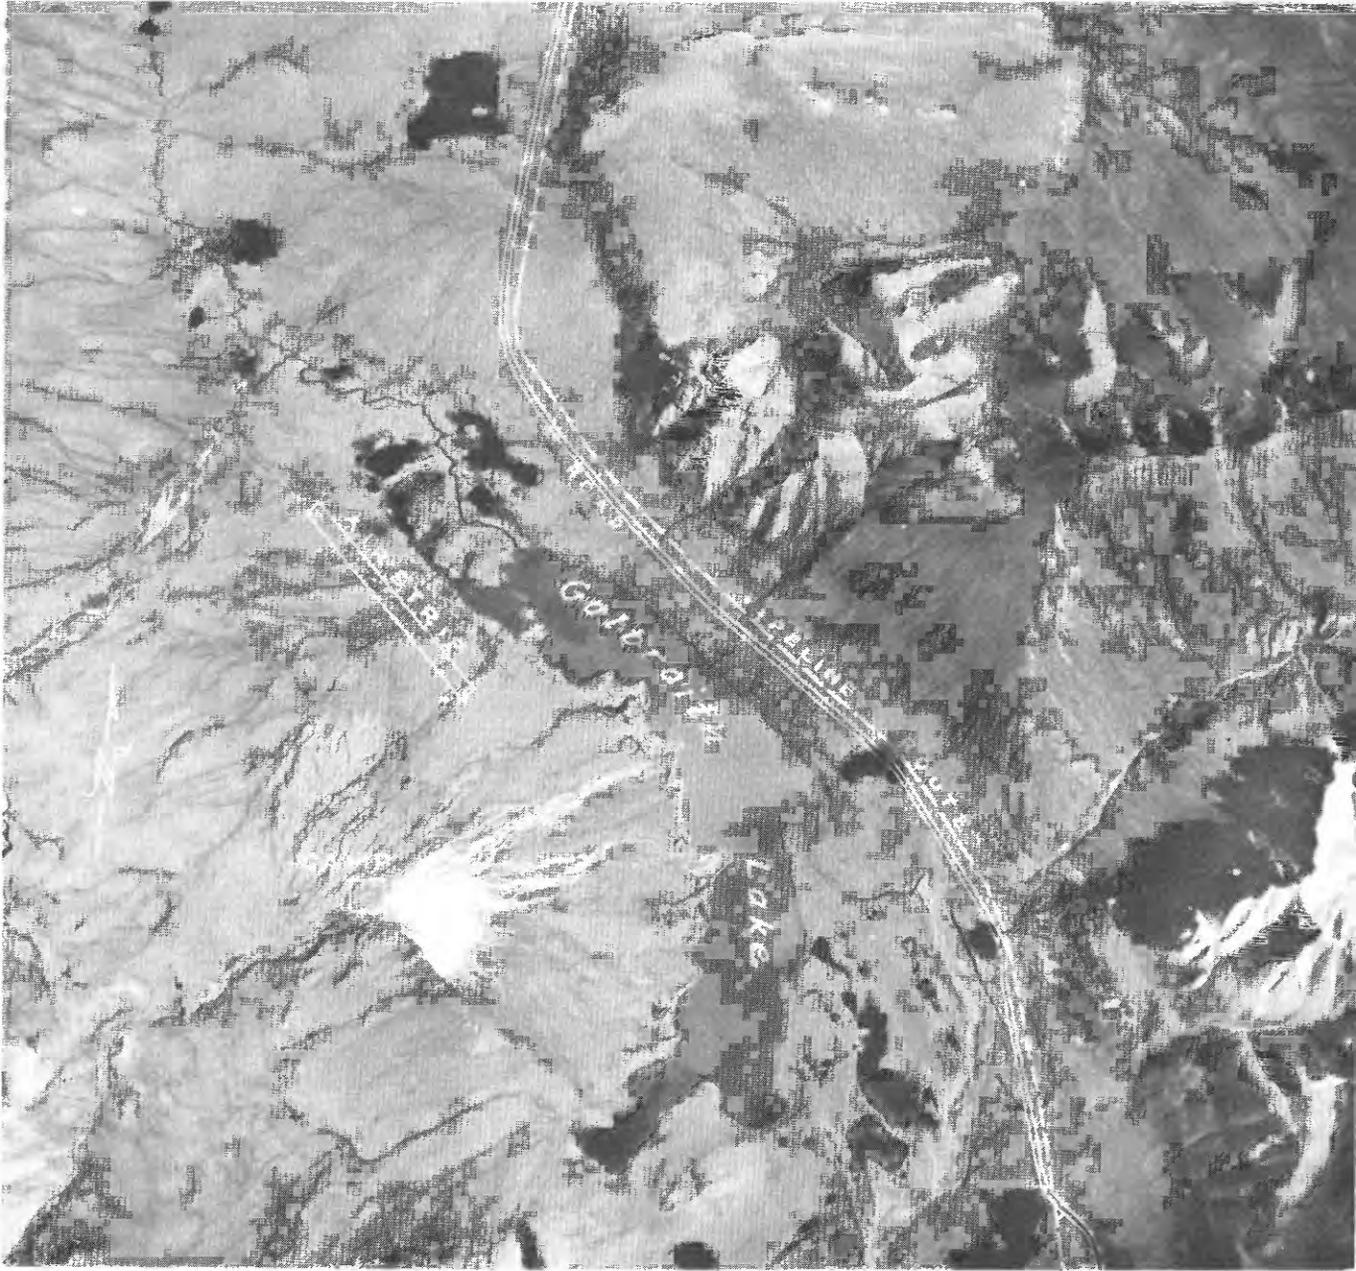
A large icing forms annually on the alluvial fan west of Galbraith Lake (figs. 11 and 12). Large icings also occur at wide, braided channel reaches of the upper Atigun River valley (figs. 11 and 13).

Figure 12.--Icing on alluvial fan at Galbraith Lake, July 21, 1956.  
(Approximate scale: 1 inch = 4,000 feet or 1 centimetre  
= 480 metres.)

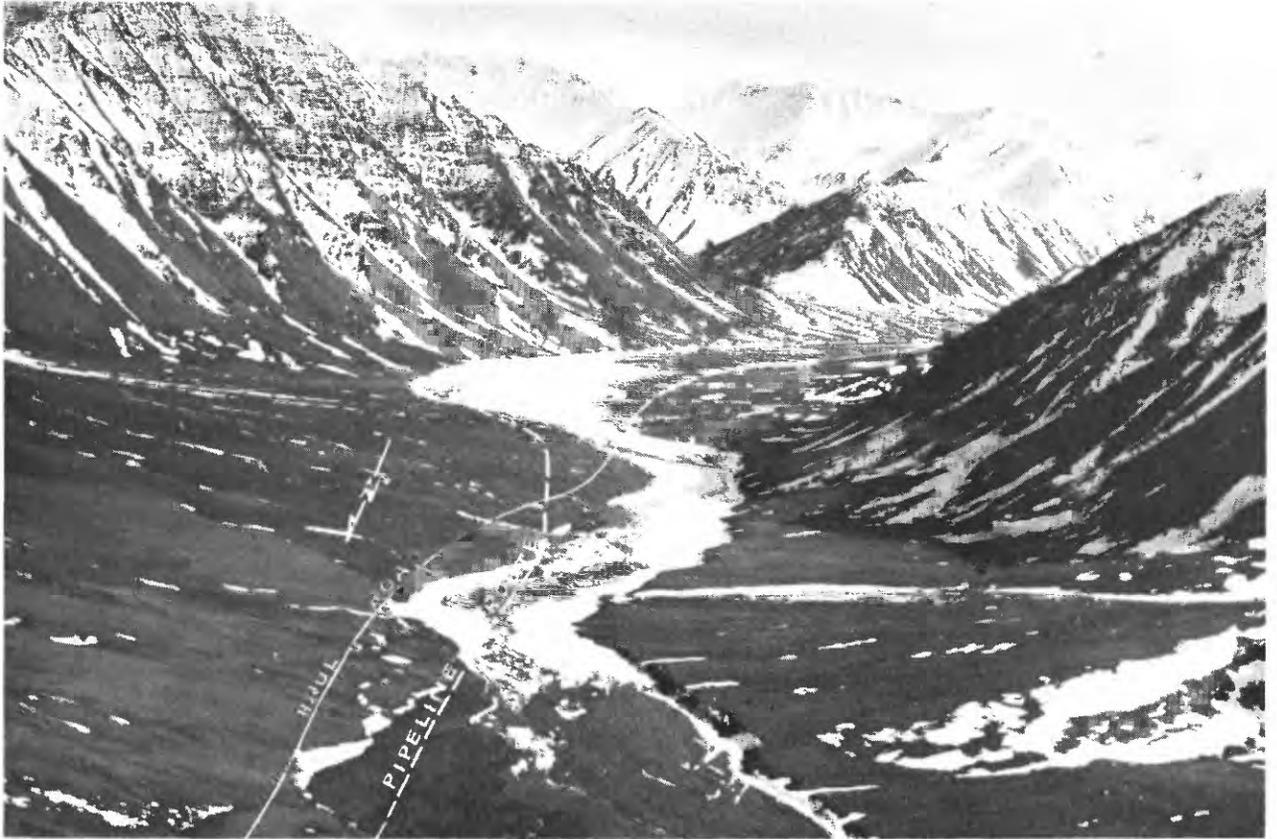
Figure 13.--Icings in braided reaches of Atigun River, May 29, 1973.

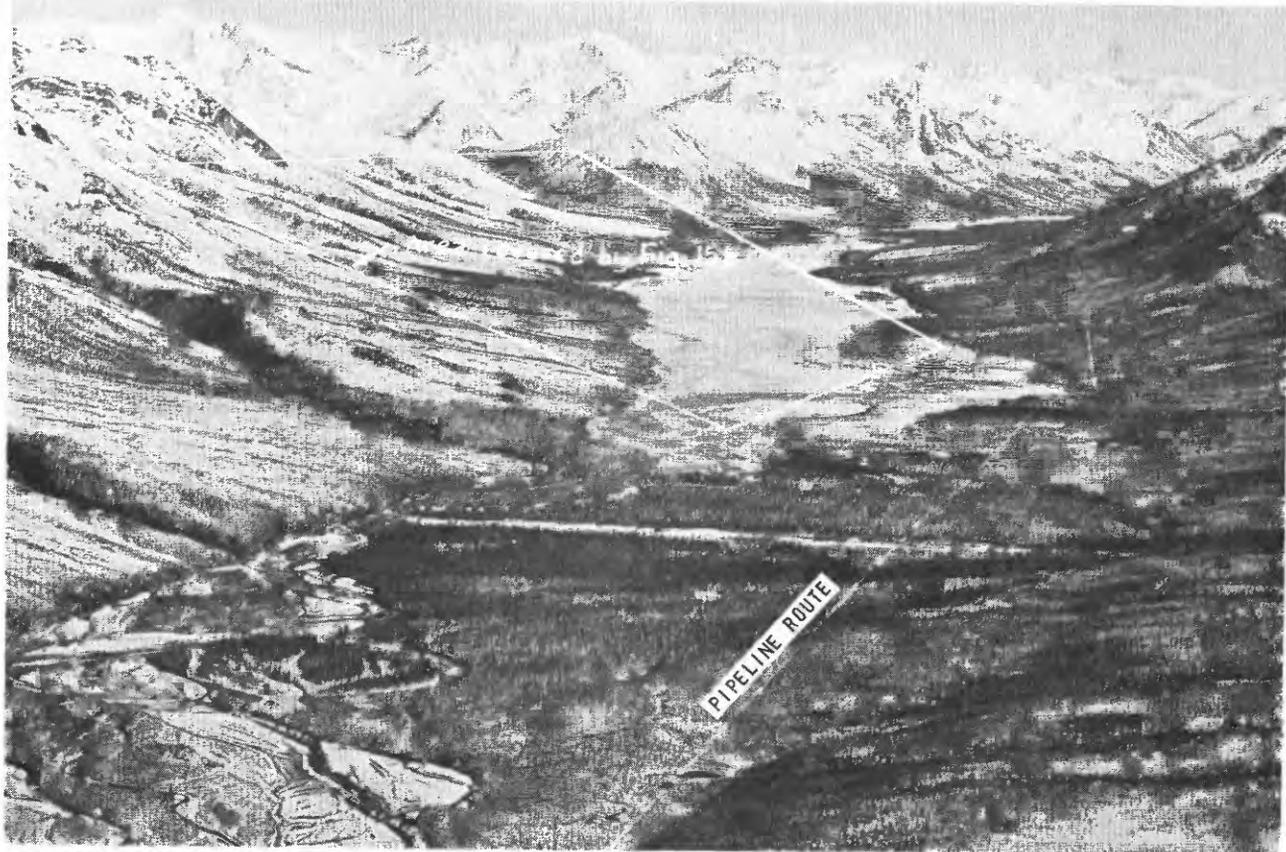
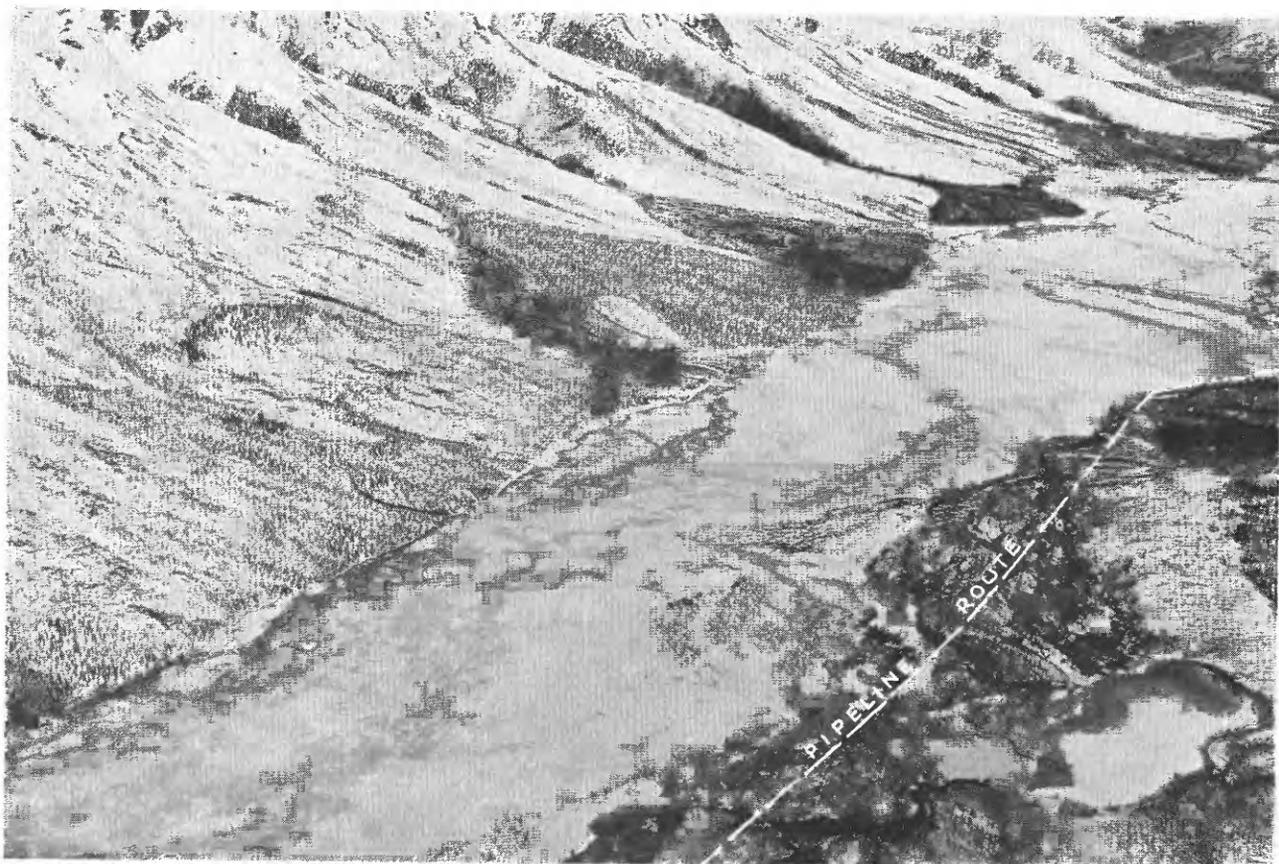
Figure 15a.--Icing in Dietrich River valley upstream from Snowden Creek, May 1, 1974.

Figure 15b.--Close-up view of part of icing shown in figure 15a.

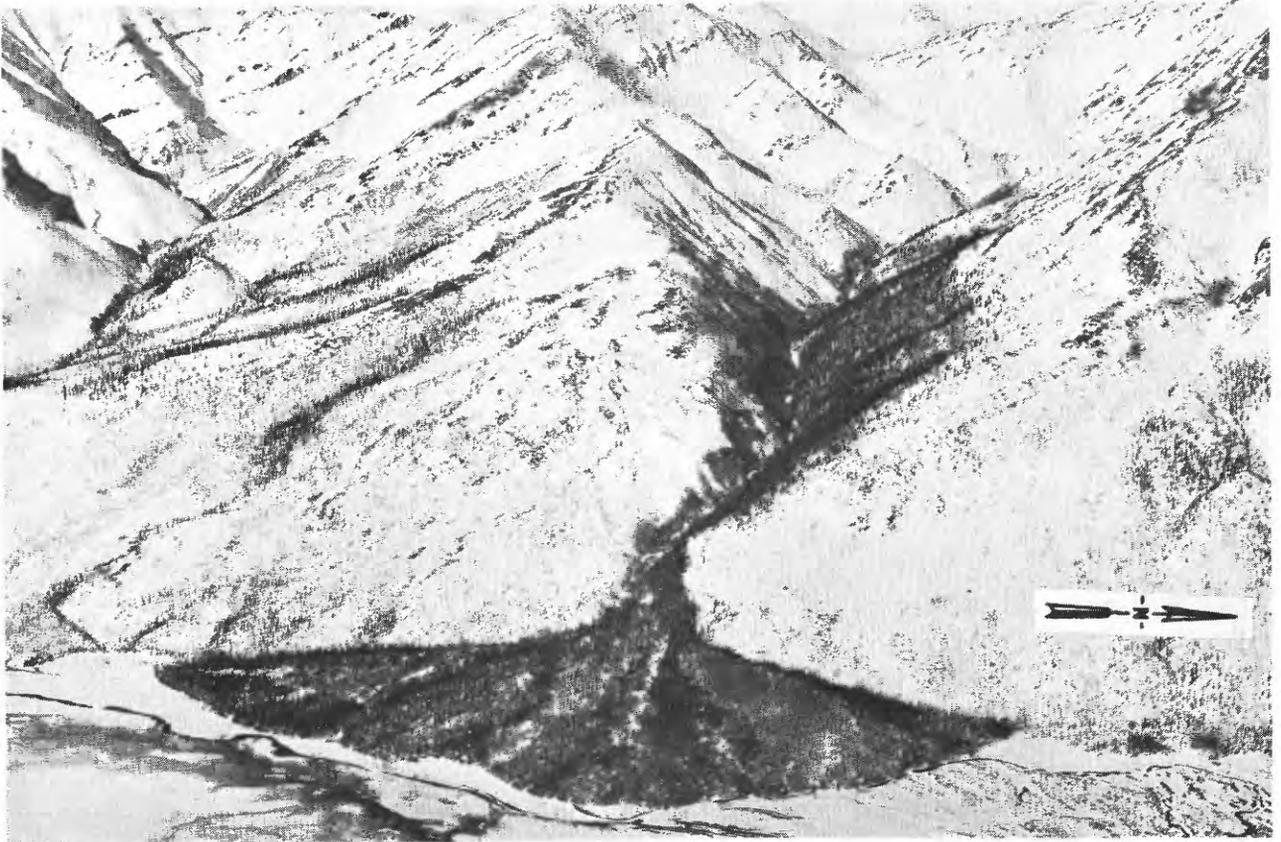
Icings inundate almost the entire active flood plain along braided channel reaches of the Dietrich River (fig. 14). Where the river channel is incised and the reach not braided, channel ice or only minor overflow icing occurs. The large icings on the Dietrich River seem to have their water source from the steep alluvial fans which have built out onto the Dietrich River flood plain (figs. 15a and 15b). Open leads in the Dietrich River icings can be seen at the base of the alluvial fans where ground water is emerging (fig. 16).

Figure 16.--Alluvial fan in Dietrich River valley upstream from Snowden Creek, May 1, 1974. Open leads at toe of fan are source of water for downstream icings.

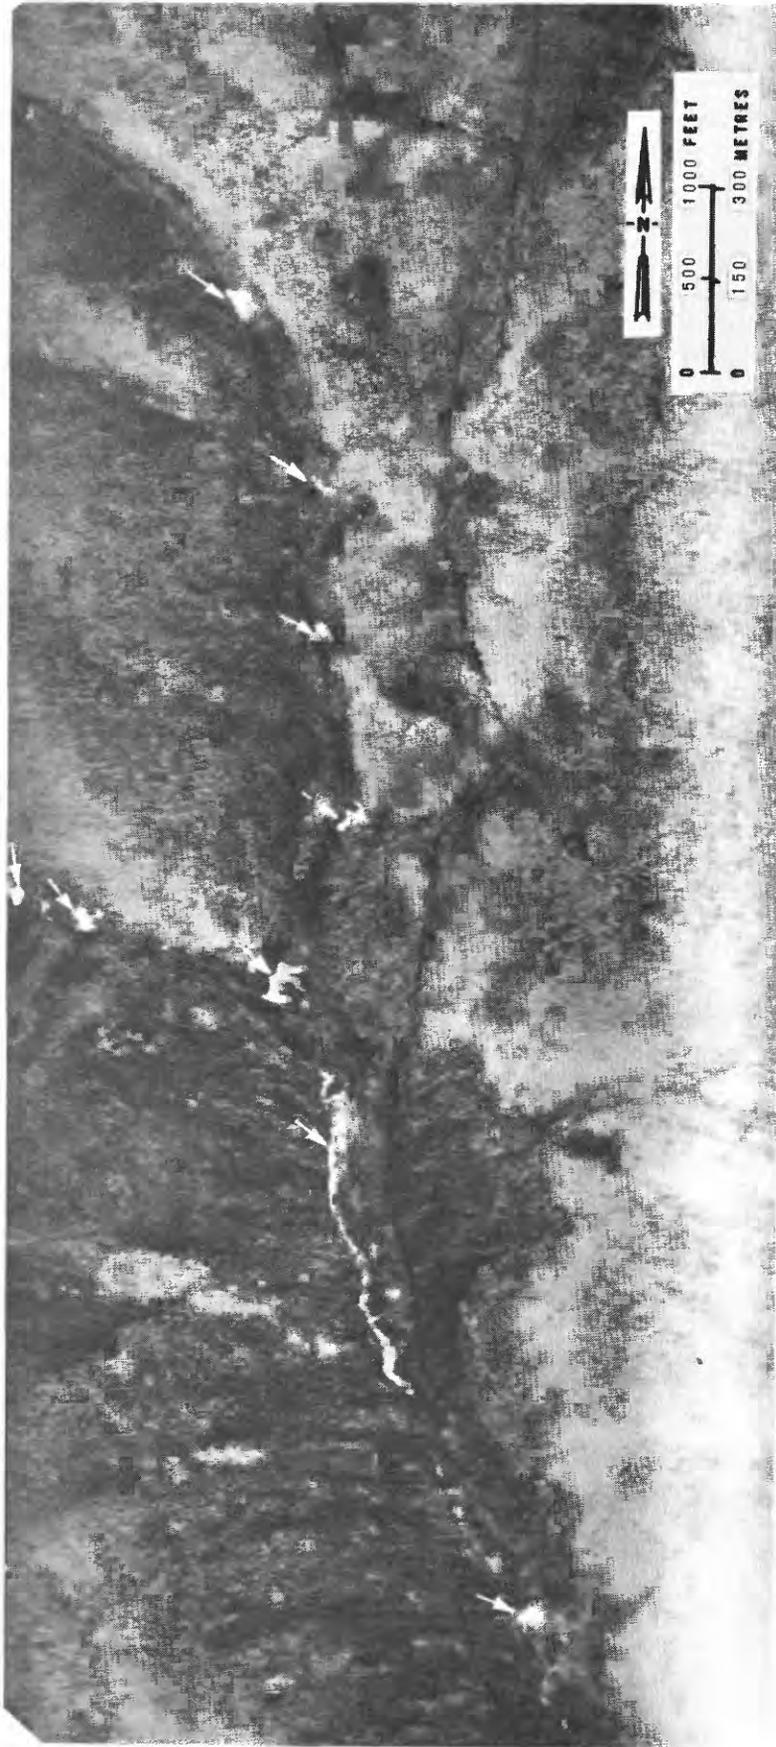
Channel ice and minor overflow icing occurs on the major streams crossed by the pipeline between Fairbanks (fig. 20) and Big Delta (fig. 21). Icings form on many smaller streams draining the Yukon-Tanana Uplands. Thermal infrared imagery obtained in February 1974 shows water overflowing the icings in the Minton Creek area (fig. 22). In this imagery, the presence of water is indicated by the white areas that signify relatively higher temperatures. A large icing occurs along the pipeline route in the flats north of Shaw Creek (fig. 23). An open channel is usually maintained along the Tanana River at the planned pipeline crossing because relatively warm ground water is discharged along the south bank.

Figure 22.--Thermal infrared image of icings along Minton Creek February 4, 1974. Water surfaces (arrows) contrast with snow and vegetation background.

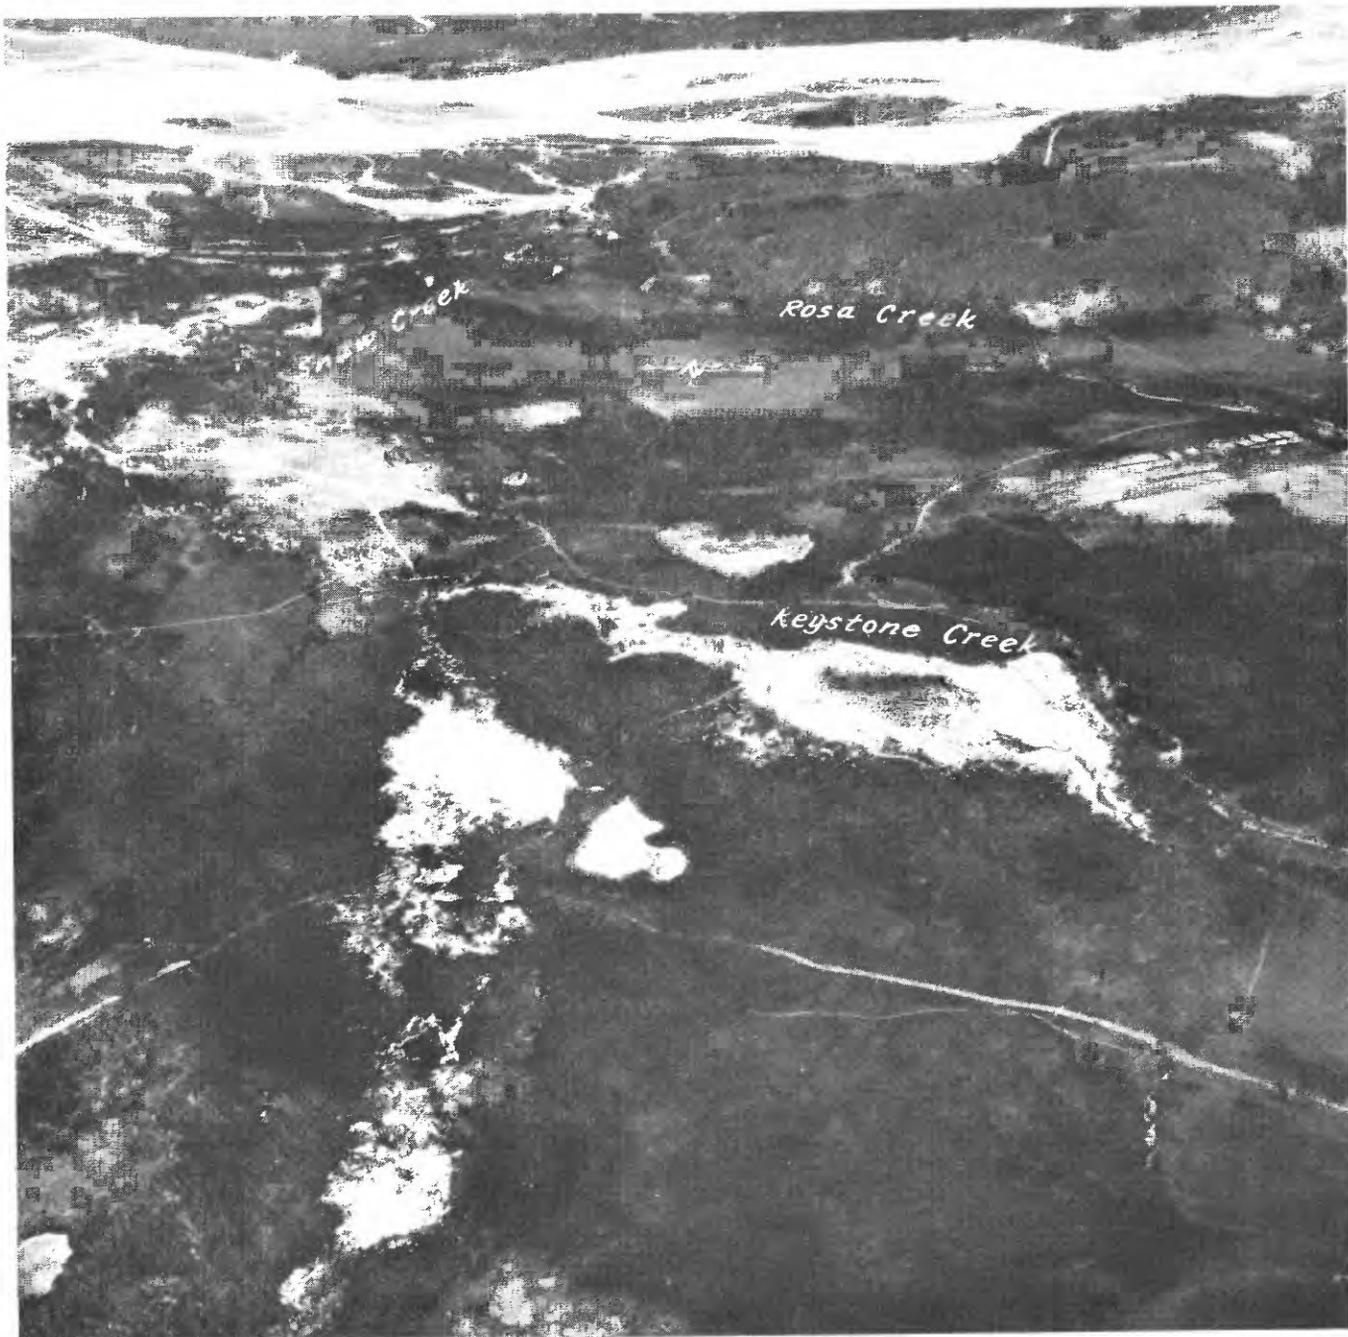
Figure 23.--Icings in flats north of Shaw Creek, May 22, 1972.

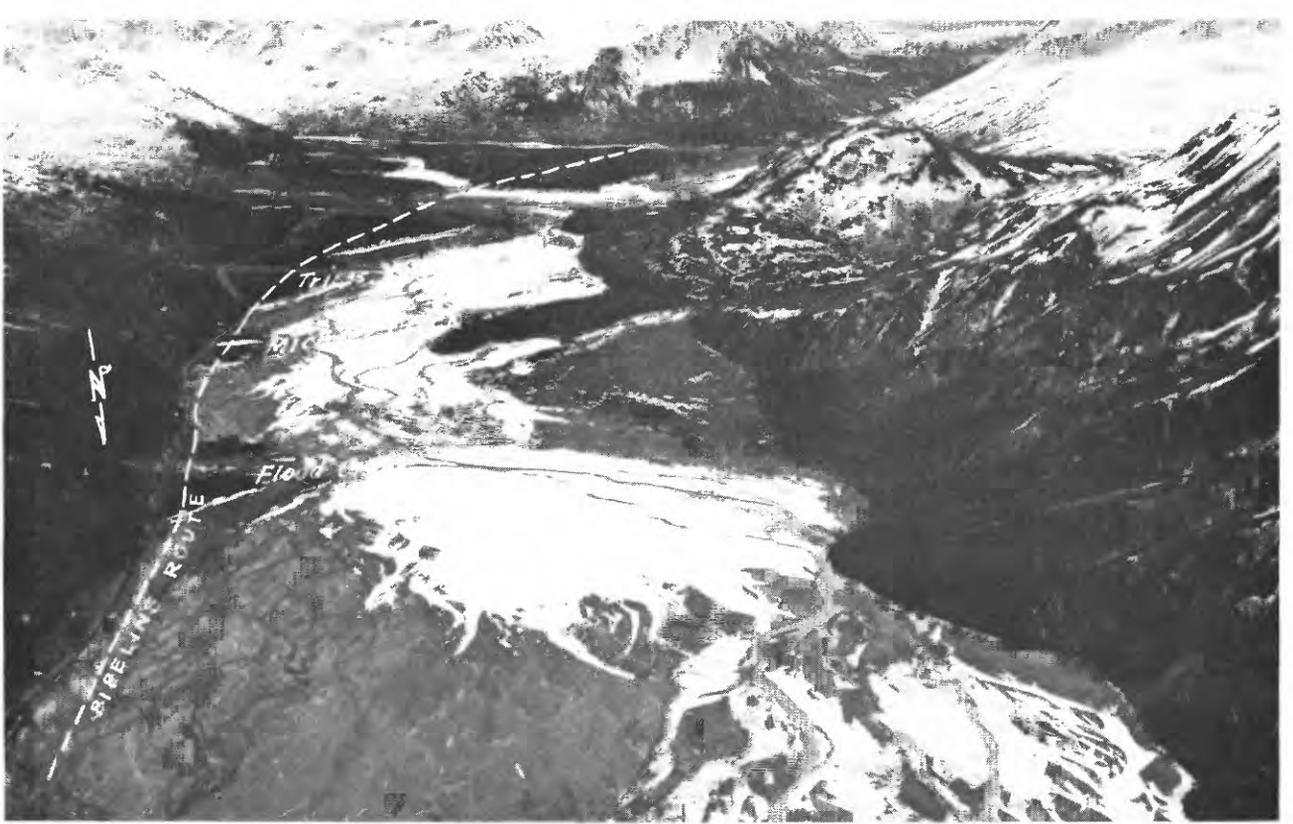
Figure 25.--Flood-plain icings along Delta River. Alluvial fans of Flood, Michael, and Trims Creek in left foreground. View south (upstream) on May 29, 1973.

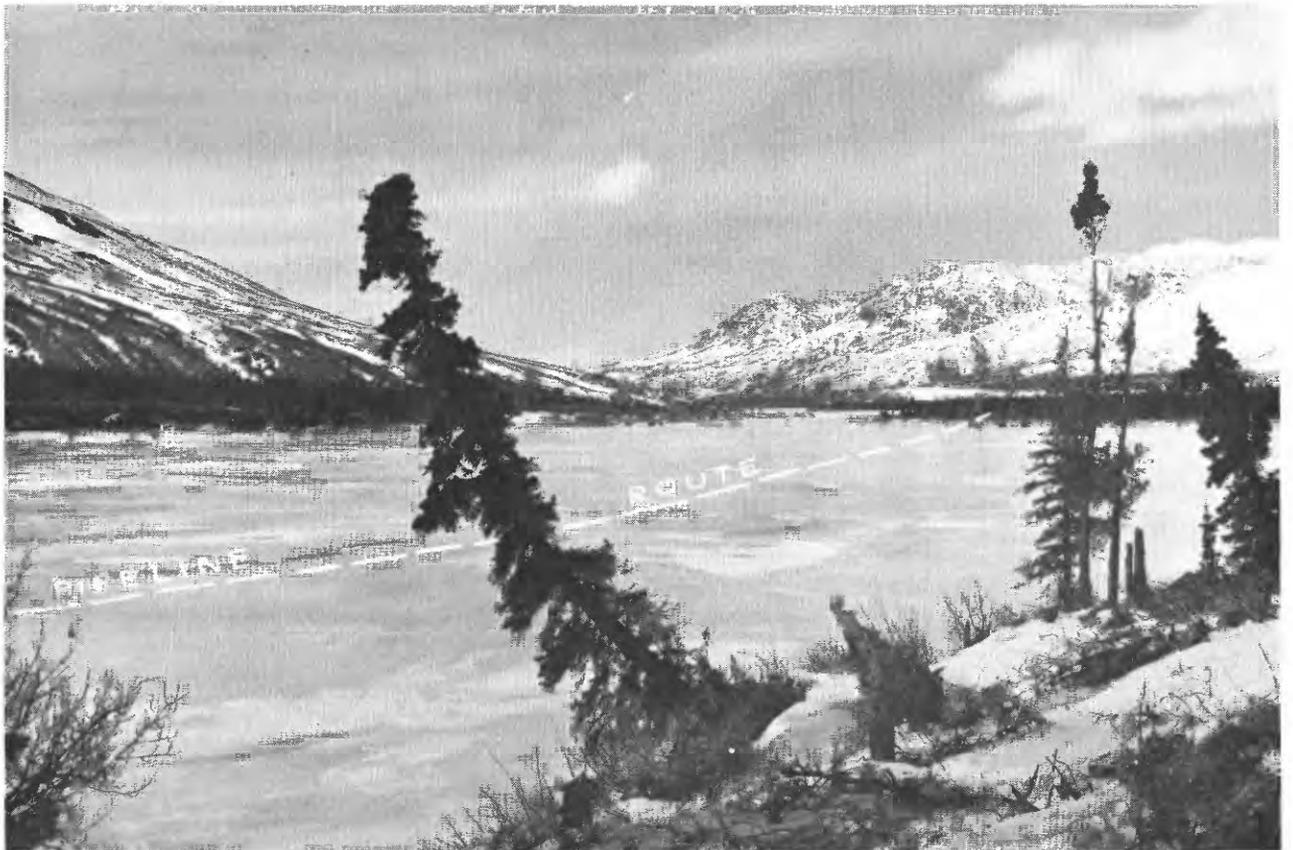
Figure 26.--Flood-plain icing in Delta River valley upstream from Miller Creek, April 18, 1974.

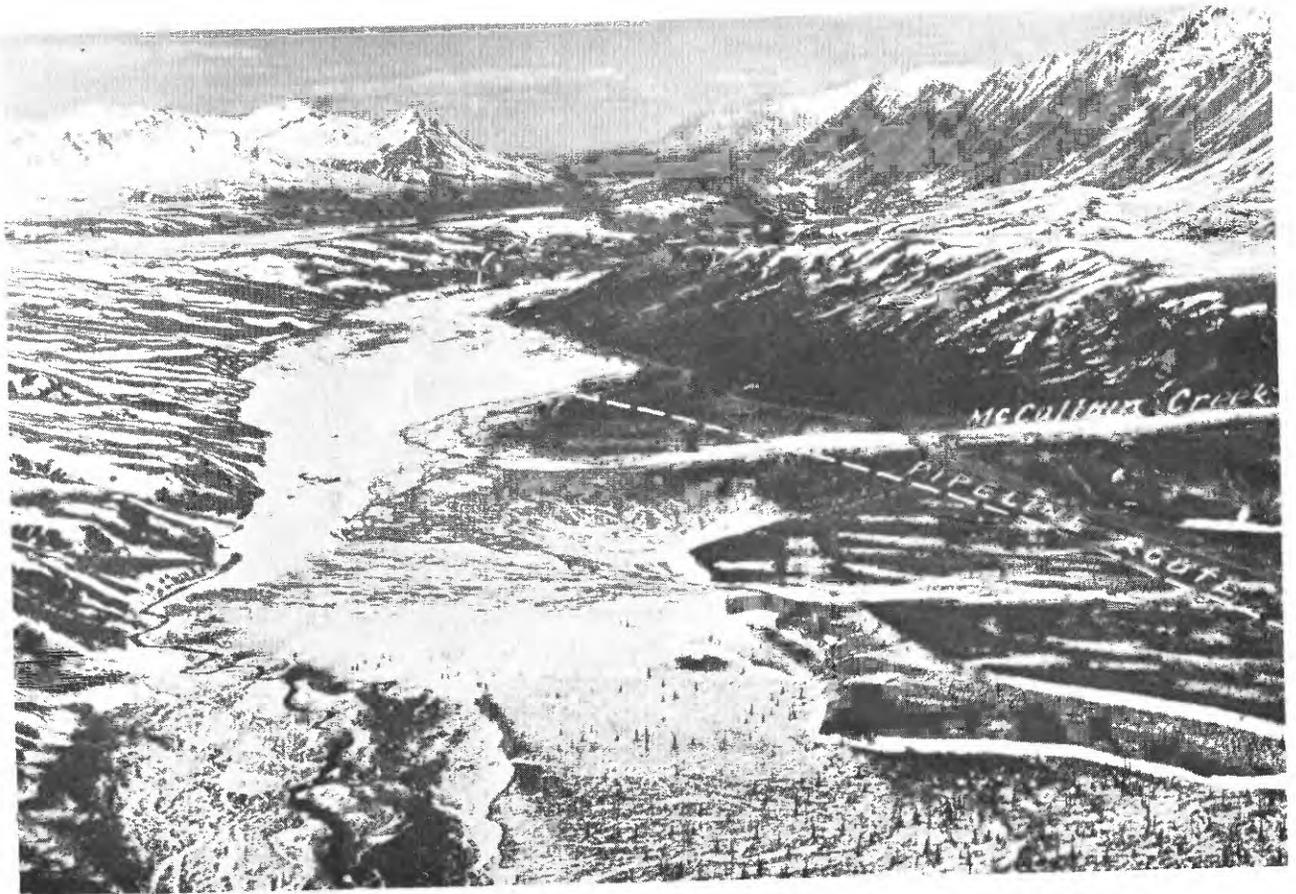
Figure 27.--Icing in Phelan and McCallum Creeks, May 29, 1973.

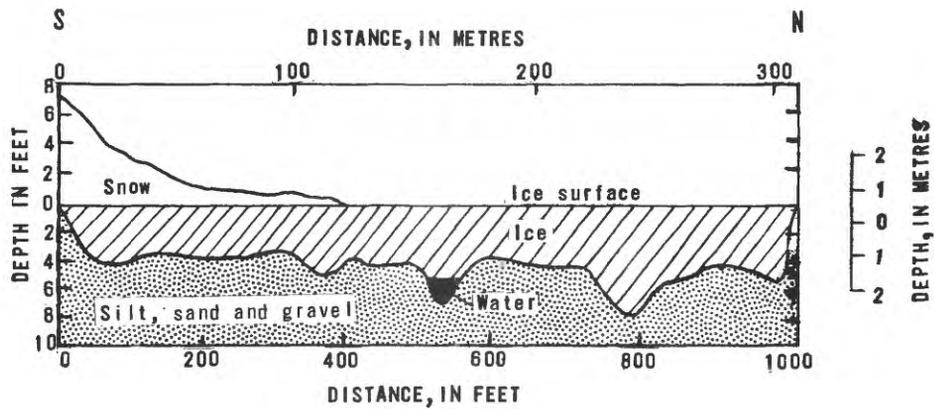
Borings were made through the Phelan Creek icing at the confluence of the Delta River and Phelan Creek on April 27, 1972 (fig. 28). The ice averaged about 5 feet (1.5 m) thick and of 31 holes drilled along a 1,000-foot (305-m) section, only one reached water in a channel under the ice. In the remainder of the holes, ice was resting directly on sand and gravel channel deposits.

Figure 28.-- Cross section through icing at mouth of Phelan Creek, April 27 1972. (See location of section in figure 2.)
