ICINGS ALONG THE TRANS-ALASKA PIPELINE ROUTE

By Charles E. Sloan, Chester Zenone,  
and Lawrence R. Mayo

Open-File Report 75-87

Anchorage, Alaska  
1975

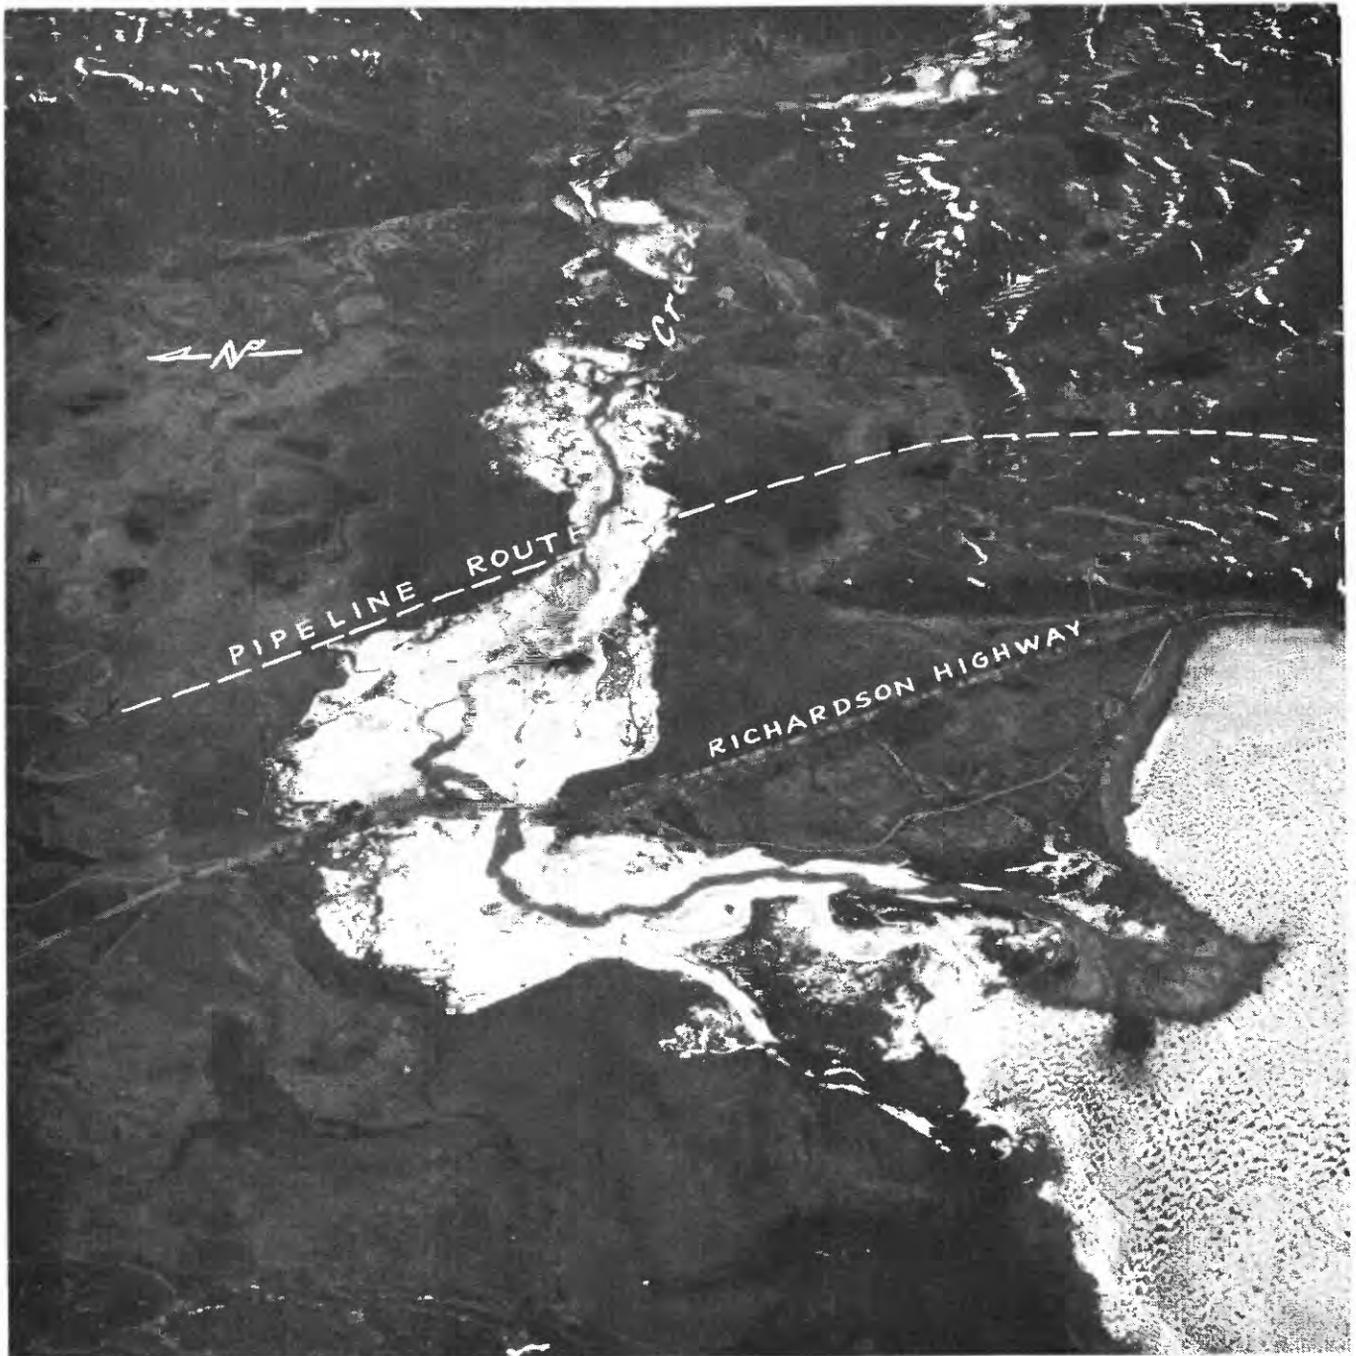
Near Isabel Pass a large icing forms annually on Gunn Creek at the Richardson Highway bridge (fig. 29).

Figure 29.--Icing on Gunn Creek at Richardson Highway and pipeline crossing, June 6, 1970.

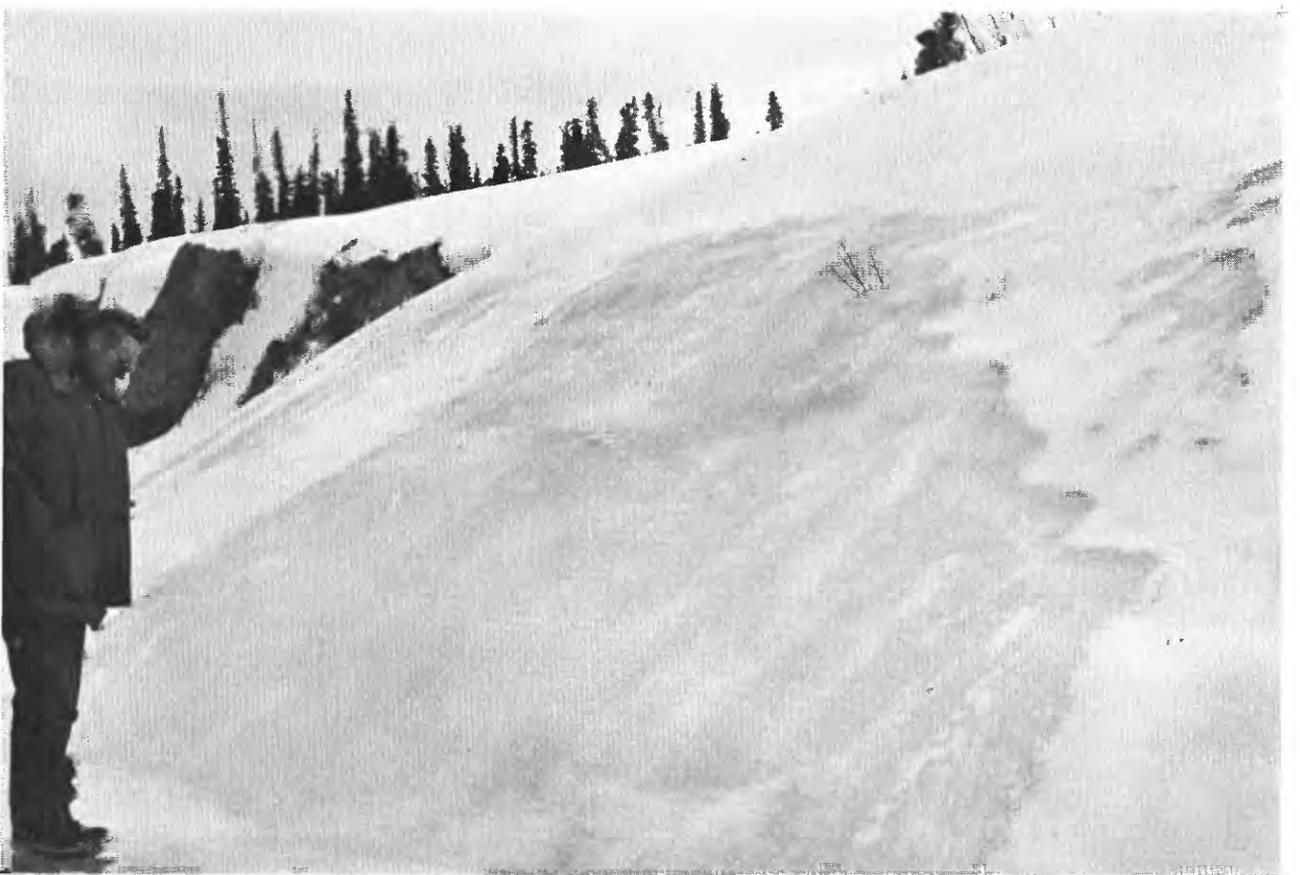
Hillside icings formed by seeps and springs in the Little Tonsina valley (fig. 32) have been particularly bothersome requiring repeated culvert maintenance by the Alaska Department of Highways. The occurrence of icings in the Chugach Mountains indicates that icings are not unique to the northern parts of Alaska. They are scattered along the entire length of the trans-Alaska pipeline route.

Figure 32.--Icing formed from ground-water seepage at face of gravel pit near Little Tonsina River, April 1, 1971.
