FLOOD OF JUNE 18, 1978, ON HONEY CREEK  
TRIBUTARY, THORNVILLE, OHIO

U.S. GEOLOGICAL SURVEY  
WATER-RESOURCES INVESTIGATIONS  
OPEN-FILE REPORT 80-16

Prepared in cooperation with the Ohio Department  
of Transportation

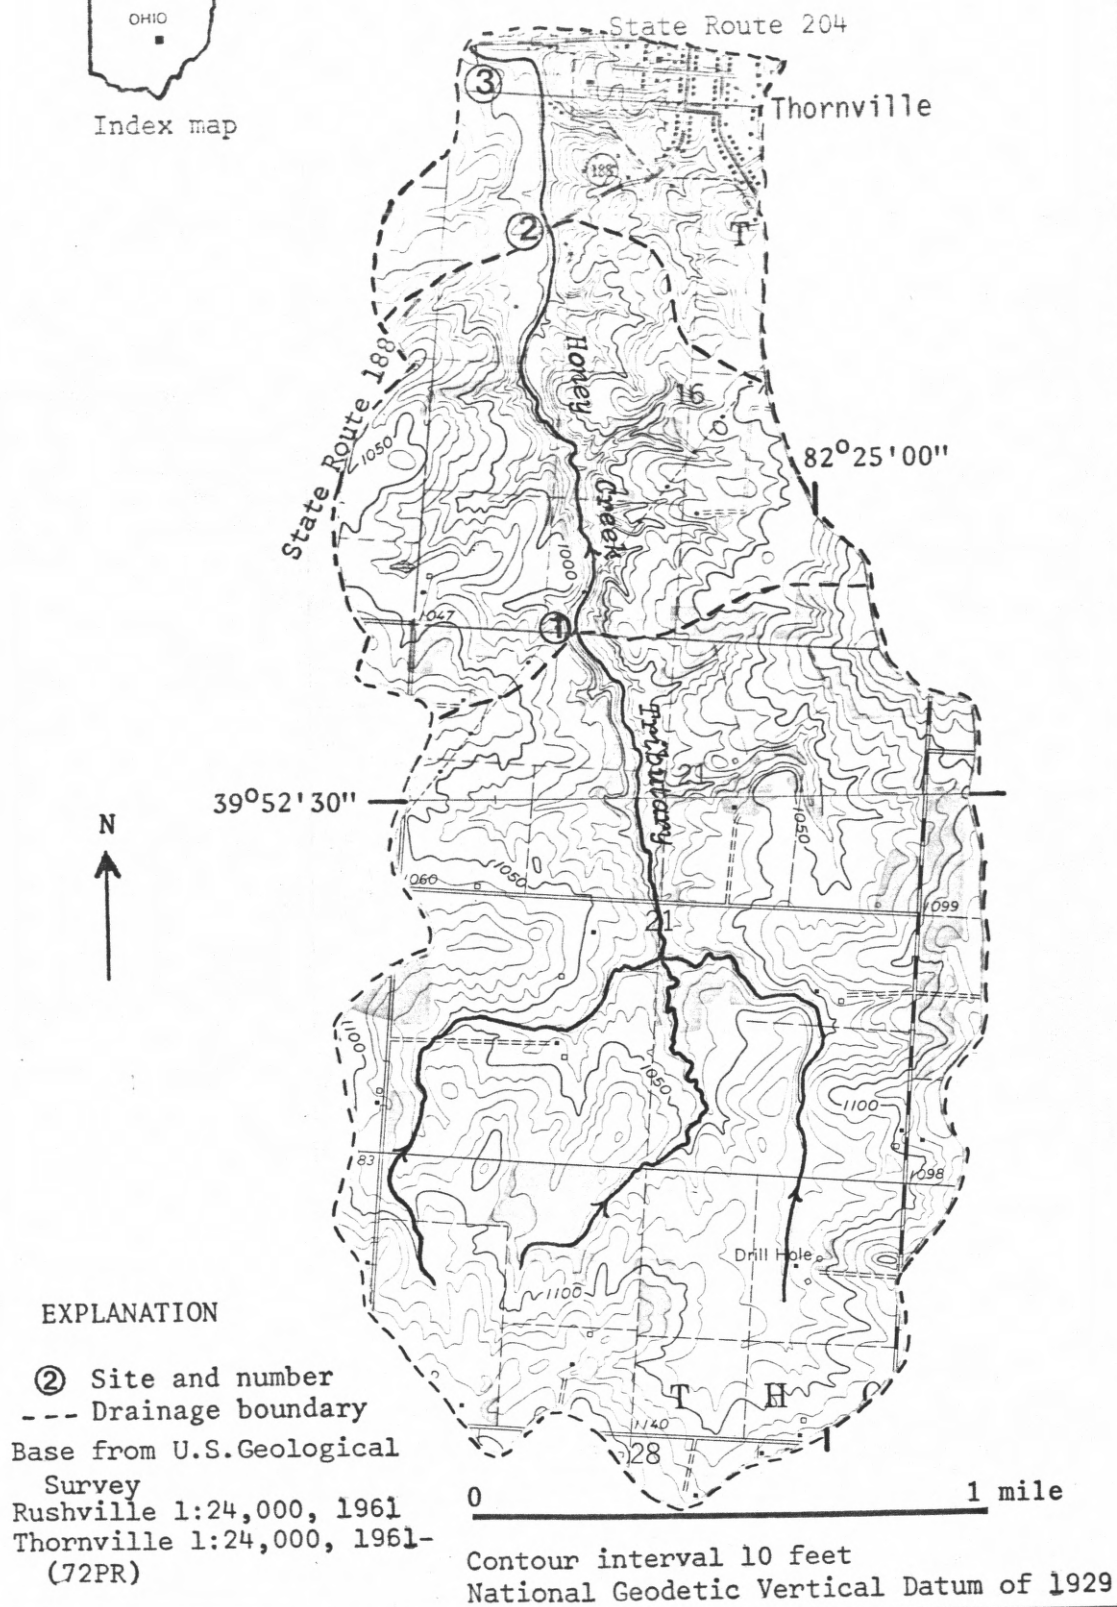
Figure 1.--Study area for flood of June 18, 1978, at Thornville, Ohio

Subsequent to the storm, high-water marks and associated hydrologic data were recovered and surveyed at three sites: site 1 at a slope-area reach 4,400 ft upstream from State Route 188; site 2 at State Route 188; and site 3 at State Route 204 (fig. 1). Drainage areas were computed for the three sites, and peak discharges were computed by standard U.S. Geological Survey methods at sites 1 and 3. No reliable peak discharge could be computed at site 2, and only maximum high-water elevations above and below State Route 188 were determined. The resulting hydrologic data are listed in table 1. A description of the analysis of each site follows.

No reliable indirect determination of peak discharge was possible here due to the destruction of the 16-foot 7-inch x 10-foot 1-inch corrugated multiplate arch culvert and the partial destruction of the earthfill on State Route 188. Average maximum high water above State Route 188 was 961.1 ft (NGVD of 1929), and average maximum high water below State Route 188 was 951.2 ft. Drainage area at State Route 188 is  $2.32 \text{ mi}^2$ .

A peak discharge determination of  $4,050 \text{ ft}^3/\text{s}$  on  $2.62 \text{ mi}^2$  was obtained at State Route 204 by contracted-opening and flow-over-road methods. This peak discharge was affected by storage above and subsequent failure of State Route 188 highway fill 2,500 ft upstream.

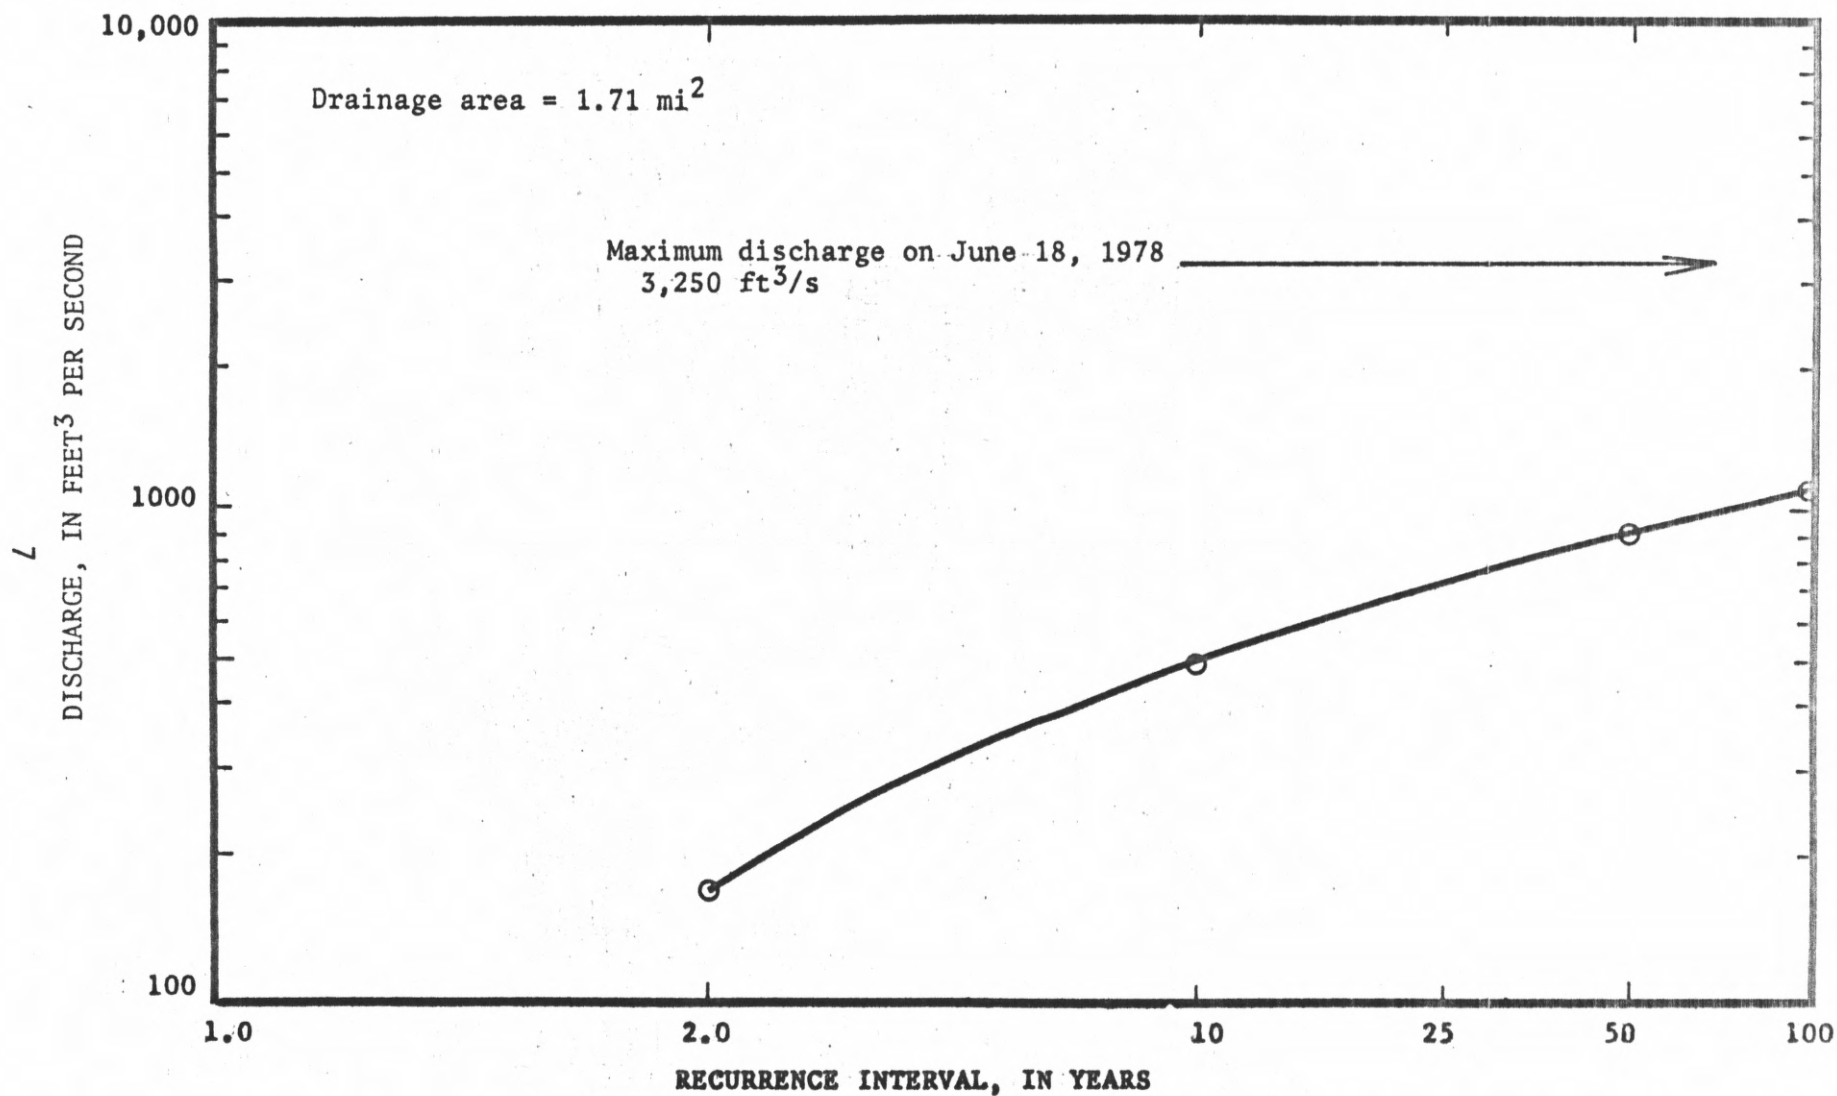
Figure 2.--Magnitude and frequency of floods on Honey Creek tributary at site near Thornville, Ohio

A flood magnitude and frequency curve was developed at site 1 (1.71 mi<sup>2</sup>) by recently developed methods (Webber and Bartlett, 1976) and is shown in figure 2. The 100-year flood was computed as 1,120 ft<sup>3</sup>/s. Peak discharge on June 18, 1978, was 3,250 ft<sup>3</sup>/s, which is 2.9 times larger than the estimated 100-year flood at this site. The relative magnitude of the computed peak discharge and observed rainfall to their 100-year frequency indicates that both the rainfall and runoff associated with this storm were rare.
