# 16060000 South Fork Wailua River near Lihue, Kauai, Hawaii

(Gaging station, USGS Hawaii Water Science Center)

## Review of peak discharge for the flood of April 15, 1963

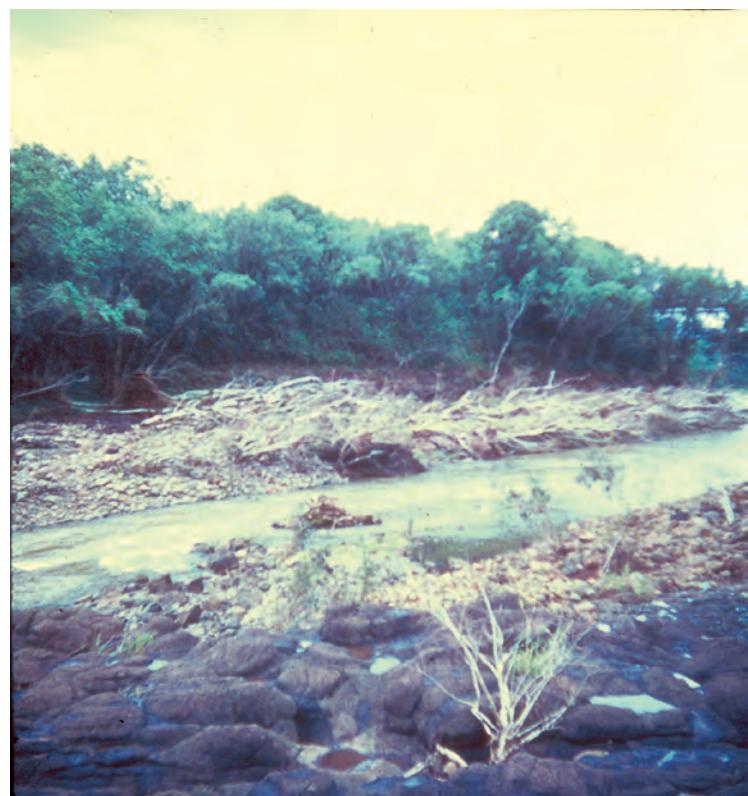
**Figure A240.** Reach looking downstream of streamgaging-station, South Fork Wailua River near Lihue, Kauai, 1963.

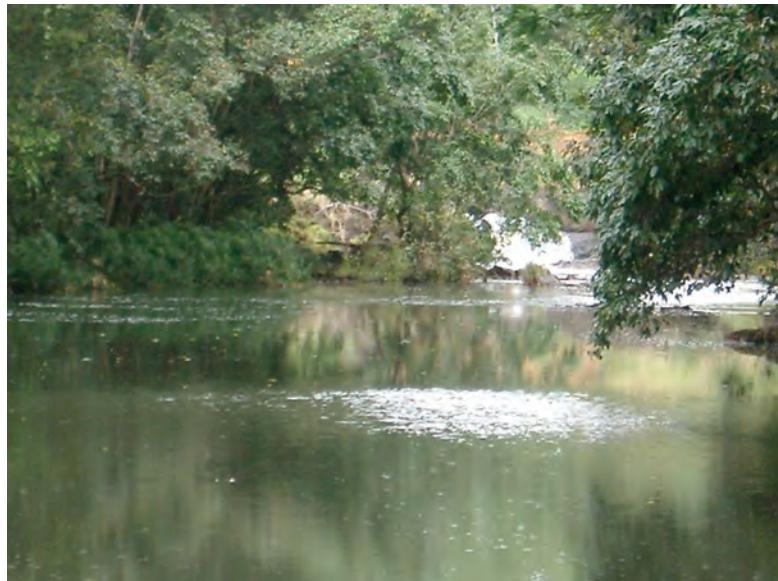
**Figure A241.** View upstream from cross-section 2, South Fork Wailua River near Lihue, Kauai, 2003.

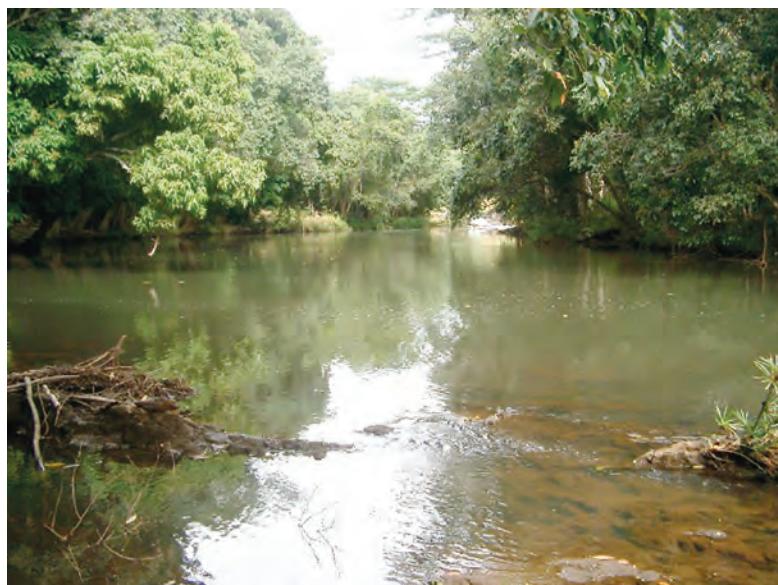
The hydraulic conditions are less than ideal because of road overflow and a road embankment failure at the upstream end of the reach and a wide cross section B with assumed flow reversal (noncontributing flow) along the right bank. The magnitude of the presumed eddy is unknown, but the right-bank profile had almost no fall along the right bank from about half way between the sections to the end of the reach. Reverse flow possibly was present at the time of the peak discharge. The eddy effect probably was caused by channel geometry and debris caught on an old railroad bridge abutment just downstream of section B. The conveyance did not likely vary uniformly between sections. Hydraulic conditions are further questioned because of the very rapid rise and decline in stage. The stage rose 6 ft in a matter of a few minutes that followed a fairly significant decline in stage. This type of change often occurs when water is released from storage behind an obstruction upstream. The rapid onslaught of a very wet period following a very dry period could have triggered slope failures in the upstream part of the basin. Slope failures could have created a series of dams, but direct evidence for this possibility is not available.

Section B was subdivided, but a composite “*n*” value of 0.055 was used and may be low. Manning’s “*n*,” computed from the highest discharge measurements using the energy slope from the slope-area computation, ranged from 0.070 to 0.075. The bank vegetation was flattened by the high flow, and the peak discharge occurred so quickly that the downed trees and brush may be a remnant of flow duration rather than the peak discharge. Most of the bank vegetation could have survived the peak discharge and been flattened by debris pileup during the receding stage. Froude numbers were about 0.8, and velocity was about 20 ft/s.

**Figure A242.** View downstream at cross sections A and B, South Fork Wailua River near Lihue, Kauai, 2003.

A third section would have been beneficial. It would have been interesting to locate section A upstream about 40 ft and insert a third section about 60 ft downstream of section A at the break in slope on the right bank.

Subdividing the sections would yield a more accurate result. Using the field selected “*n*” values for each subsection would further refine the discharge estimate. The upstream part of the basin could have been inspected to look for possible landslide dams and their failure.

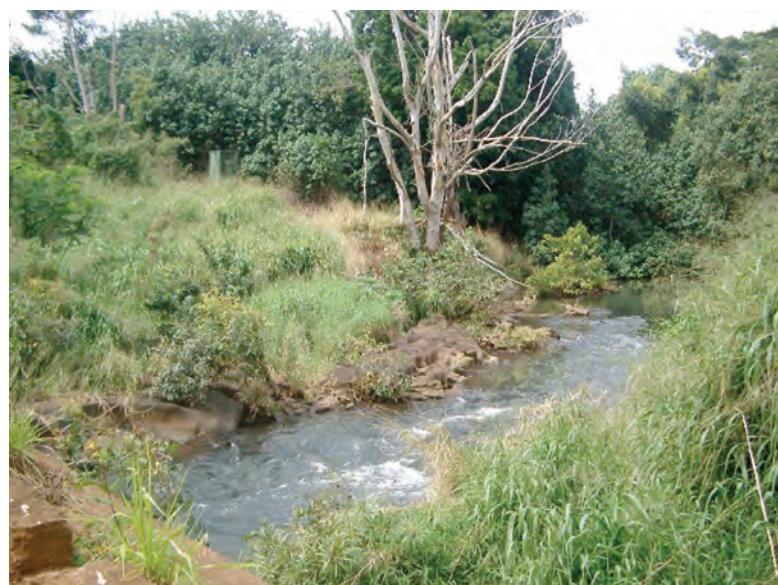
The recorded gage height for this peak discharge is verified by an inside high-water mark. No profile of outside high-water marks was surveyed past the gage, so it is unknown if the recorded peak discharge reflects the actual gage height. The alignment of the channel could cause a sloped water surface at the gage similar to the bank-to-bank discrepancy measured downstream. The road embankment breach assumably increased the peak stage by as much as 0.6 ft. Any increase in the rate of change in stage from the recorder trace is difficult to confirm. Peak stage should be verified by outside high-water marks for future peak discharges.

**Figure A243.** View upstream at streamflow-gaging station, South Fork Wailua River near Lihue, Kauai, 2003.

A critical depth cross section could be established at the head of Wailua Falls assuming flow is subcritical approaching the Falls. This may be a good assumption because Froude numbers of 0.8 were computed for the peak discharge. A high-water profile should have been surveyed past the gage to verify peak stage.

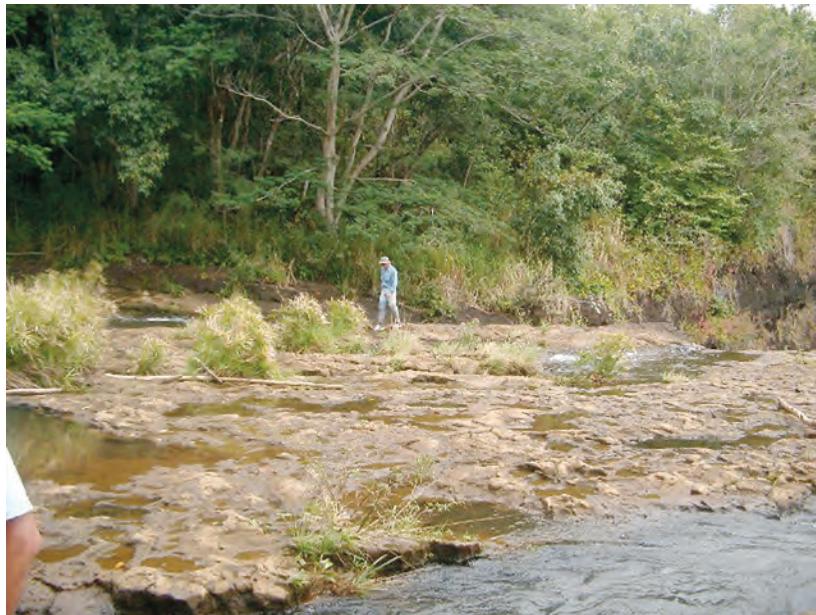
**Figure A244.** Top of Wailua Falls waterfall downstream of streamflow-gaging station but upstream of slope-area reach, South Fork Wailua River near Lihue, Kauai, 2003.

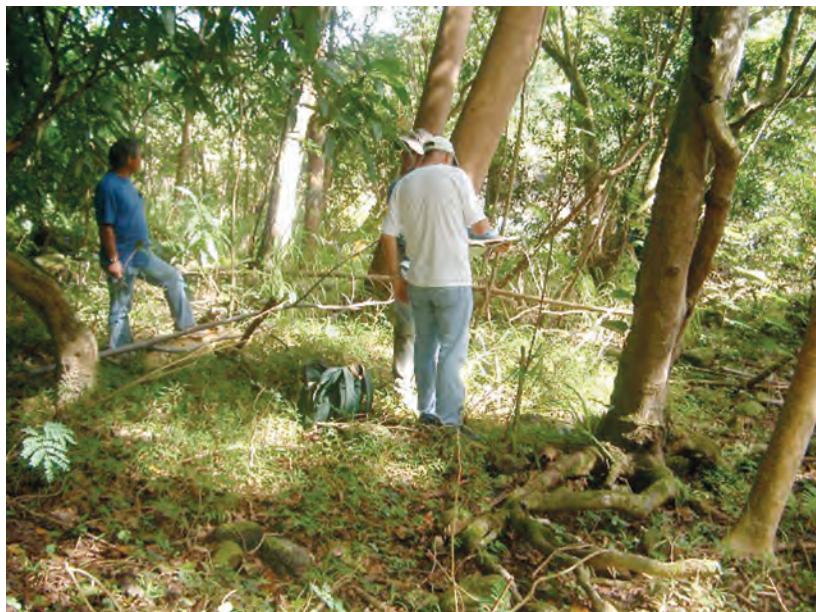
**Figure A245.** Left bank floodplain at cross section 1, South Fork Wailua River near Lihue, Kauai, 2003.
