Water-Supply Paper 866-C

**GEOLOGY OF DAM SITES ON THE
UPPER TRIBUTARIES OF THE COLUMBIA RIVER
IN IDAHO AND MONTANA**

**Part 3. MISCELLANEOUS DAM SITES ON THE
FLATHEAD RIVER UPSTREAM FROM
COLUMBIA FALLS, MONTANA**

By
C. E. ERDMANN

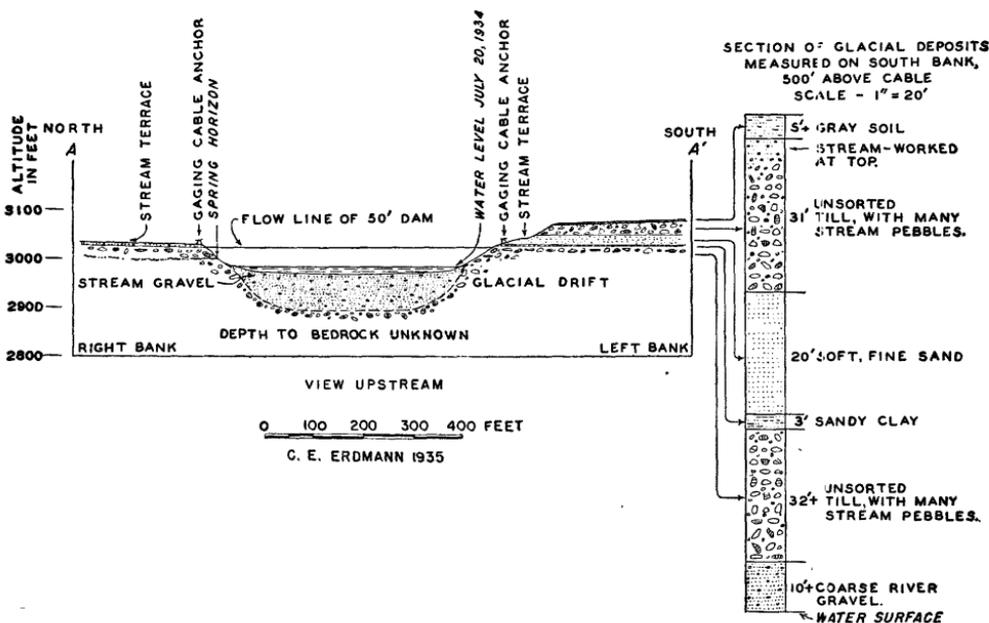
FIGURE 10.—Geologic cross section at Columbia Falls dam site along stream-gaging cable, sec. 17, T. 30 N., R. 20 W., Flathead County, Mont.

Foundation conditions.—Bedrock at this site probably lies too deep to be reached by excavation, and any structure considered would have to rest upon the valley fill. The unconsolidated stream gravel is not satisfactory foundation material. The unstable character of this gravel is attested by the washing out on at least two occasions of the pier foundations of the old county bridge at Columbia Falls about half a mile upstream. The records of these bridge foundations and the cause of their failure should be investigated in connection with any complete study of foundation conditions at this site.

The spring zone described under "Ground Water" on page 145 occurs in the north abutment at altitudes of 2,990 to 2,995 feet. If a dam were to raise water to an altitude of only 3,000 feet, the flow of the springs upstream from the gaging cable (dam axis) would be reversed, and the spring flow, as well as the inflowing river water would bypass the north (right) abutment. Under a 30- or 40-foot head the flow would be so considerable as to wash out the north abutment quickly and entirely. Conditions favoring such an occurrence are so widespread in that area that a cut-off wall to arrest the bypassing water would be prohibitively long. These defects are so serious that they alone are sufficient to condemn the entire site.

Recommendations.—This site may be dismissed from further consideration for the following reasons: (1) Deep foundation with respect to the greatest possible height of dam; (2) condition in the north (right) abutment dangerous and difficult to remedy; (3) large spillway capacity required for so small a dam; (4) expenditure required to overcome the defects of this site greatly out of proportion to the benefits to be derived; (5) a dam at this locality would be an especial menace to all settlements in the river valley between it and Flathead Lake.

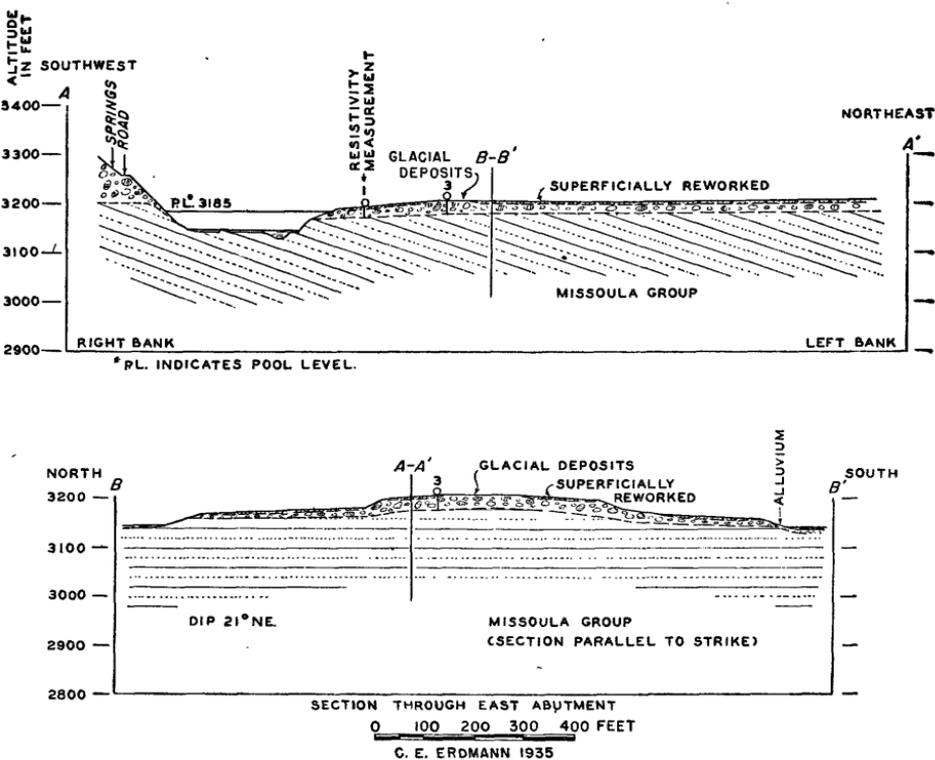
Abutments.—The right (west) abutment is the highest and most massive. From the river bed up to an altitude of about 3,150 feet the argillites and quartzites are exposed, and they probably extend upward under a mantle of glacial debris to about 3,185 feet. Above that altitude the bank consists entirely of glacial material. Inasmuch as it would be impossible to erect a dam with a higher crest, the glacial material will not be involved in the abutment. The principal weakness of the west abutment is the thin-bedded character of the rock and its inclination toward the open valley. This attitude does not provide great natural security against sliding.

The left (east) abutment is the weak feature of this site, it consists of a rather wide rock-cut bench upon which some glacial material has been heaped. The present superimposed course of the river includes a bend at this locality, resulting in a rather flat, thin spur through which leakage could occur. In this abutment the top of the rock-cut bench is somewhat lower than to the west, standing at about 3,180

FIGURE 11.—Geologic cross sections at Lower Canyon Creek dam site, sec. 35, T. 32 N., R. 20 W., Flathead County, Mont.
