# Geologic Investigations of Proposed Powersites at Baranof and Carbon Lakes Baranof Island, Alaska

GEOLOGICAL SURVEY BULLETIN 1031-B

By KENNETH S. SOWARD

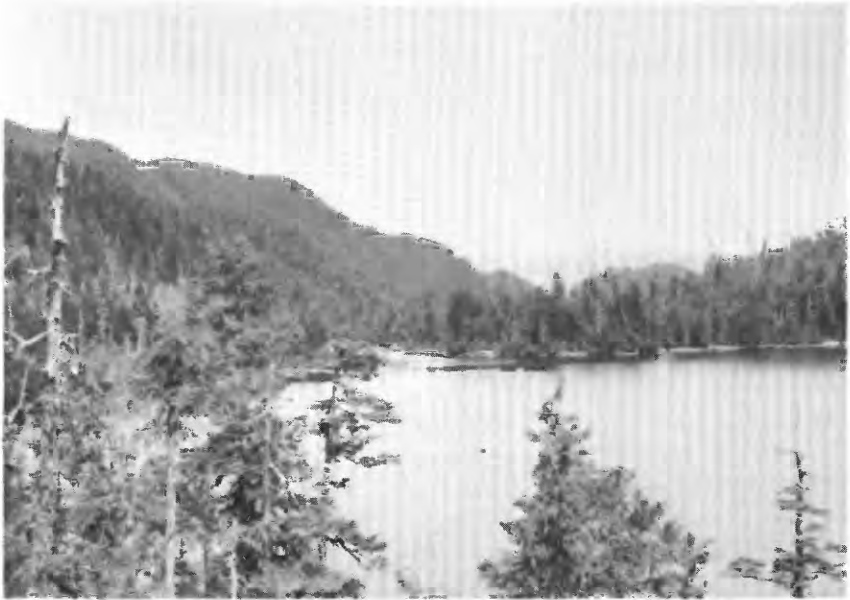
The damsite is immediately downstream from the lake outlet. (See pl. 5 and figs. 3 and 4.) Near the possible axis line of the dam shown in section *A-A'* (pl. 5) the valley is 110 feet wide at the river surface at altitude 145 feet; 150 feet wide at 150 feet; 790 feet wide at 200 feet; 1,040 feet wide at 240 feet; and about 2,300 feet wide at 300 feet.

FIGURE 3.—East end of Baranof Lake. Outlet of lake is slightly left of center of view.

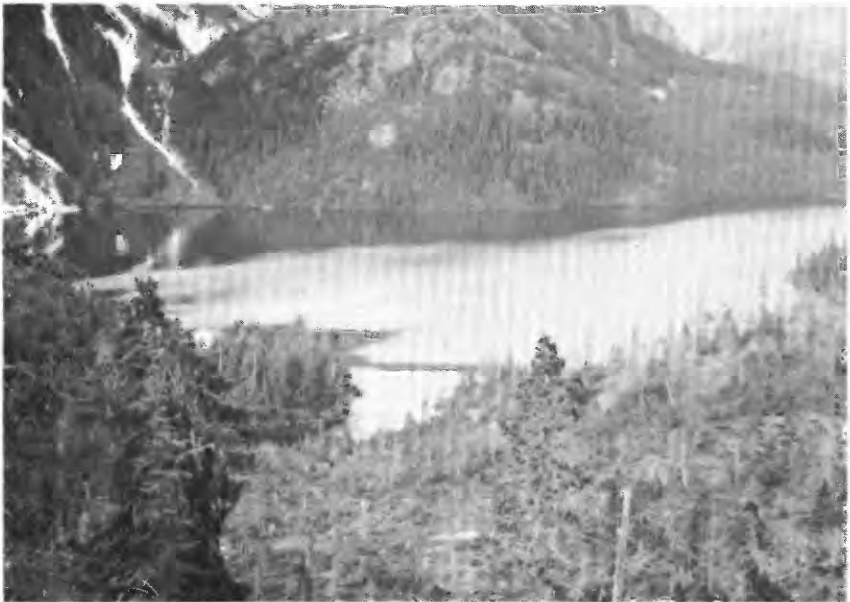
FIGURE 4.—View southwestward across lower end of Baranof Lake. Lake outlet in lower left center of view.

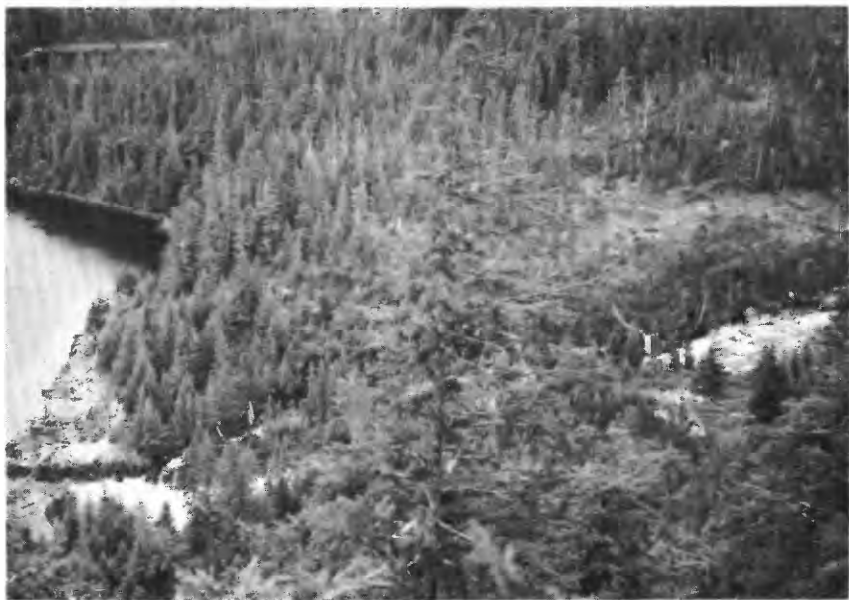
FIGURE 5.—Shore of Warm Spring Bay south from mouth of Baranof River. Note lagoon in upper left part of view.

Baranof River the conduit (pipeline) would cross the bench in the cleared area above the river on the right side of the view in figure 5. If the powerhouse were located on the lagoon, water would be conveyed to it from the lake by a tunnel through the ridge shown in the upper right part of the view.

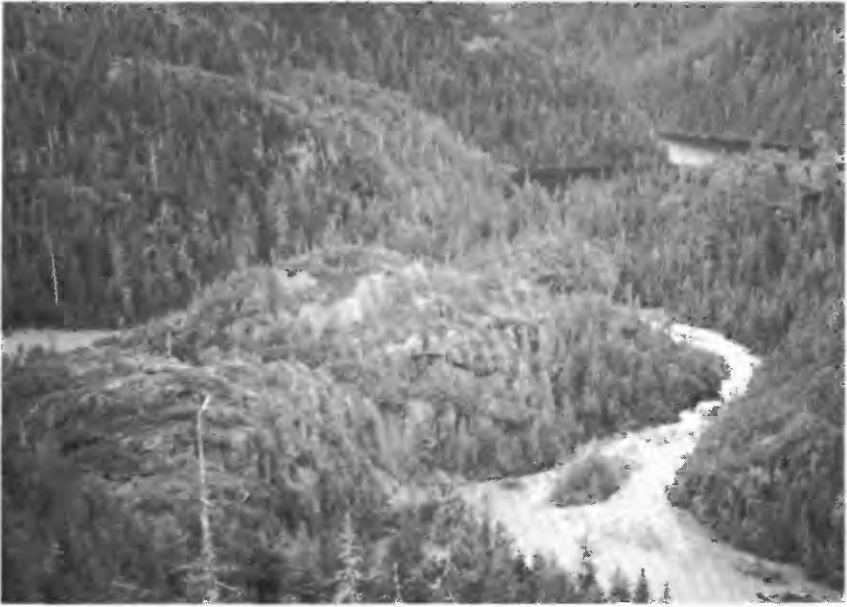
FIGURE 6.—Rock ridge at east end of Carbon Lake. Lower end of Carbon Lake in left edge of view. Unnamed lake in upper right part of view drains into Coal Creek 650 feet downstream from Carbon Lake outlet.

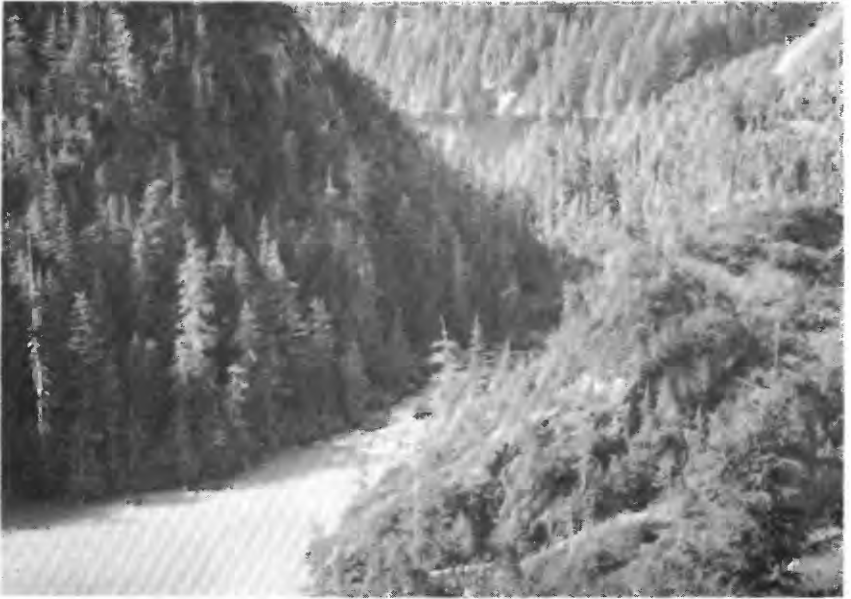
The control of Carbon Lake would in addition to a main dam on Coal Creek require two auxiliary dams in the saddles described on page 58. If the lake is raised to an altitude of more than about 280 feet, these three dams would be connected and become a single structure with an overall length of about 950 feet. The main dam would be located 300 feet downstream from the lake outlet. The geologic conditions along the axis of the main dam as well as of the two additional dams are shown by section *C-C'* (pl. 5). The left (west) abutment is formed by a hill that rises to altitude 1,095 feet. The right (east) abutment for the main dam would be formed by the rock knob that rises to altitude 331 feet. (See fig. 7.)

FIGURE 7.—Carbon Lake outlet. Probable axis for dam would cross channel at upper end of rapids. Unnamed lake in upper center part of view drains into Coal Creek 650 feet downstream from Carbon Lake outlet.
