# Geology of Waterpower Sites on the Bradley River Kenai Peninsula, Alaska

GEOLOGICAL SURVEY BULLETIN 1031-C

By KENNETH S. SOWARD

*A description of the geologic settings of  
dam, tunnel, and reservoir sites on the  
Bradley River, with recommendations  
for future explorations*

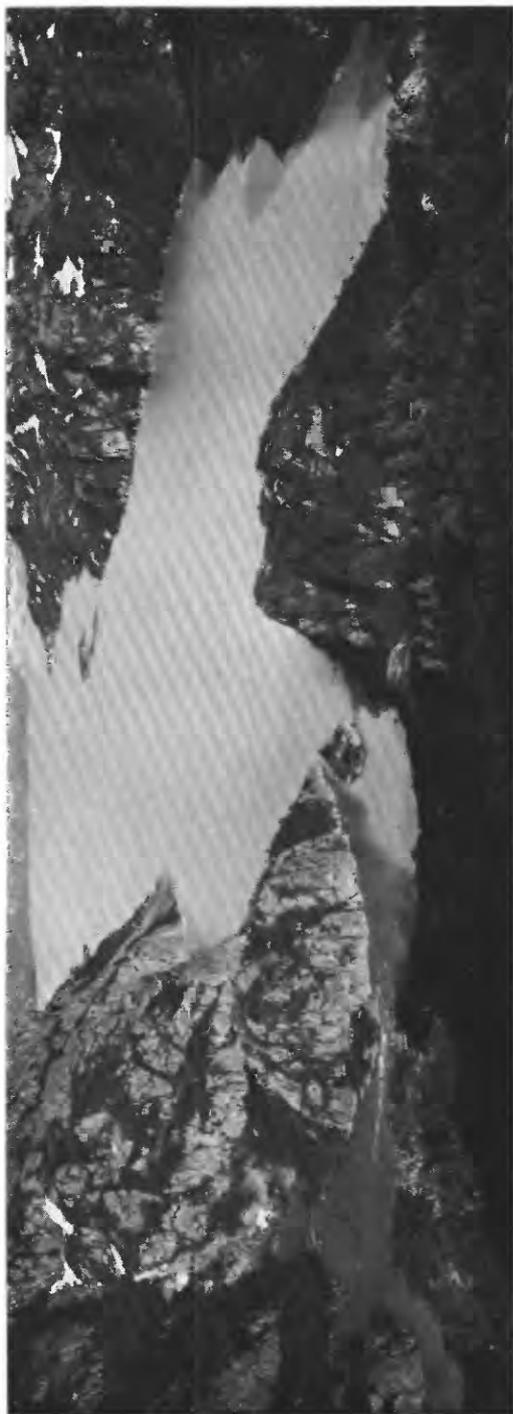
The most favorable location for a dam is in the first 200 feet downstream from the lake outlet, where the channel is 140 to 170 feet wide. (See figs. 9 and 10.) A small rock island 22 feet high is near the center of the river 100 feet downstream from the outlet. The right (northeast) abutment is formed by a rounded knob that rises to an altitude of 1,229 feet. A small saddle, with a low at 1,150 feet, is between the knob and the main valley wall. Northeast of the saddle a steep cliff rises to 1,550 feet, where the slope flattens but continues to

FIGURE 9.—View, looking southeast, of the damsite at the outlet from Bradley Lake. July 1955.

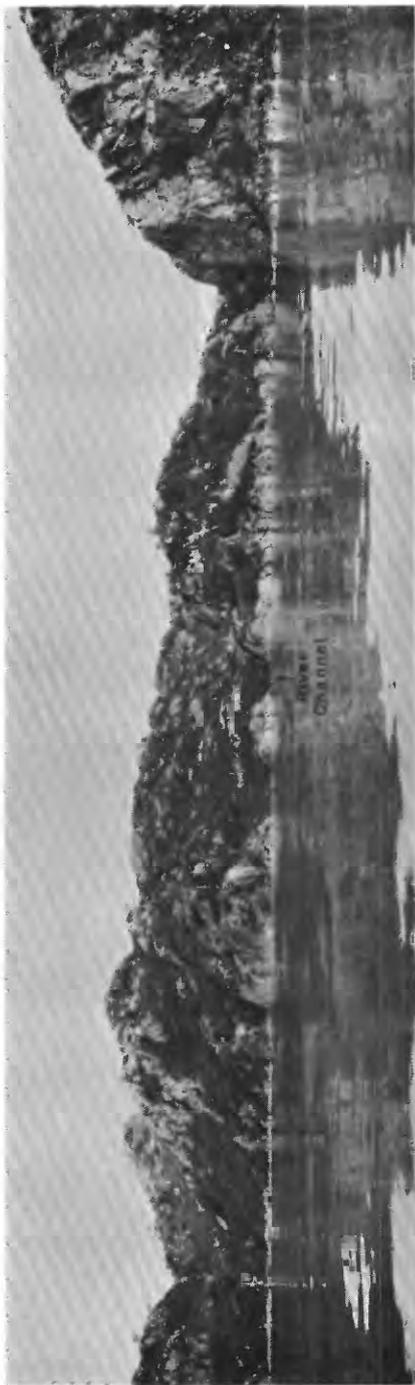
FIGURE 10.—Panorama of the west end of Bradley Lake. The lake outlet and damsite are at the center, and the main stream channel is to the right (northeast) of the small rock island. For geologic and topographic features, the right two-thirds of the view is comparable to the right two-thirds of section A-A', plate 6. July 11, 1955.

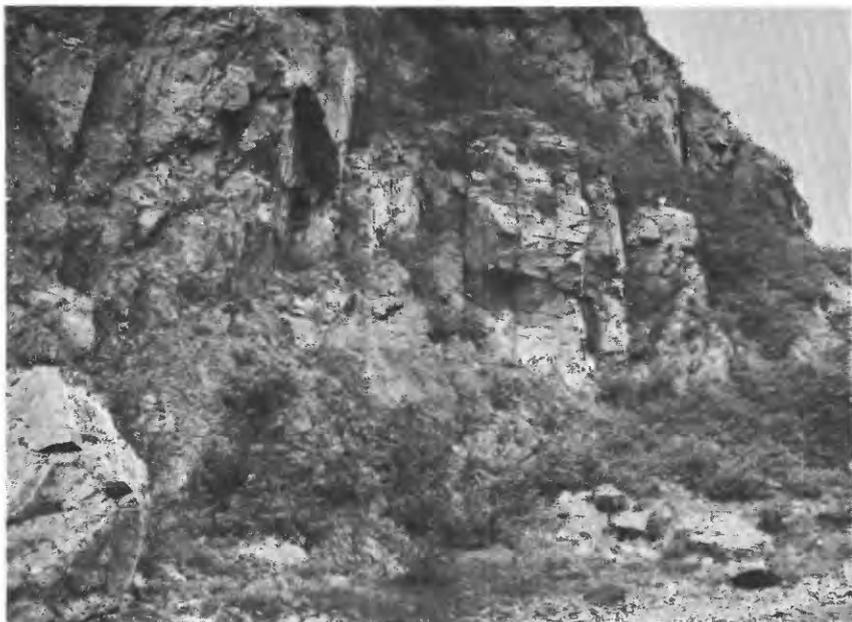
The rock is moderately jointed, and the greatest concentration of joints is in the more argillaceous rock on the west side of the river (fig. 11). Most of the joints are tight, and those with narrow

FIGURE 11.—Closeup of the joints and fractures in the left (southwest) abutment. The photograph covers a distance of about 150 feet from a point 60 to 70 feet upstream from the island to about opposite the downstream end. The almost vertical joints, striking parallel to the line of sight, are in a set that strikes N.  $65^{\circ}$  W. to W. and dips  $81^{\circ}$  SW. to  $83^{\circ}$  NE. August 3, 1955.

openings bound loosened blocks. It appears that the openings will be tight within a few feet below the ground surface. Most of the joints fall into five sets, with the following attitudes: (a) Strike N.  $65^{\circ}$  W. to W., dip  $81^{\circ}$  SW. to  $83^{\circ}$  NE.; (b) N.  $35^{\circ}$ – $57^{\circ}$  W.,  $63^{\circ}$  NE. to  $87^{\circ}$  SW.; (c) N.  $31^{\circ}$ – $50^{\circ}$  E.,  $72^{\circ}$ – $89^{\circ}$  SE.; (d) N.  $60^{\circ}$ – $74^{\circ}$  E.,  $57^{\circ}$ – $84^{\circ}$  SE.; and (e) N.  $10^{\circ}$ – $15^{\circ}$  E.,  $56^{\circ}$ – $80^{\circ}$  SE.

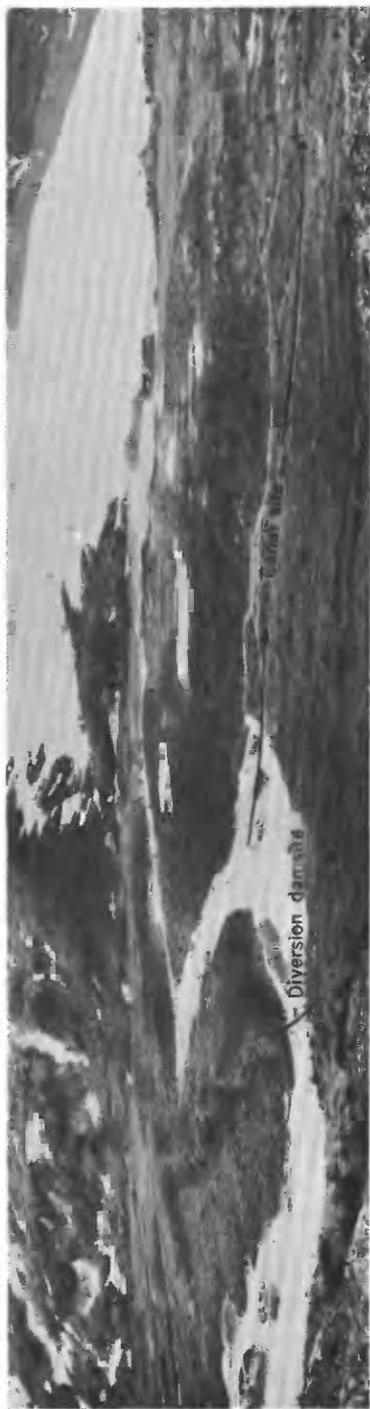
*Diversion damsite and canal site at Bradley-Nuka divide.*—The glacier at the divide has deposited low gravel-covered ridges that trend parallel to the valley. Most of the exposed material is fairly clean gravel, but below the ground surface considerable sand and silt are intermixed. Till is exposed at three places in the moraine 1,000 to 1,500 feet south of the divide and at a point in the left (east) bank 400 feet downstream from the diversion damsite (fig 12).

FIGURE 12.—Panorama of the diversion dam site and canal site south of Bradley-Nuka divide. The diversion dam site is in the lower left at the near end of the moraine. The canal site extends from the sharp bend in the river to the right (north) along the low in the foreground. August 1, 1955.

At the proposed site of the diversion dam, till is exposed in the right (west) abutment, and silt, sand, and gravel are in the river bottom and on the left (east) abutment. The till probably is tight, but the alluvium in the left abutment may be quite permeable. Graywacke and graywacke conglomerate in a slate matrix crop out 200 to 250 feet east of the left abutment near altitude 1,310, or 25 to 30 feet above the river surface at the damsite.

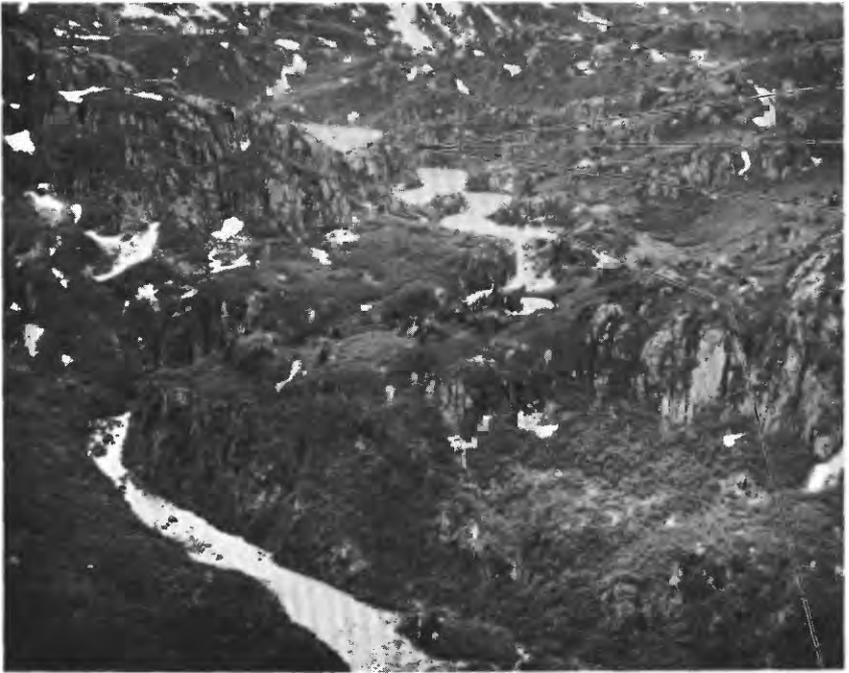
For a one-stage development, 3 all-tunnel routes have been suggested to carry water to 3 different powerhouse sites at tidewater. (See pl. 6 and fig. 13.) Line *C-C'*, which was proposed by the Corps of Engineers, bears about N. 75° W. from the lake. Lines *D-D'* and *E-E'* bear N. 37° W. and N. 60° W., respectively. The topography in the vicinity of lines *C-C'* and *D-D'* would allow pipelines to be substituted for parts of the tunnels. The tunnel lines would penetrate all three geologic formations previously described. Because of the high-angle dip of the beds, the relative amount of the various rock types that would be traversed along any tunnel line is approximately that shown on the geologic map of the tunnel sites.

For construction purposes the quality of the rock along the tunnel routes ranges from fair to excellent. In the massive graywacke a tunnel will not require support while being driven; in fact, the strength of the rock may be high enough that a concrete lining may

FIGURE 13.—View of Bradley River looking upstream from river mile 8.9 to Bradley Lake. The three lines extending from the lake to the right show the approximate location of possible tunnel routes leading to powerhouse sites at tidewater. The line in the lower right shows the location of part of a possible tunnel route leading to a powerhouse site at river mile 8.2. About 0.9 of a mile of the river channel can be seen, and in that distance the river descends 250 feet. The river is in flood, and the flow is 1,300 cubic feet per second. July 13, 1955.

not be required even during operation. The only structural defect noted in this rock is the jointing; however, lineaments on the aerial photographs may indicate shear zones or small faults. Possibly some lenses of argillite or cherty slate may be present. If so, short sections of the tunnel might have to be lined. In the interbedded cherty slate and argillite, a tunnel probably will require support over 75 percent of its length during excavation. The entire section in this rock will require a concrete lining for operation. In the interbedded graywacke, cherty slate, and argillite, only short reaches of the tunnel will require light support during excavation. However, the tunnel probably would have to be lined for operation, although some sections in the thicker graywacke beds could stand without lining. Extremely difficult tunneling conditions will be found where the tunnel line intersects faults.
