Geology of Waterpower Sites on Crater Lake, Long Lake and Speel River near Juneau Alaska

GEOLOGICAL SURVEY BULLETIN 1031-D

*A preliminary examination of the
geologic feasibility of proposed
damsites*

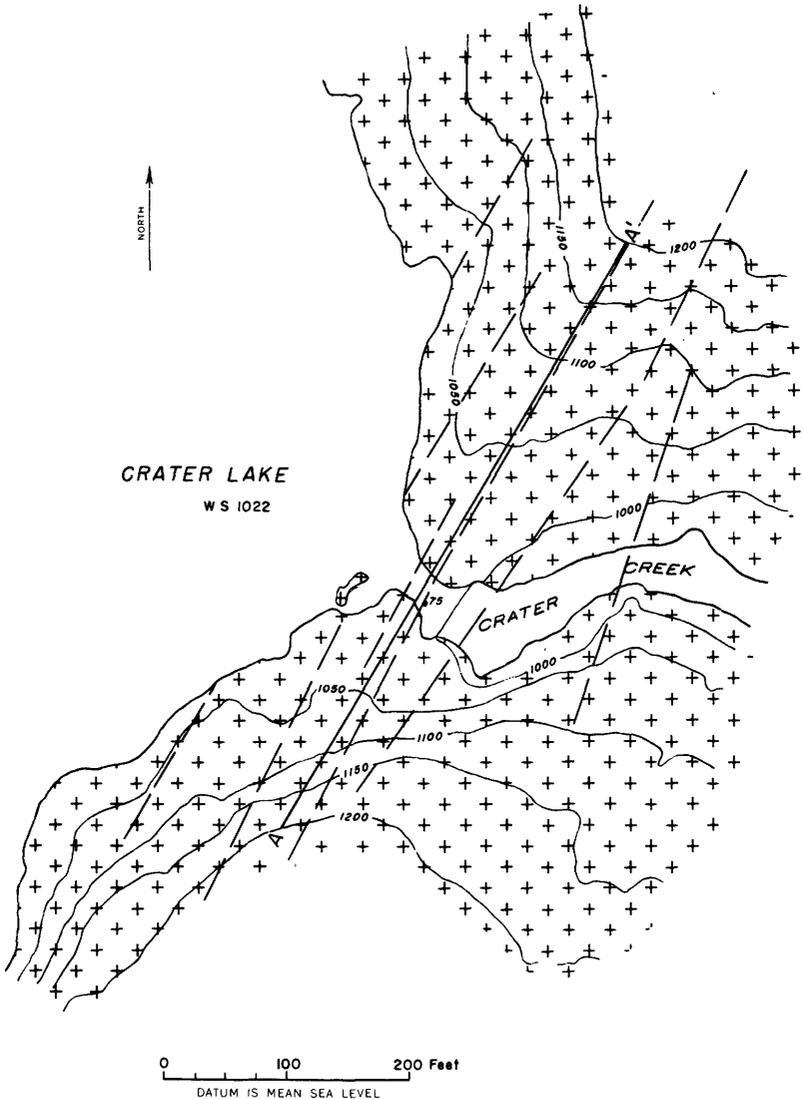
FIGURE 15.—Geologic map of Crater Lake powersite.

The damsite at the outlet of the lake is in hornblende-quartz diorite broken by northwestward-trending vertical joints or fractures. Only minor fractures were observed which intersected the principal joints or fractures. The principal fractures are transverse to the streamflow and could be grouted to prevent possible leakage. These joints and the geology of the site are shown on figure 15. The foundation and abutments would be in hornblende-quartz diorite which should be capable of supporting a dam 150 to 200 feet high. Leakage around the damsite seems unlikely, and, based on conditions observed in the field, no damage from rockslides or snowslides is anticipated.

The reservoir area of Crater Lake is entirely in quartz diorite. The jointing or fracturing within the reservoir area is not considered of sufficient magnitude or of such character as to cause leakage. The upper valley of Crater Creek contains alluvium (pl. 7) in part reworked by the stream but largely deposited by the valley glacier to an unknown depth.

The valley walls around most of the lake are steep and in places almost vertical. Near the head of the lake on the south bank there are large snowslides and rockslides. A few streams, which carry boulders and debris enter the lake on the north side. There is no evidence of snowslides of any consequence from the ridge across the outlet end of the lake. Landslides are not believed to pose a damage threat to the proposed reservoir or power facilities. Erosion by frost and ice action may result in some movement of large blocks of rock into the lake.

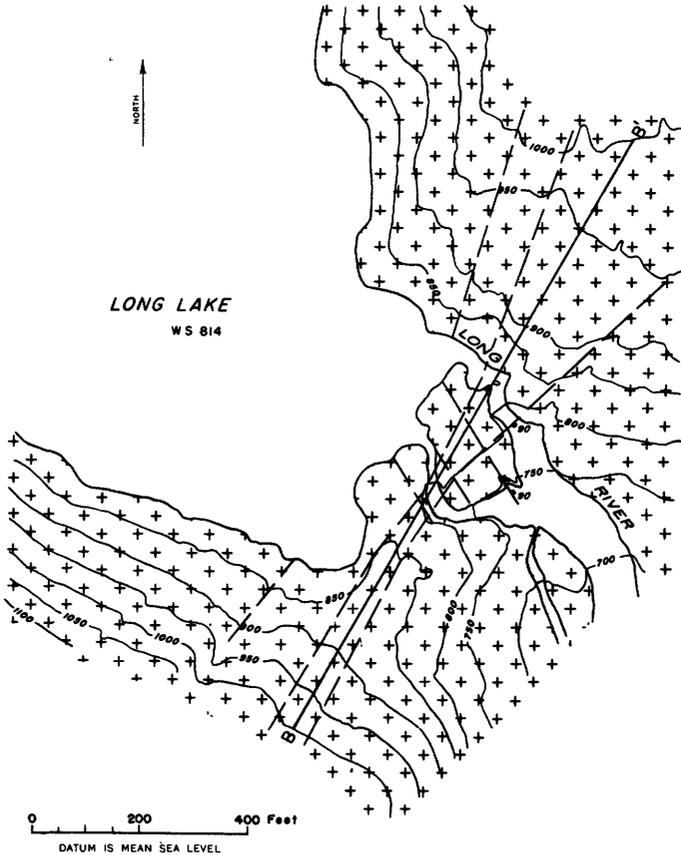
FIGURE 17.—Geologic map of Long Lake powersite.

The proximity of the Long Lake damsite to the fractured quartz diorite at the outlet of the lake requires that it be thoroughly explored by drilling as the first step in any plans for development.

The bedrock is chiefly quartz diorite containing biotite with minor amounts of hornblende and quartz in small veins and stringers. There is a slight lamination of the dark minerals present, mainly in the rock on the south side of the damsite. The geology of the Long Lake damsite and a geologic section along the axis of the probable dam are shown on figures 17, 18, on which the major intersecting joints or fractures are also indicated. There is doubt as to the continuity of the fractures at depth, but, as indicated by observations downstream

and at the damsite, excessive leakage may be induced by the north-westward-trending fractures at the outlet unless extensive scaling or removal of perhaps 20 to 50 feet of bedrock is done in addition to grouting. An extensive drilling program will be necessary to determine how deep these fractures extend and whether excessive leakage may be expected. If exploratory drilling verifies the lack of an impervious foundation it may be possible to select another site about 150

feet downstream to avoid this fractured area. Such a location would add about 50 feet to the height of the required dam.

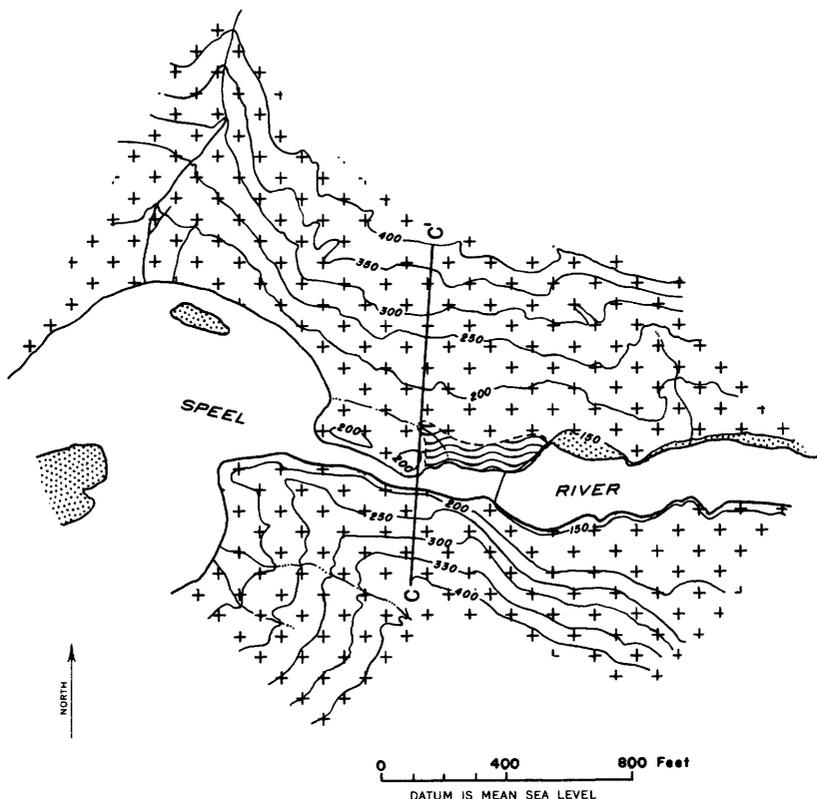
FIGURE 19.—Geologic map of Speel River powersite.

The foundation rock and the abutments appear capable of supporting a masonry dam 160 feet high, which is the maximum height that would likely be considered for this site.

The right abutment wall is fractured to some extent and may require grouting, while the left abutment area appears less fractured. The bedrock above an altitude of 200 feet is not well exposed, but aerial photographs and the observations in the escarpments above river level indicate that some fracturing may be present. Section C-C', figures 19, 20, show the general character of bedrock.

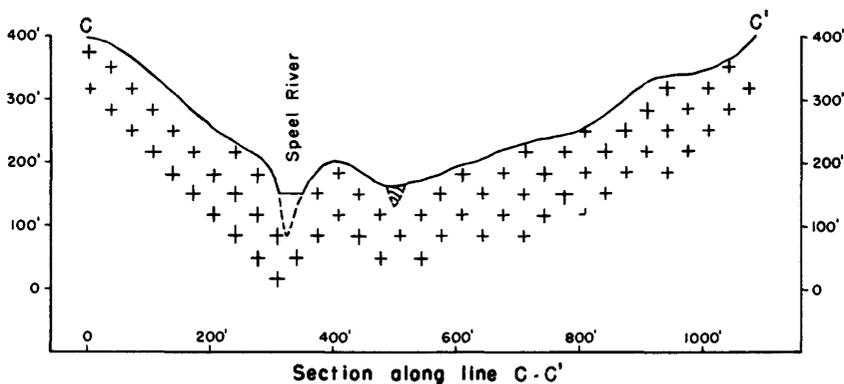
FIGURE 20.—Geologic section of Speel River powersite.

route from the Saddle dam to a powerhouse site on the shore of Speel Arm about 3,000 feet west of the mouth of Glacier Creek. This route is indicated at F-H on plate 7 and is shown in section on figure 20.

The entire tunnel course would be in quartz diorite. The rock, however, is disturbed in varying degrees by the fracture zones noted. No serious hindrance to tunneling is anticipated in these zones, and the rock is considered stable enough to maintain tunnel openings. The required tunnel would be about 3,800 feet long, and the penstock about
