Geologic Reconnaissance of the West Creek Damsite near Skagway, Alaska

GEOLOGICAL SURVEY BULLETIN 1211-A

By JAMES E. CALLAHAN and RUSSELL G. WAYLAND

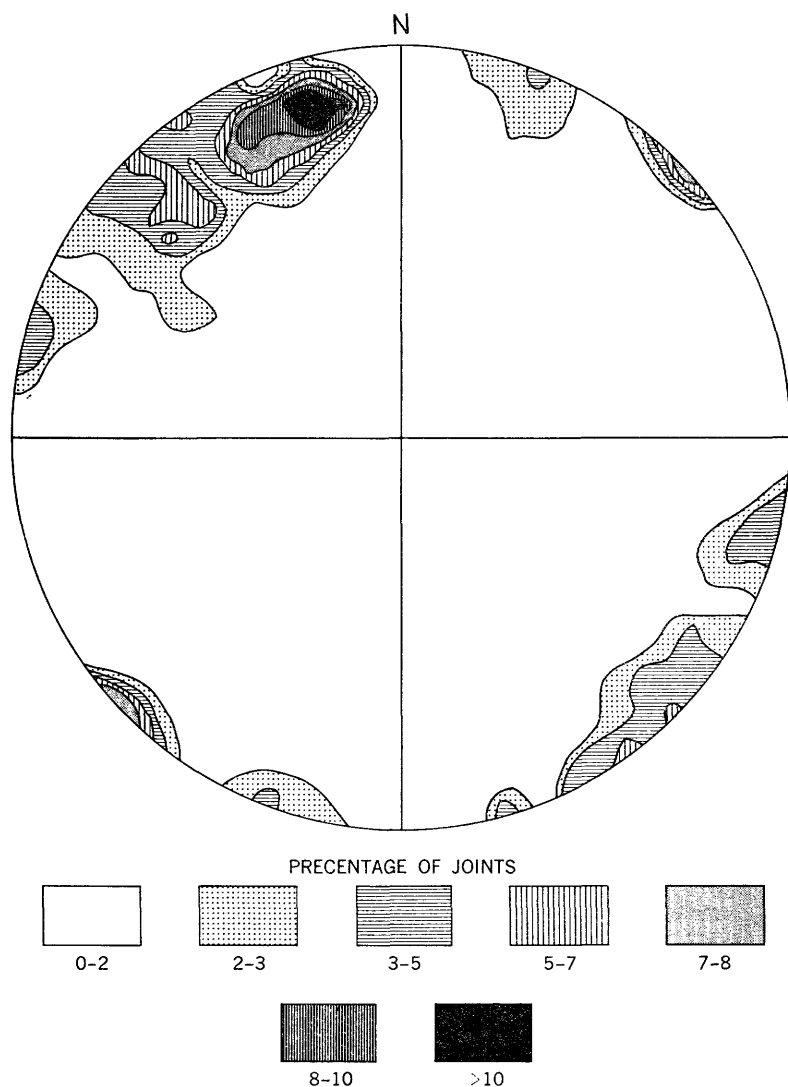
The joint system in the granodiorite is well developed and consists of steeply dipping or vertical conjugate joints typical of massive granitic rocks. As indicated by the equal area diagram (fig. 2) of 60 joint poles, the system consists of two northeastward-trending sets, one striking N. 60°-80° E., the other striking N. 40°-50° E., and both dipping from 65° south to vertical. A third set strikes about N. 45° W. and has consistently vertical dips. The northeastward-striking joints are most abundant, and can be traced as far as 2 miles on the aerial photographs (pl. 1). Spacing between joints is variable, but the average is on the order of 10 to 20 feet. No slickensides or crushed rock were observed along any of the joints in the immediate damsite area.

FIGURE 2—Equal-area diagram of poles of 60 joints measured in West Creek damsite area. Poles plotted on lower hemisphere. Contoured on percentage of joints per 1 percent of area of circle.

In the design, construction and maintenance of a dam, the north-eastward-striking joints could present some problems. The course of West Creek in the upper part of the gorge parallels the major joint set (N. 60°–80° E.). The direction of thrust of an arch dam would be roughly parallel to the joint direction. The design of such a dam should take possible local slippage along the joints into consideration. Leakage under the dam along joints belonging to the major set should

also be considered. Leakage is also likely along joints of both north-eastward-trending sets through the left abutment, particularly in the saddle areas where both ice plucking and glaciofluvial erosion were joint controlled. Leakage might also be expected along the gulch east of the right abutment that roughly parallels the major joint direction. Only drilling and pressure testing would determine whether joints and sheeting fractures are open at depth.

The stability of the left abutment during and after excavation might be locally affected by the southward-dipping joints of the major set unless care is taken to prevent undercutting.
