Geologic Reconnaissance of Possible Powersites at Tyee, Eagle, and Spur Mountain Lakes, Southeastern Alaska

GEOLOGICAL SURVEY BULLETIN 1211-B

By JAMES E. CALLAHAN *and* ALEXANDER A. WANEK

*A description of the geological factors
which could affect the feasibility of three
powersites on the mainland of southeastern
Alaska, northeast of Ketchikan*

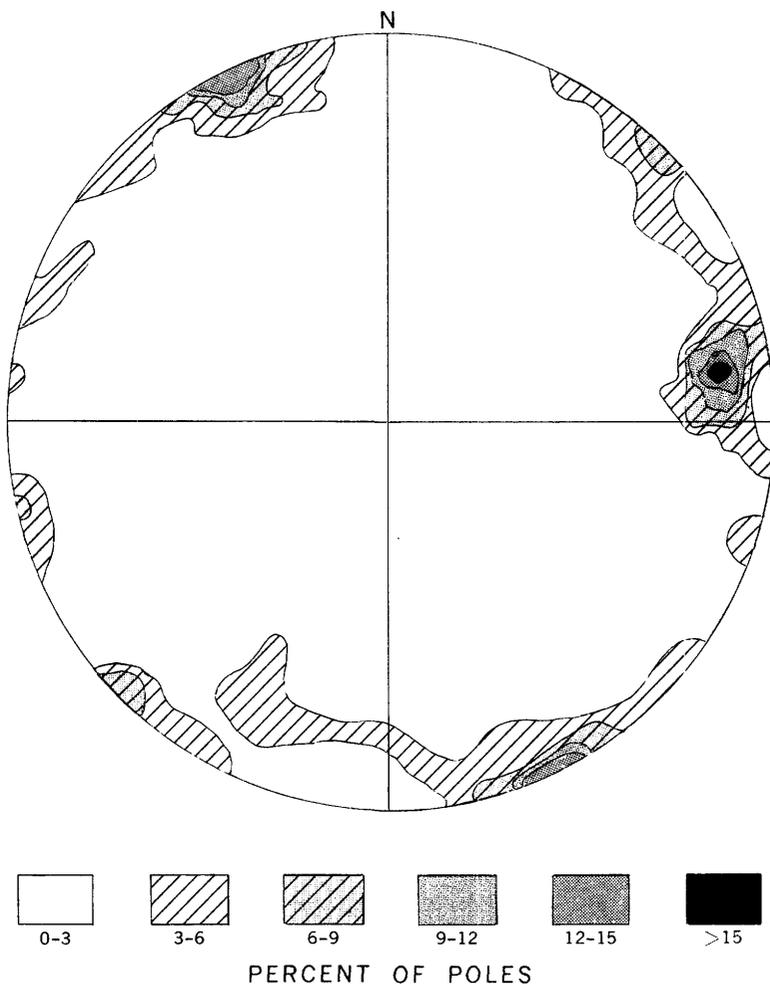
Joints are steeply dipping to vertical. Figures 2, 3, and 4 are contour diagrams of poles plotted to joints measured at Spur Mountain Lake, Tyee Lake, and Eagle Lake, respectively. The joint systems at Spur Mountain Lake and Eagle Lake are similar; two major sets strike N. 65° E. and N. 10° W., respectively, and dip vertically or near vertically. The northeasterly striking set is also present at Tyee Lake.

In the main, joints are laterally persistent but widely spaced. No slickensides or other evidence of movement on joint faces were observed.

FIGURE 2.—Contour diagram of poles of 120 joints measured in the Spur Mountain Lake powersite area. Poles plotted on lower hemisphere. Contoured on percent of poles. (Billings, 1954, p. 108-114.)

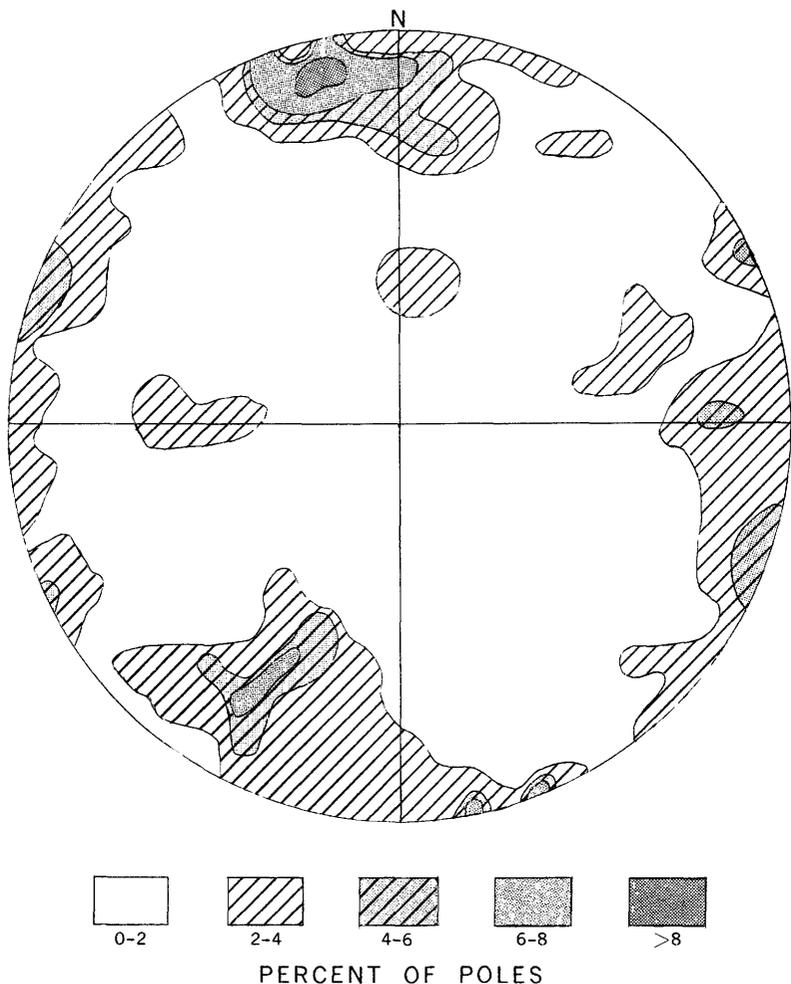
FIGURE 3.—Contour diagram of poles of 127 joints measured in the Tye Lake powersite area. Poles plotted on lower hemisphere. Contoured on percent of poles. (Billings, 1954, p. 108-114.)

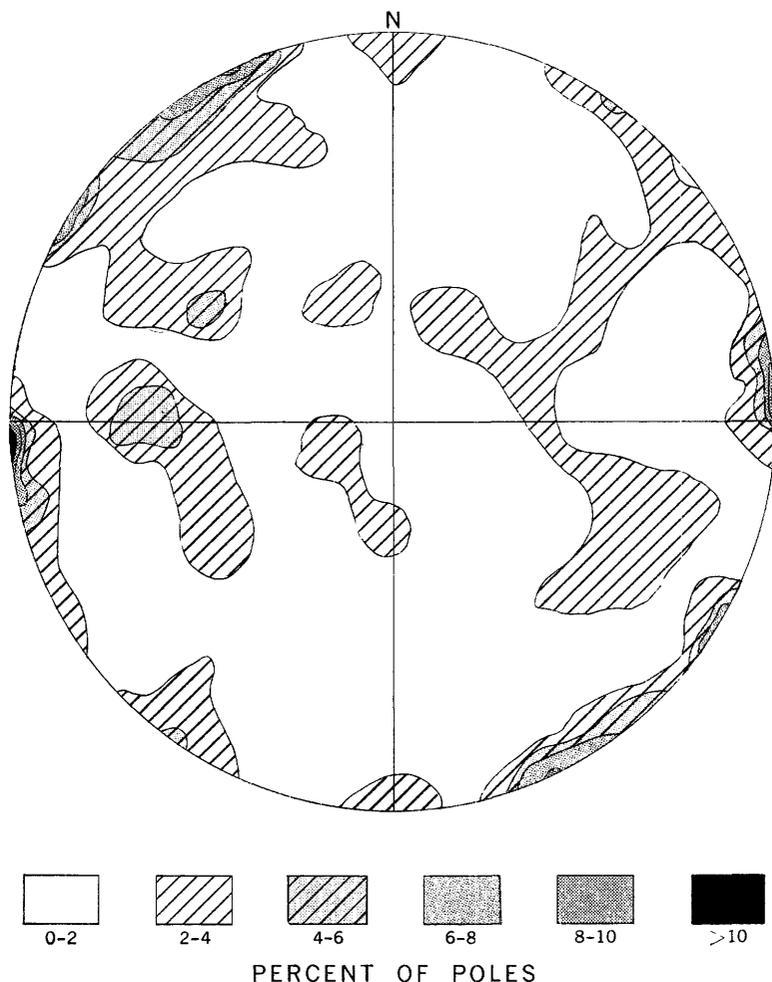
FIGURE 4.—Contour diagram of poles of 96 joints measured in the Eagle Lake powersite area. Poles plotted on lower hemisphere. Contoured on percent of poles. (Billings, 1954, p. 108-114.)
