GEOLOGICAL SURVEY CIRCULAR 136

September 1951

GEOLOGY AT THE SITE OF A PROPOSED
DAM AND RESERVOIR ON POWER CREEK
NEAR CORDOVA, ALASKA

Don J. Miller

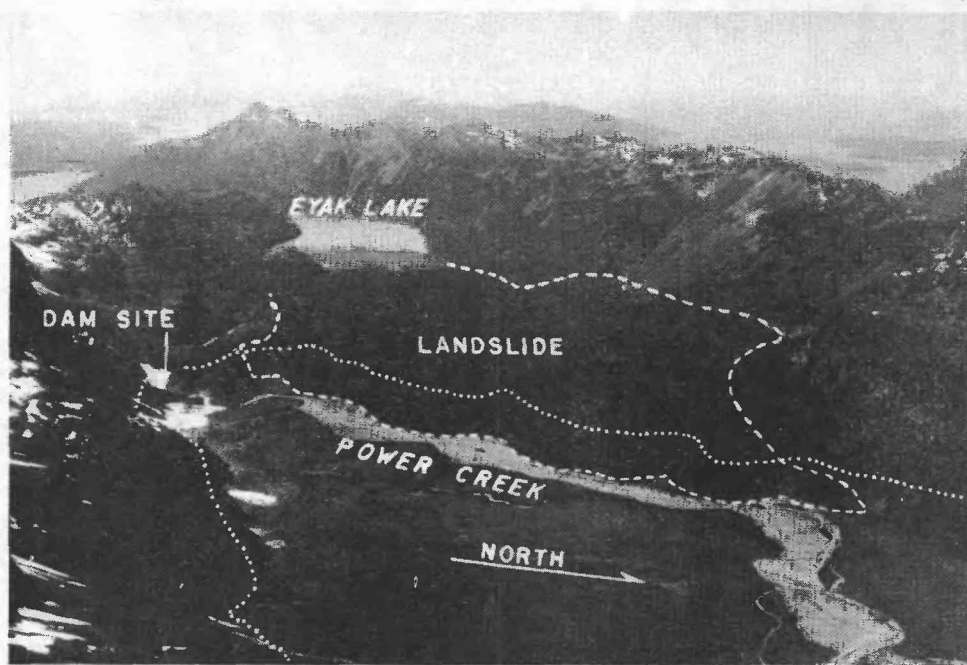
Figure 1. --Aerial photograph of the lower part of Power Creek valley showing the fanlike ridge extending across the valley. The approximate extent of the material interpreted as landslide debris is indicated by the dashed line, the approximate location of the maximum flow line of the proposed reservoir by the dotted lines.

The fanlike ridge extending across the lower part of Power Creek valley from the northwest side to the previously described area of deformed bedrock is believed by the writer to be in large part a slide of loose rock (a landslide) that came from the northwest valley wall, partially filling the glaciated valley and forcing Power Creek to cut through a bedrock spur along the southeast side of the valley. The following features support this interpretation: (1) The northwest valley wall, adjacent to and above the fan-like ridge, shows a relatively smooth, sloping surface bounded on the northeast and southwest by steep scarps, suggestive of the source of the debris in the valley and the surface along which movement occurred (pl. 1 and fig. 1); (2) The surface of the fan-like ridge shows many terraces and elongate depressions which approximately parallel the valley wall or the outer margin of the ridge (pl. 1 and fig. 1); (3) Loose, angular blocks of rock are exposed on the surface of the fan-like ridge at many places (fig. 2). Blocks of rock as much as 40 feet in largest dimension were observed in ground traverses on the ridge, and other blocks estimated to be at least 100 feet in largest dimension were observed from the air; (4) Drainage on the fan-like ridge, about 2 square miles in area, is almost entirely underground in spite of the heavy precipitation. No permanent streams flow across the feature and none of the larger depressions, which are as much as 100 feet in depth and several hundred feet in largest diameter, contain water.

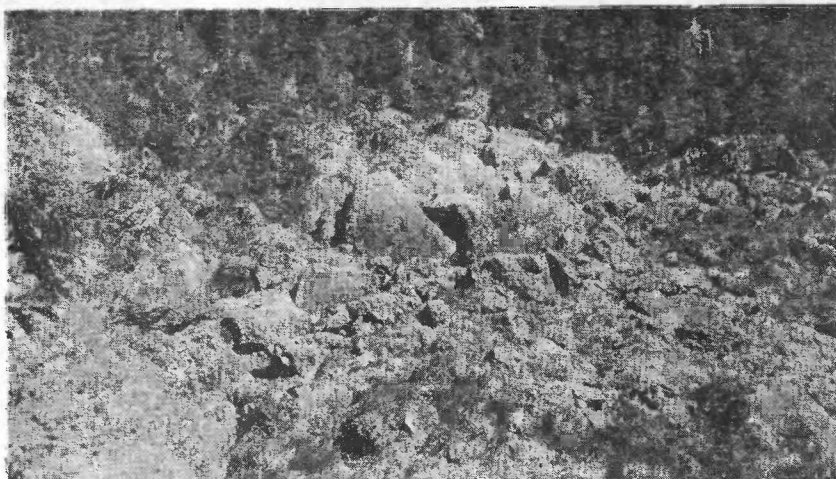
Figure 2. --Ground view near center of landslide area, showing blocky character of the surface. The exposed part of the large block of graywacke near the center of the view is about 15 feet high.

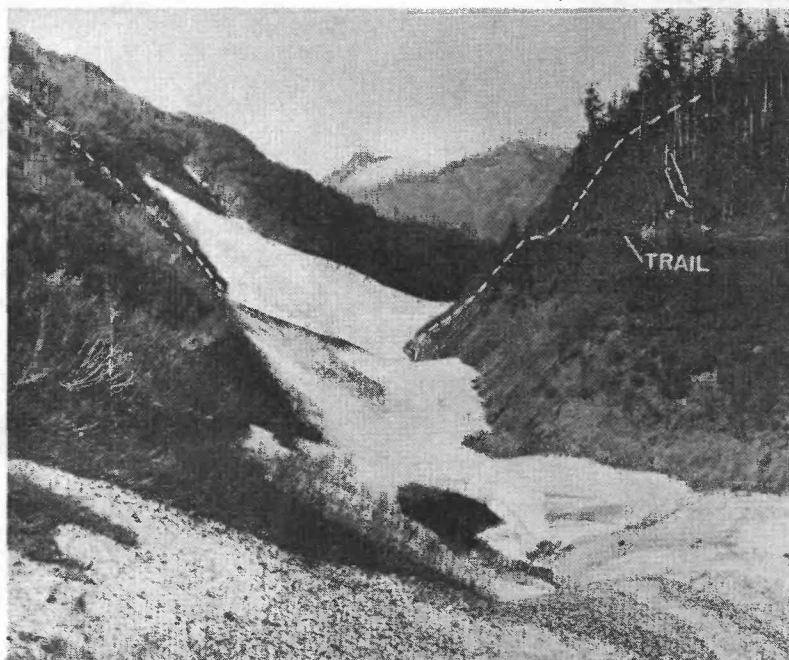
Figure 3. --Ground view of the proposed dam site on Power Creek. Dashed line indicates approximate location of the section A-A', plate 2.

The evenly bedded argillite-graywacke sequence that would form the southeast (left) abutment, the foundation, and the lower part of the northwest (right) abutment appears to be sufficiently strong to support a gravity-type dam, either rigid or flexible, and sufficiently tight to prevent excessive leakage around the dam. Both the argillite and graywacke are hard, little altered by weathering, and show slight to moderate fracturing. The freshest exposures, in the stream bed and the canyon walls immediately adjacent to it, show few fractures, indicating that the open fractures are largely a surface weathering phenomenon and that relatively tight bedrock would be encountered within a few feet of the surface. The scattered outcrops in the upper part of the northwest wall of the canyon, which would form part of the right abutment of the dam site, on the other hand, indicate that the bedrock there is intensely fractured. If, as suggested in this report, the fracturing is due mainly to faulting rather than to surface weathering, little improvement in the strength and tightness of the bedrock could be expected within feasible depth.

Bedrock is exposed continuously in the floor and lower part of the canyon walls in the vicinity of the section A-A' (pl. 2) and probably is not covered by more than a few feet of loose rock and soil anywhere in the southeast wall of the canyon at the proposed dam site. The mantle of loose rock and soil is generally thicker and more continuous in the upper part of the northwest wall of the canyon. Natural and artificial exposures of the bedrock-mantle profile suggest that the maximum thickness of the mantle in this part of the proposed dam site probably is less than 20 feet and possibly is less than 10 feet.

3. Information on the strength and solubility of the bedrock at the proposed dam site could be obtained by suitable laboratory tests, and information on the water-tightness of the bedrock could be obtained by observing the rate of leakage of water from pits or drill holes sunk into the bedrock. Shallow pits or drill holes will provide suitable rock samples and an adequate test of the water-tightness of the bedrock in the southeast wall, floor, and lower part of the northwest wall of the canyon at the proposed dam site, but at least one fairly deep pit or drill hole may be required to adequately test the upper part of the northwest canyon wall.

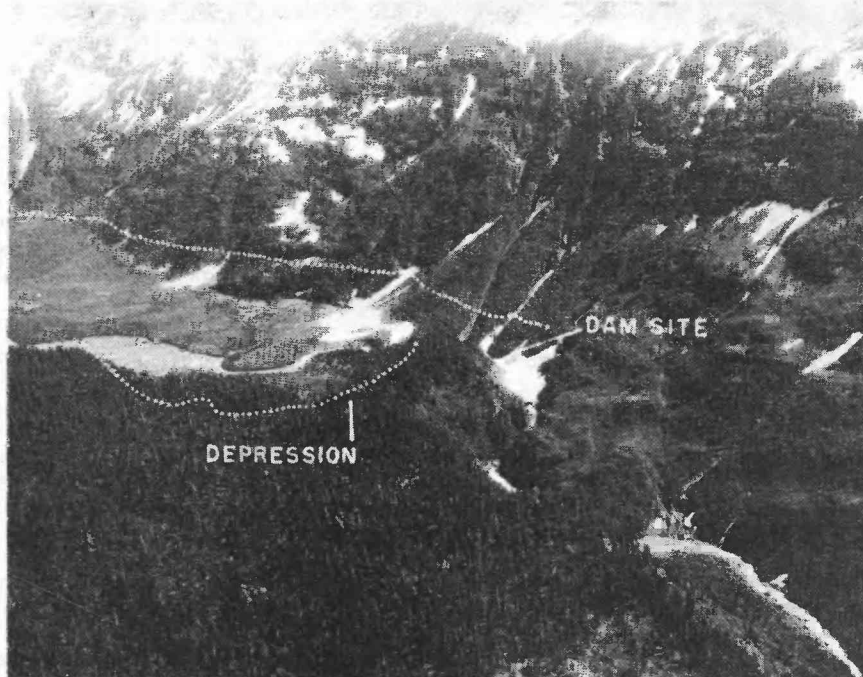
Figure 4. --Aerial photograph of the proposed dam site and adjacent area, Power Creek. Dotted lines indicate approximate location of maximum flow line of proposed reservoir. Note blocky character of landslide surface in lower left corner.

In the interval from about 1,000 to 6,000 feet above the dam site the northwest wall of the proposed reservoir is formed of coarse, angular, loose blocks of bedrock, interpreted in this report as landslide debris (pl. 1). If the interpretation of the origin of the fan-like ridge, as outlined on pages 10 and 12, is correct, then the loose debris may extend to a depth of several hundred feet and may also form part of the floor of the reservoir, beneath the cover of alluvium. The blocky, loose character of the surface, the lack of surface drainage, and the presence of drained depressions all attest to the porous character of the fan-like ridge. The most critical locality probably is in the vicinity of the depression approximately 1,500 feet northwest of the proposed dam site, near the margin of the area mapped as landslide debris. (Johnson, 1949, p. 11; published map of Power Creek). This depression, which is formed in loose angular blocks of rock, is about 300 feet across and 75 feet deep. The upstream rim of the depression at one point is less than 20 feet above the maximum flow line of the proposed reservoir, and the bottom of the depression is about 40 feet lower than the maximum flow line. Water could be heard running beneath the blocks in the bottom of the depression when it was examined by Johnson in 1948 and by the writer in 1950.

The northwest wall and the adjacent floor of the proposed reservoir for a distance of 1 1/2 miles above the dam site consists in part of intensely deformed and fractured bedrock and in part of loose, angular blocks which are believed to be landslide debris. The lack of surface drainage, the presence of springs, and other features of this area indicate that subsurface leakage is substantial under the present conditions and might prevent storage to the desired level in the proposed reservoir. The bedrock that would form the wall and floor (beneath alluvium) of the remainder of the proposed reservoir almost certainly is sufficiently tight and insoluble to insure negligible leakage.

1. Information on the water-tightness of the part of the reservoir wall formed of landslide debris could be obtained at the narrowest, and therefore most critical, point by pumping water into the drained depression about 1,500 feet northwest of the proposed dam site.

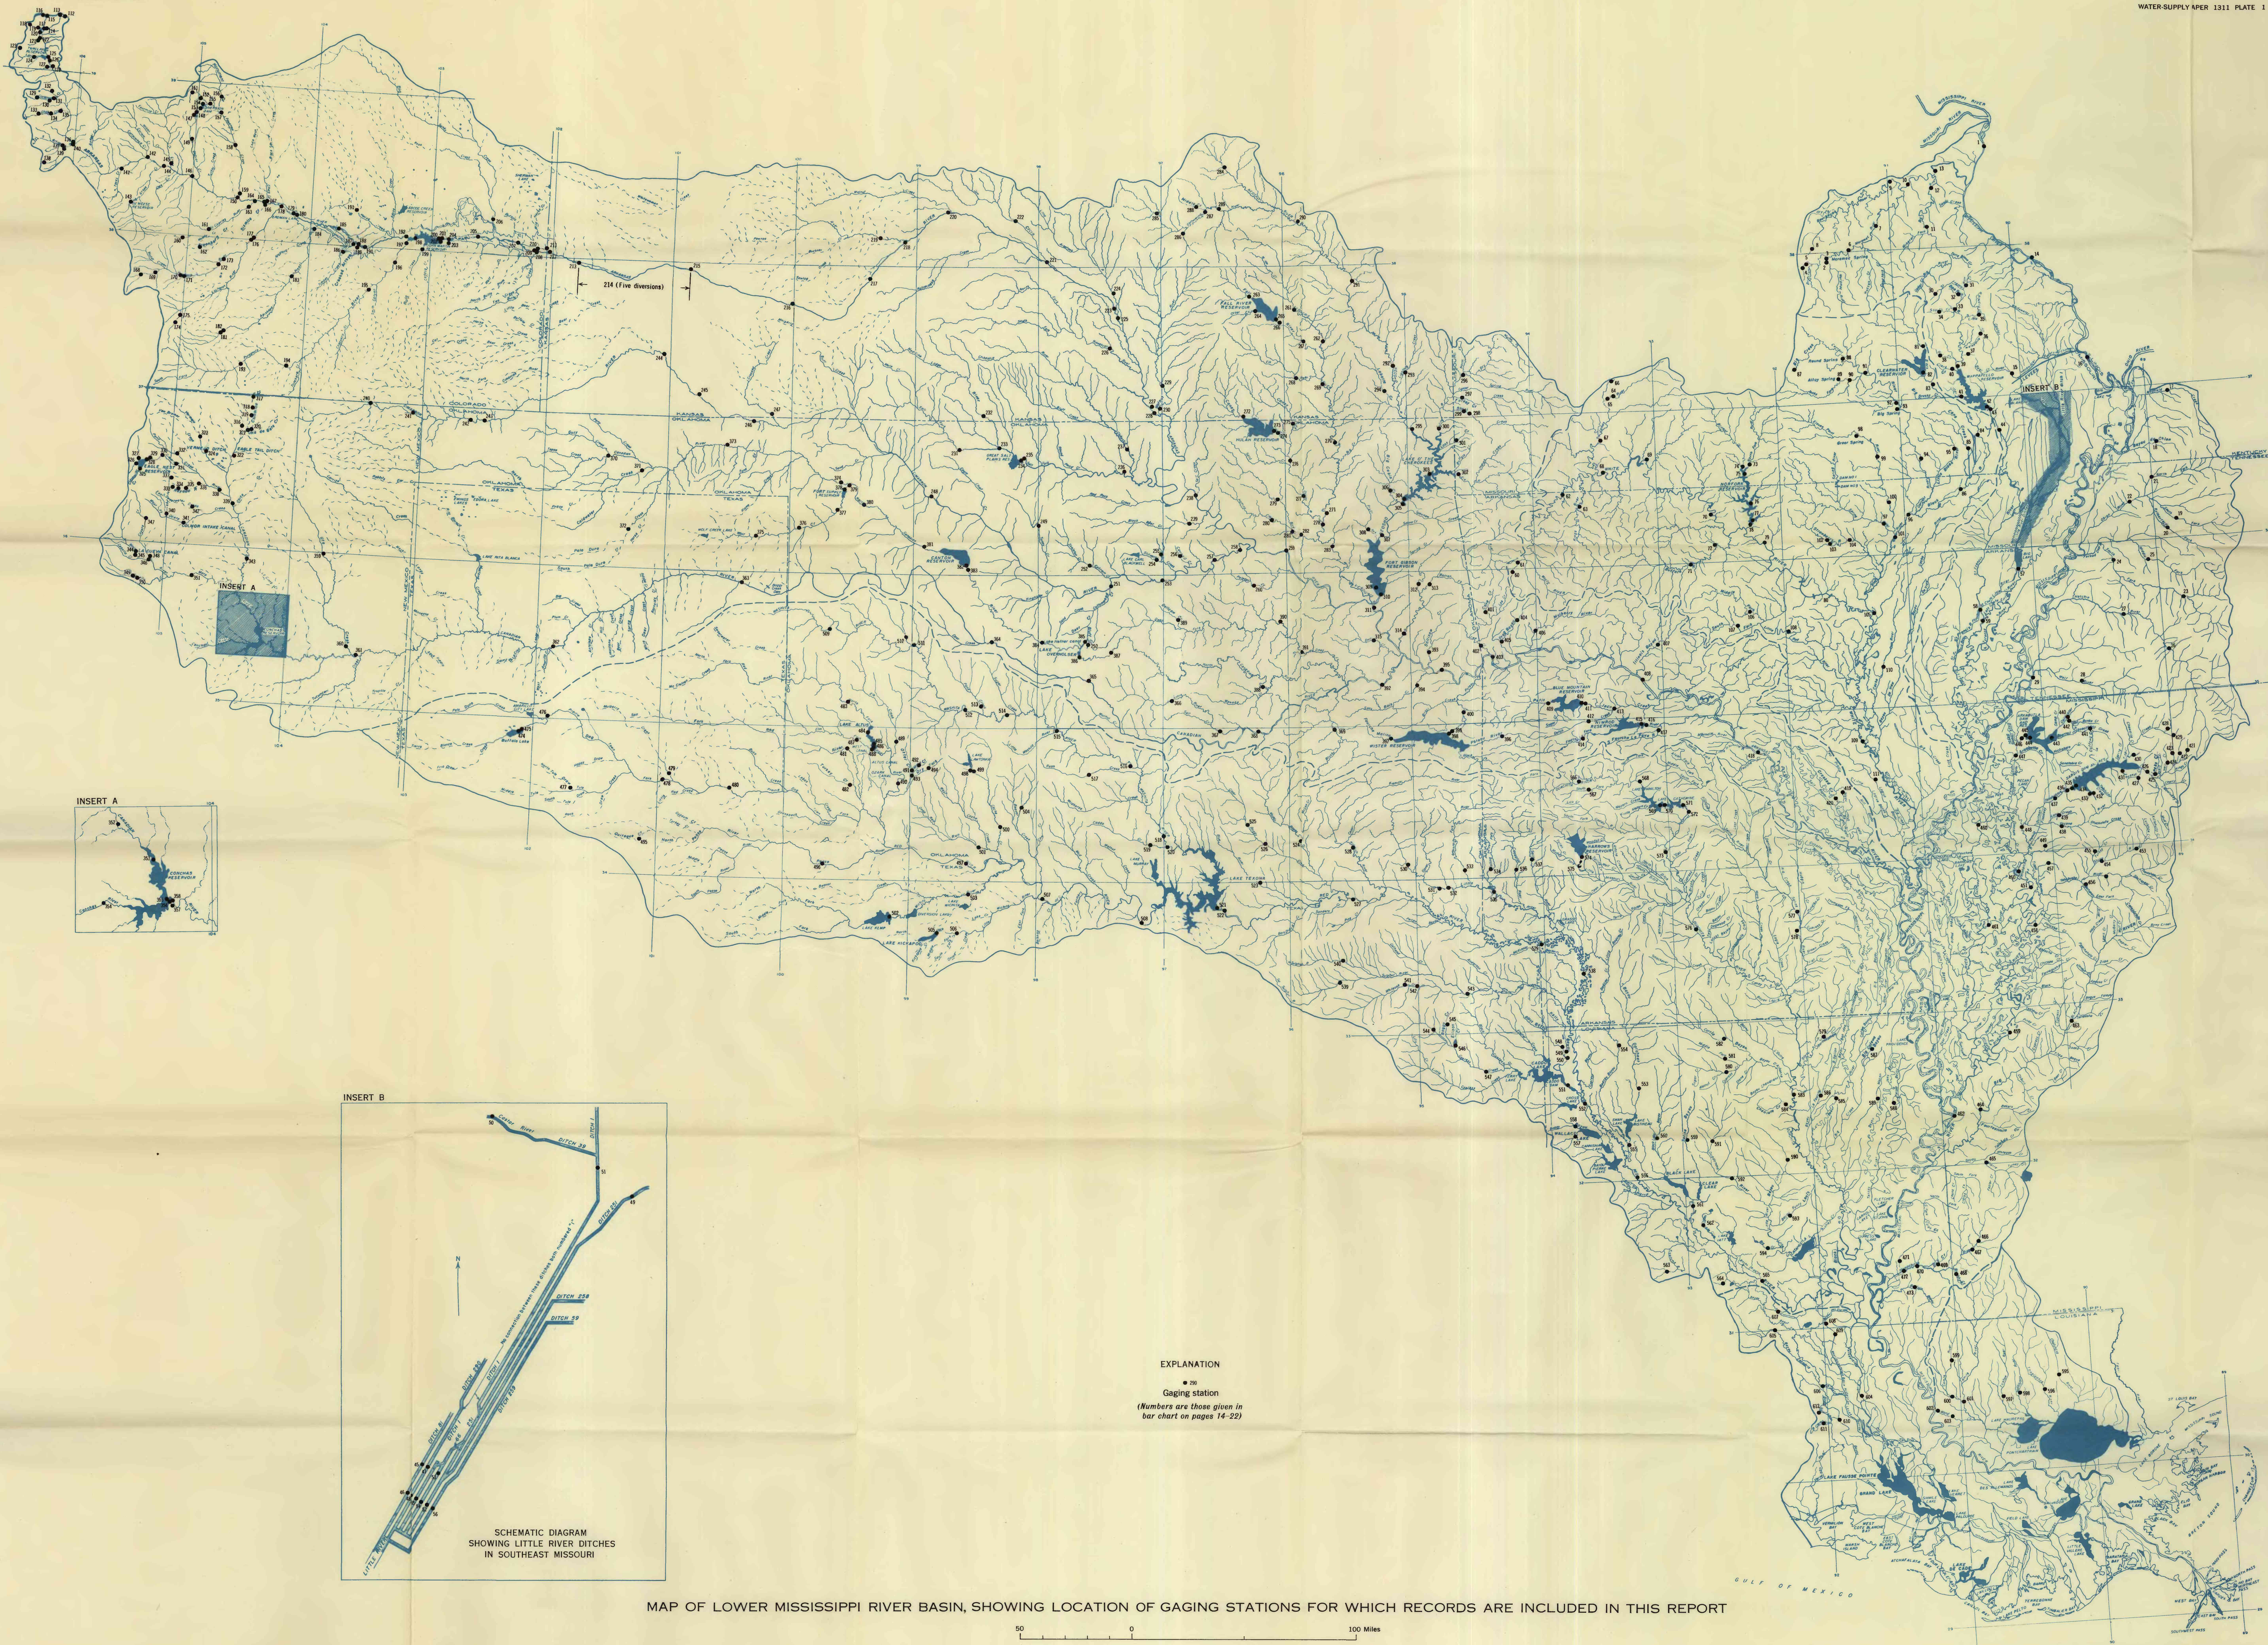
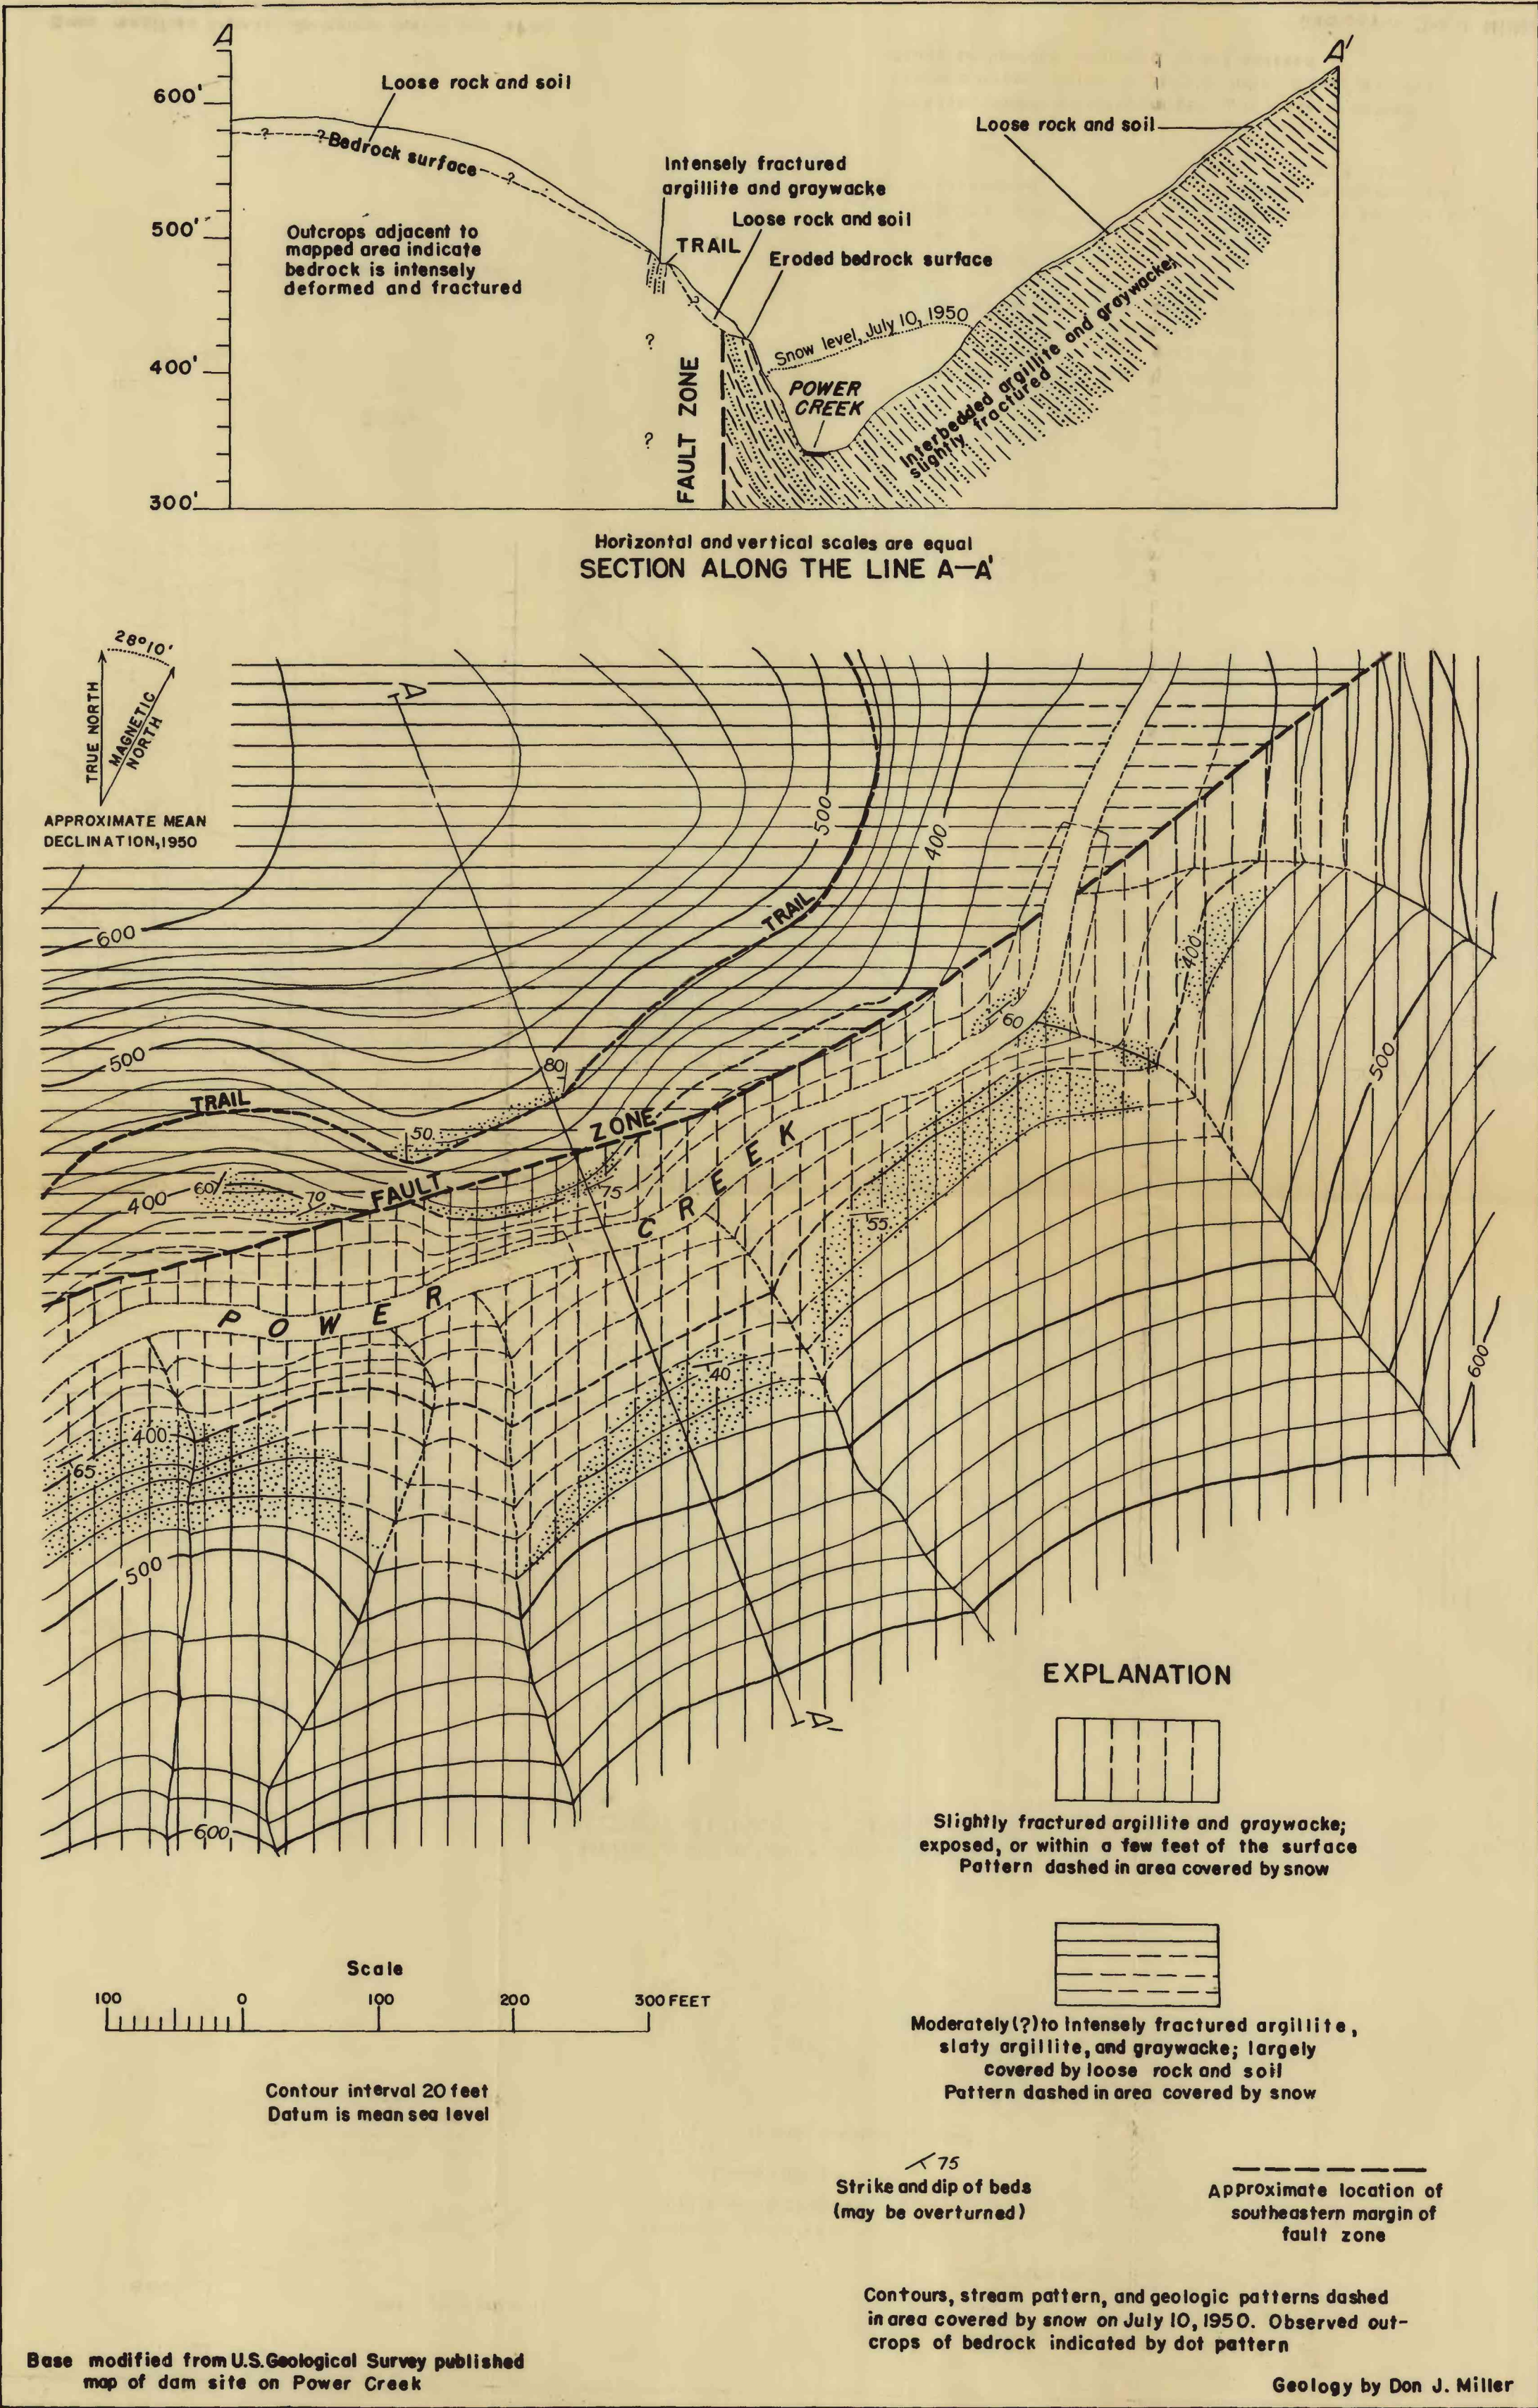
MAP AND SECTION SHOWING GEOLOGY AT PROPOSED DAMSITE ON POWER CREEK NEAR CORDOVA, ALASKA.

The bedrock exposed in the southeast wall, the floor, and a small part of the northwest wall of the canyon at the proposed dam site consists of evenly bedded, relatively slightly deformed and fractured argillite and graywacke which lies southeast of a fault zone (pl. 2). The strike of the beds ranges from N. 55° E. to N. 85° E. and the dip ranges from 40° to 75° SE. The dip decreases gradually from northwest to southeast across the canyon. It is about 75° SE. in the northwest wall of the canyon near the level of Power Creek, about 60° SE. in the bed of Power Creek, and about 40° SE. in the southeast canyon wall at a height of 100 feet above Power Creek. Sedimentary features in several oriented rock specimens of the evenly bedded argillite-graywacke sequence at the proposed dam site suggest that the sequence is overturned to the northwest. The sequence of evenly bedded argillite and graywacke continues up the southeast valley wall above the proposed dam site to the top of the ridge, with approximately the same range in strike and apparent dip as in the floor and lower part of the southeast wall of the canyon. A few hundred feet downstream from the dam site the evenly bedded argillite-graywacke sequence is in depositional contact with a sequence of volcanic rocks, including massive beds of lava, tuff, and volcanic breccia. The volcanic sequence does not crop out along Power Creek immediately northwest of the fault.

Except for a narrow band of relatively slightly deformed and fractured argillite and graywacke that forms the lower canyon wall at the narrowest part, the bedrock exposed in scattered outcrops in the northwest wall of the canyon at the proposed dam site consists of intensely deformed and fractured argillite, slaty argillite, and graywacke. These outcrops lie in or northwest of the fault zone along Power Creek. The attitude of the bedding varies widely within outcrops, and from one outcrop to another.

The upper part of the northwest wall of the canyon at the proposed dam site, however, apparently consists of intensely deformed and fractured bedrock, covered in part by a mantle of loose rock and soil possibly as much as 20 feet thick at some places. If, as seems likely, the excessive fracturing of the bedrock here is due to faulting rather than to surface weathering, little improvement in the strength and tightness of the bedrock could be expected within feasible depth.
