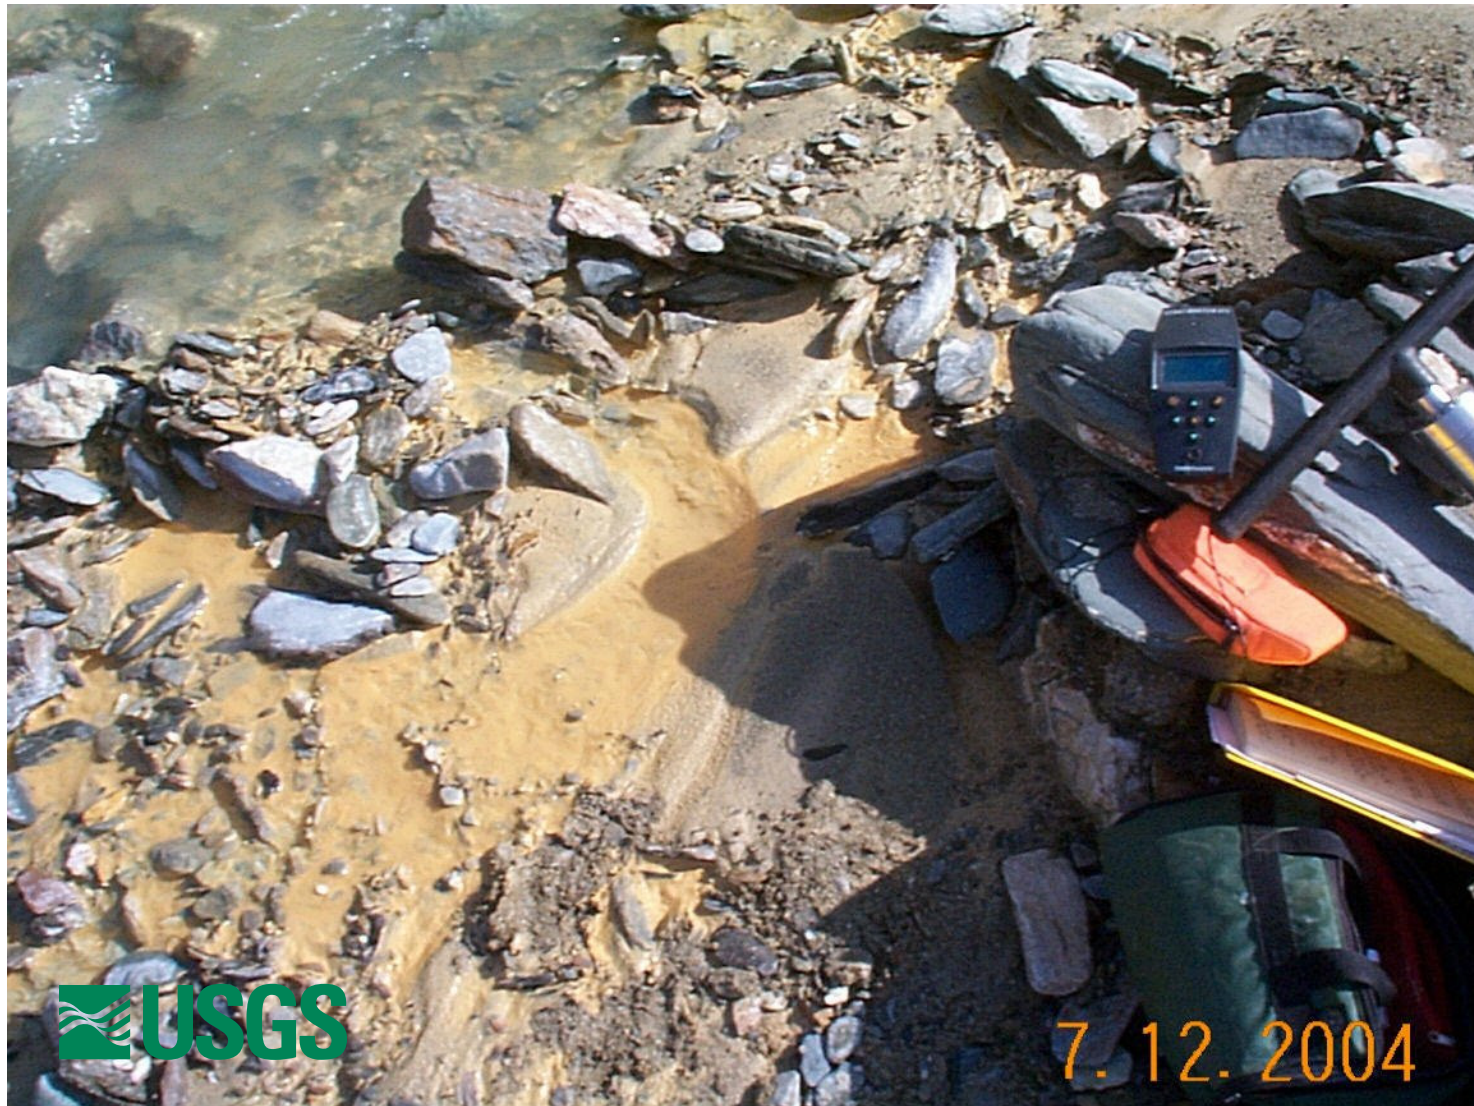
Photo 04JHBF14. Buff-colored Al- and Fe-rich precipitate along Foster Creek downstream of Lago Creek and all acidic inflows.
