FLOOD OF AUGUST 1967 AT
FAIRBANKS, ALASKA

By
Joseph M. Childers and James P. Meckel
1967

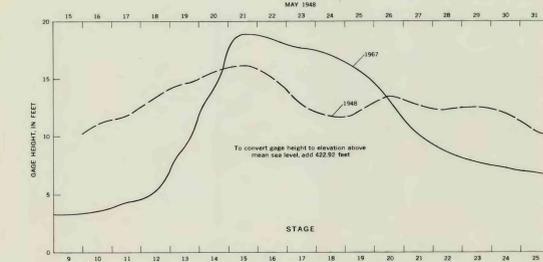
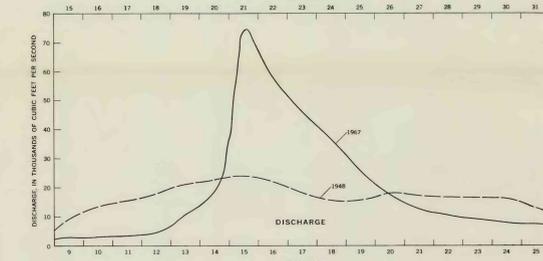
FIGURE 2.—Hydrographs of stage and discharge for floods of May 1948 and August 1967, Chena River at gaging station at Hall Street Bridge at Fairbanks, Alaska.

The stage hydrographs for the floods of May 1948 and August 1967 are shown in figure 2.

Flood discharge.—Discharge is the rate at which water flows, expressed as volume per unit time, usually cubic feet per second (cfs). Peak discharge is the maximum value of the discharge attained during a flood. The peak discharge of the Chena River on August 15, 1967, was 74,400 cfs. The discharge hydrograph for August 1967 is shown in figure 2.

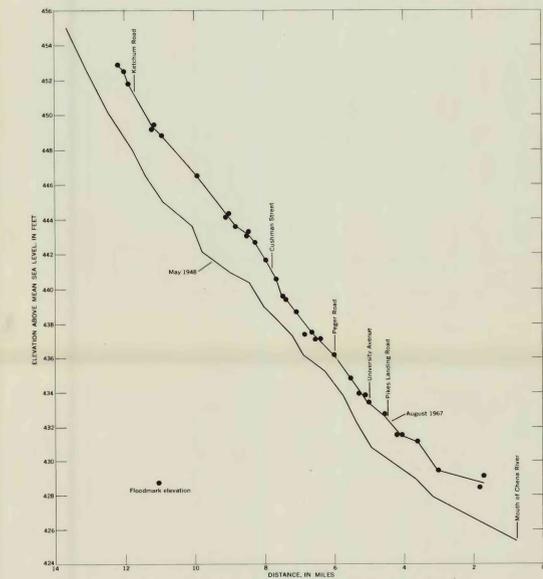
FIGURE 3.—Flood-crest profiles of Chena River at Fairbanks 1948 profile adapted from Corps of Engineers data.

Flood-crest profiles.—The profiles of the flood crests of May 21, 1948, and August 15, 1967, are shown in figure 3. The base line to establish distances for the flood profile was arbitrarily drawn along Airport Way and projected southwestward from the airport and eastward from Cushman Street as shown on the map. Elevations of high-water marks left by the August 1967 flood have been plotted on the flood map and are the basis for the 1967 flood profile. The profile stationing for a specific point can be obtained from a projection perpendicular to the base line. The 1967 profile is applicable to both sides of the Chena River upstream from mile 9 and only to the south or left bank downstream from mile 9.

Profiles of floods are a reflection of the capacity of the main channel, the degree to which bridge openings are obstructed, and the extent of man's encroachment on the flood plain. The 1967 flood profile, figure 3, is smooth with only minor breaks in slope. This smooth profile indicates that bridges and other structures were not serious obstructions to the floodflow. About two-thirds of the peak discharge occurred over the flood plains rather than within the main channel. Figure 2 shows that the increase in discharge from 40,000 cfs to 74,400 cfs at the peak raised the stage less than a foot.

Depths of inundation can be estimated from the map by subtracting the ground elevation at a specific point from the water-surface elevation at the same point as indicated by the profiles in figure 3. Ground elevations can be estimated from contours on the map, although more accurate elevations can be obtained by leveling to nearby bench marks. The depth of inundation in 1967 at the site of most high-water marks is shown in blue numerals on the flood map.
