**SURFACE FRACTURES FORMED IN THE POTRERO CANYON, TAPO CANYON, AND McBEAN PARKWAY AREAS IN ASSOCIATION WITH THE 1994 NORTHRIDGE, CALIFORNIA, EARTHQUAKE**

By  
MICHAEL J. RYMER<sup>1</sup>, JEROME A. TREIMAN<sup>2</sup>, THOMAS J. POWERS<sup>1</sup>, THOMAS E. FUMAL<sup>1</sup>,  
DAVID P. SCHWARTZ<sup>1</sup>, JOHN C. HAMILTON<sup>1</sup>, and FRANCESCA R. CINTI<sup>3</sup>

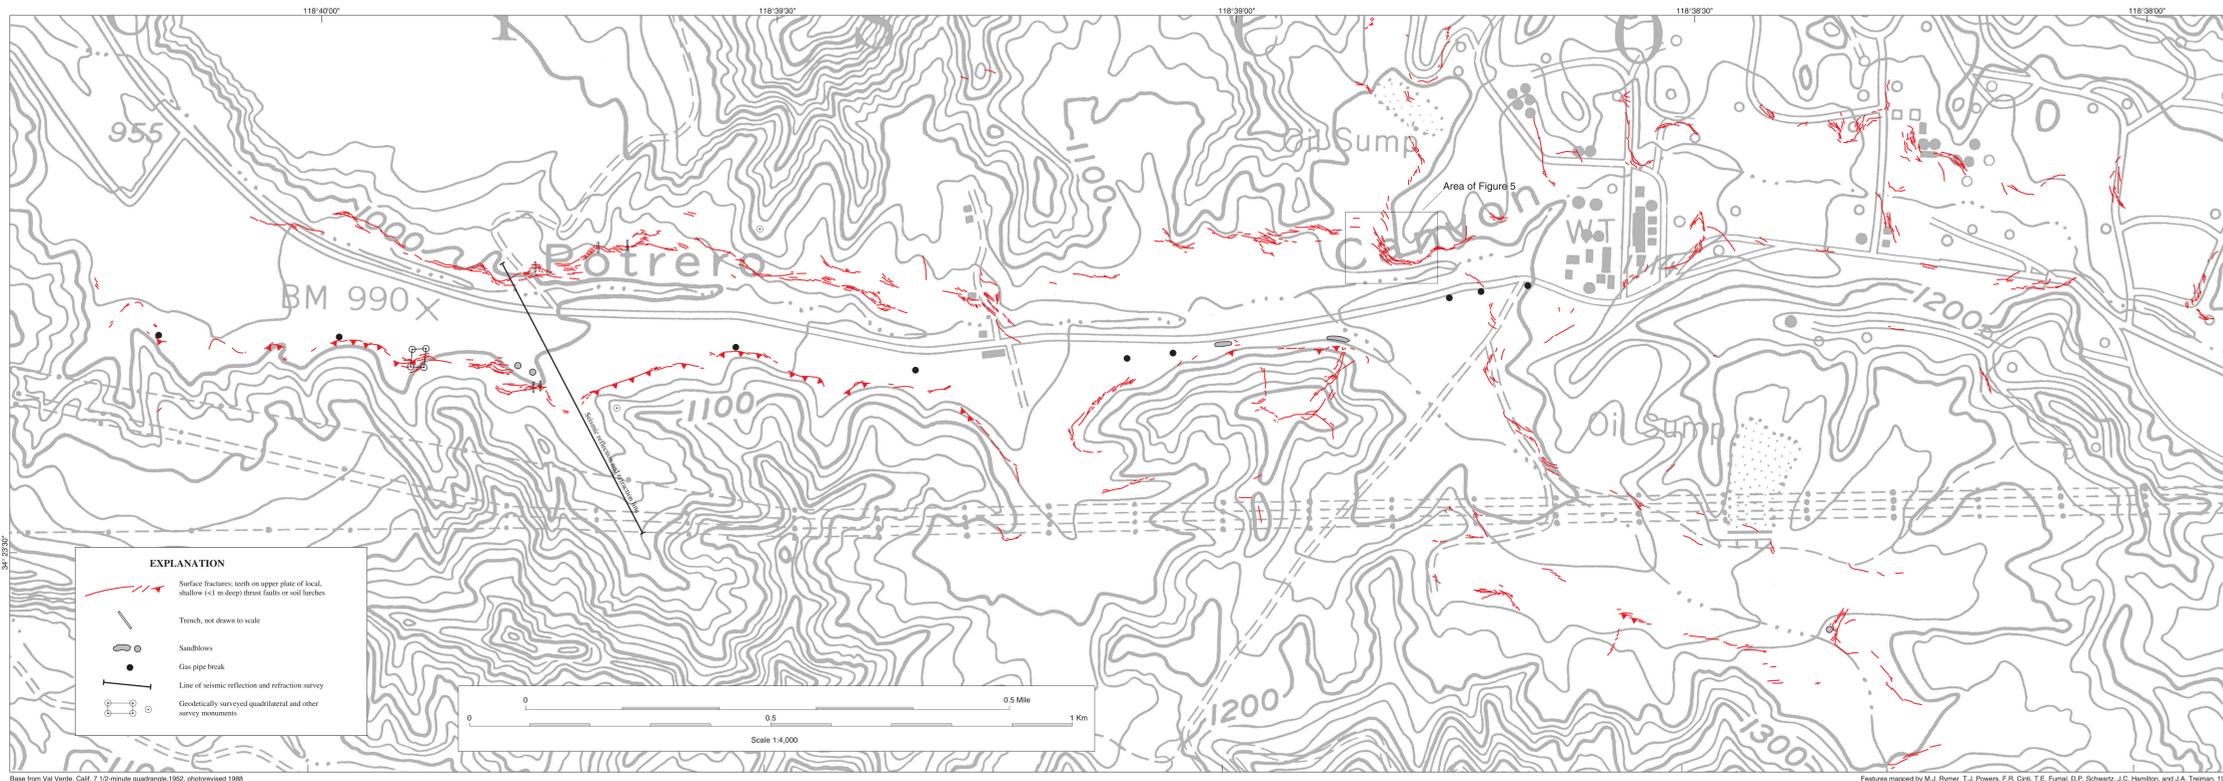
Map 1. Surface fractures and other earthquake-induced features formed in Potrero Canyon in association with the 1994 Northridge earthquake (see Fig. 1). Features mapped by P.J. Rymer, T.J. Powers, F.R. Chel, T.E. Fumal, D.P. Schwartz, J.C. Hamilton, and J.A. Treiman, 1994. Manuscript approved for publication February 20, 2001.

Extensive sets of surface fractures formed in alluvium around the margins of Potrero Canyon in association with the earthquake. Map 1 is a plot of the fractures, which extend east-west and north-south about 1.6 km and 1.1 km, respectively. Most fractures are in the upper 50 cm of the bedrock and alluvium contact at depth, near the base of the hill slopes (Figs. 2, 3). In areas where bedrock can be traced to the hill slopes, surface cracks were associated with this bedrock-alluvium contact in spite of the artificial change in topography.

Characteristics of surface fractures varied somewhat along the north and south sides of the canyon. On the north side of Potrero Canyon, discontinuous crack sets developed with extensional displacements, commonly in areas as wide as 30 m (Map 1). Fractures found along the south side were most commonly restricted to discontinuous narrow zones (Fig. 4), and there were smaller fractures moved toward the north side of the canyon, including the south edge of a side canyon that extends to the southeast from Potrero Canyon (Map 1).

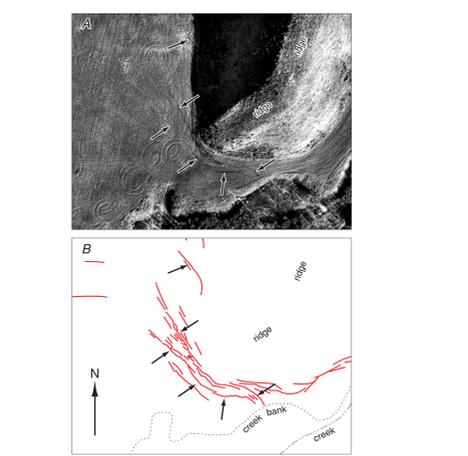
Figure 2. Surface fractures on north side of Potrero Canyon showing better developed cracks on west side of ridge spot that protrudes into canyon. Aerial photograph of surface fractures, prominent fractures marked by arrows. Features seen on cultivated ground include flower marks, tractor turn marks (see crop circles), and cattle trails. Late drawing of same area shown in 4. Heavy red lines, surface fractures.

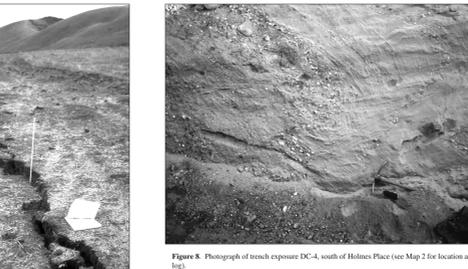
Figure 8. Photograph of trench exposure DC-4, south of Holmes Place (see Map 2 for location and Fig. 7 for logs).
