OBJECTIVE

Studies of bluff erosion and slope stability along the western shore of Chesapeake Bay suggest relative evolution from steep, eroding cliffs to stable slopes over decades. The present study estimates relative time required for eroding bluffs to reach stability.

STUDY

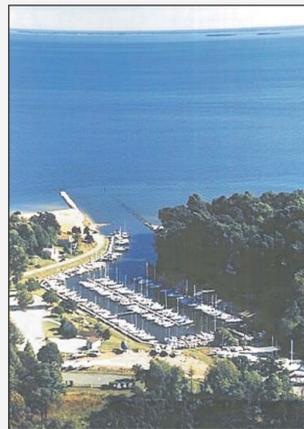
View of the marina at Flag Harbor. Updrift deposition behind the northern jetty (on the left) created beach that protects cliffs nearest to the marina from wave erosion.

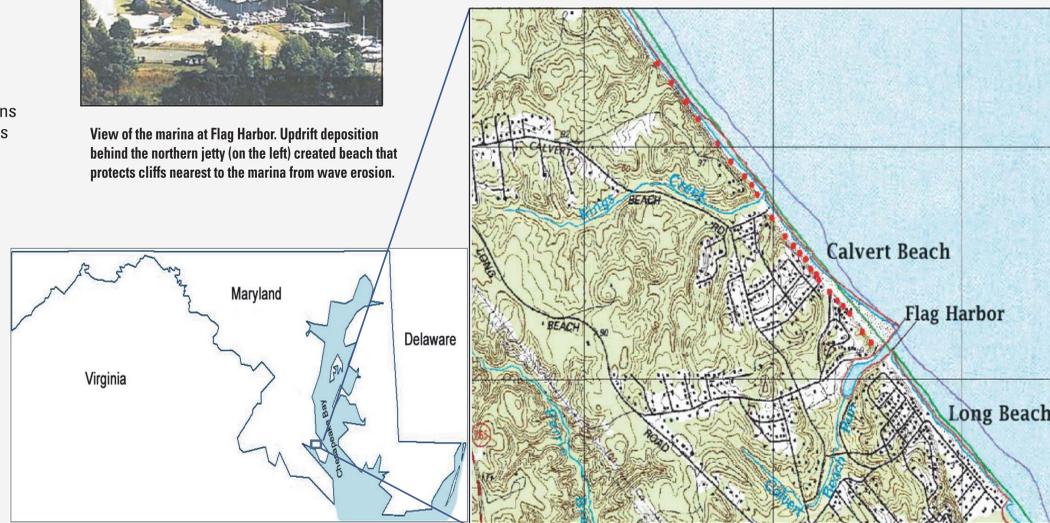
Fig. 1 Location of profile stations and historical migration of the Chesapeake Beach shoreline (courtesy of the Maryland Geological Survey): blue line - 1848; green line - 1942; red line - 1993. Topography - 1981. Construction of two jetties at Flag Harbor in 1947 altered the natural pattern of erosion. Parallel retreat of shoreline in this area subsided and finally changed to the deposition of beach sediments.

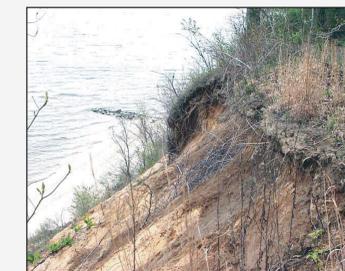
pic 4 Actively eroding cliff. Rotational slides at the top of the bluff created by oversteepened slope

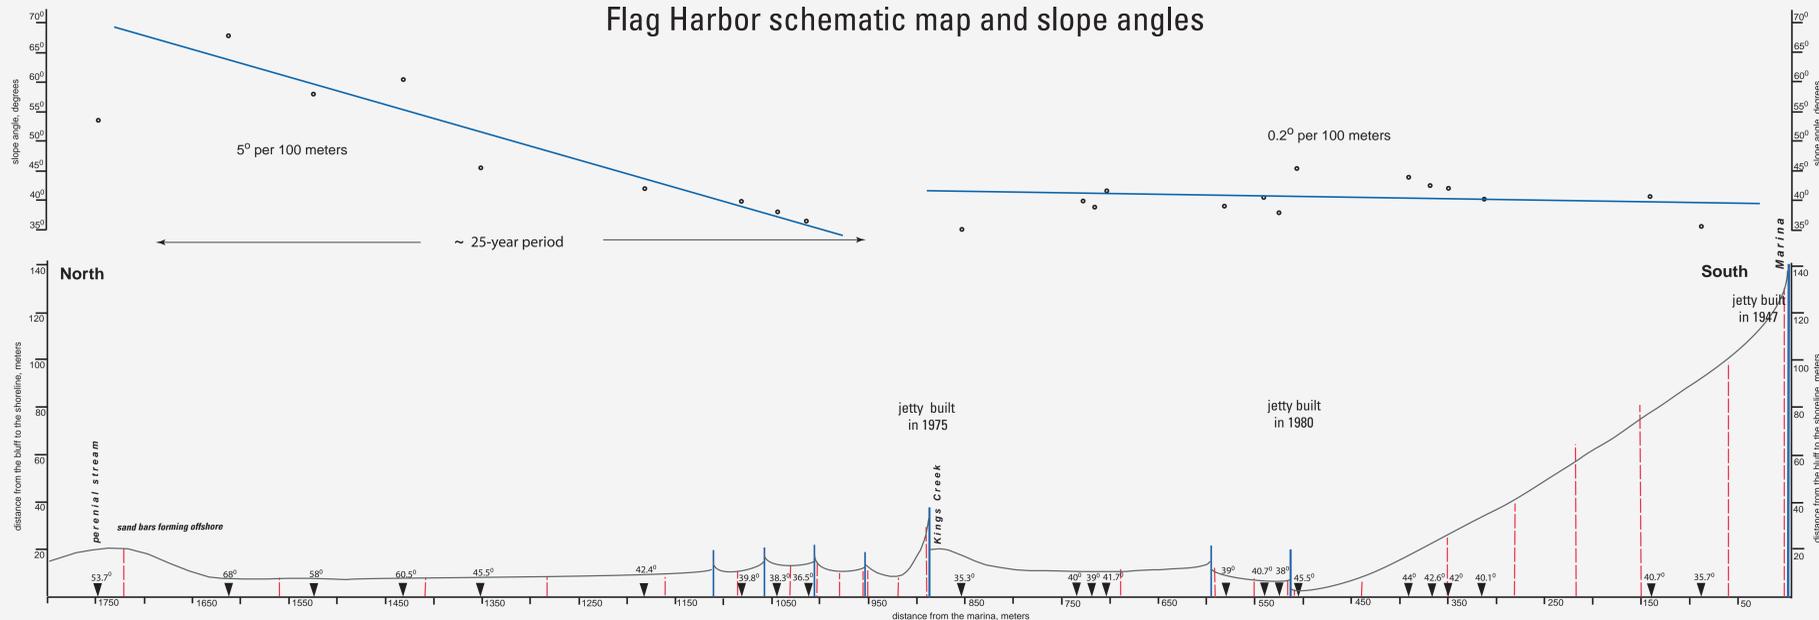
Flag Harbor schematic map and slope angles

A least squares regression of slope angle vs. distance showed progressive decrease in angle from north to south. On this section of shoreline, bluffs closest to the marina were protected for a longer period of time than the bluffs behind the Kings Creek jetty. Thus, the change in angle for these slopes is only 0.2° per 100 meters while it is 5° per 100 meters for the later ones. A relationship between time and distance along the shore allowed us to estimate a stabilization time for this location. Construction of the jetty at the Flag Harbor marina in 1947 and at Kings Creek in 1975, created conditions for the deposition of sand bodies that protected cliffs to the north of it. When undercutting at the toe of the bluffs was eliminated, slope recession still continued until stable slope angles were reached. Actively eroding 60 - 70 degree bluffs gave way to vegetated, but slumping slopes, and finally to stable slopes at angles of 35 - 40 degrees at the north side of the jetties. Bluffs at the distance of 250 -- 300 meters to the north of a jetty attain stability in less than 25 years. The shortness of this time scale allows us to suggest that attempts to artificially stabilize eroding bluffs along this coast is not a simple task of protecting the toes of the slopes from wave action. Once shoreline retreat ends, sloughing of sediment from bluff faces gives way to longer-term landslide processes. The bluff top recedes until a stable 35-degree slope is attained. Thus, simple shoreline protection methods do not preserve property at the bluff edge.
