Geology of some dam sites on Little Colorado
River and its tributaries, Arizona

Edwin B. Eckel

December, 1939

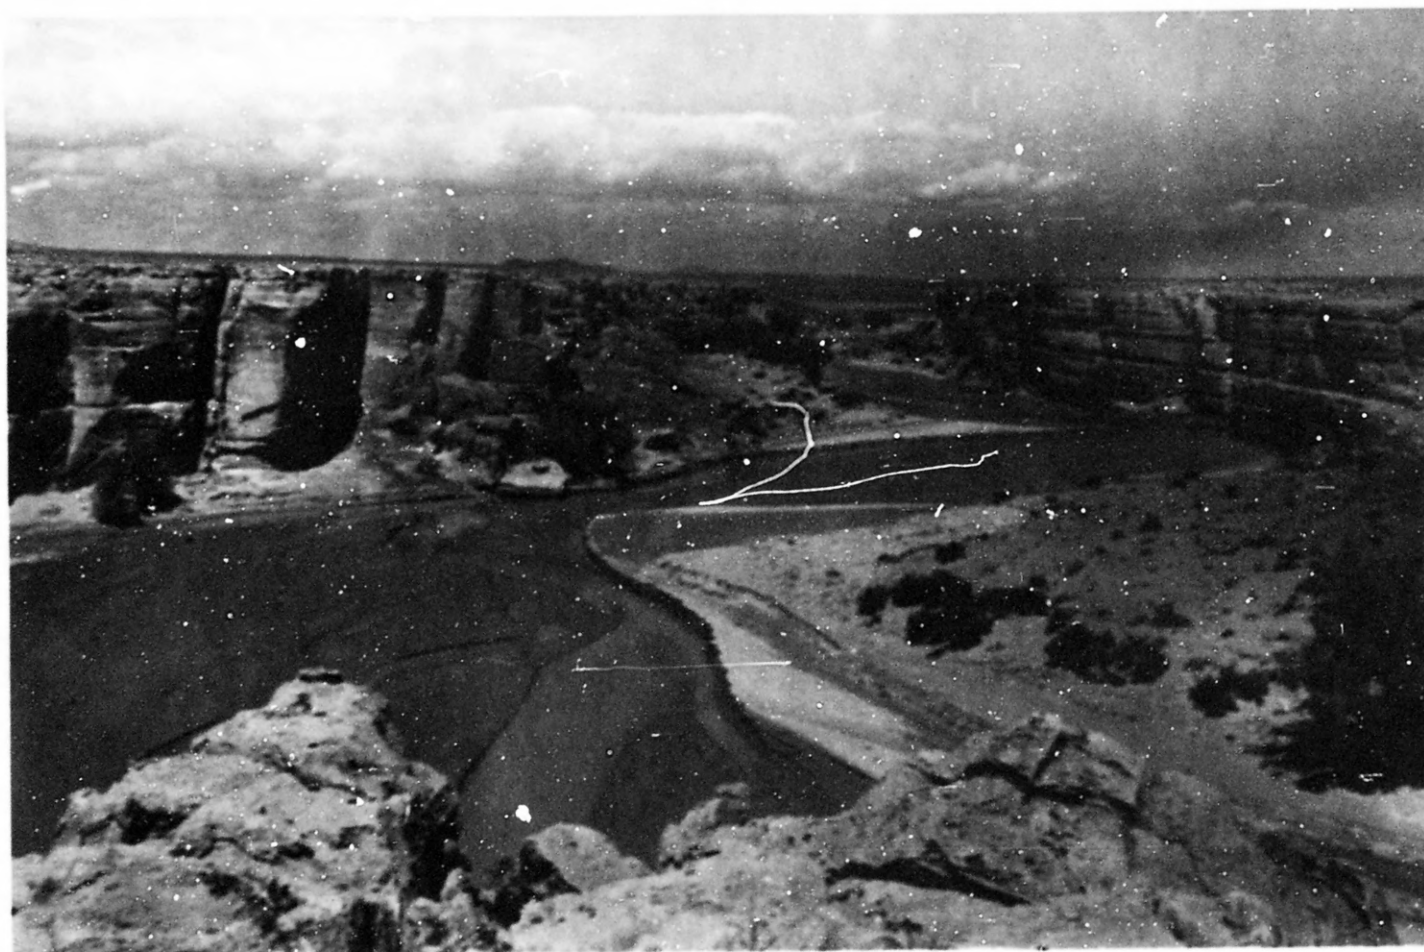
Figure 10

- 10 Tolchico site on Little Colorado River, looking downstream. Shows northwesterly -trending fractures parallel to canyon walls. Also note extensive sand dune deposits along left abutment.
- 11 Little Colorado River near Tolchico site, looking northwest. The site is in center distance, beyond main cliff in center foreground. The river's angular course is almost entirely due to two predominant fracture systems. Note character of erosion along northwesterly trending fractures.

Tolchico site on Little Colorado River, looking downstream.

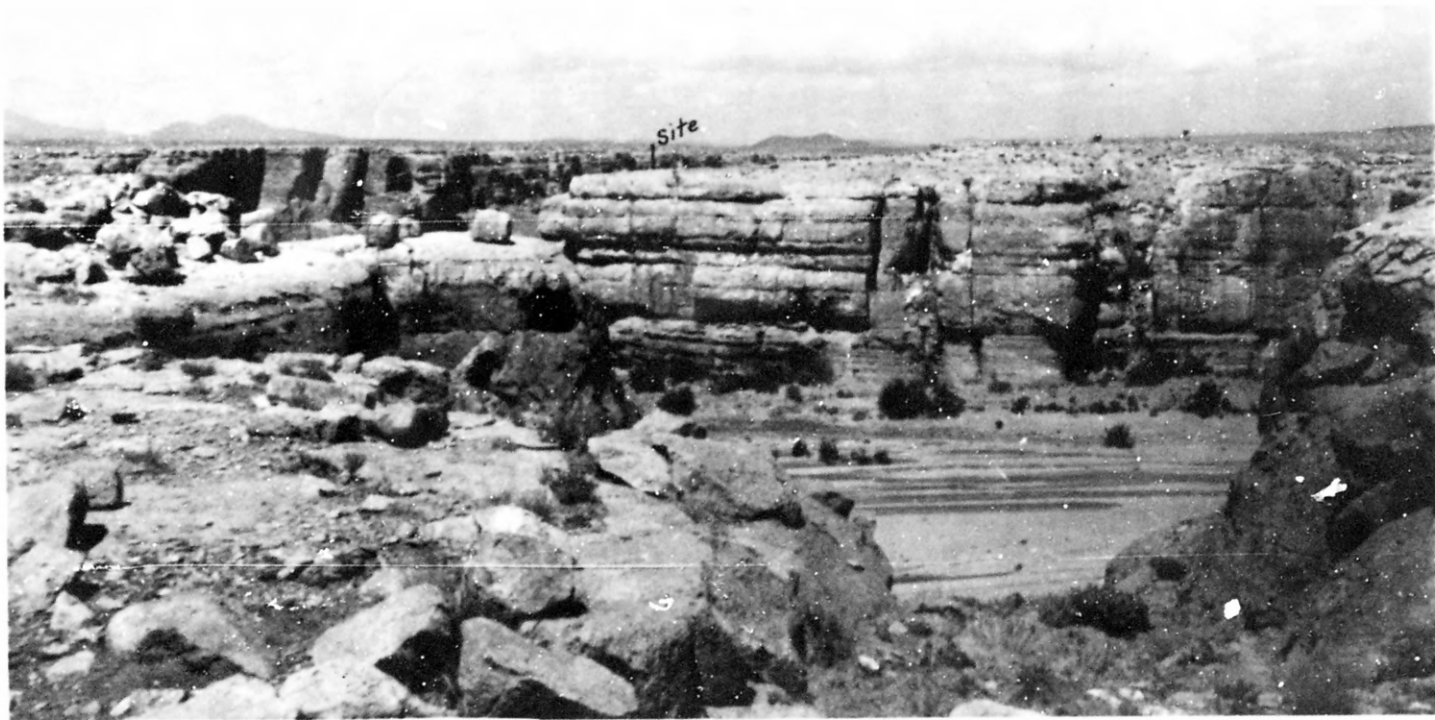
Figure 11
Little Colorado River near Tolchico site, looking northwest.

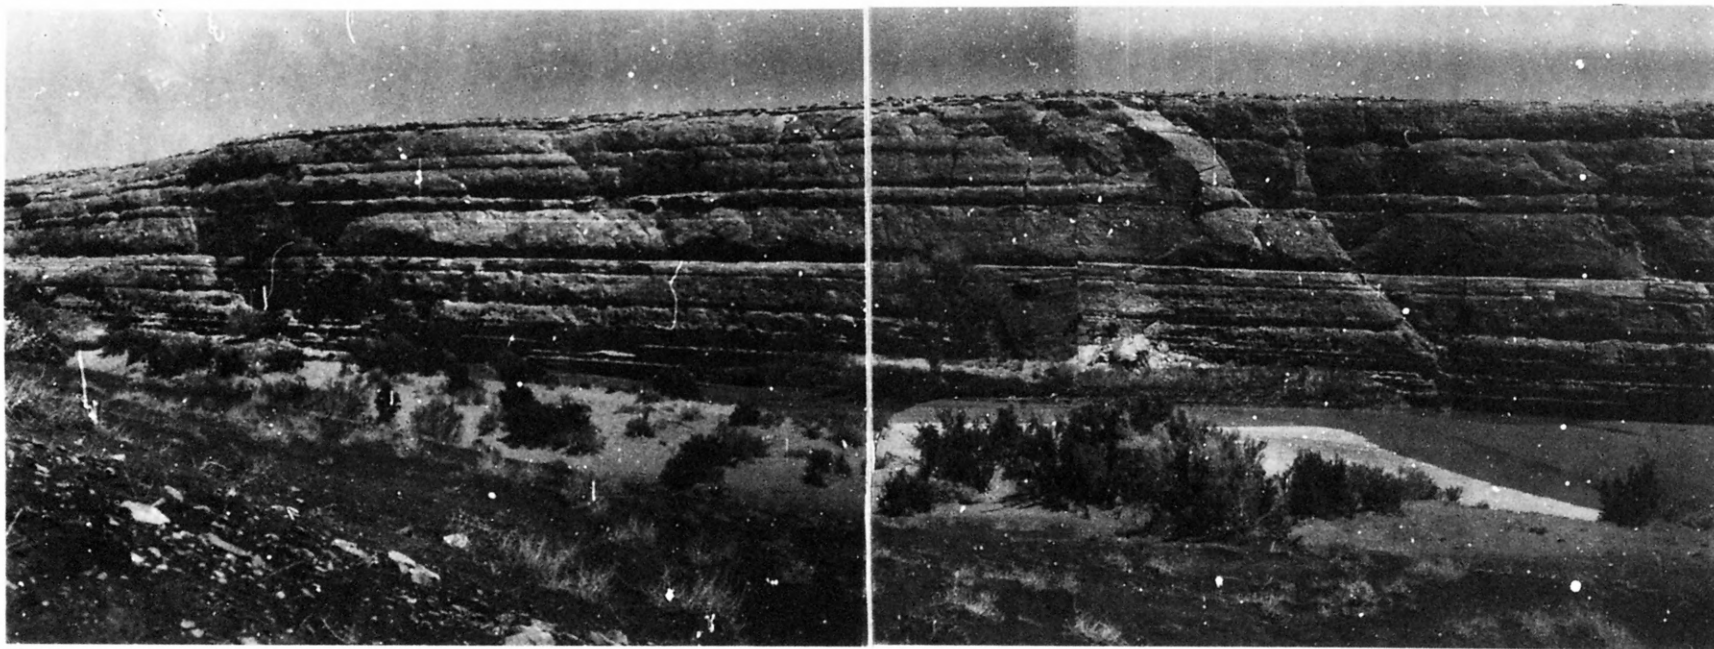
- 12 Tolchico site; right abutment, looking northeast. Shows differential weathering along sandy and limy beds in Kiabab limestone and weakness of northeasterly trending set of fractures.

Figure 12
Tolchico site; right abutment, looking northeast.

As shown in the photographs the canyon walls are slabby. All loose slabs should of course be removed before the dam is built. This will necessitate removal of 5 to 25 feet of rock in most places. Regardless of the type of dam that is selected, it should penetrate the dune sand and river alluvium with its included limestone blocks and be securely tied into bedrock.

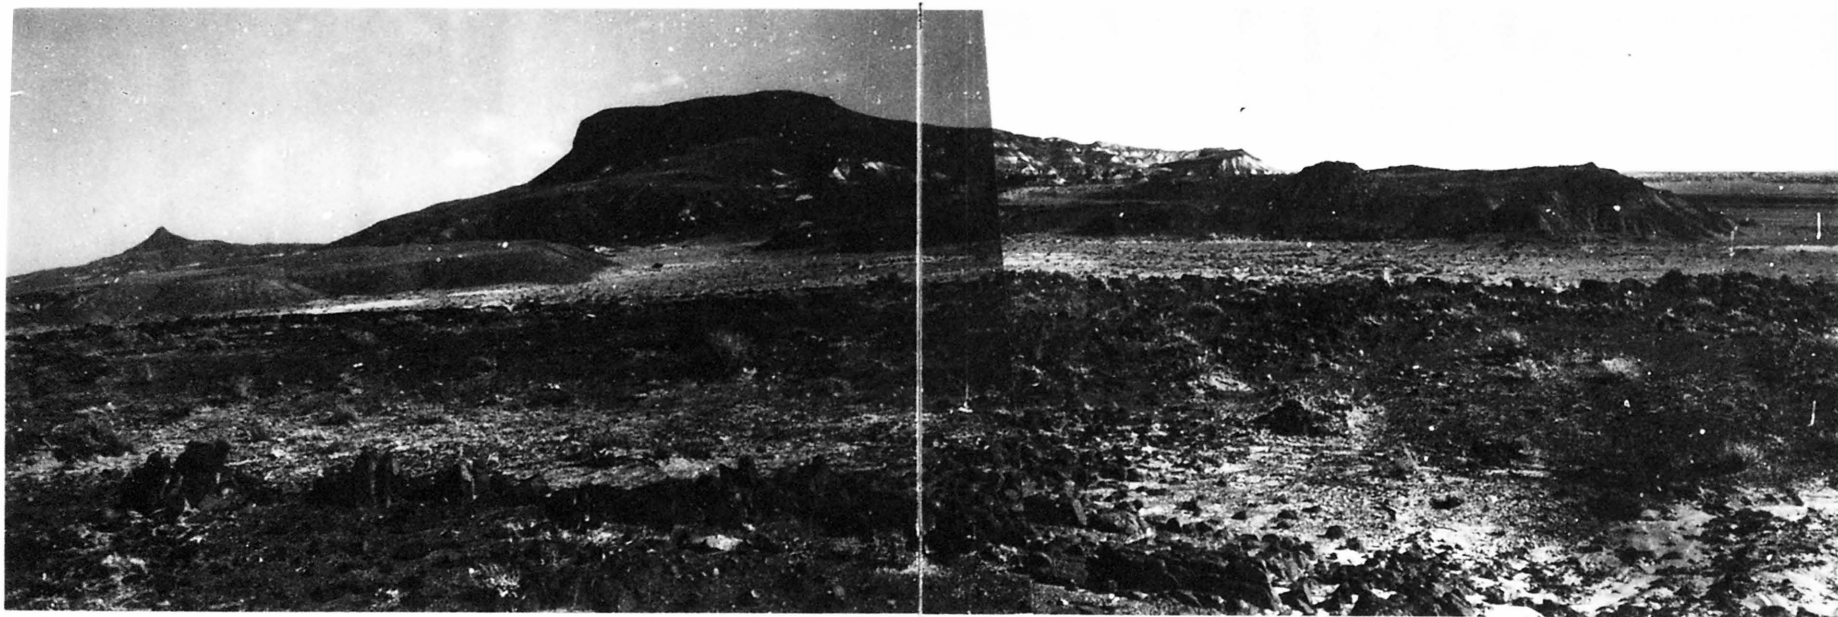
Figure 13

Blackrock Mountain site on Cottonwood Wash, looking southeast toward Blackrock Mountain from lava capped hill in center of valley.

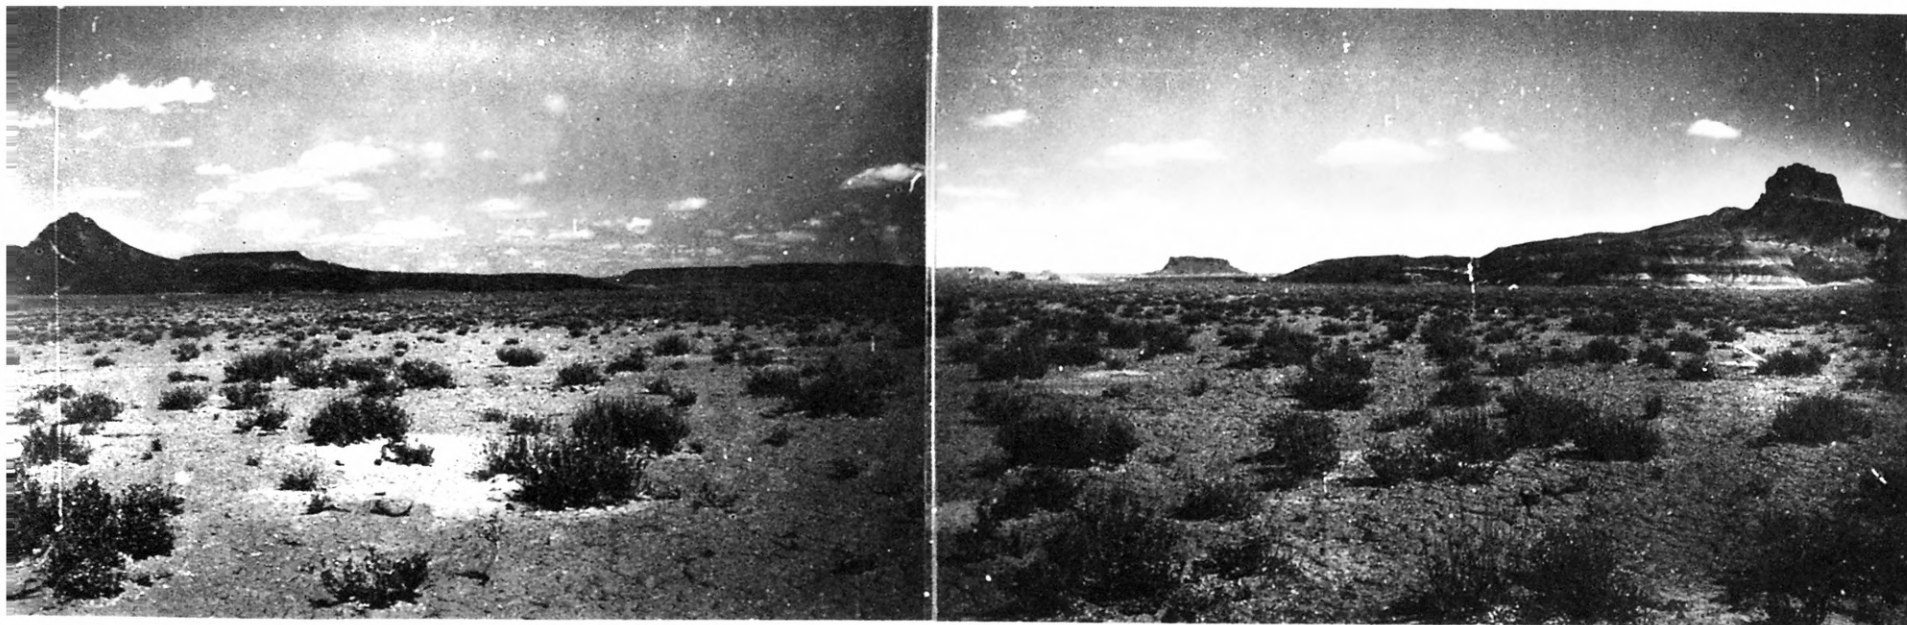
Figure 14

Castle Mountain site on Cottonwood Wash; panoramic view looking upstream.

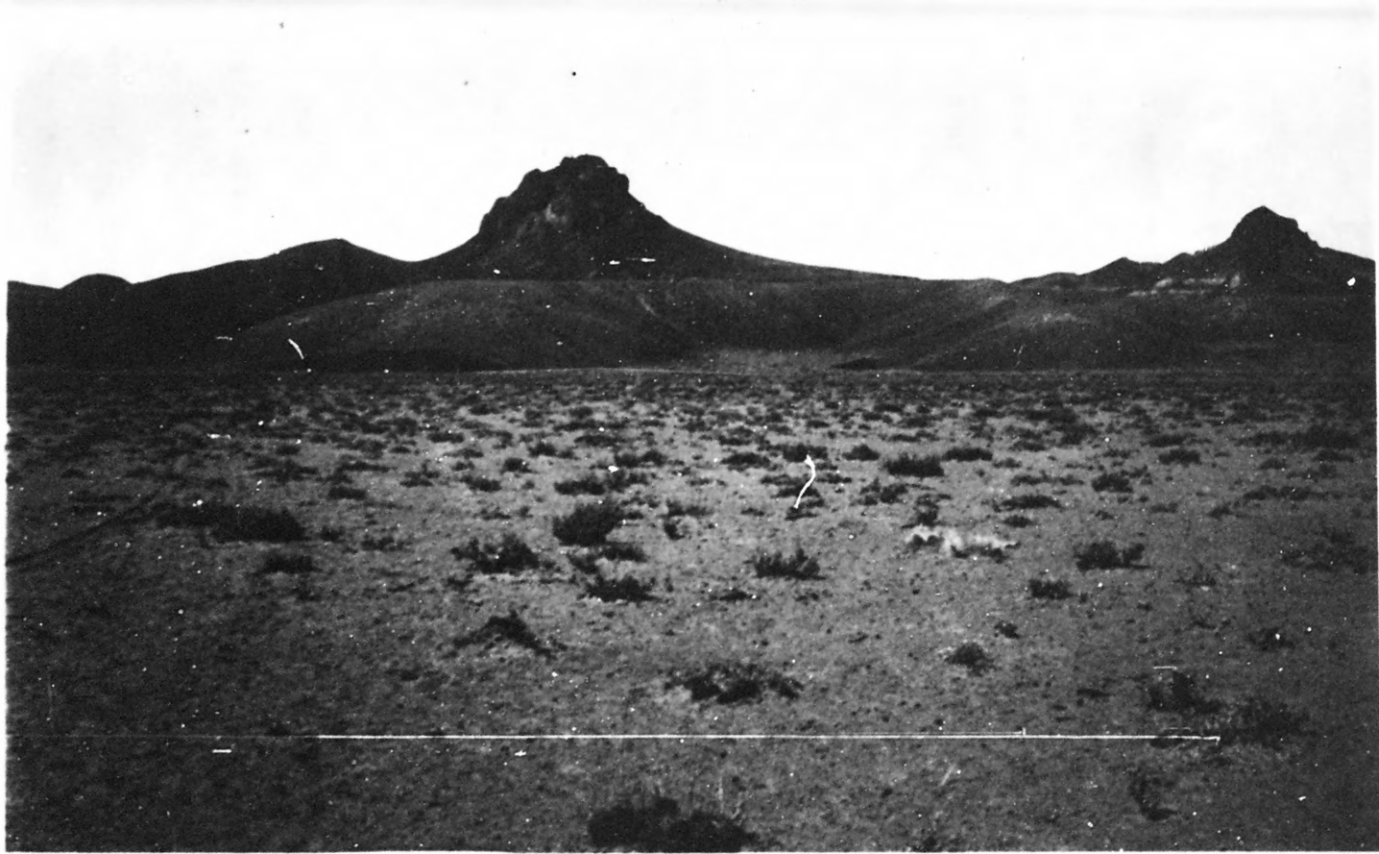
Figure 15
Castle Mountain site, looking west toward right abutment.

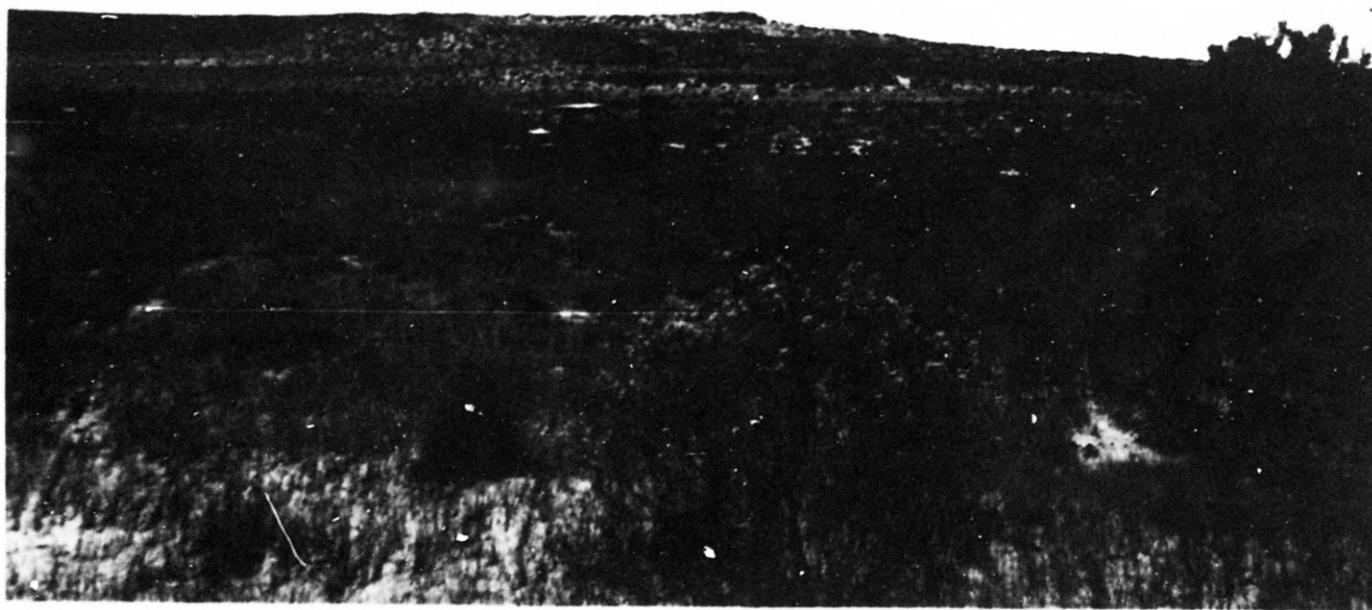
Figure 17

Lower Leroux Wash site looking toward left abutment from near center of valley

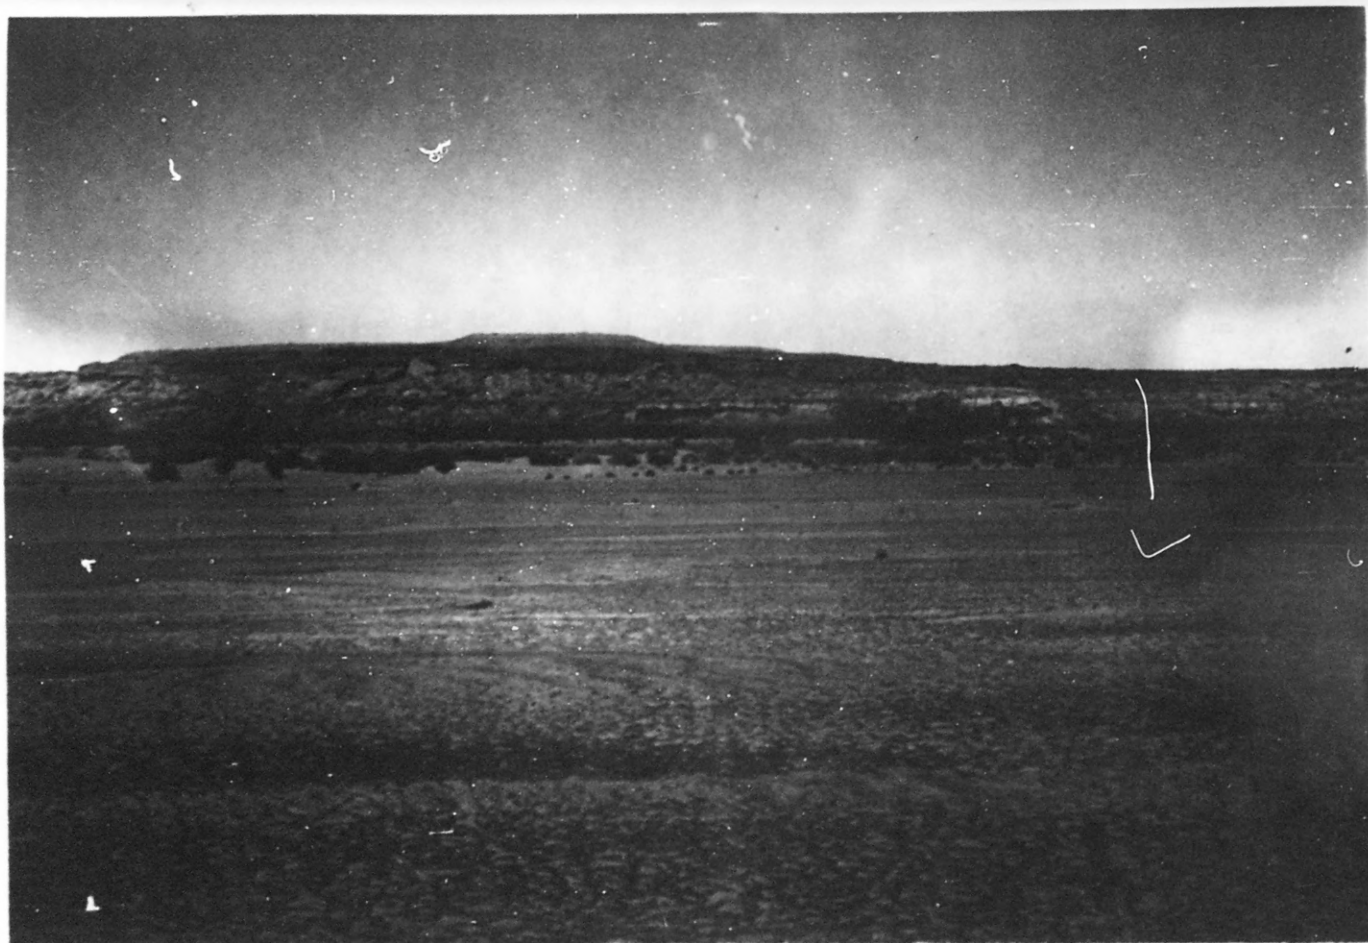
Figure 18
Lower Leroux Wash site, looking toward right abutment from center of valley.

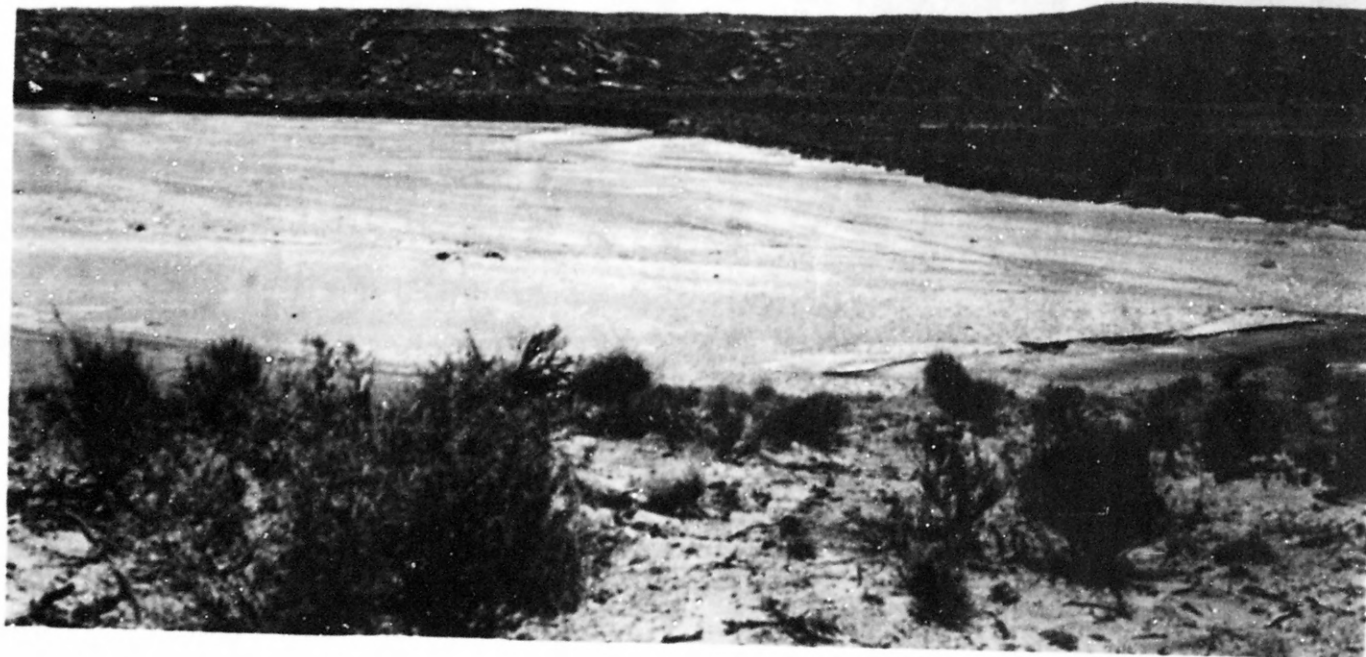
Figure 19
Upper Leroux Wash site, looking toward left abutment

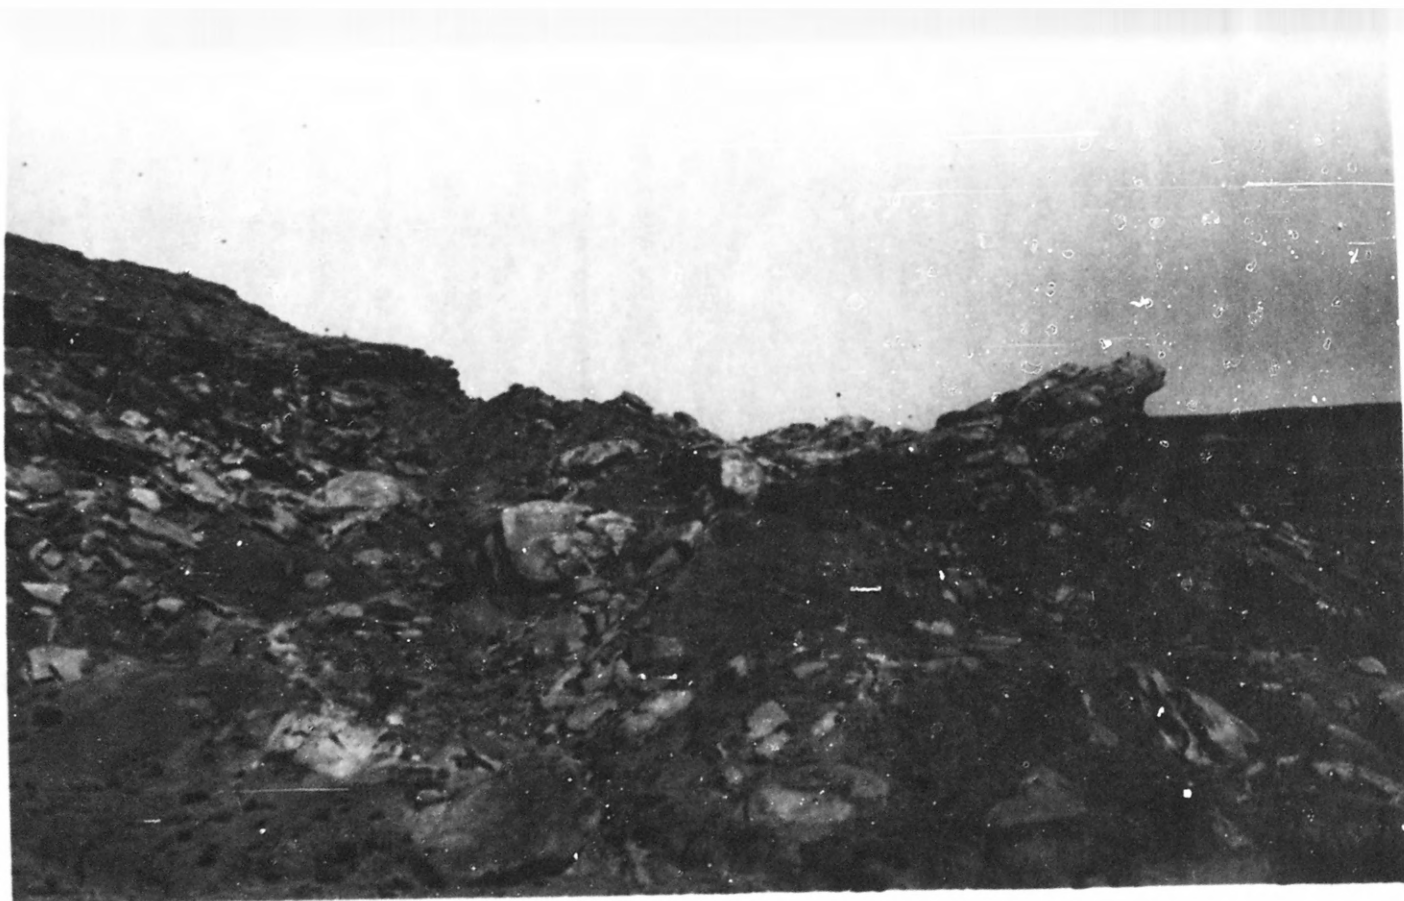
Upper Leroux Wash site, showing landslide in right abutment looking upstream

A moderate-sized landslide mass characterizes the right abutment. All of the beds in the abutment are involved and the mass is a confused jumble of blocks of sandstone and shale. Figure 20 shows its character. The slide was doubtless caused by oversteepening of the slope by stream erosion. Its shape was controlled in part by fractures in the brittle rocks and in part by slippage of these rocks over the layers of soft shale.

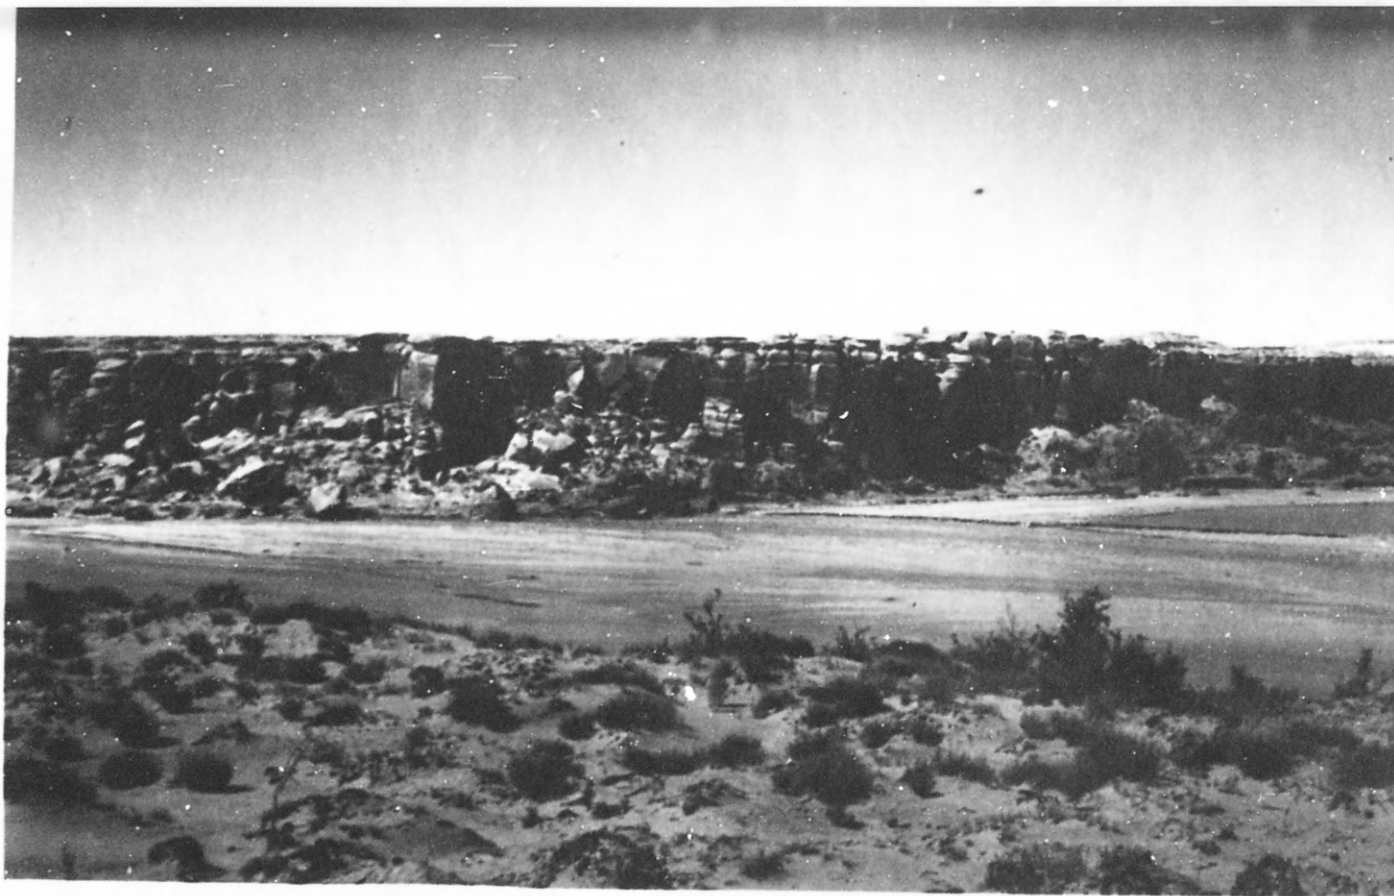
Figure 21

- 21 Lower Big Carrizo Wash site, looking toward right abutment from near left abutment. The sandstone cliff, about 50 feet high, is underlain by soft shale. Note fractures in sandstone. Left abutment is almost exactly similar to thei except for presence of sand dunes between cliff and stream channel.
- 22 Oak Springs site, looking upstream toward head of Black Creek canyon. The ridges at head of canyon are of Coconino sandstone that dips steeply away from the observer. The rocks beneath this formation (left foreground and right middle ground) are red shaly and sandy beds of the Supai formation. Note deeply trenched alluvium along stream.
- 23 Left abutment of upper Oak Springs site. The cliff is Coconino sandstone that dips almost vertically. Slope on left of cliff is underlain by Moenkopi shales. A small seep spring issues from near top of alluvial bench in center of view.

Lower Big Carrizo Wash site, looking toward right abutment from near left abutment

necessary to search out and seal all open fractures and it may also be found advisable to remove 15-20 feet of partly weathered rock from each abutment. There will doubtless be some tendency for the massive sandstone to slide on its soft shale foundations. Since the beds are nearly or quite horizontal this tendency will be slight and unless very concentrated loads are to be imposed can probably be ignored in large measure. It offers a second good reason for sealing all fractures in the sandstone, however. That is, all available means should be taken to prevent percolation of water to and along the sandstone-shale contact.

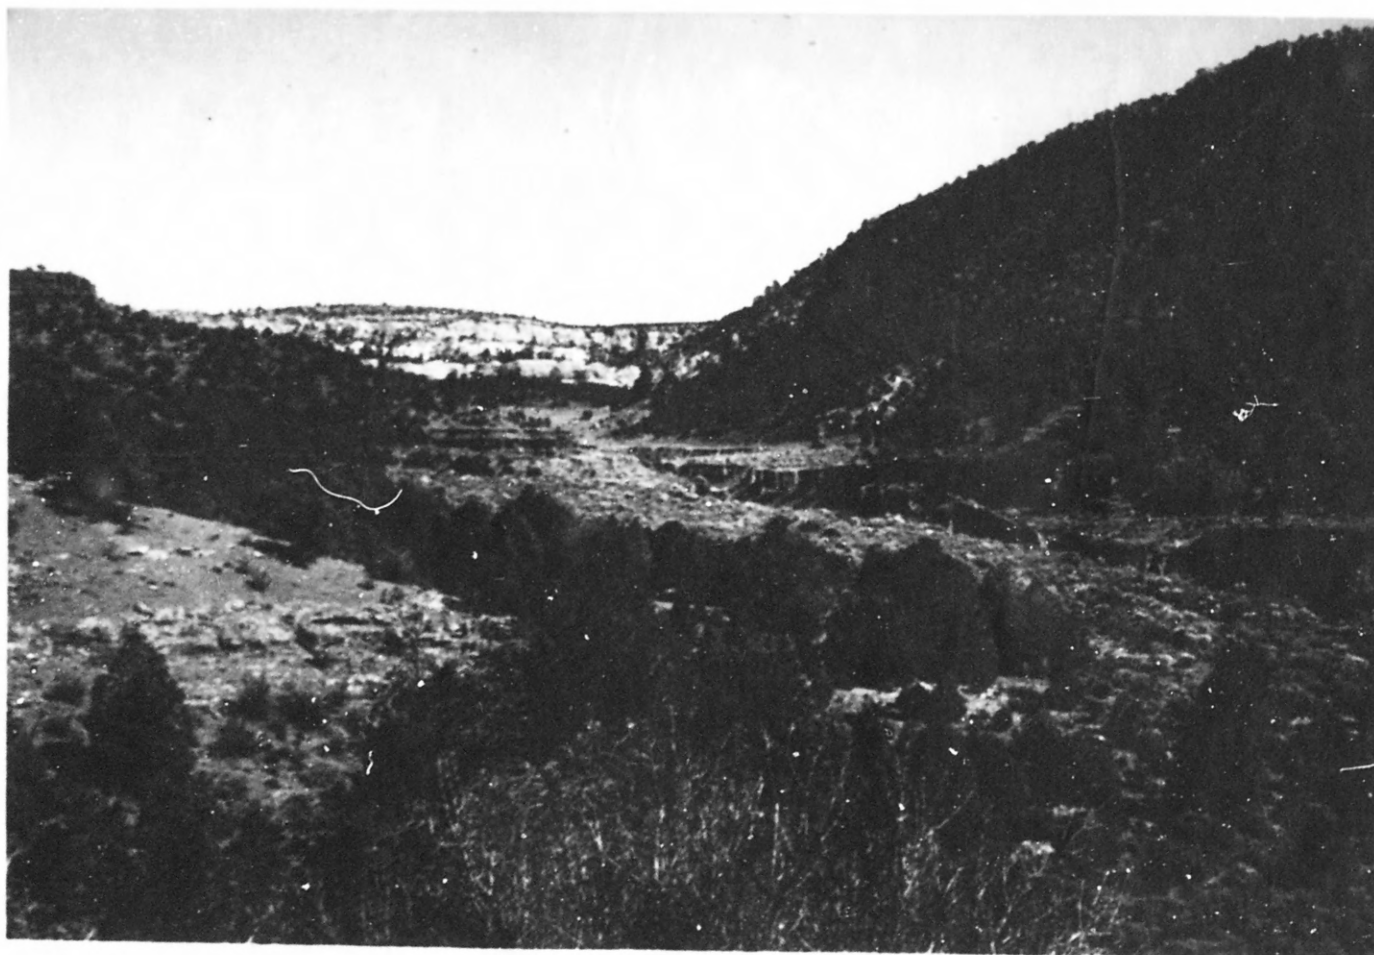
Figure 22
Oak Springs site looking upstream toward head of Black Creek canyon

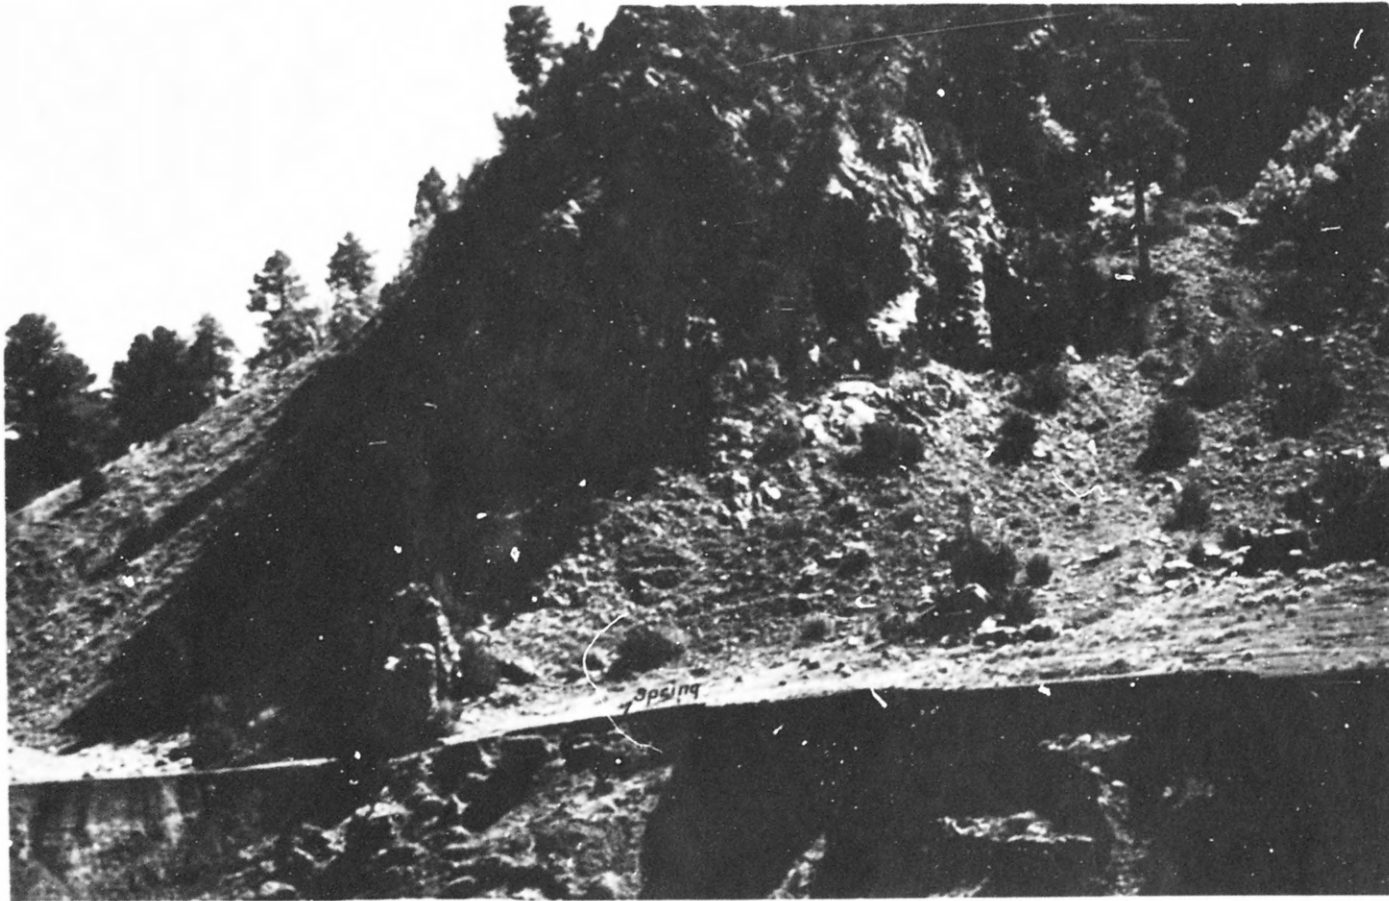
Figure 23
Left abutment of upper Oak Springs site
