Geologic features of certain dam sites  
in the  
Bear River, Colorado River, and Rio Grande basins,  
1936-37  
by

Arthur M. Piper

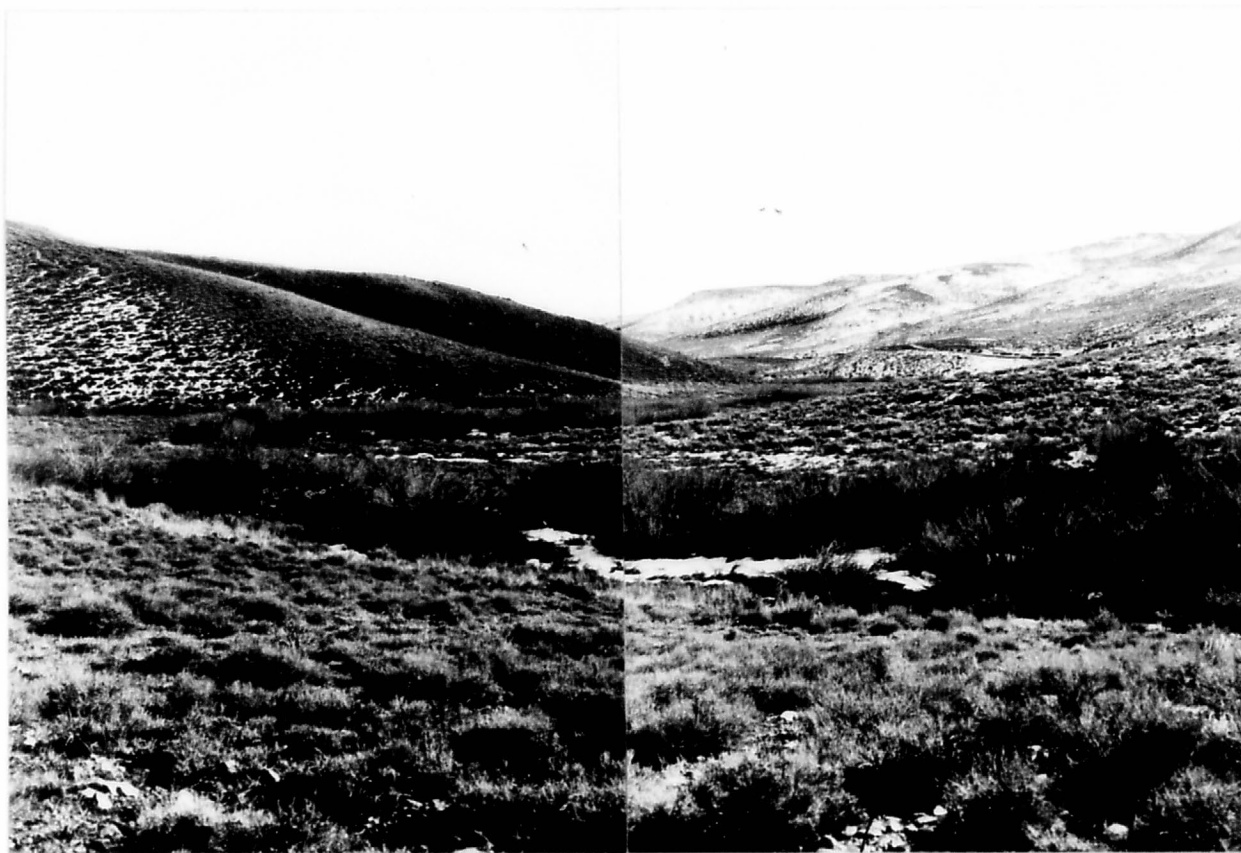
Yellow Creek dam site, viewed upstream

block displaced eastward. (Two cross faults with such displacement occur just north of the area shown on plate 1, A.) The presence or absence of such secondary faults should be thoroughly explored by pits and trenches sunk through the alluvium of the flood plain and through the slope wash on the lower part of either abutment.

As has been stated, the load-sustaining power and perviousness of foundation and abutments depends upon features of the thrust faulting. Thus, if the main fault plane is as steep as has been suggested and if there are no cross faults, the foundation material along the line AB is all of the Beckwith formation and is essentially no stronger than shale to a depth of several hundred feet. Under load, this material might deform plastically if it became saturated by percolation through the fractured and brecciated sandstone members, which are pervious. To assure stability under these conditions, only a flexible and moderately broad dam should be constructed. Also, adequate provision should be made to prevent saturation of the foundation materials. If a zone of cross faulting passes along the creek, blocks or slices of the Almy formation may lie immediately beneath the flood-plain deposit along the line AB. These would neither increase nor decrease the bearing power of the foundation materially. However, they might increase the perviousness decidedly by more intense brecciation of the sandstone and conglomerate members in both bedrock formations.

As a basis for determining width of dam and depth of cut-off, it is recommended that a series of exploratory holes be drilled along the line AB for cores to be tested in compression, also for leakage tests under pressure. This exploration should be especially thorough across the flood plain and on the lowest part of each abutment.

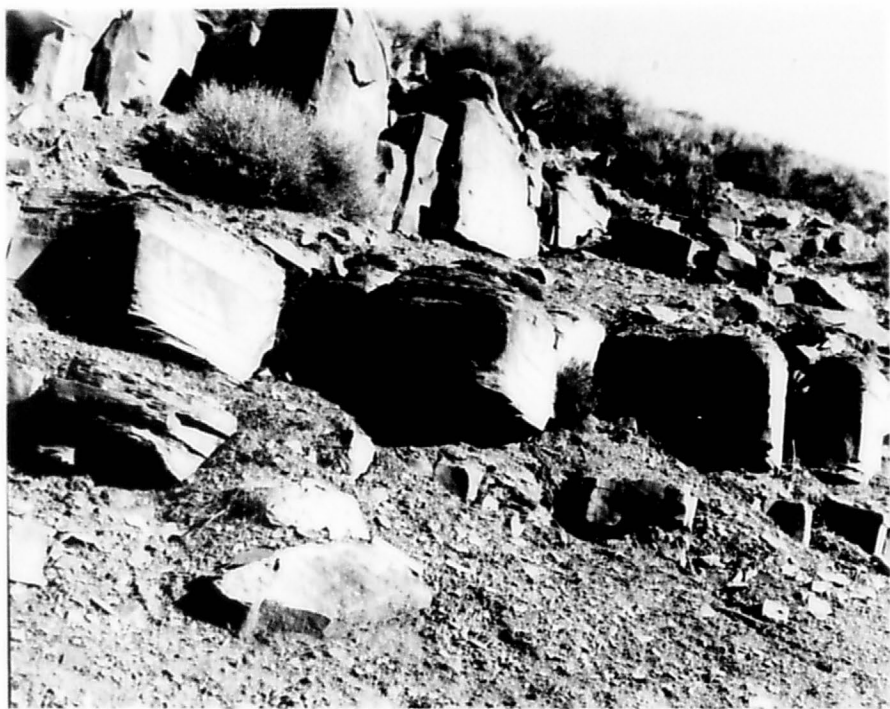
B. Outcrop of laminated sandstone low on the right  
abutment at the Woodruff Narrows lower dam site

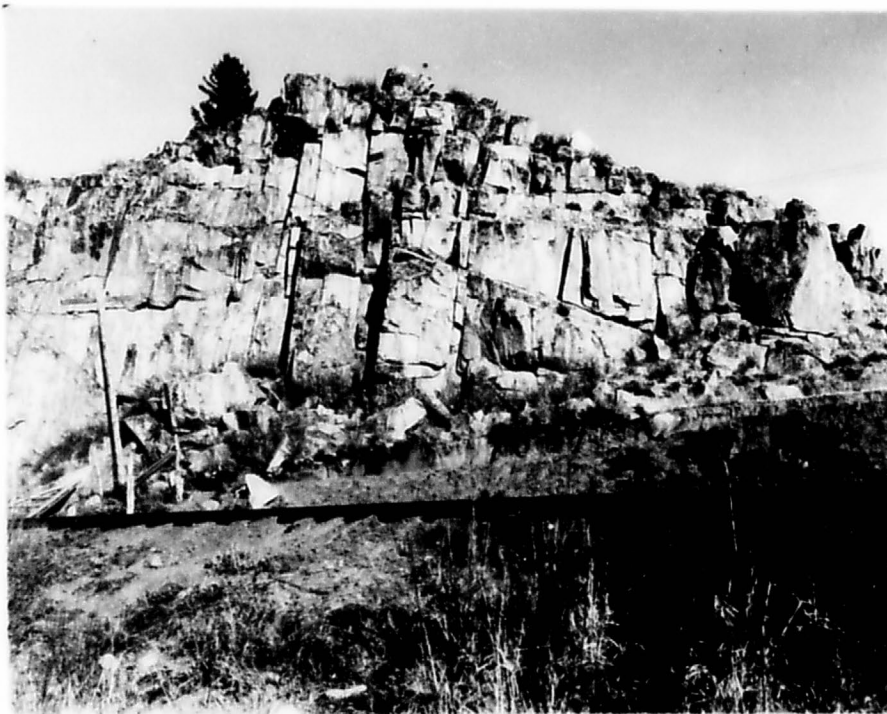
B. Fractures in granitoid rock that forms the left  
(east) abutment of the East River dam site.

Throughout the abutment the granite is parted by fractures (pl. 8, B), of which the most extensive fall into two sets, as follows: (1) Dip subvertical, strike N.  $55^{\circ}$  E. or diagonally across the stream, subparallel, commonly from 1 to 5 feet apart, walls usually snug and without selvages of crushed rock. At a few places, fractures of this set are only a few inches apart and are closely braided into rude shear zones. (2) Strike N.  $80^{\circ}$  W., dip  $20^{\circ}$  -  $30^{\circ}$  S., or downstream. One prominent fracture in this direction passes through the lower part of the abutment just above the flood plain. Secondary fractures of slight extent and with various directions of strike and dip are common. Together, the fractures that have been described part all the granite into a mosaic of rhomboidal or wedge-shaped blocks that are imperfectly interlocked.

At the land surface these fractures commonly are open spaces 1 or 2 inches wide, owing largely to sag and creep in thin spurs and small pinnacles of the blocky granite. At moderate depth below the land surface, however, most fractures are probably fairly tight; nevertheless they render the granite somewhat pervious throughout. Being without selvages of crushed rock, however, they could be easily and thoroughly sealed by grouting or other appropriate measures.

The depth of stripping to expose unweathered granite probably averages less than 10 feet over most of the left abutment. However, in the tip of the spur that forms the lower part of the abutment there is considerable insecure rock which must be removed if a rigid foundation of uniform bearing power is to be made ready.

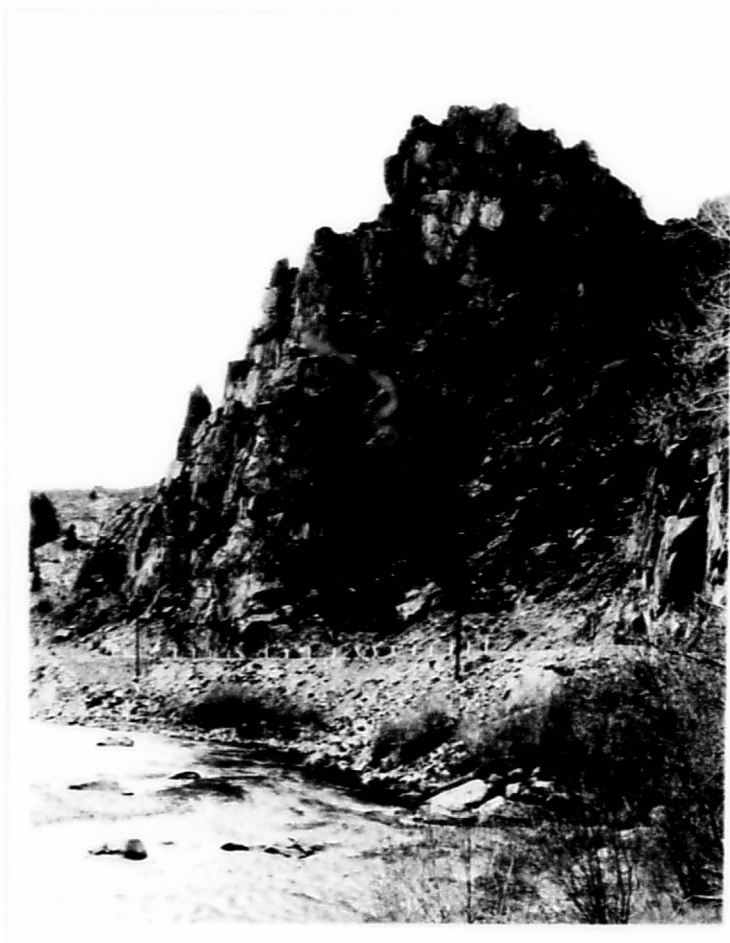
B. Fractured granitoid rock forming the  
right (west) abutment of the  
North Beaver middle dam site.

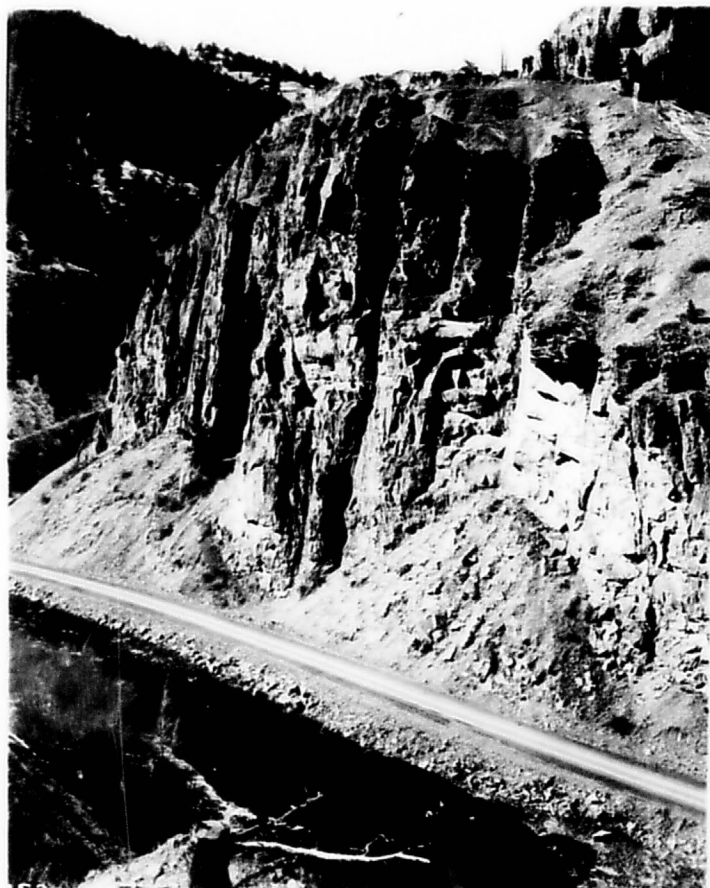
Fractured volcanic rock forming the left  
(west) bank of the Lake Fork at the In-  
dependence dam site. (The canyon of  
Independence Creek is at the left of the  
view.

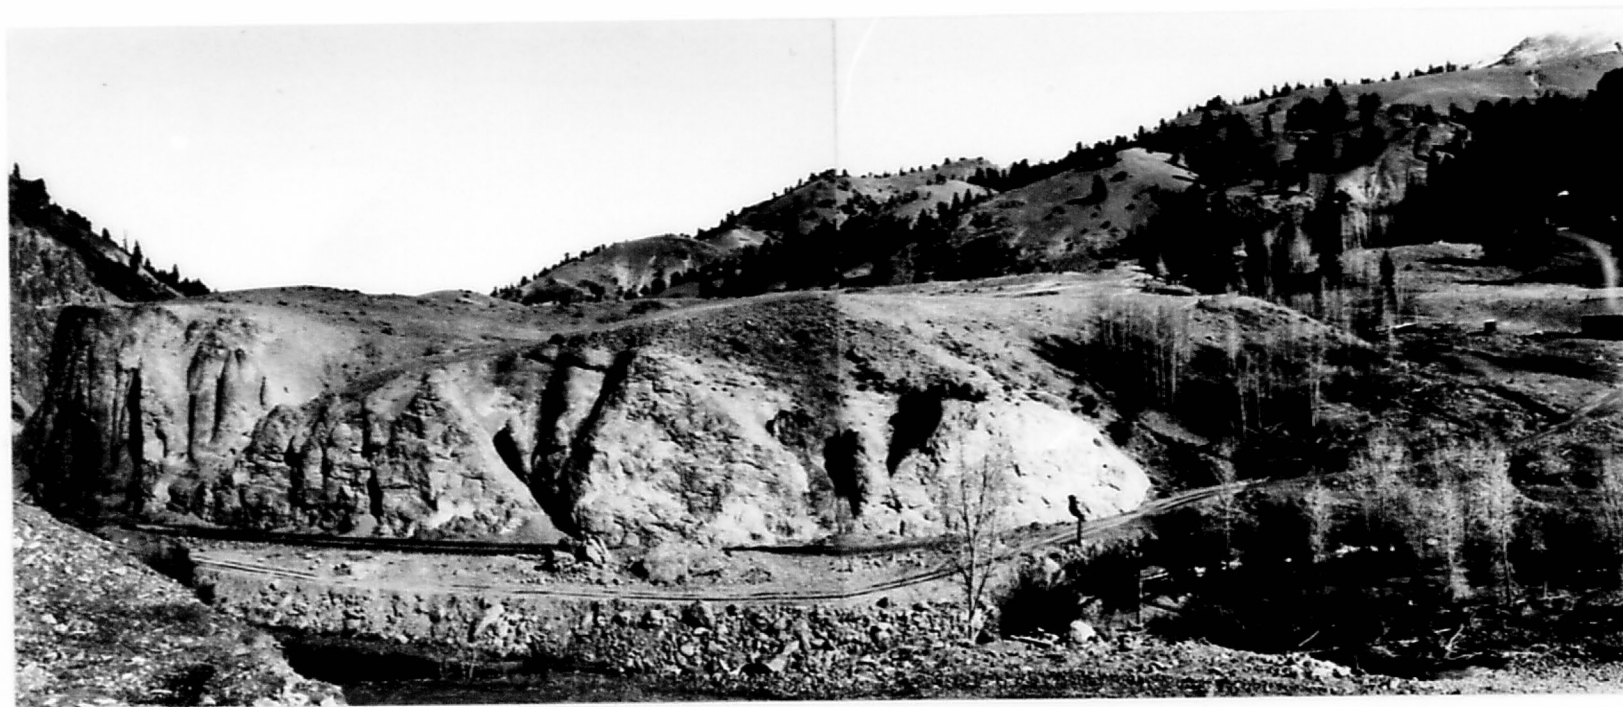
Summary.- With respect to the construction of a dam, the most critical two geologic features of the Independence site are the thickness and perviousness of the terrace deposit on the right bank and the load-sustaining capacity of the latite. The terrace deposit doubtless has a relatively high permeability. If, as has been suggested, the downstream lip of the underlying bedrock floor is 8,510 feet in altitude a dam with pool level at the 8,550-foot contour would require the deposit to withstand a percolation coefficient of about 18 to 1. It seems likely, therefore, that leakage would ensue unless an impervious cut-off is sunk through the terrace deposit and seated in bedrock.

Right (east) abutment of the Independence dam site; a gravel-capped terrace.

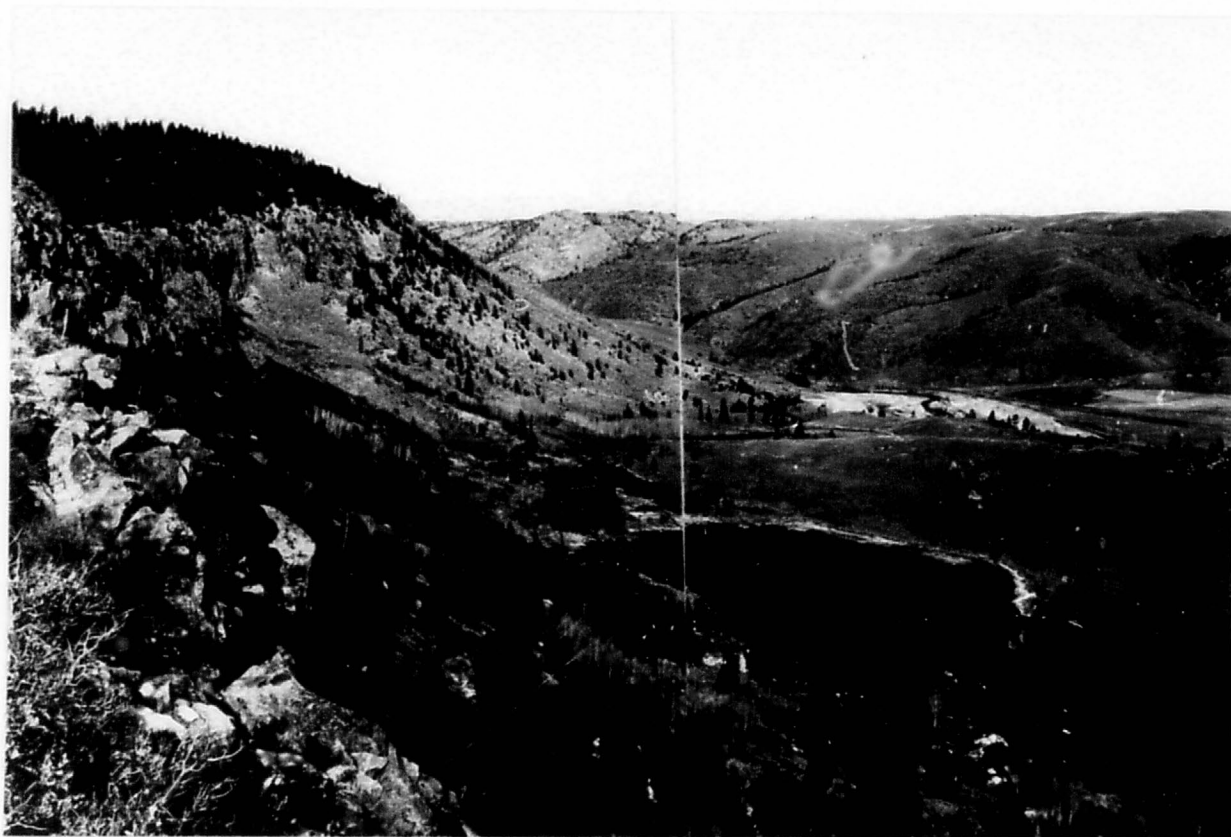
the landslide mass is composed of fragments of andesite such as form the cliff high above the site. These fragments range from small chips to blocks 10 feet long and are embedded in a fine-grained earthy matrix. This landslide on the left bank of the stream appears to be decidedly older than that on the east bank and to have been stable for a relatively long time, even where the Lake Fork is now cutting back its toe. The material of which it is composed appears not to be highly pervious, for no springs break out along its margins below the two high-level ponds in spite of the steep hydraulic gradient. Nevertheless, it is quite likely that some of the material would become unstable if it were saturated with water above stream level.

Landslide alcove high on the left (east) bank of the Lake Fork opposite the Riverside School dam site. (Viewed from flank of the ridge about 1,000 feet above the stream; the toe of the slide, whose top lies to the right of the two small lakes, forms one abutment of the dam site.)

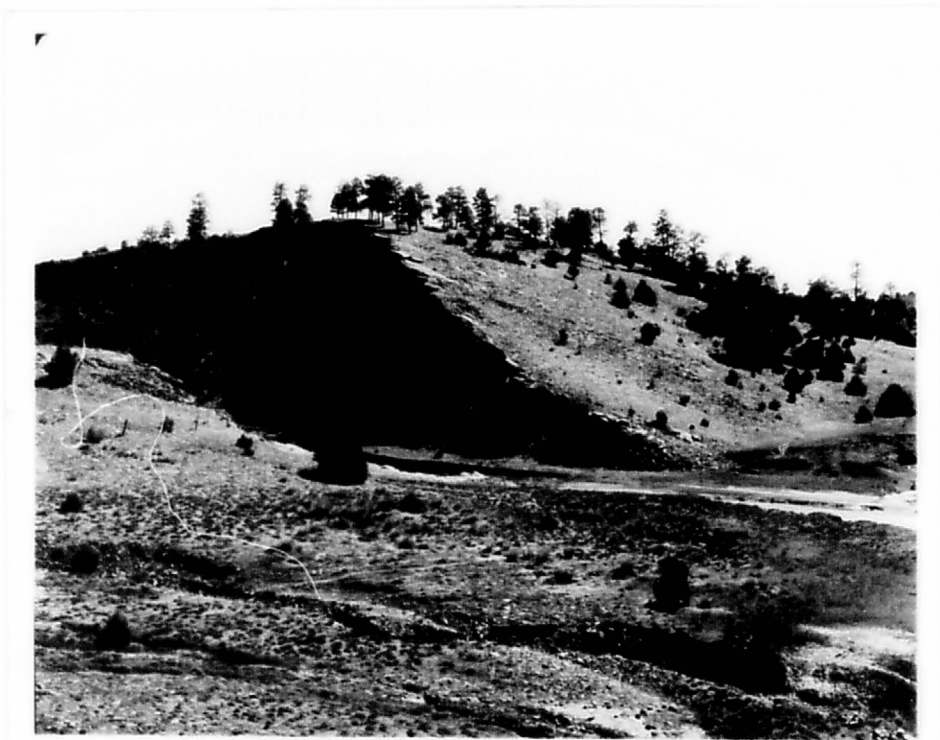
Sharp dome in the Dakota sandstone at the upper dam site  
on Willow Creek, viewed upstream

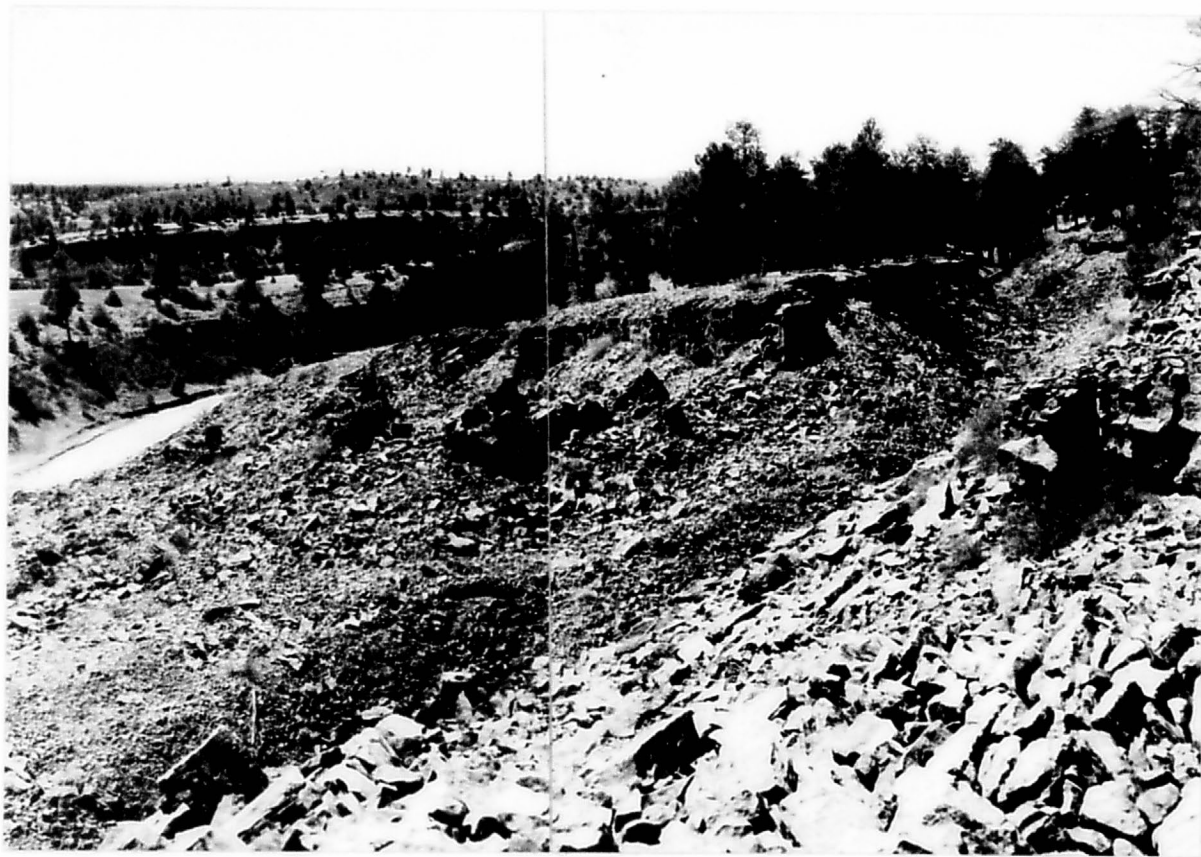
Central part of landslide on the right bank of Willow Creek at the  
middle dam site.
