UNITED STATES  
DEPARTMENT OF THE INTERIOR  
Geological Survey

Geologic features of dam sites in the  
Nehalem, Rogue, and Willamette River basins,  
Oregon, 1935-37

Arthur M. Piper

OFR 47-12

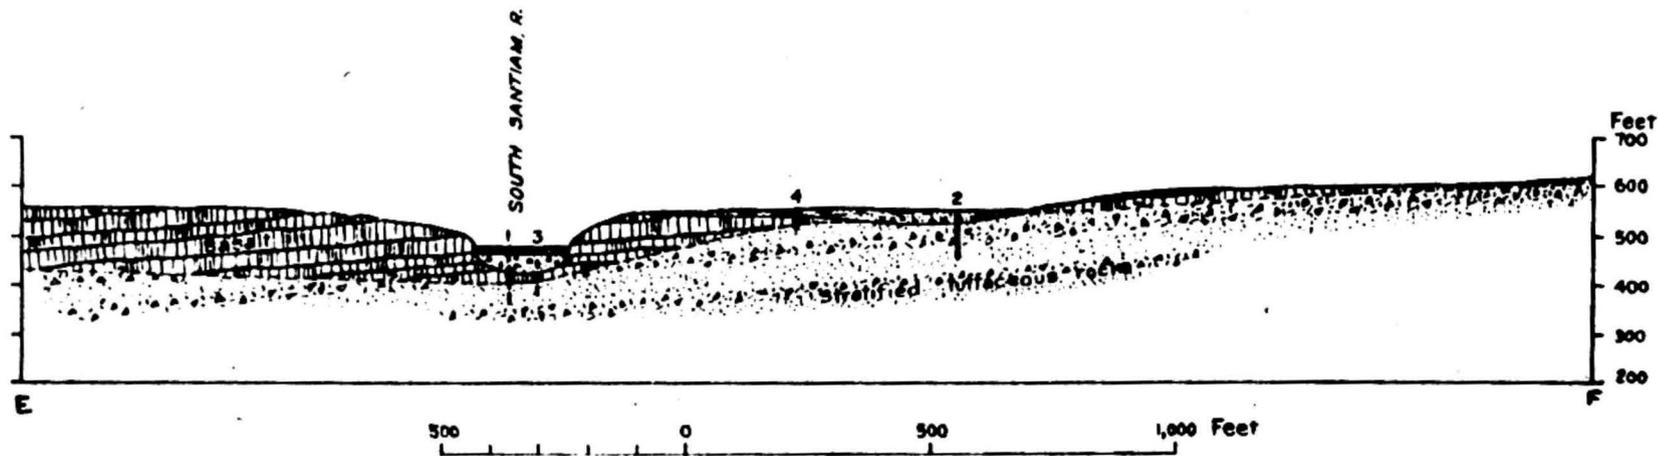
Figure 7.- Tentative geologic section of the Sweet Home dam site along the line EF

Character and extent of the rocks.- The stream-bed and flood-plain deposits consist of unassorted pebbles, cobbles, and boulders as large as 18 inches long. Nearly all the particles are from dense volcanic rocks, all are quite fresh and sound, and except in their range of sizes would be suitable aggregate for concrete. As a whole, the deposit is highly pervious. Its greatest thickness, to judge from the records of diamond-drill holes nos. 1 and 3 (see p. 83 ), is about 75 feet - that is, from about 10 feet above to about 65 feet below the ordinary low-water stage of the river.
