ENGINEERING GEOLOGY AS APPLIED TO

### HIGHWAY CONSTRUCTION

· Leonard M Gard, Jr.

Engineering Geology of the Relocation Alignment of State Highway 93 near Marshall, Colo.

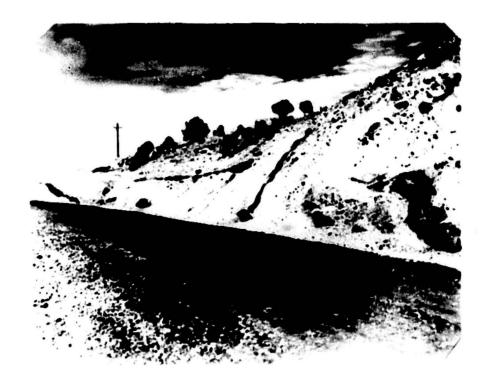
At station 65 the highway crosses a normal fault that strikes northeast and is down-thrown on the northwest side (Plate 3). This fault has brought the six foot thick coal seam nearly in contact with the same sandstone bed that crops out at the surface between stations 33 and 52 and at station 62. The sandstone is stratigraphically nearly 55 feet below the coal. Local inhabitants indicated that the High View mine, which was on the northwest side of the fault, had been abandoned because the coal had been faulted out. A new mine, the Premier, was

Plate 3. Fault at station 65. Coal seam at left has been dragged up along fault in center of photo.

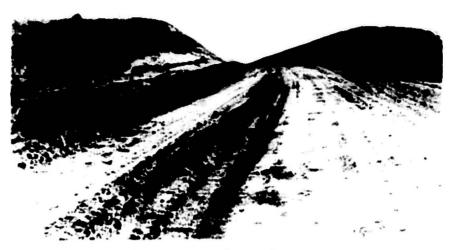
Every place where the grade line of the road intersects the gravel-bedrock contact represents a potential source of trouble (Plates 5, 6). Near station 180, test pits were dug in the gravel by a cement company to test overburden thickness. The gravel here was nine feet thick. Many of these pits filled with water overnight to depths of as much as seven feet.

Plate 5. A. Looking ahead (south) from station 82 toward proposed cut at station 90. Note springs in gully below edge of pediment. B. After excavation of same cut. Note pediment gravel-bedrock (Laramie) contact in left cut bank. Bedrock dips 45° to left (east).

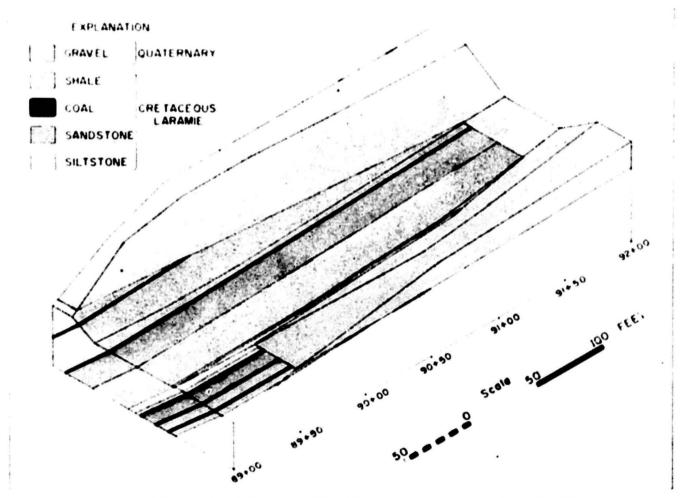
BLOCK DIAGRAM OF ROAD CUT FROM STATION 89+00 TO STATION 92+00

By using information from the cross sections and the center line profile it is possible to construct a three dimensional picture of the geology at any given place along the right of way, thus enabling an accurate prediction to be made of the geologic materials that will be encountered during construction. Plate 6 is an isometric block diagram of the cut between stations 89/90 and 92/00 that was constructed in such a manner.

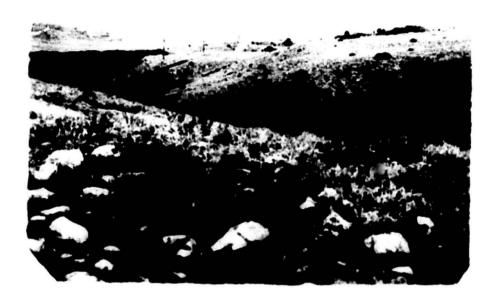
Plate 7. A. Looking back (north) from station 180 before excavation of cuts from station 166 to 183. Note Pleistocene terraces in valley of Coal Creek in middle distance.

B. After excavation of same cuts. Foreground cut in Pierre shale capped by pediment gravel. Cut with trucks in arenaceous zone of Pierre shale capped by terrace gravel.
