GEOLOGIC INVESTIGATIONS OF PROPOSED SHEEP CREEK, CARLSON
CREEK, AND TURNER LAKE POWER SITES, ALASKA

George Plafker, 1929-

1956

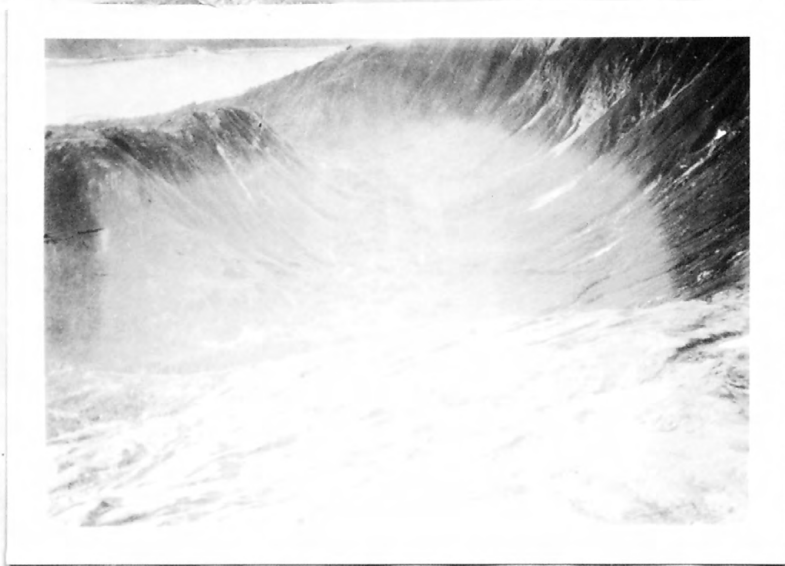
Figure 2. Aerial view of Sheep Creek basin looking downstream (west) from drainage divide northwest of Hawthorne Peak. Note smooth, U-shaped profile of valley and talus cones at base of slopes. Buildings on valley floor near center of picture are at the Portal Camp of the Alaska-Juneau Gold Mining Company. The proposed dam site is at the lower end of the basin. Gastineau channel in background.

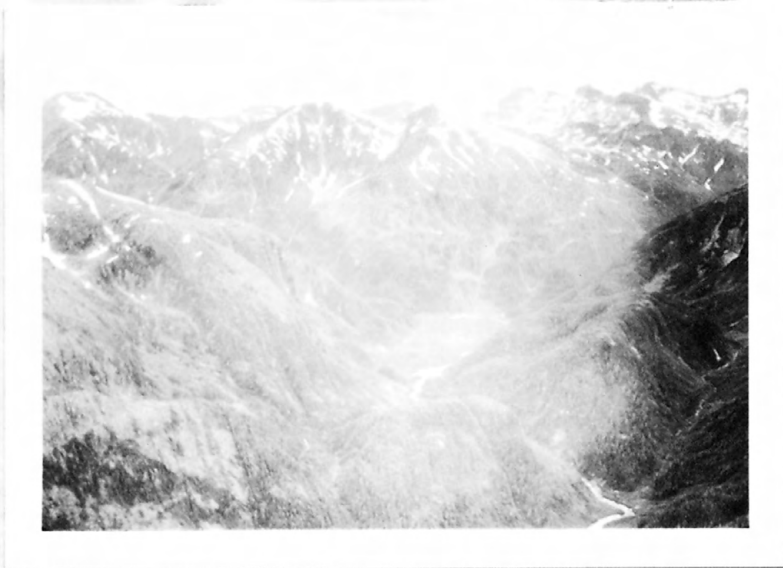
Figure 3. Aerial view of part of Carlson Creek basin looking upstream (west) from a point over the mouth of Carlson Creek. Dam site is in gorge cut through ridge in foreground. Trend of creek at the dam site and parallel gullies on the ridge in foreground define prominent northeast-trending joint set. Creek in lower right corner of picture defines trend of the foliation. Flat-floored basin above the dam site is an alluvium-filled lake.

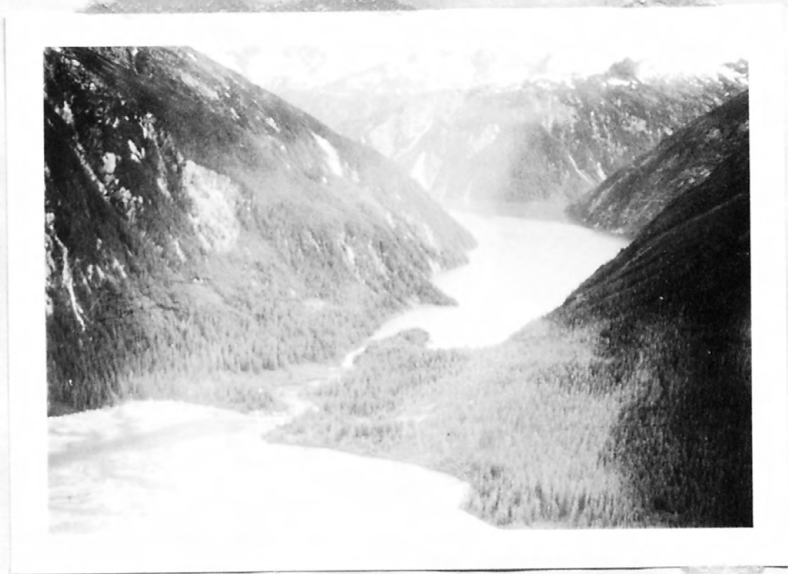
Figure 4. Aerial view of Turner Creek and lower end of Turner Lake looking east from over Taku Inlet. Note steep-sided glaciated valley occupied by Turner Lake. Large scar on steep slope to left of the lake outlet (light area) is probable source of rockslide debris at the dam site. Light-colored area at creek mouth is tidal mud flat.

Rock slide deposits.--Near the lake outlet and along Turner Creek a jumbled mass of loose angular unsorted blocks, some of which are 40 feet or more across, overlie the granodiorite bedrock. This mass of loose rock is interpreted to be a landslide that came down the slope north of the lake outlet from a cliff at about the 1,000-foot elevation (fig. 4) and filled most of the valley now occupied by Turner Creek. The landslide debris is extremely permeable and Turner Creek probably was able to maintain its course by flowing through the many openings within the mass. A part of the landslide debris has been cleared from the channel by the creek, but much of the creek course is still choked with large blocks and some water flows through openings in the debris on the south side of the lake outlet.

Dam site.--The foundation at the lake outlet consists of granodiorite bedrock largely concealed by blocks of landslide debris. The small outcrops of granodiorite at the outlet, as shown on plate 3, were distinguished from large, loose blocks of the same material by comparing the foliation and joint planes to those in nearby exposures of undoubted bedrock. Another distinguishing feature of the bedrock is that it is the only lithologic unit on which cedar trees will grow in this area. All of the landslide debris and surficial organic matter would have to be removed to expose fresh rock at the dam site. The foundation rock here is excellently suited for a concrete or rock-fill dam. From surface indication the joints are sufficiently tight to insure a minimum of seepage through the foundation. It may be necessary to erect a diversion wall on the steep north abutment of the dam site to prevent slide rock from falling on the dam.
