GEOLOGY OF THE DEVIL CANYON DAM SITE, ALASKA

Reuben Kachadoorian

74-40

Open-file report

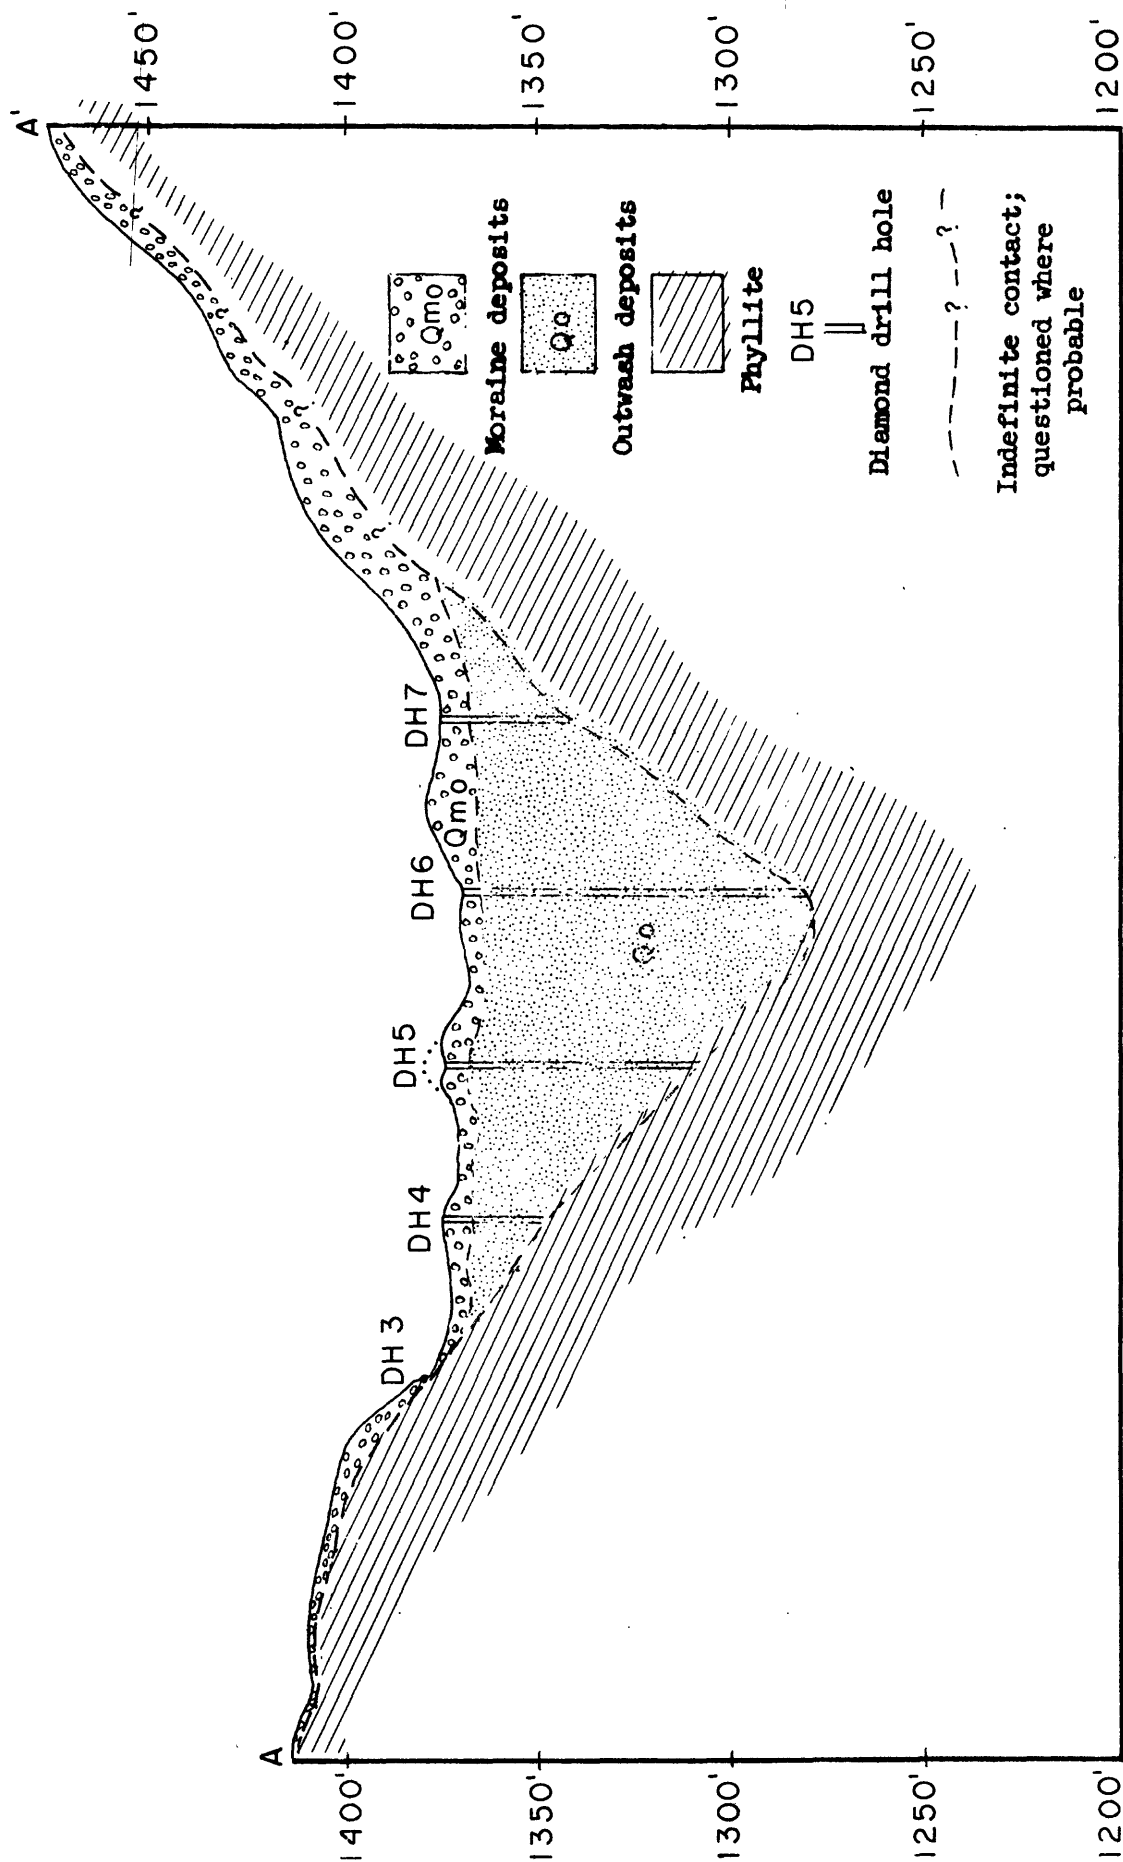
Figure 2. Profile through Section A-A'

Figure 2 shows that the original valley in which the outwash was deposited was V-shaped. This shape indicates that the valley was cut by water and not by ice, and that the outwash was deposited in front of an advancing glacier. After the deposition of the outwash, the advancing glacier overrode the debris and deposited the thin veneer of morainal material. The additional weight of the moraine and ice compacted the underlying outwash material.

Along Section A-A', the maximum depth to sound rock is about 92 ft at an approximate altitude of 1,280 ft. Drill hole 15, located on Triangulation Station John, shows that bedrock is 52.7 ft below the surface at an approximate altitude of 1,276.4 ft.

The depression containing two lakes in the southern part of the mapped area may be used as the spillway for the dam. The foundation of the site consists of outwash and moraine that have been deposited in a pre-existing V-shaped valley. The maximum thickness of these deposits is at least 86 ft. Although the outwash has been compacted by overriding ice, it is doubtful that this compaction is sufficient to prevent a large water loss from percolation through the outwash. In addition, it is doubtful that the outwash and morainal deposits are sound enough to maintain structures such as a small dam. If maximum utilization of the Devil Canyon dam site area is considered, a dam is necessary in the spillway area. If such is the case, the glacial debris will have to be removed before construction of the spillway dam.
