**RECONNAISSANCE OF SEDIMENTATION
IN THE RIO PILCOMAYO BASIN, MAY 1975,
ARGENTINA, BOLIVIA, AND PARAGUAY**

U.S. GEOLOGICAL SURVEY
Open-File Report 77-327

By **JOHN R. RITTER**

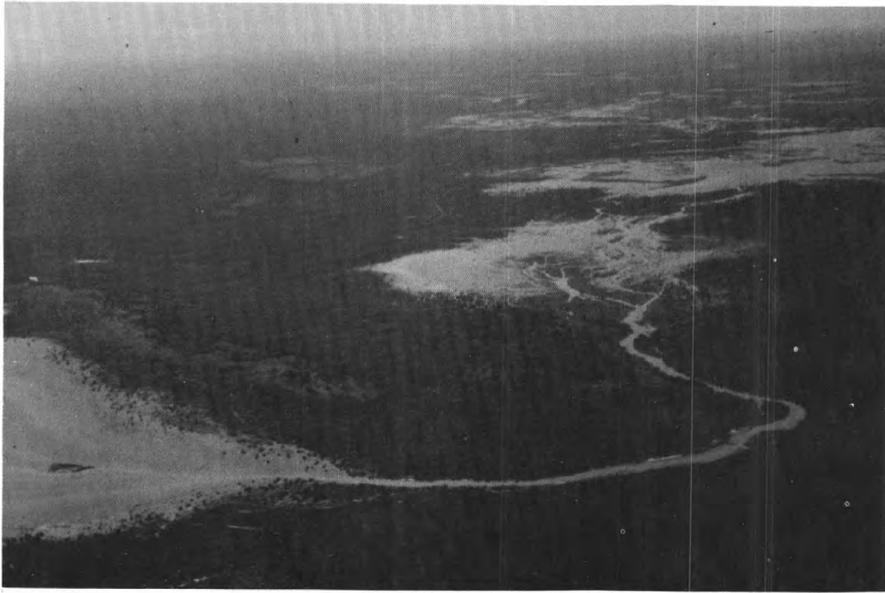
Figure 2.--Outlet of Laguna Escalante. Flow from Laguna Escalante (left) is contained in channel for a few kilometers but overtops the banks and floods the areas downstream such as Laguna Tres Palmas (right background).

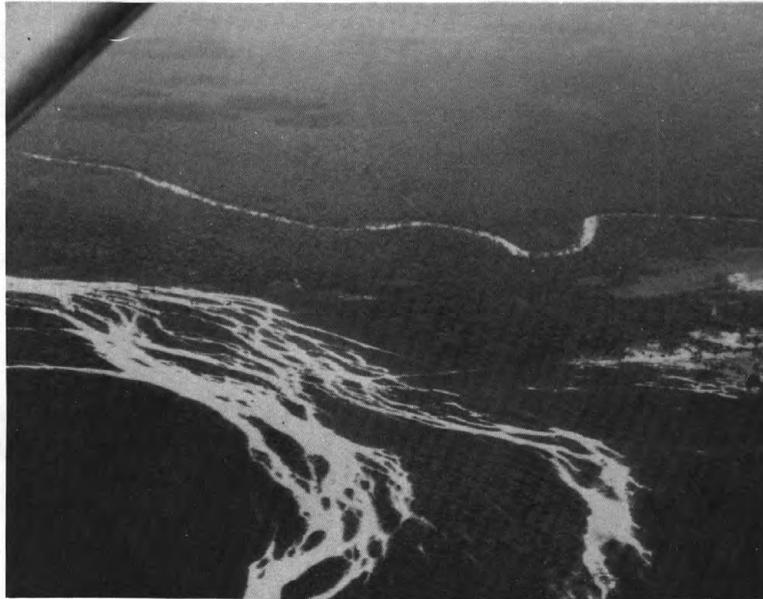
Figure 3.--Braided channel and meandering channel upstream from Laguna Escalante. The channels parallel each other for many kilometers. The braided channel may be an overflow channel.

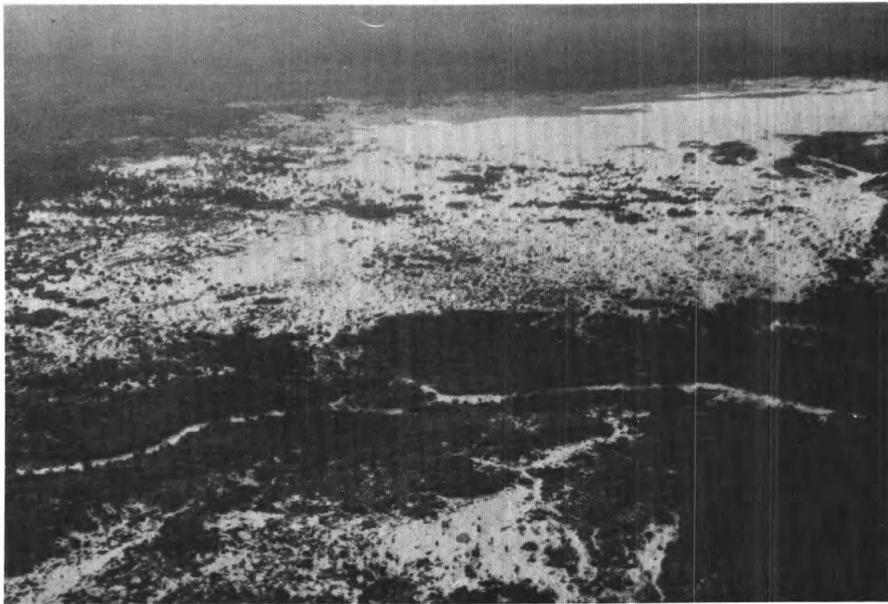
Figure 4.--Flooding west of Laguna Escalante. The channels are those shown in figure 3.

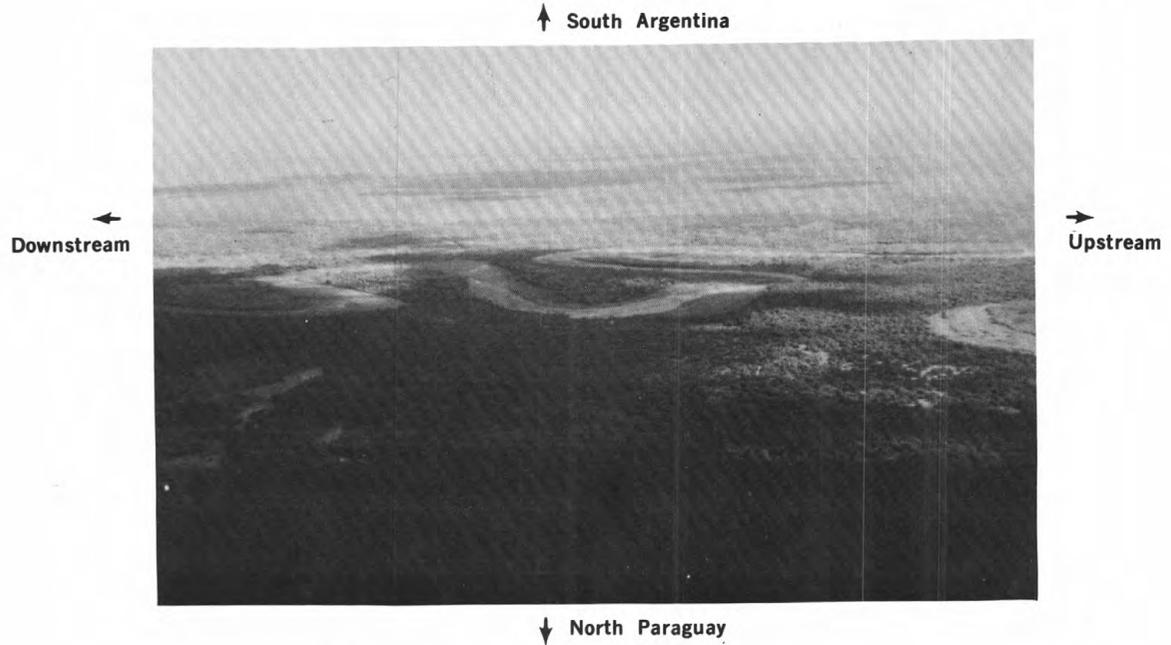
After passing over many kilometers of flooded lands we saw an abandoned channel filled with sediment and covered with vegetation to the south (fig. 5). The vegetation in the channel became sparser as we flew westward (upstream) until a point was reached where the channel was filled with recently deposited sediment as denoted by the lack of vegetation (fig. 6). This recent deposition continued upstream for about 15 km, at which point the Río Pilcomayo "Superior" was seen spilling over to its banks causing the wide-spread flooding noted previously (fig. 7). In other words, the river was contained within its banks until it reached the area where sediment deposition had plugged the channel forcing the river to overflow (fig. 8). The flooding was not only into Paraguay but also into Argentina where the flooding was reported to have reached almost to Laguna Yema and to have isolated Fortín Soledad. The sediment plug was located near Sombrero Negro. From there upstream to Fortín P.P. Peña the river was contained within its channel which is perhaps 100 m wide. At one spot, where there is a hairpin meander, the river has broken through the apex of the meander and formed a narrow channel that parallels the old channel for several kilometers before reentering it. Both the new and old channels had flowing water. Between Fortín Cabello and Fortín P. P. Peña the channel has considerable deposition and in several places, the deposition almost closes off the channel (fig. 9).

Figure 5.--Channel filled with sediment and becoming covered with vegetation. The vegetative cover decreases to the west (upstream, right).

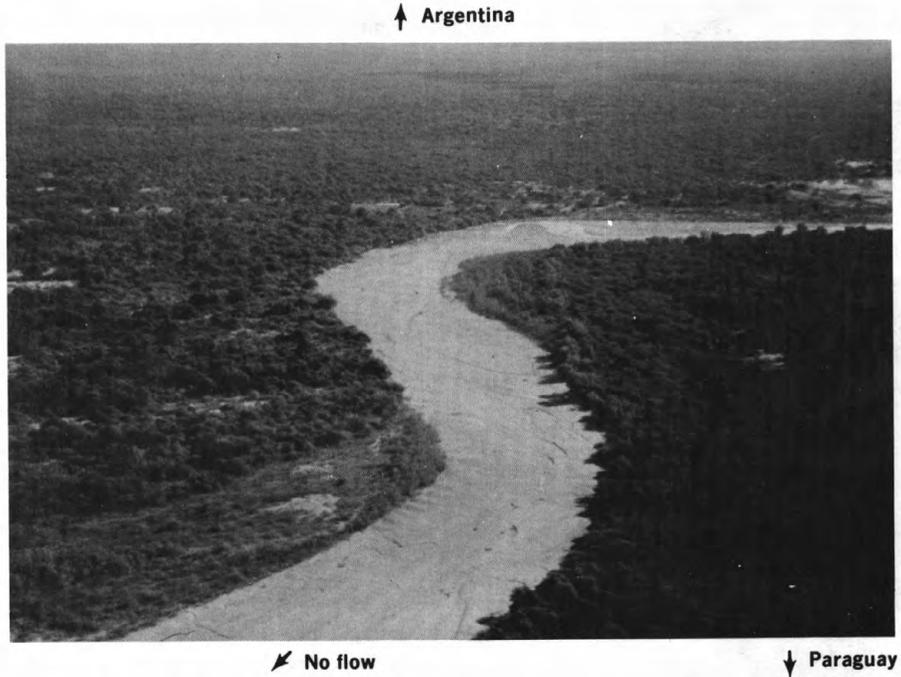
Figure 6. Channel of the Río Pilcomayo "Superior" recently filled with sediment. This picture was taken a few kilometers upstream from the site in figure 5.

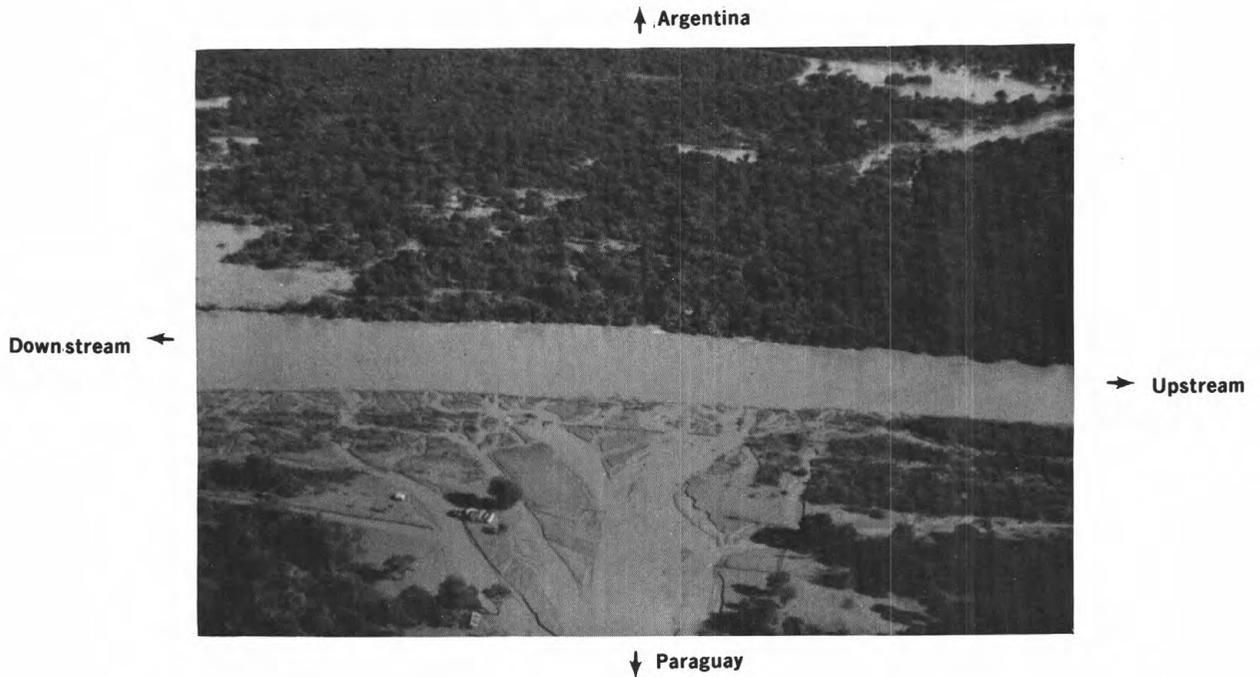
Figure 7.--Río Pilcomayo "Superior" overflowing its banks near the end of the sediment plug. This site is upstream of that shown in figures 6 and 8. Argentina is in the background; Paraguay in the foreground.

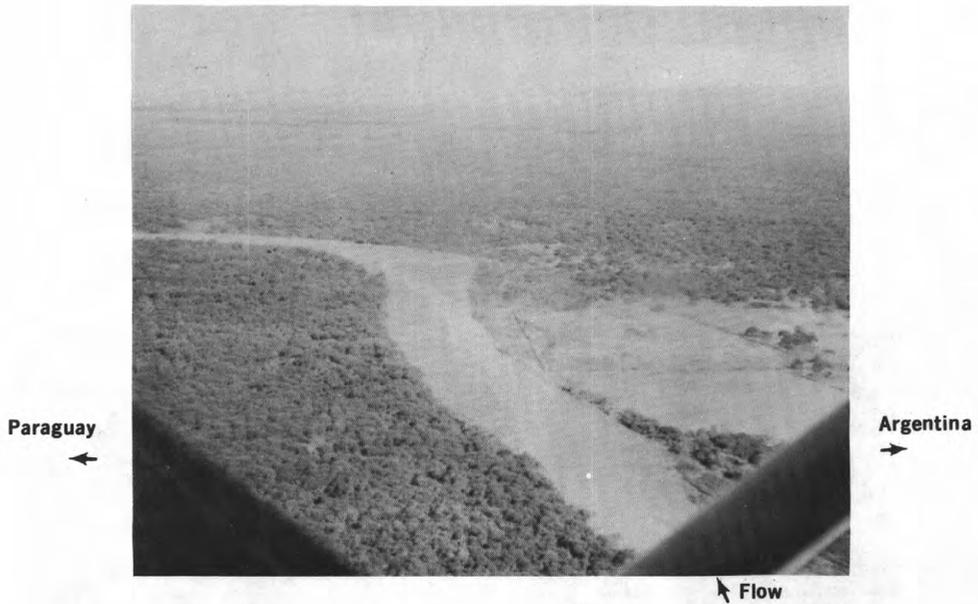
Figure 8.--Bank overflow near the site shown in figure 7. This shows the upstream end of the sediment plug.

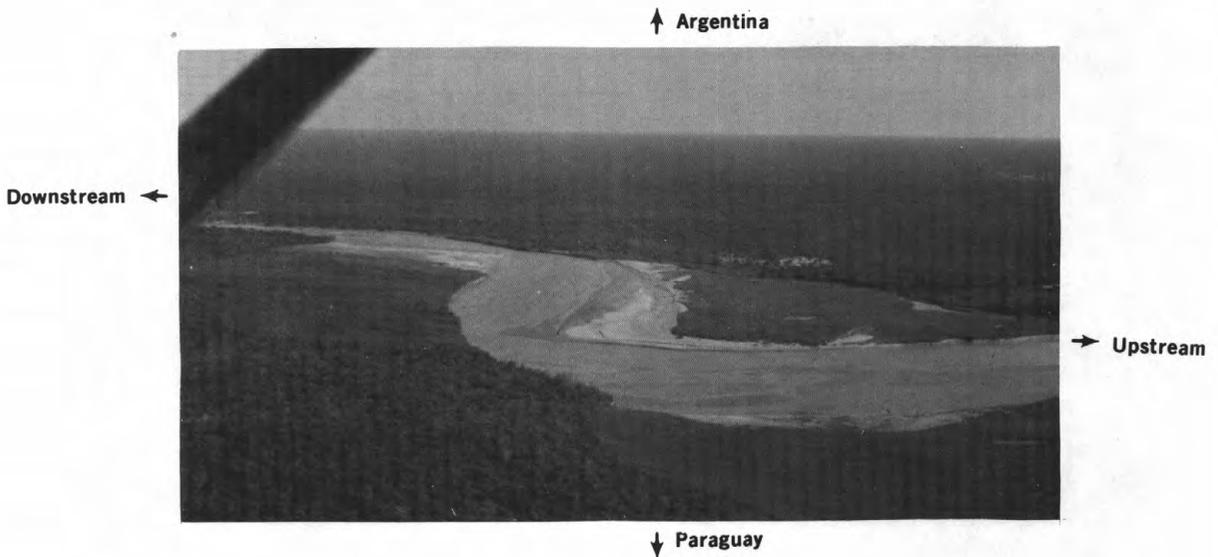
Figure 9.--Río Pilcomayo "Superior" downstream from Fortin P. P. Peña, Paraguay.

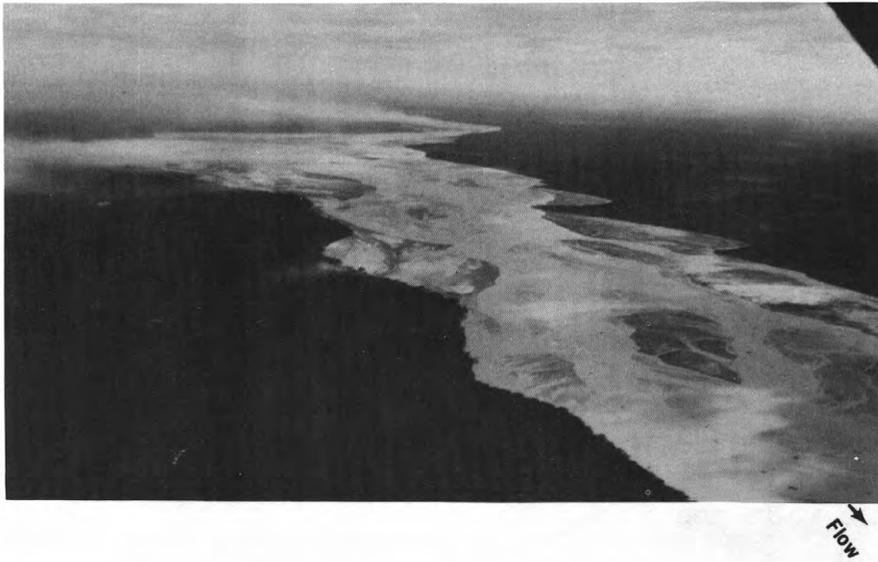
The Río Pilcomayo "Superior" from D'Orbigny to Villa Montes has a wide, braided channel (fig. 10). The area has considerable deposition and the channel near D'Orbigny often shifts. The bed material there is probably mostly sand. The channel near Villa Montes is more stable although it is still braided (fig. 11). The bed material is mostly gravel (fig. 12) and there is some lateral erosion and downcutting where the river breaks out of the mountains, just above Villa Montes (fig. 13).

Figure 10.--Braided channel of the Río Pilcomayo "Superior"
between D'Orbigny and Villa Montes, Bolivia.

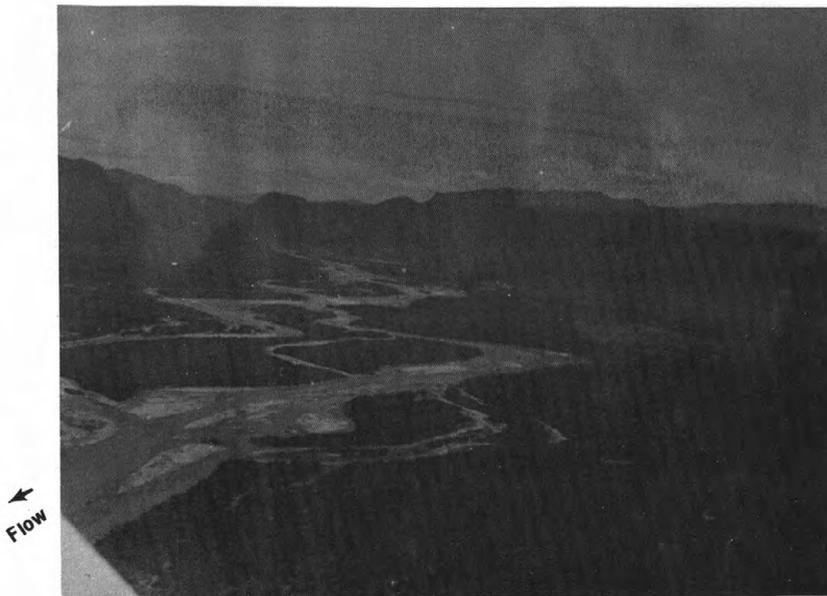
Figure 11.--Río Pilcomayo "Superior" near
Villa Montes.

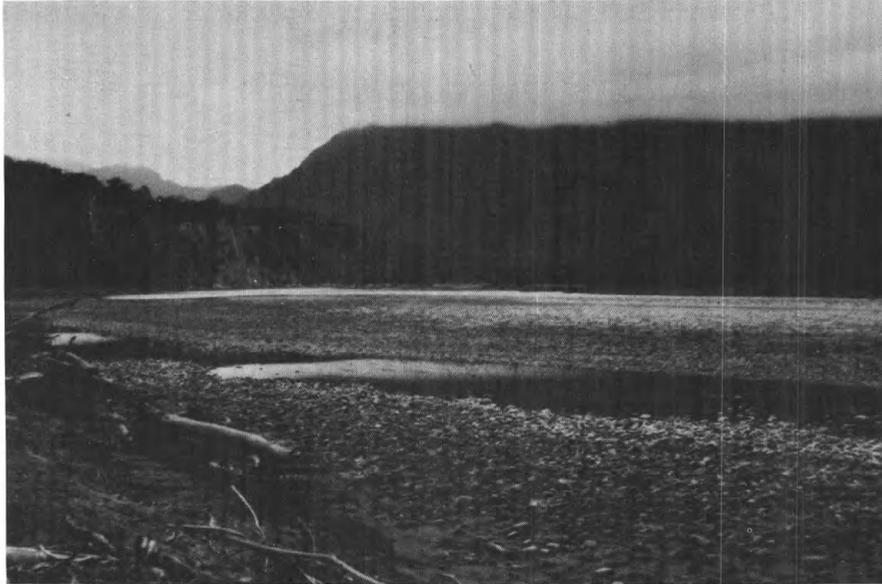
Figure 12.--Gravel bed material at Villa Montes.

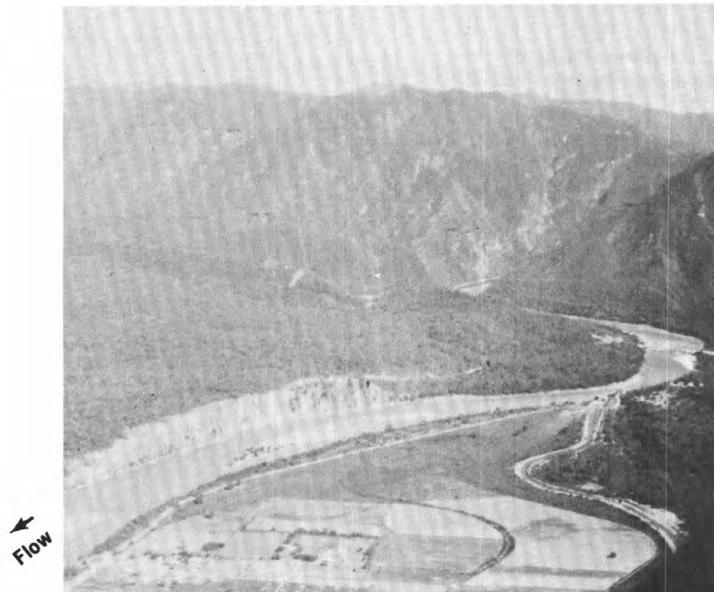
Figure 13.--Río Pilcomayo where it breaks out of the mountains. Note erosion of bank.

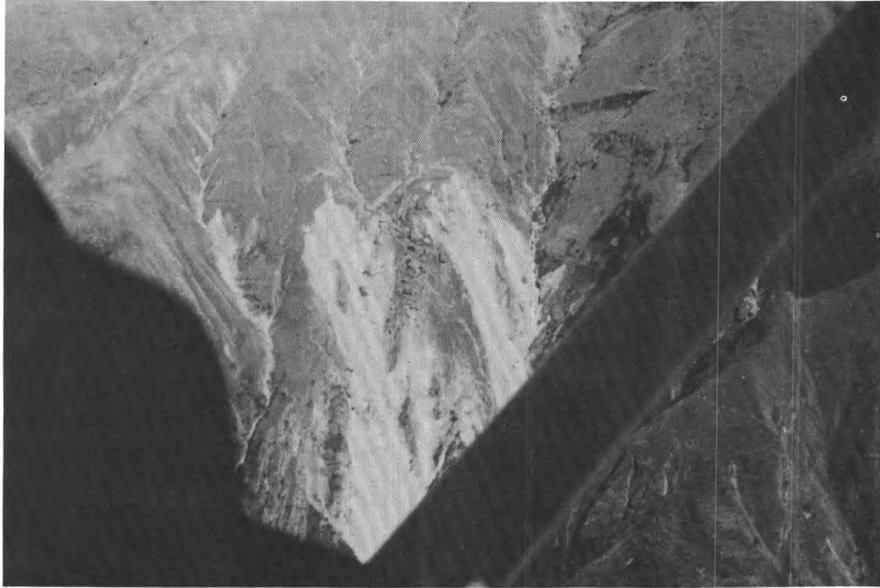
The Río Pilcomayo from Villa Montes to Huaclaya is narrow and flows between steep mountainsides. The bed material is gravel. What deposition exists is on the bed of the channel. The valley at Puesto Margarita, however, seems to be a site of deposition. Most of the sediment reaching the Río Pilcomayo "Alto" is probably transported by the river to Villa Montes and beyond. Landslides were observed in the mountains (fig. 14) and these may be a major contributor of sediment to the river between Villa Montes and Huaclaya.

Figure 14.--Landslide scars on the mountains in the
Río Pilcomayo "Alto" basin.

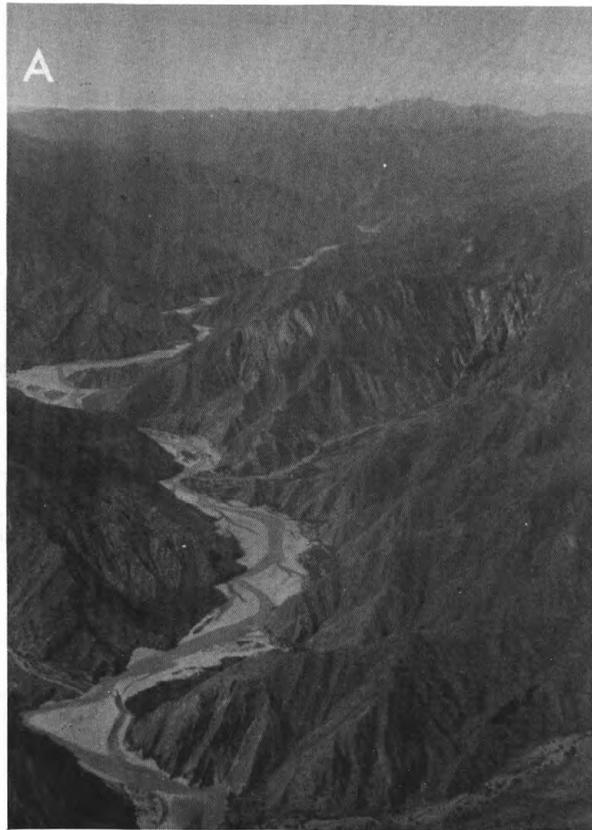
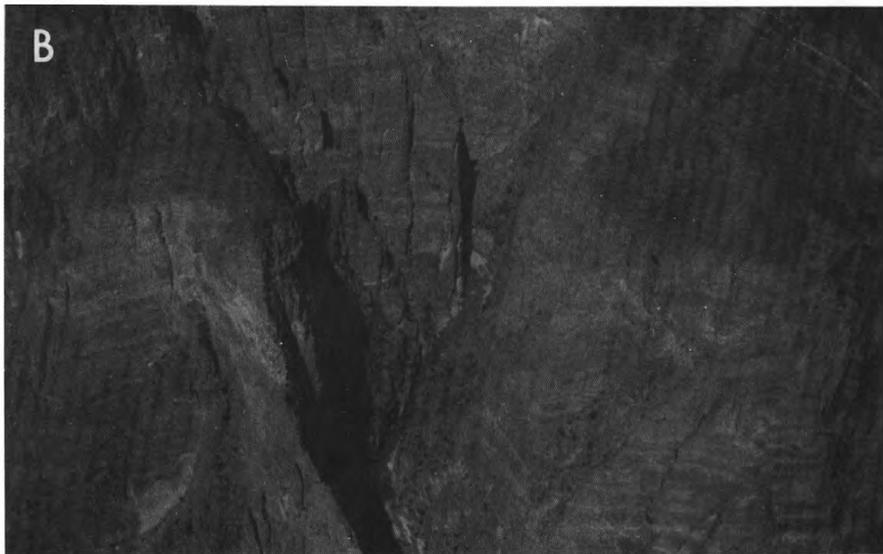
In general the vegetation on the mountainsides become sparser in a westward direction and there is little vegetal cover to be seen in the Río Pilaya basin between Pampa Grande and Villa Abecia. The lack of cover in conjunction with the steepness of the mountain slopes is conducive to the erosion and transportation of sediment to the river (fig. 15). The Río Pilaya is narrow and meandering and has coarse bed material. Little deposition was seen.

Figure 15. Río Pilaya, Steep mountains are common along this tributary to the Río Pilcomayo. Oblique (A) and near vertical (B) views.

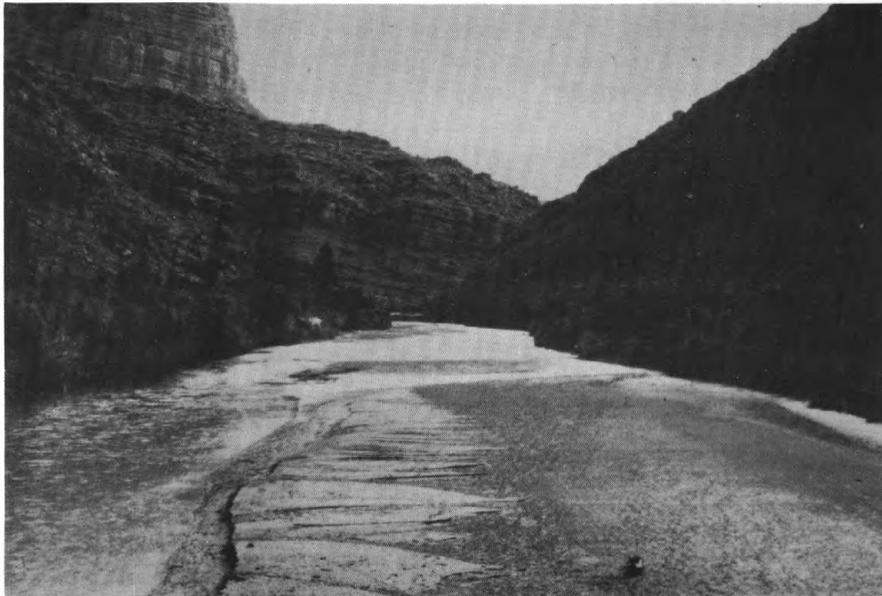
The Río Pilaya between Villa Abecia and Camargo flows through a valley where there is farming on river deposits and where some of the largest wineries in Bolivia are located (fig. 16). The Río Tumusla at Palca Grande (fig. 17), a gaging station site, was muddy, a condition which perhaps was caused by mining upstream. The Río Chico de Camargo, which joins the Río Tumusla near Palca Grande, was clear.

Figure 17.--View upstream of the Río Tunusla at
Palca Grande.

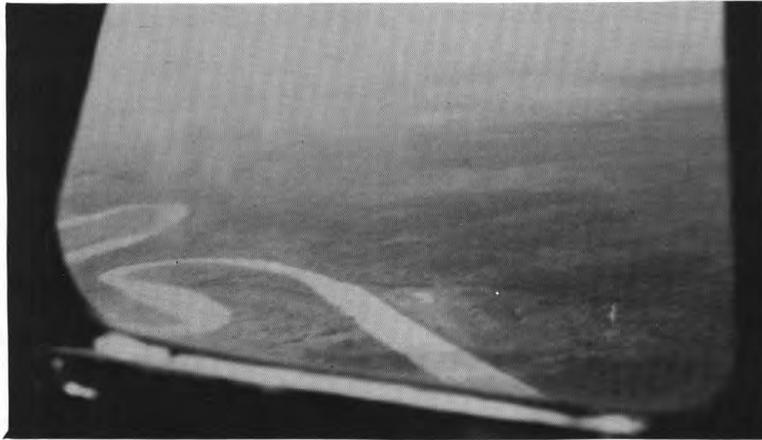
The reason for the initial deposition which plugged the channel is not apparent. Possibly the channel was first dammed by dead trees as suggested by Cordini (1947, p. 24) and the sediment filled in behind that obstruction. Perhaps the meanders of the river (fig. 20) are so tortuous that during high flows the river must drop its load because its velocity is reduced when the river tries to negotiate the bends. Again, perhaps the elevation of the land somewhere downstream (possibly in the area where the river disappears) has been raised by tectonic activity which in turn has decreased the velocity of the river to point where it can no longer transport its load. At the point of plugging or damming by the most recent deposition, the river overflows its banks, flooding large areas, and sometimes picking a new channel or even re-occupying one that has been abandoned previously.

Figure 20.--Meandering channel in the sediment-filled reach of the Río Pilcomayo "Superior".
