DEPTHS OF CHANNELS IN THE AREA OF THE SAN JUAN BASIN REGIONAL URANIUM STUDY,
NEW MEXICO, COLORADO, ARIZONA, AND UTAH

U. S. Geological Survey Open-File Report 79-1526

February 1979

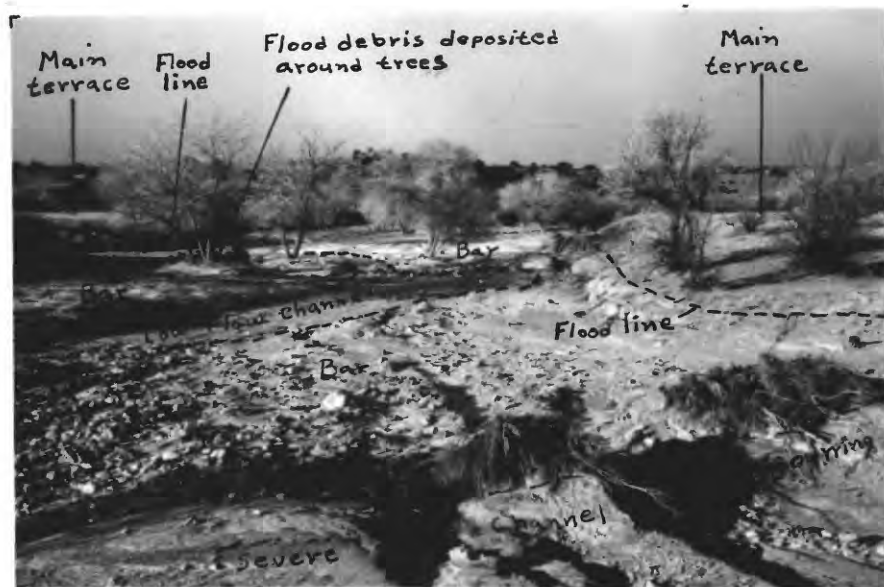
Figure 3. View upstream along Mexican Springs Wash near Mexican Springs shows the effects from a large flood that occurred after a major thunderstorm during the summer of 1977. This flood and previous large floods have built a series of gravel bars separated by low-flow channels and reaches where severe scouring occurred. Trees growing on bars that are bent in the downstream direction indicate that flood flows are relatively common along this wash. Large floods cause most of the channels deepening and arroyo cutting.

Floods resulting from thunderstorms during the summer of 1977 caused some change in channel depths in the southwestern part of San Juan Basin (figs. 3 and 11). Such floods occurred west of Ya-ta-hey, along streams crossed by U.S. 666 between Ya-ta-hey and Sanostee Wash, near Iyanbito, and in the Indian Creek drainage between Coyote Canyon and Standing Rock. Other measurements made of the streams between Ya-ta-hey and Sanostee Wash and a few other streams in western San Juan Basin indicate that no significant change in depths of channels occurred between 1966 and 1971 (table 1).

Along the channel of Mexican Springs Wash (site 28-30, 32) and a tributary of Coyote Wash (site 42) near Coyote Canyon the floods caused 2 feet of scouring to the approximate channel depths of 1966. Both channels appear to have been aggrading prior to the 1977 floods.

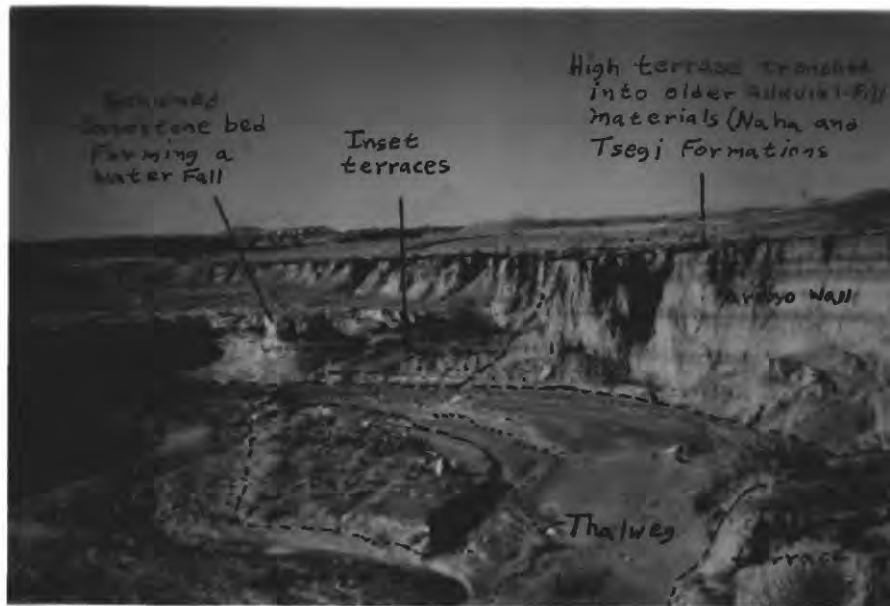
Figure 4. Arroyo of Salado Creek, a tributary of the Rio Puerco southwest of Mesa Prieta. The arroyo is 54 feet deep, which is the amount of post-1850 trenching along this stream. Inset terraces are between 3 and 10 feet high. The stream is actively cutting laterally at the bend. A ledge of sandstone forms a waterfall about 30 feet high. Large boulders on sand and gravel bar at center were eroded from the sandstone ledge.

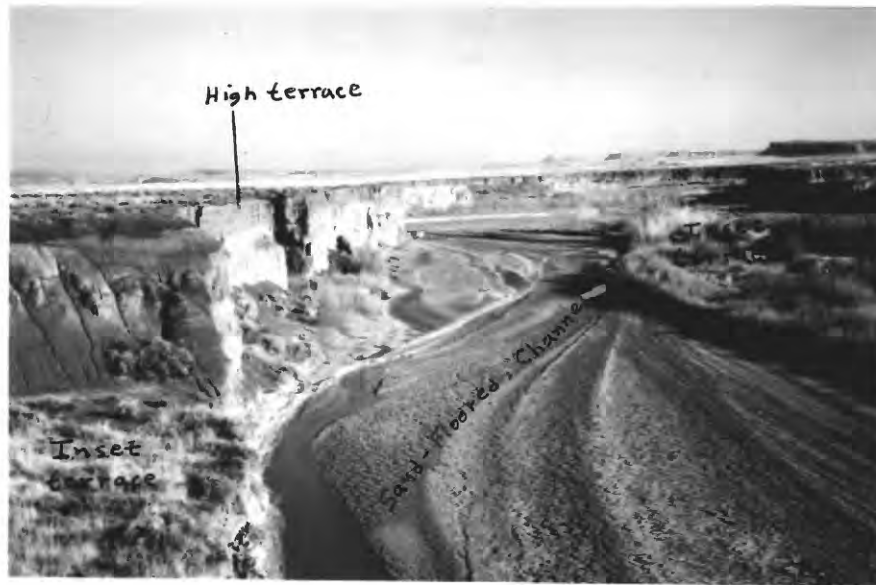
Figure 7.--Arroyo of the Rio Puerco south of Mesa Prieta. The arroyo is trenched 50 feet below the high terrace and is as much as a quarter mile wide. It is the largest arroyo in the San Juan Basin area. According to Bryan (1925) arroyo trenching began in 1840 in the Rio Puerco drainage. The summit of the high terrace represents the pre-1840 flood plain. Dark stripes in the channel are tire tracks.

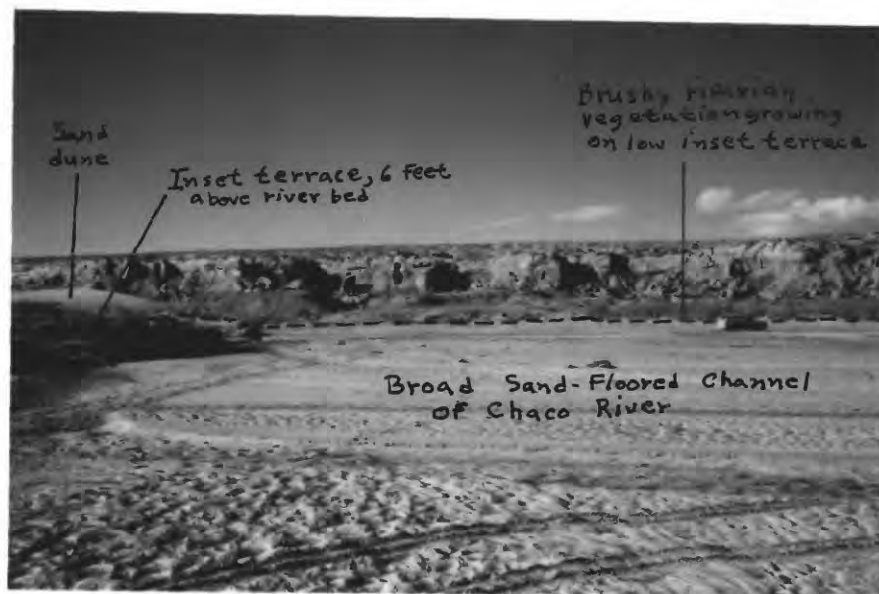
Comparison of channel depths in 1965-71 with depths in 1977-78 shows that more channels in the western San Juan Basin are filling than are downcutting (pl. 1, table 1). The amount of downcutting or filling was generally less than 2 feet. About two-fifths of the sites measured had less than half a foot of downcutting or filling. Maximum downcutting was 4.5 feet along a tributary to Salt Springs Wash near Naschitti (pl. 1, site 59). Three feet of downcutting also occurred near Coyote Canyon (pl. 1, site 37) partly as a result of a dam breached during a flood. A maximum of 7 feet of filling occurred in the narrow inner channel of the Chaco River in the Chaco Canyon National Monument (pl. 1. site 15). Downstream from the monument near Lake Valley (pl. 1. site 17) the Chaco River had aggraded its channel by 4 feet and at site 22 (pl. 1.), above the mouth of Indian Creek (fig. 8), the channel had aggraded about 2 feet.

Figure 8.--Broad aggrading channel of Chaco River at site 22 upstream of the mouth of Indian Creek. Two feet of aggradation occurred between 1966 and 1978. Subdued appearance of the channel features indicate that large flows have not occurred recently. This reach of the Chaco River is upstream of the reach affected by the floods of 1977 (see fig. 12). Cliffs on the far side of the river are of the Cliff House Sandstone.

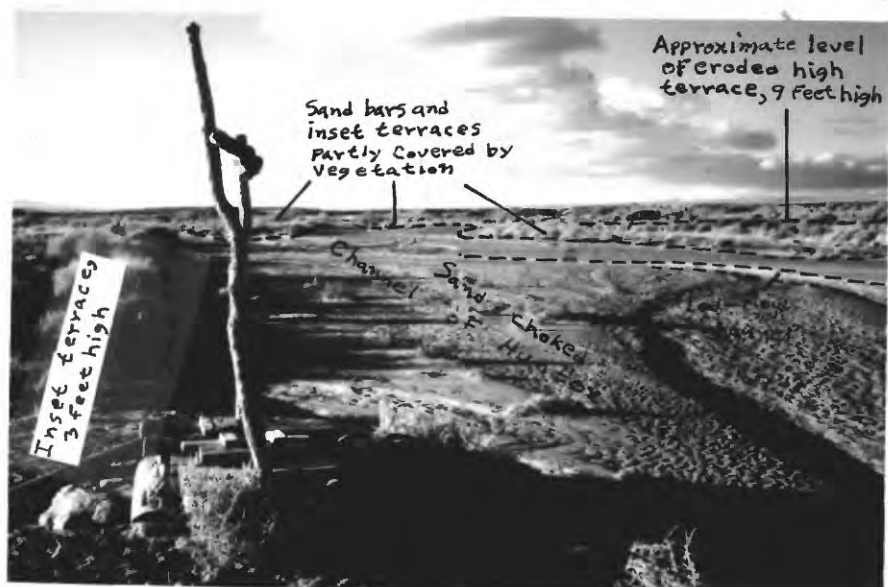
Figure 9.--View downstream of the aggrading sand-floored channel of Hunter Wash at site 69, 3 miles upstream of its confluence with the Chaco River. The amount of aggradation between 1966 and 1978 was 3 feet. If aggradation continues, the low inset terrace and small dug well used by the Navajo Indians will be buried by sand. A low-flow channel is present between the broad sandbars.

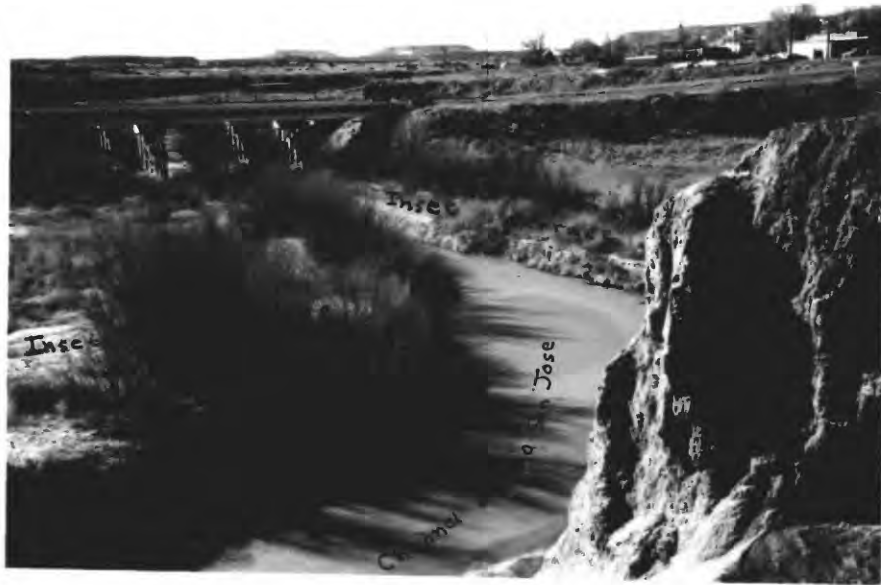
The few measurements made in southeastern San Juan Basin indicate that since the original observations in 1964-67 downcutting predominated over filling (table 1). As much as 4 feet of cutting occurred along Rio San Jose at Laguna (fig. 10) and near Mesita (pl. 1, sites 14 and 15), and 2

Figure 10.--Upstream view of the channel of Rio San Jose at site 14, at Laguna. Bridge is of old U.S. Highway 66. The channel is between well-developed inset terraces 3 to 5 feet high. Eroded edge of the high terrace, 36 feet high, is at lower right. The upright riparian vegetation on the inset terraces indicate that these terraces have not been inundated recently by large floods. Between 1967 and 1978 the channel was deepened 4 feet. Effects of urban development around Laguna and encroachment of riparian vegetation probably caused narrowing of the channel and its subsequent deepening. Ripples in the sand bed can be seen through the nearly clear flow of the river. At this time the stream carried little suspended sediment.

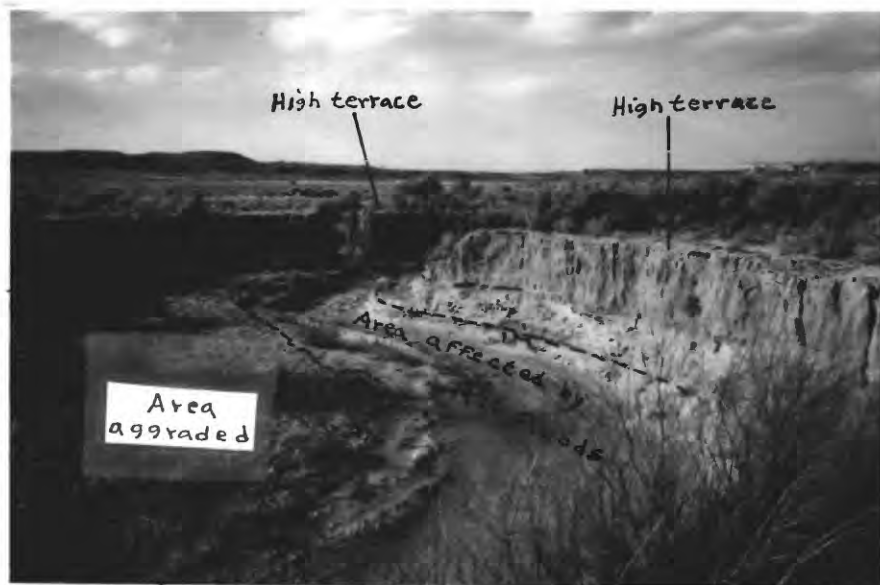
Figure 11.--Channel of an unnamed wash crossed by State Highway 56, at site 20, 11 miles northeast of Crownpoint. The channel had been aggrading prior to the 1977 summer floods. Flood flows scoured the channel to a depth of 2 feet, which was the channel depth in 1966. The high terrace is 15 feet above the bed of the wash.

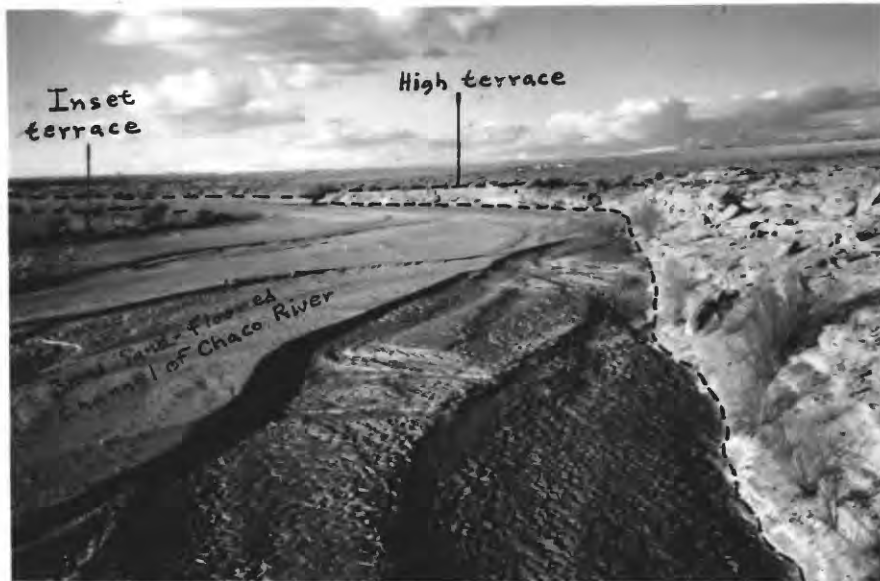
The 1977 floods at Indian Creek, Coyote Wash, and other drainages caused considerable scouring and some deepening of the Chaco River channel downstream from the mouth of Indian Creek. At site 73 the river channel was deepened by 1 foot (fig. 12). In contrast, the river channel upstream from Indian Creek has aggraded and its appearance indicates a large flow has not occurred during the past several years (fig. 8).

Figure 12.--Downstream view of the broad channel of the Chaco River at a road crossing 10 miles northeast of Newcomb (site 73). The channel shows effects of the 1977 summer flood (see also fig. 8). The angular and steplike appearance of the sandbars were caused by flood flows. The amount of change in channel depth between 1966 and 1978 was only about 1 foot. The high terrace is about 10 feet above the channel.

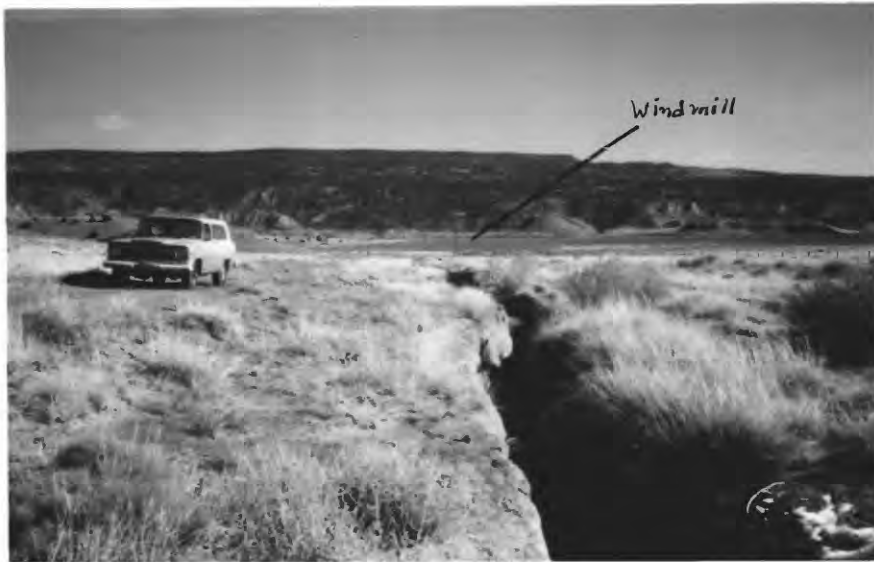
Figure 13.--Small arroyo formed along stock trails and a dirt ranch road leading to a windmill. Arroyo is about 3 feet wide and has a maximum depth of 5 feet. Long-straight arroyos commonly result from man's activities.

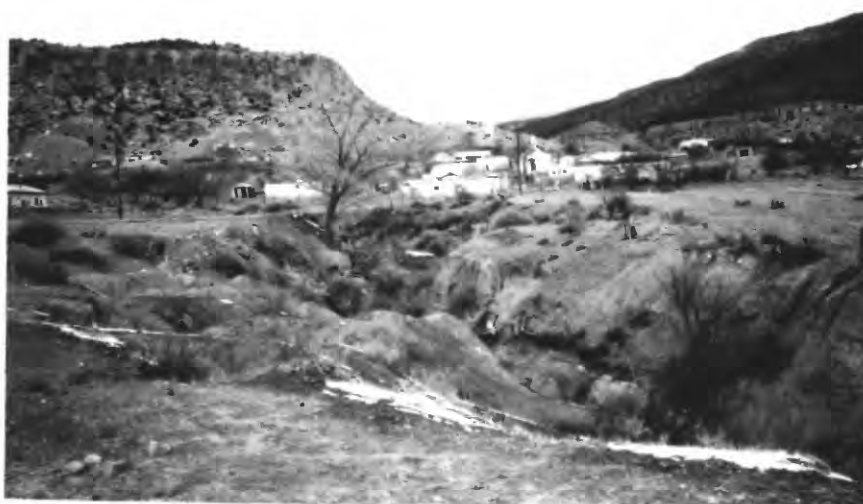
Figure 14.--Accelerated erosion and arroyo formation east of Mesa Chivato at Seboyeta. Vegetation has been nearly denuded by overuse of the land near this village. Accelerated sheet erosion occurring on both slopes of this small arroyo contribute significantly to the suspended sediment load of streams.

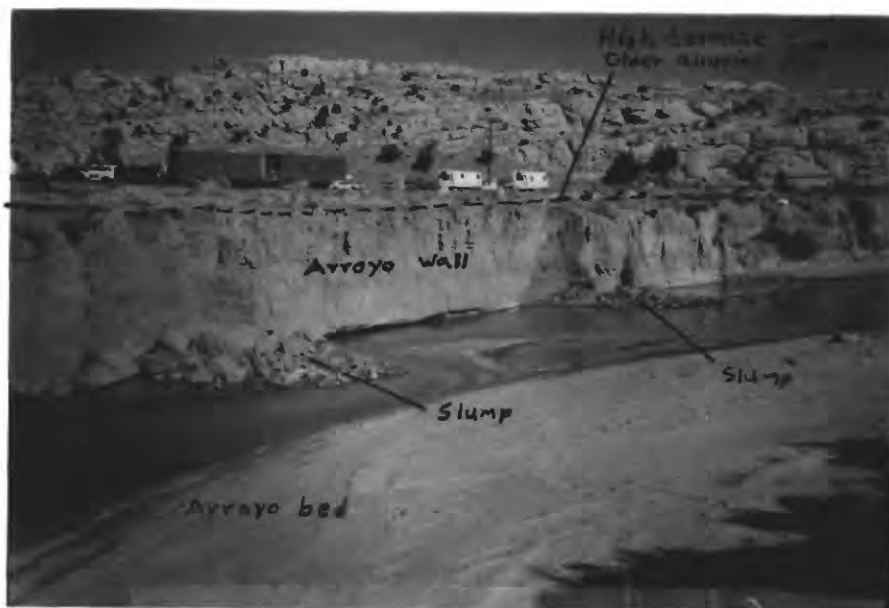
The mine water flows along the North Fork and the main stem of the Puerco River through Gallup to beyond the Arizona State line. The flow has caused some aggradation and widening of the arroyo upstream from Gallup. Much of the sediment filling the channel has been obtained through lateral cutting and slumping of the arroyo walls (fig. 15). At site 4 (pl. 1), along the North Fork, 4 feet of filling occurred between 1966 and 1977. Some of the filling resulted from large flows during the summer of 1977. Until 1971 the channel of the Puerco River at the hogback ridges east of Gallup (site 19, pl. 1; table 1) had gradually deepened. Since 1971 about 2 feet of filling has resulted from a combination of the effects of mine water discharge, the floods of the summer of 1977,

Figure 15.--Arroyo of the Puerco River at the hogback ridges

upstream from site 19 east of Gallup. Water discharged from the Church Rock mines is cutting laterally into the arroyo wall. Part of the arroyo wall is undercut near center of photograph. Two recent slumps of alluvium from the arroyo wall has locally diverted the streamflow. The arroyo is 25 feet deep and 100-150 feet wide.

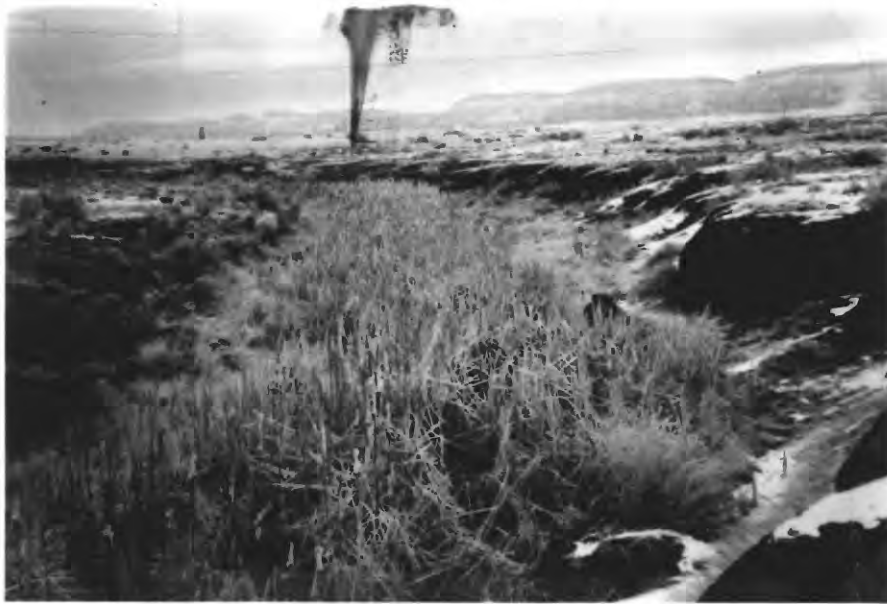
In the Ambrosia Lake area, the discharge of mine and mill water has resulted in the growth of a lush stand of cattails and tall grasses in the arroyo of Puertocito Wash that drains the area (fig. 16). The vegetation has caused sediment to accumulate in the arroyo. The sediment is derived from a large tailings pile that adjoins the creek, from erosion of the arroyo walls, and from overland flow that enters the arroyo from the adjacent bottom land. Owing to the absence of previous depth of channel measurements, the depth of the filling is not known.

Figure 16.--View upstream (north) along arroyo of Puertocito Wash that drains the Ambrosia Lake area. The arroyo is 6.5 feet deep. Mine-mill effluent supports the lush growth of cattails and tall grasses on the arroyo bed. The vegetation has resulted in accumulation of sediment in the arroyo. The sediment is derived from a tailings pile that adjoins the creek, from erosion of the arroyo walls, and from overland flow that enters the arroyo from the adjacent bottom land. The sloping arroyo walls indicate the lack of recent cutting--perhaps since the mine-mill effluent has been discharged into the arroyo.
