Unevaluated Reconnaissance Report (December 1948)  
on Geology of Lower Eagle River Valley,  
Alaska

By A. F. Bateman, Jr.

Open-File Report 80-275

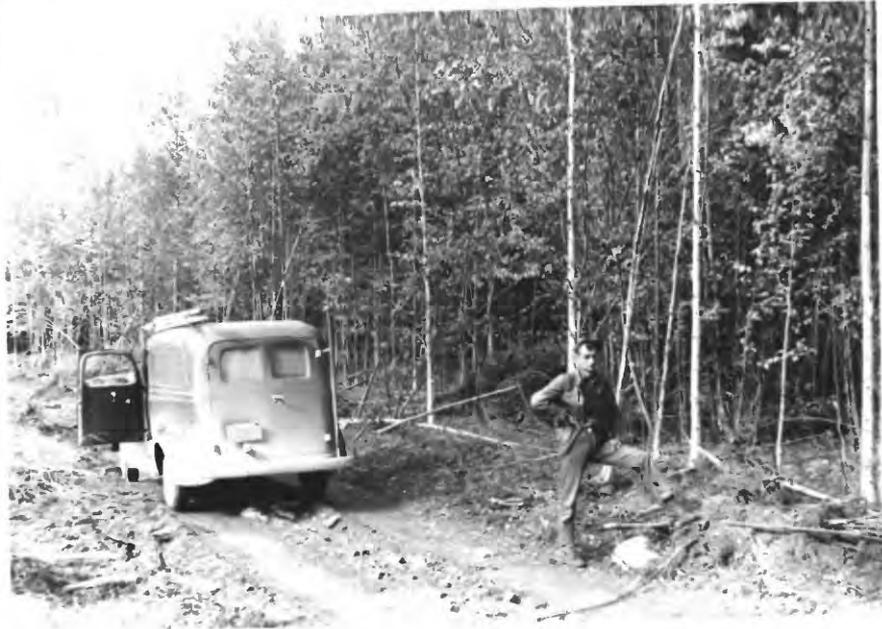
A. TYPICAL FOREST COVER ON FILL SURFACE, LOWER EAGLE VALLEY

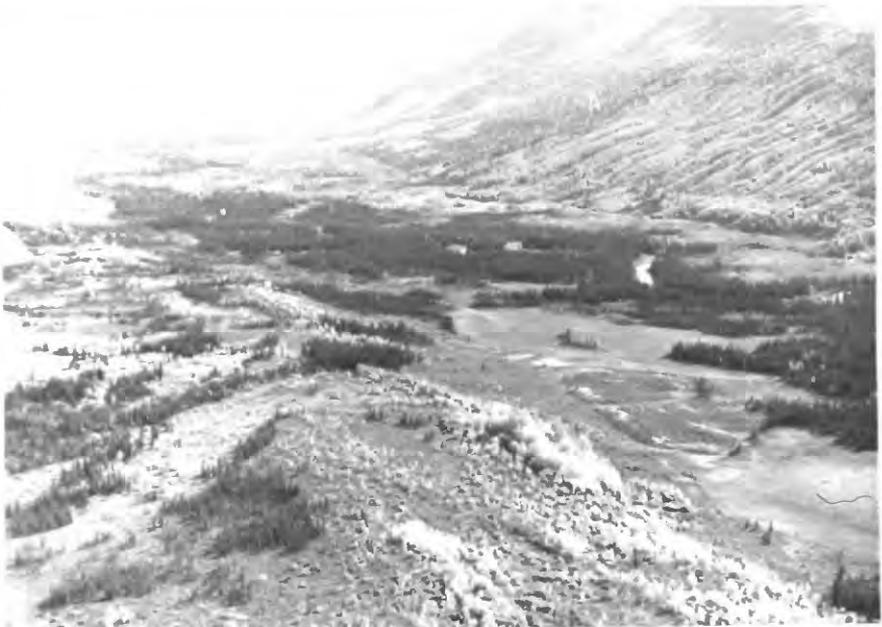
B. OBLIQUE AERIAL VIEW OF RESERVOIR AREA LOOKING UPSTREAM FROM ABOUT 1,000 FEET OVER A POINT OPPOSITE MOUTH OF SOUTH FORK EAGLE RIVER. In foreground is upstream end of mass of glacial debris that partially fills lower valley. Eagle Glacier can barely be seen at upper end of valley.

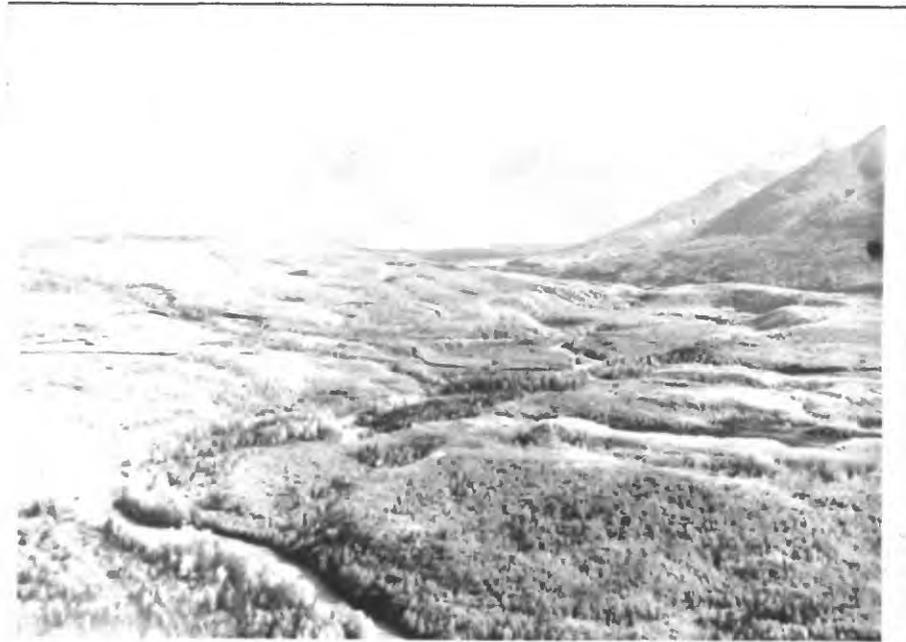
A. OBLIQUE AERIAL VIEW UP EAGLE RIVER VALLEY FROM ABOUT 1,000 FEET ABOVE RAILROAD BRIDGE. Glacial debris that partially fills lower end of valley makes up foreground and middle ground. Steep valley walls are underlain by bedrock.

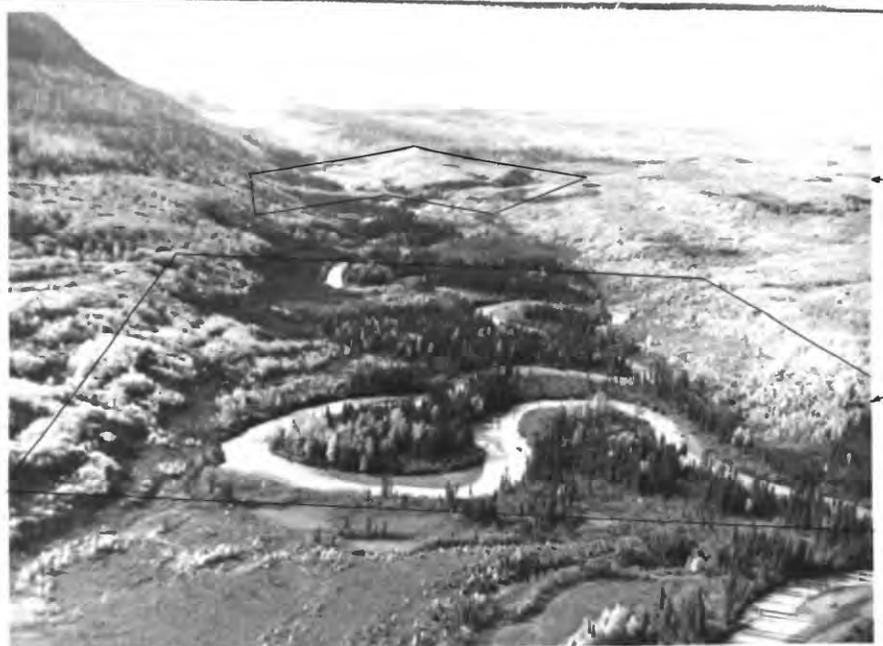
B. OBLIQUE AERIAL VIEW DOWN EAGLE RIVER VALLEY FROM ABOUT 1,000 FEET ABOVE A POINT 6.6 MILES UPSTREAM FROM RAILROAD BRIDGE. Notice large mass of glacial debris in right middle and background and depression between this mass and left valley wall. Eagle River occupies this depression in foreground (dam site area No. 1), but in middle ground leaves it to cut through the debris mass. Dam site area No. 2 is in this cut. Knik Arm is in background.

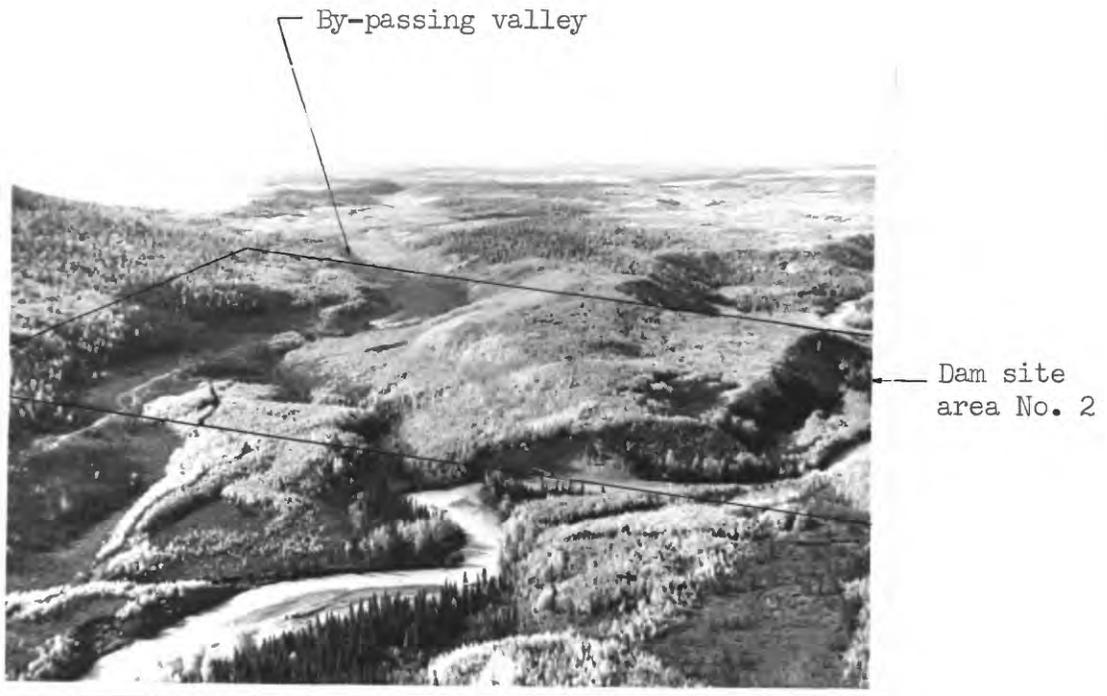
OBLIQUE AERIAL VIEW DOWN THAT PART OF DEPRESSION NOT OCCUPIED BY EAGLE RIVER. VIEWPOINT ABOUT 1,000 FEET ABOVE THE RIVER, 3.9 MILES UPSTREAM FROM THE RAILROAD BRIDGE.

Note breach in glacial deposits made by Eagle River in right middle ground. This is dam site area No. 2.

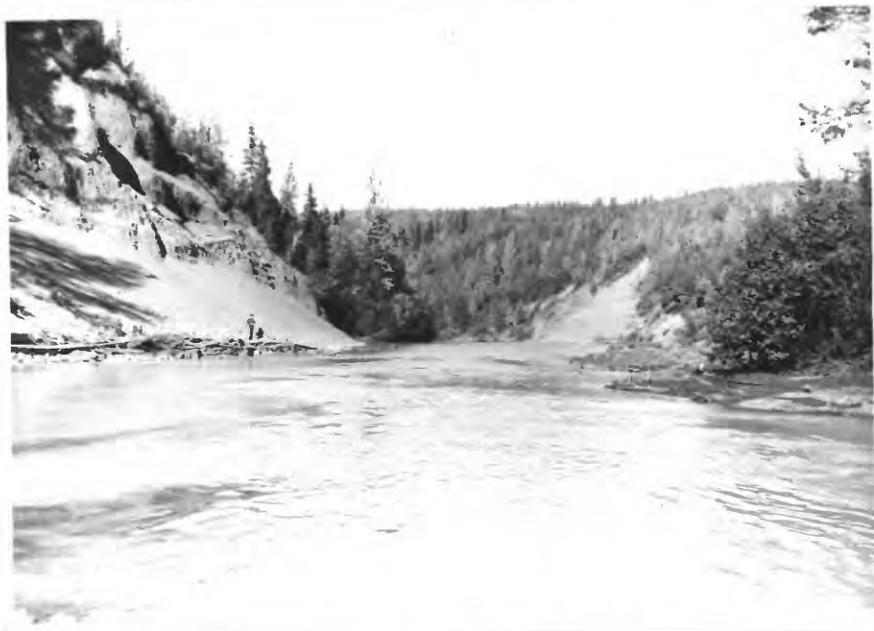
- A. LOOKING DOWN EAGLE RIVER FROM LEFT BANK, 3.55 MILES ABOVE RAILROAD BRIDGE.  
Note cliff of glacial deposits. This is at upper end of dam site area No. 2.

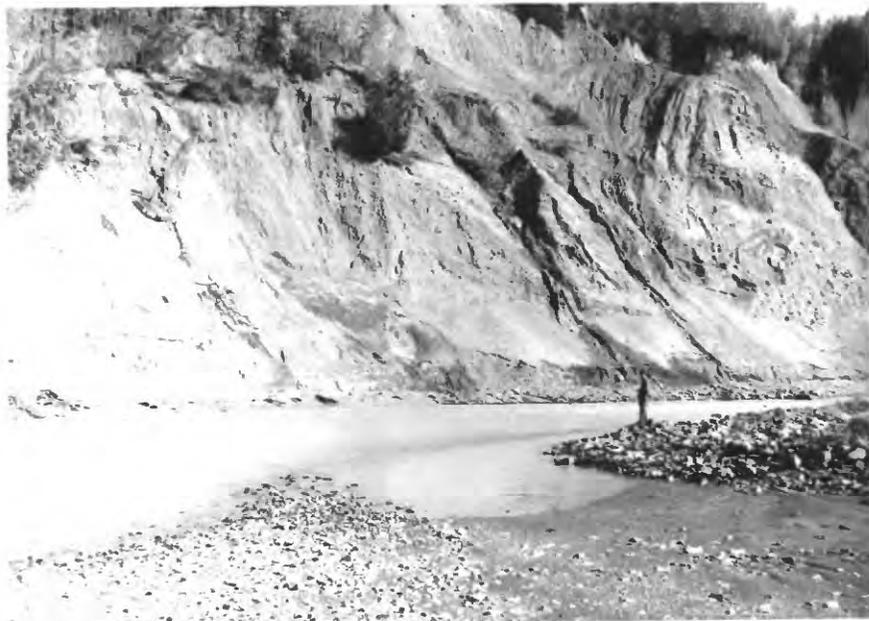
From 3.2 to 3.4 miles above the railroad bridge in the right bank of the river are some deposits of gravels and sands that are slumped and contorted, contain interbedded masses of till and show extreme range and abrupt changes in grain size (plate 4B). These are interpreted as ice-contact deposits.

- B. GLACIAL DEBRIS IN RIGHT BANK EAGLE RIVER, 3.25 MILES UPSTREAM FROM RAILROAD BRIDGE, DAM SITE AREA NO. 2.  
Several feet of thinly laminated, nearly horizontal, bluish-gray clays are exposed just above the water level in left middle ground. Remainder of deposit is mostly folded and faulted gravels with interbedded masses of sand, silts, and till.

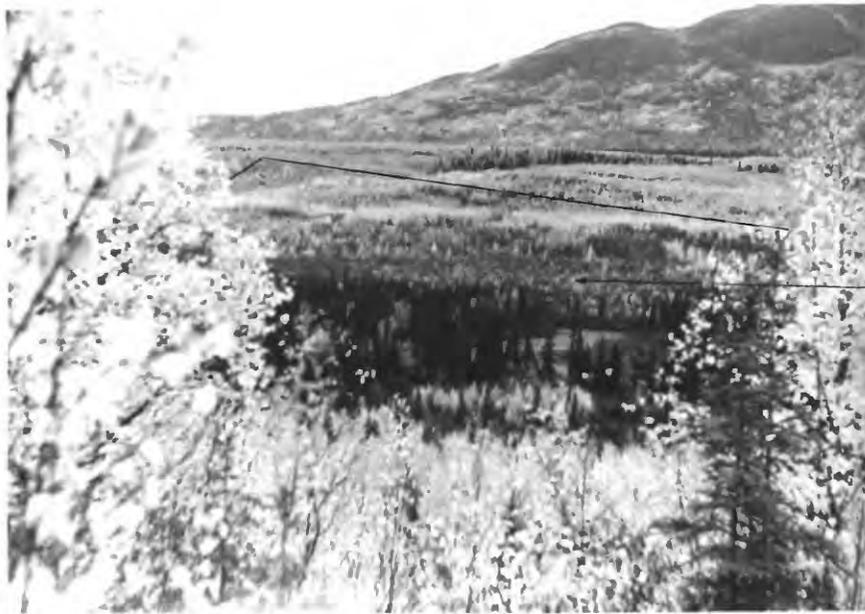
Dam site  
area No. 1

A. LOOKING ACROSS AND SLIGHTLY DOWN EAGLE RIVER VALLEY TOWARD RIGHT BANK FROM POINT ON LEFT WALL OF VALLEY 0.4 MILE UPSTREAM FROM R.P. 16 AT 428 FEET ALTITUDE.

Note abrupt change in slope between fill surface and right wall of valley.

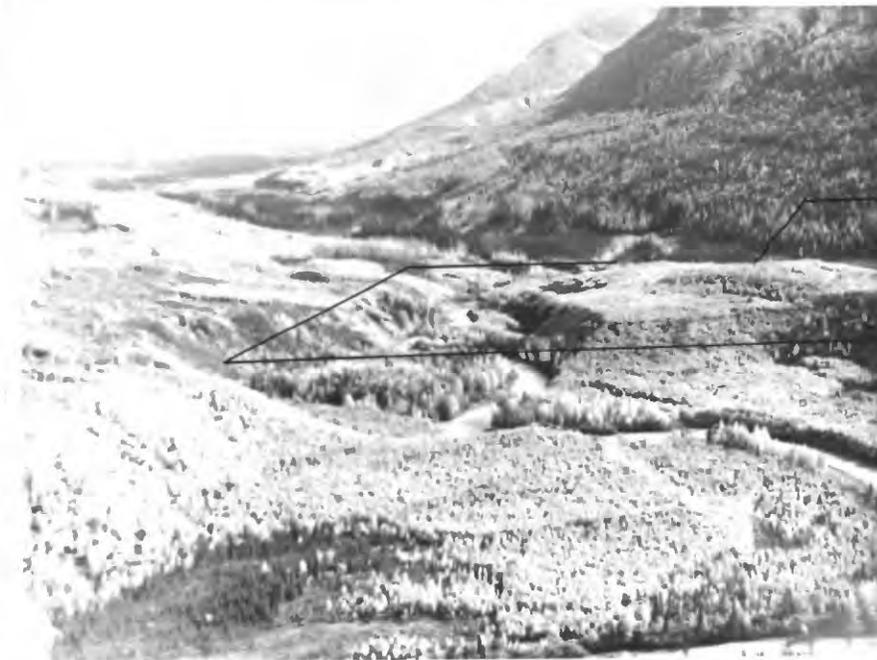
Dam site  
area No. 2

B. OBLIQUE AERIAL VIEW UP EAGLE RIVER VALLEY FROM ABOUT 1,000 FEET  
ABOVE RIVER, 2.6 MILES UPSTREAM FROM RAILROAD BRIDGE.

Dam site area No. 2. - A general view of this area is shown on plate 6B. The glacial sediments exposed in the right abutment consist of the clays and silts previously described overlain by contorted and slumped gravels containing interbedded sands, silts, and masses of till. The deposit as a whole is suggestive of ice-contact sediments. Small seeps emerge from the gravels at their contact with the clays, but on the whole the deposit does not appear highly permeable.

The left abutment is also underlain by gravels, but they are poorly exposed in the dam site area. At the upper end of the area, across the river from R.P. 21 (see figure 1), a series of gravels is exposed in a 90-foot cut bank. These gravels are heavily bedded, slightly silty, probably of medium and low permeability, and dip gently northward. They contain one interbedded till layer 2 feet thick and a channel filled with rather permeable gravels and clean sands in lenticular beds. Plate 4A shows this cut bank. Before a dam site in this area is considered, extensive drilling will be necessary to establish the permeability of the various materials and to outline the downstream extent of this channel. This exposure would provide an excellent intake for reservoir waters to enter the glacial sediments, and the channel might provide a rather short and highly permeable conduit throughout the dam site.

Behind the ridge making up the left abutment is the depression described under "Topography." Water backed into this valley would bypass the dam site and have a short path of percolation either back into Eagle River or into Fossil Creek. The area through which seepage could take place is designated on figure 1 as "Area A." It should be mapped and permeability studies made of the sediments underlying it. From the topographic mapping now available, it appears that the minimum percolation path would be in the neighborhood of 1,000 feet under a maximum head of 150 feet with reservoir level at 450 feet altitude. This situation could be avoided by construction of an auxiliary dam across this valley as an extension of the main dam.
