TRENCH I

PLATE 2 SHEET I
TRENCH LOG
BARHAM RANCH, SITE I
LOS ALAMOS FAULT

USGS CONTRACT: 14-08-0001-18256		CONSULTING ENGINEERS, GEOLOGISTS AND ENVIRONMENTAL SCIENTISTS
PROJECT NO.: 41173I		APPROVAL: PDG

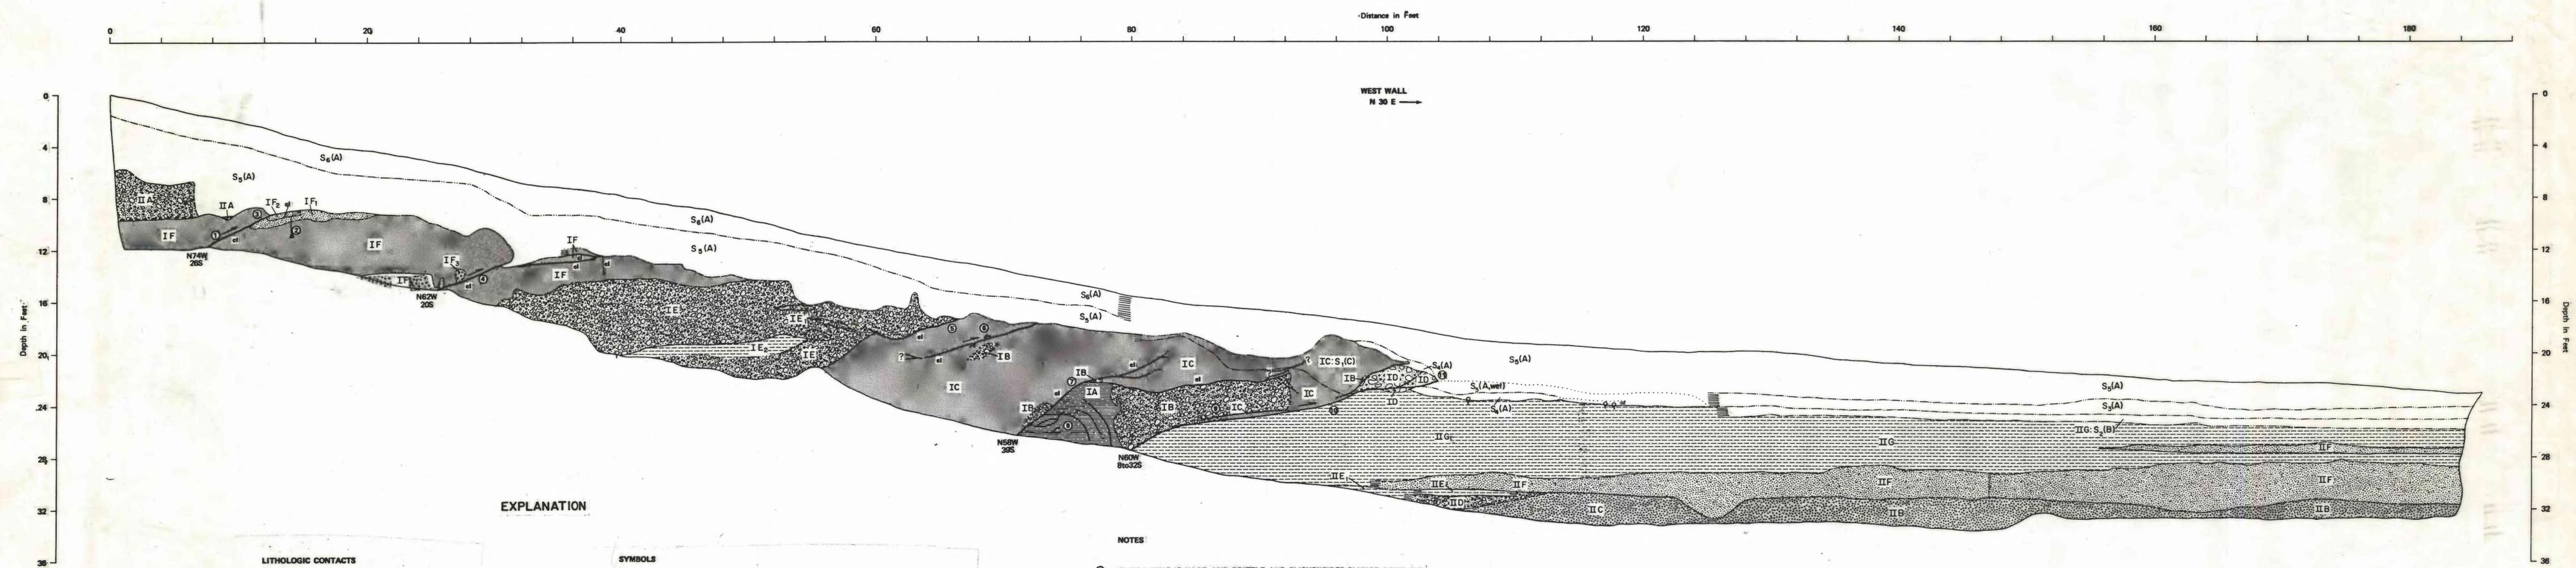
- ① CLAY LINING IS HARD AND BRITTLE AND SLICKENSIDES PLUNGE DOWN DIP.
- ② CLAY SEAM 1/2" THICK.
- ③ NUMEROUS VERTICAL FRACTURES.
- ④ CLAY LINING IS HARD AND BRITTLE AND SLICKENSIDES PLUNGE S25W.
- ⑤ SHEARED, CLAY-LINED CONTACT.
- ⑥ APPARENT OFFSET OF PEBBLES ACROSS CLAY-LINED SHEAR.
- ⑦ CLAY LINING IS SOFT AND SLICKENSIDES PLUNGE DOWN DIP.
- ⑧ SLICKENSIDED PLANAR SHEARS IN CONCENTRIC PATTERN.
- ⑨ FLAT PEBBLES ARE DRAGGED INTO SHEARS AND ALIGNED ALONG SHEAR SURFACES.
- ⑩ SOFT CLAY SHEARS, SOMETIMES WET.
- ⑪ 2.5 FEET OFFSET AT BASE OF SOIL.
