TRENCH 2

PLATE 3 SHEET I TRENCH LOG BARHAM RANCH, SITE 2 LOS ALAMOS FAULT

USGS CONTRACT: PROJECT NO. : 411731

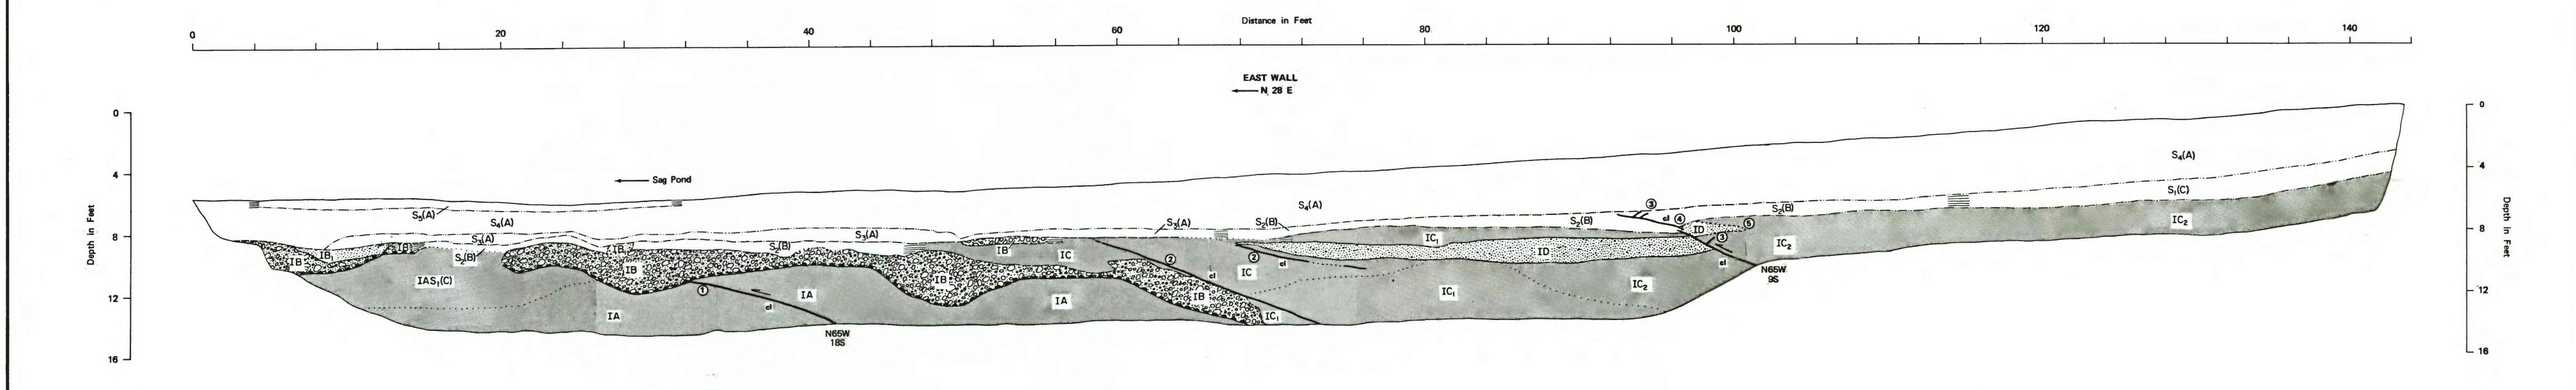
- ① 0.2 FOOT OFFSET AT BASE OF GRAVEL.
- 2 THIN CLAY SEAM IS PROBABLE SHEAR.
- 3 ANTITHETIC SHEARS IN CLAY B SOIL HORIZON,
- ① 0.8 FOOT OFFSET AT BASE OF B SOIL HORIZON.
- 5 ID IS APPARENTLY THRUST OVER ITSELF BUT THE LITHOLOGY SOUTH OF THE FAULT IS MORE SILTY THAN NORTH OF THE FAULT.
