In-Situ Stress Project

Technical Report Number 2:

Televiewer Data Report for the Test Interval 6250-6935 ft,
Cajon Pass Well, California

Open-File Report 87-290

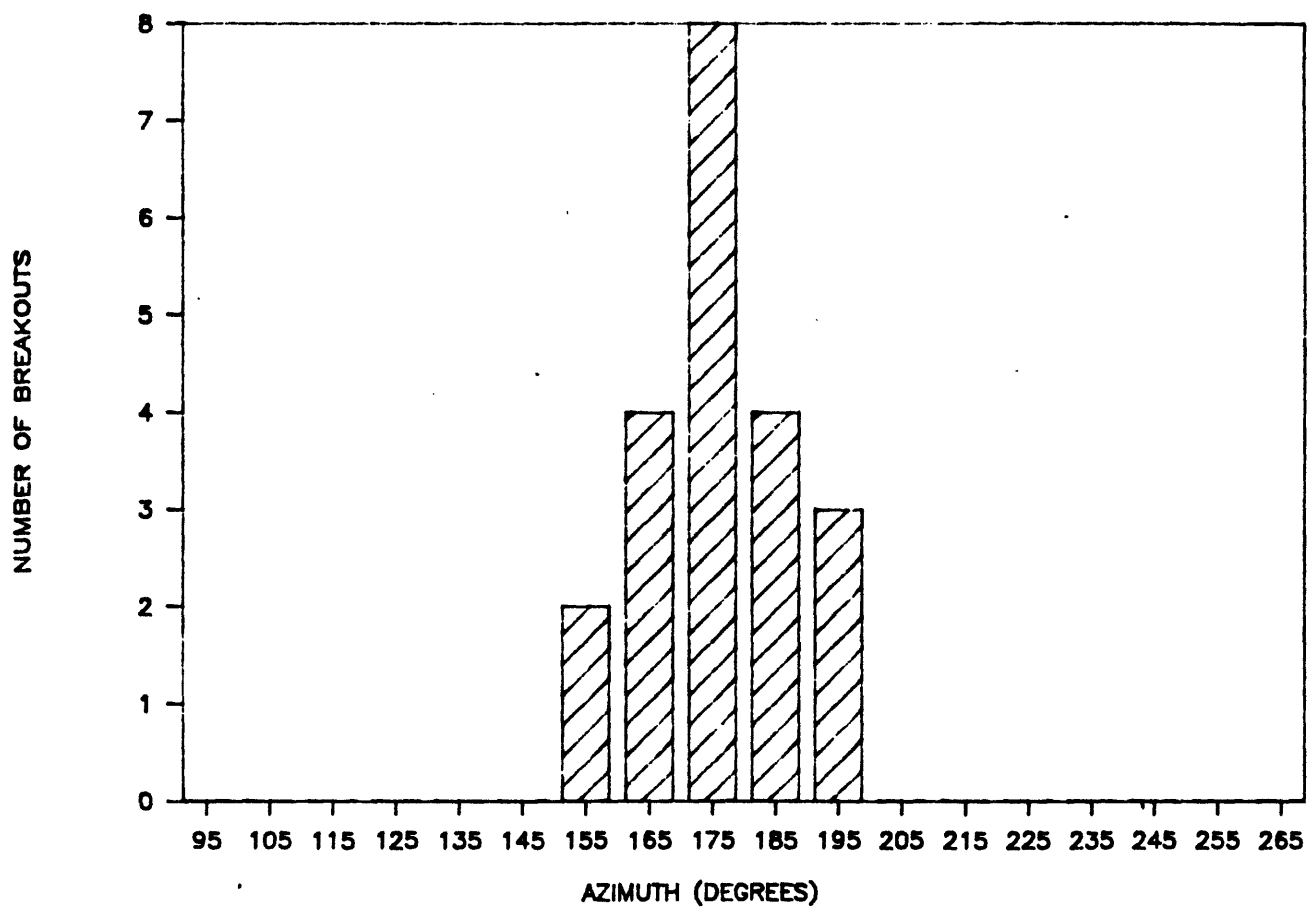
Fig. 1. Breakout frequency vs azimuth.

The breakout orientations were plotted on histograms (figs. 1 and 2). In fig. 1, the number of breakouts was plotted as a function of azimuth. In fig. 2, the length of hole affected by breakouts were plotted as a function of azimuth. The mean orientation was N6W and the standard deviation was 11 degrees. When the data are weighted according to the length of hole affected by breakouts, the mean orientation is N5W. When the data are combined with that from the interval from 6000 ft to 6250 ft (1829 m to 1905 m) (Ader and Springer, 1987), the resulting histograms show bimodal distributions (figs. 3 and 4).

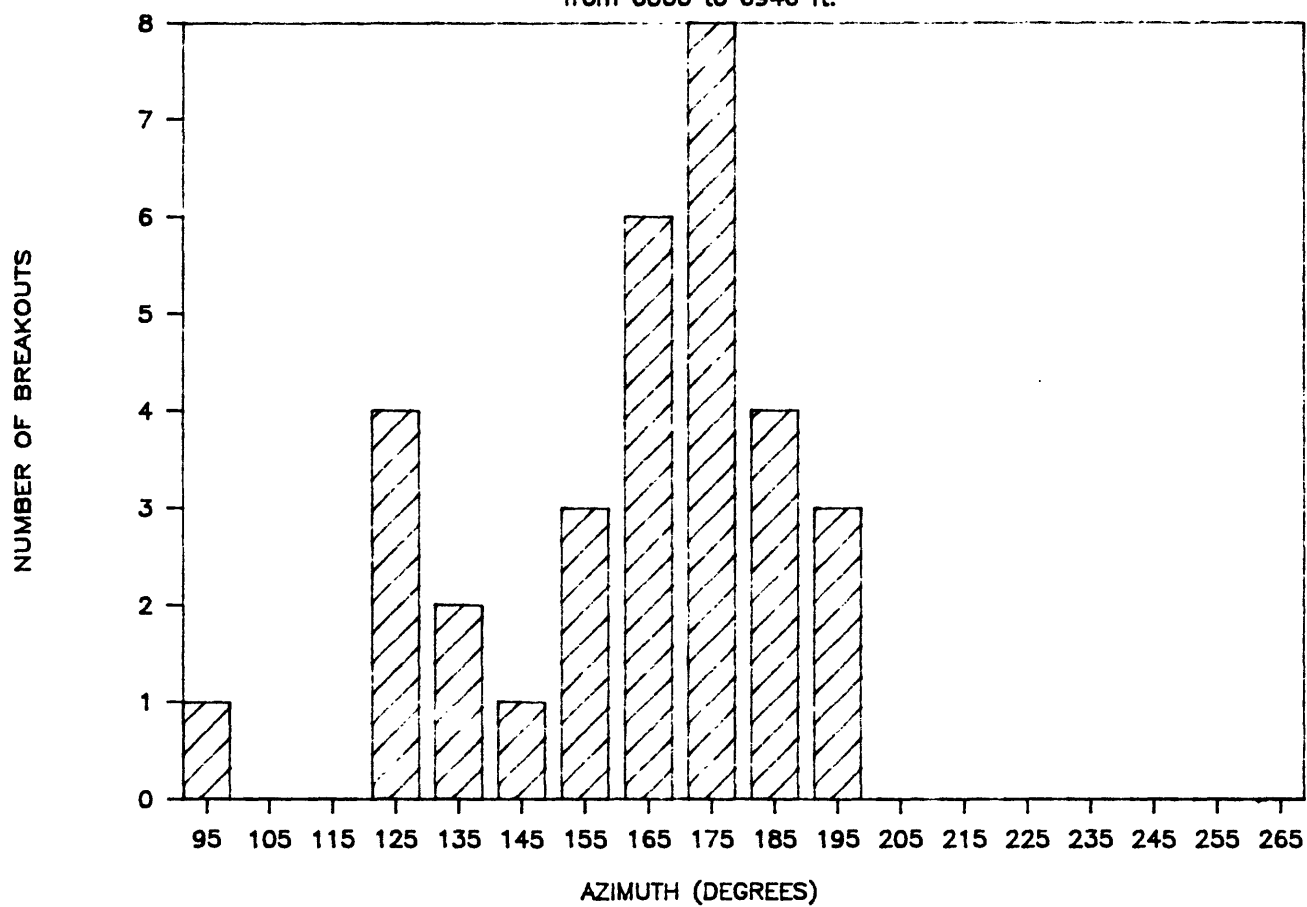
Fig. 3. Breakout frequency vs azimuth

This orientation implies that the maximum horizontal stress is oriented N84-85E which is rotated 35 degrees clockwise from

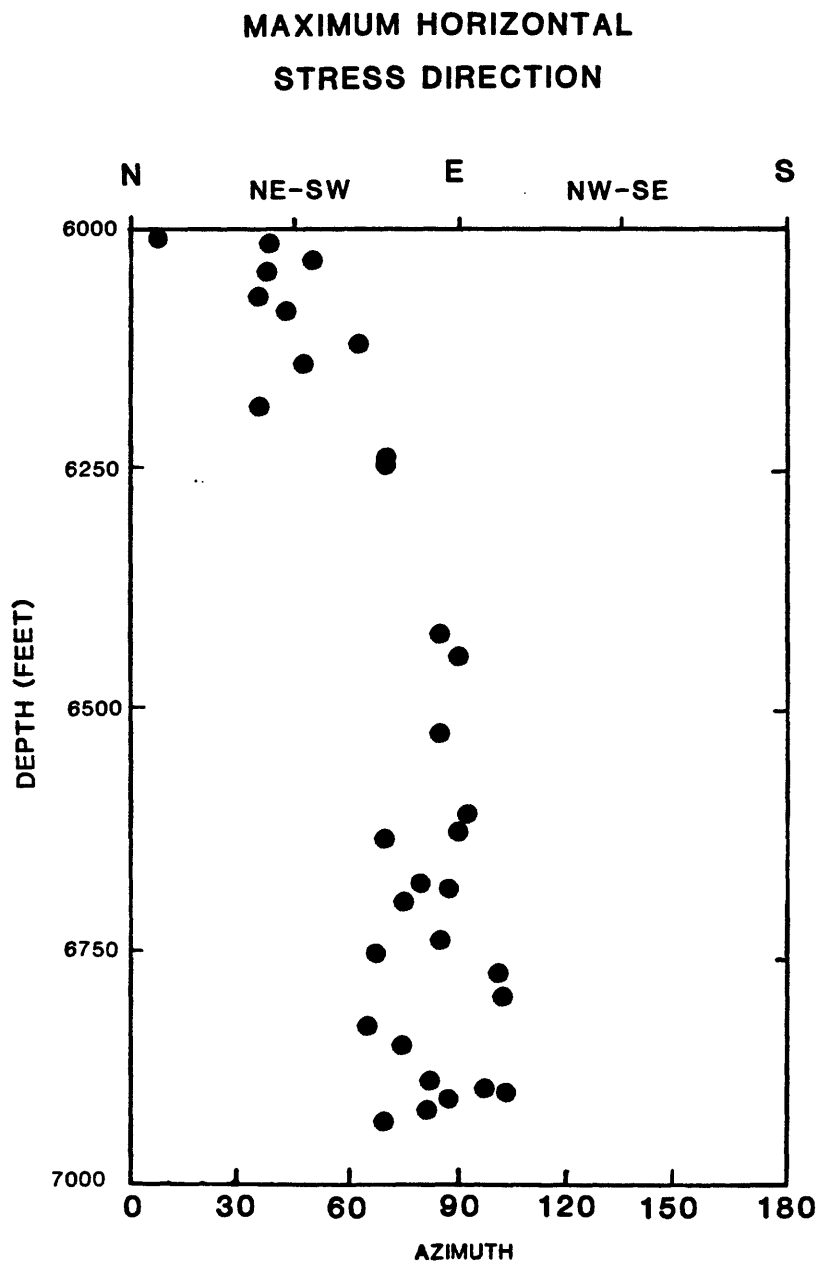
Fig. 5. Azimuth of the maximum horizontal stress vs depth as determined from well bore breakouts.

the orientation in the first test interval (6000-6250 ft, see Ader and Springer, 1987). Plotting the maximum horizontal stress direction derived from the breakouts as a function of depth (fig. 5) shows the change. Where the log coverage overlaps with that from the previous test interval, the breakout orientations are the same, indicating that the change is real and not an artifact of the imaging process.

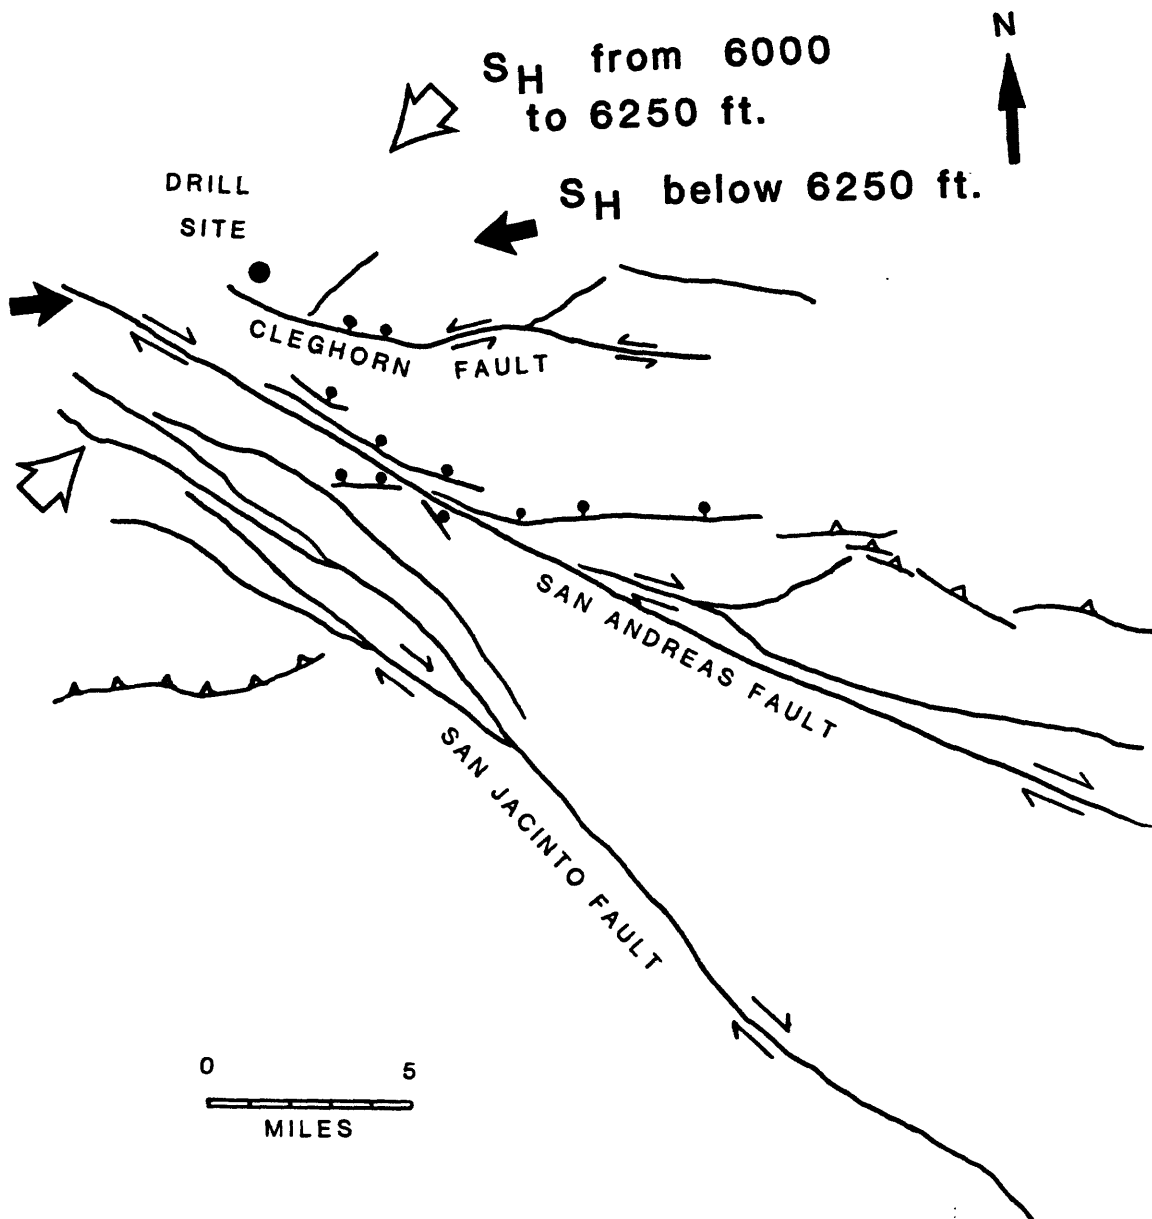
Fig. 6. Generalized fault map of the Cajon Pass area showing the directions of maximum horizontal compressive stress in the drill hole (Map from Weldon, 1986).

Faults in the core indicate reverse movement which may be related to late Miocene thrusting on the Squaw Peak fault (Weldon, 1986). Late Quaternary faulting in the vicinity of the well is both normal and strike-slip (Weldon, 1986), indicating an extensional to strike-slip stress regime. The maximum horizontal stress direction, as indicated from breakouts and hydraulic fractures in this test interval, is sub-parallel to the trend of the Cleghorn fault (fig. 6). This fault is an oblique-slip fault with both normal and left-lateral movement on it (Meisling and Weldon, 1982; Weldon, 1986). The stress direction in this section of the well is consistent with the normal motion on it while the direction from the previous interval (Ader and Springer, 1987) is consistent with left-lateral movement.

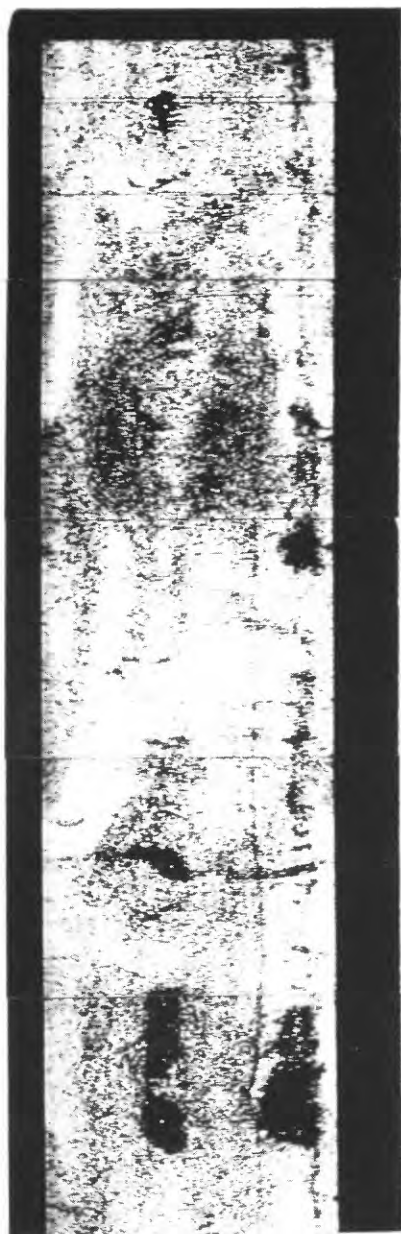
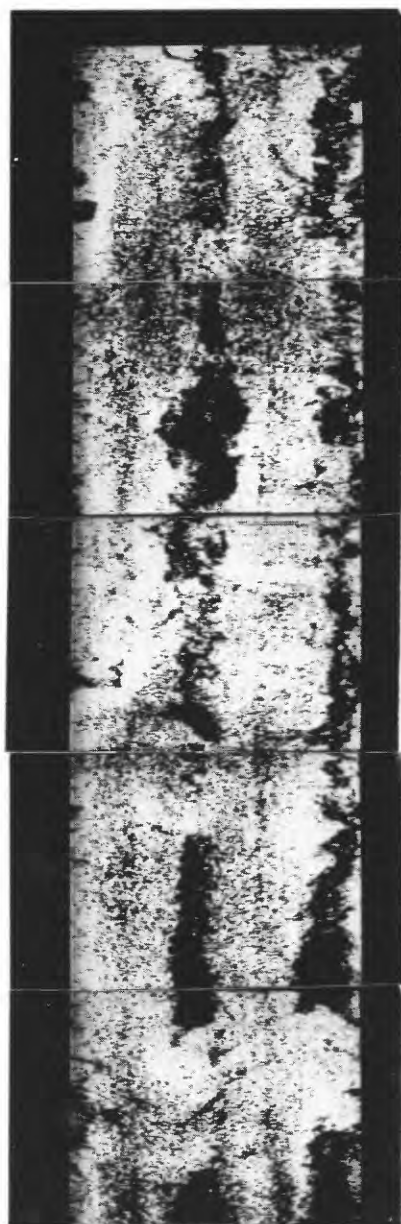
FRAC 6

In frac interval 6 (6732 ft; 2052 m), incipient breakouts, can be seen on the pre-frac log. These show up as vertical cracks close to the breakout directions. One such crack extends from about 6730 ft (2052 m) to the edge of a breakout at 6745 ft (2056 m). In the post-frac log, a well developed breakout is present in the frac interval and 90 degrees from it, a vertical hydraulic fracture can be seen. A rubber impression was taken from this interval, confirming that there was an elongation with a vertical fracture oriented 90 degrees to it.

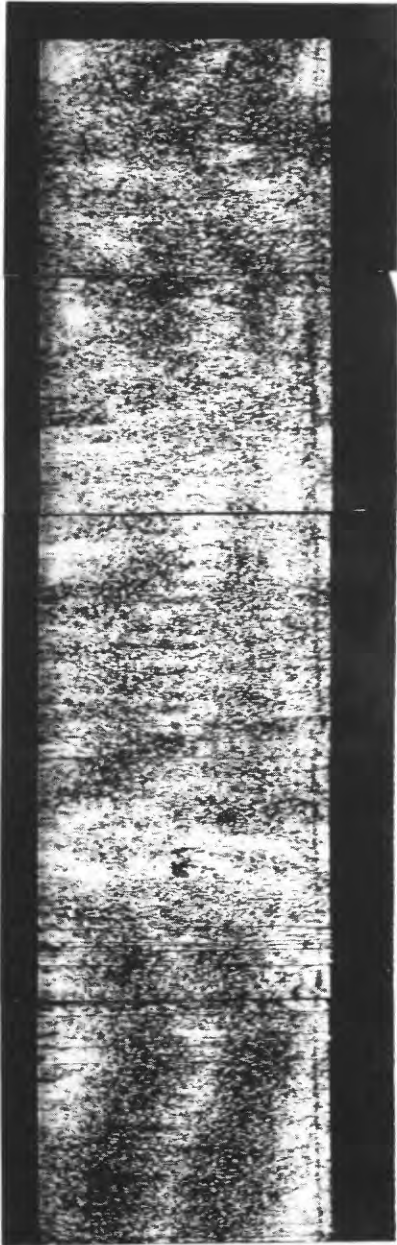
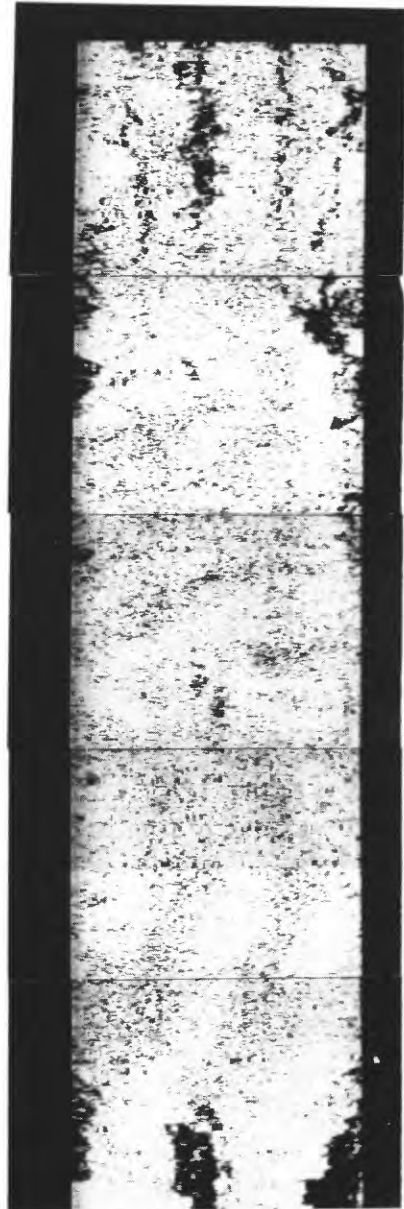
FRAC 5
6840

In frac interval 5 (6839 ft; 2085 m), the pre-frac log does not show any cracks. The post-frac log shows two vertical cracks, 180 degrees apart between 6829 ft (2082 m) and 6856 ft (2090 m). These fractures extend 8 ft (2.4 m) above the frac interval and 12 ft (3.7 m) below the interval. The average strike of this fracture, after correcting for magnetic declination is N76E-S76W. This is within one standard deviation of the orthogonal to the mean breakout orientation. Two holes, approximately orthogonal to the direction of the vertical cracks are visible within the frac interval on the post-frac log. Two more are visible at 6835 ft (2084 m). These are probably the beginning of breakouts that occurred after the pre-frac log was run. Below the frac interval, incipient breakouts appear on the post-frac log. These extend from 6845 ft to 6856 ft (2087 m to 2090 m) and are characterized by pairs of irregular vertical cracks enclosing the breakout azimuth. These are similar to the incipient breakouts described by Springer et al. (1987) from downhole photographs at the Nevada Test Site.
